GEOTECHNICAL REPORT

Eric Gary and Yaqain Zhang
5 and 9 Grand Hills Lane
Resource Consent Application

Appendix F: Engineering Suitability Report

ENGINEERING SUITABILITY REPORT FOR SUBDIVISION – Rev 1

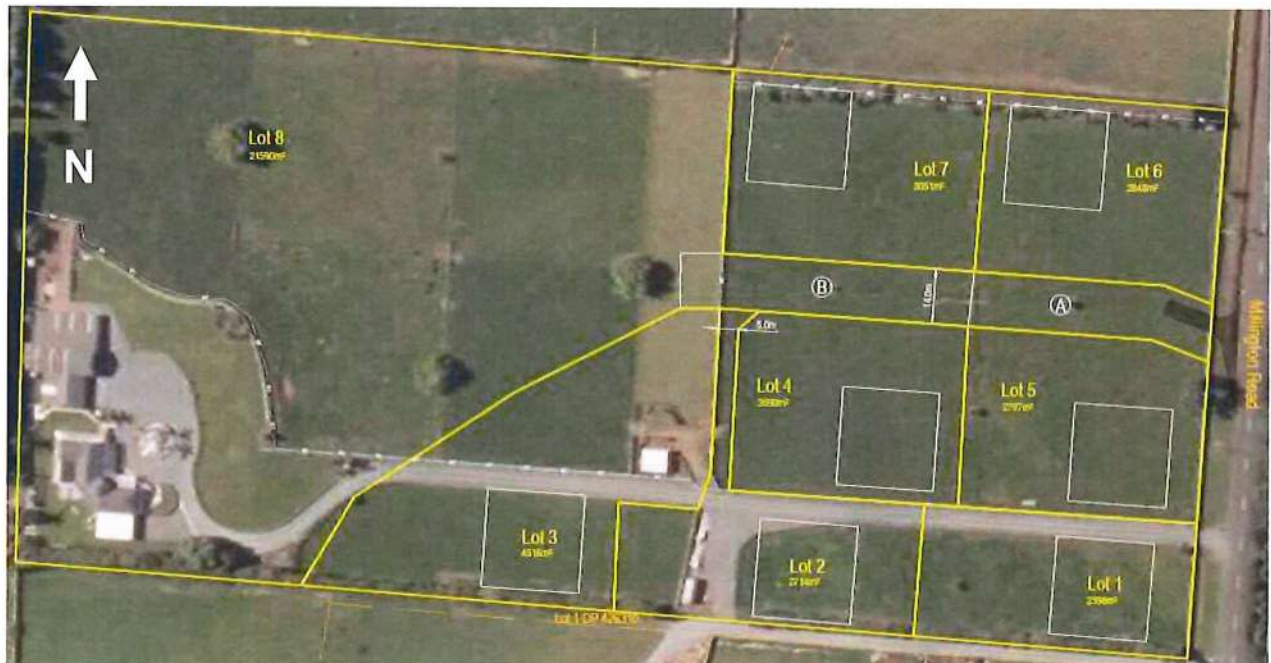
Figure A: Proposed subdivision scheme plan (provided by CatoBalam, No: 45265-DR-PLN-1200, Rev A).

It is proposed to subdivide the existing Lots, legally described as Lots 1 - 3 DP 308070, into 8 new lots (lots 1 - 8). The new lots will have land areas in the range of 2398m² to 4516m², with the exception of lot 8 at 21.6ha.

Access to the proposed lots (2 - 8) will be from a shared ROW connected to Millington Road. Access to proposed lot 1 will be directly from the road.

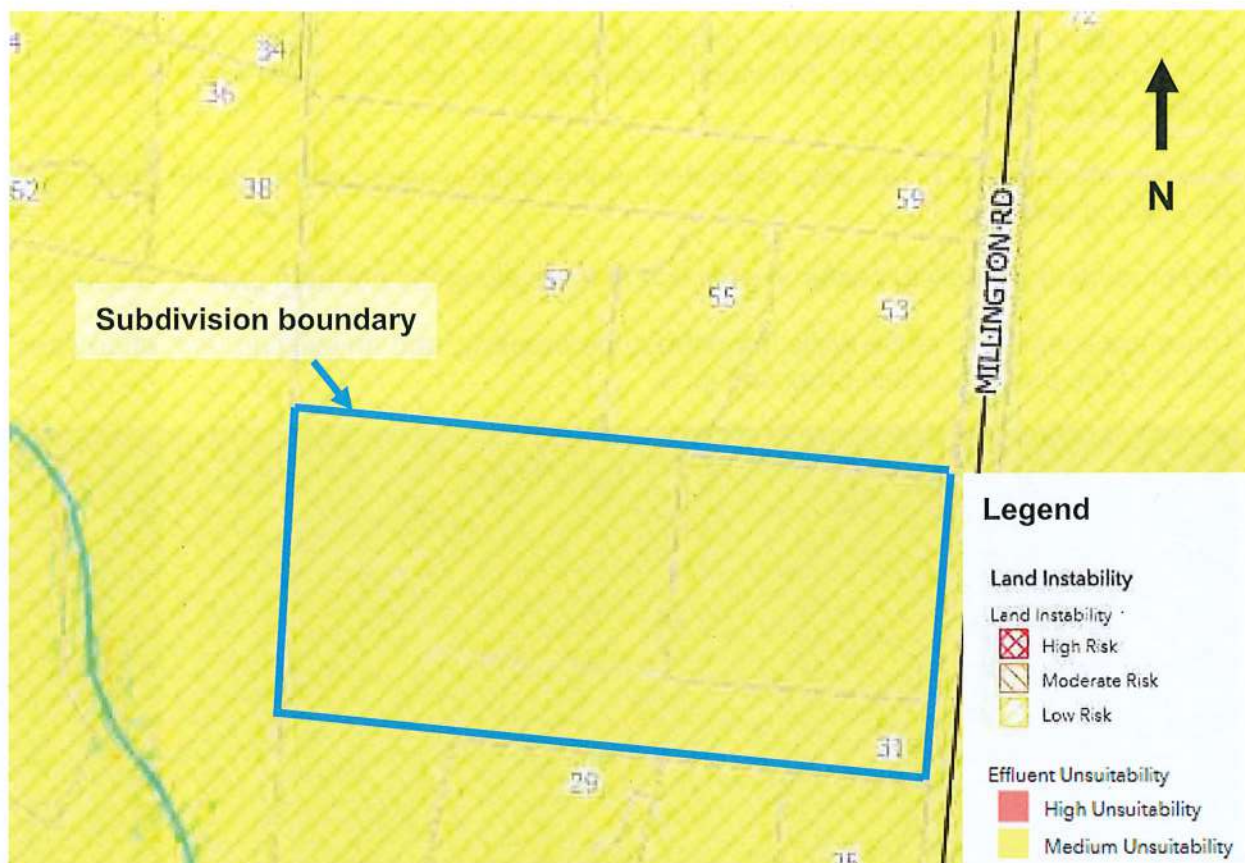
Figure B: Land instability and effluent unsuitability areas (source: WDC GIS Hazard Maps).

The Whangarei District Council (WDC) Hazard Maps show that the property is low instability hazard and medium effluent unsuitability. The property is not subject to Acid Sulphate Soils (ASS). The property is not mapped for flooding.

The property is mapped as low-risk instability according to WDC GIS Hazard Map. Slopes across the property are broad, gentle to near flat land (less than 8°) with no indication of shallow or deep-seated instability. We therefore conclude that the proposed development is stable.

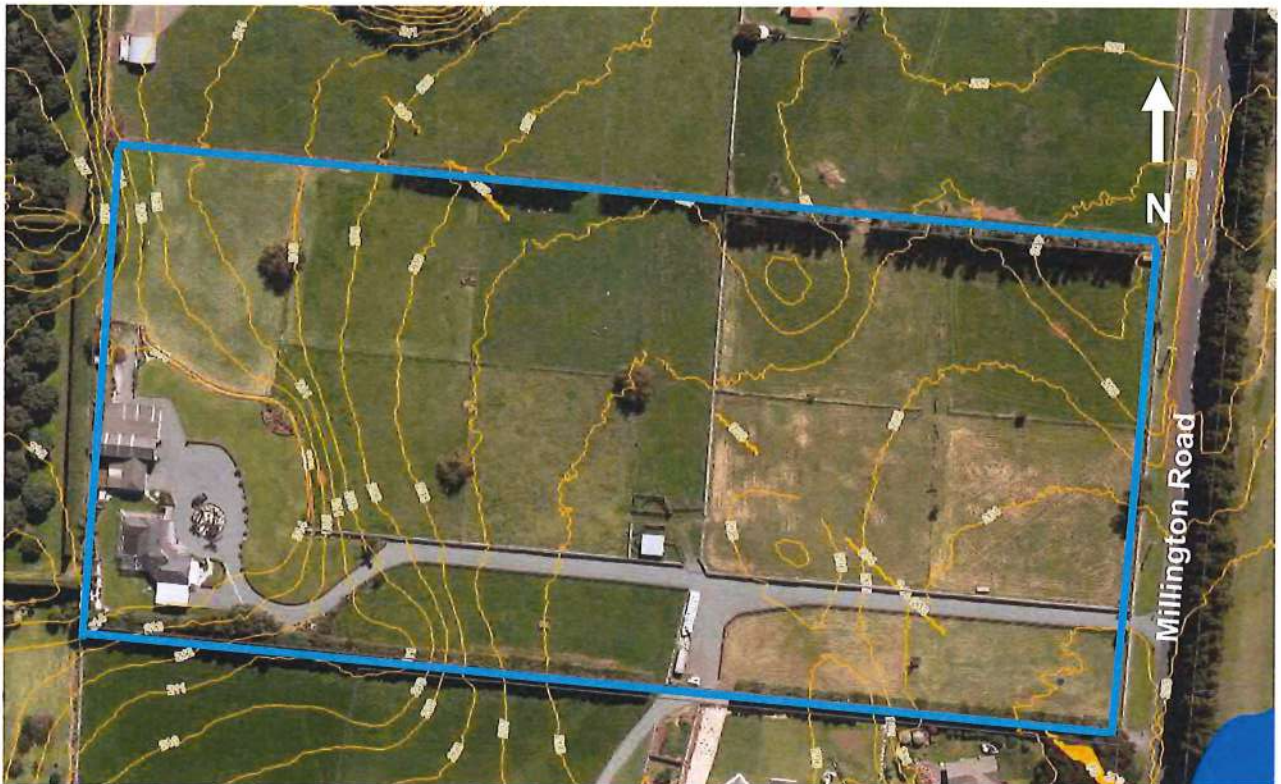
Figure C: Aerial view of the site (source: NRC map).

The property generally comprises gentle slopes (less than 8°) to near-flat pastoral land descending gradually towards Millington Road, with the existing ground level in the range of 203m to 214m OTPD.

A locally steeper (14° - 18°) area is located on the south-western corner of the property, near the existing dwelling.

The property is entirely in pasture with a line of trees along the northern property boundary.

There are lines of old stone walls throughout the property, and an existing farm shed near the centre of the property within proposed lot 3.

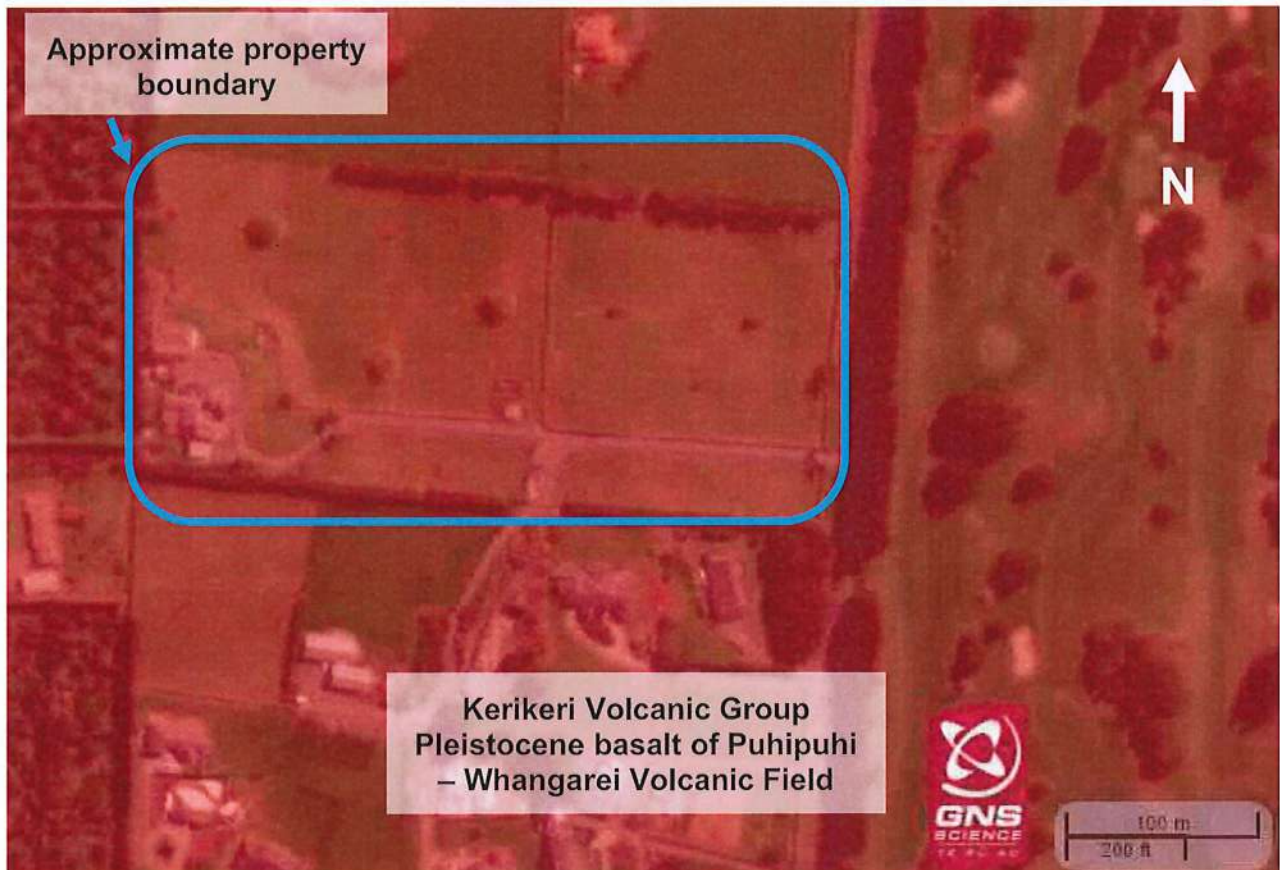
Figure D: Geology of the site (source: GNS Science).

The geological map of the local area, indicated on GNS Science website, indicates that the property is underlain by “Kerikeri Volcanic Group Pleistocene basalt of Puhipuhi – Whangarei Volcanic Field”. This formation is described as “Basalt lava and volcanic plugs”.

Soils encountered in the hand augered boreholes are consistent with the mapped geology.

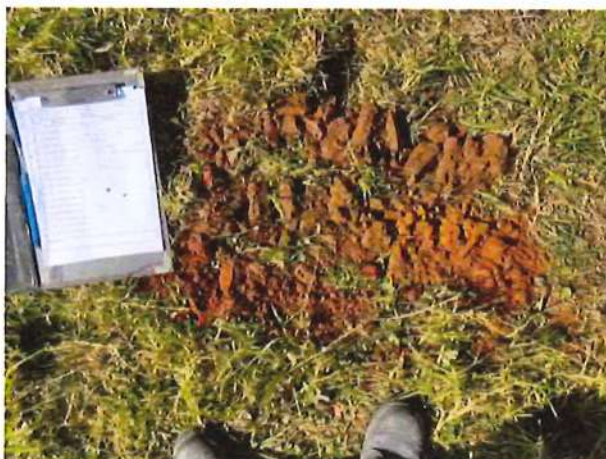
PHOTO / SKETCH

DEPTH (m)	SCALA (Blows / 100mm)	TESTS	GRAPHIC LOG	MATERIAL DESCRIPTION	WATER	DEPTH (m)
				TOPSOIL: SILT; dark brown, moist, some organics		
			0.20			
		SV = UTP (GEO287)		silty CLAY; reddish brown, moist, highly plastic, hard		
		SV = UTP (GEO287)				
1		SV = 233+ kPa (GEO287)				
		SV = UTP (GEO287)				
			1.50			
		SV = UTP (GEO287)		clayey SILT; reddish brown, moist, highly plastic, hard		
2		SV = UTP (GEO287)				
		SV = 233+ kPa (GEO287)				
		SV = UTP (GEO287)				
		SV = 166 / 91 kPa (GEO287)				
3	18 20	SV = UTP (GEO287)		3.00 EOH: 3.10m		
				3.0m: some basalt gravels (MPS=5mm)

Groundwater Not Encountered

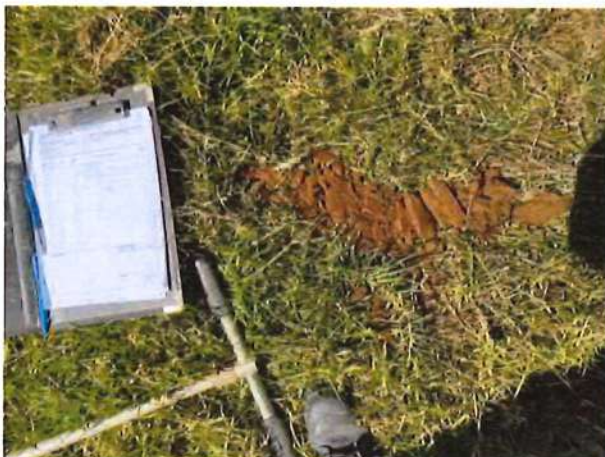
PHOTO / SKETCH

DEPTH (m)	SCALA (Blows / 100mm)	TESTS	GRAPHIC LOG	MATERIAL DESCRIPTION	WATER	DEPTH (m)
				TOPSOIL: SILT; dark brown, moist, some organics		
			0.20	clayey SILT; reddish brown, moist, hard, highly plastic	Groundwater Not Encountered	
1			1.00 EOH: 1.00m			
2

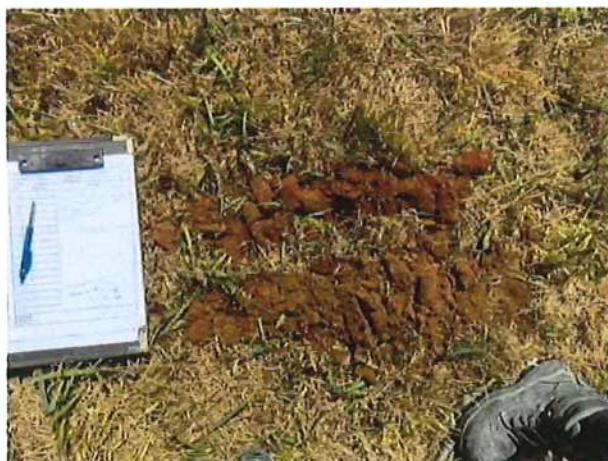
PHOTO / SKETCH

DEPTH (m)	SCALA (Blows / 100mm)	TESTS	GRAPHIC LOG	MATERIAL DESCRIPTION	WATER	DEPTH (m)
				TOPSOIL: SILT; dark brown, moist, some organics		
			0.20			
		SV = UTP (GEO952)		silty CLAY; reddish brown, moist, highly plastic, hard		
		SV = UTP (GEO952)				
1		SV = UTP (GEO952)				
		SV = UTP (GEO952)				
		SV = UTP (GEO952)				
		SV = UTP (GEO952)				
2	14		2.00	EOH: 2.40m		
	15			2.0m: poor recovery (refusal)		
	12					
	18					
	20

Groundwater Not Encountered

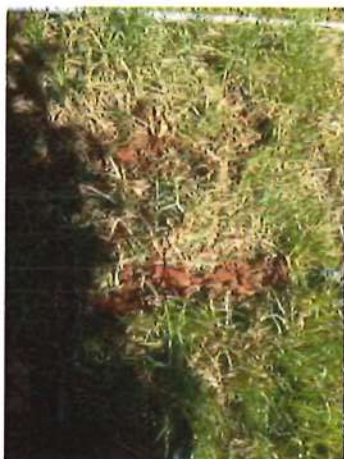
PHOTO / SKETCH

TOPSOIL: SILT; dark brown, moist, some organics	Groundwater Not Encountered	
		SV = UTP (GEO952)		SILT; some clay, reddish brown, moist, hard, moderately plastic		
		SV = UTP (GEO952)		1.00 EOH: 1.00m 1.0m: No recovery

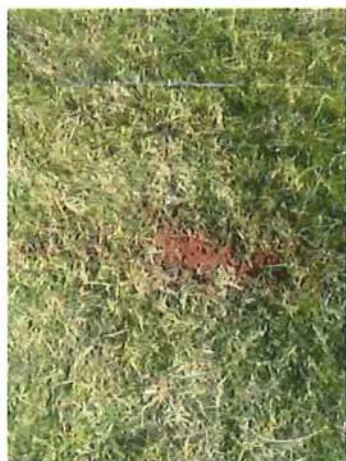
PHOTO / SKETCH

DEPTH (m)	SCALA (Blows / 100mm)	TESTS	GRAPHIC LOG	MATERIAL DESCRIPTION	WATER	DEPTH (m)
				TOPSOIL: SILT; dark brown, moist, some organics		
		SV = UTP (GEO952)	0.30	SILT; minor clay, reddish brown, moist, hard, slightly plastic	Groundwater Not Encountered	
1		SV = UTP (GEO952)	1.00 EOH: 1.00m 1.0m: No recovery			
2

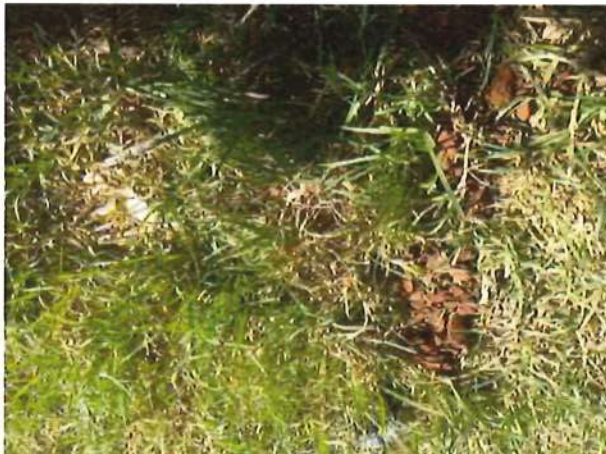
PHOTO / SKETCH

DEPTH (m)	SCALA (Blows / 100mm)	TESTS	GRAPHIC LOG	MATERIAL DESCRIPTION	WATER	DEPTH (m)
				TOPSOIL: SILT; dark brown, moist, some organics		
			0.20	SILT; minor clay, reddish brown, moist, slightly plastic	Groundwater Not Encountered	
1			0.80 EOH: 0.80m 0.8m: No recovery			
2

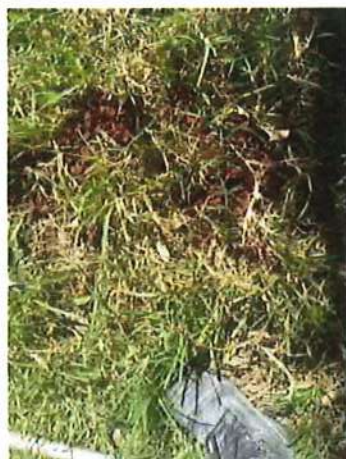
PHOTO / SKETCH

DEPTH (m)	SCALA (Blows / 100mm)	TESTS	GRAPHIC LOG	MATERIAL DESCRIPTION	WATER	DEPTH (m)
				TOPSOIL: SILT; dark brown, moist, some organics	Groundwater Not Encountered	
			0.20	SILT; minor clay, reddish brown, moist, hard, slightly plastic		
			0.60 EOH: 0.60m 0.6m: No recovery			
1						
2

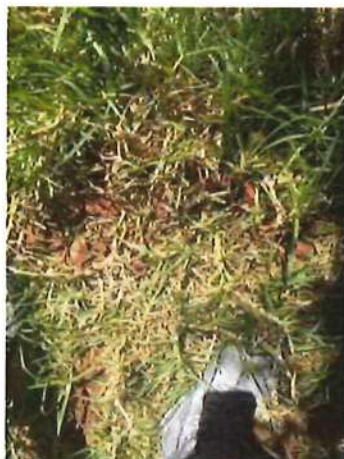
PHOTO / SKETCH

TOPSOIL: SILT; dark brown, moist, some organics SILT; minor clay, reddish brown, moist, hard, slightly plastic EOH: 0.50m 0.5m: No recovery	Groundwater Not Encountered

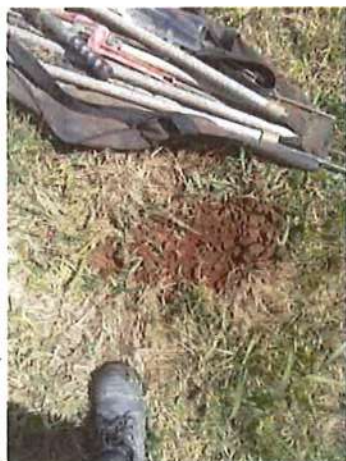
PHOTO / SKETCH

DEPTH (m)	SCALA (Blows / 100mm)	TESTS	GRAPHIC LOG	MATERIAL DESCRIPTION	WATER	DEPTH (m)
				TOPSOIL: SILT; dark brown, moist, some organics		
		SV = UTP (GEO287)	0.20	SILT; minor clay, reddish brown, moist, hard, slightly plastic	Groundwater Not Encountered	
	20	SV = UTP (GEO287)				
1		SV = UTP (GEO287)	0.90 EOH: 0.90m 0.9m: No recovery			
2

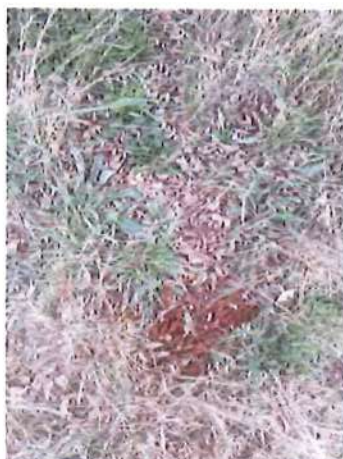
PHOTO / SKETCH

DEPTH (m)	SCALA (Blows / 100mm)	TESTS	GRAPHIC LOG	MATERIAL DESCRIPTION	WATER	DEPTH (m)
				TOPSOIL: SILT; dark brown, moist, some organics		
		SV = UTP (GEO287)	0.30	SILT; minor clay, reddish brown, moist, hard, slightly plastic	Groundwater Not Encountered	
	20	SV = UTP (GEO287)	0.80 EOH: 0.80m 0.8m: No recovery			
1						
2

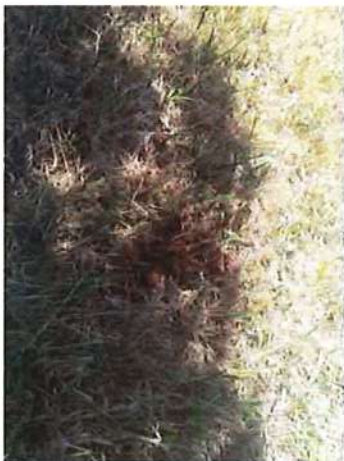
PHOTO / SKETCH

DEPTH (m)	SCALA (Blows / 100mm)	TESTS	GRAPHIC LOG	MATERIAL DESCRIPTION	WATER	DEPTH (m)
				TOPSOIL: SILT; dark brown, moist, some organics		
				0.30		
				SILT; some clay, reddish brown, moist, hard, moderately plastic		
				0.60 EOH: 0.60m		
				0.6m: No recovery		
1						
2

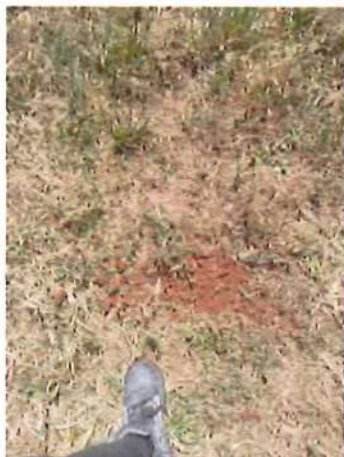
PHOTO / SKETCH

DEPTH (m)	SCALA (Blows / 100mm)	TESTS	GRAPHIC LOG	MATERIAL DESCRIPTION	WATER	DEPTH (m)
				<p>TOPSOIL: SILT; dark brown, moist, some organics</p> <p>0.20</p> <p>clayey SILT; reddish brown, moist, highly plastic, hard</p> <p>0.60 EOH: 0.60m</p> <p>0.6m: No recovery</p>	Groundwater Not Encountered

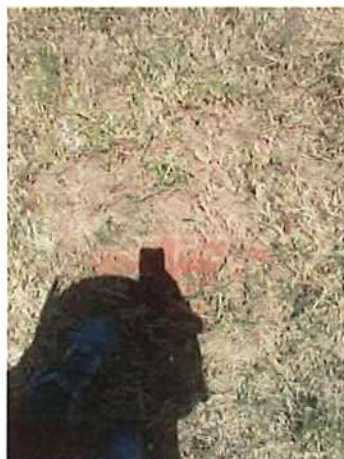
PHOTO / SKETCH

0.10 TOPSOIL: SILT; dark brown, moist, some organics SILT; some clay, reddish brown, moist, hard, moderately plastic 0.60 EOH: 0.60m 0.6m: No recovery	Groundwater Not Encountered	
1						
2

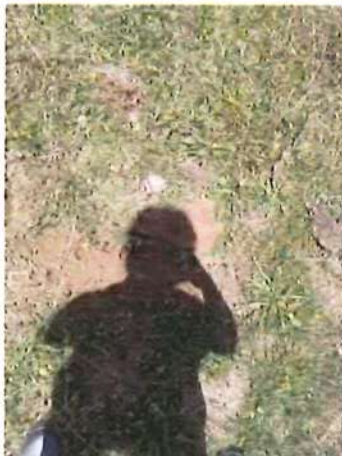
PHOTO / SKETCH

DEPTH (m)	SCALA (Blows / 100mm)	TESTS	GRAPHIC LOG	MATERIAL DESCRIPTION	WATER	DEPTH (m)
				TOPSOIL: SILT; dark brown, moist, some organics		
			0.30	SILT; minor clay, reddish brown, moist, slightly plastic	Groundwater Not Encountered	
			0.80 EOH: 0.80m 0.8m: No recovery			
1						
2

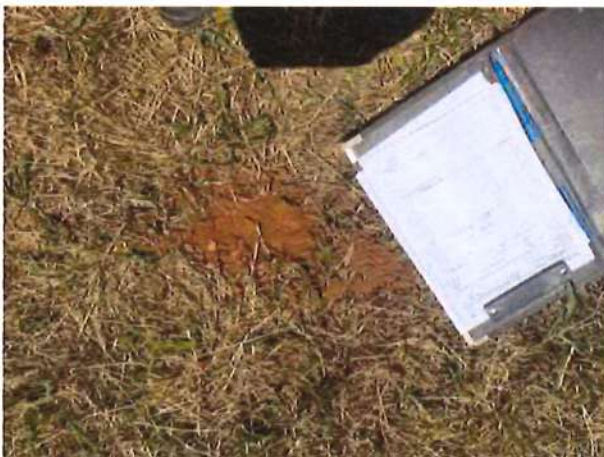
PHOTO / SKETCH

DEPTH (m)	SCALA (Blows / 100mm)	TESTS	GRAPHIC LOG	MATERIAL DESCRIPTION	WATER	DEPTH (m)
				0.10 TOPSOIL: SILT; dark brown, moist, some organics SILT; minor clay, reddish brown, moist, slightly plastic	Groundwater Not Encountered	
				0.50 EOH: 0.50m 0.5m: No recovery		
1						
2
