# Your Building Inspection Report

CONFIDENTIAL REPORT FOR  
Andrew Cromie  
ID 159820  
Friday, December 05, 2025

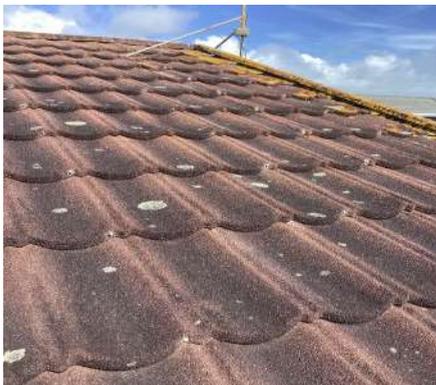
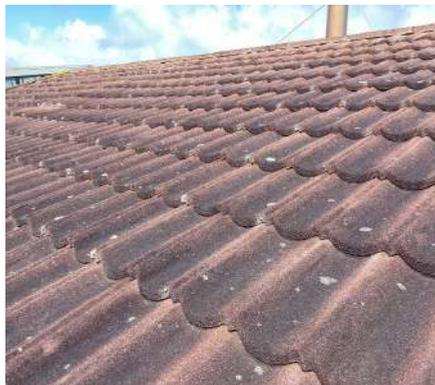
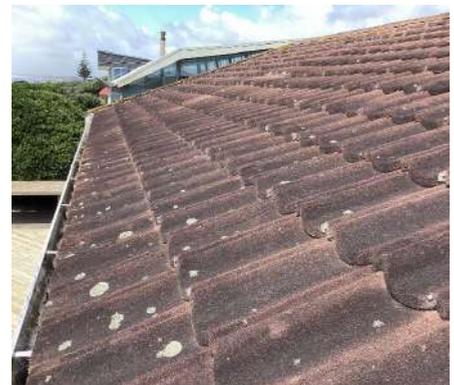
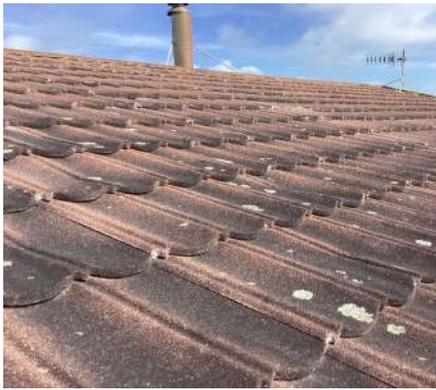
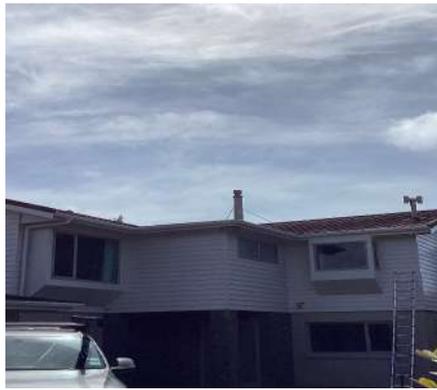
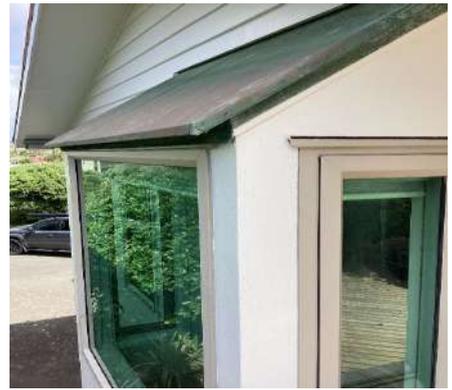
Decramastic pressed metal tiles with embedded stone chip roof. Copper  
Please find copies below for the warranties for the roofing material used on this property.  
Please seek advice from vendor relating to this.

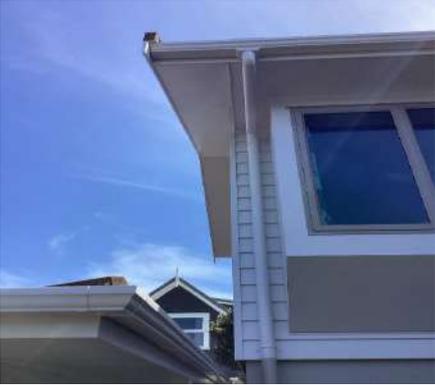
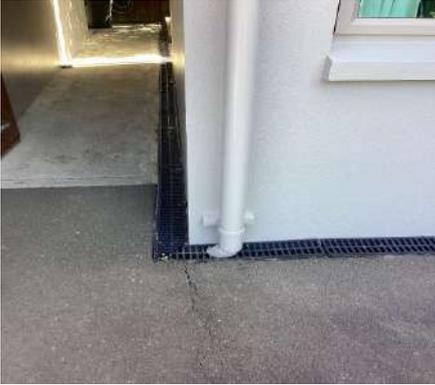
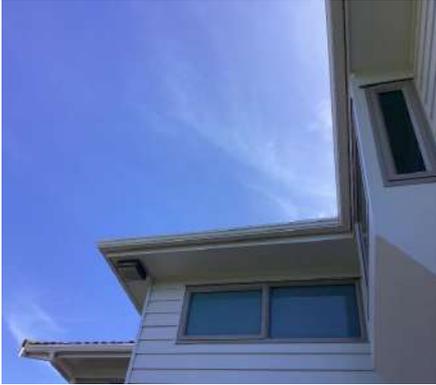
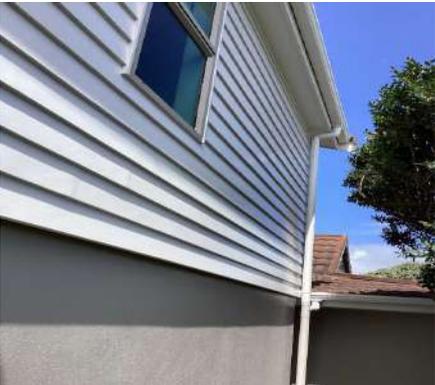
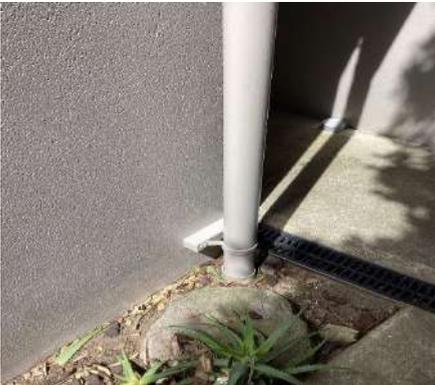
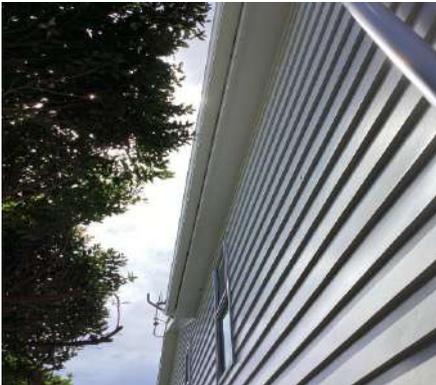
Downpipe - PVC. Gutter - PVC.

PVC gutters are prone to becoming brittle due to the high sunshine hours and UV in New Zealand's climate. The gutters have vegetation in areas. This will lead to the inadequate discharge of rainwater. We recommend these are cleaned. (the vendor has now had this work carried out and all gutters are now clean)

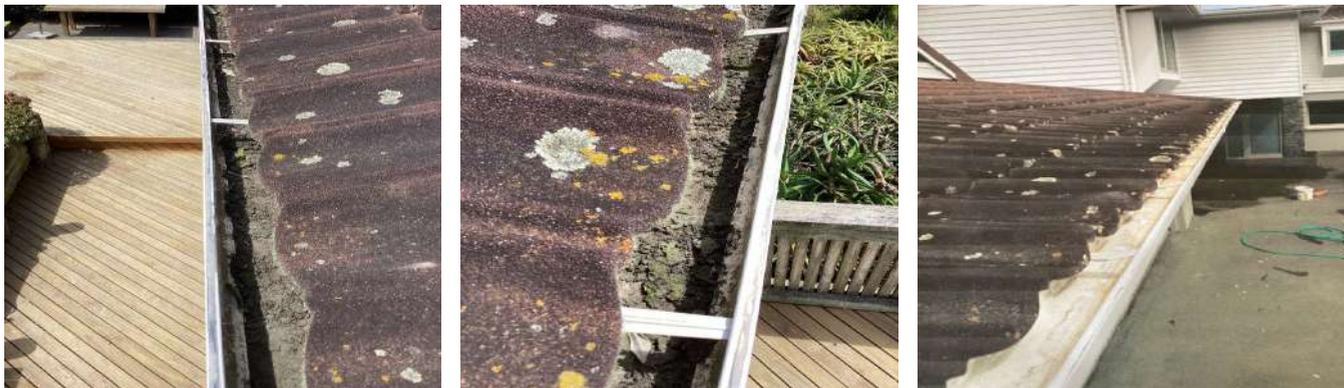
Please see photo below showing clean guttering. All guttering has now been cleaned. This changes are coloured coded system from orange to green relating to this item.

All gutter vegetation has now been removed which will allow all rainwater to discharge correctly through the guttering and downpipe system.

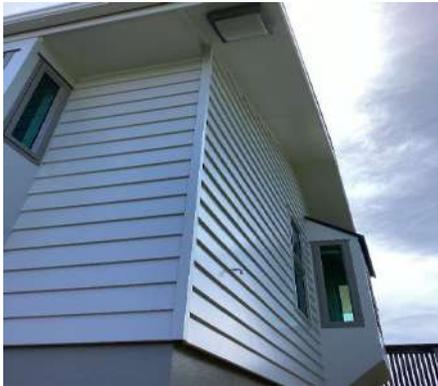
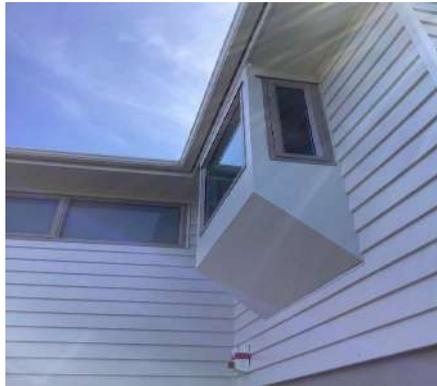
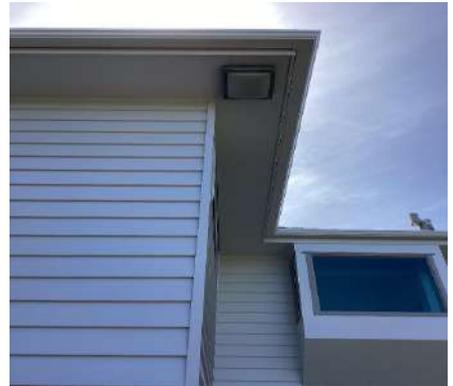
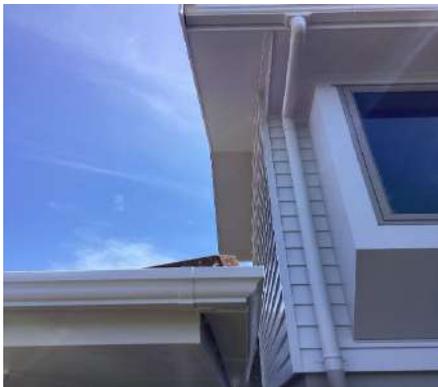
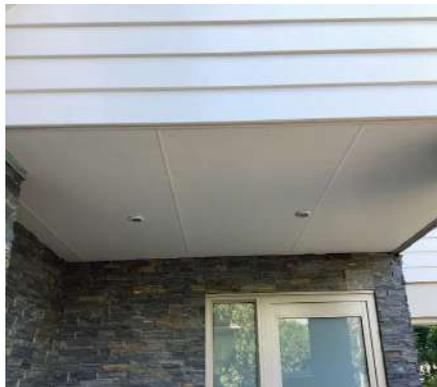
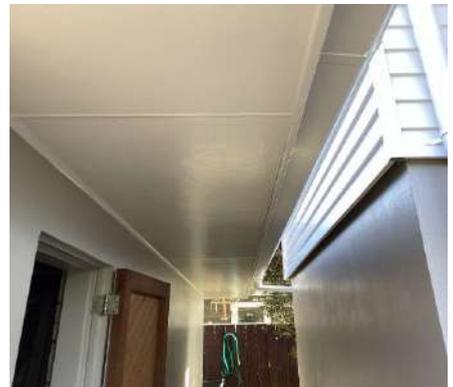
Fascia - timber. Soffit - fibre cement sheeting.

No visible issues were noted during the inspection. Allow to constantly monitor and maintain as required.

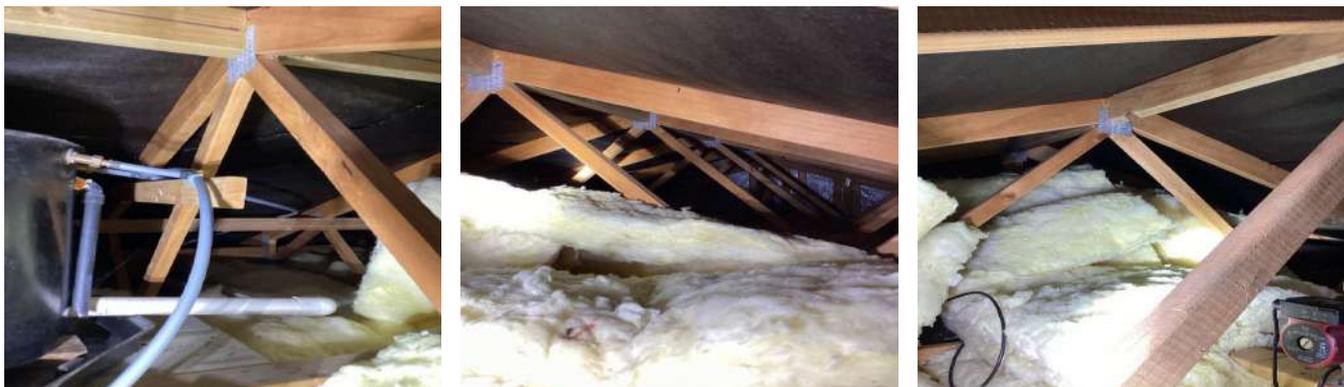
Timber, Trussed roof.

No visible issues noted during the inspection. Allow to constantly monitor and maintain as required.

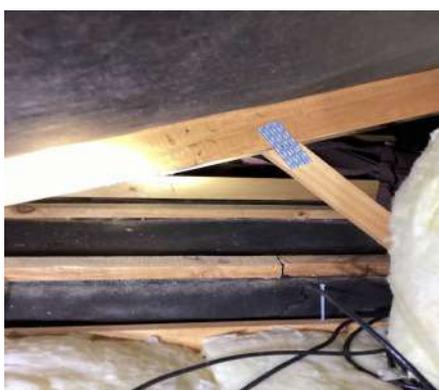
Building alterations. We recommend the Council files are inspected to confirm suitable consents and sign off were achieved for this alteration.

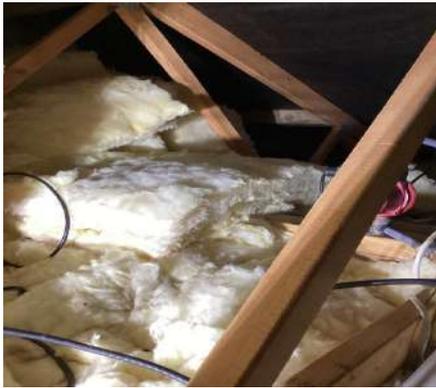
Fiberglass batts.

Allow to constantly monitor and maintain as required.

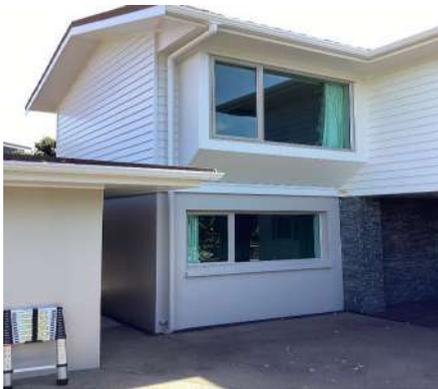
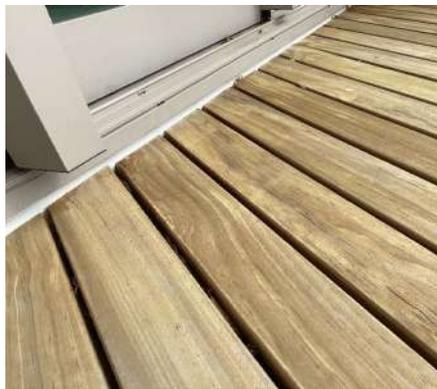
Some cladding could not be inspected due to ground level. ( Height) There is a structure prohibiting inspection of some cladding( deck) .

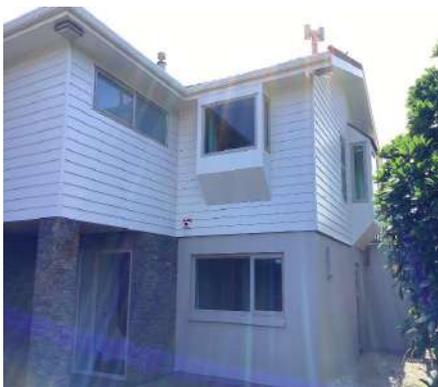
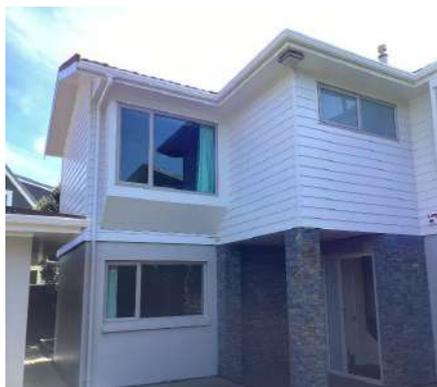
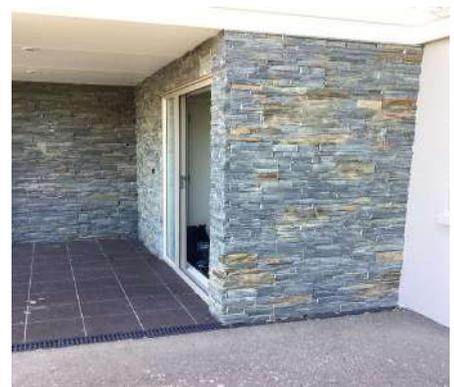
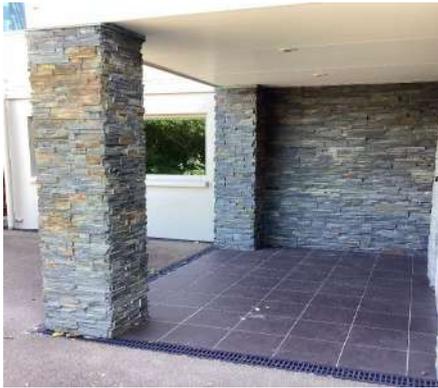
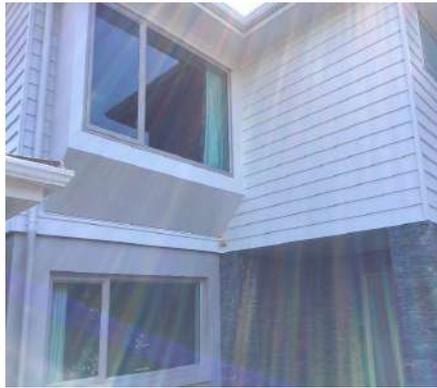
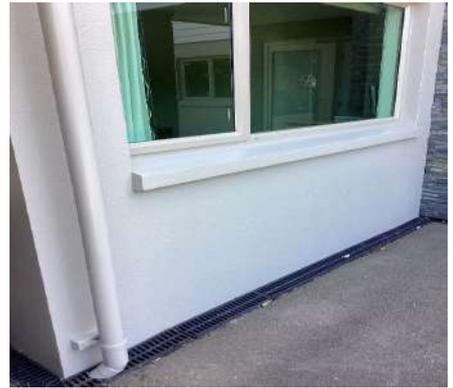
### TYPE

Fibre cement weatherboard (or similar material). Masonry block veneer (note we cannot identify any defects behind the veneer). Stone.

Plastered render over a backing substrate relies on a coating to resist the penetration of moisture. This system is therefore of high concern. Systems such as the one on this dwelling have the potential to allow water entry and deterioration through poor application and installation, lack of maintenance, poor detailing and complexity. This tends to occur particularly on buildings built between 1990 and 2006. We suggest as a result a thorough examination is completed bi-annually (ideally at the end of winter and end of summer), and any sealant breakdown, sheet joints, penetrations and complex junctions or any signs of deterioration of the exterior envelope should be investigated by a specialist and remediated. The plaster cladding appears to have been repainted since its original construction. We are unable to confirm if the cladding has been painted following remedial work. Allow to constantly monitor and maintain as required.

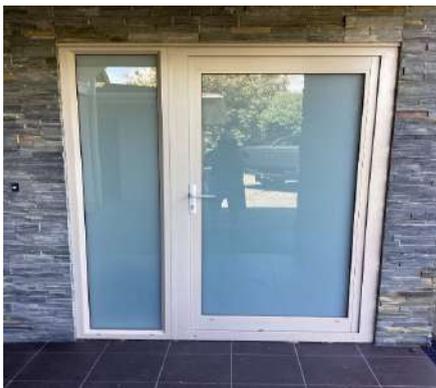
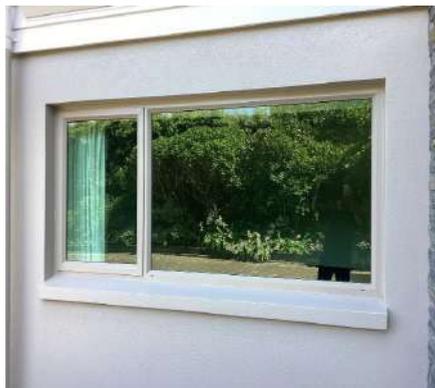
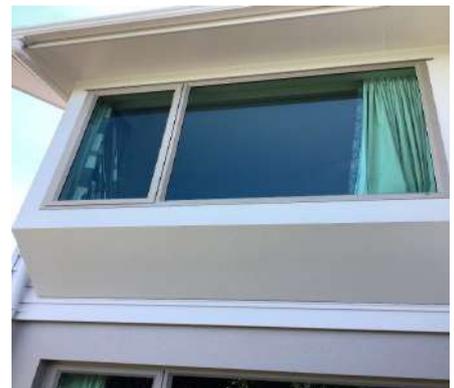
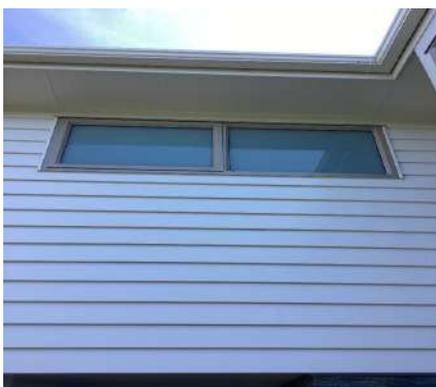
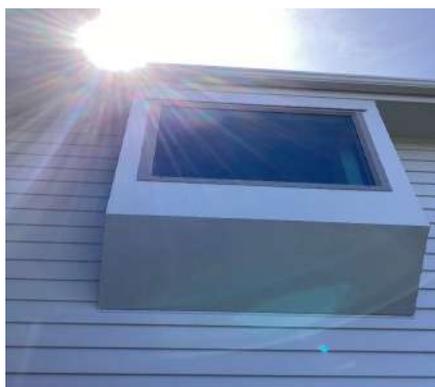
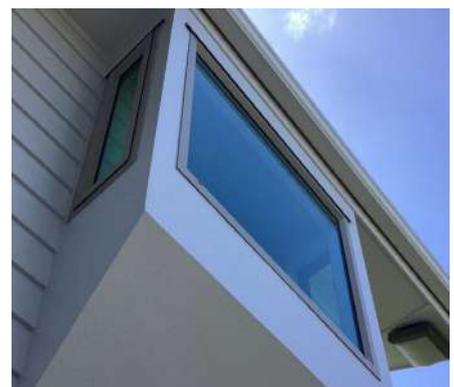
### TYPE

Aluminium.

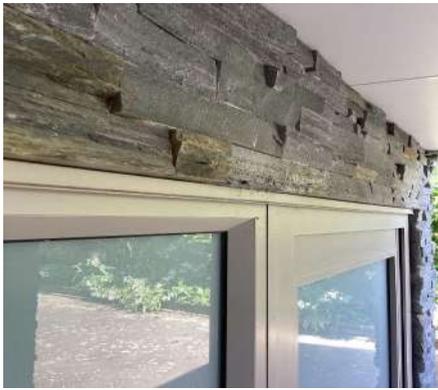
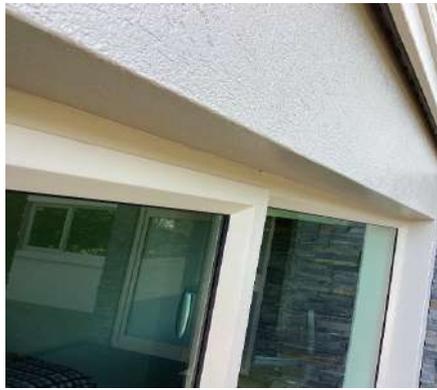
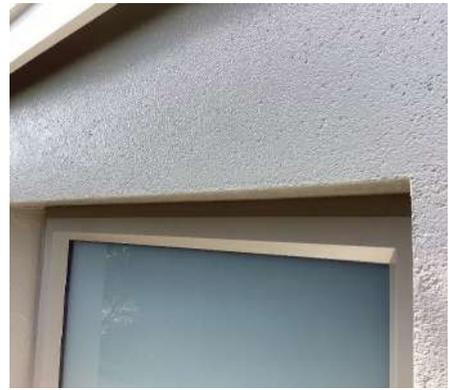
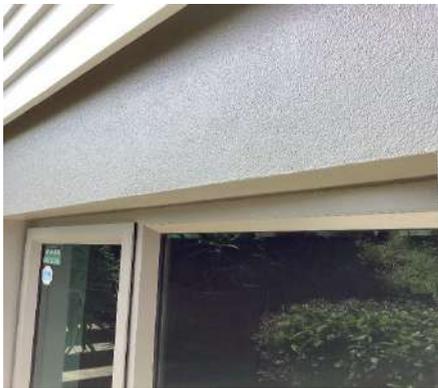
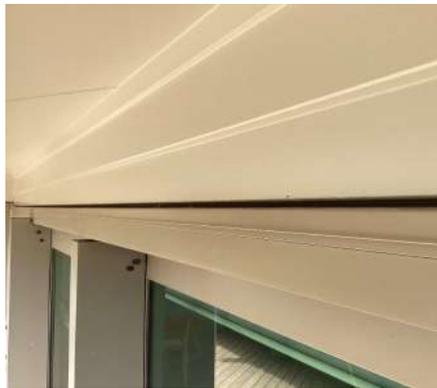
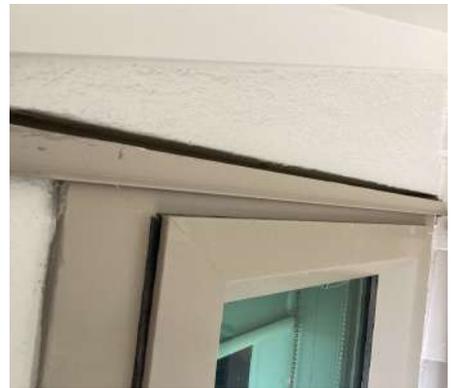
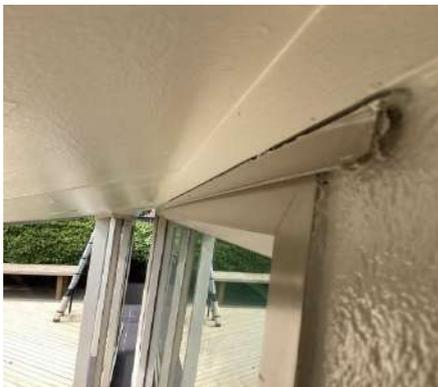
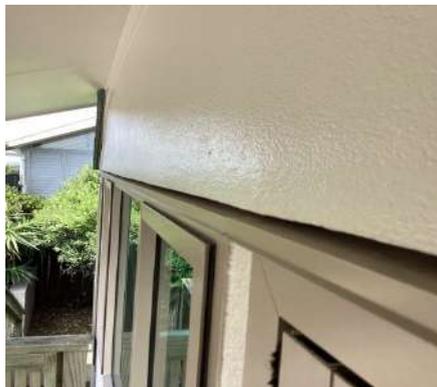
Aluminium flashing. Exterior cladding provides the flashing over joinery.

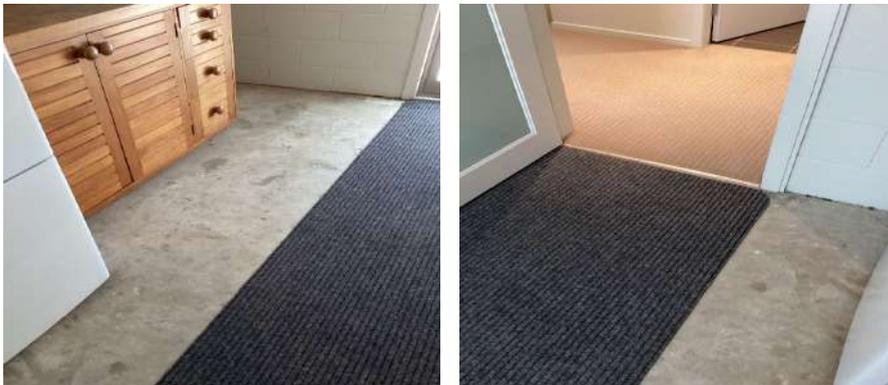
Concrete slab.

Due to the concrete slab there is no sub-floor space. We are unable to confirm the condition of the concrete slab or the soil beneath. For more detailed information and specification on the concrete floor slab we recommend that a search of the council building files be undertaken. No visible issues noted during the inspection. Allow to constantly monitor and maintain as required.

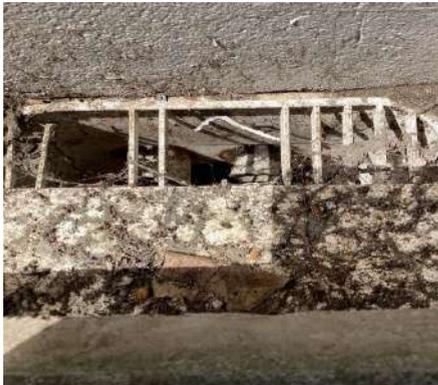
PVC.

No visible issues noted during the inspection. Allow to constantly monitor and maintain as required.

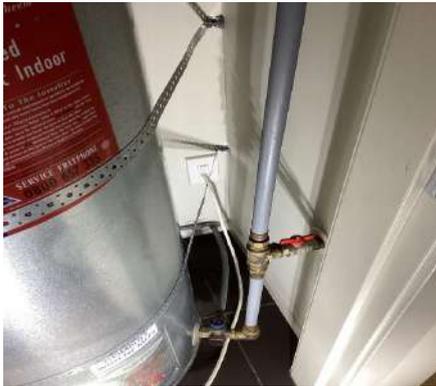
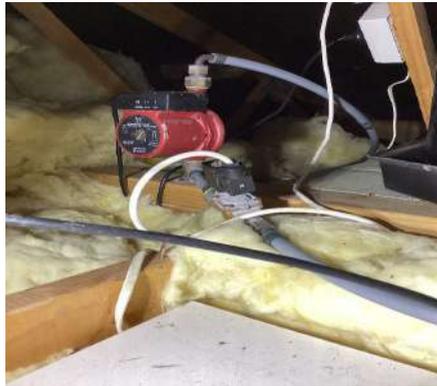
Polybutylene.

Copper crimps have been used on the installation of this plumbing system to join the pipes. This type of joining method has proved problematic in some installations as small fractures in the copper appear and cause leaking. Crimps of this type are very common. There was no leaking sighted during the inspection. We recommend monitoring bi-annually. No visible issues were noted during the inspection. Allow to constantly monitor and maintain as required.

If water storage tank is still in use , recommend seismic restraints are installed.

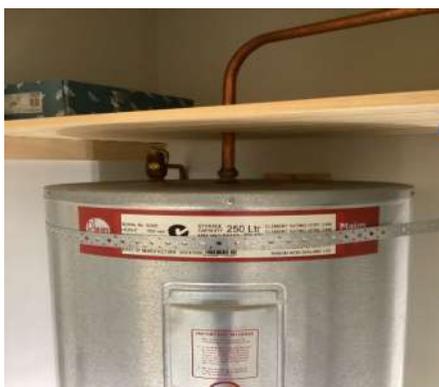
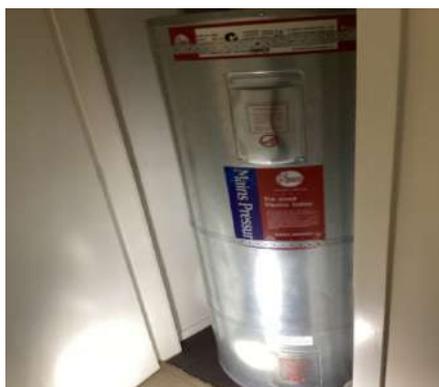
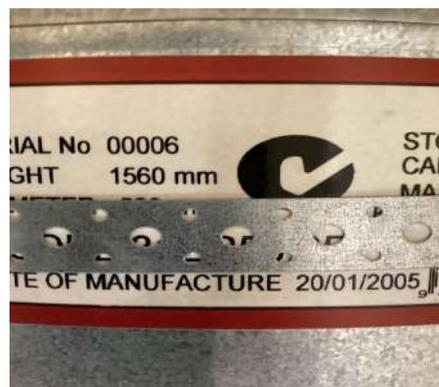
Manufacture date 2005

Mains-pressure system.

The average life span of this type of hotwater system is 10-12 years. This system is estimated to be older than this time frame. We suggest that a thorough examination is completed bi-annually (ideally at the end of winter and end of summer), and any pipe or cylinder breakdown, water pooling or any signs of deterioration should be investigated by a qualified plumber. No visible issues noted during the inspection. Allow to constantly monitor and maintain as required.

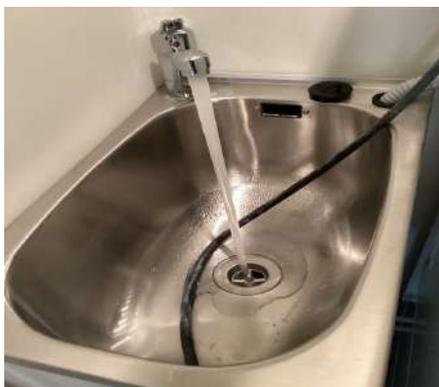
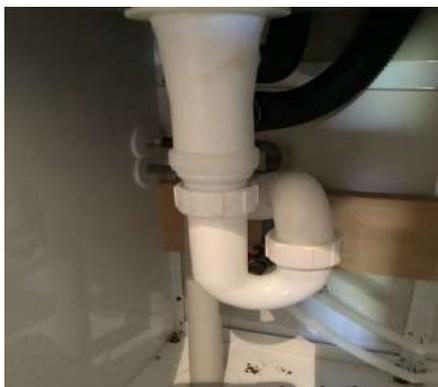
The laundry tub is functioning as intended. We recommend this is checked annually as it is a high use plumbing fixture. No visible issues noted during the inspection. Allow to constantly monitor and maintain as required.

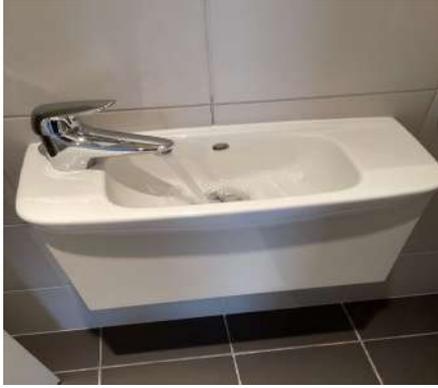
Downstairs toilet vanity

The vanity is functioning as intended. We recommend this is checked annually as it is a high use plumbing fixture. No visible issues noted during the inspection. Allow to constantly monitor and maintain as required.

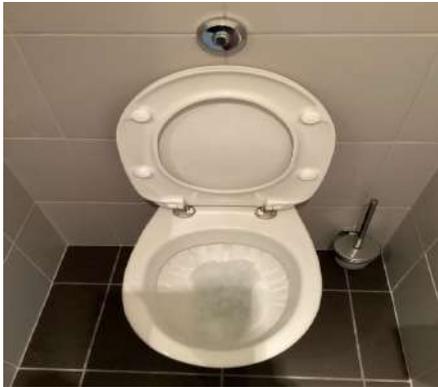
Downstairs toilet Off hallway

The toilet bowl and cistern are functioning as intended. We recommend this is checked annually as it is a high use plumbing fixture. No visible issues noted during the inspection. Allow to constantly monitor and maintain as required.

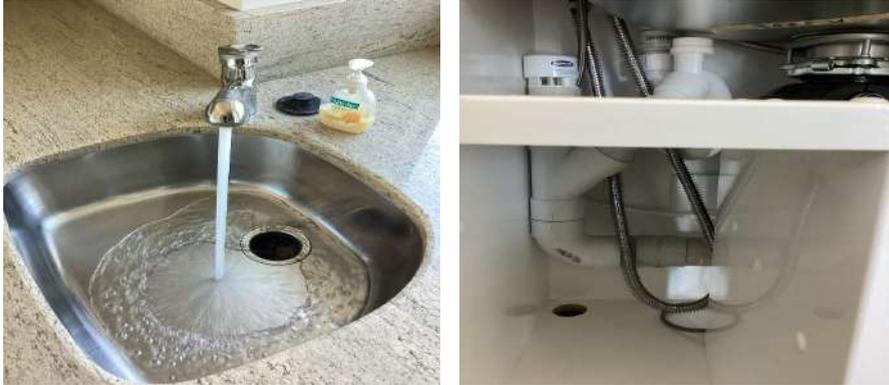
The kitchen sink is functioning as intended. We recommend this is checked annually as it is a high use plumbing fixture. No visible issues noted during the inspection. Allow to constantly monitor and maintain as required.

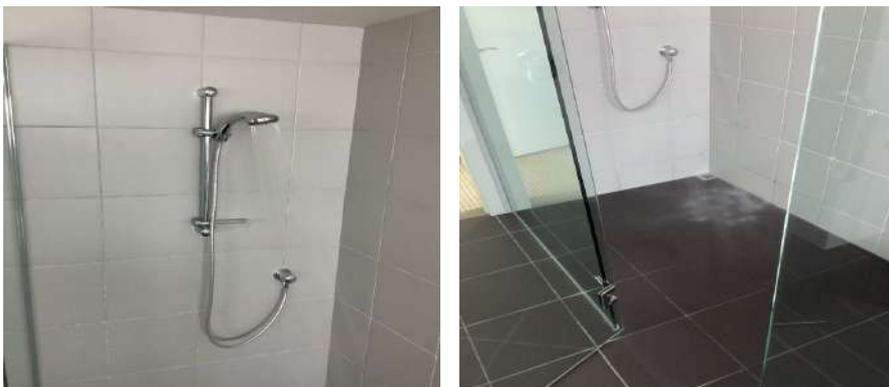
Top level ensuite shower.

Wet floor showers are high maintenance showers and are prone to leaking, with their water tightness relying on the floor covering and a waterproof membrane under the floor covering. We are not able to comment on the condition or function of this membrane during our visual inspection. Moisture testing cannot be undertaken around the base or internal shower linings due to inconsistencies in the readings. We recommend inspection annually and all areas kept sealed. The shower was tested. There was no visible indications of water penetration to surrounding areas. **IMPORTANT NOTE:** The test may not reveal water leaks until the system has been tested under normal or constant use. Allow to constantly monitor and maintain as required.

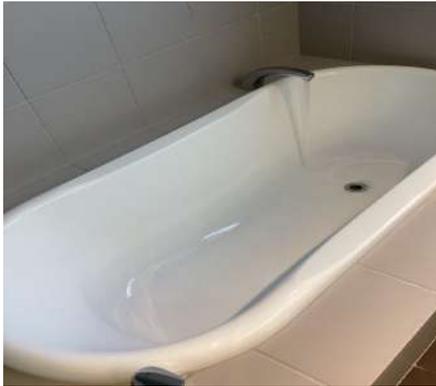
Upstairs ensuite bath

Inbuilt baths can be prone to maintenance issues, failing and leaking. Depending on the quality of the bath, the installation workmanship and how the bath has been maintained depends on how water tight it remains and how much future maintenance it will require. Moisture testing cannot be undertaken around the base or internal bath linings due to inconsistencies in the readings. Typical failure points are where the bath meets the wall and around the tap units. It is recommended you constantly monitor these junctions to ensure damage is not occurring to the adjacent walls. The bath was tested. There was no visible indications of water penetration to surrounding areas. **IMPORTANT NOTE:** The test may not reveal water leaks until the system has been tested under normal or constant use. No visible issues noted during the inspection. Allow to constantly monitor and maintain as required.

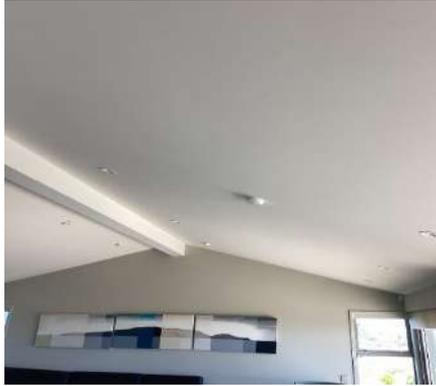
Part of lighting circuit is not working upstairs recommend this is rectified by a qualified electrician.

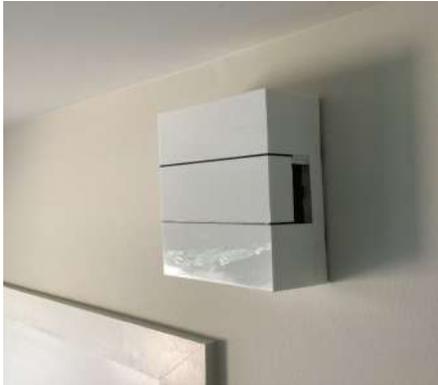
Recommend rectifying noisy doorbell fitting as shown in picture and checking operation of doorbell as the bell push doesn't work outside.

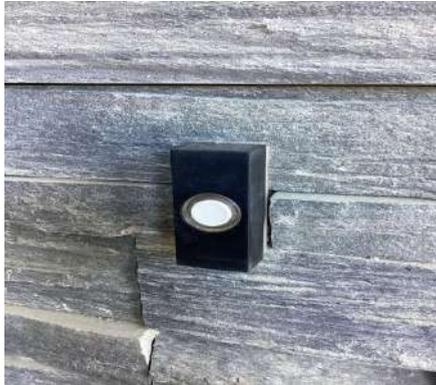
Bell push appears to be stuck.

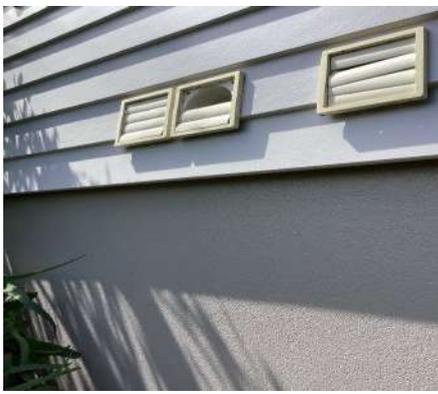
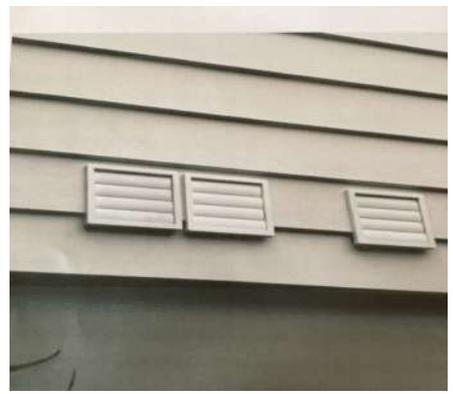
Recommend the grill covers are replaced where broken

Please see picture above showing the damaged vent covers. These vent covers have now been replaced as shown in this picture.

Please find copy of electrical safety certificate showing the items that have been addressed which were initially picked up on the first inspection. These items have now been addressed this changes this section of our colour-coded system from orange to green.

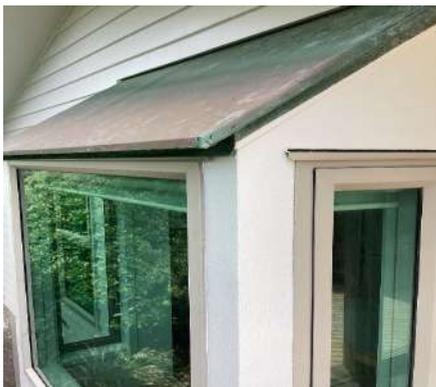
There is a high risk junction installed that has raised concern to the inspector. These junctions are where the roofline and exterior wall meet. The high risk junction such as the one on this dwelling has the potential to allow water entry through poor application and installation, lack of maintenance, poor detailing and complexity. This tends to occur particularly on buildings built between 1990 and 2006. We suggest that a thorough examination is completed bi-annually (ideally at the end of winter and end of summer), and any sealant breakdown, water pooling or any signs of deterioration of the junction should be investigated by a weather tightness specialist. Allow to constantly monitor and maintain as required.

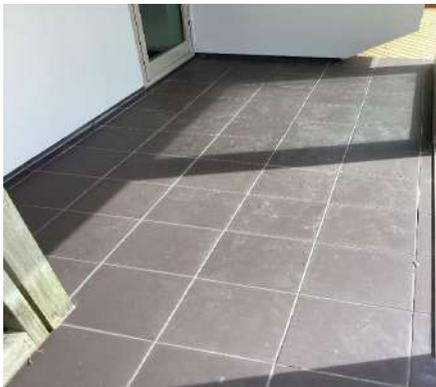
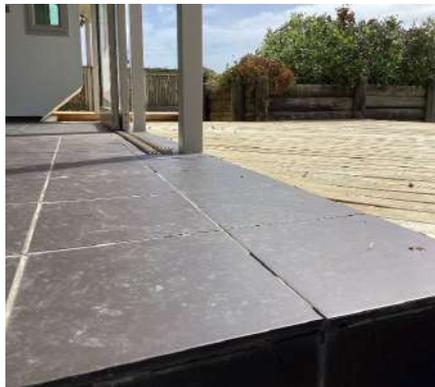
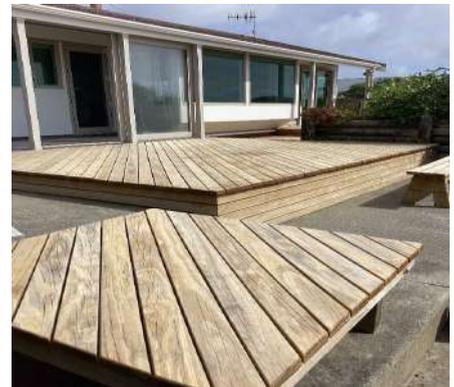
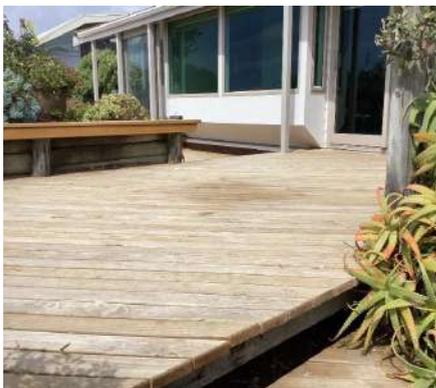
Internal membrane decking systems relies solely on the membrane and application to resist the penetration of moisture. This system is therefore of high concern. Systems such as the one on this dwelling have the potential to allow water entry and deterioration through poor application and installation, lack of maintenance, poor detailing and complexity. This tends to occur particularly on buildings built between 1990 and 2006. We suggest that a thorough examination is completed bi-annually (ideally at the end of winter and end of summer), and any raising sheets, lap joint deterioration, sealant breakdown, water pooling or any signs of deterioration of the membrane should be investigated by a weather tightness specialist. Allow to constantly monitor and maintain as required.

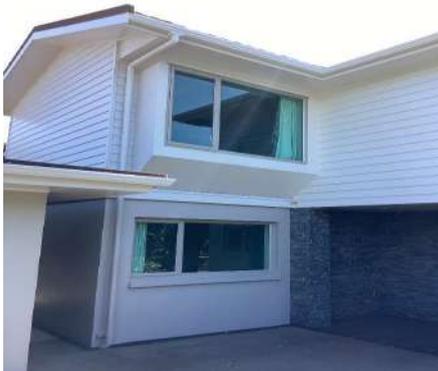
Houses built in a higher wind zone are most at risk of water penetration. This dwelling is located in a higher wind zone. We suggest that a thorough examination is completed bi-annually (ideally at the end of winter and end of summer), and any sealant breakdown, cracking, flashing lifting or any signs of deterioration of the exterior envelope should be investigated by a specialist. Allow to constantly monitor and maintain as required.

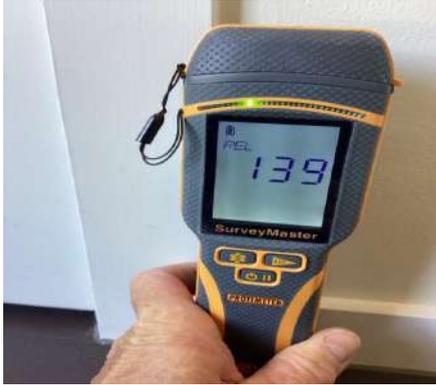
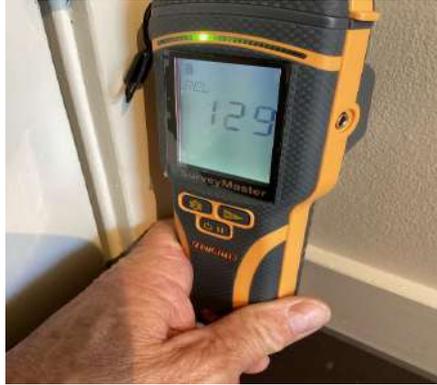
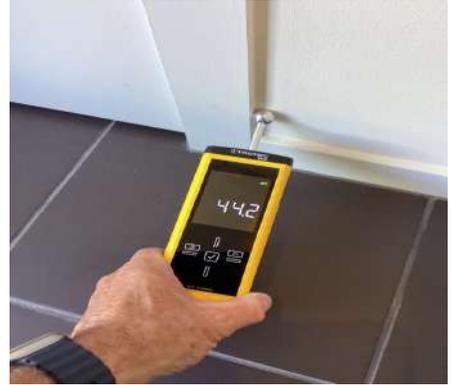
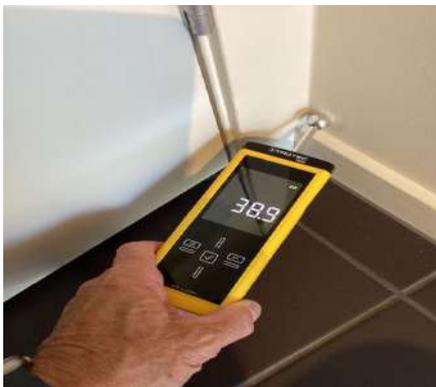
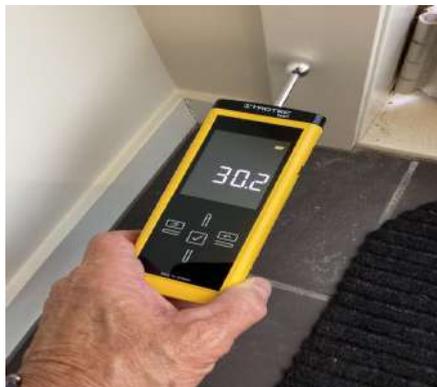
Hall

G

No visible issues noted during the inspection. Allow to constantly monitor and maintain as required.

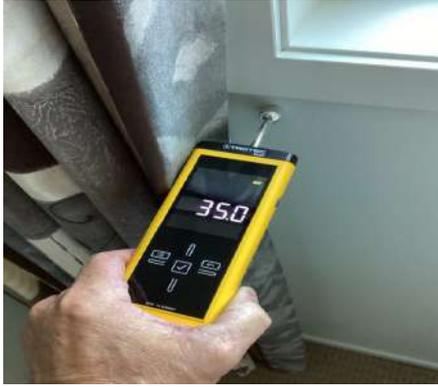
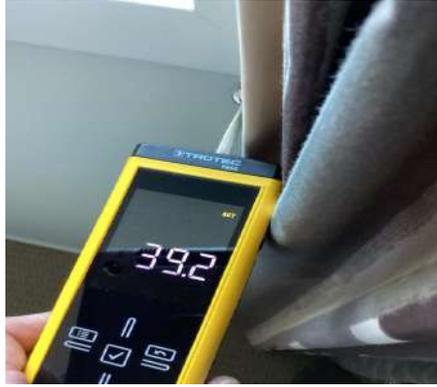
Bedroom two

No visible issues noted during the inspection. Allow to constantly monitor and maintain as required.

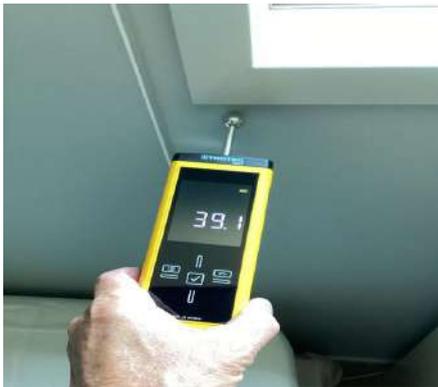
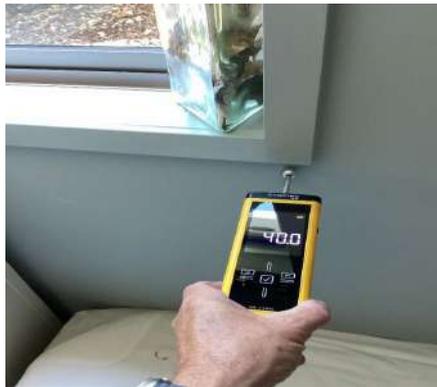
Bedroom three

No visible issues noted during the inspection. Allow to constantly monitor and maintain as required.

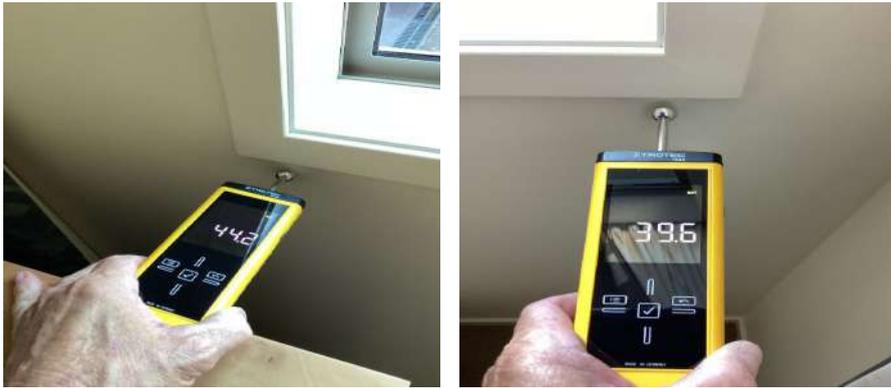
Bedroom four

No visible issues noted during the inspection. Allow to constantly monitor and maintain as required.

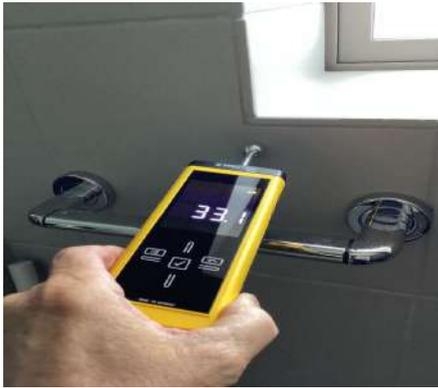
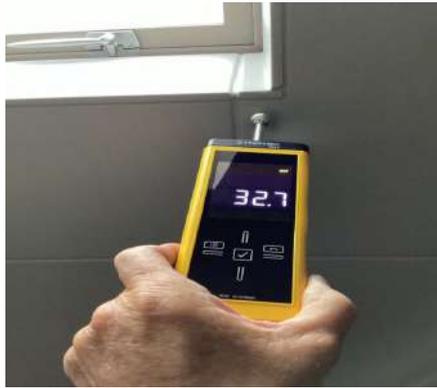
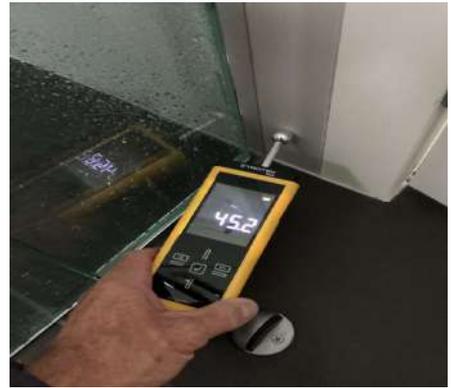
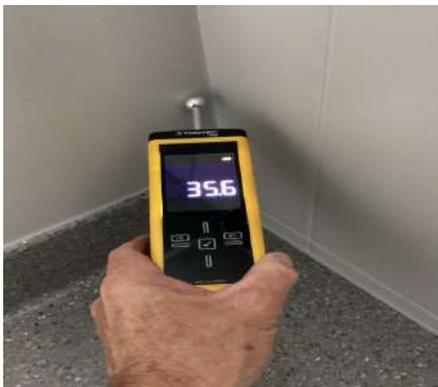
Ground floor ensuite

G

No visible issues noted during the inspection. Allow to constantly monitor and maintain as required.

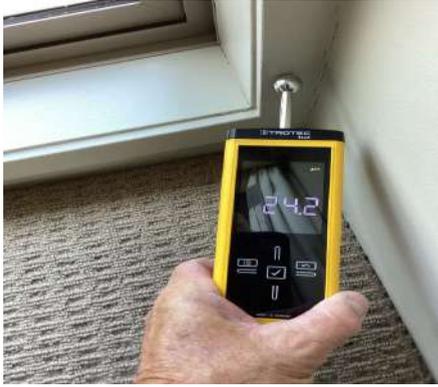
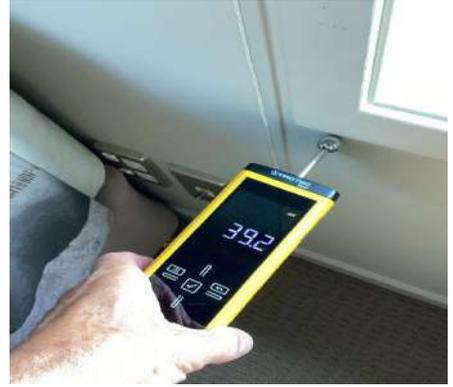
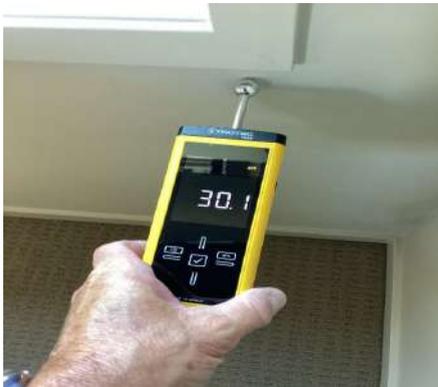
Master bedroom

G

No visible issues noted during the inspection. Allow to constantly monitor and maintain as required.

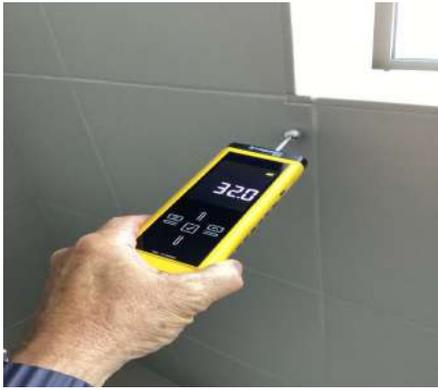
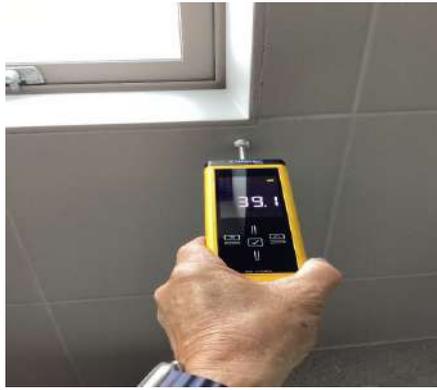
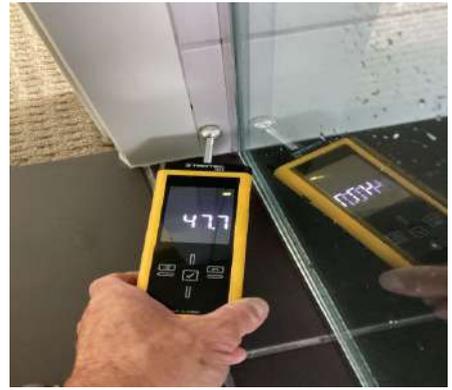
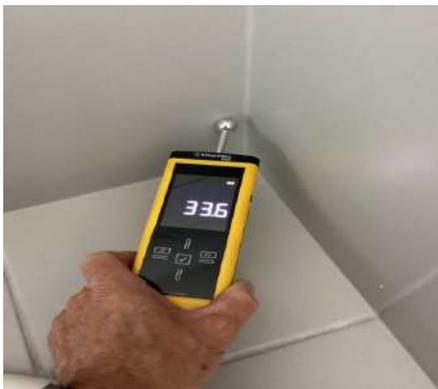
Upstairs ensuite

G

No visible issues noted during the inspection. Allow to constantly monitor and maintain as required.

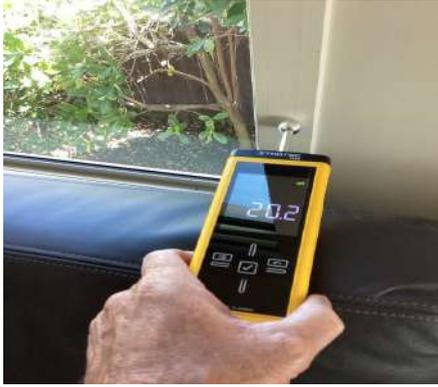
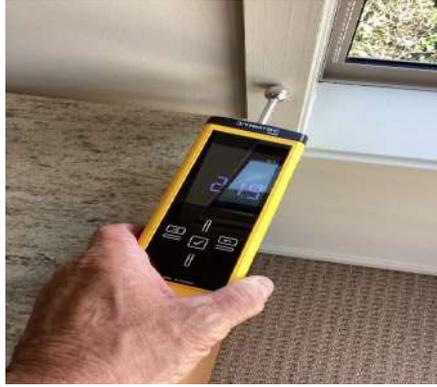
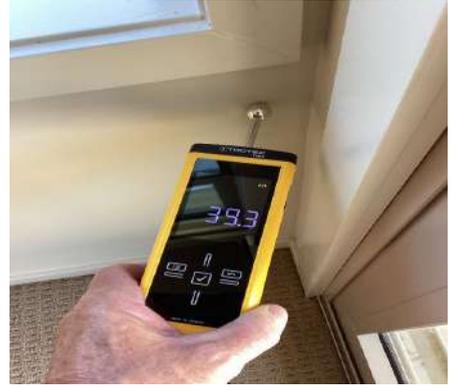
Lounge

No visible issues noted during the inspection. Allow to constantly monitor and maintain as required.

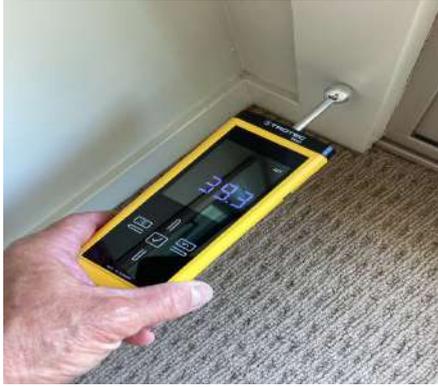
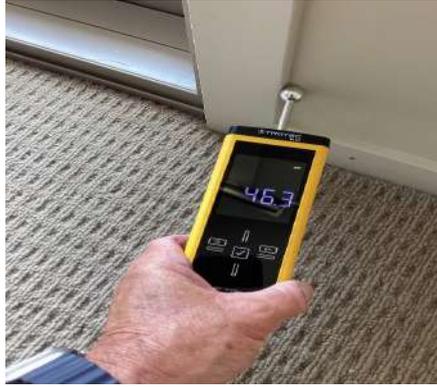
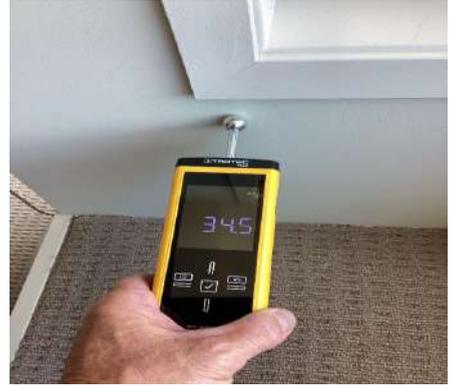
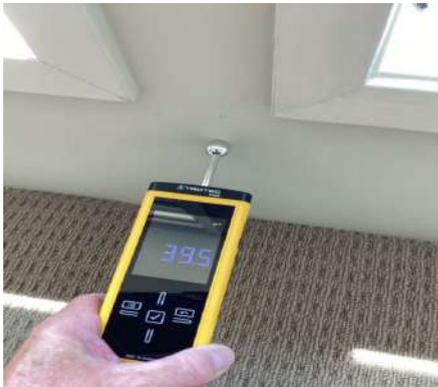
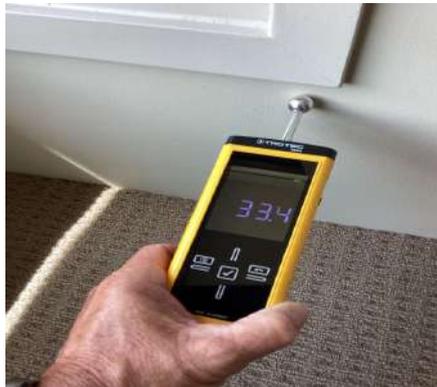
Dining room

No visible issues noted during the inspection. Allow to constantly monitor and maintain as required.

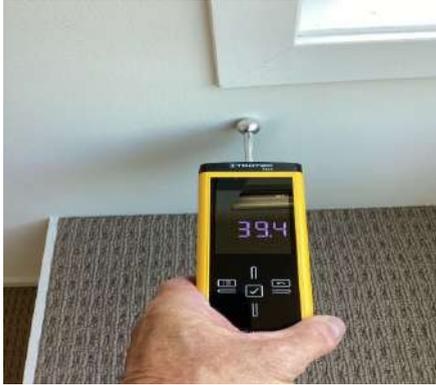
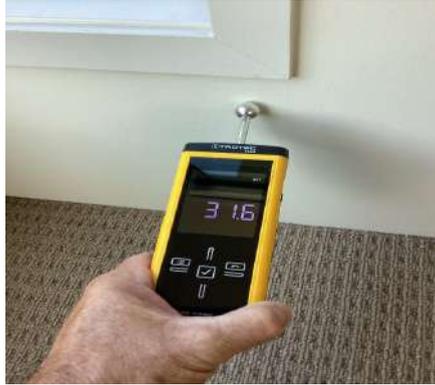
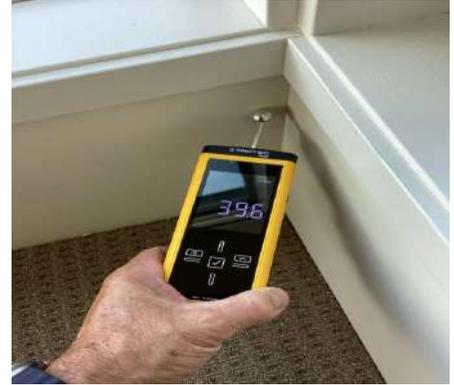
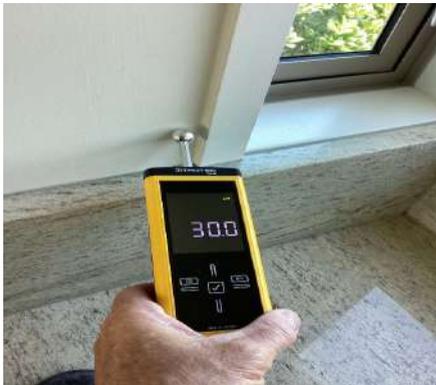
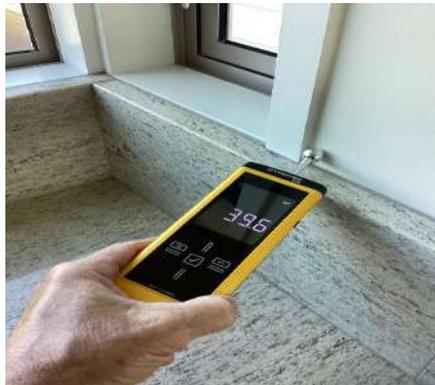
Kitchen

G

No visible issues noted during the inspection. Allow to constantly monitor and maintain as required.

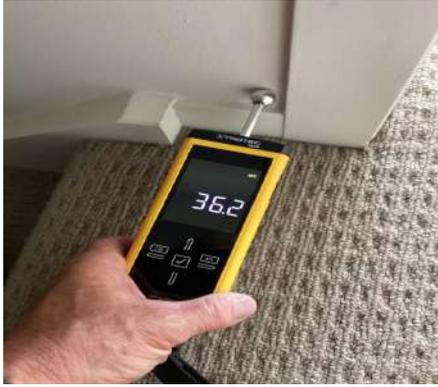
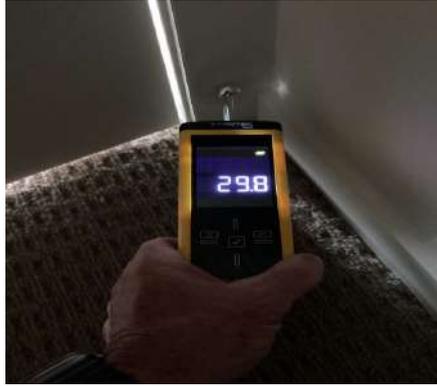
Top landing

No visible issues noted during the inspection. Allow to constantly monitor and maintain as required.

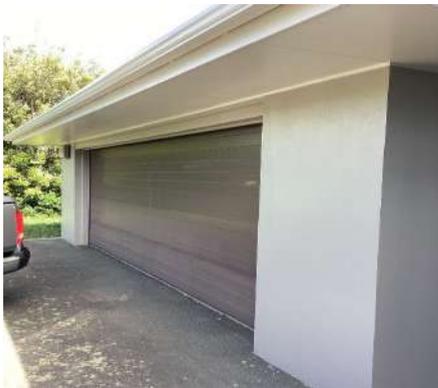
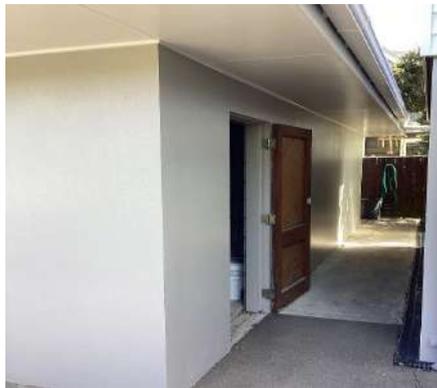
Garage.

Please see last picture below relating to the rubber window seal to the garage window which has now been reinstalled correctly. This now takes a colour-coded system from orange to green.
