# Your Building Inspection Report

CONFIDENTIAL REPORT FOR  
Andrew Cromie  
ID 159820  
Friday, December 05, 2025

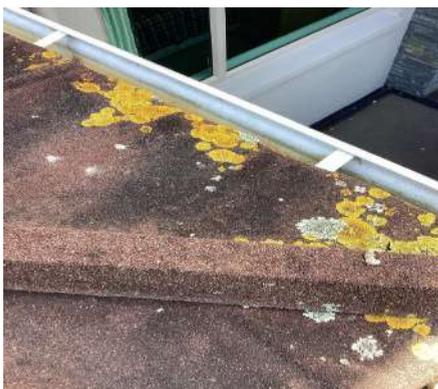
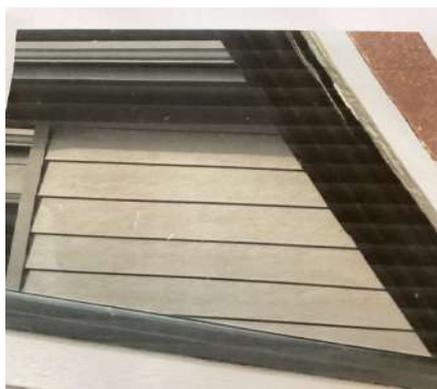
Rubber Window seal has now been re-fitted as shown in picture.

Recommend moss and lichen are removed from garage roof as required

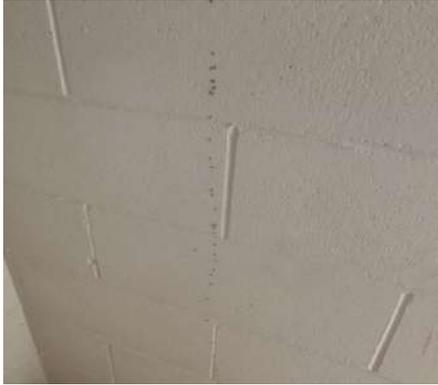
Inside house

Ants.

There are ants in the house and around the deck area. We recommend further investigation by a qualified pest controller.

Please see invoice below for work which was carried out on 18 December 2025. This was for the removal of the ants. This now changes our colour-coded system from orange to green.

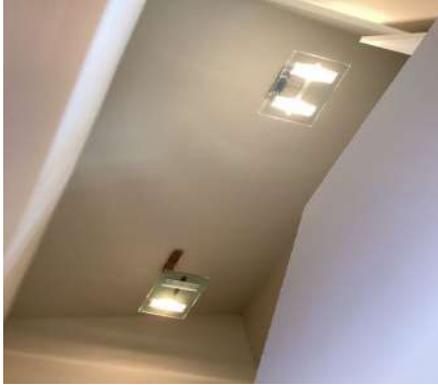
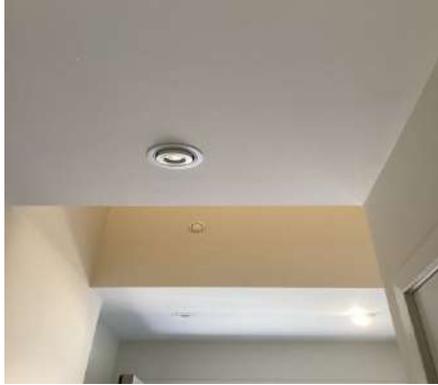
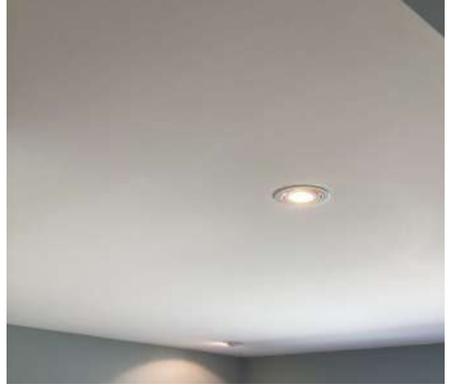
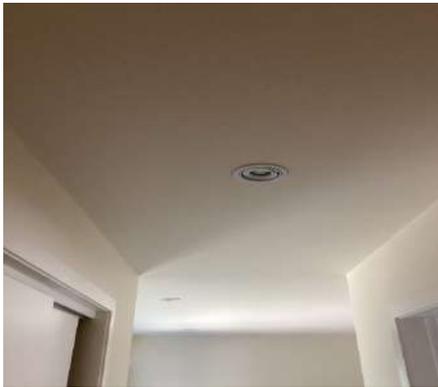
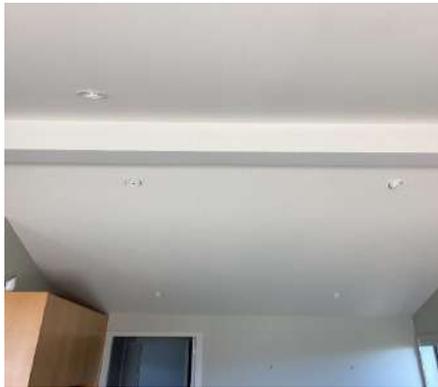
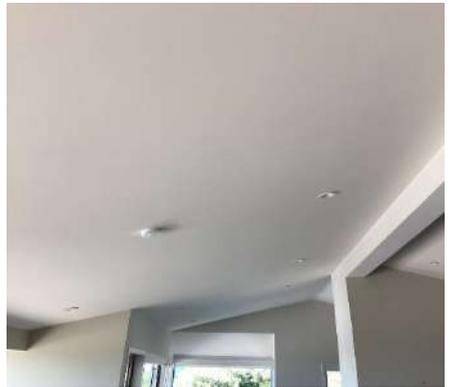
No visible issues noted during the inspection. Allow to constantly monitor and maintain as required.

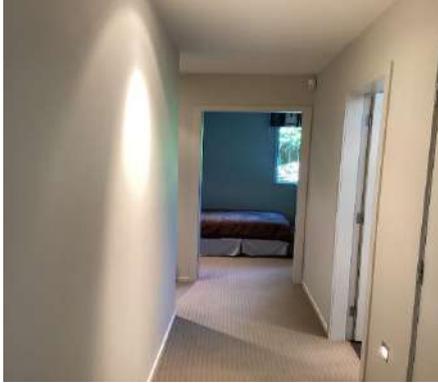
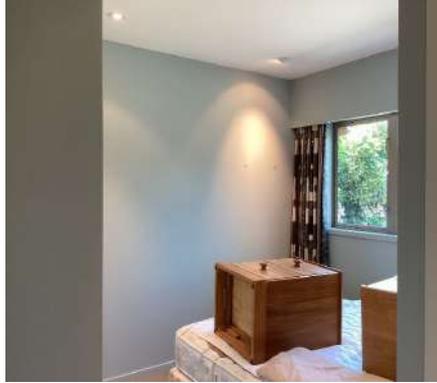
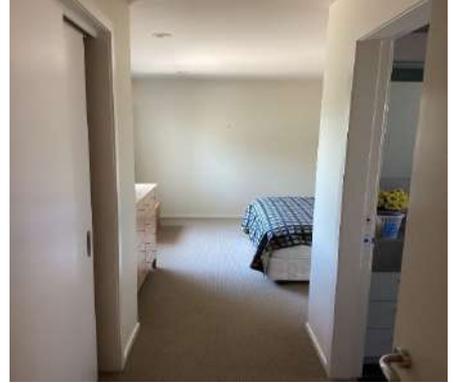
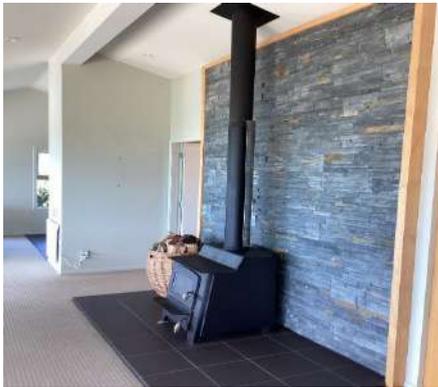
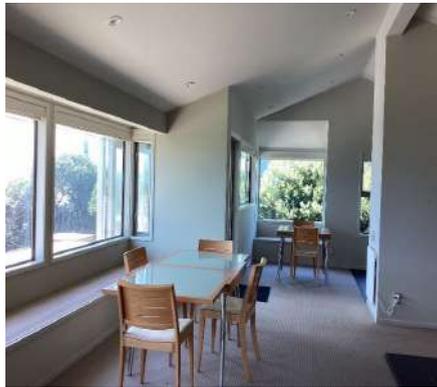
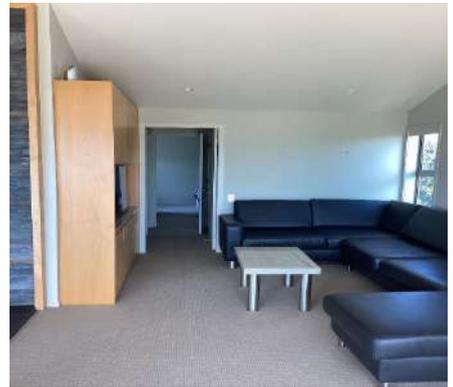
No visible issues noted during the inspection. Allow to constantly monitor and maintain as required.

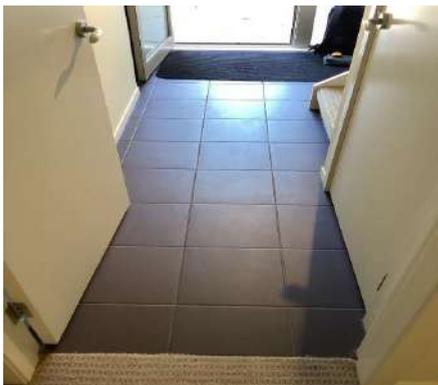
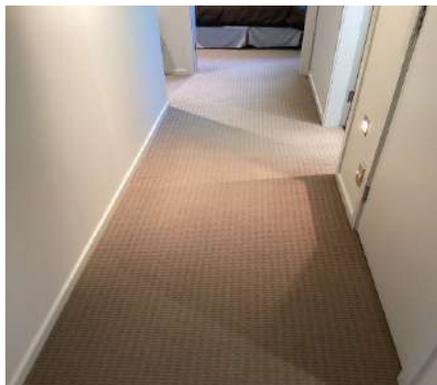
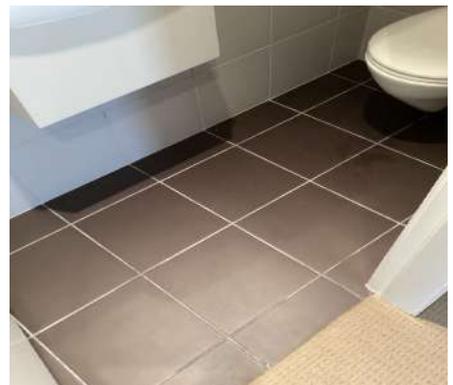
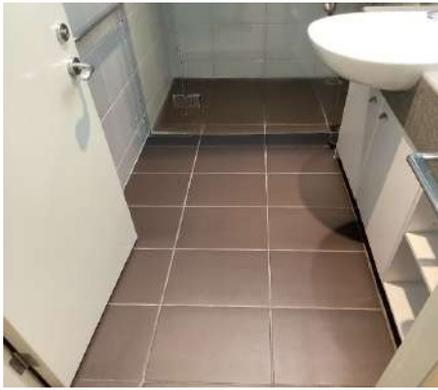
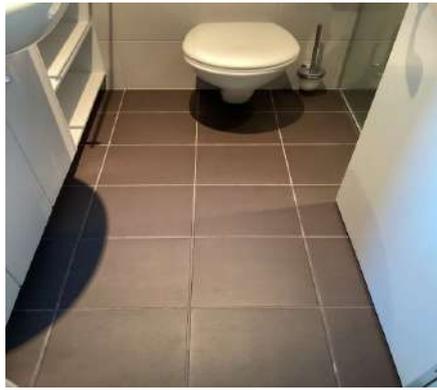
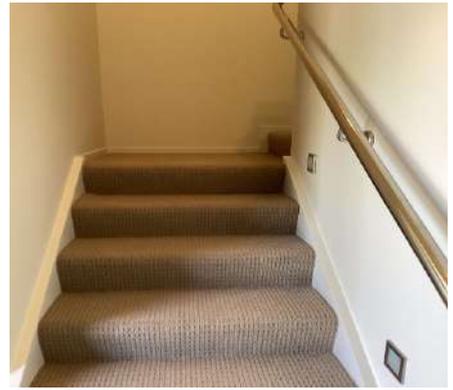
No visible issues noted during the inspection. Allow to constantly monitor and maintain as required.

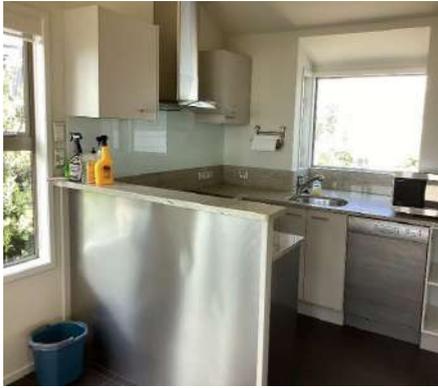
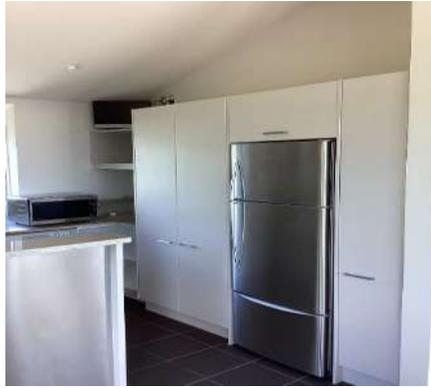
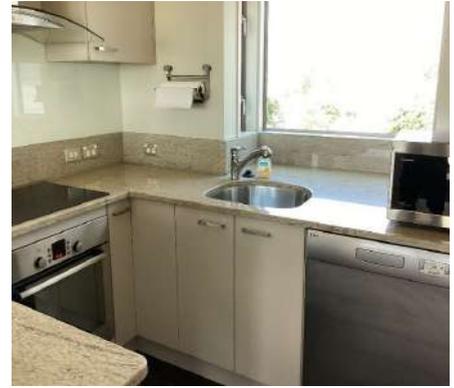
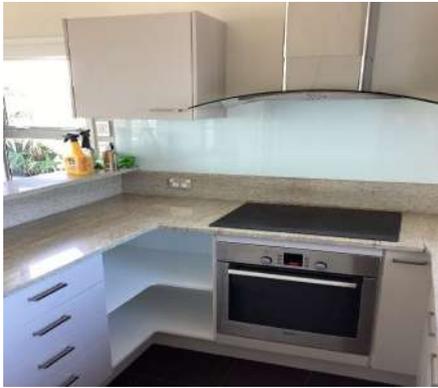
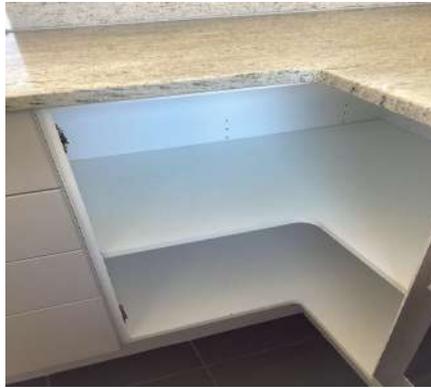
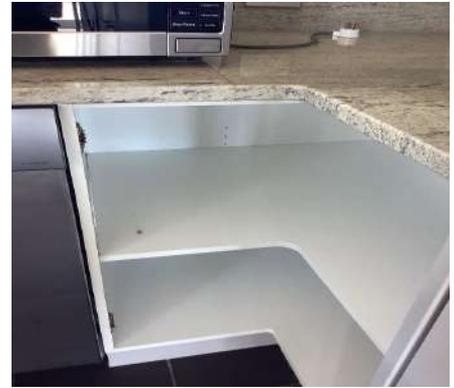
Allow to constantly monitor and maintain as required.

Recommend corner cabinet doors are installed this affects the aesthetics only.

Recommend installing cabinet doors to corner unit this affects the aesthetics only

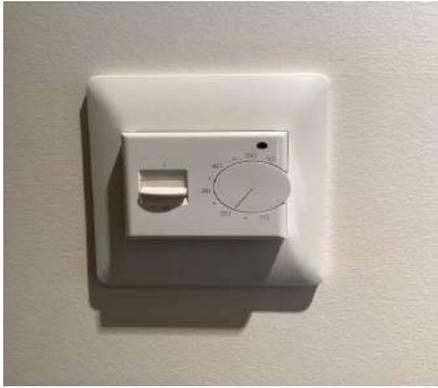
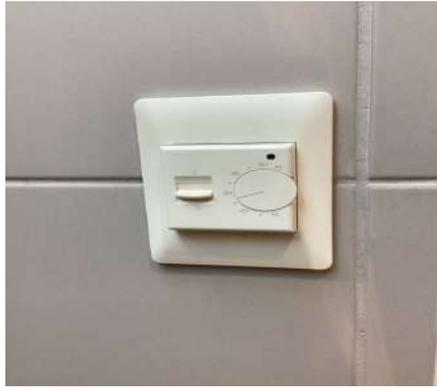
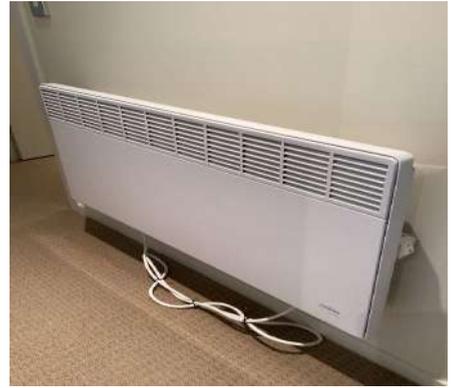
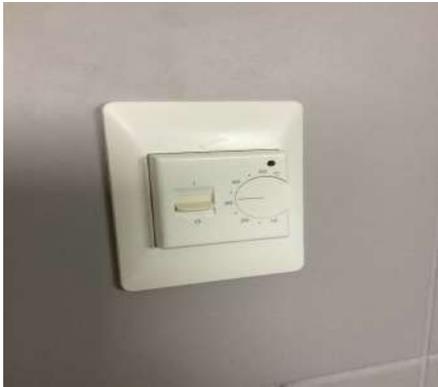
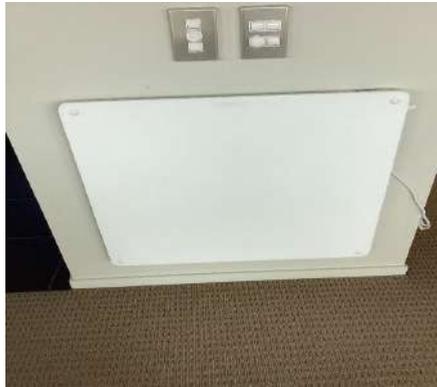
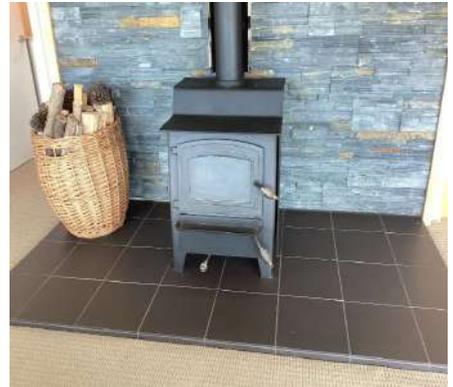
Panel wall heater. Under floor heating. Wood burner Chimney - metal flue.

The operation, efficiency and integrity of any heat source was not tested. This was not tested as it is beyond our scope and expertise. It is recommended that all heating and ventilation systems are tested by the purchaser, or a suitably qualified professional or confirmation that they are all functional before the unconditional date is received. No visible issues noted during the inspection. Allow to constantly monitor and maintain as required.

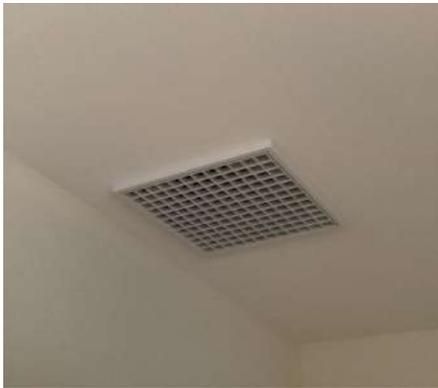
Downstairs toilet

Passive ventilation (window) to upstairs ensuite bathroom.  
Mechanical fans fitted to downstairs areas.

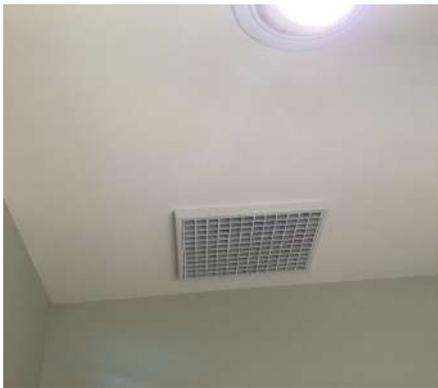
Mechanical fan.

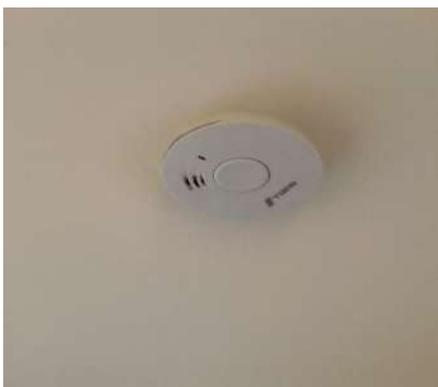
Battery. Testing smoke alarms does not form part of our inspection as it is outside the scope of a visual inspection and our expertise.

The number and location of smoke alarms is vital to ensure occupants have the maximum time to escape in the event of a fire. We strongly recommend seeking professional advice on the location, number and type of smoke alarms. If the property is required to meet the Healthy Homes Standard, we would then recommend further investigation by our Beta Property Compliance team to ensure the property meets the compliance Standard. We recommend these are tested or replaced before moving into the property. As noted above.

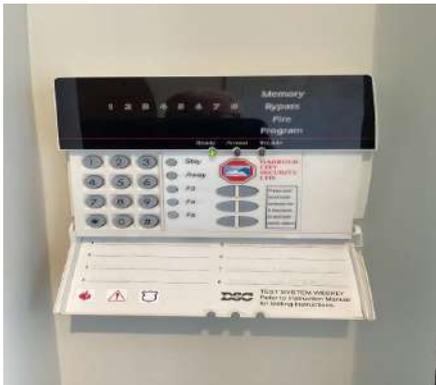
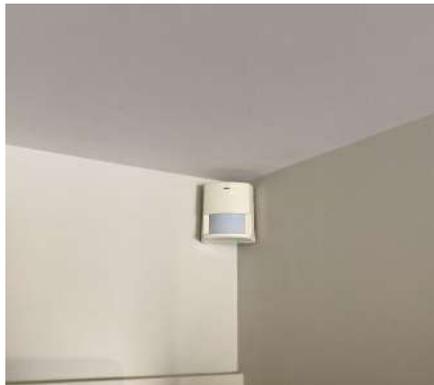
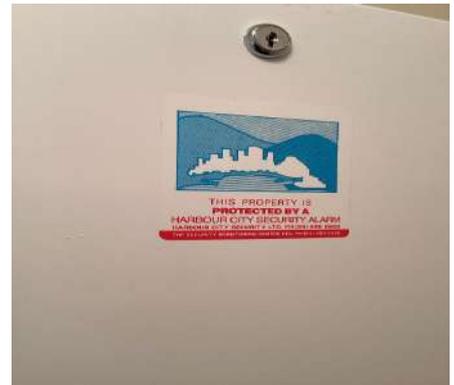
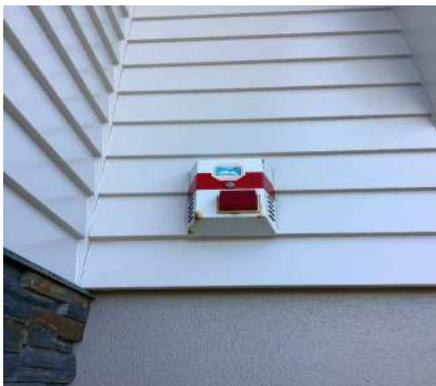
There is an alarm system installed. The operation and efficiency of these were not tested. This was not tested as it is beyond our scope and expertise. We recommend this is tested by a suitably qualified professional

No visible issues noted during the inspection. Allow to constantly monitor and maintain as required.

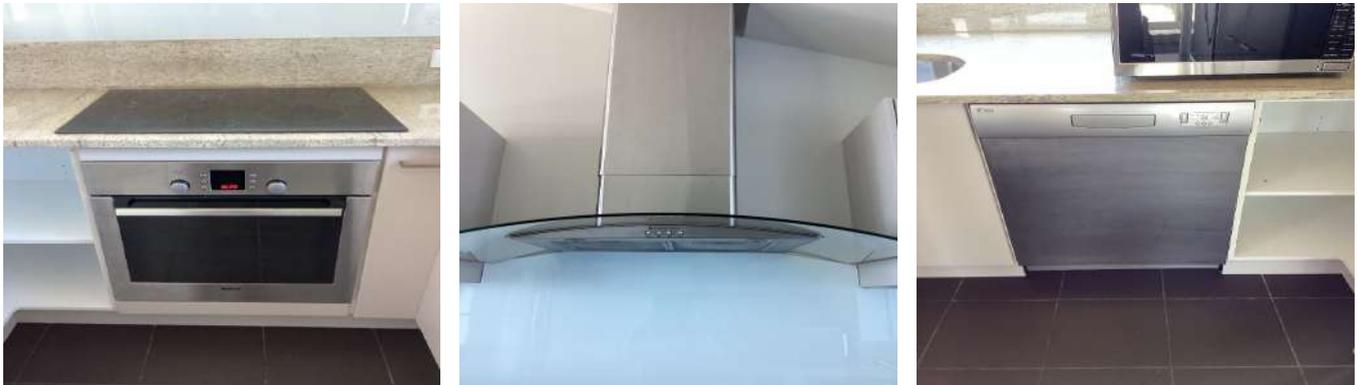
Electric. Electrical appliances such as the range hood, oven, hob, dishwasher and waste disposal system are not tested as part of the visual inspection. It is recommended that all appliances are tested by the purchaser or confirmation that they are all functional before the unconditional date.

No visible issues noted during the inspection. Allow to constantly monitor and maintain as required.

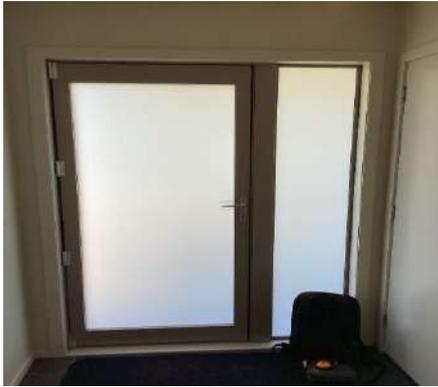
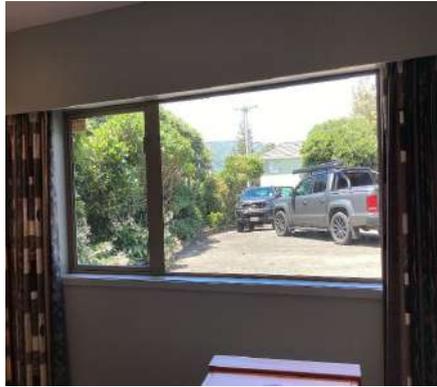
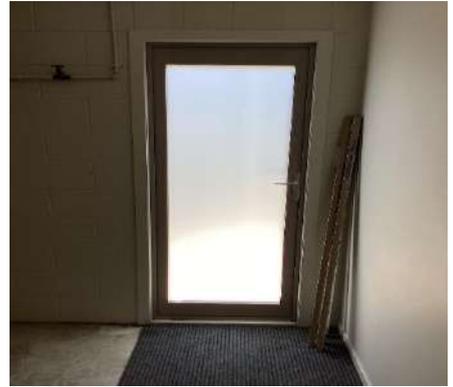
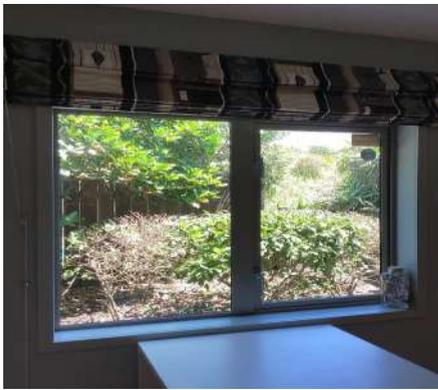
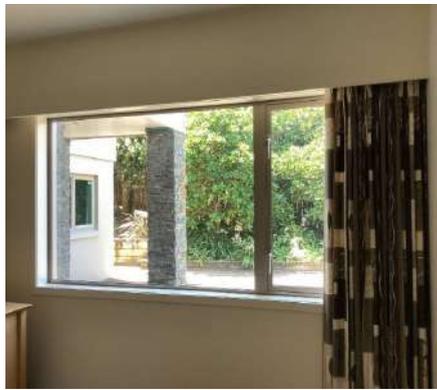
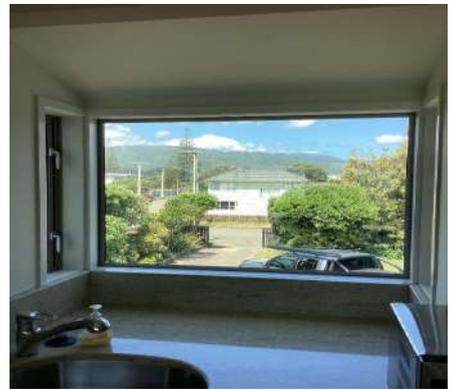
Recommend monitoring joinery hardware they are showing signs of corrosion in areas . They still function as they should , this affects the asthetics only at this stage. Recommend this is closely monitored and if concerned replace as required.
