# Land Information Memorandum

Property address:  
132B Hoon Hay Road

LIM number: H00959092  
Page 1

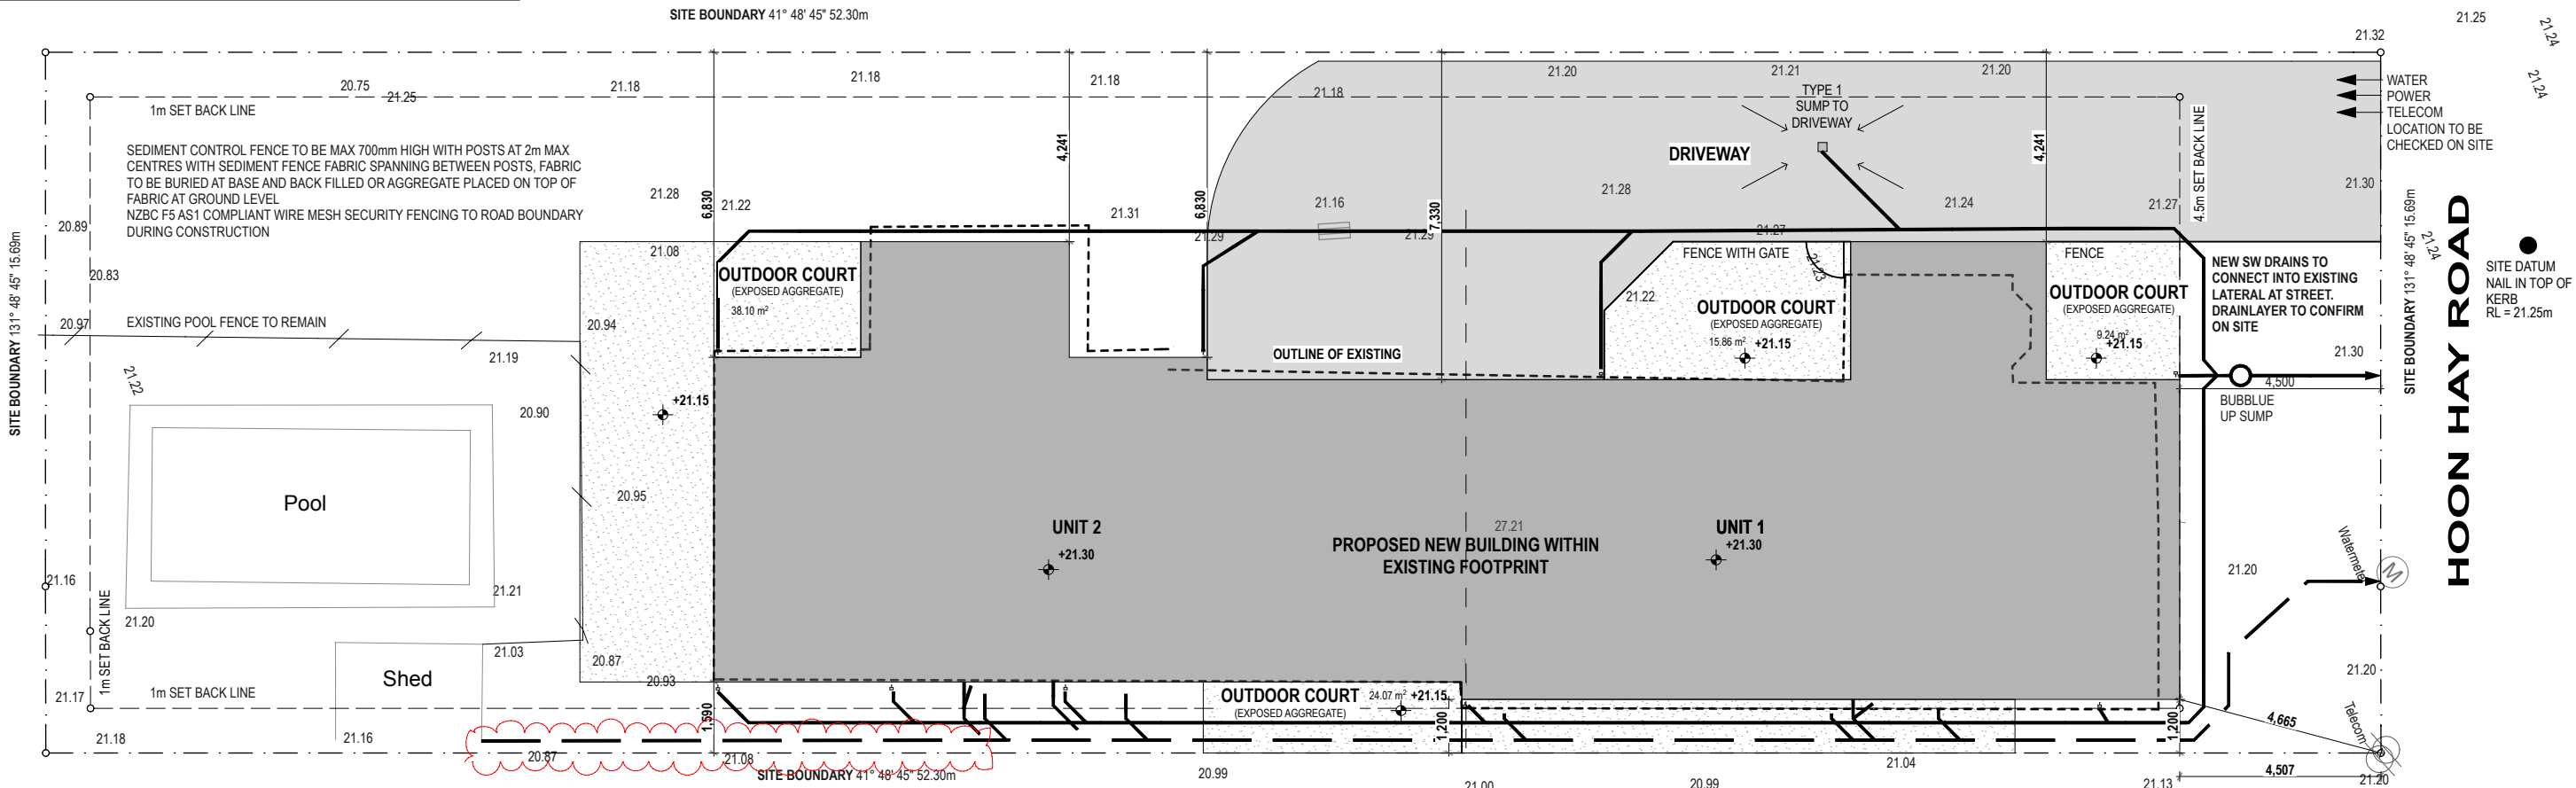
**SITE / DRAINAGE PLAN**  
**1:150**

**SITE DRAINAGE**  
DRAINLAYER TO CONFIRM DRAINAGE ON SITE PRIOR TO CONSTRUCTION TO VERIFY ADEQUATE FALLS FROM REAR UNIT TO STREET LATERALS

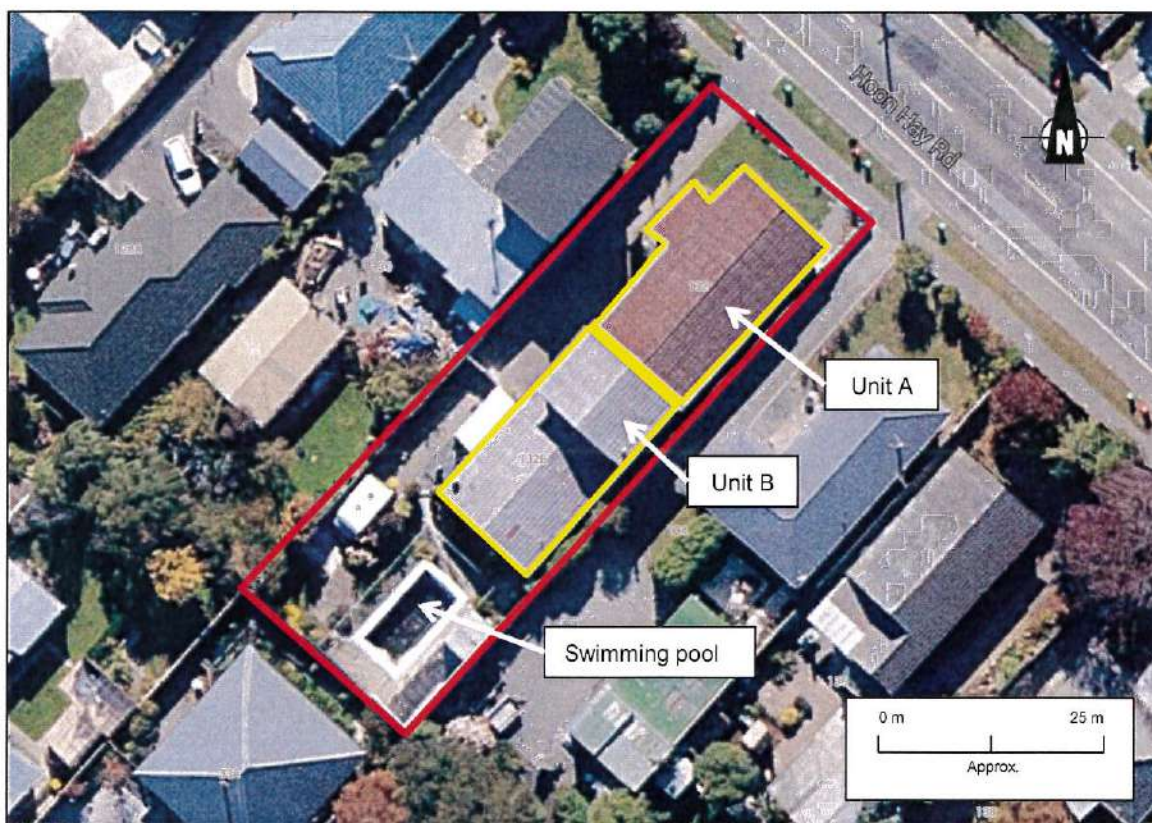
**Figure 1: Annotated site plan (Google Earth Pro, 2016)**

The site is bounded by residential properties to the north-west, south-west and south-east, and Hoon Hay Road to the north-east. The surrounding topography generally slopes gently down towards the south-east. A tributary of the Heathcote River is present approximately 300 m to the north-east.

A site layout plan is presented in Figure 1.

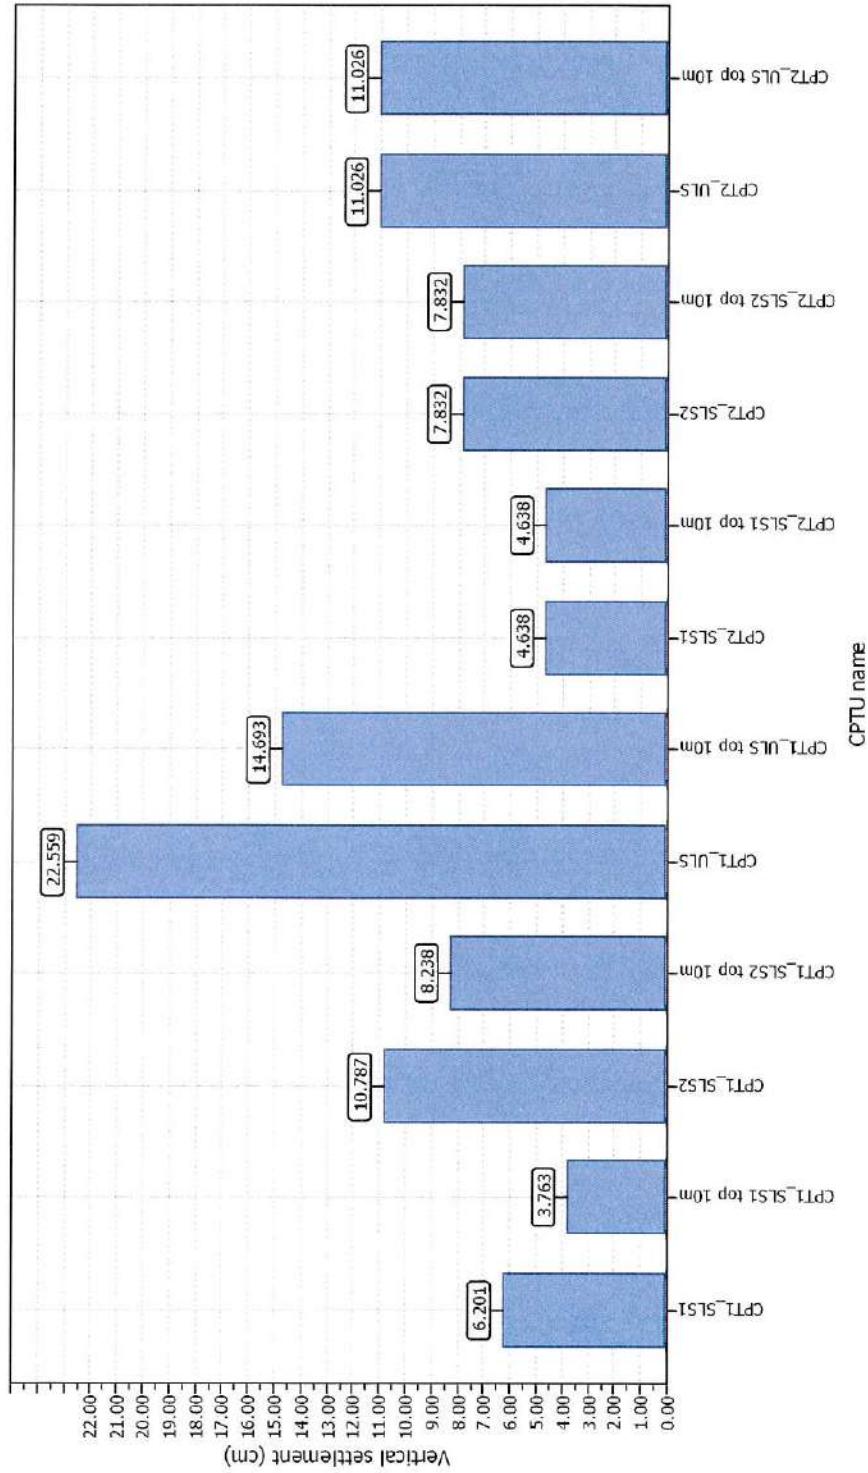
Overall vertical settlements report

Liquefaction-induced differential settlement can also be estimated as half of the total calculated liquefaction-induced settlement. Therefore, liquefaction-induced differential settlement could be up to 55 mm following an SLS event, and up to 115 mm following a ULS event. New foundations should be designed to accommodate this magnitude of differential settlement.

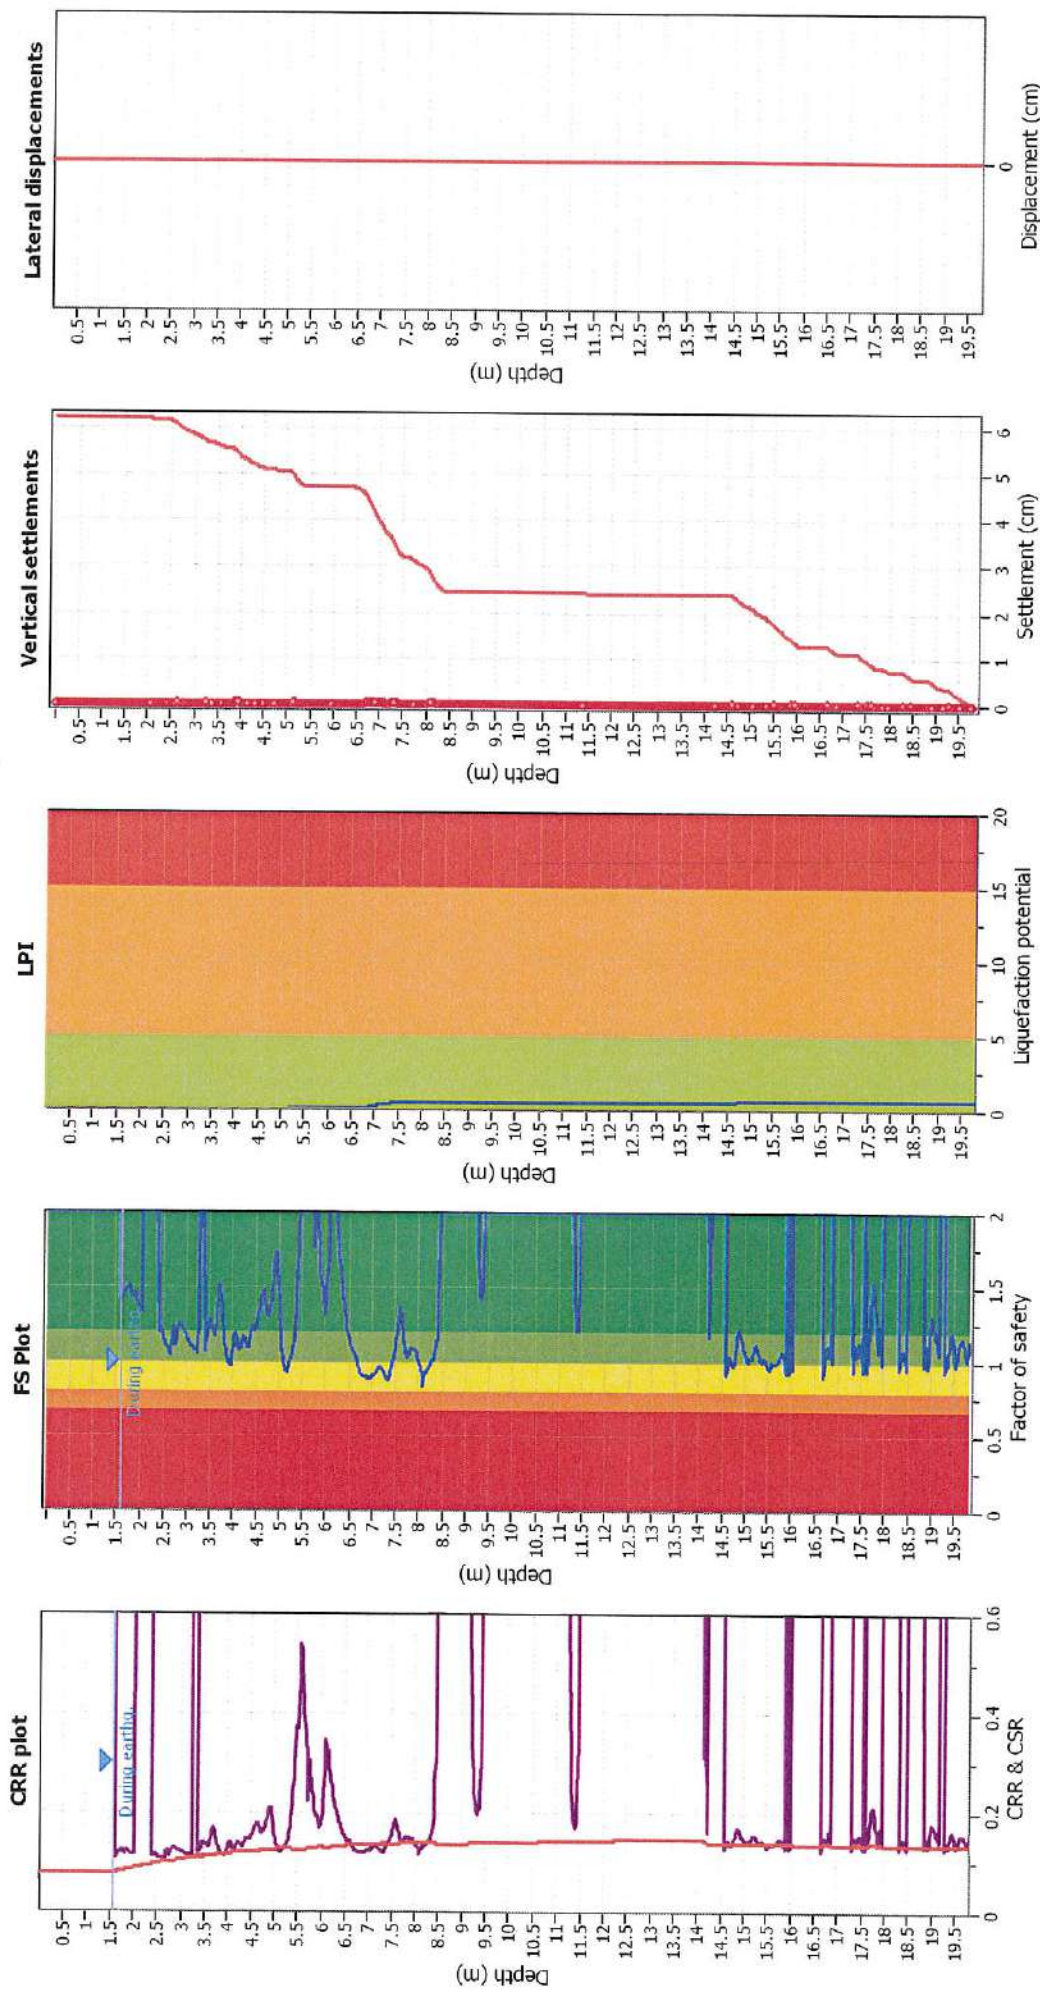
### Liquefaction analysis overall plots

Analysis method:	B&I (2014)	Fill weight:	N/A
Fines correction method:	B&I (2014)	Transition detect. applied:	No
Points to test:	Based on 1c value	$K_v$ applied:	Yes
Earthquake magnitude $M_w$ :	7.50	Clay like behavior applied:	Sands only
Peak ground acceleration:	0.13	Limit depth applied:	No
Depth to water table (instu):	1.60 m	Limit depth:	N/A

- Liquefaction potential evaluation according to Boulanger and Idriss (2014).
- Fines correction according to Boulanger and Idriss (2014).
- Settlement estimation according to Zhang et al (2002).

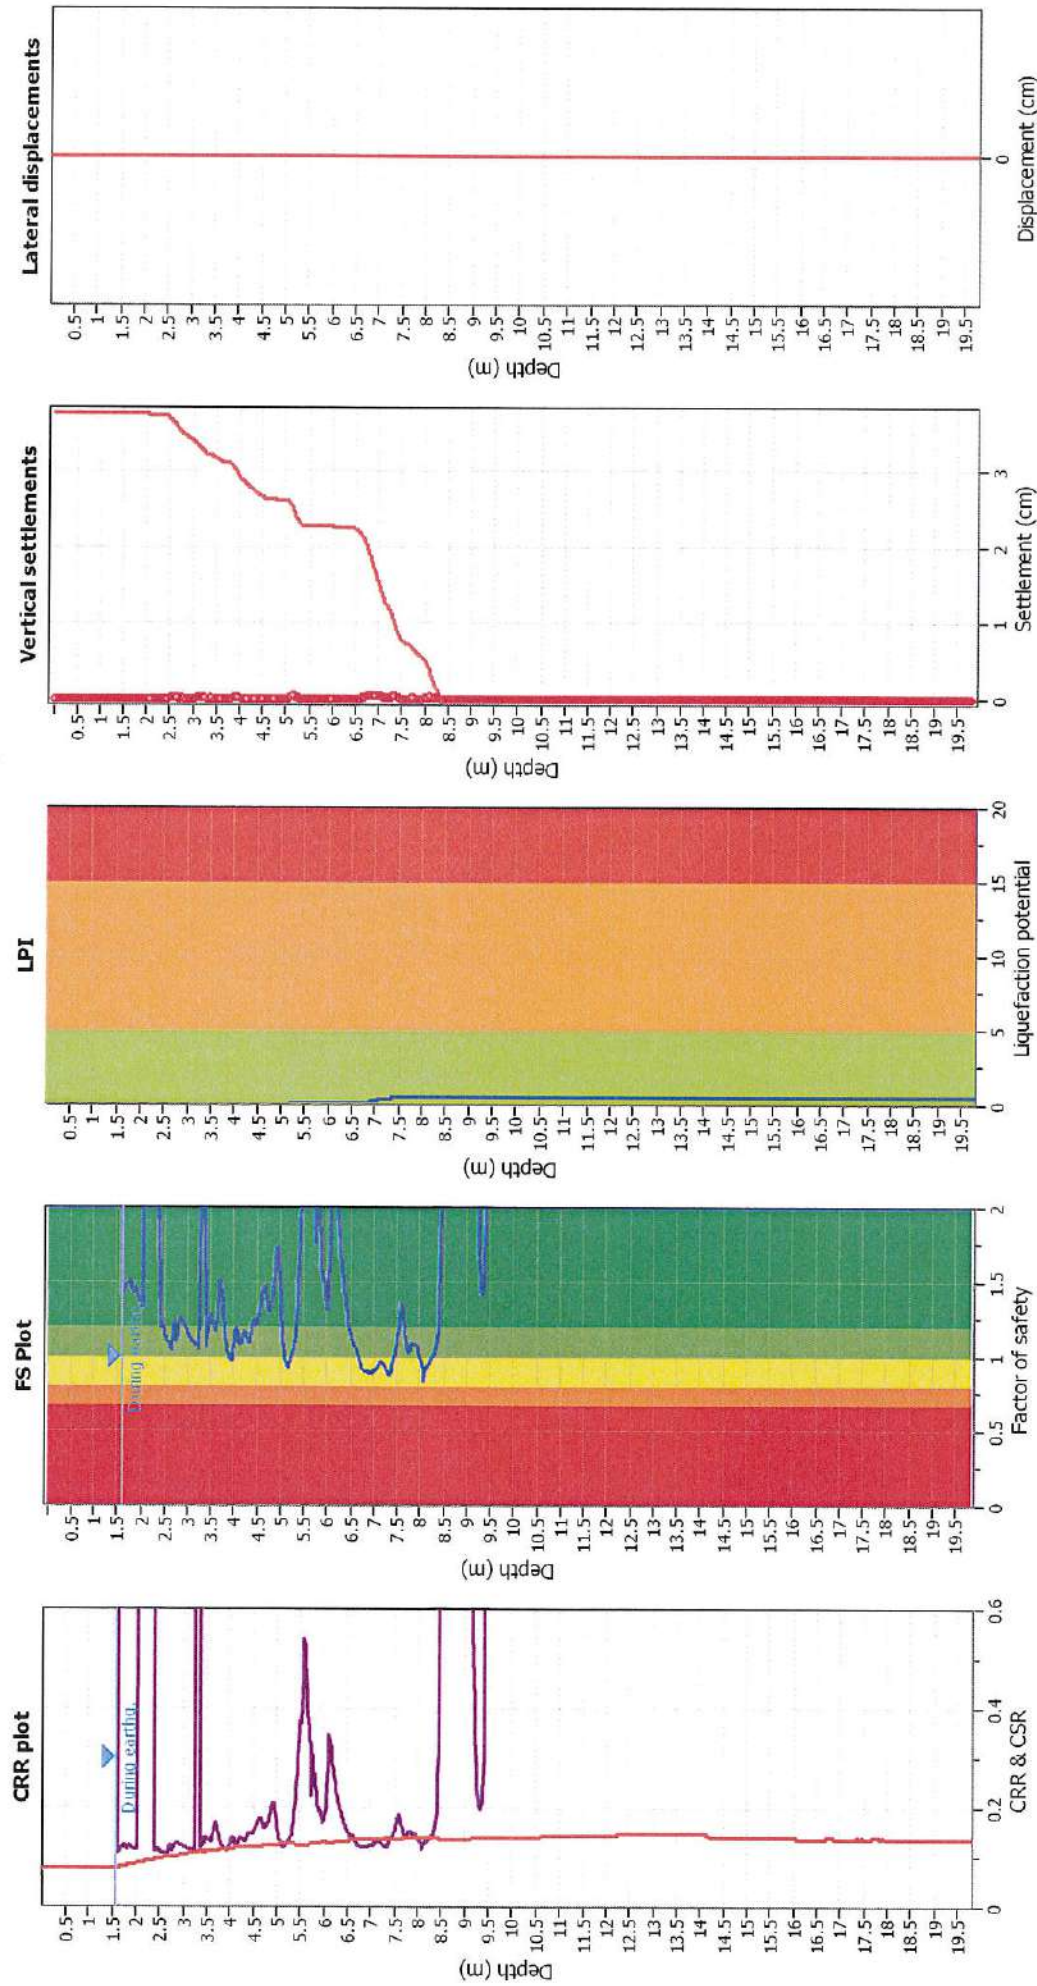
### Liquefaction analysis overall plots

Analysis method: B&I (2014)  
 Fines correction method: B&I (2014)  
 Points to test: Based on I<sub>c</sub> value  
 Earthquake magnitude M<sub>w</sub>: 7.50  
 Peak ground acceleration: 0.13  
 Depth to water table (msitu): 1.60 m
