LAND INFORMATION MEMORANDUM

Please find enclosed your Land Information Memorandum for 48 Travers Road TE KAUWHATA.

Valuation Reference:	04390/693.02
Legal Description:	Lot 2 DP 353641
Area:	8000 square metres more or less
Property Location:	48 Travers Road TE KAUWHATA
Owners:	Christopher Paul Woodham, Nicole Patricia Woodham, Gail Frances Drain

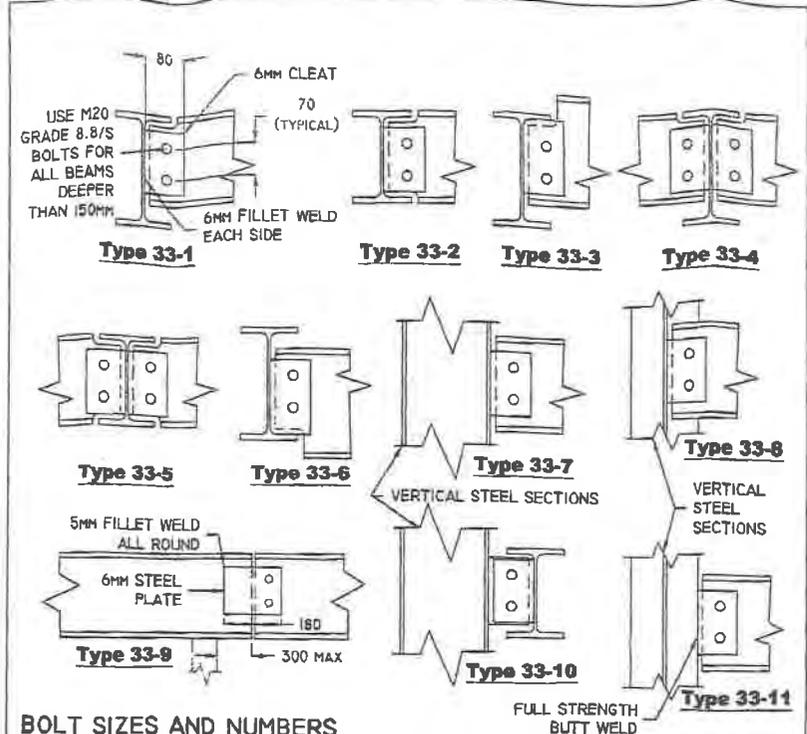
- BOLT SIZES AND NUMBERS**
- 1) USE M20 GRADE 8.8/S BOLTS AT 70MM CENTRES FOR ALL BEAMS DEEPER THAN 150MM
 - 2) 150MM DEEP BEAMS - USE 2 M16 GRADE 8.8/S BOLTS AT 60MM CENTRES AND 50MM EDGE DISTANCE
 - 3) 180MM TO 250MM DEEP BEAMS - USE 2 BOLTS
 - 4) 310MM TO 410MM DEEP BEAMS - USE 3 BOLTS
 - 5) 460MM BEAMS AND DEEPER - USE NUMBER OF BOLTS ARISING FROM BOLTS SPACED AT 70MM

- GENERAL NOTES**
- 1) SIZE CLEATS TO ACHIEVE A 35MM EDGE DISTANCE TO BOTH THE CLEAT EDGES AND BEAM EDGES
 - 2) COPE BEAMS AS NECESSARY AS SHOWN
 - 3) THE CONNECTIONS SHOWN ABOVE MAY BE REPLACED WITH STANDARD HERA WEB SIDE PLATE CONNECTIONS (IE THE "WP" SERIES) AS SHOWN IN THE HERA REPORT R4-100 IF DESIRED
 - 4) ALL DIMENSIONS AND DETAILS TO BE AS TYPICALLY SHOWN FOR TYPE 33-1

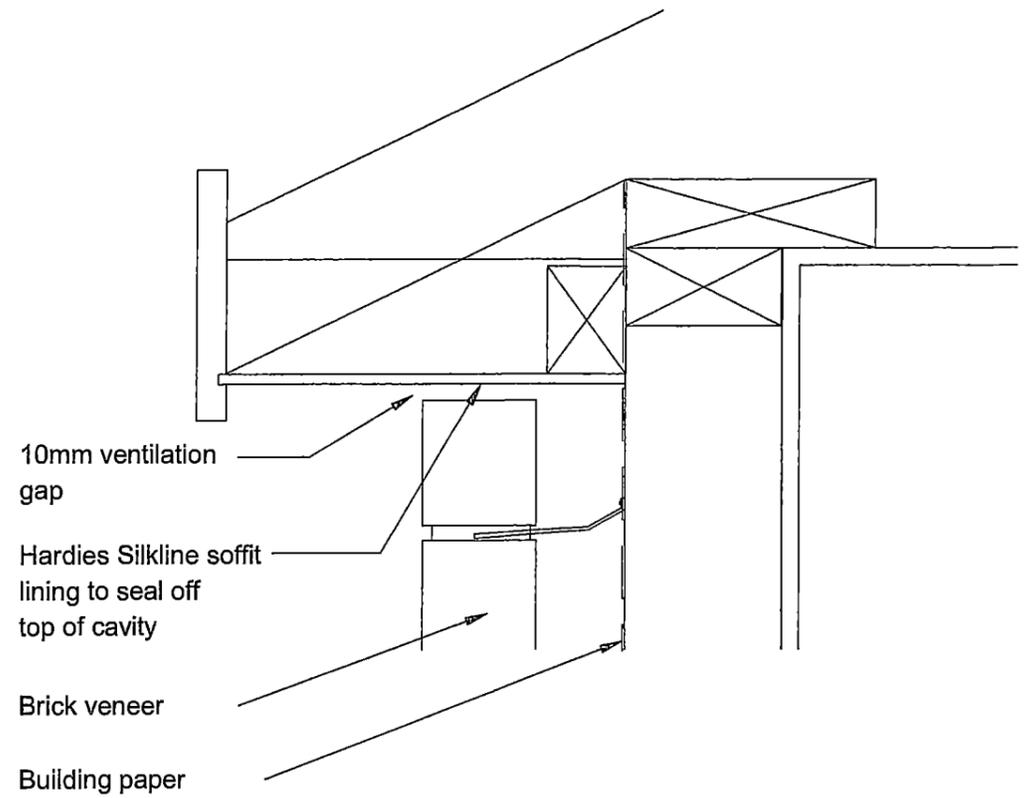
FLAT SOFFIT
 See plans for soffit widths and if frieze board is used.

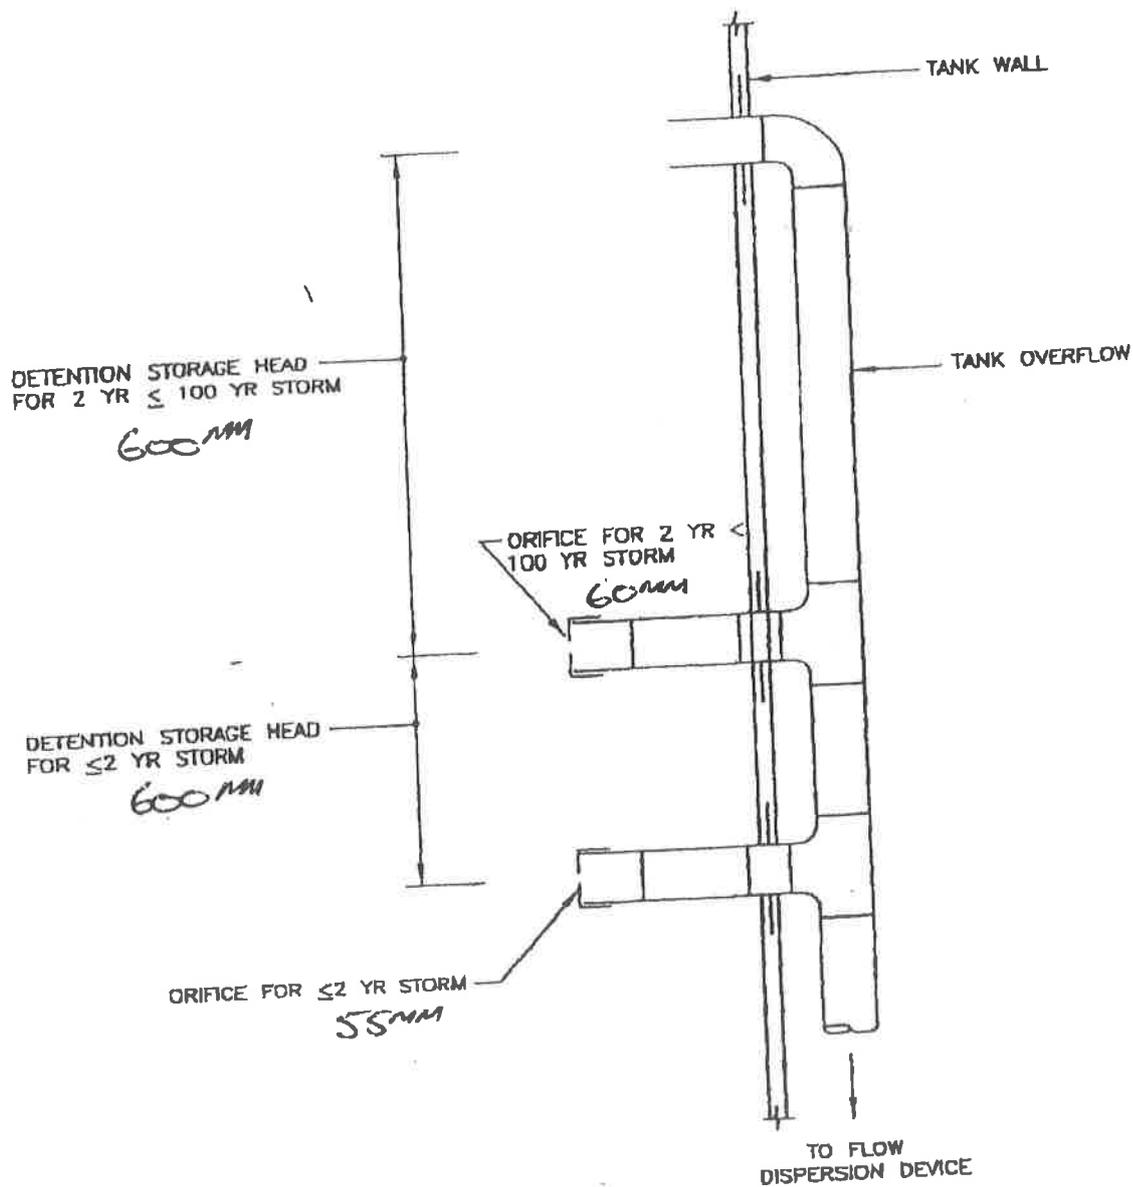
ORIFICE CONTROLLED OUTLET

FOR ORIFICE DIAMETER AND DETENTION STORAGE HEAD DIMENSIONS REFER TO TABLE 6-1 & 6-2.

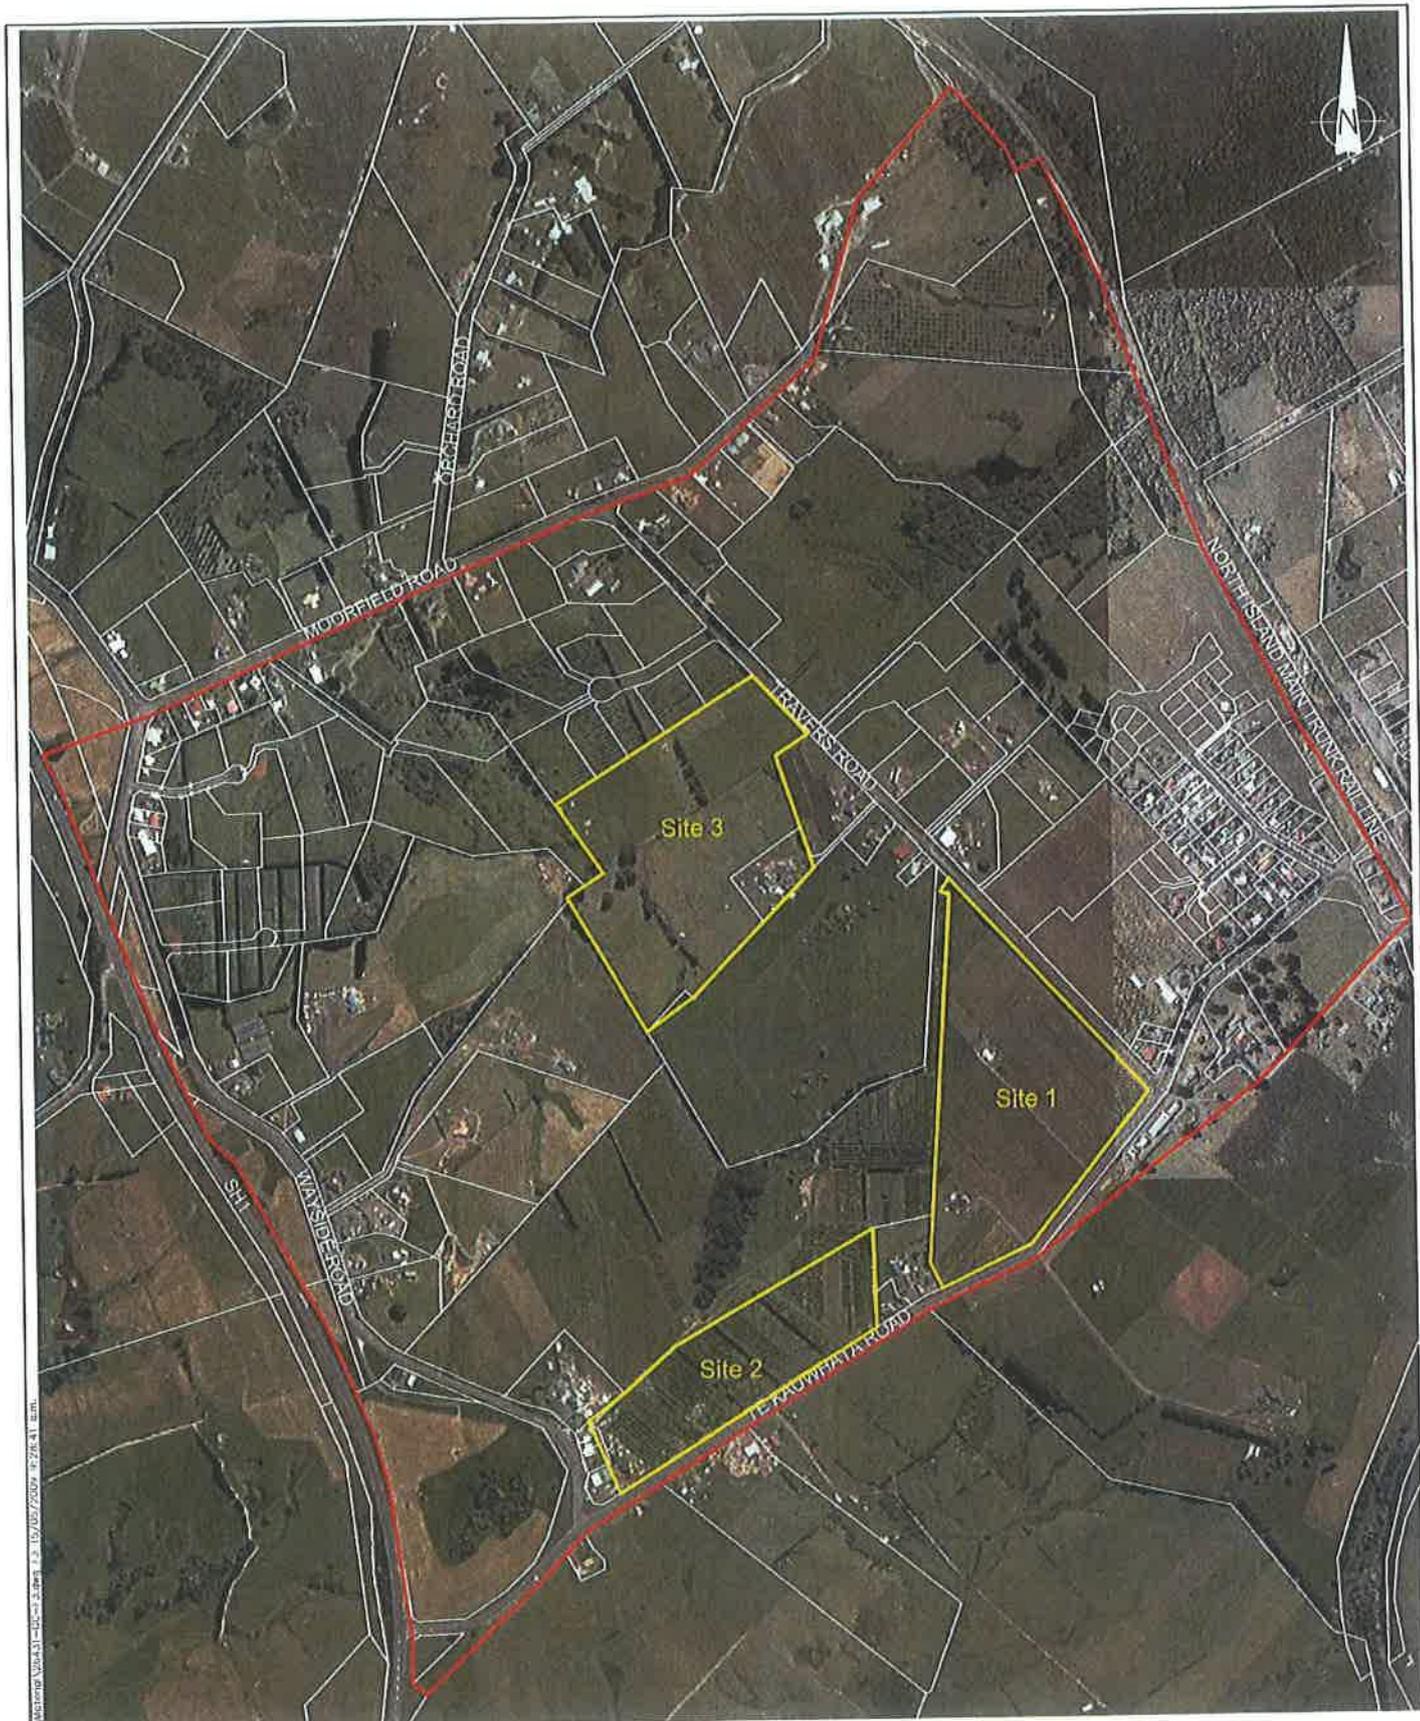
Review of the historical aerial photographs showed that the majority of the site (about 90%) has been used for horticulture at one time or another. This type of land use has been prominent since prior to 1942. Figure 2 shows the areas within the site that were observed to have been used for horticultural purposes, including an estimate of the length of time in which these activities have occurred on that part of the site. Potential 'hotspot' areas for horticultural contamination are also marked on Figure 2. About 80% of the site has been used for horticultural use for more than 20 years.

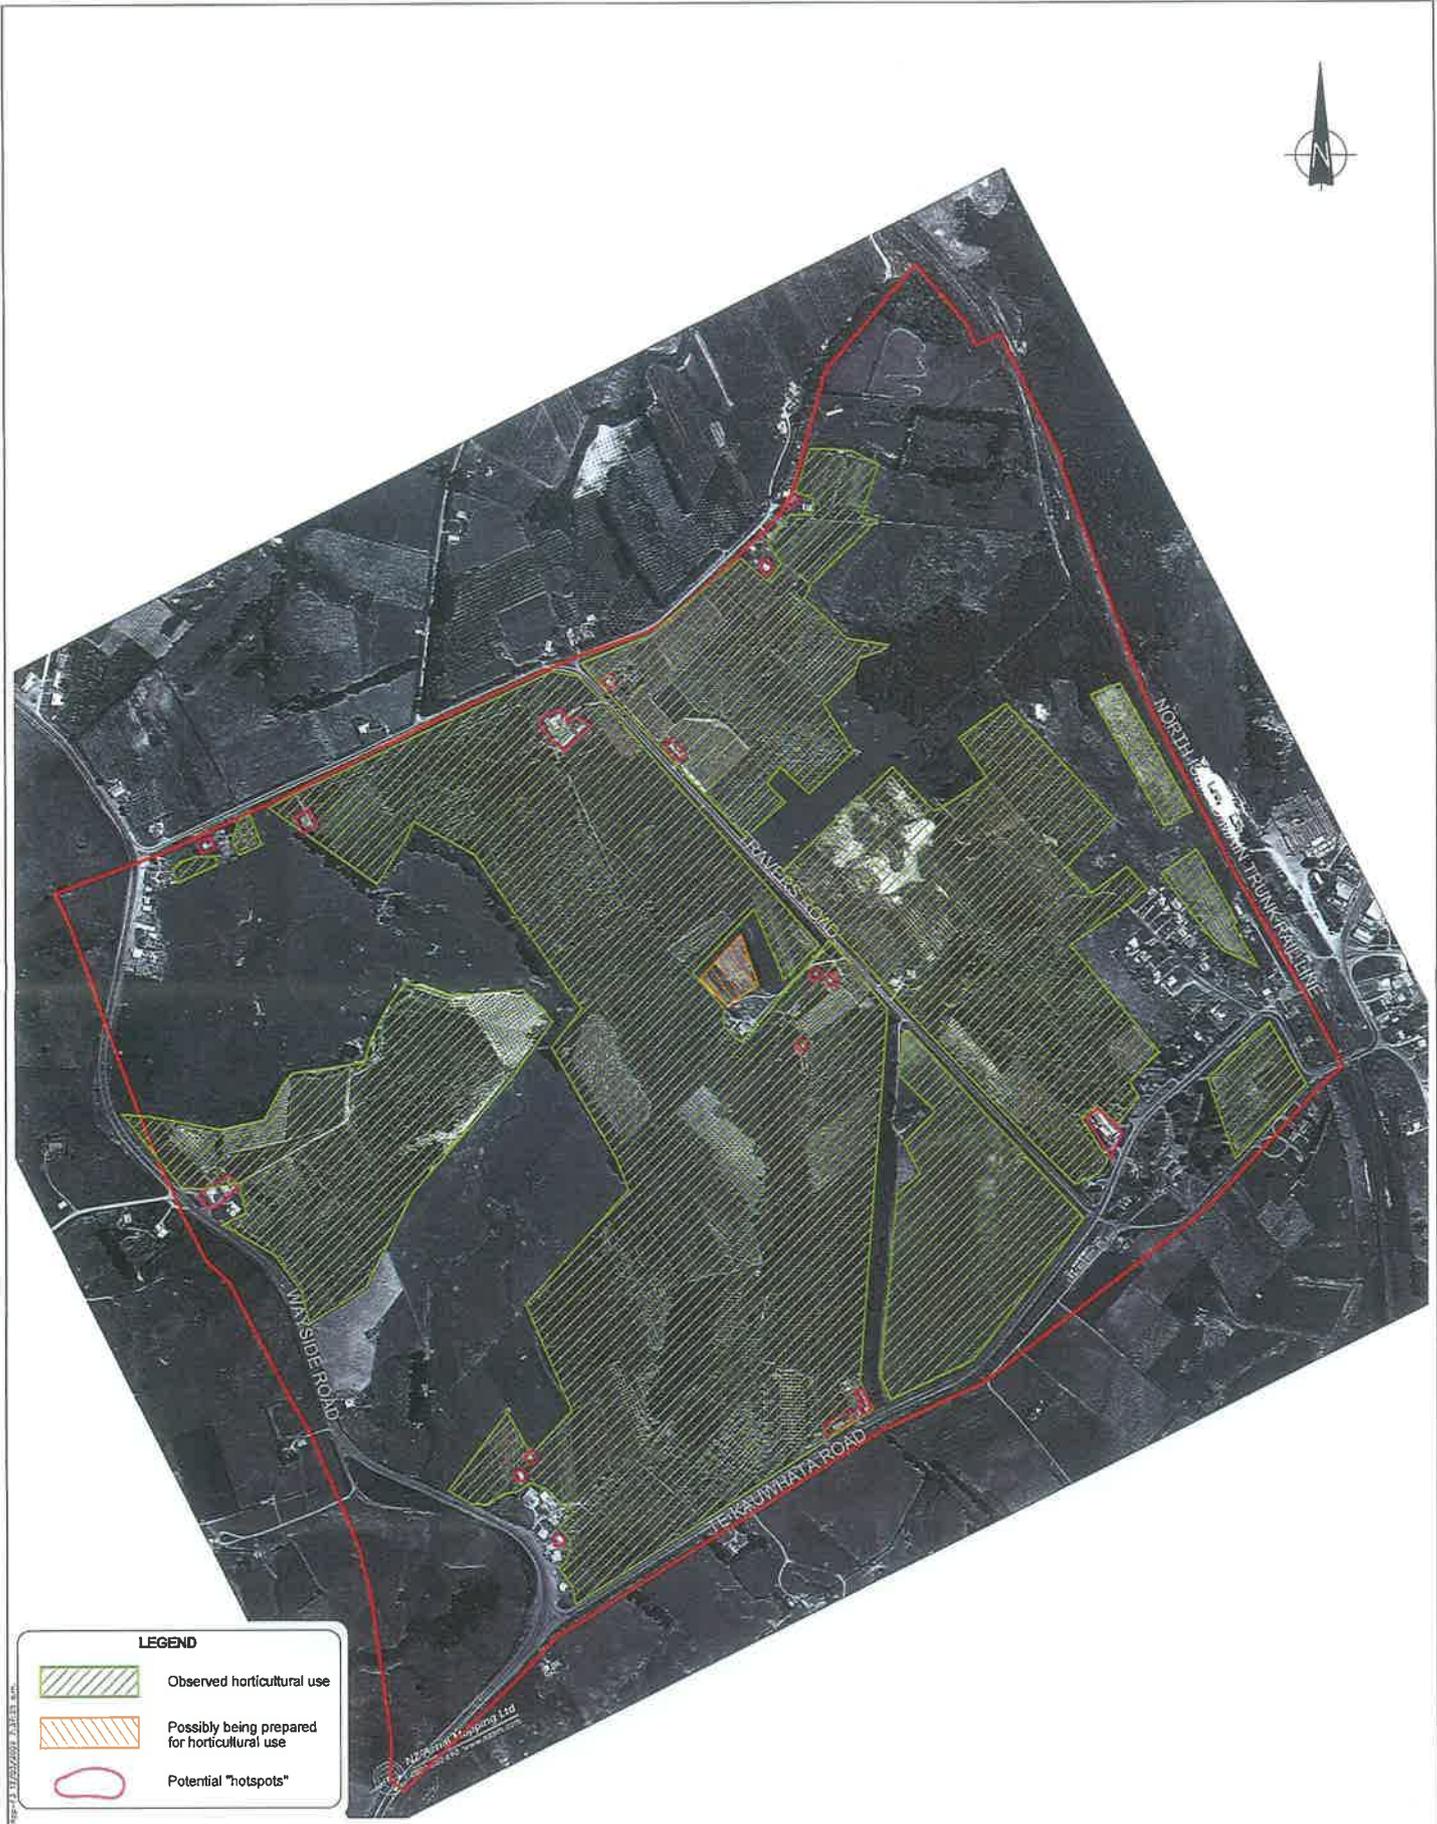
FIG No	Appendix F3	REV	0
--------	-------------	-----	---

WAIKATO DISTRICT COUNCIL
GROUND CONTAMINATION ASSESSMENT DESK STUDY
TE KAUWHATA REZONING
Aerial 1973

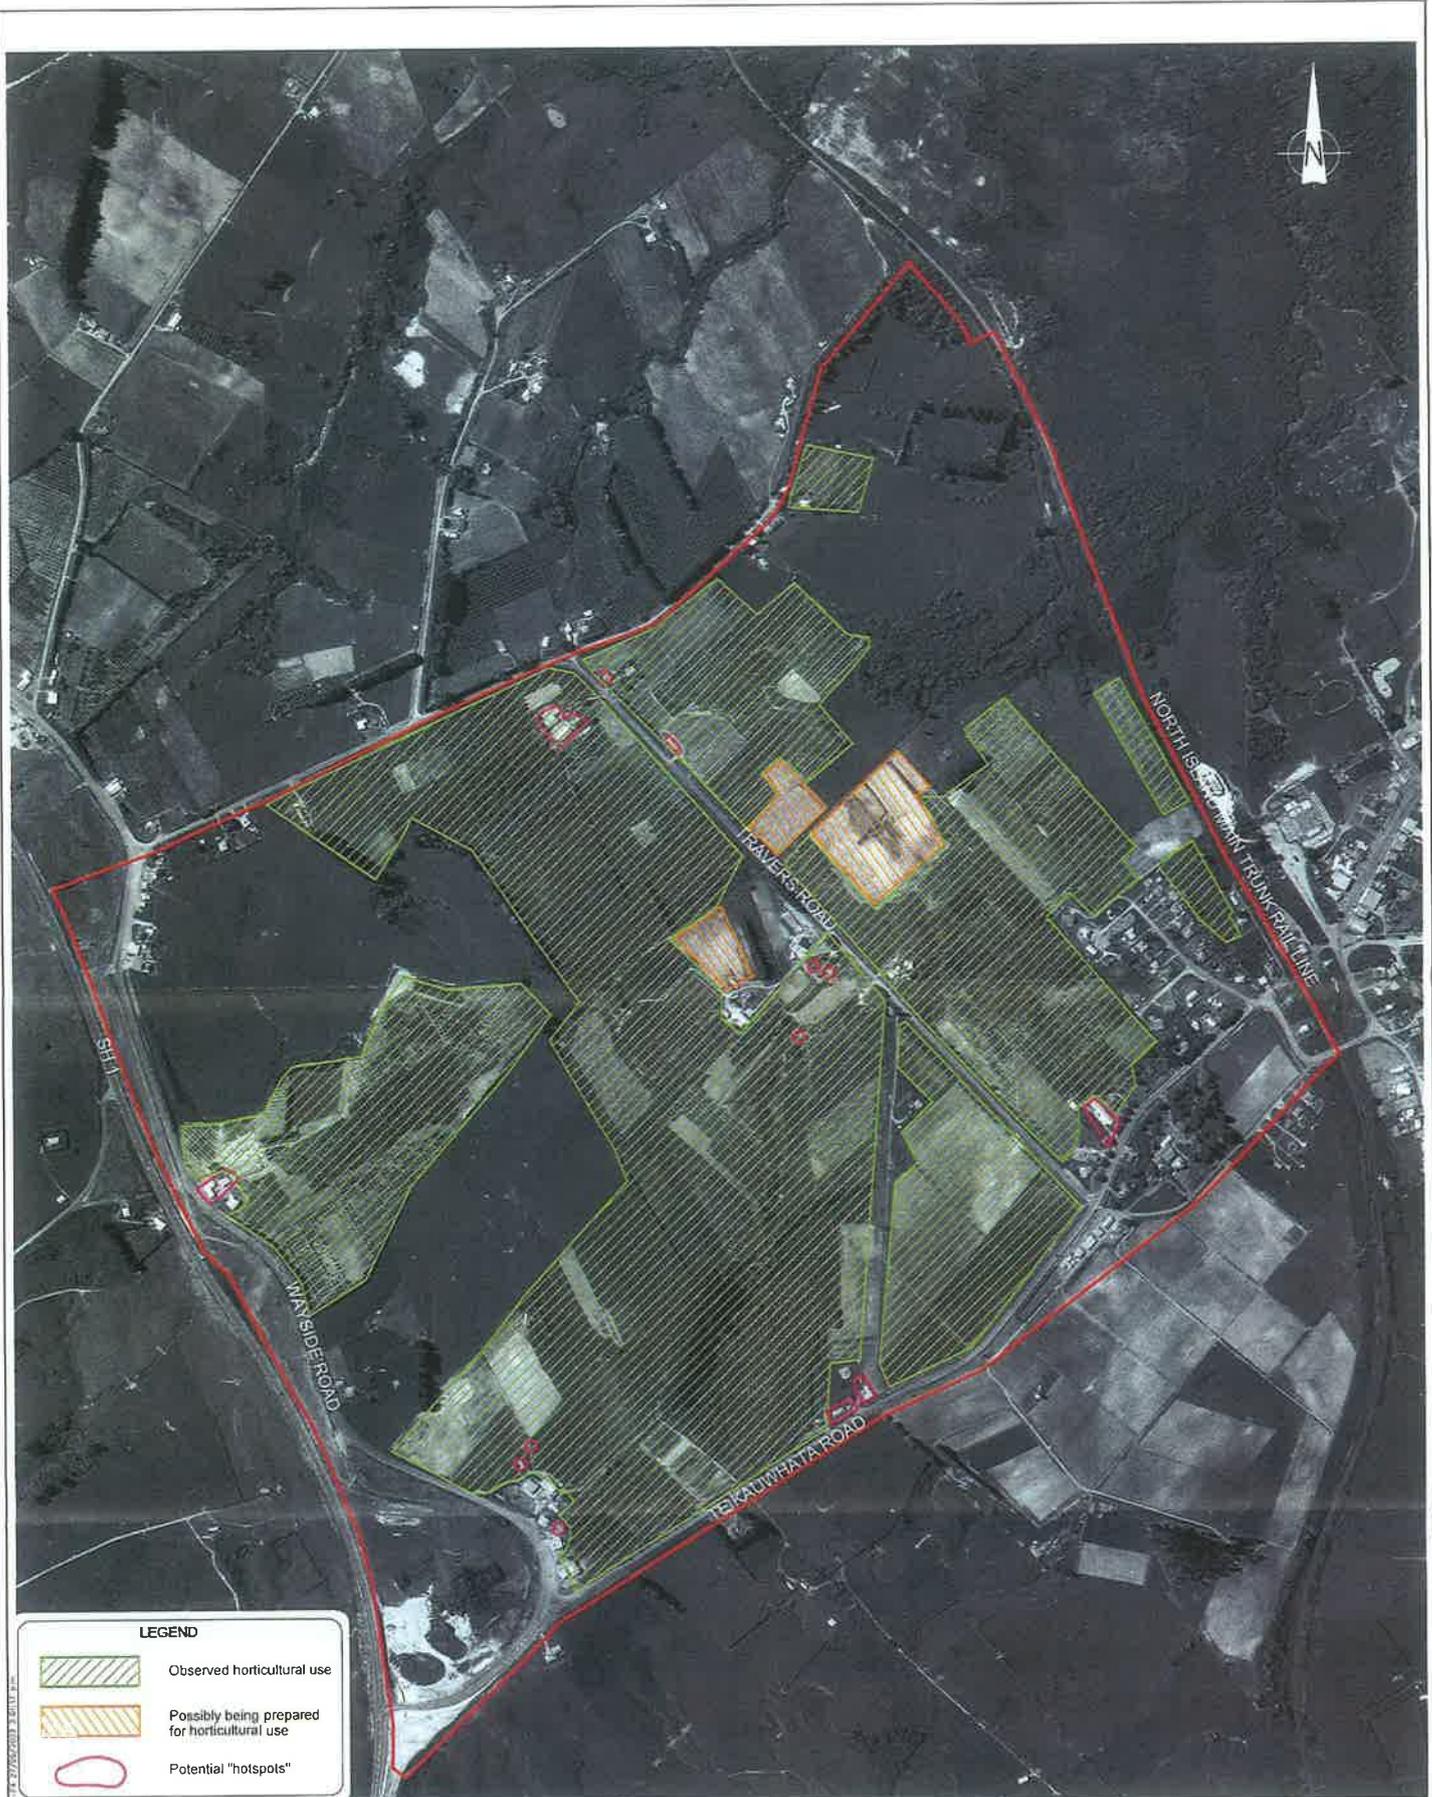
FIG. No.	Appendix F4	REV.	0
----------	-------------	------	---

WAIKATO DISTRICT COUNCIL
 GROUND CONTAMINATION ASSESSMENT DESK STUDY
 TE KAUHATA REZONING
 Aerial 1977

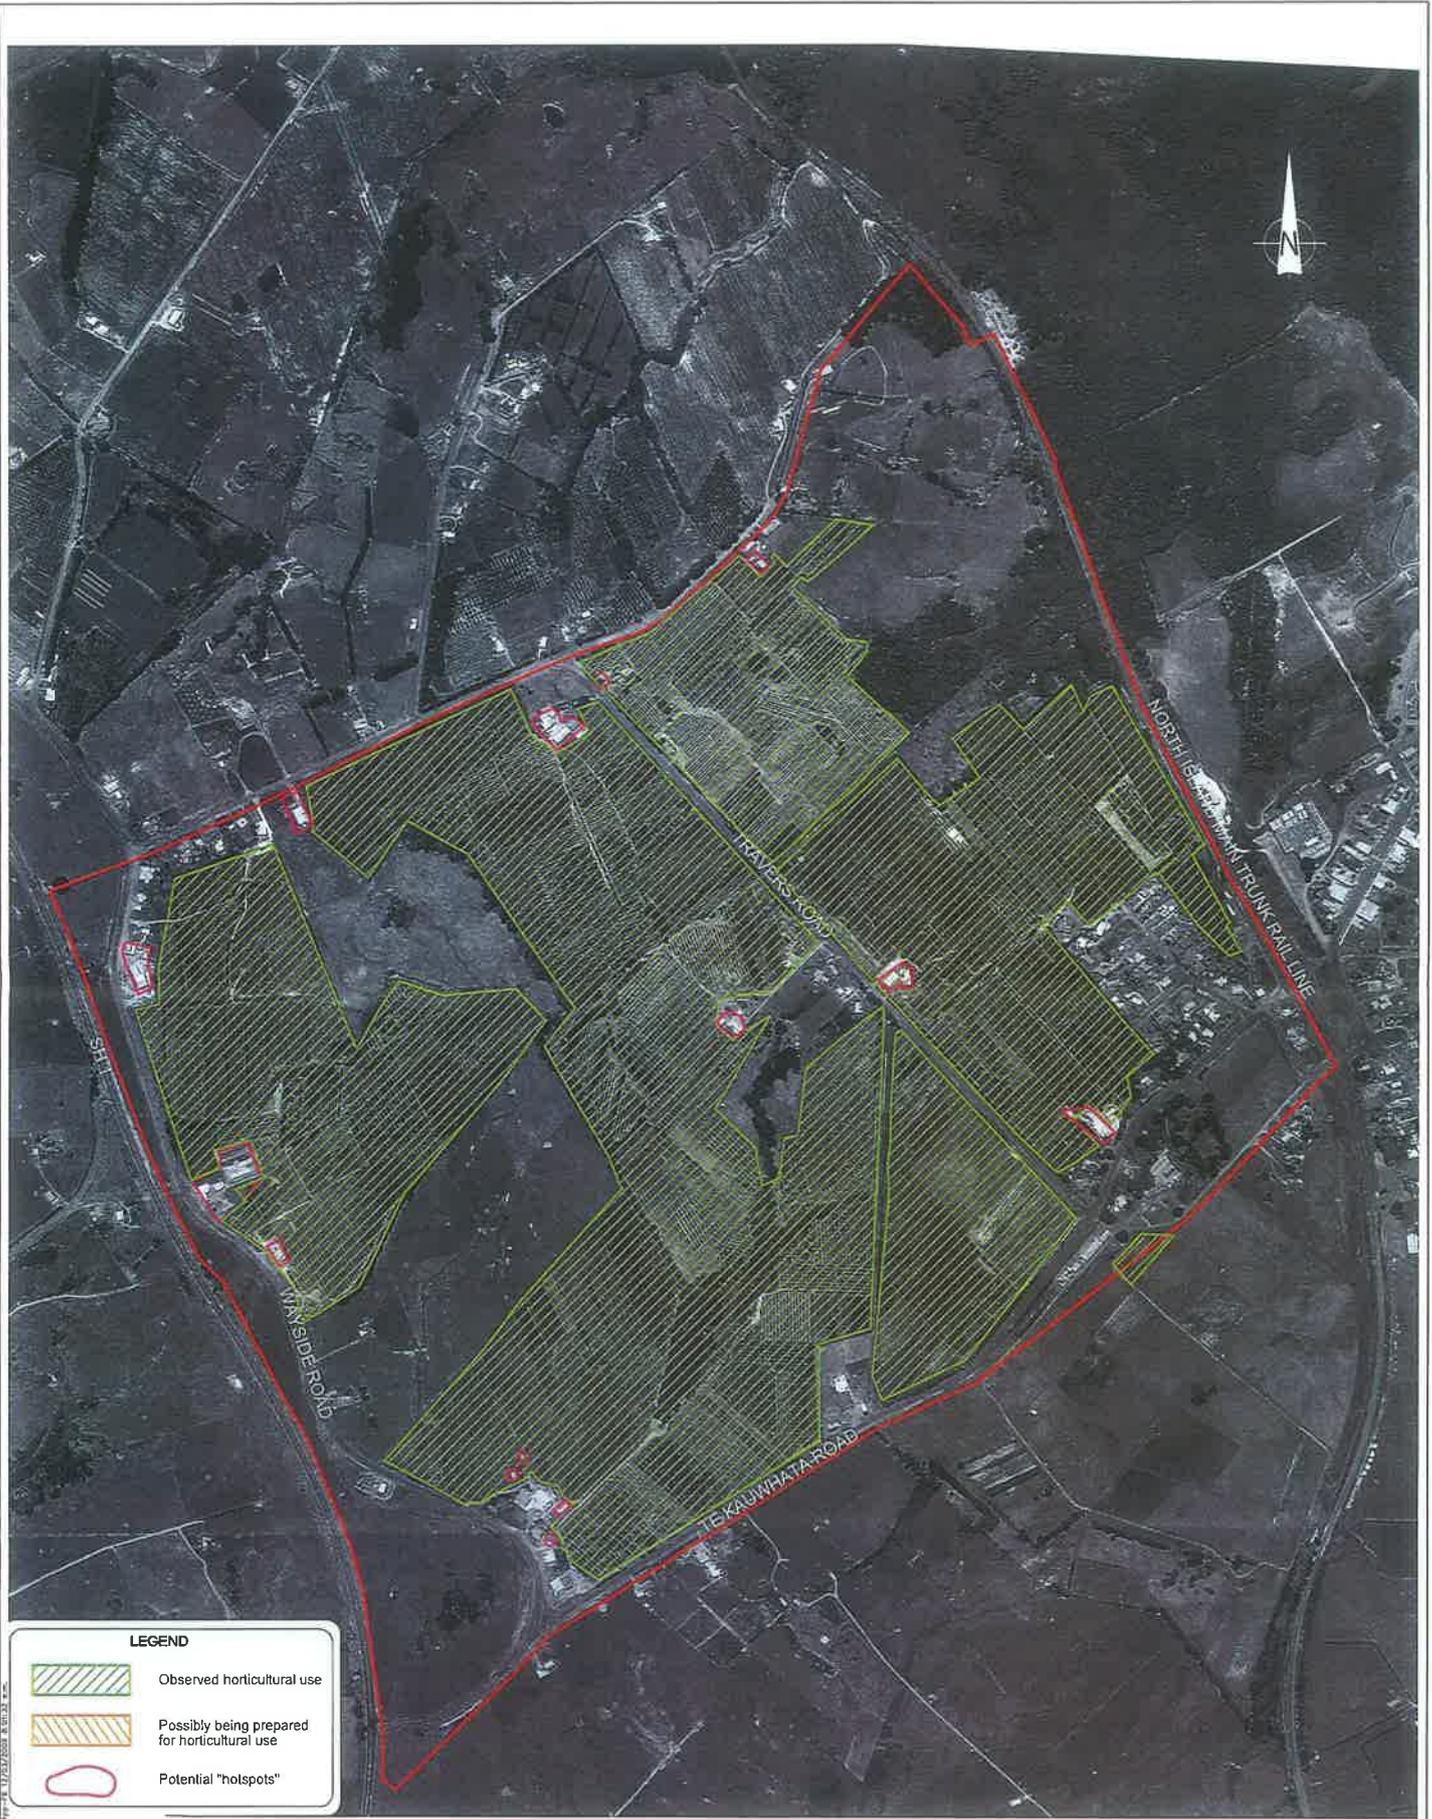
FIG. No. Appendix F5 REV 0

WAIKATO DISTRICT COUNCIL
GROUND CONTAMINATION ASSESSMENT DESK STUDY
TE KAUWHATA REZONING
Aerial 1984

- Observed horticultural use
- Possibly being prepared for horticultural use
- Potential "hotspots"
