LAND INFORMATION MEMORANDUM

Please find enclosed your Land Information Memorandum for 48 Travers Road TE KAUWHATA.

Valuation Reference:	04390/693.02
Legal Description:	Lot 2 DP 353641
Area:	8000 square metres more or less
Property Location:	48 Travers Road TE KAUWHATA
Owners:	Christopher Paul Woodham, Nicole Patricia Woodham, Gail Frances Drain

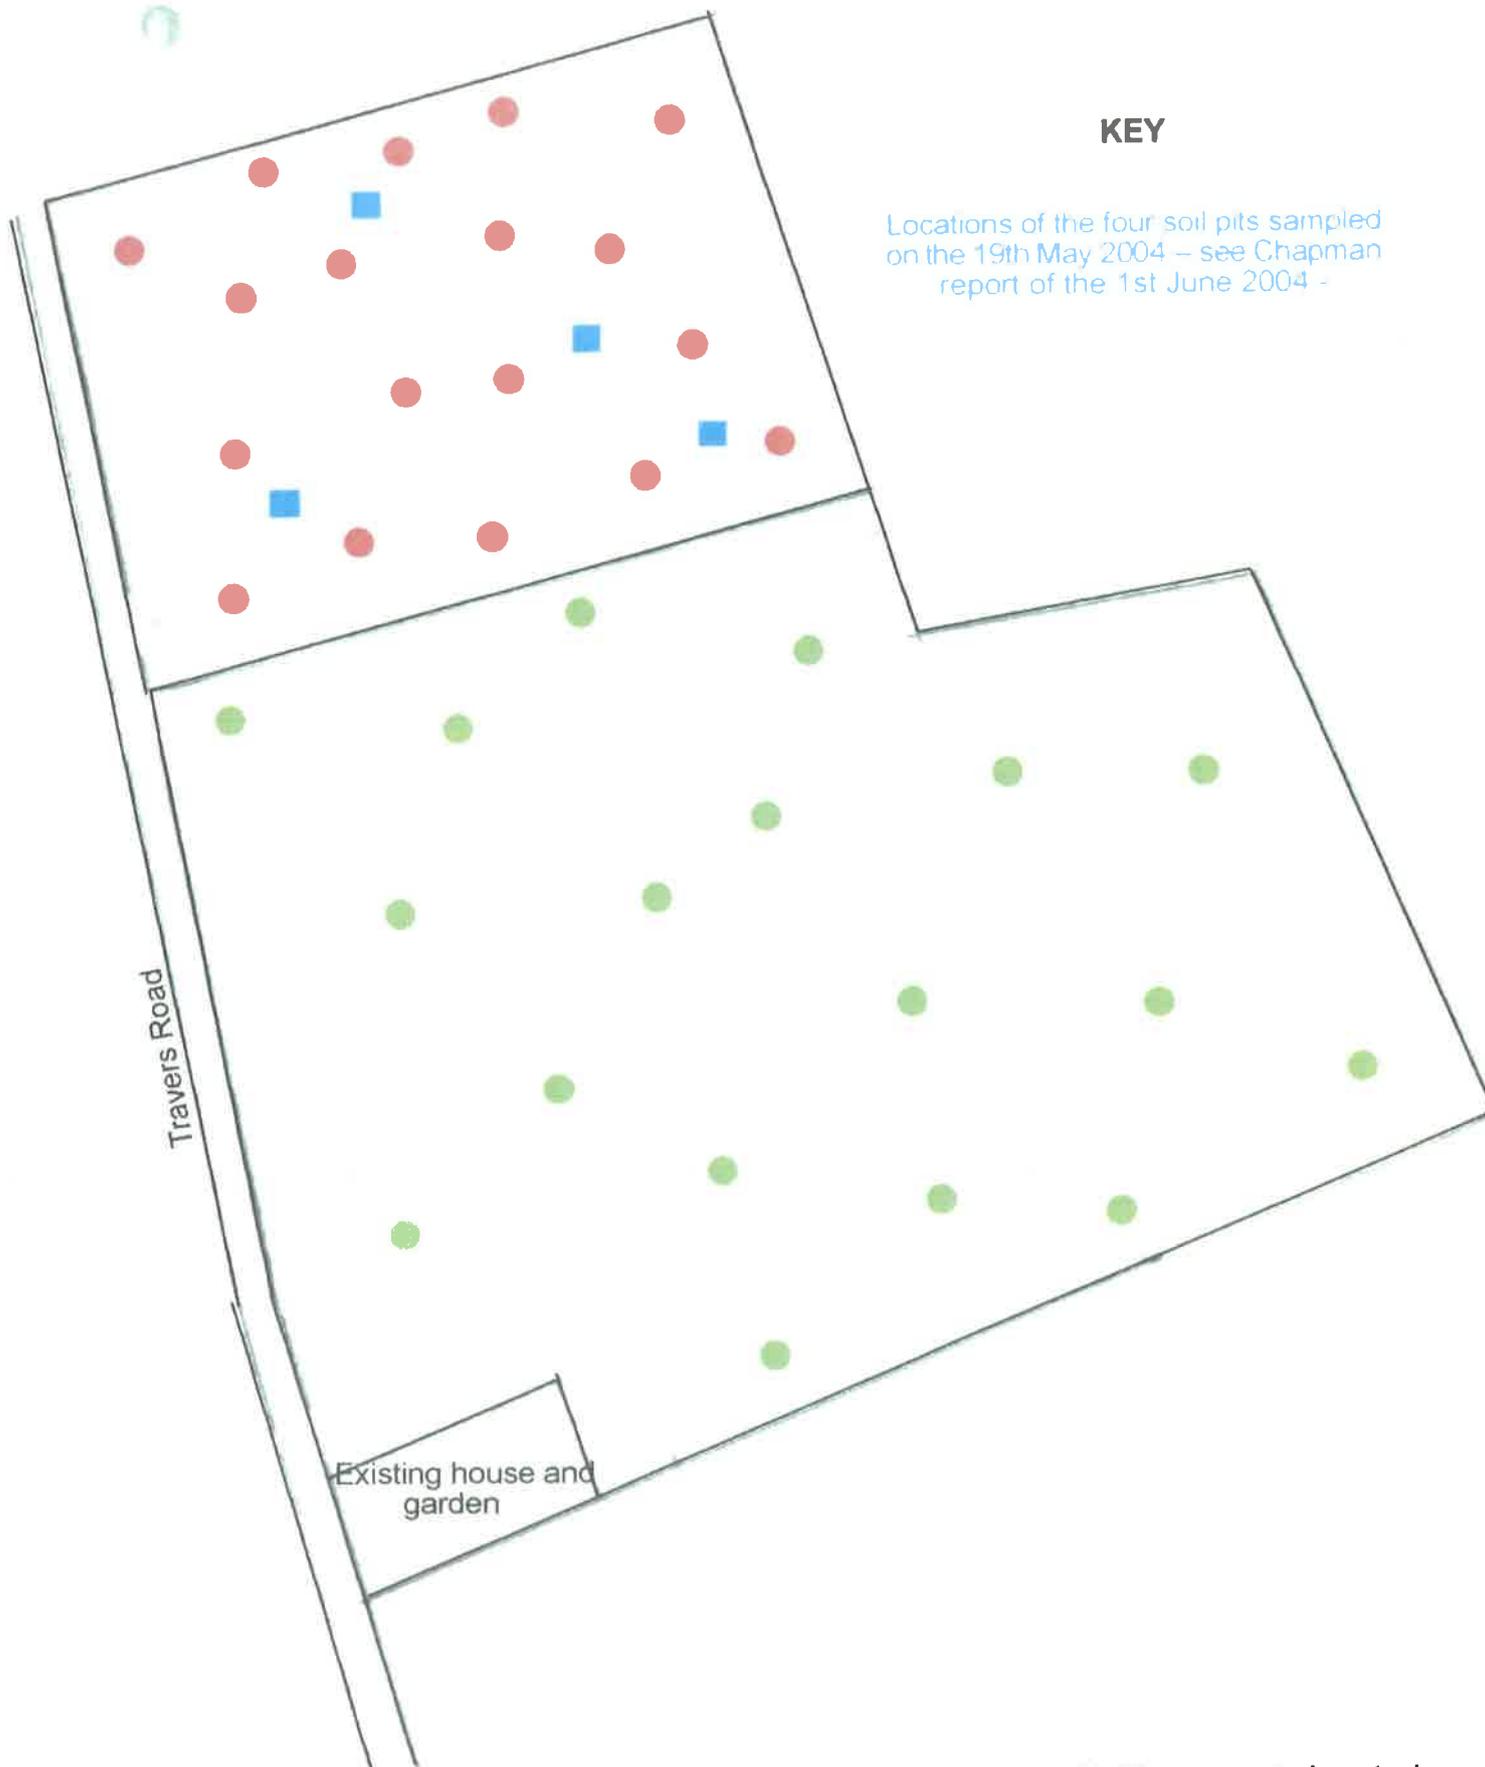
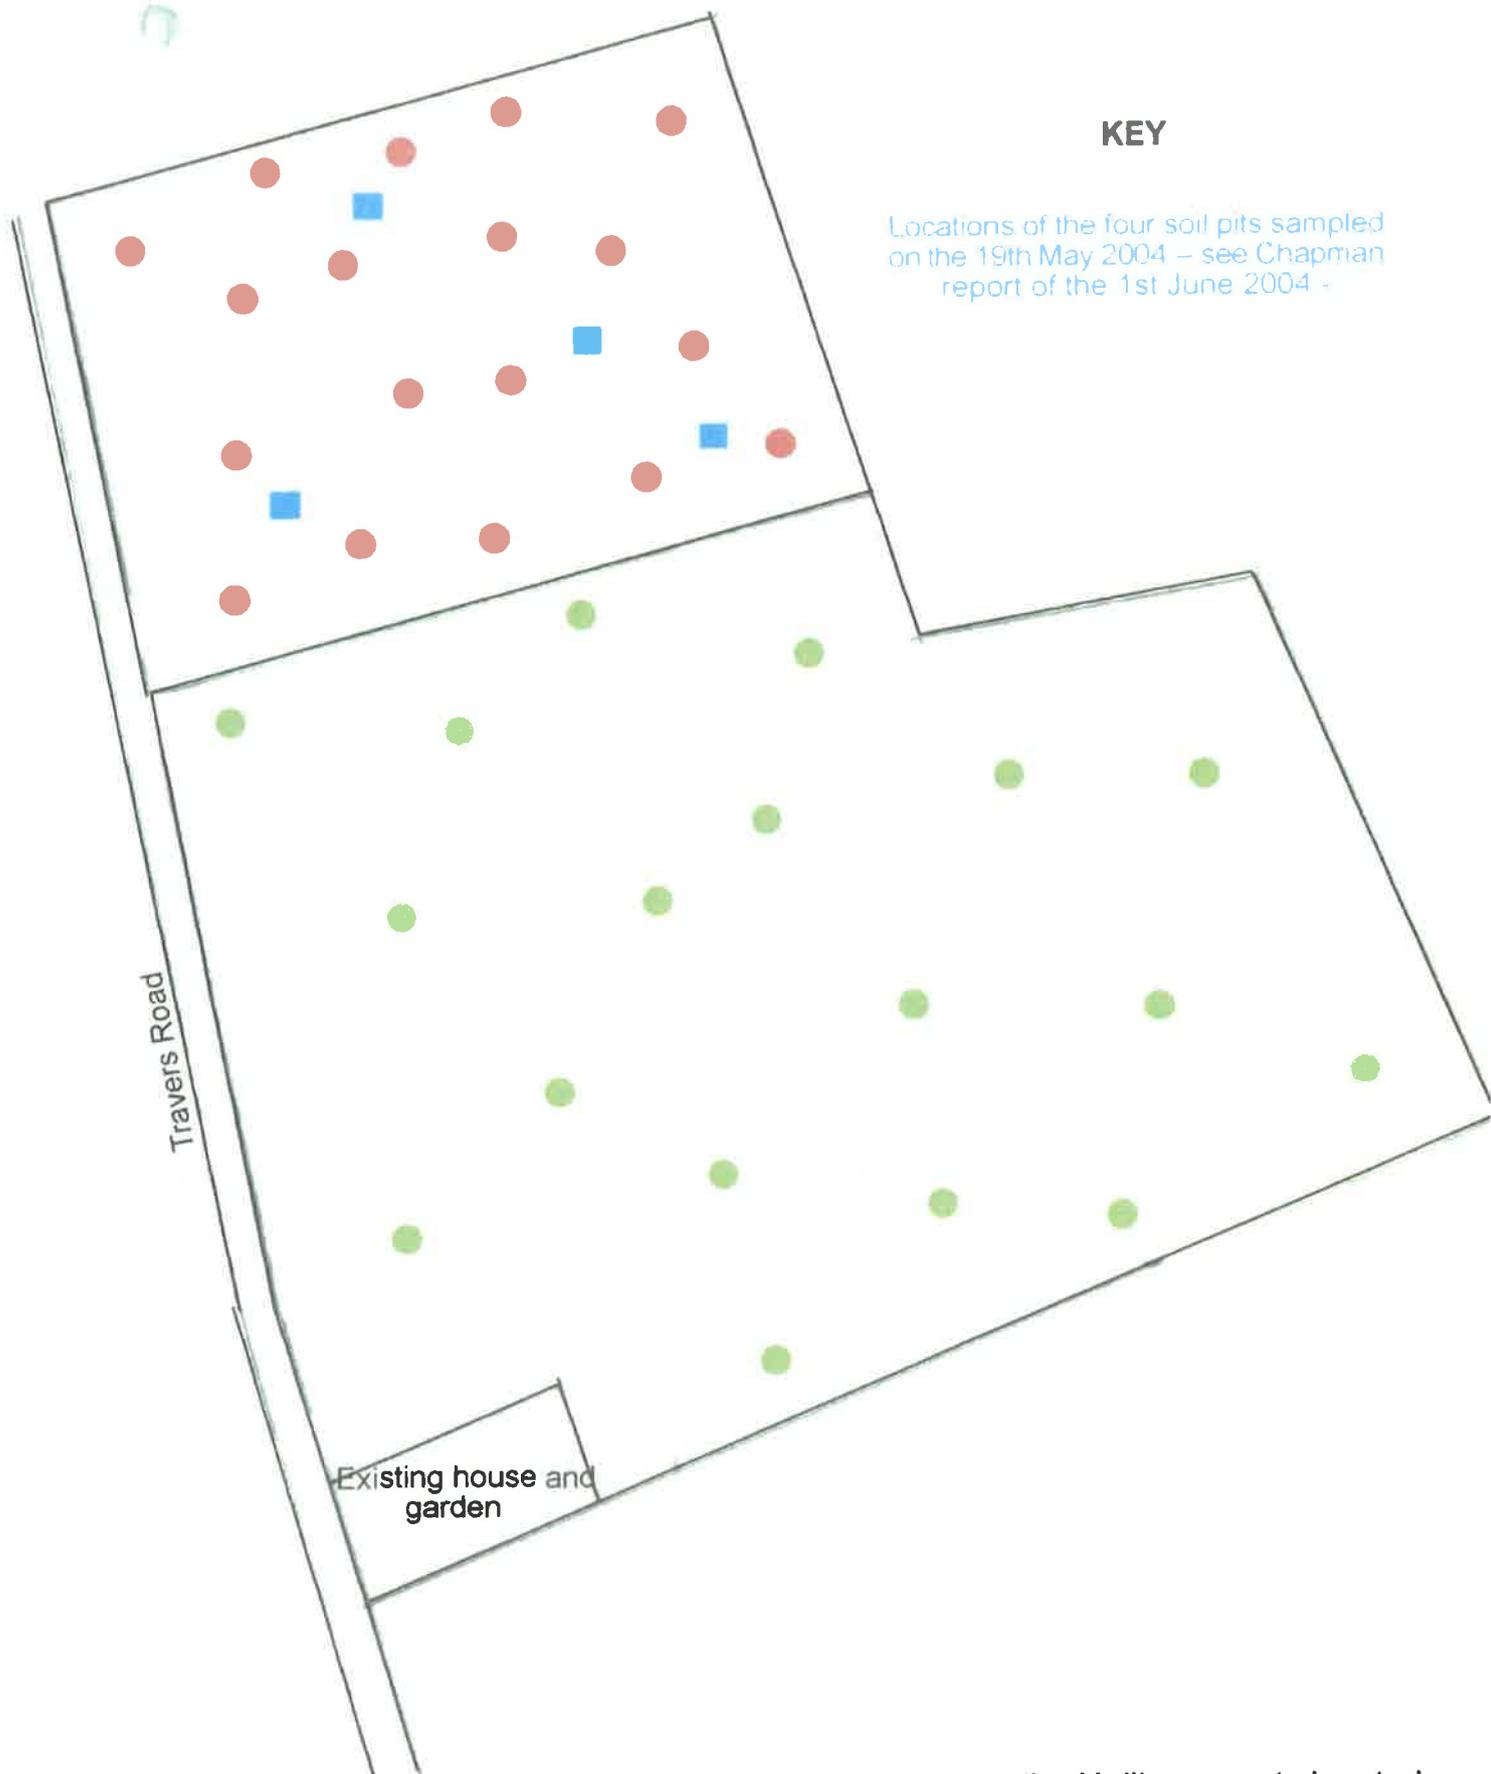
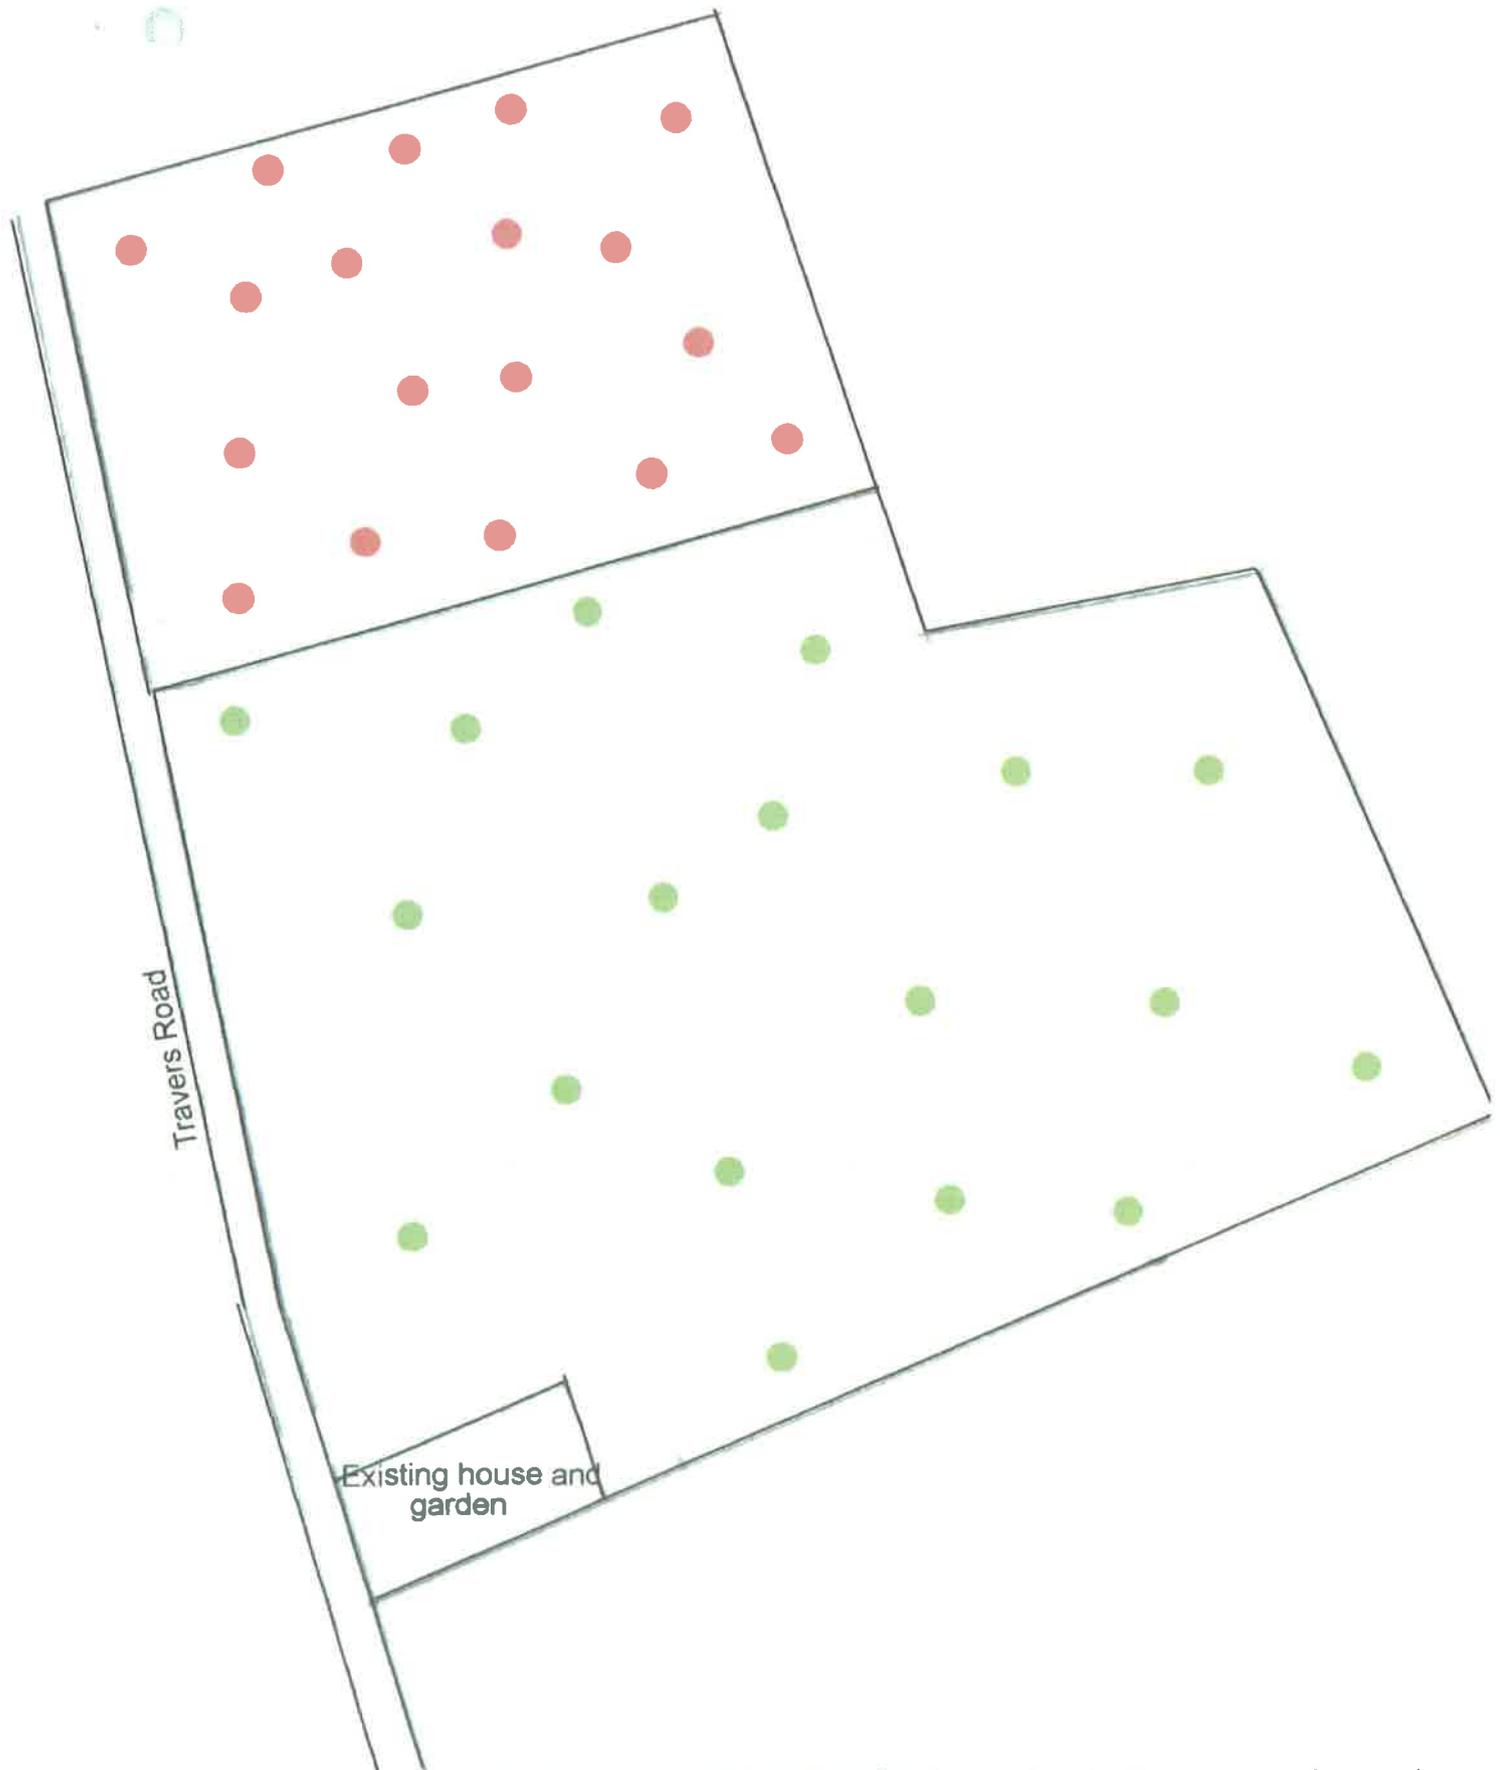
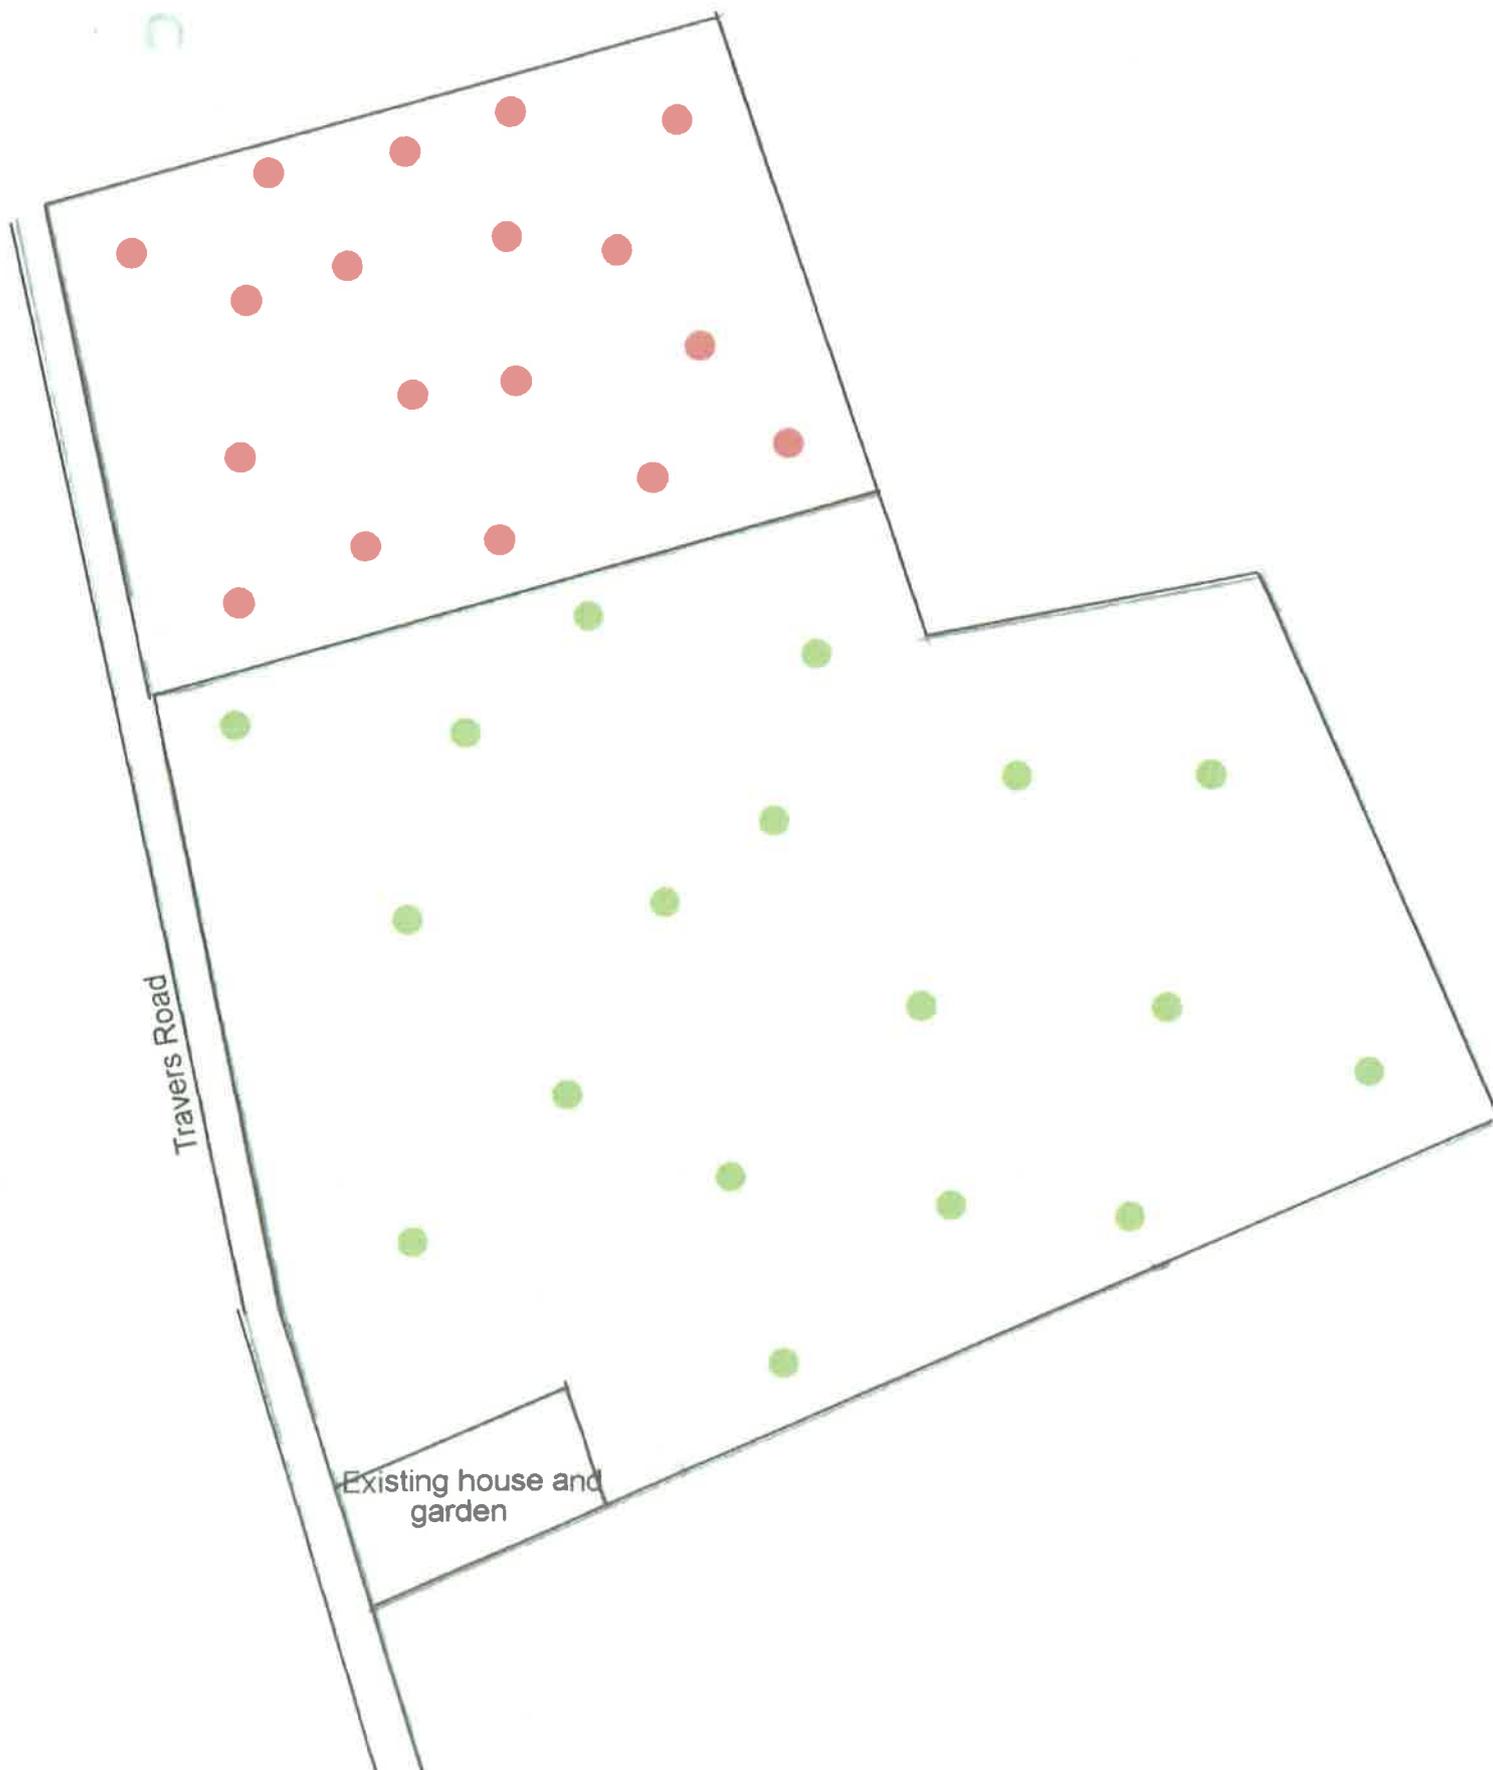
Locations of the four soil pits sampled on the 19th May 2004 – see Chapman report of the 1st June 2004 -

Soil core sampling locations for potential contamination at the Hall's property located at 26 Travers Road - Te Kauwhata. Total area of the property is about 3 ha.
Composite soils - **Sample Lot 1** and **Sample Lot 2**

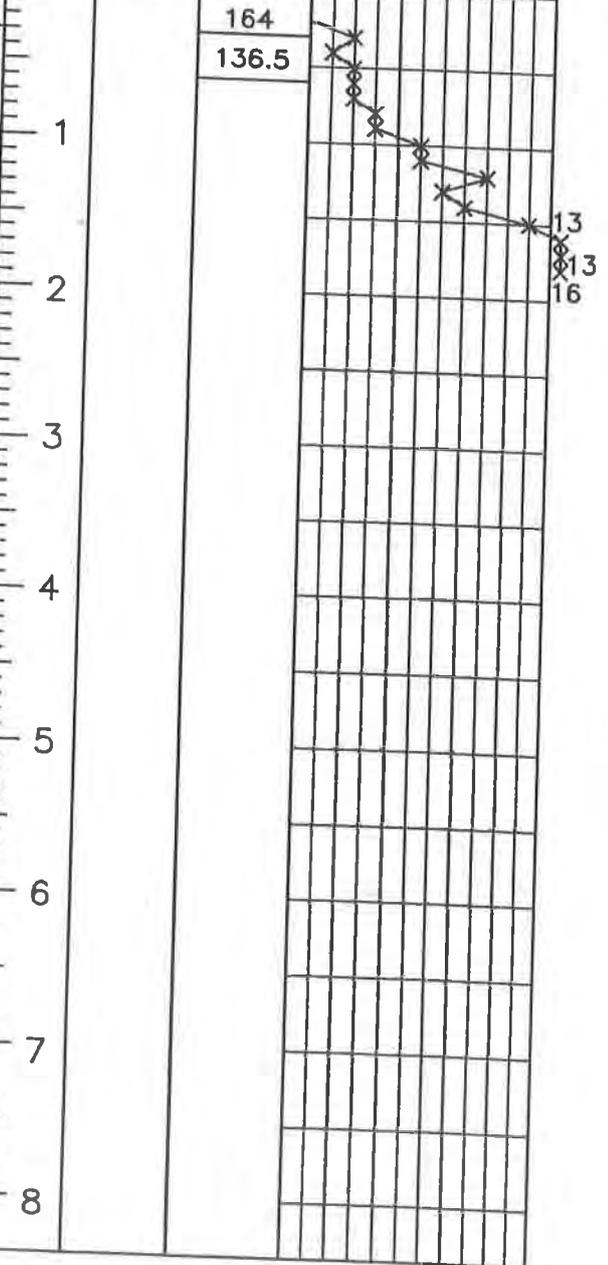
Depth in Metres	Vane Shear Strength (kpa)	Scala Penetrometer (blows per 100mm drop)
0		
0.1	164	
0.2	136.5	
0.5		
1.0		
1.5		
2.0		
2.5		
3.0		
4.0		
5.0		
6.0		
7.0		
8.0

Note: The stratification lines represent the approximate boundary between soil types and the transition may be gradual

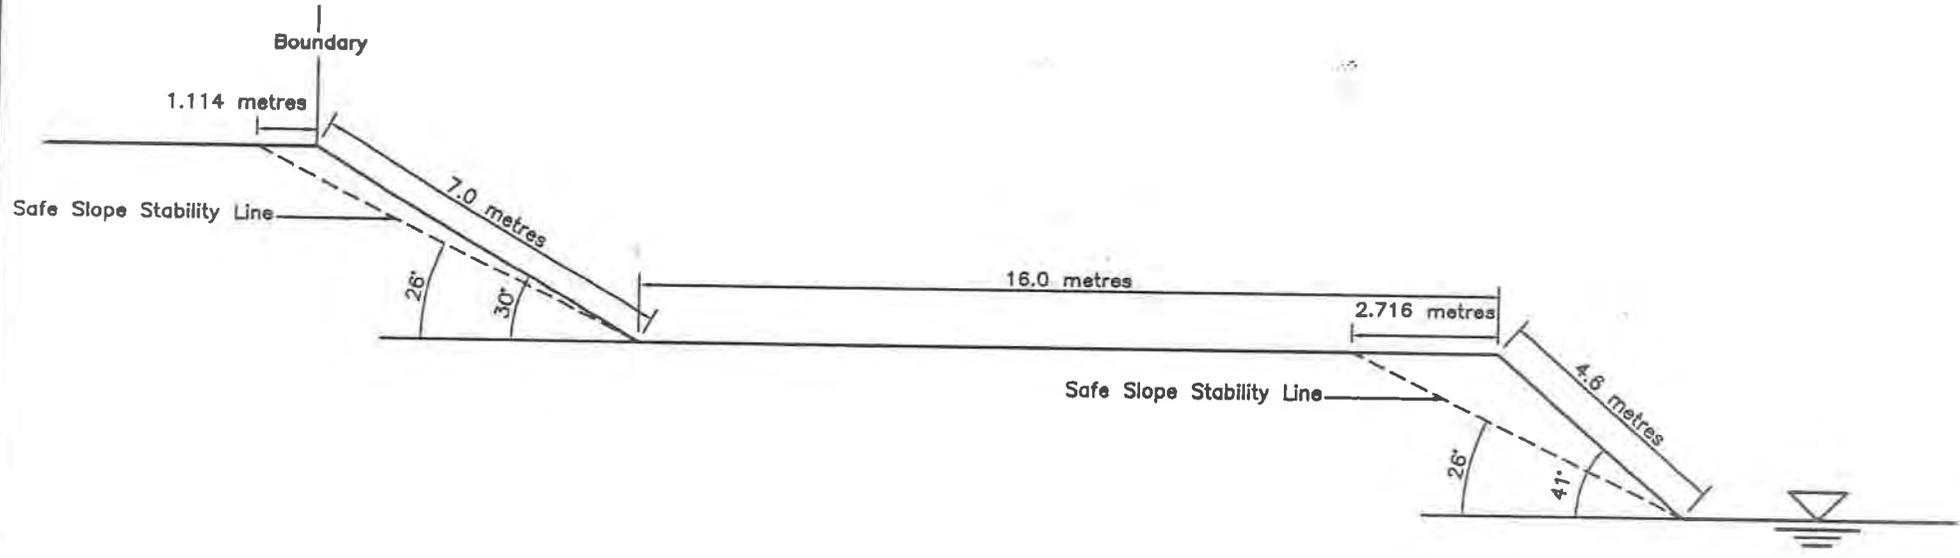
SECTION 'A-A' NTS

Cross Section	Proposed New Residence At #48 Travers Road, Te Kauwhata, For Phil Massey.	G.A.HUGHES & ASSOCIATES Ltd.		SHEET 7674/3
		CONSULTING CIVIL & STRUCTURAL ENGINEERS Cnr. Graham & Newall Streets, Hamilton East. P.O. BOX 4306		
		DRAWN J.LANG	CHECKED	NO 4
		TRACED	DATE 05/06/07	REF 055635
			SCALES NTS

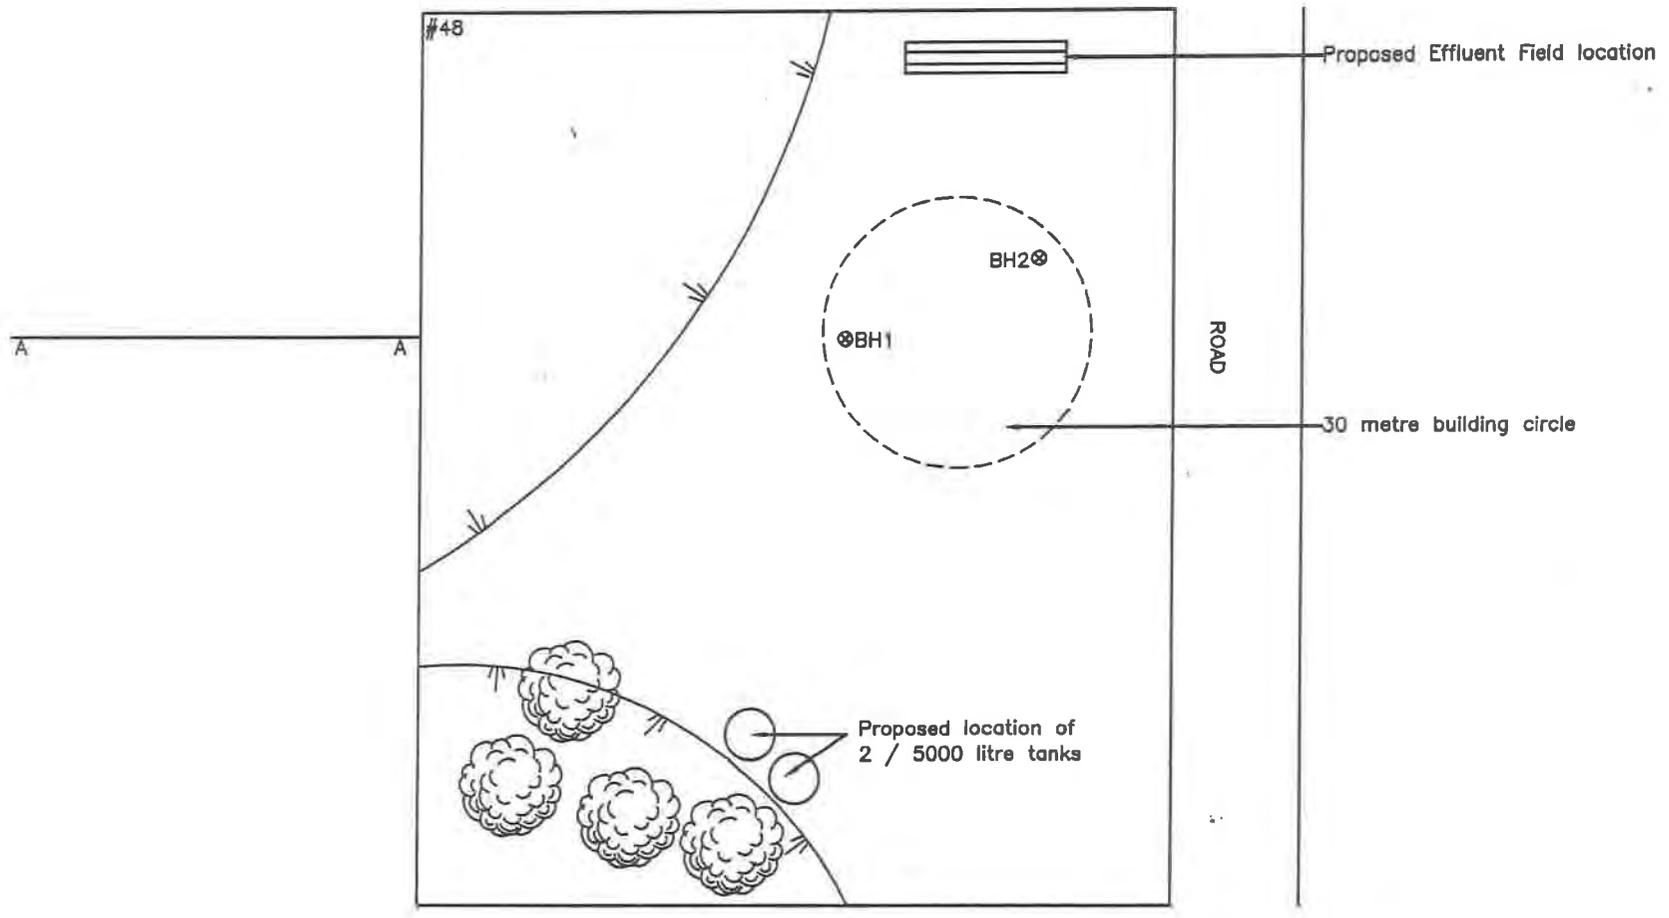
Site Plan	Proposed New Residence At #48 Travers Road, Te Kauwhata, For Phil Massey.	G.A.HUGHES & ASSOCIATES Ltd.		SHEET
		CONSULTING CIVIL & STRUCTURAL ENGINEERS Cnr. Graham & Newall Streets, Hamilton East. P.O. BOX 4306		7674/4
		DRAWN J.LANG	CHECKED	SCALES
		TRACED	DATE 05/06/07	NTS
				NO 4
				REF 055635
