INSIGHT BUILDING INSPECTIONS

RESIDENTIAL INSPECTION

8 Thornaby Cl
Christchurch, Canterbury Region 8053

18/03/2026

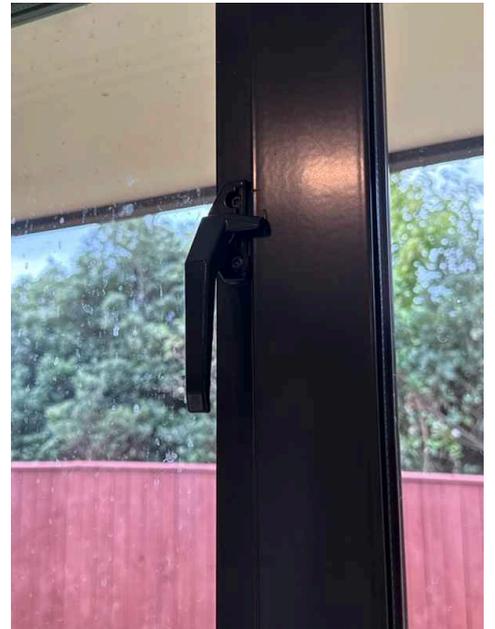
6.5.1 Windows & Reveals

MISSING STRIKER PLATE

The striker plate is missing from the window latch, preventing the window from sealing correctly. We recommend the latch and striker plate be replaced.

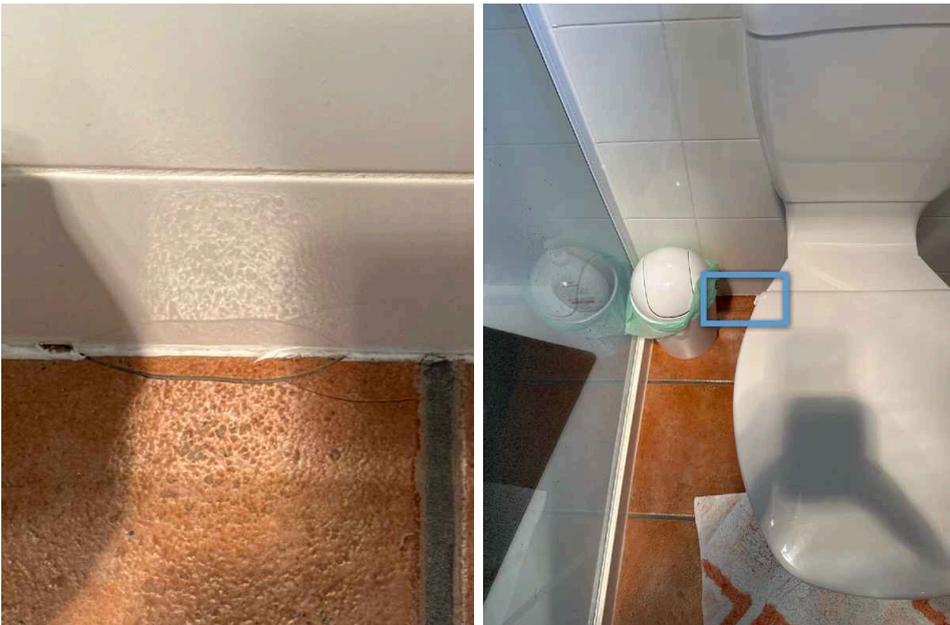
12.6.1 Floors

CRACKED TILE

There is a cracked floor tile to the left of the toilet. This is considered a cosmetic issue only.

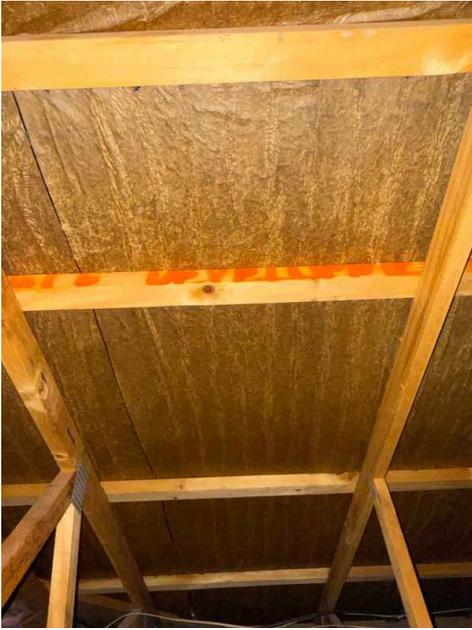
15.6.1 Roof Underlay

DETERIORATING

The roofing underlay is deteriorating and showing signs of age-related breakdown. No active leaks were observed at the time of inspection; however, its effectiveness is reduced.

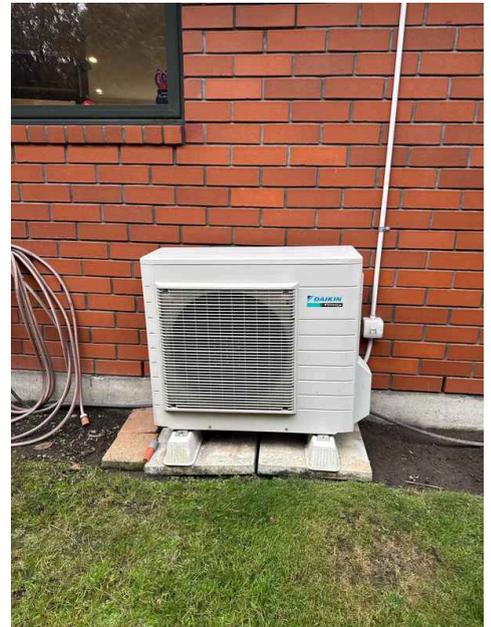
17.1.1 Heating & Air Conditioning

POSITIONED

The exterior heat pump unit is installed on an uneven/leaning base. This may affect performance and long-term operation. We recommend the unit be re-levelled and adequately supported.

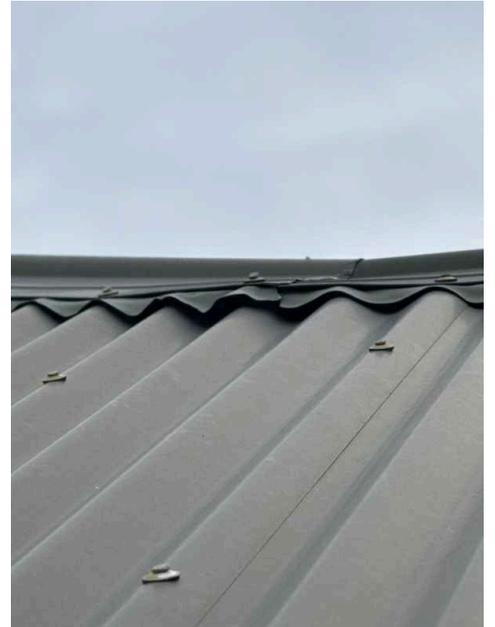
LOOSE RIDGE CAP FIXING

There is a loose ridge capping fixing on the west side of the roof. We recommend this be assessed and repaired by a qualified roofer.

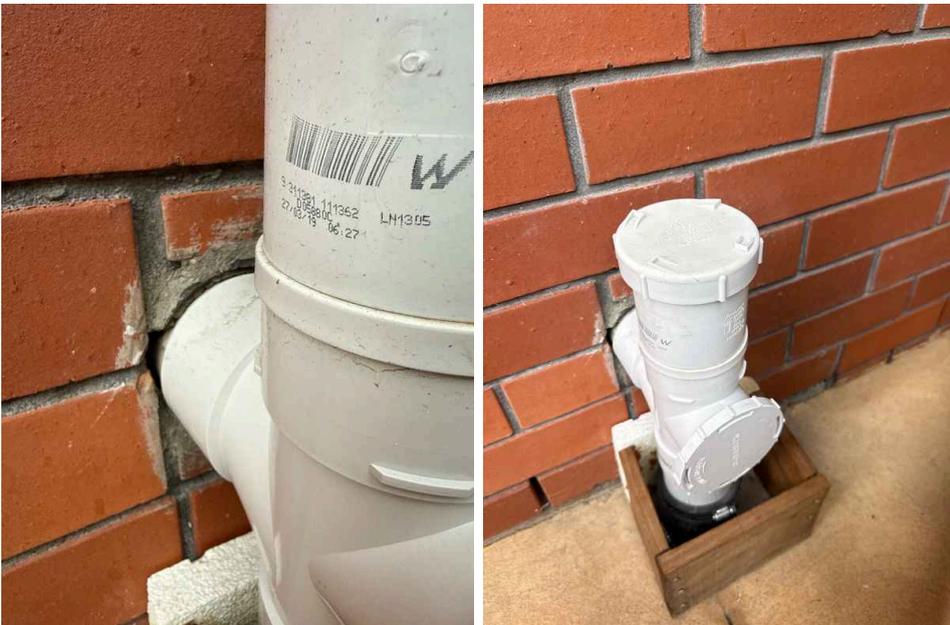
22.7.1 Cladding Type

The cladding penetration for the ensuite toilet waste is not sealed, presenting a risk of moisture ingress. We recommend this be sealed by an appropriate tradesperson.

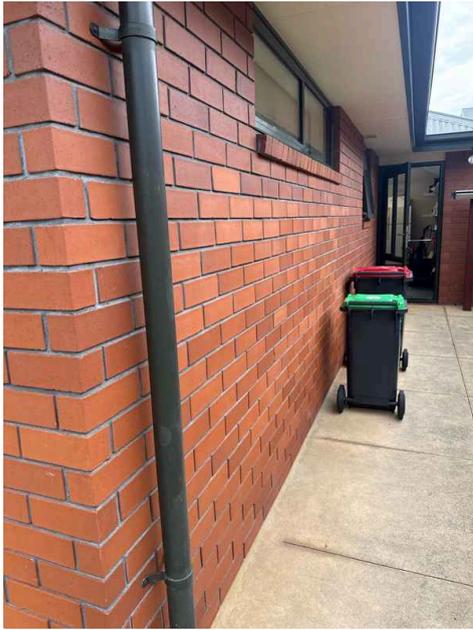
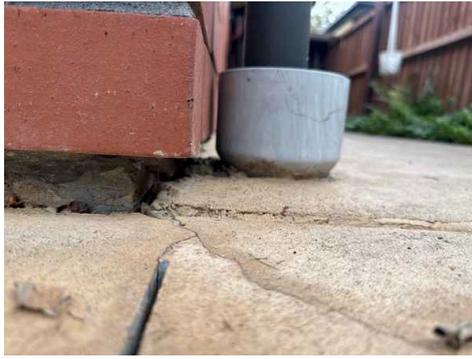
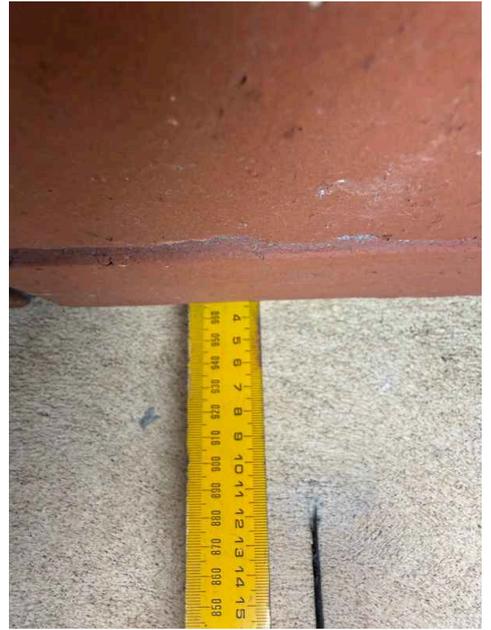
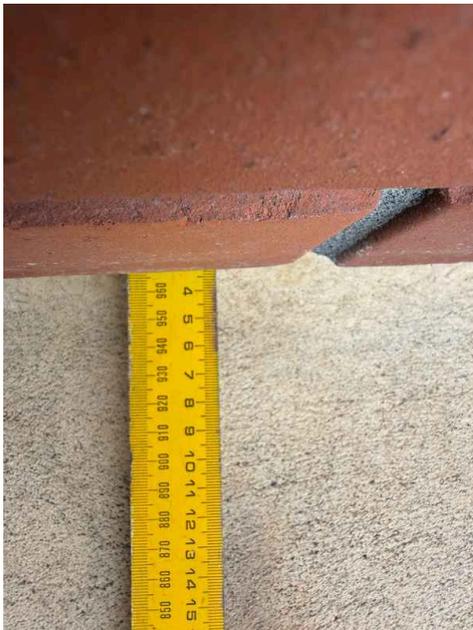
22.7.2 Cladding Type

BRICK OVERHANG (WEST)

The brick cladding on the west elevation overhangs the foundation by approximately 35mm. This exceeds typical trade practice, where an overhang of approximately 15mm is generally expected. While no issues were observed at the time of inspection, we recommend ongoing monitoring.
