BUILDING INSPECTION REPORT

53 Marshall Street, Woolston. Building Report

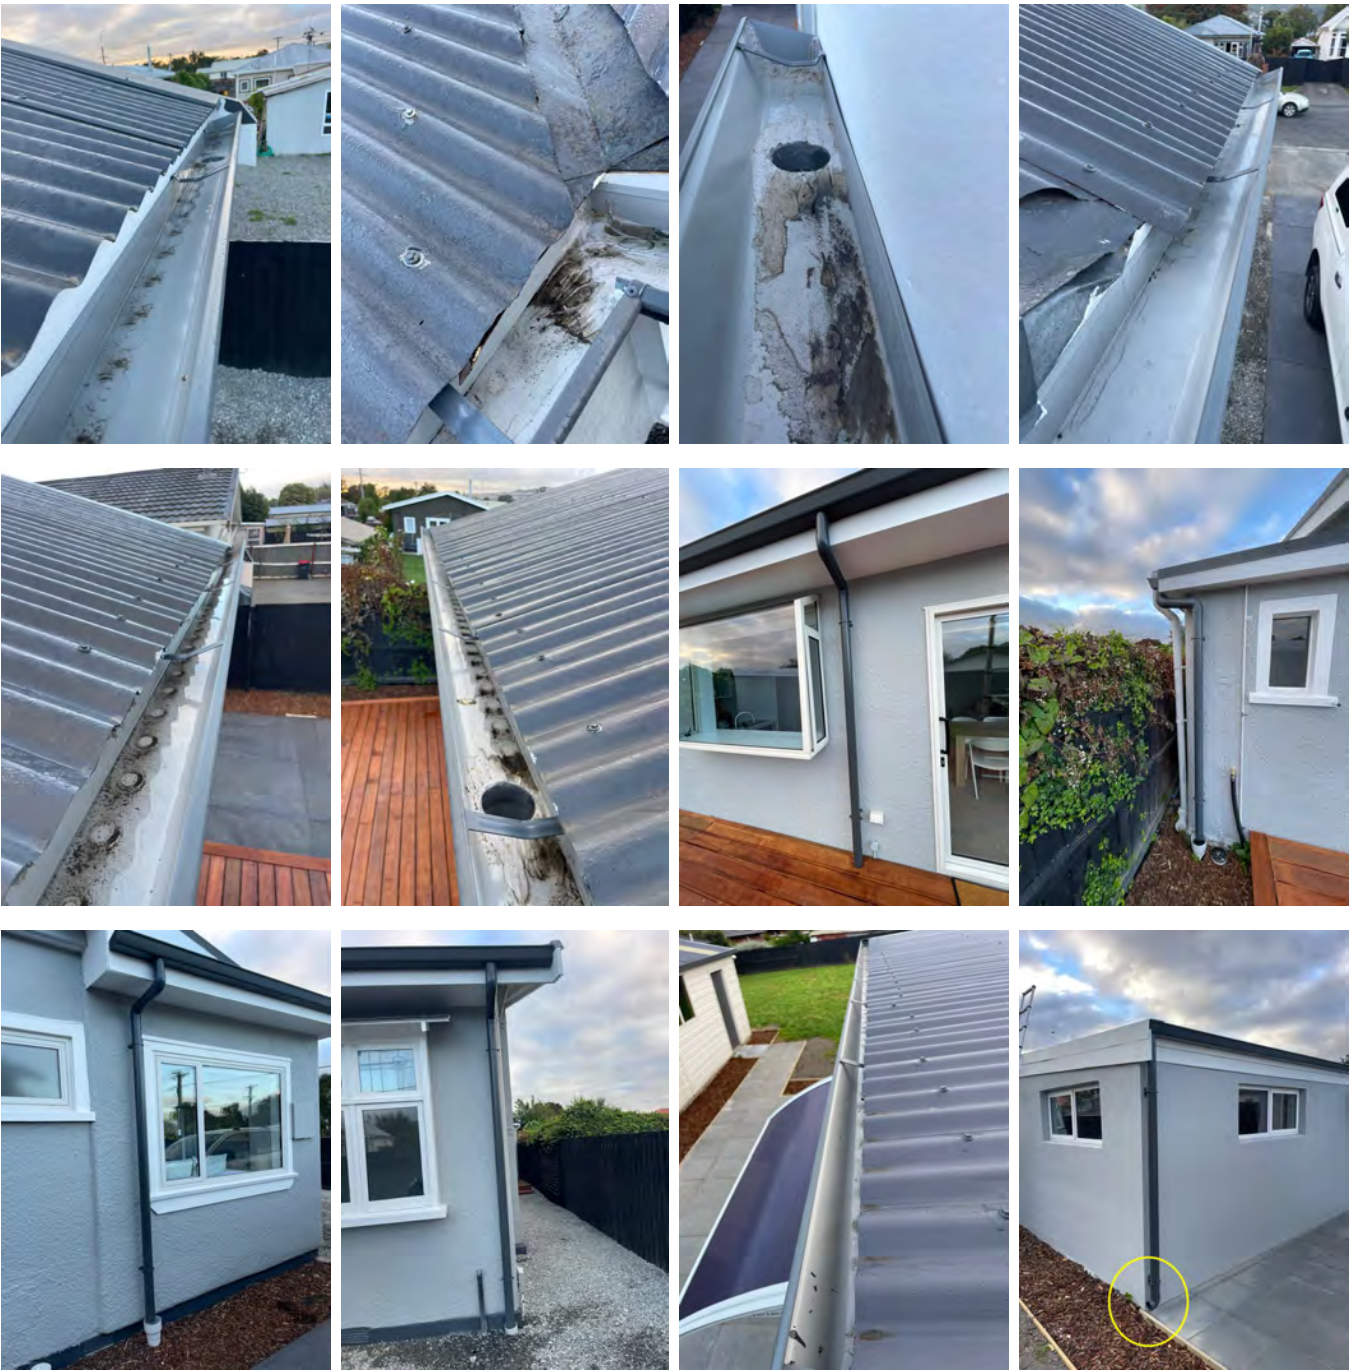
Downpipes and gutters fixed well in place and not loose. Downpipes on the main dwelling discharge into ground risers. Gutters and downpipes clear from debris build up.

No stormwater riser noted for sleep out.

It is recommended to check and clear gutters and stormwater risers regularly to maintain good drainage.

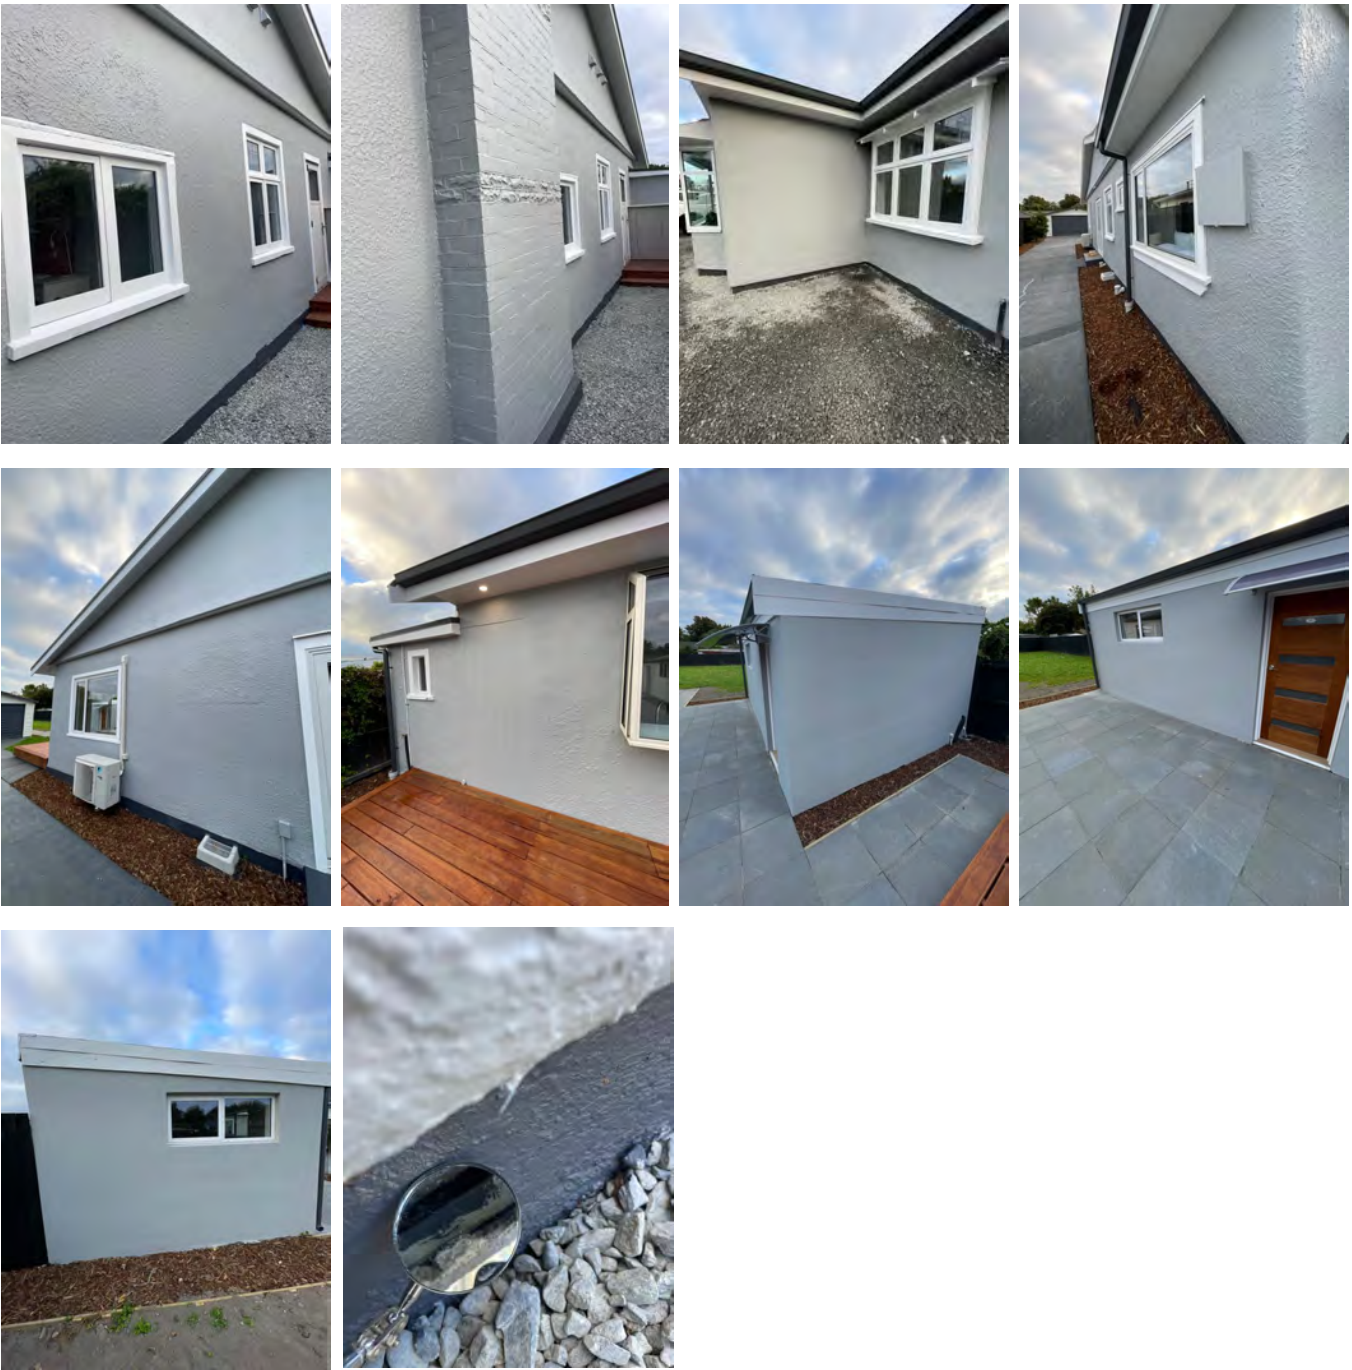
Maintained well. No general concerns. Direct-fixed, plaster finish claddings are prone to weather tightness issues, especially if the exterior of the cladding system is not properly maintained; this is particularly evident in homes that have polystyrene (EIFS) or fibre cement substrate. Also included in this are older plaster finish claddings like rough-cast/stucco over original timber weatherboards or other substrates. If moisture ingress occurs, it is difficult for the internal frames to dry due to the lack of a cavity, which can cause premature deterioration of the internal frames, rot, mould growth and structural damage. Further to this, flashings and junctions on these systems can pose a risk if they have not been installed or finished well. Ensure regular maintenance and cleaning of the cladding system is carried out. Where cracks may appear for an extended period of time, invasive investigation will be required to ensure no moisture has penetrated the cladding. More recent minor cracks should be professionally fixed as they appear. These generally occur at joins, junctions, or corners of exterior joinery, re-plaster and paint using an elastomeric membrane; this ensures that if the plaster does crack, the flexible elastomeric membrane will bridge the crack, assisting with maintaining its weather tightness. This is a visual and non-invasive assessment of the exterior condition. If the home has previously had points of moisture ingress that have since been repaired, it can be difficult to identify moisture potentially trapped behind the cladding inside the framing through a non-invasive assessment.

Example of what looks to be stucco over a timber weatherboard cladding system on south end of the main dwelling.

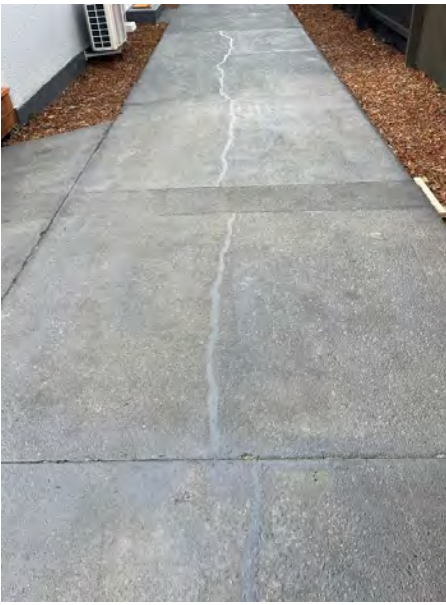
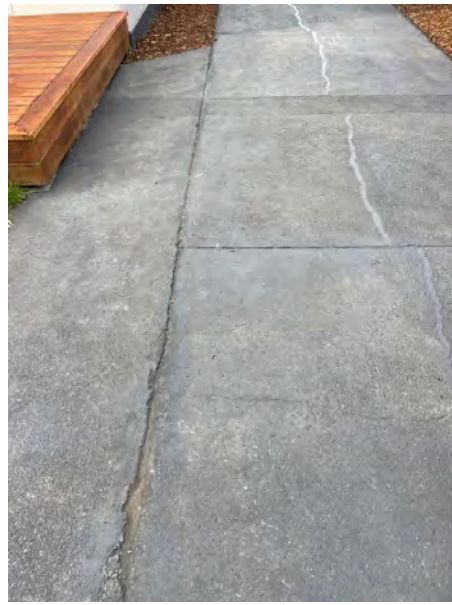
General aging concrete with crack repair and minor existing cracks noted.

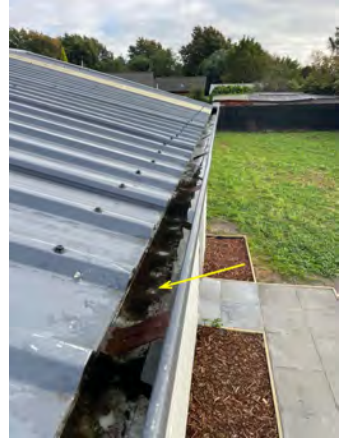
No stormwater risers noted.

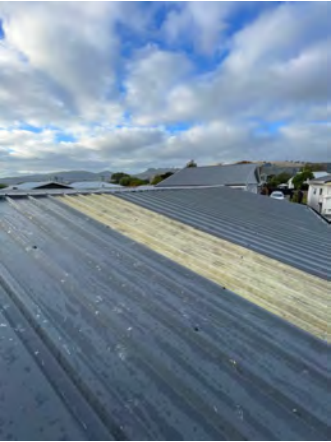
Some pooling noted to the east face guttering needing realigned.

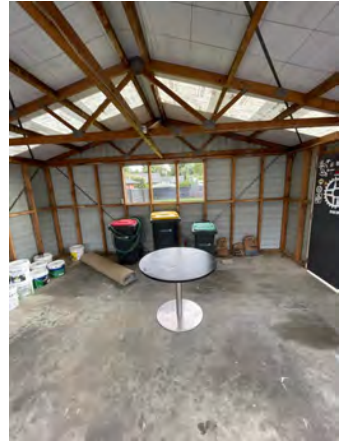
Some silicone repairs noted to some of the roofing fixings.

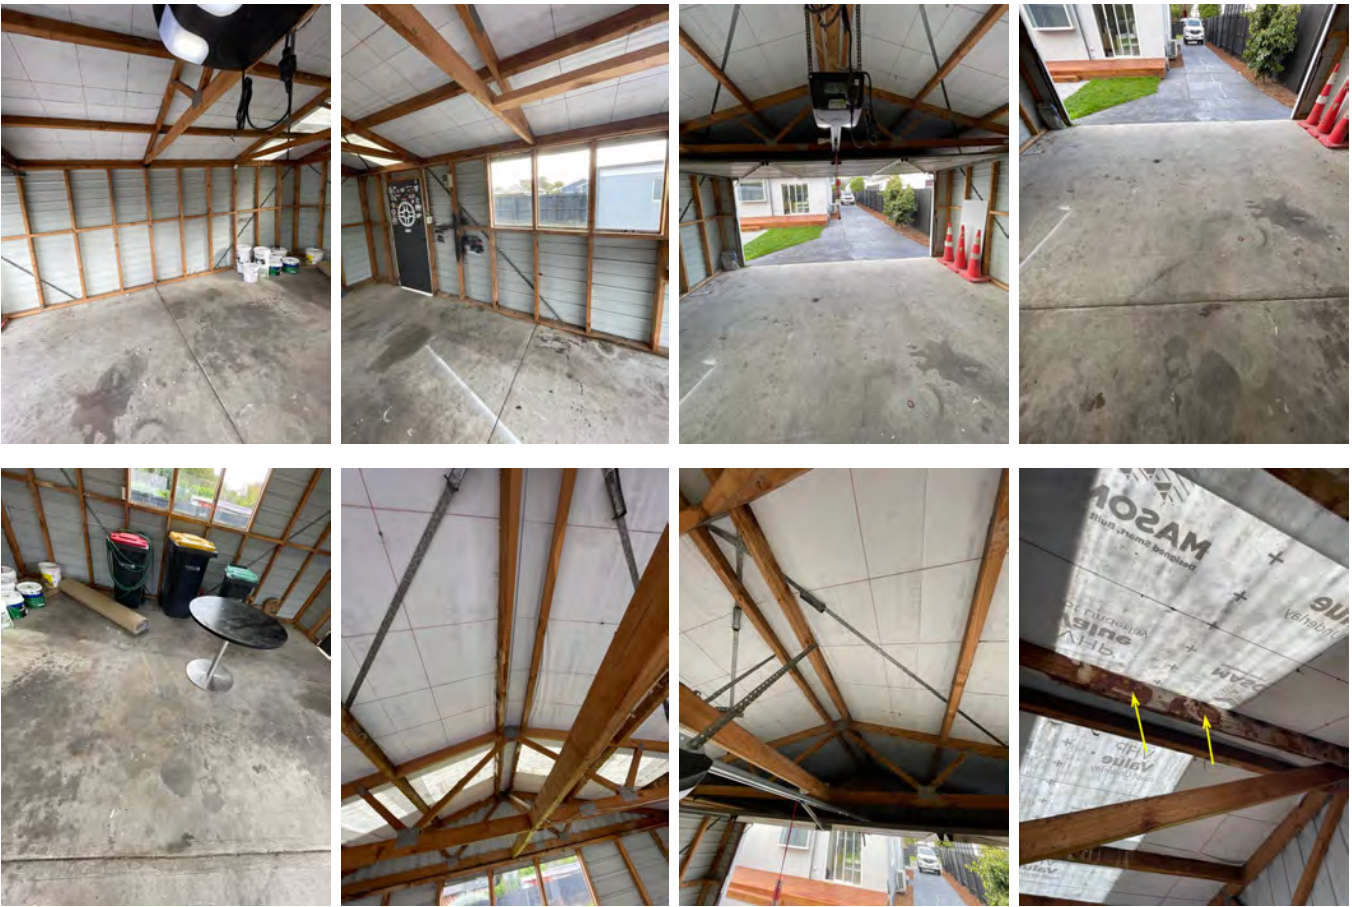
Example of moisture marks on the roof framing. Likely from previous popped roof fixings.

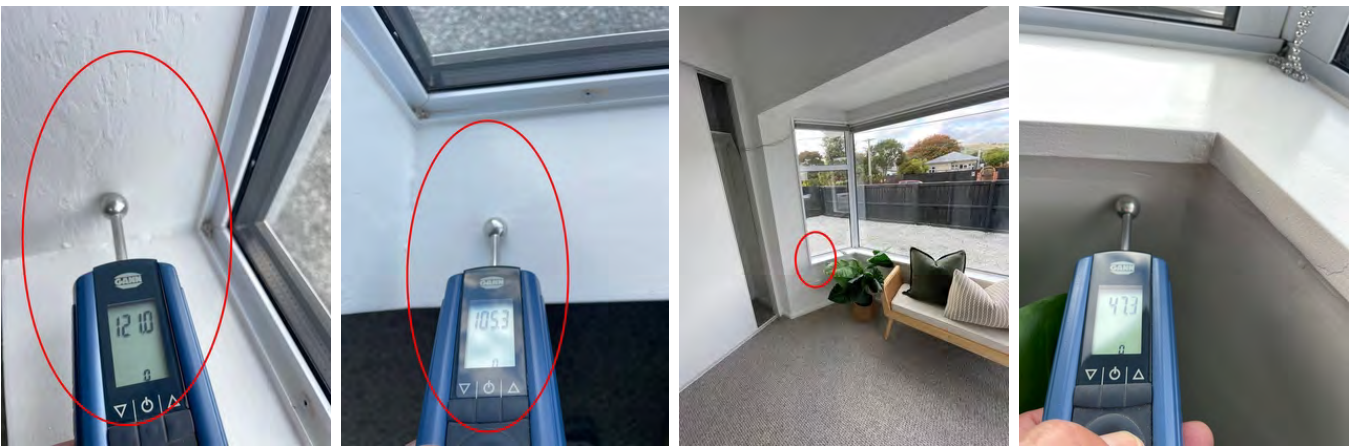
Wet moisture reading noted in the SW bedroom window. Recent sealing has been done around the exterior of this window. It is recommended to retest for lower moisture levels here at a later date.

Elevated wet moisture readings noted in the SW bedroom window. Recent sealing has been done around the exterior of this window. It is recommended to retest for lower moisture levels here at a later date once this area has had time dry.

Wet moisture reading noted in the SW bedroom window. Recent sealing has been done around the exterior of this window. It is recommended to retest for lower moisture levels here at a later date.

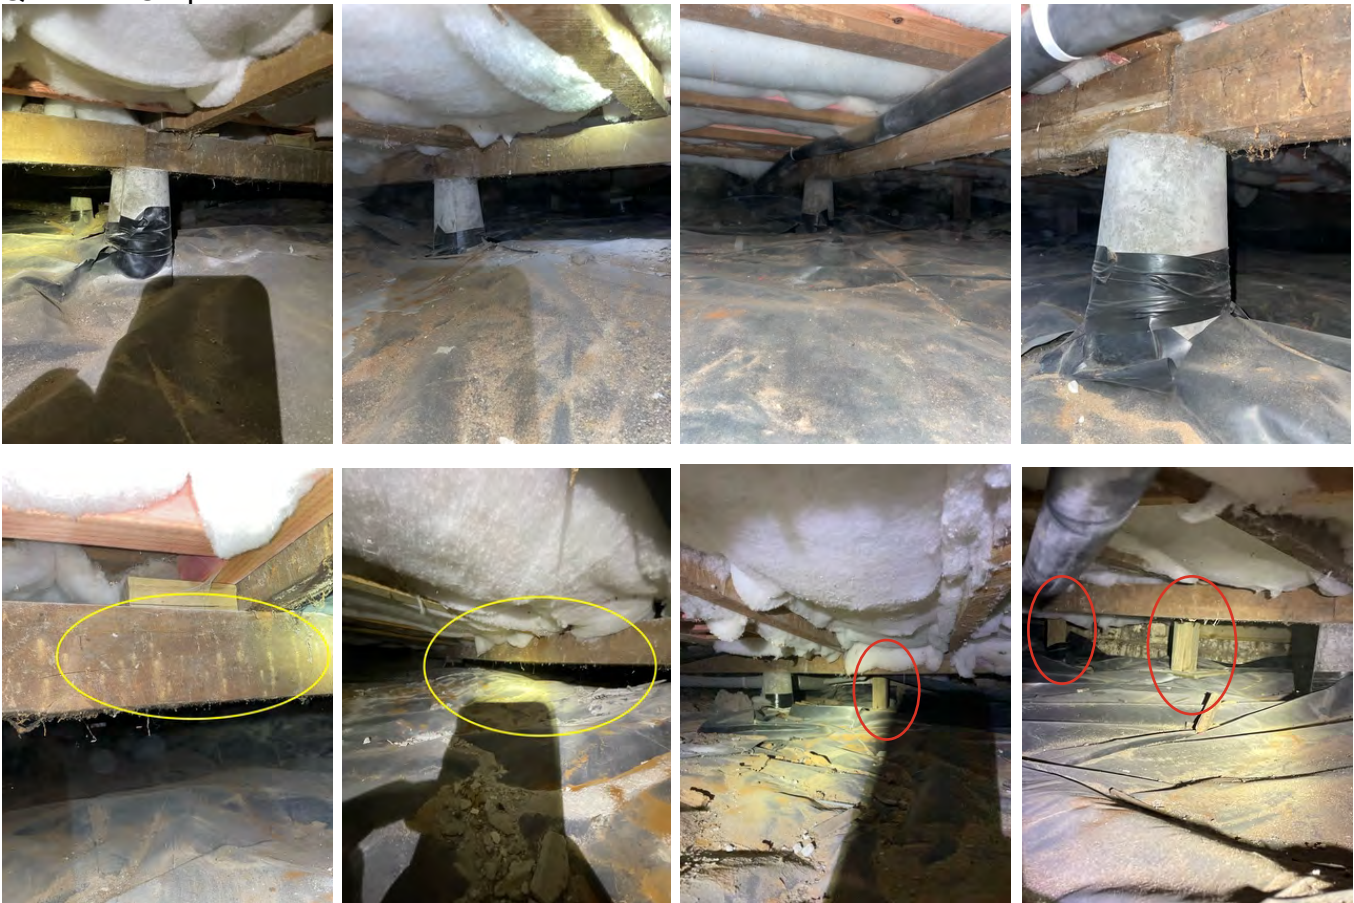
Some borer evidence noted in the subfloor framing. The client has provided evidence (photos and receipts) of recent borer bombs used in the subfloor area. Some timber propping was noted remaining under the subfloor from what looks to be recent construction work. See example photos.

Example of borer noted on the subfloor framing. The client has provided evidence (photos and receipts) of recent borer bombs used in the subfloor area.

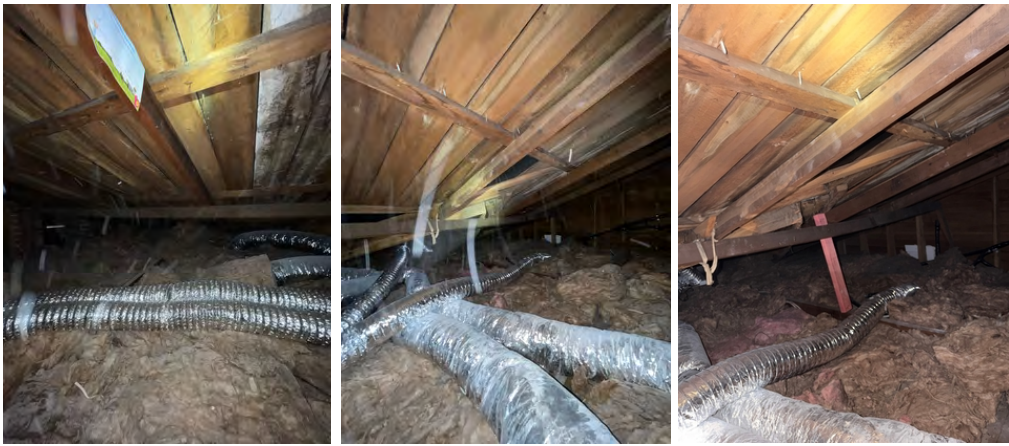
Fixed well into place. Some extra vertical bracing was noted to help support the roof load. Some historic signs of moisture ingress noted on the timber framing. This is likely due to previous roofing fixings popping. No current leaking noted from what could be seen during the inspection.

Extra vertical bracing has been added to help support the roof load.

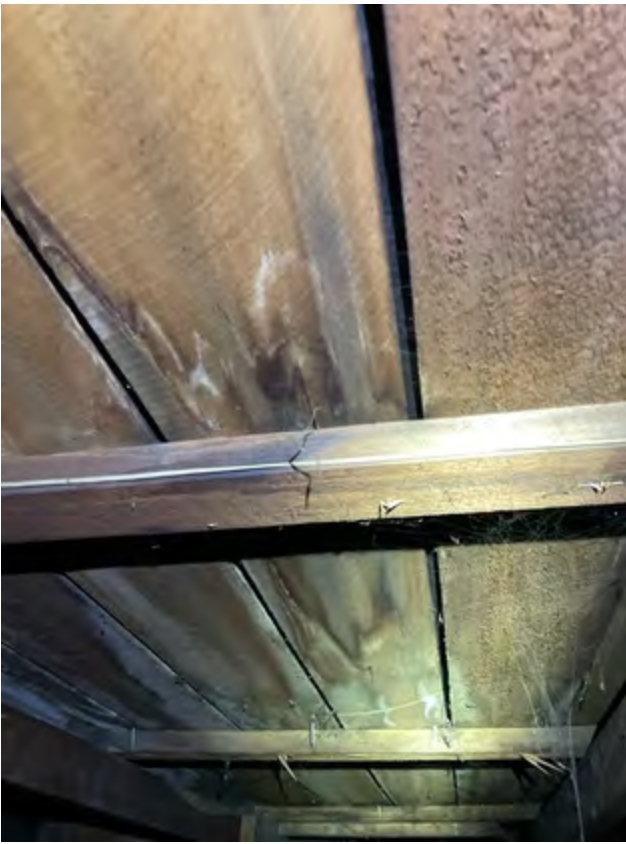
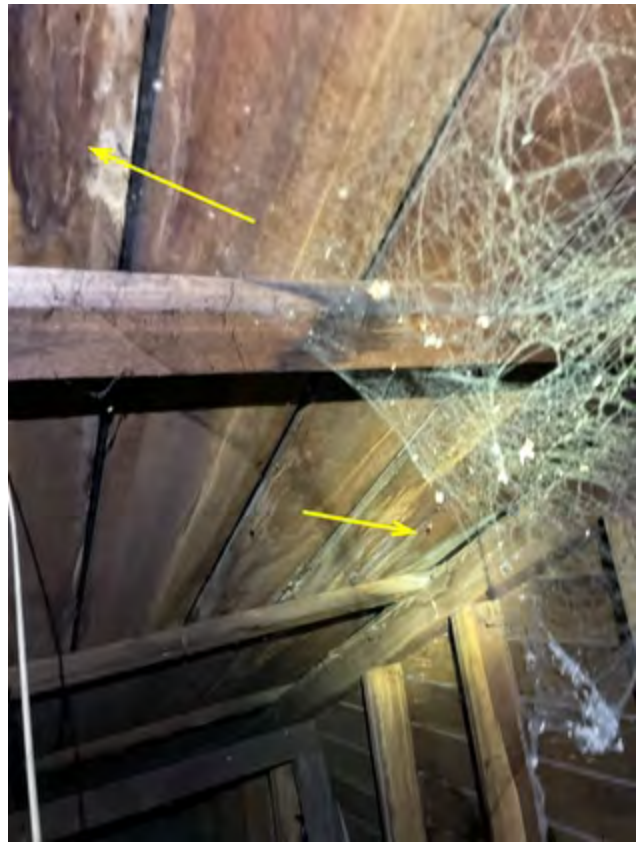
Some historic signs of moisture ingress noted on the timber sarking. This is likely due to previous roofing fixings popping. Monitor these and replace where needed to maintain weather tightness.

Historical signs of moisture marks on sarking. Likely from previously popped roof fixings.
