## BUILDING INSPECTION REPORT

# 18 Heathglen Avenue, Parklands

## Building Report

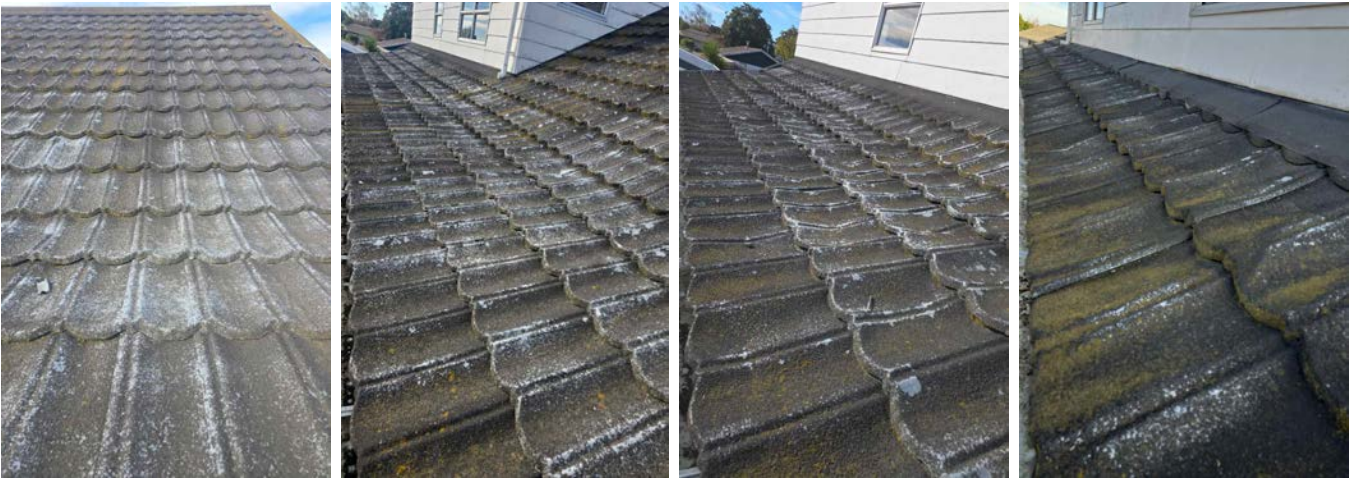
Some roofing nail fixings have popped throughout the roof system; this is typical for roofing nails. Replace these where necessary with suitable roofing screws to maintain weather tightness. The decramastic tiles are missing their protective coating in isolated patches across the roof cladding; it is advised that the tiles be re-painted by a suitably qualified roofing specialist to restore the protective layer and help prevent corrosion. Denting is visible throughout the roof. This is only a concern where the dents allow water to pond.

An example. Denting of the metal tiles is visible throughout the roof.

Denting of the pressed metal tiles is visible throughout the roof. This is only a concern where the dents can allow water to pond, as water pooling will accelerate deterioration of the tiles and coating. Some of the nail fixings have popped and the tiles are sitting loose. The noted flashing is pulling up and is in need of attention to prevent any water intrusion. Its best to to have the tiles inspected by a suitably qualified roofer and any compromised tiles replaced where necessary.

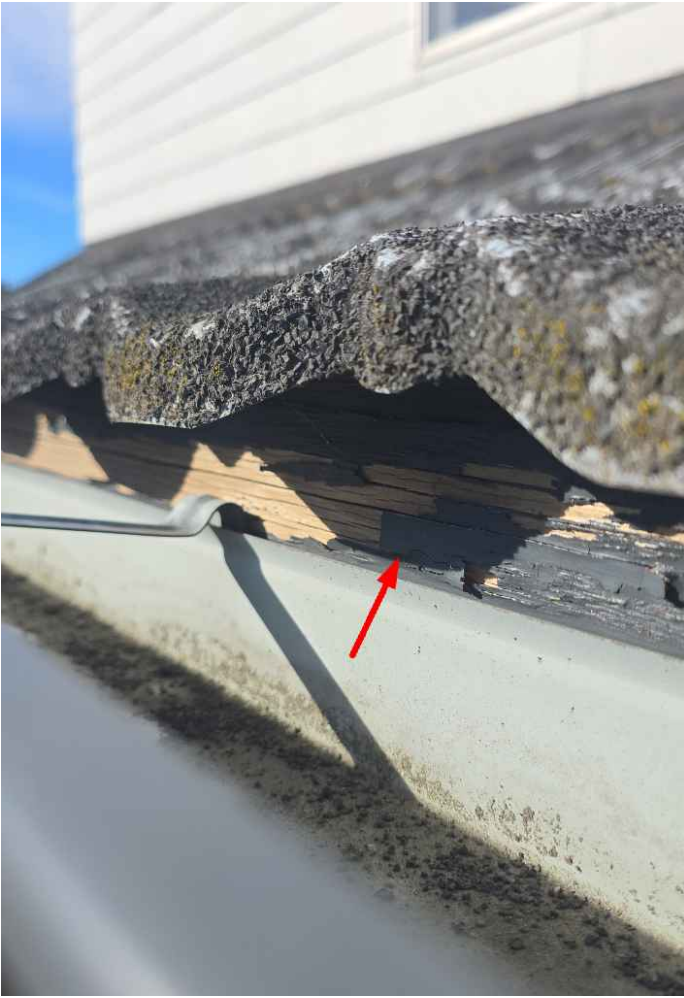
The paint is flaking along the fascia above the top level of the guttering.

Minor paint defects are visible throughout which can be expected for its age. Some paint touch ups are needed to protect the timber and improve the longevity of the timber.

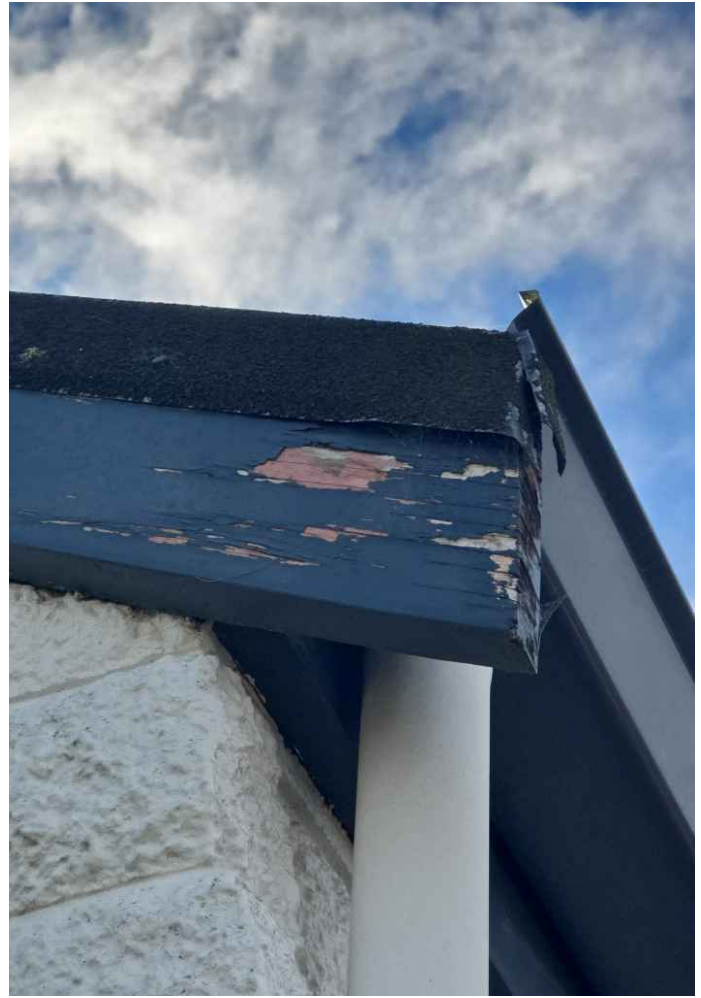
An example. Paint flaking noted throughout the fascia.

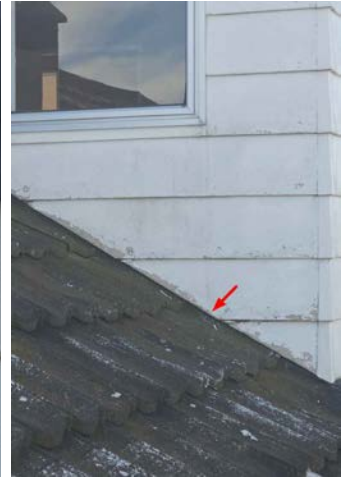
Isolated patches of cracking noted on the upstairs cladding.

Surface rust noted on the southeastern corner soaker.

Minor paint defects.

The upstairs fiber cement weatherboards would benefit in the near future with a fresh paint to help protect and improve the longevity of the cladding. Surface rust has been noted to the corner soaker. Strip back the rust and apply a rust prevention paint to prevent further corrosion.

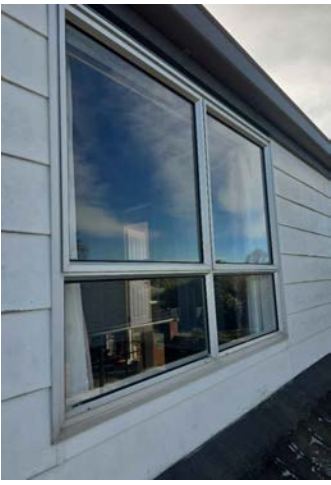
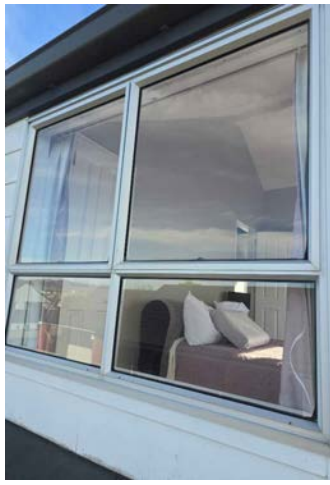
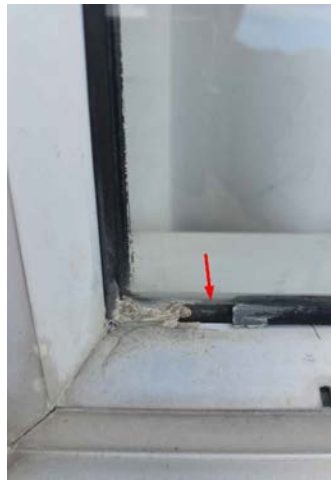
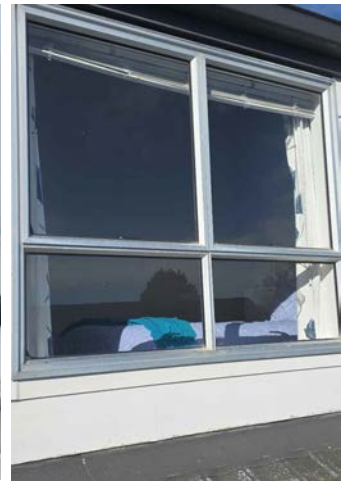
Exterior joinery comments are based on a visual assessment only; testing of the joinery function is found in the interior section of this report. Rubber seals are coming out and have perished slightly in places; where seals have pulled out or perished, replace them with new seals. The noted areas require sealant to prevent water from tracking in and around the aluminium framing.

An example. The window rubbers have perished slightly.

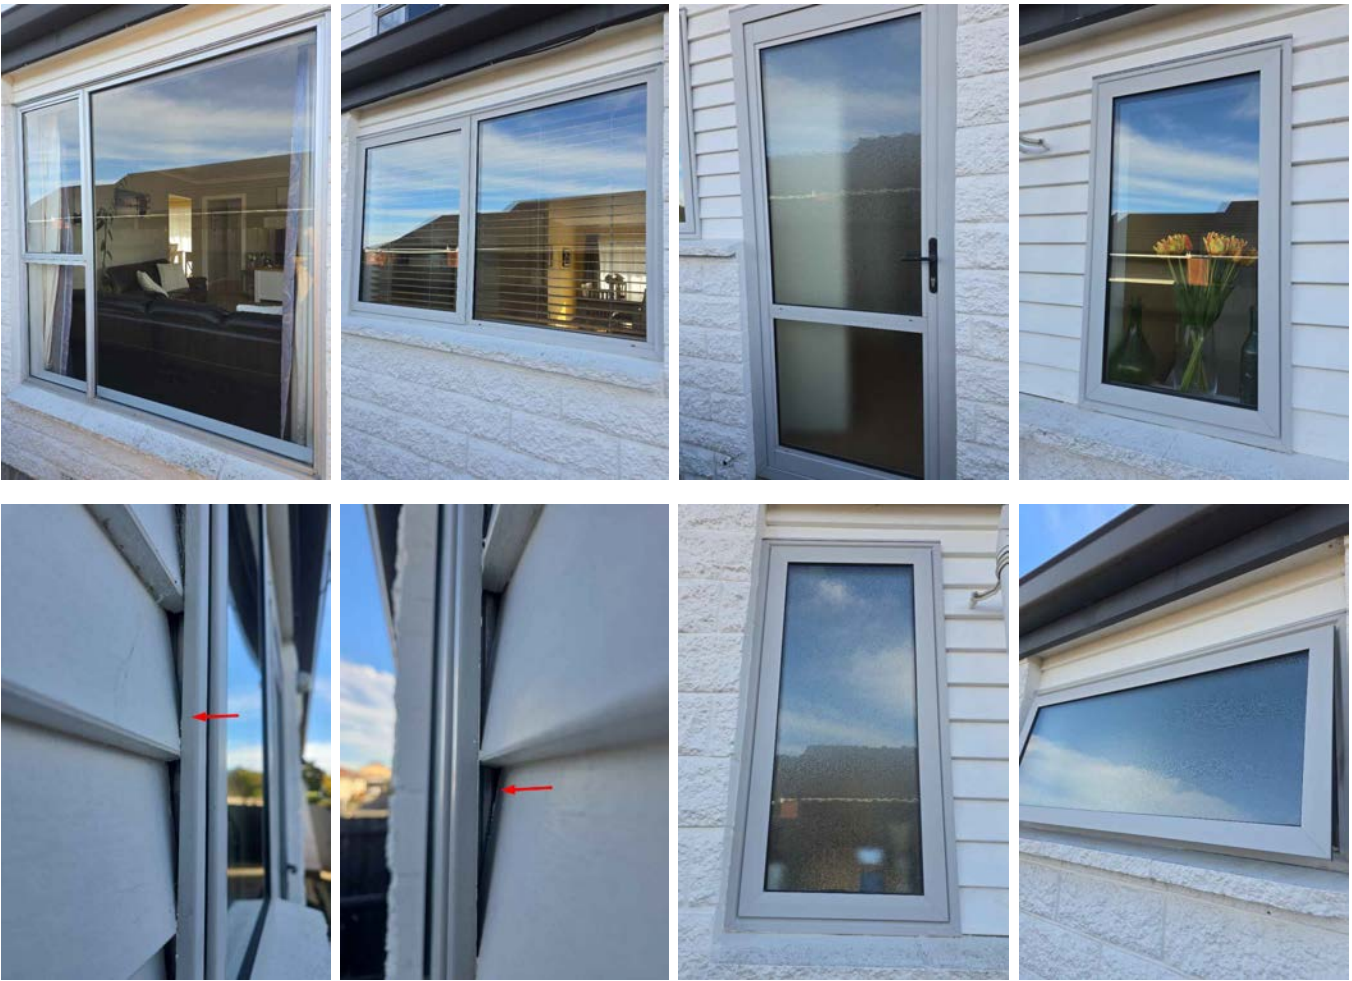
The laundry window is missing sealant against the cladding.

The west side toilet window is missing sealant against the cladding.

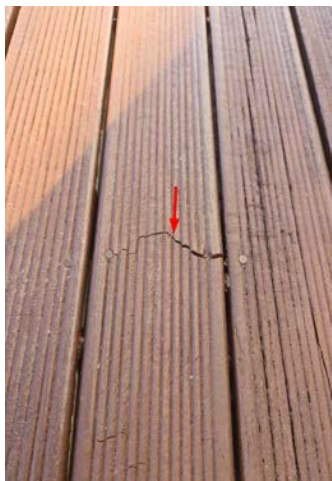
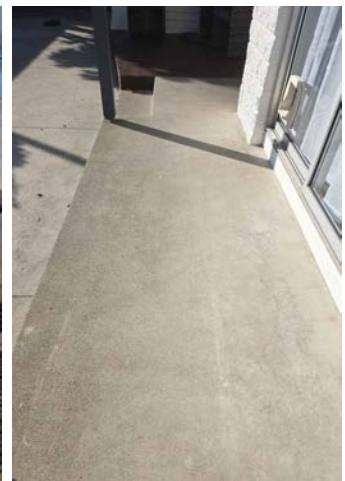
General aging throughout. Expansion gaps cut to help prevent cracking to hardscaping. Some of the decking timber has snapped from general wear and tear. Its best to replace any snapped boards to improve the integrity of the deck.

An example. The decking timber has snapped.

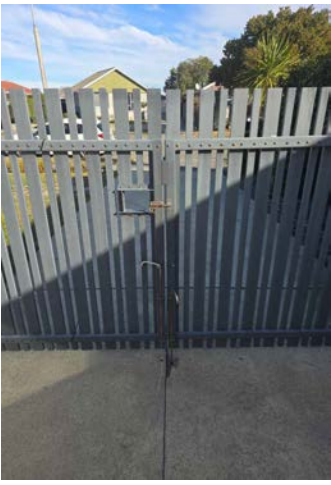
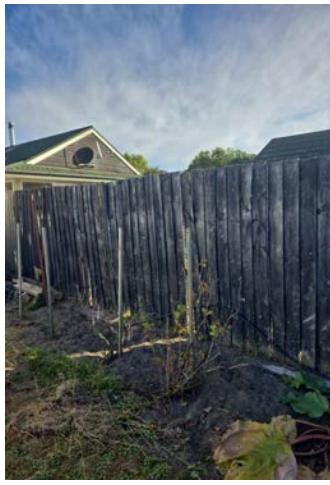
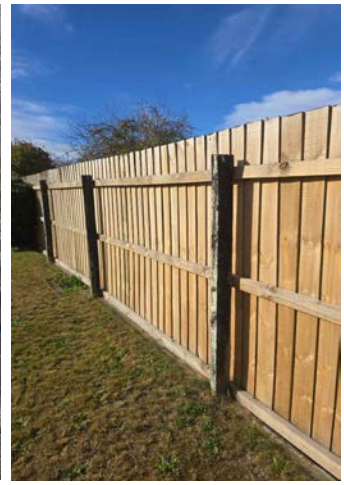
The gates are working fine. Some sections of the fencing is weathered and are in need of some maintenance and repairs. It's unclear the condition of the fencing behind the vegetation. Several nails have missed the railings along the noted fence. For safety, its best to have the nails removed and new nails installed correctly.

General maintenance required.

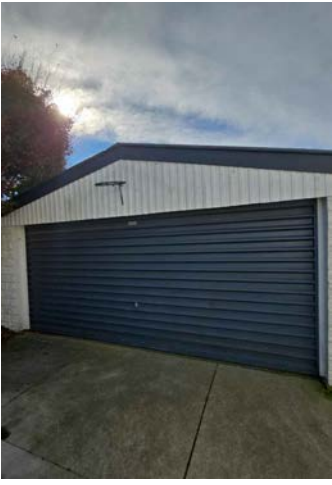
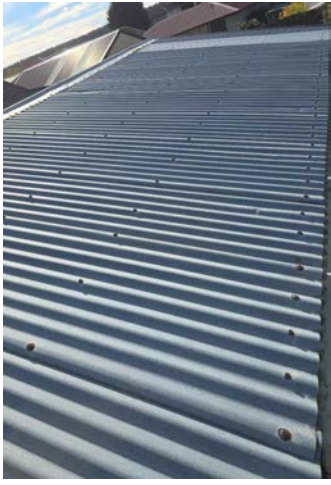
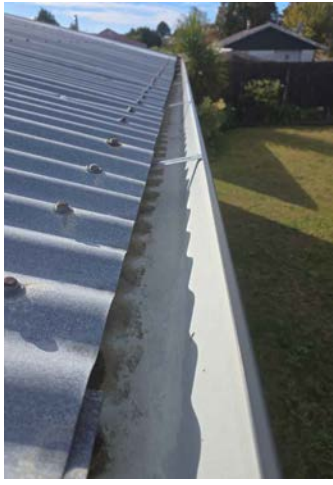
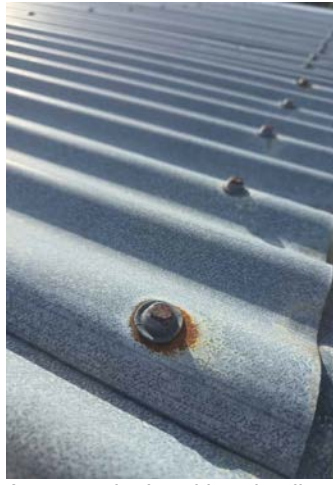
The garage door is working fine. The roof is fastened down with roofing nails. These are prone to popping over time. These should be periodically inspected and, where necessary, replaced with suitable roofing screws as part of general maintenance. Due to the era in which the dwelling was built, the fibre cement cladding could contain asbestos. However, this was not tested or confirmed. Cracking has been noted to the foundation. The cracking should be monitored and if the cracking widens, consult with a suitably qualified engineer for assessment. Minor paint defects are visible throughout exterior. The noted window pane has cracked and could be repaired to improve weather tightness and improve the integrity of the glazing. Surface rust to the roof has been noted. Strip back the rust and apply a rust prevention paint to prevent further corrosion. The noted area of guttering has come loose and requires re-attachment. Borer has been noted. If left unchecked, the borer can weaken the timber and cause rot and structural damage. It is recommended borer activity be inspected and treated to prevent any further infestation as ongoing maintenance.

An example. Lead head nails.

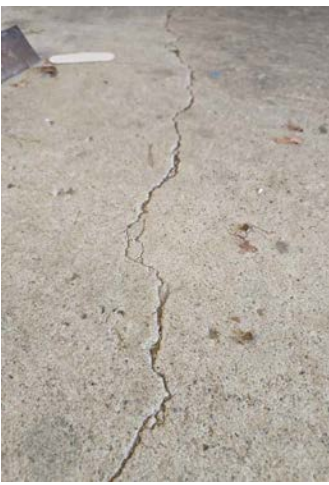
Cracking to the garage noted.

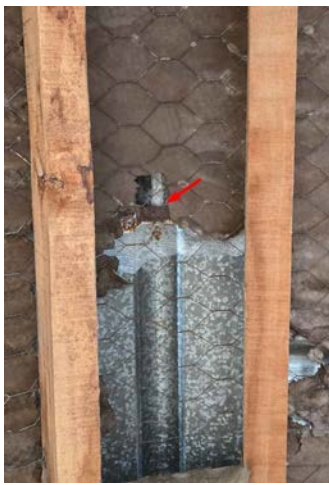
Rust noted to the ridge capping.

Borer holes noted within the roof structure.

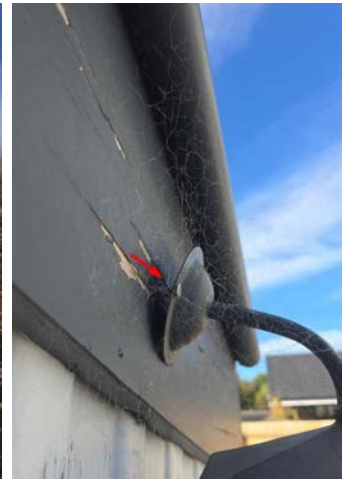
The external light fitting is loose.

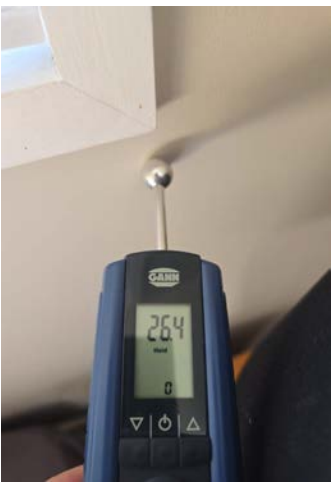
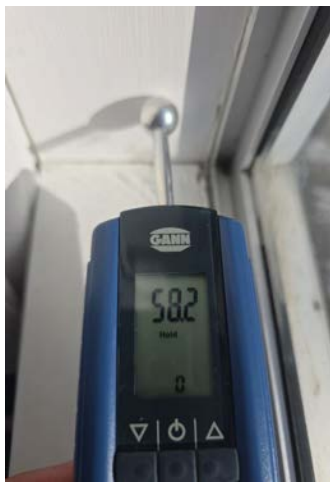
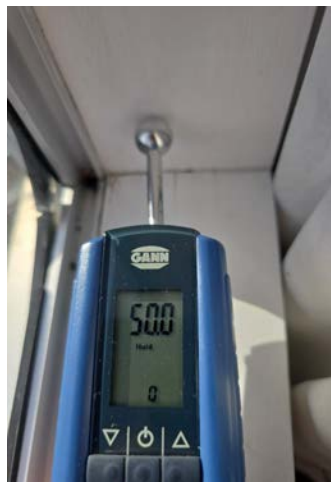
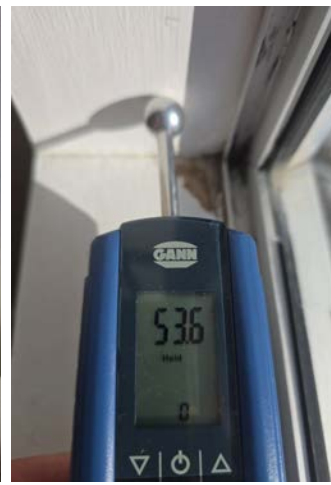
Elevated reading indicated on the external laundry door sill.

A slightly damp reading was recorded on the external laundry door sill, although the exact cause is unclear. Elevated moisture on door sills is commonly associated with condensation or blocked weep holes within the aluminium joinery. Ensure the weep holes are clear and monitor the area for any further changes.

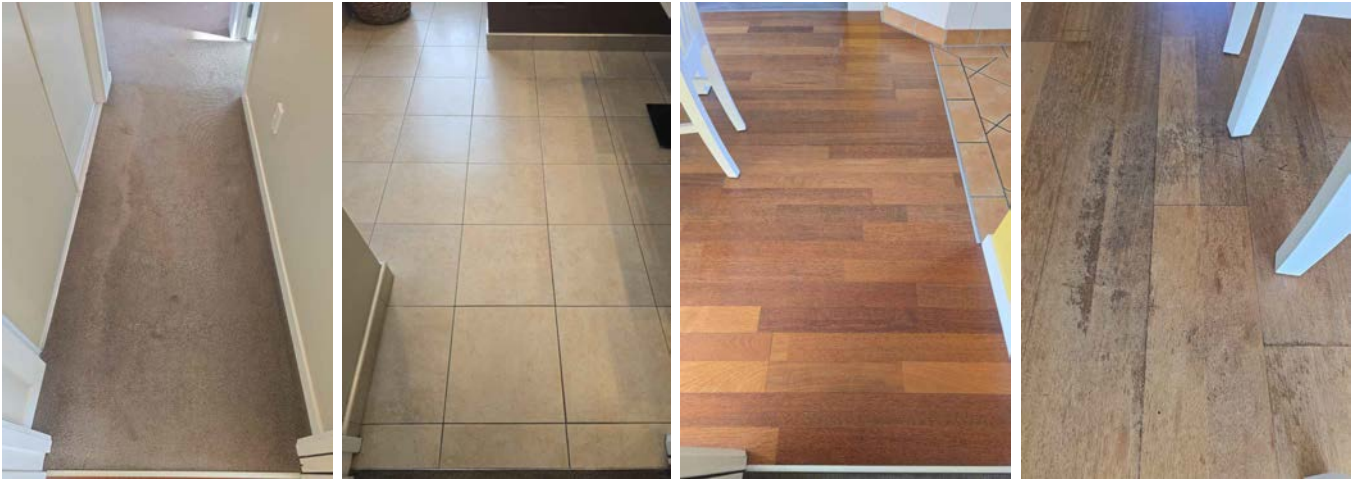
General wear and tear is visible throughout. Nothing significant or concerning was identified.

General wear and tear.

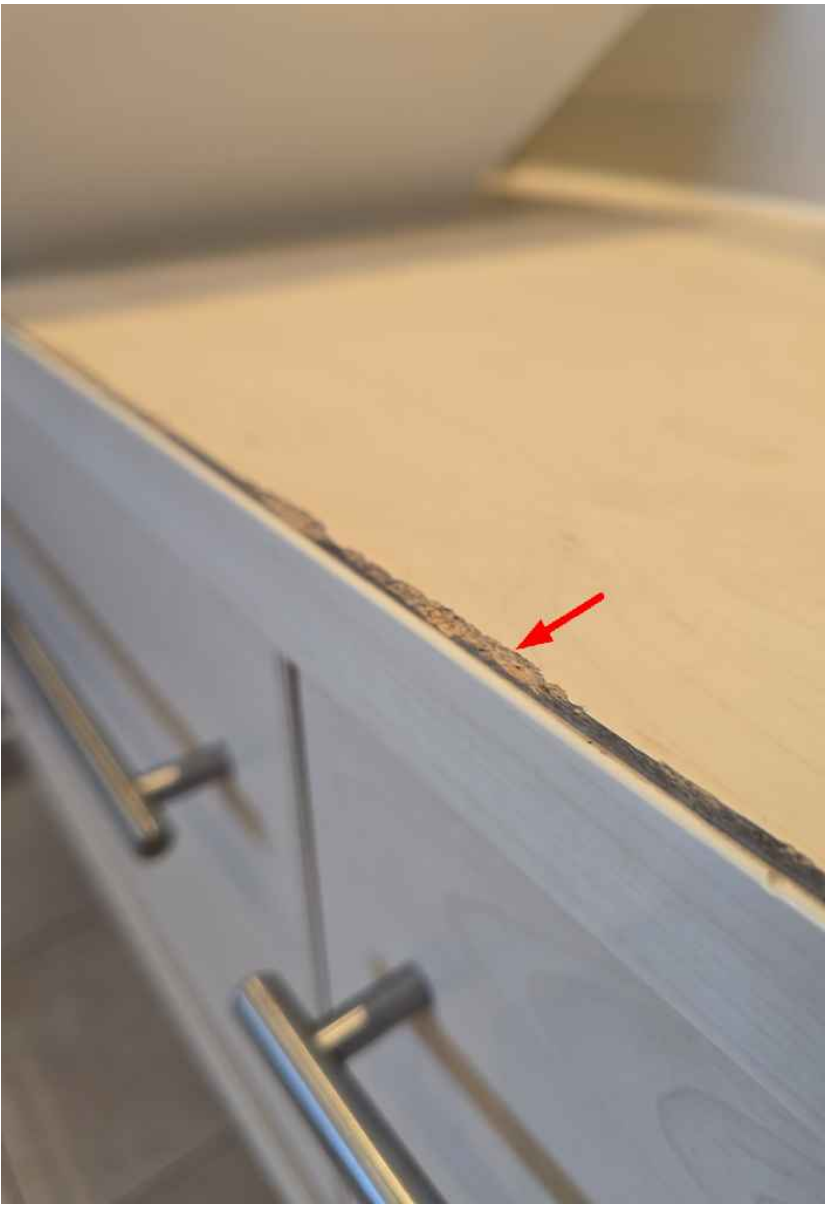
No adjustments needed to cabinetry. Signs of water damage.

Water damage along the bathroom cabinetry.

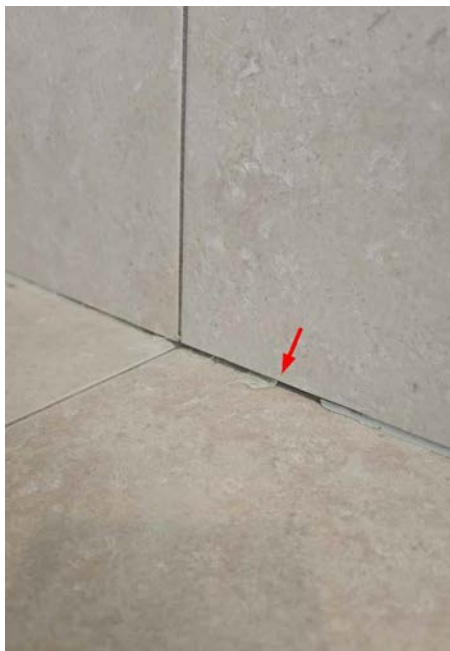
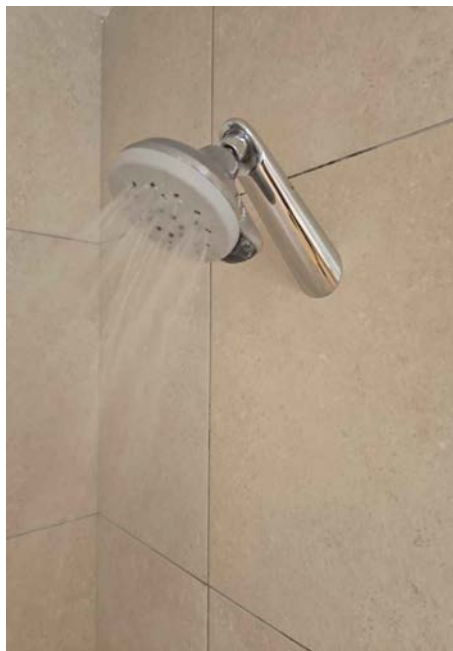
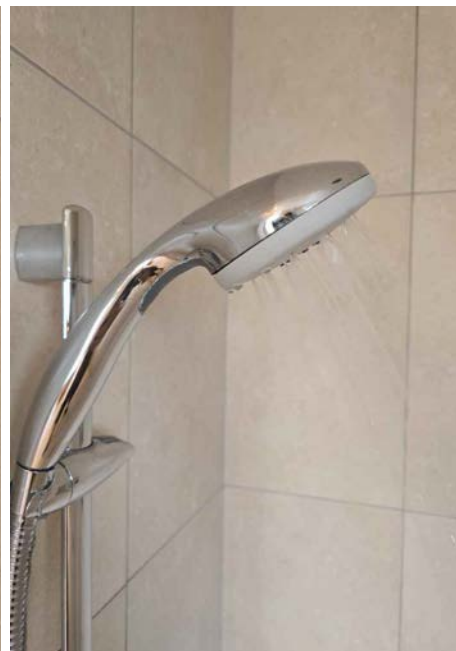
Missing sealant has been noted.

Sealant is missing along an isolated patch in the shower.

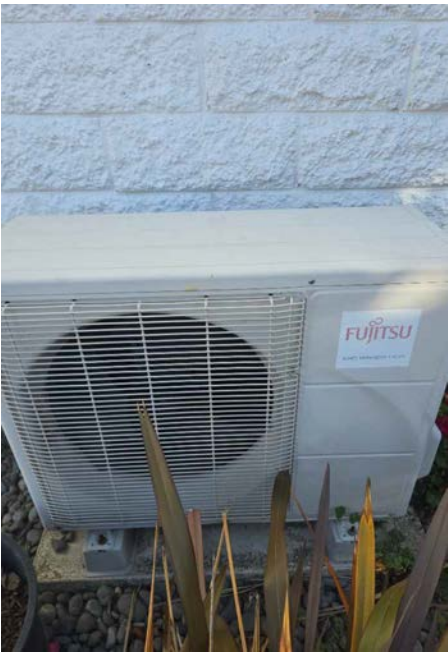
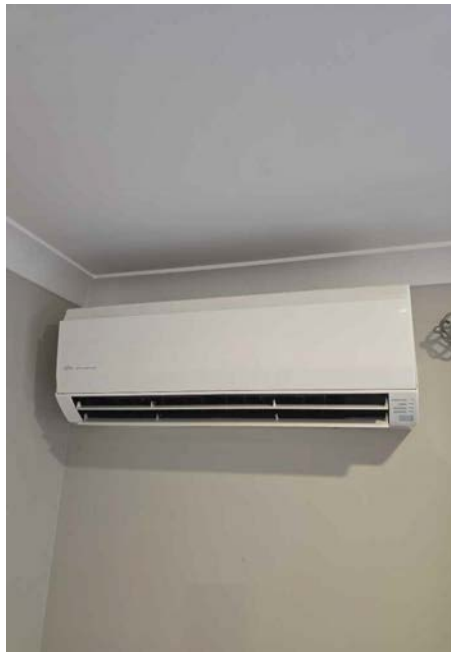
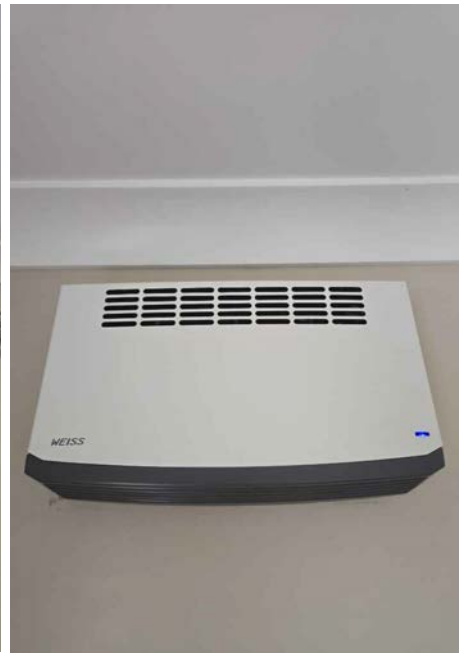
The heat pump(s) powered on fine and appeared to operate. The electrical wall heater(s) powered on fine and appeared to operate. The fins on the noted heat pump would not shut properly.

The fins on the heat pump would not shut properly.

The fins on the heat pump would not shut properly. Consult with a suitably qualified heat pump specialist for assessment and repair.
