Healthy Home Inspections

Address of Property 1 Inverell Place, Waikanae 5036,
New Zealand
(-40.8793613, 175.0611947)

Summary of Report 7 / 7 (100%)

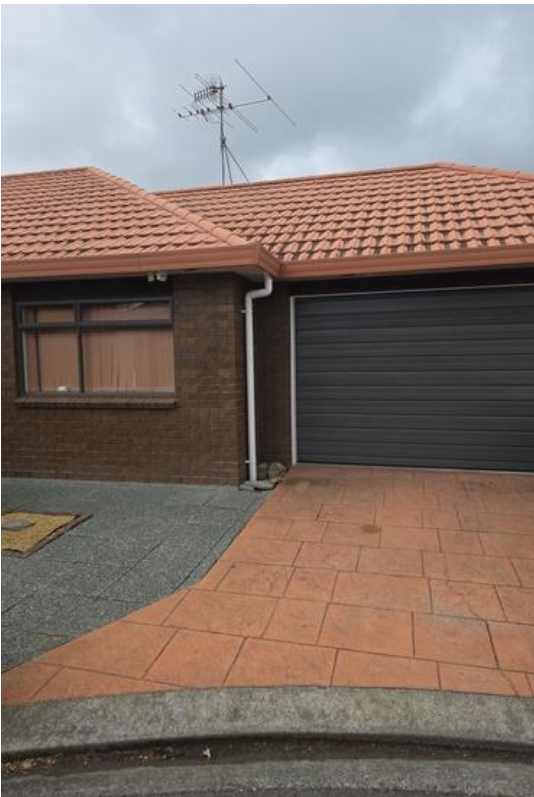
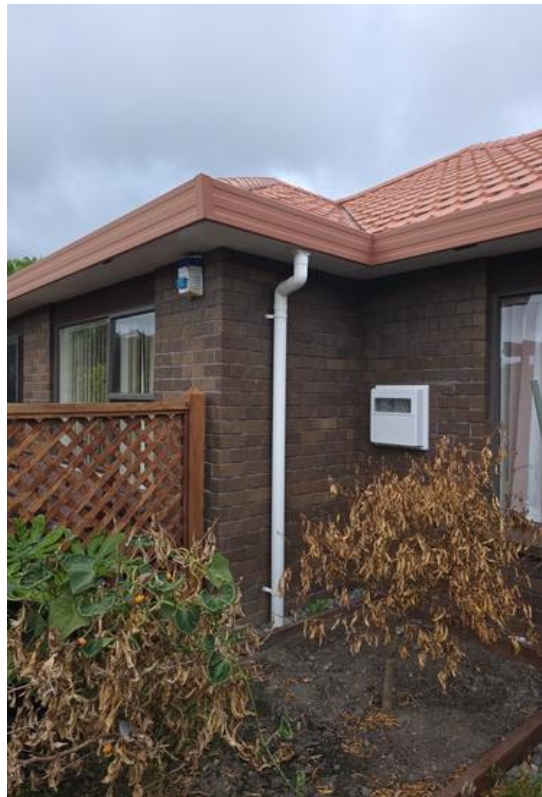
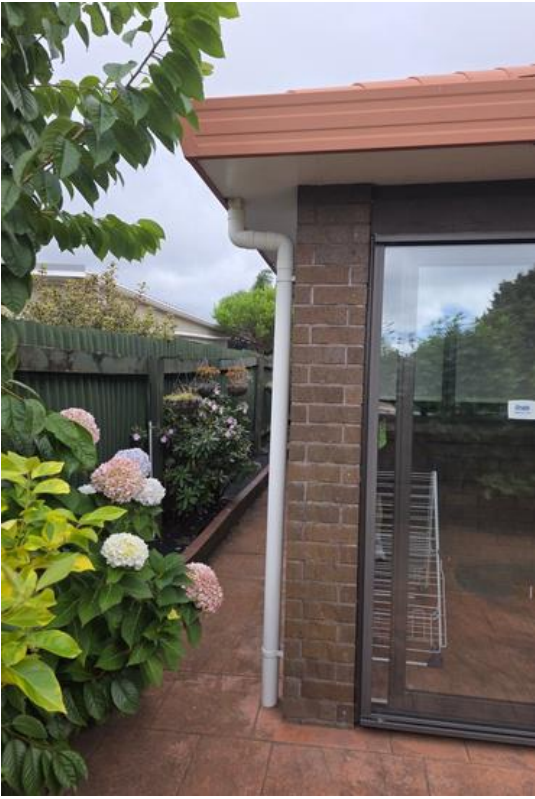
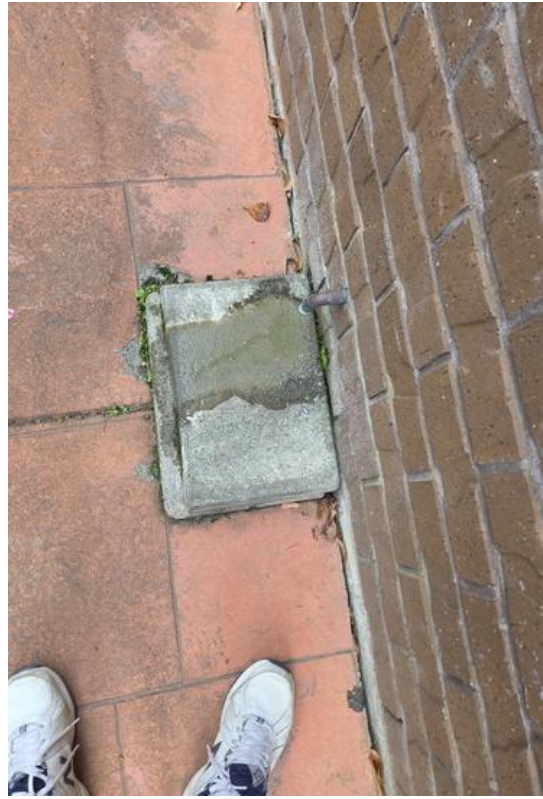
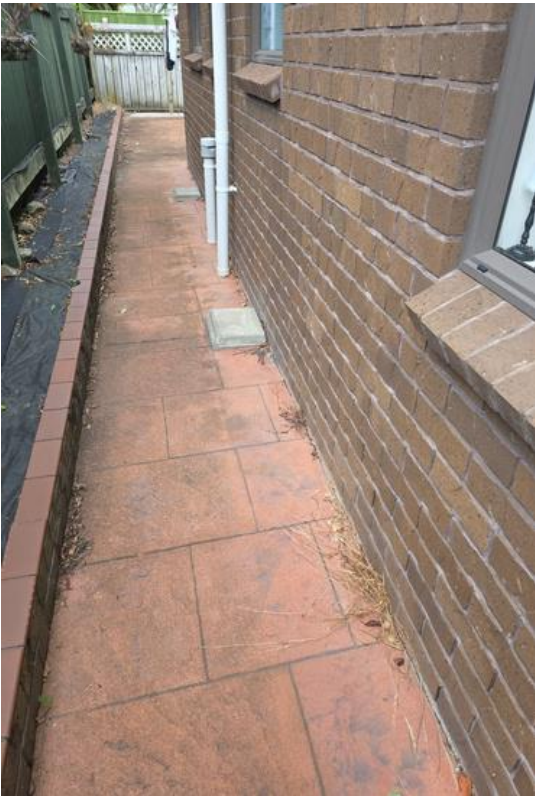
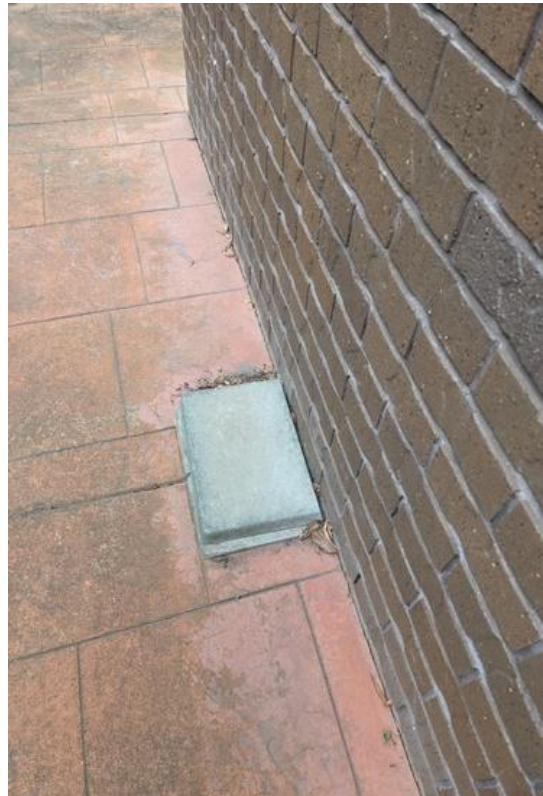
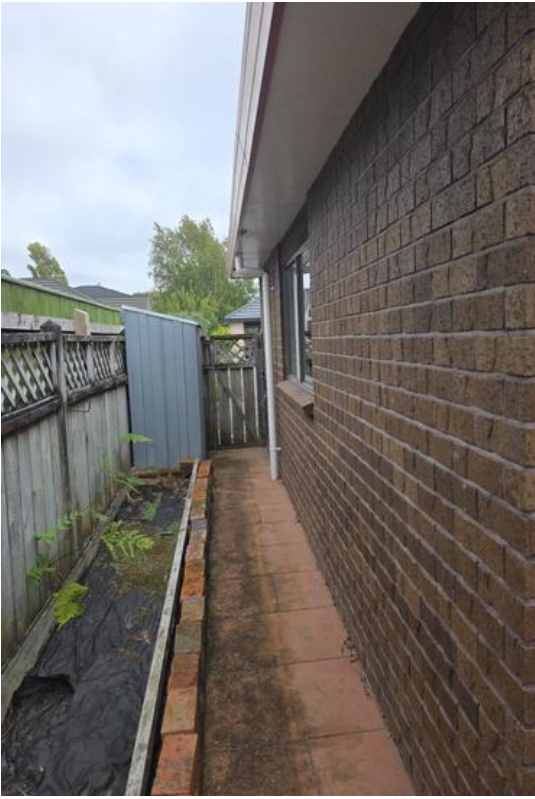
Photos of guttering and downpipes. Are there any issues?

Do all the roof areas have gutters & downpipes catching the roof water?

Yes

Gutter & Downpipe Condition

Good

Do the downpipes discharge into a stormwater reticulation system?

Is there any evidence of stormwater pooling/ponding around the site?

No

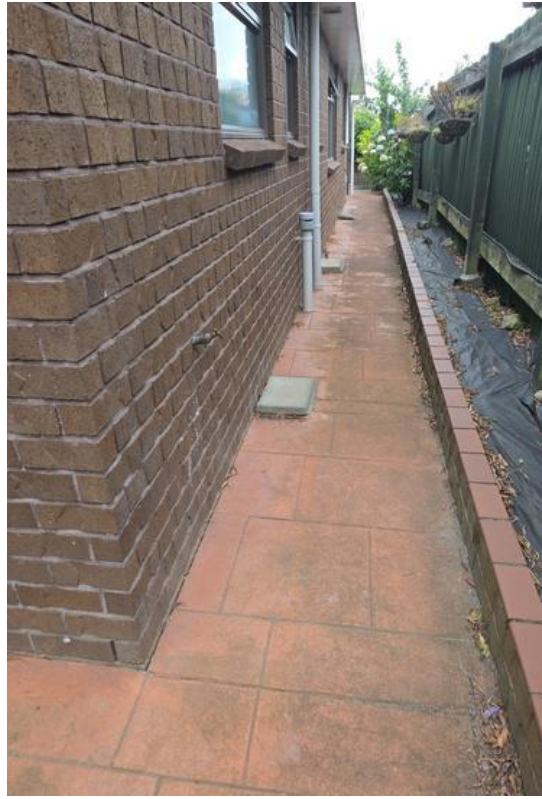
Photo 10

Concrete pad

Photos of Moisture Barrier

Is the subfloor enclosed?

N/A

Is there an adequately installed ground vapour barrier?

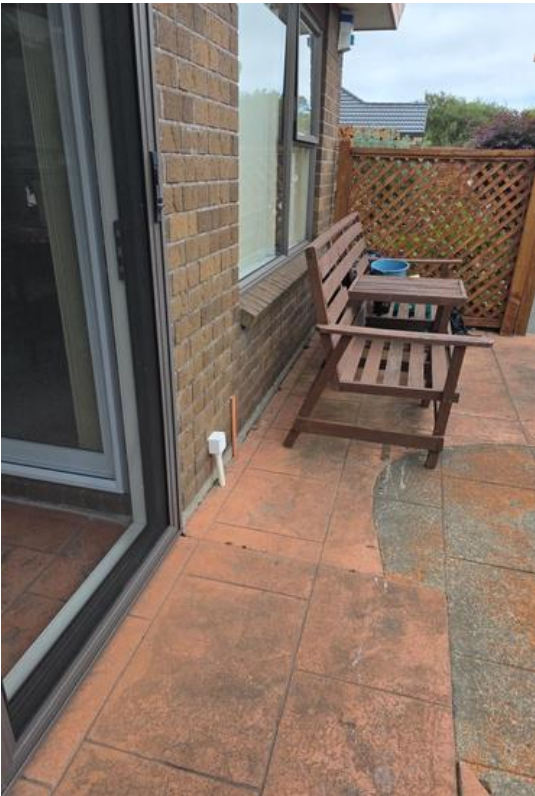
Photo 11

Restrictions	Concrete Pad
---------------------	--------------

Photo of Insulation

Insulation Condition	N/A
-----------------------------	-----

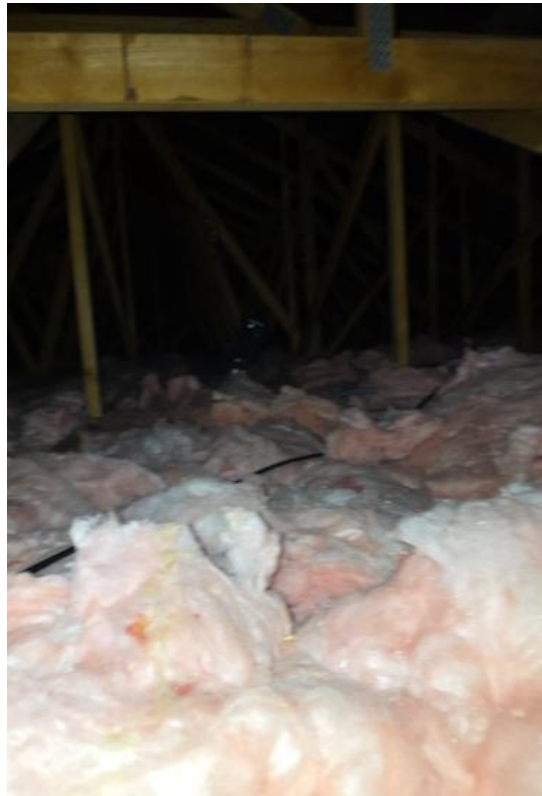
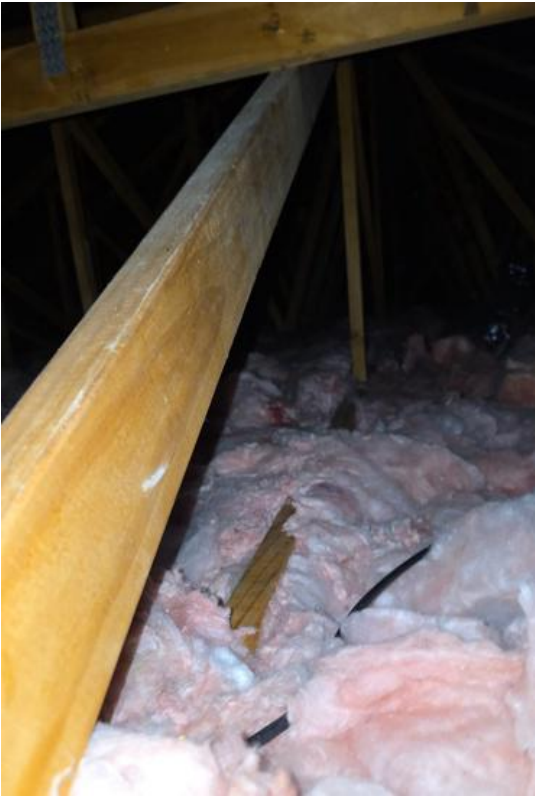
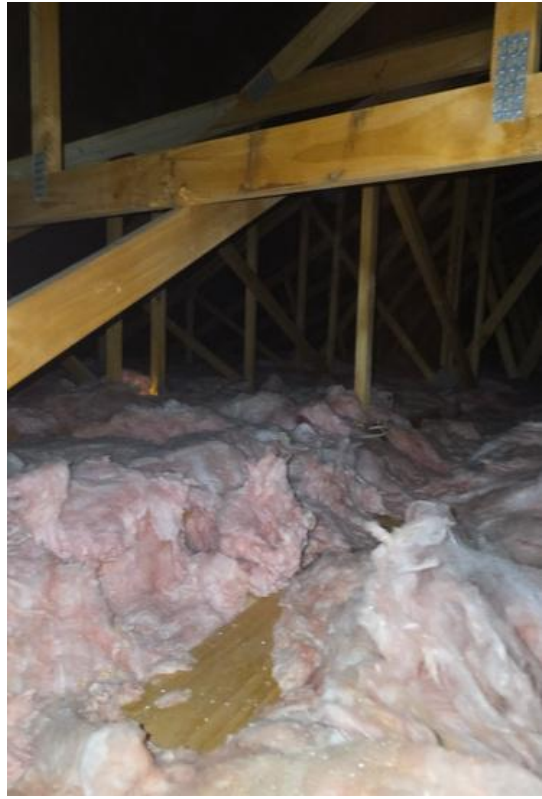
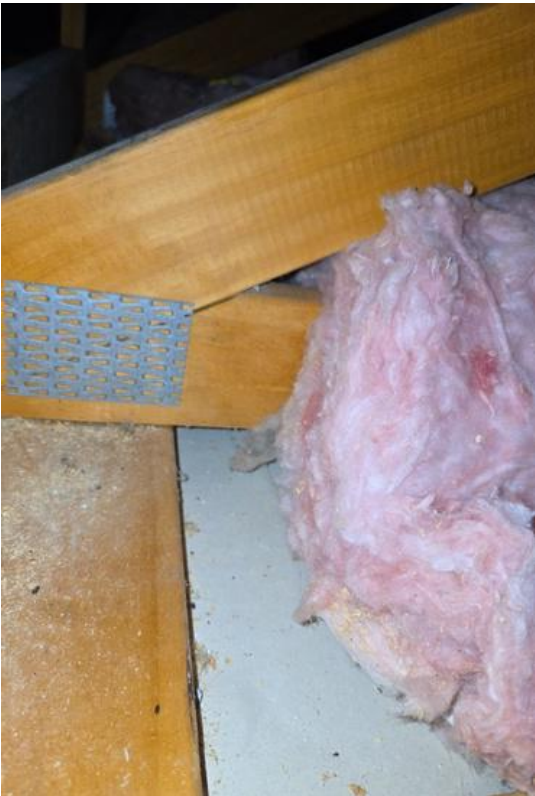
Photo of Insulation

Insulation Type	Pink batts
------------------------	------------

R-Value	2.9
----------------	-----

Is the insulation thickness 120mm? or more?	Yes
--	-----

Insulation Condition	Fair
-----------------------------	------

Will need a top up at some stage as part of Maintenance

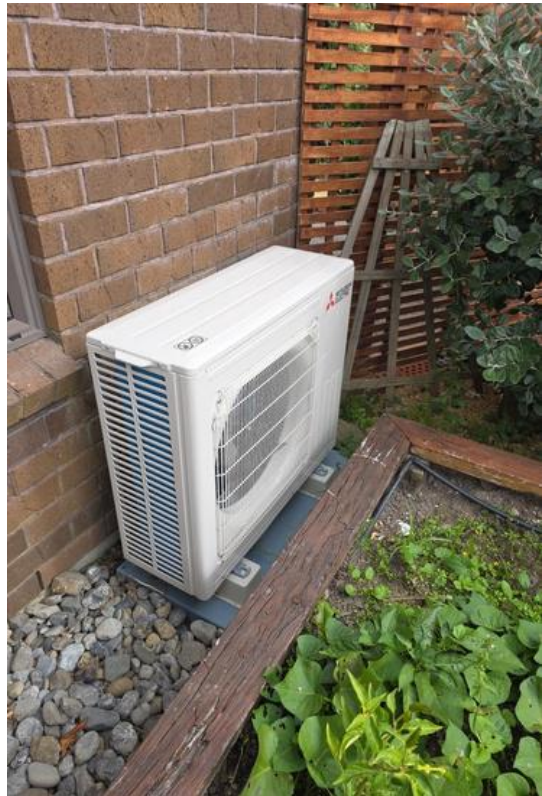
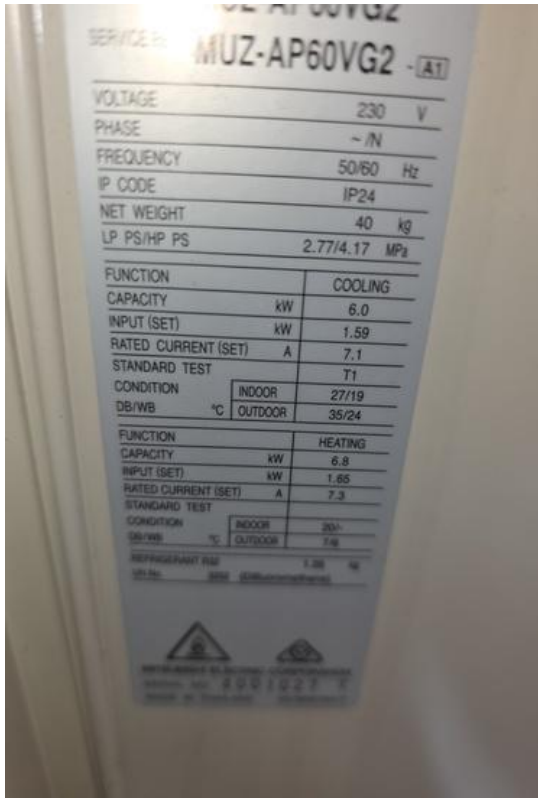
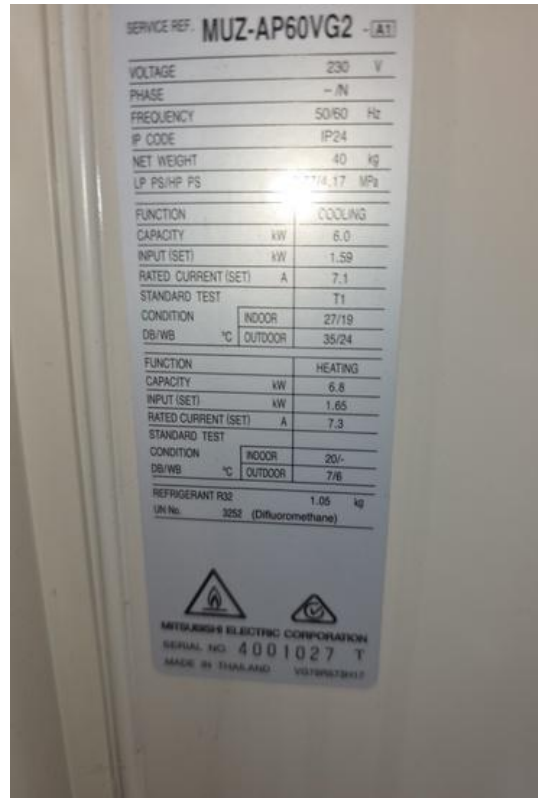
HEATING	4 / 4 (100%)
	4 / 4 (100%)
Restrictions	None
Heat requirement for Room	7.2kw

Photo of Heat Source

Heat Source Type	Heat pump
Heat Source Make	Mitsubishi
Heat Source Rating/Capacity	6.8kw
Is the heat source positioned to heat the main living room?	Yes
Does the heat source have a thermostat?	Yes
Heat Source Condition	Good
Compliance	Compliant
Within 80% of Requirement

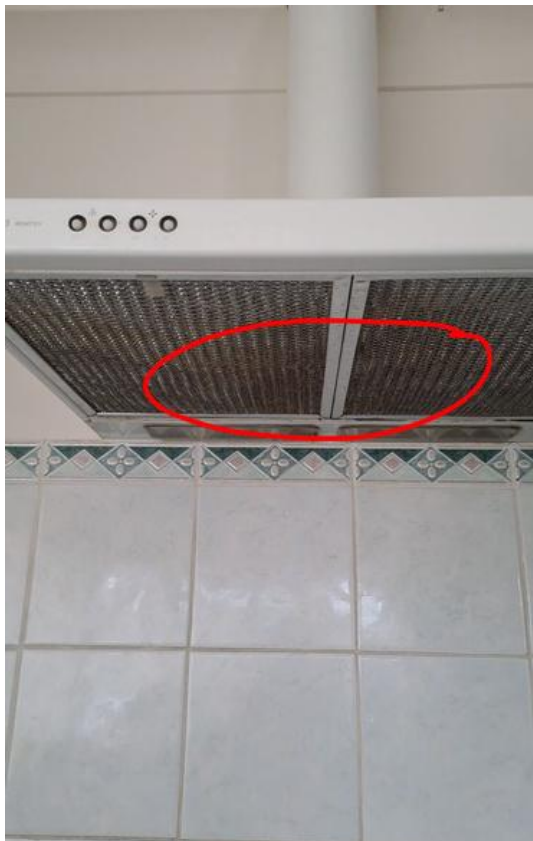
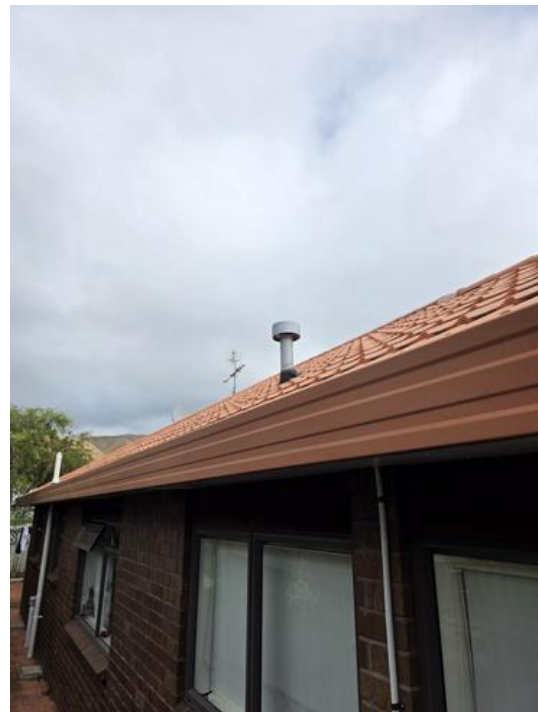
Needs cleaning to be effective

Mechanical Ventilation Type	Rangehood vented through ceiling
------------------------------------	----------------------------------

Mechanical Ventilation Condition	Fair
---	------

Is The size of the Ventilation adequate 150mm or 50lps	Yes
---	-----

Are all the Extractor vents Ventilating to the outside?	Yes
--	-----

Needs cleaning or grills replaced

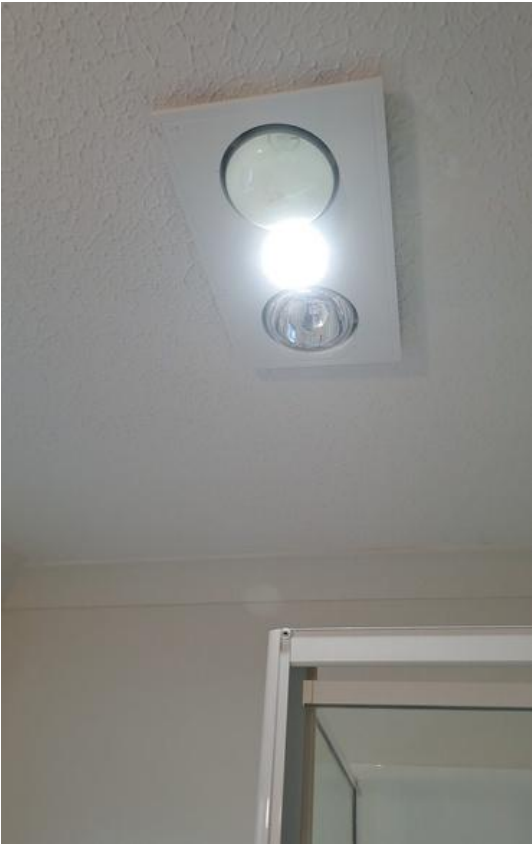
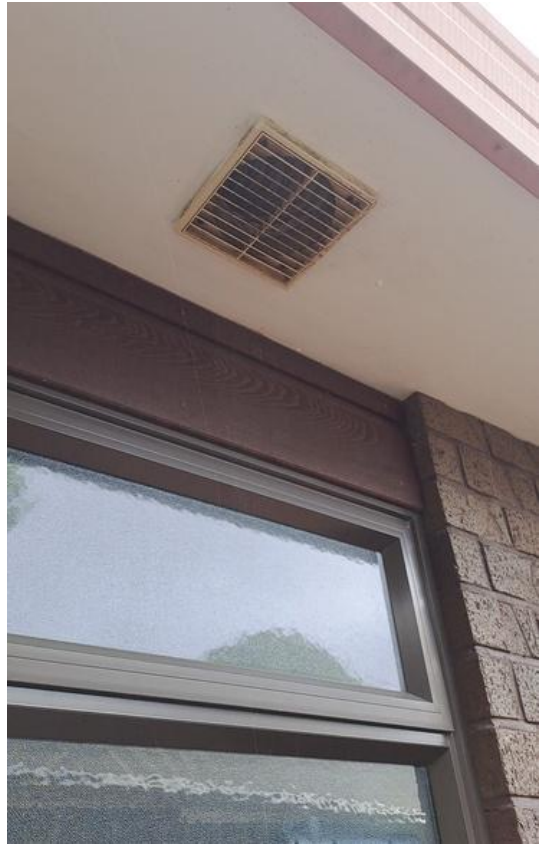
Ensuite

Mechanical Ventilation Type	Vent through ceiling
------------------------------------	----------------------

Mechanical Ventilation Condition	Good
---	------

Is the size of the Mechanical Ventilation adequate 120mm or	Yes
--	-----

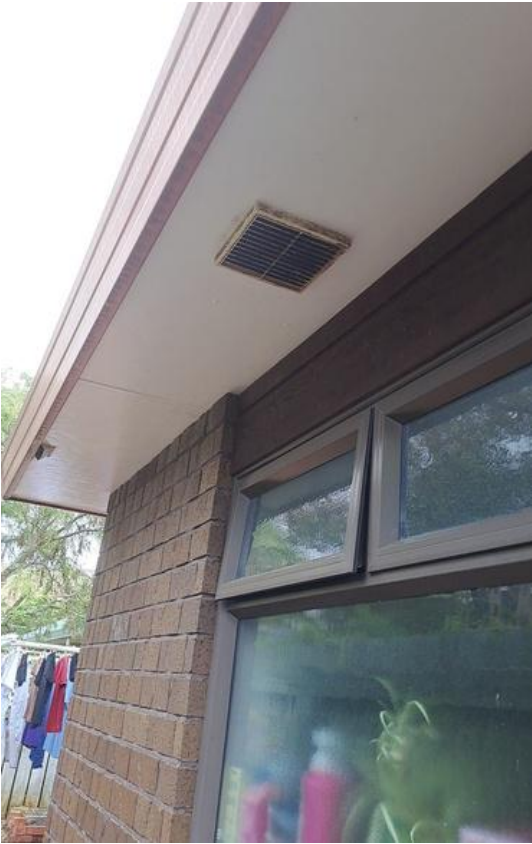
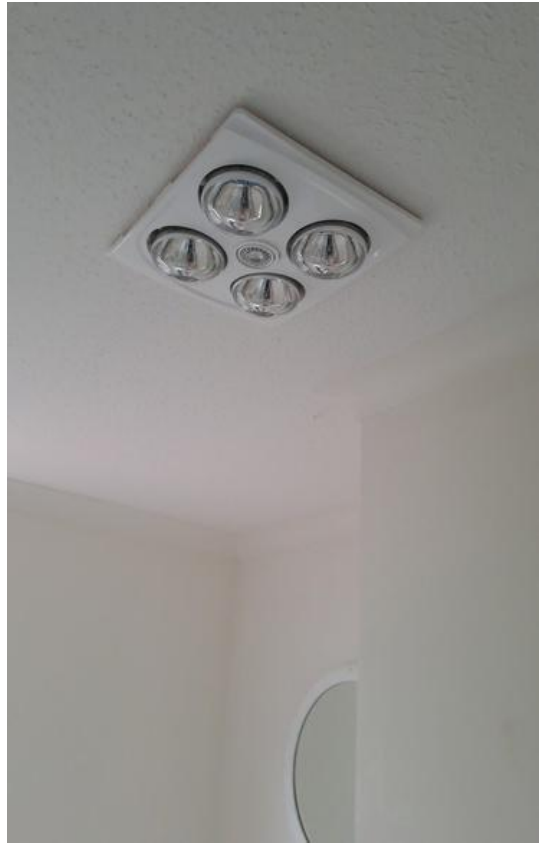
Mechanical Ventilation Type	Vent through ceiling
Mechanical Ventilation Condition	Good
Is the size of the Mechanical Ventilation adequate 120mm or 25lps	Yes
Are all the Extractions Vents Ventilating to the Outside?	Yes
Compliance	Compliant
