## Assessment & Compliance Report

| <b>Job:</b><br>#179739 | <b>Address:</b><br>40B Manse Street,<br>Kensington,<br>Whangarei 0112 | <b>Client:</b><br>Lumarni Marais |
| <b>Building Age:</b><br>1980 | <b>Date of Original Assessment:</b><br>21 January 2026 | <b>Consultant:</b><br>Way Elefante (Building Assessor & Field Technician) |

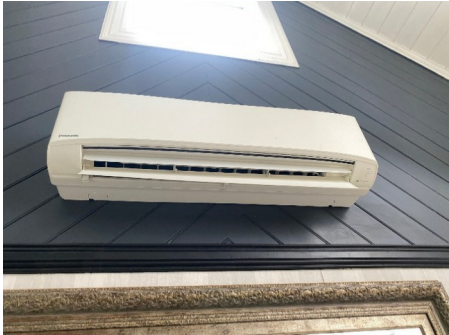
**Heater Heat pump, Panasonic CU-RZ7IVKR**  
Current heater in good working condition.  
[View High Resolution Image Here](#)

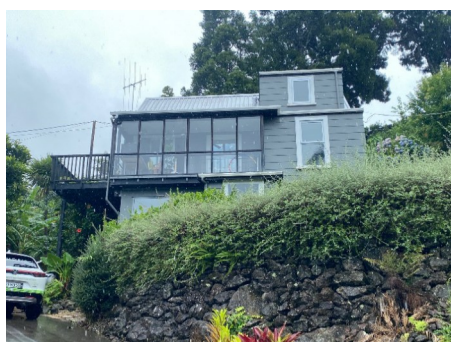
##### Roofline

The ceiling is a skillion ceiling and has no accessible cavity.

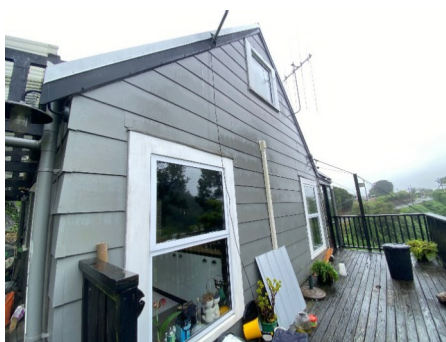
##### Roofline

The ceiling is a skillion ceiling and has no accessible cavity.

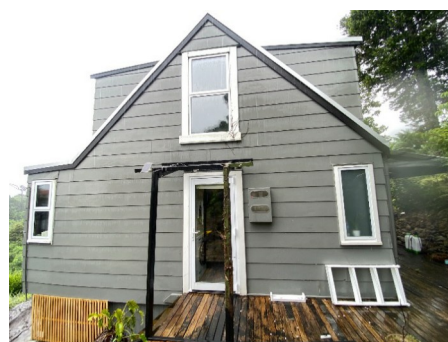
##### Roofline

The ceiling is a skillion ceiling and has no accessible cavity.

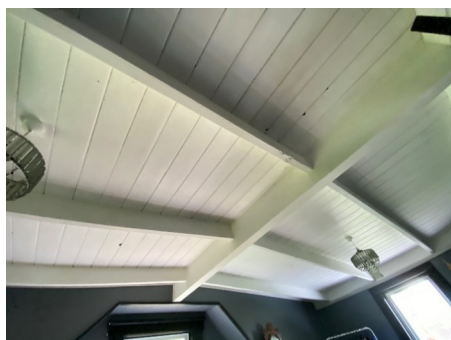
##### Ceiling Cavity

The ceiling is a skillion ceiling and has no accessible cavity.

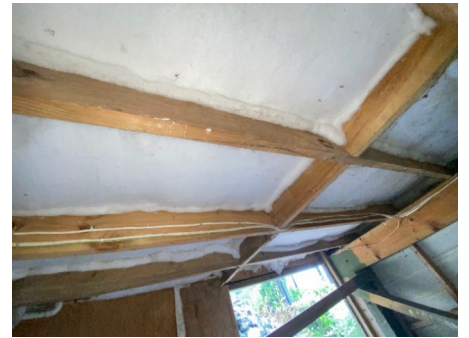
##### Sub floor Insulation

Insulation consists of Polyester blankets or segments.  
[View High Resolution Image Here](#)

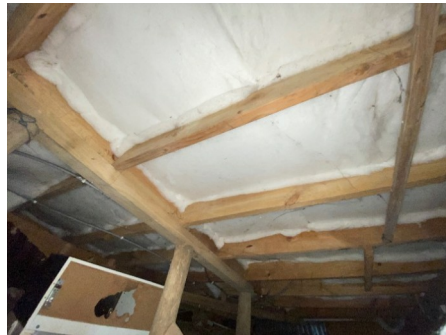
##### Sub floor Insulation

Insulation in good condition and meets the standards.  
[View High Resolution Image Here](#)

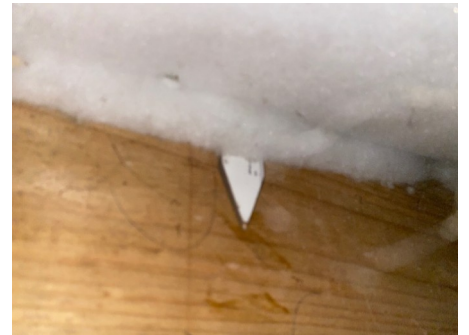
##### Sub floor Insulation

Insulation measurement is 90mm.  
[View High Resolution Image Here](#)

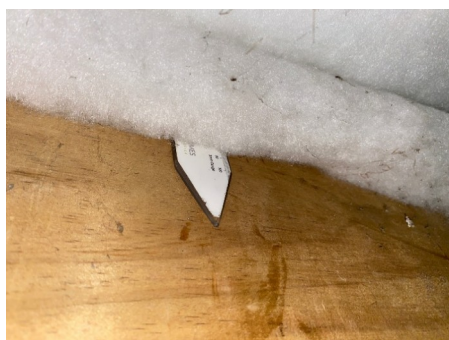
#### Sub floor Insulation

Insulation measurement is 90mm.  
[View High Resolution Image Here](#)

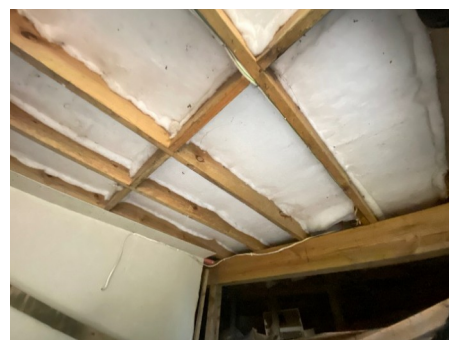
#### Sub floor Insulation

Insulation in good condition and meets the standards.  
[View High Resolution Image Here](#)

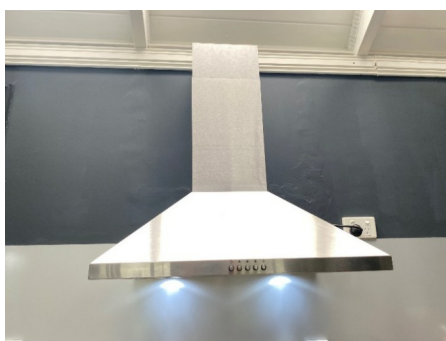
#### Kitchen 1 extraction system

The extraction system is in good working condition.

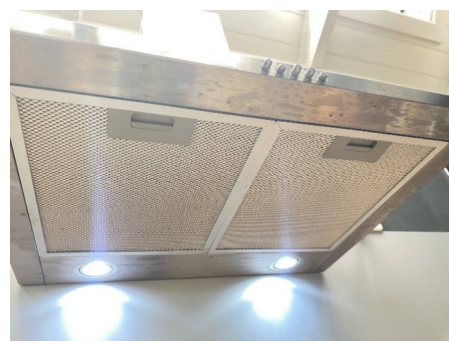
#### Kitchen 1 extraction system filters

The kitchen extraction system filters are free from grease and oil.

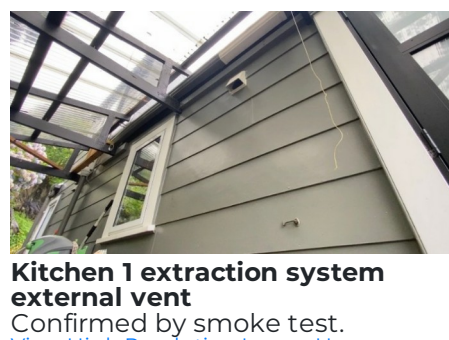
#### Kitchen 1 extraction system external vent

**Comments:** Airflow testing was completed on the extraction system within the kitchen using splintax smoke matches. This has determined that the system is connected to an external vent and adequately drawing air to the outside.

Confirmed by smoke test.

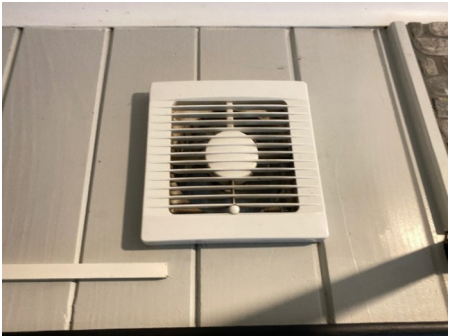
**Bathroom 1 extraction system**  
The extraction system is in good working condition.  
[View High Resolution Image Here](#)

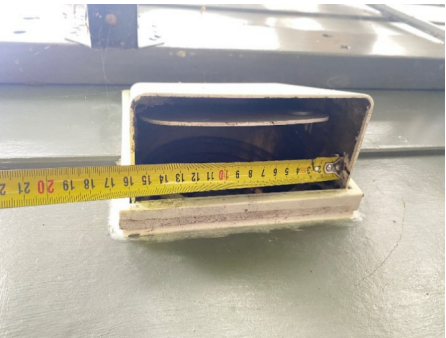
**Bathroom 1 extraction system ducting**  
Ducting measurement is 150mm.  
[View High Resolution Image Here](#)

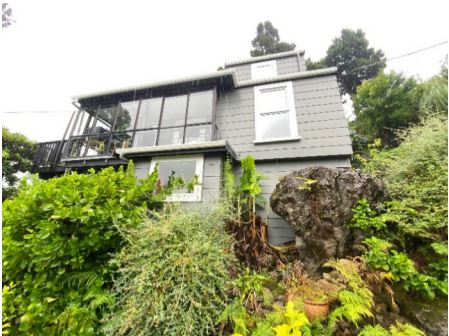
**Front of property - spouting**  
Spouting system is in good condition/ or near new condition.  
[View High Resolution Image Here](#)

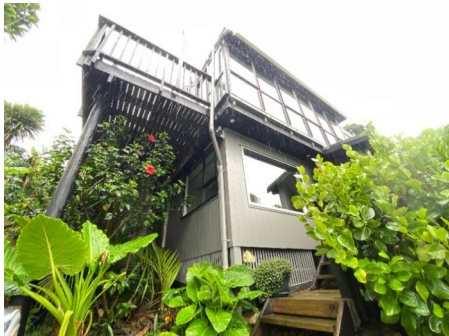
**Front of property - downpipe**  
Downpipe is in good condition/ or near new condition and affixed securely to building.  
[View High Resolution Image Here](#)

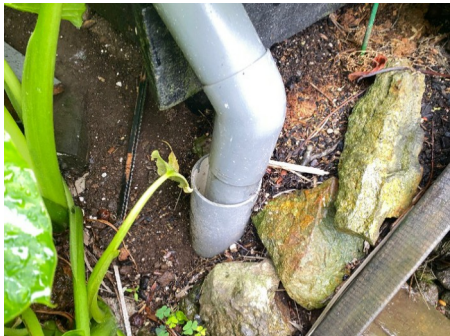
**Front of property - downpipe**  
Downpipe leads to an appropriate outfall.  
[View High Resolution Image Here](#)

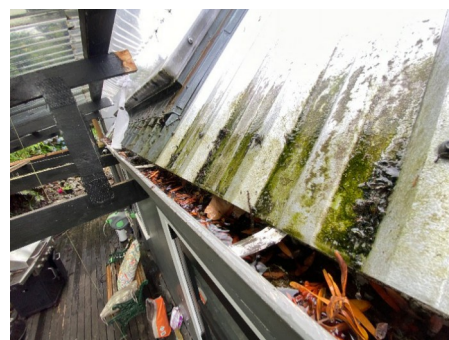
**Rear of property - spouting**  
Spouting is blocked by plants or debris preventing effective drainage.  
[View High Resolution Image Here](#)

**Comments:** The property was deemed to have appropriate gutters and down-pipes that efficiently drain storm water, surface water and ground water to an appropriate outfall.  
Compliance based on photo evidence for the remediation to the drainage system.

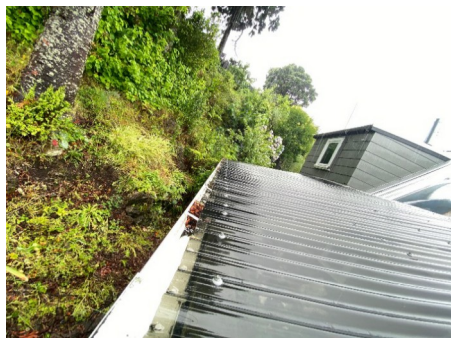
**Rear of property - spouting**  
Spouting is blocked by plants or debris preventing effective drainage.  
[View High Resolution Image Here](#)

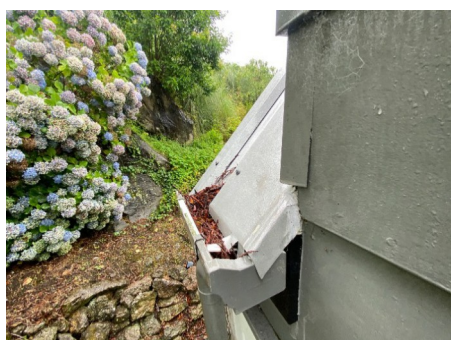
**Rear of property - spouting**  
Spouting is blocked by plants or debris preventing effective drainage.  
[View High Resolution Image Here](#)

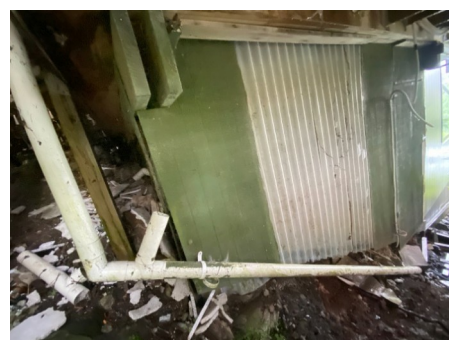
**Rear of property - downpipe**  
Downpipe not connected to an appropriate outfall.  
[View High Resolution Image Here](#)

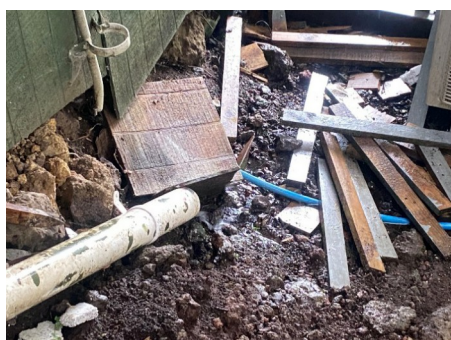
**Rear of property - downpipe**  
Downpipe not connected to an appropriate outfall.  
[View High Resolution Image Here](#)

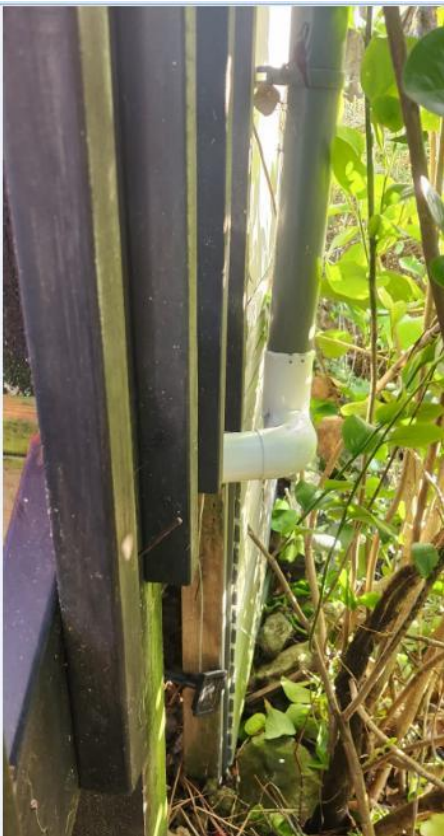
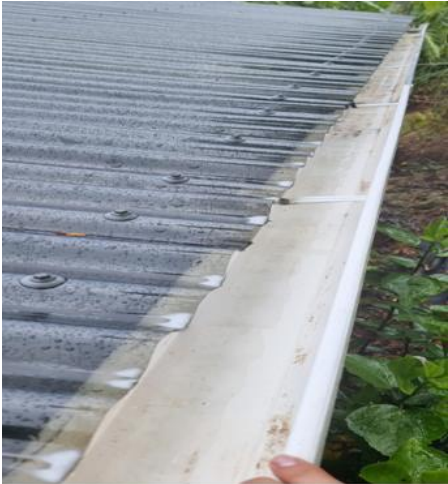
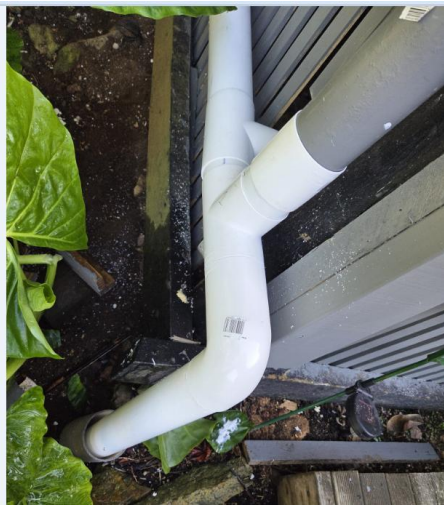
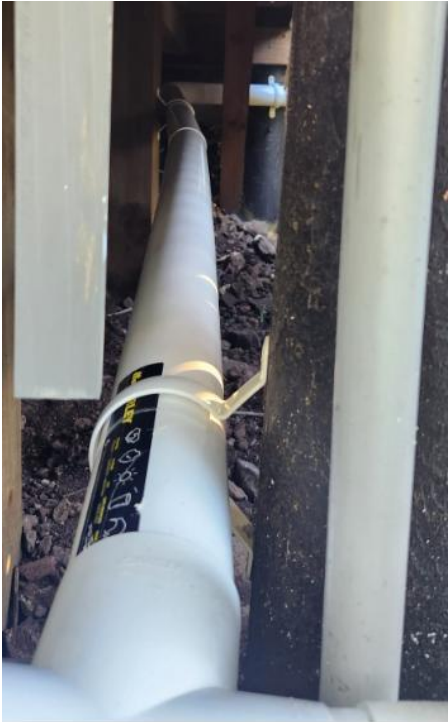
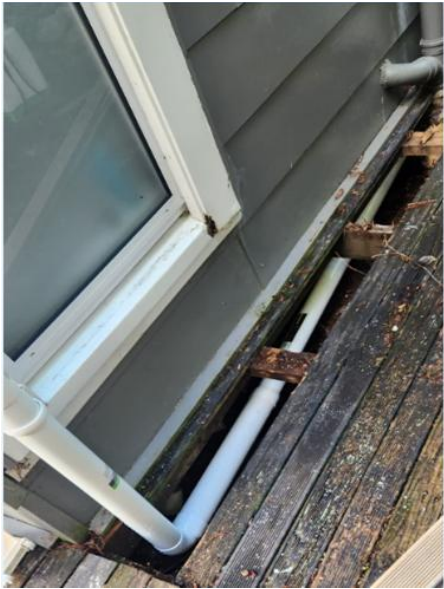
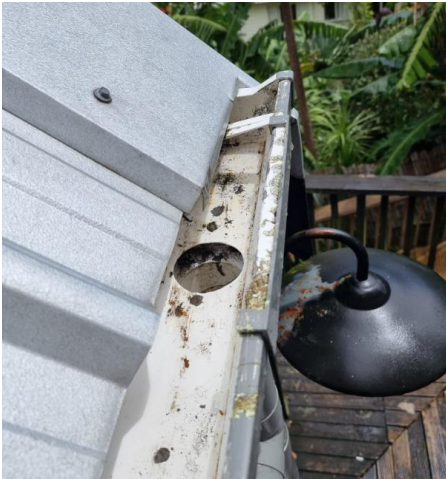
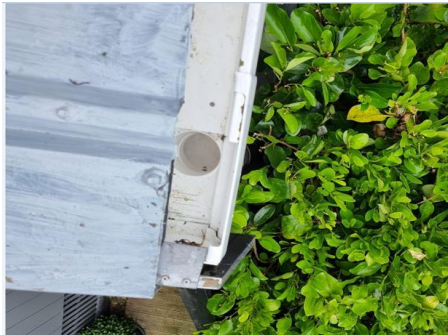
**Drainage remediation**  
[View High Resolution Image Here](#)  
02/02/2026

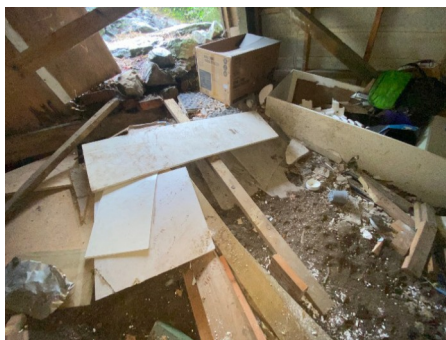
**Sub floor internal context**  
No moisture barrier has been installed in the sub floor.  
[View High Resolution Image Here](#)

**Comments:** The enclosed sub-floor has a ground moisture barrier installed that meets the requirements of the standard.  
Compliance based on photo evidence for the installation of a ground moisture barrier.

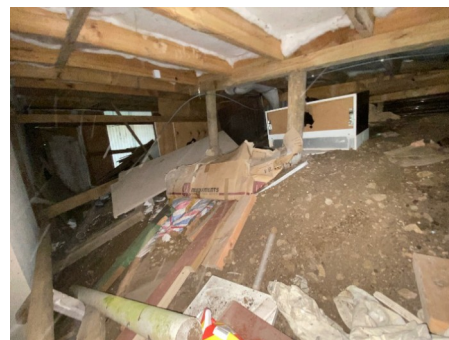
**Sub floor internal context**  
No moisture barrier has been installed in the sub floor.  
[View High Resolution Image Here](#)

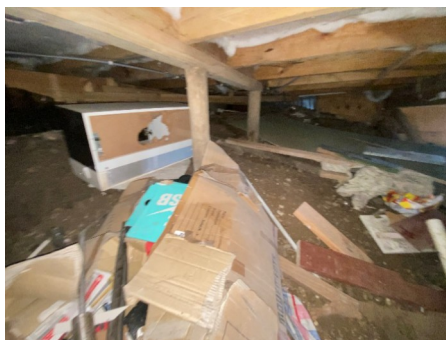
**Sub floor internal context**  
No moisture barrier has been installed in the sub floor.  
[View High Resolution Image Here](#)

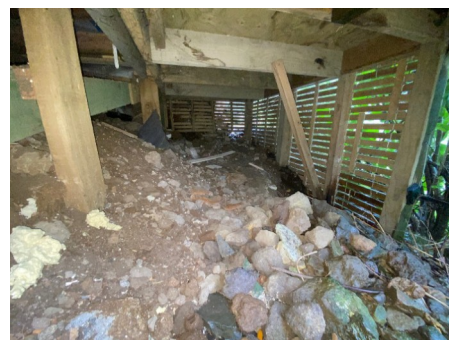
**Sub floor internal context**  
No moisture barrier required, Access too narrow and blocked.  
[View High Resolution Image Here](#)

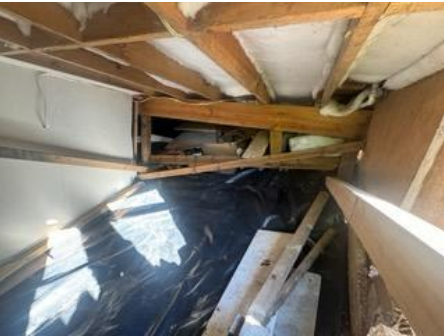
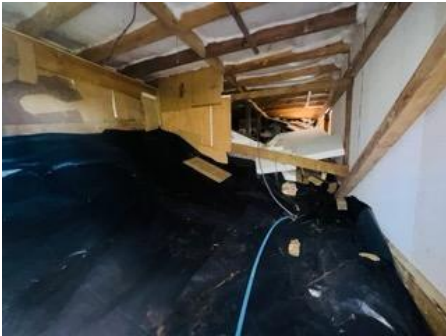
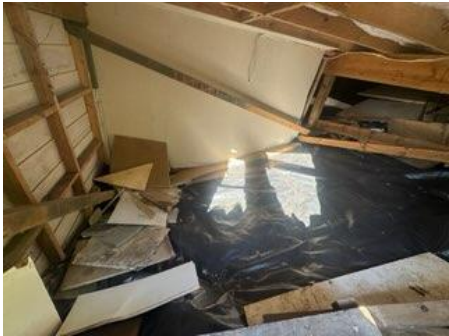
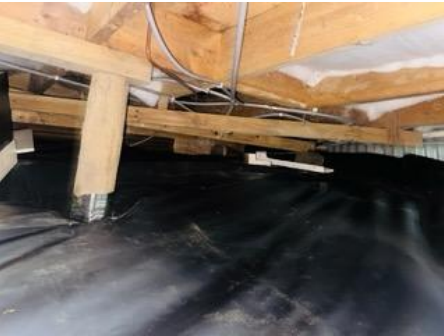
Moisture Barrier remediation  
[View High Resolution Image Here](#)  
02/02/2026

**Finding:** The Property as at 2 February 2026 was re-assessed to be compliant with the Moisture Ingress Requirements of Residential Tenancies (Healthy Homes Standards) Regulations 2019.
