# WDC LIM REPORT

## Land Information Memorandum

**LIM number:** LM2601199

**Street Address:** 34 Wainui Avenue  
Whangārei 0112

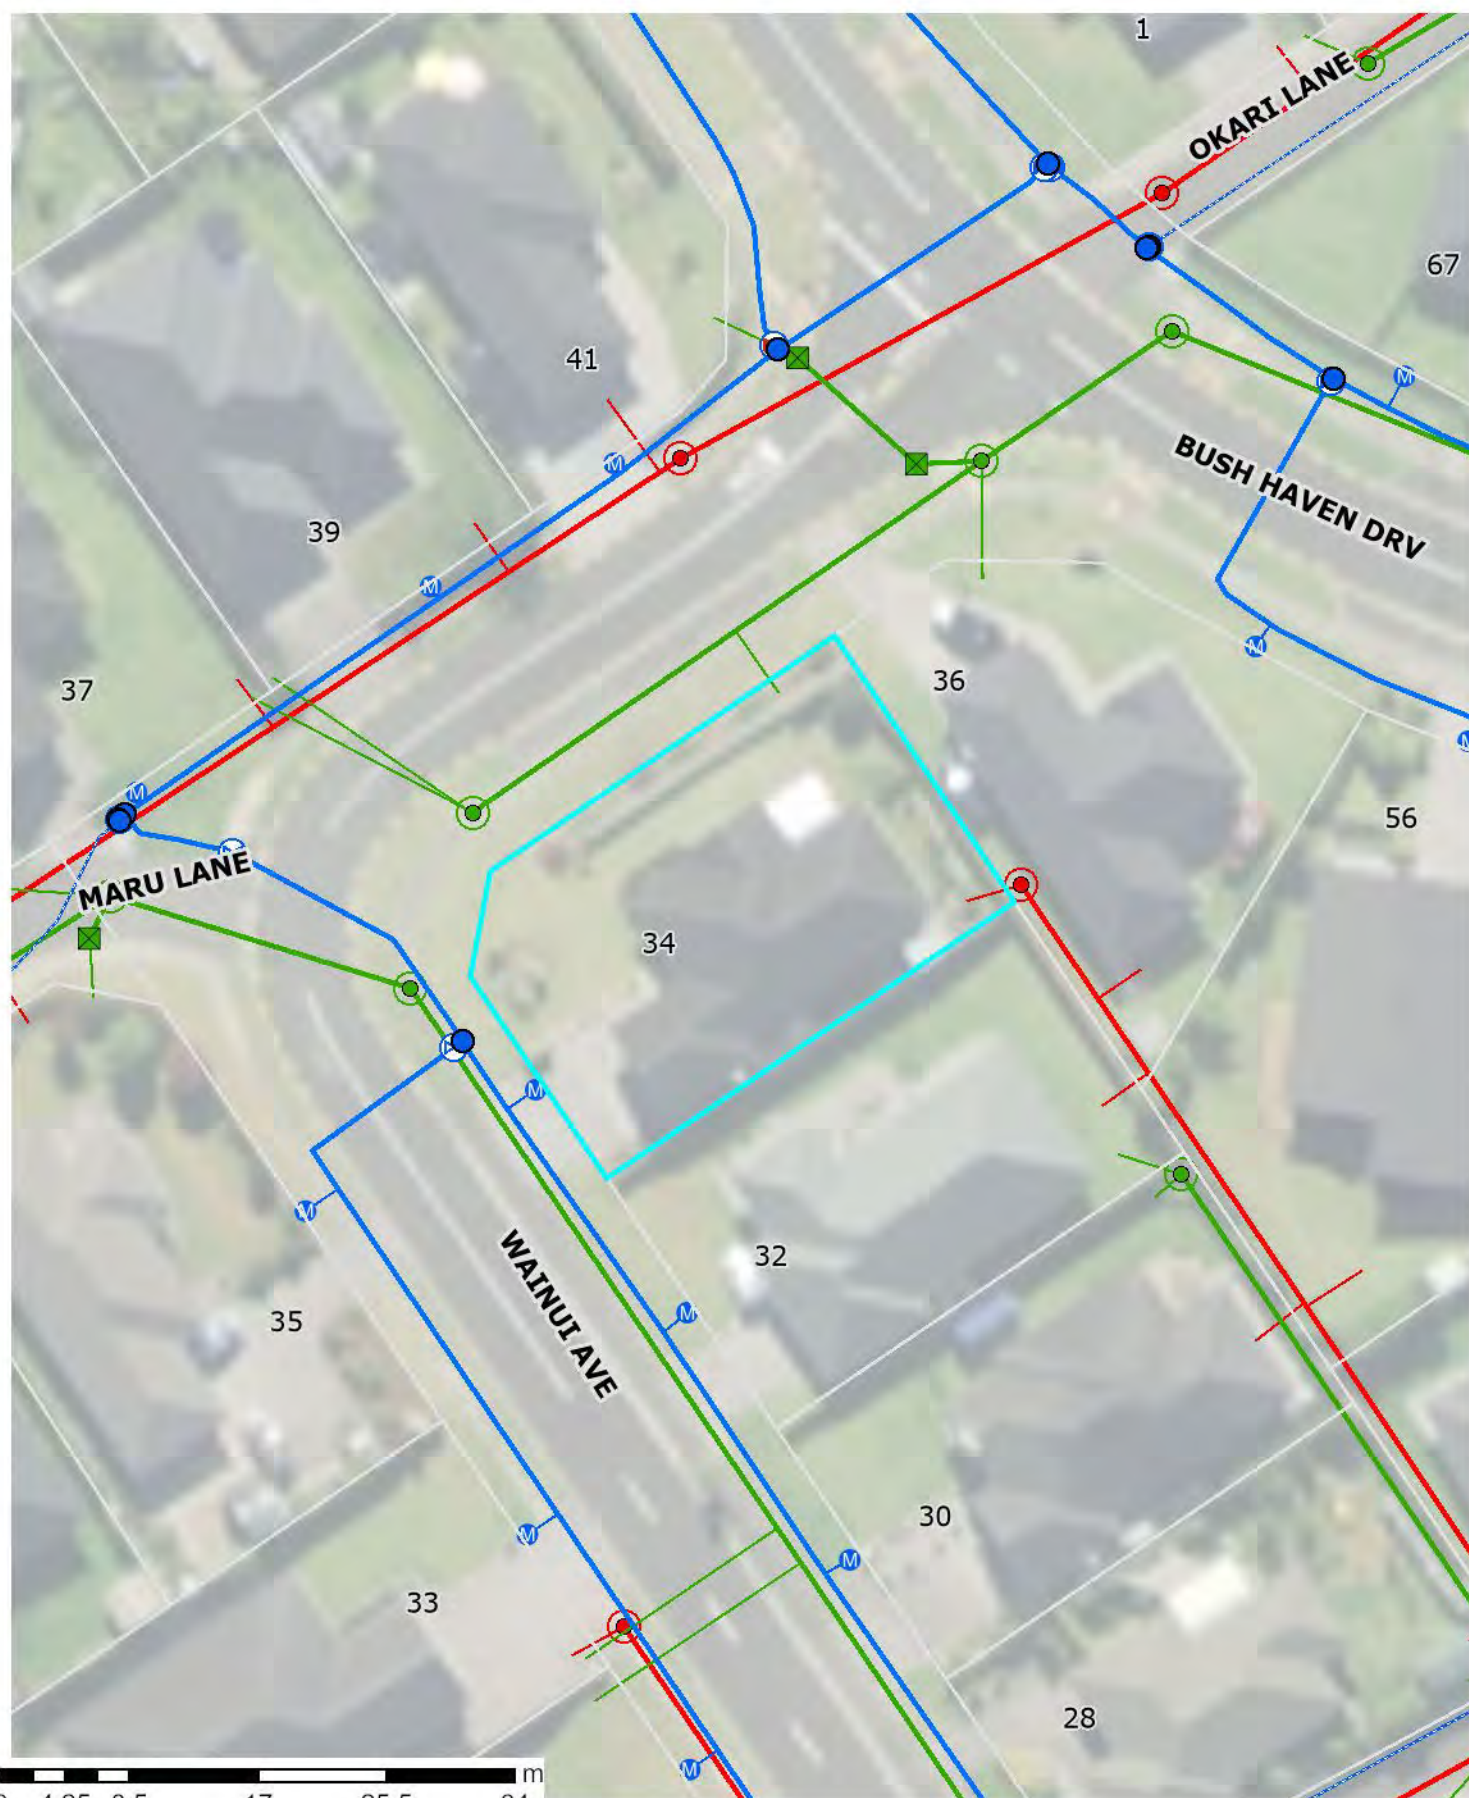
# Water, Wastewater and Stormwater

This information is generalized and shows the approximate location of the known pipeline services.  
For digging, the As-Built engineering drawings must be used to accurately locate the services.  
See WDC Customer Services.

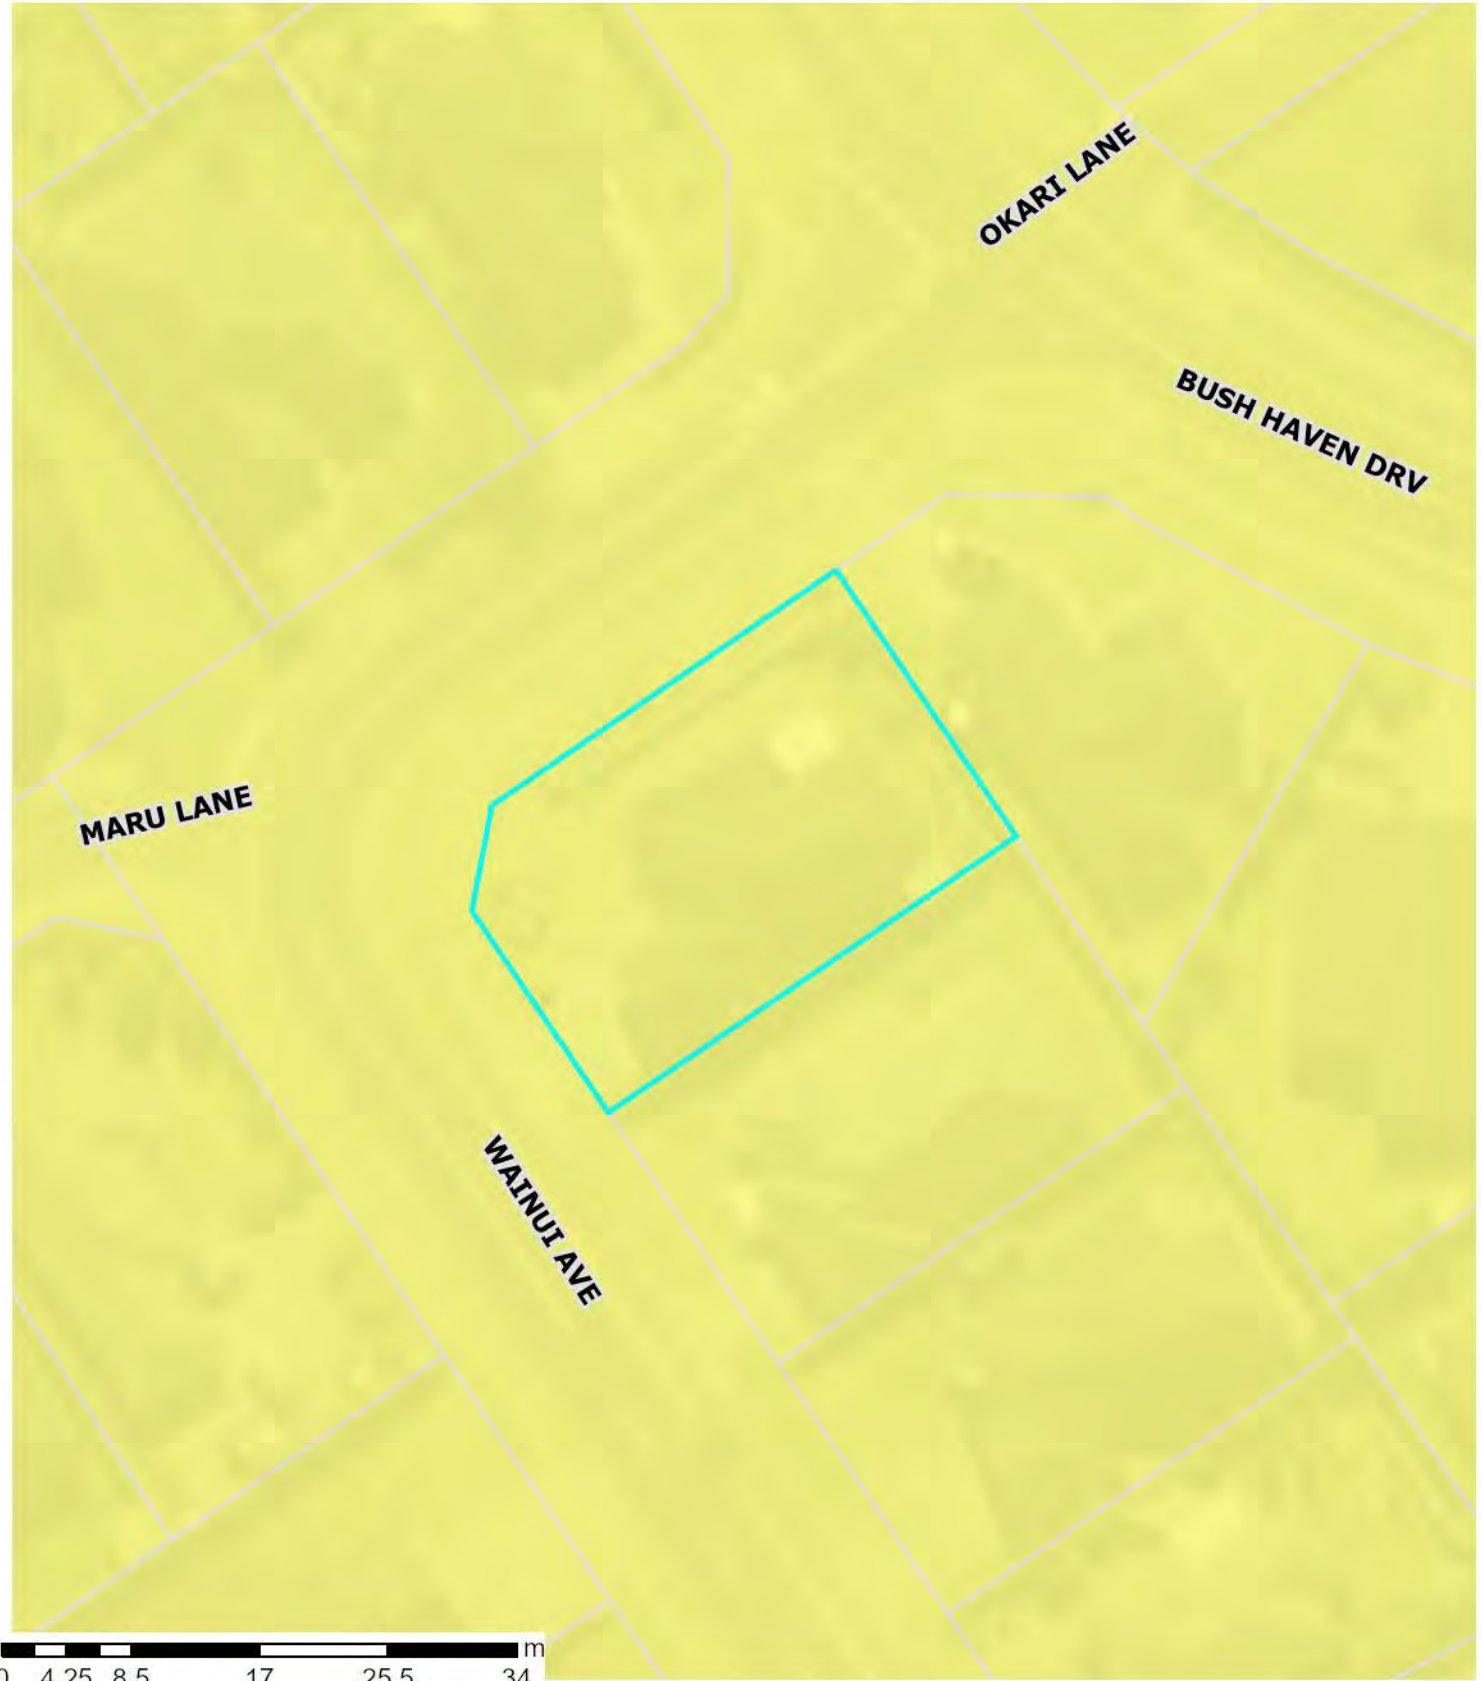
Landslide Susceptibility Zone

- High
- Moderate
- Low
