## **CONTAMINATED LAND MANAGEMENT**

### **PSI ASSESSMENT**

GOLF HARBOUR DRIVE  
WHANGAREI

**Ref:** 14037

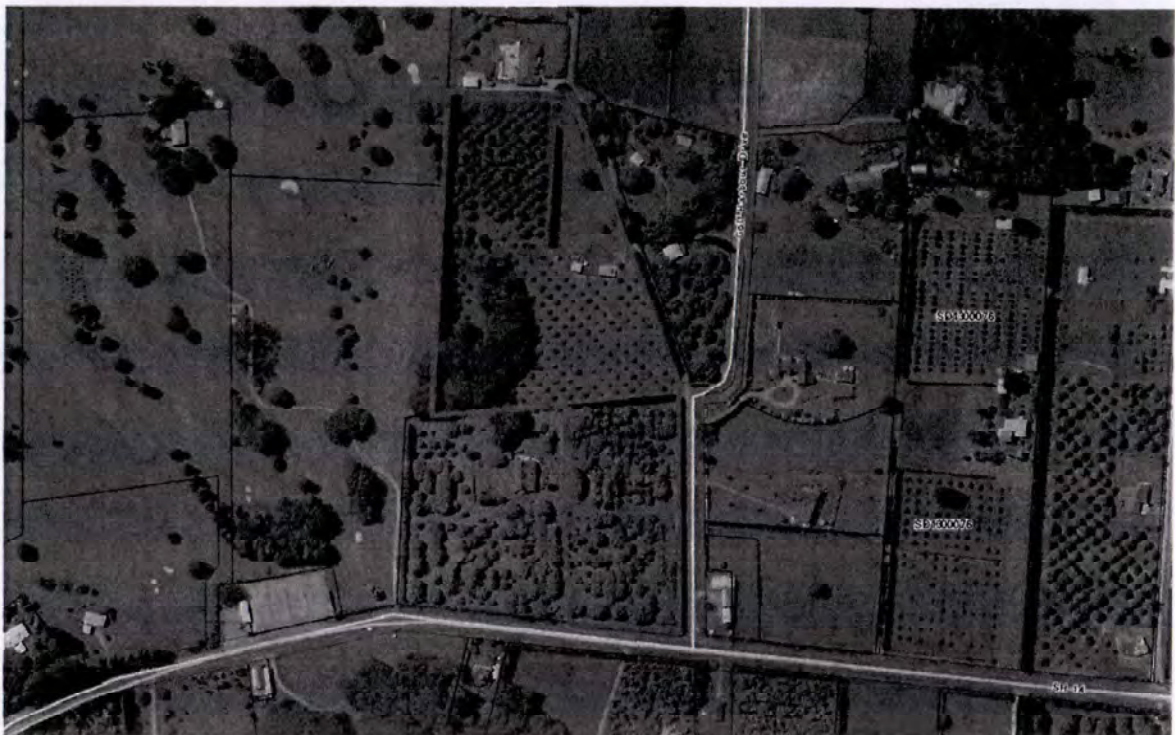
Figure 1: WDC GIS aerial image

Vehicle access is available from Golf Harbour Drive via an existing vehicle crossing. Figure 1 below taken from WDC GIS shows the site and surrounds including the existing vegetation, farm sheds and access arrangements.

The site is generally in good condition and appears to be well maintained. Post and wire fences of varying age and condition are present on all boundaries, along with shelter belts as indicated in Figure 1. Two small buildings are present on the property which are constructed around what was formerly a milking shed and stock yard. The timber sheds are used to house equipment and materials for use on the property and for occasional sheep management. The small stockyard may have historically been used as a milking shed but is only suitable for a small number of sheep and not a large scale commercial operation. It is possible that the races or stockyards were used for spraying stock in the past but this has

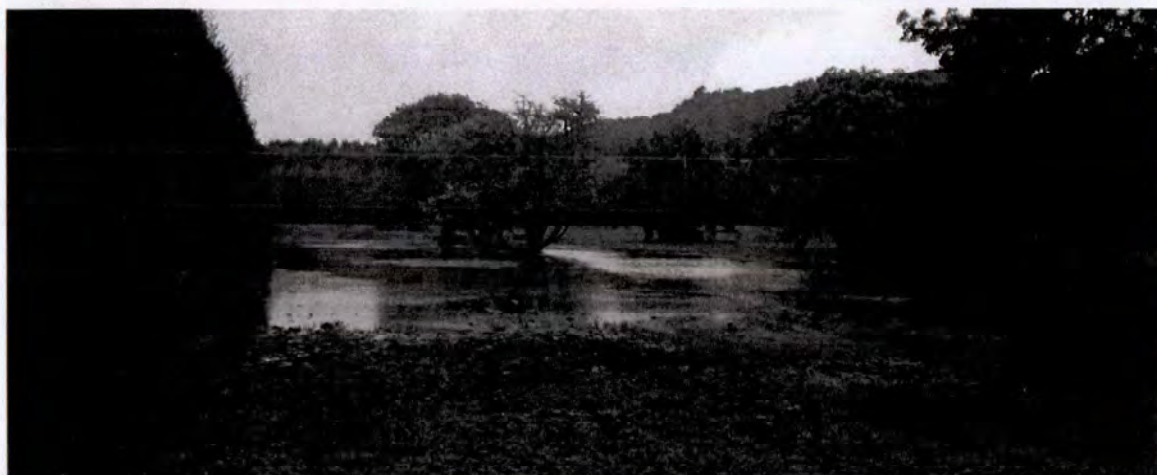
Figure 3: Existing shallow ponding basin adjacent to Golf Harbour Drive

Whangarei District Council and Northland Regional Council hazard maps do not indicate flood susceptible areas located in or adjacent to the proposed development. The site has relatively flat to gently rolling topography ground slopes increasing locally at the incised overland flow path visible in Figures 4 & 5. The southern end of the property has a gentle slope grading down to a low point adjacent to Golf Harbour Drive and during extreme rainfall events localized flooding occurs in the low points is indicated in Figure 3 below.

The flow restriction created by the limited capacity culvert and the flood basin in Figure 3 above are considered to be the primary source of flooding at the site.

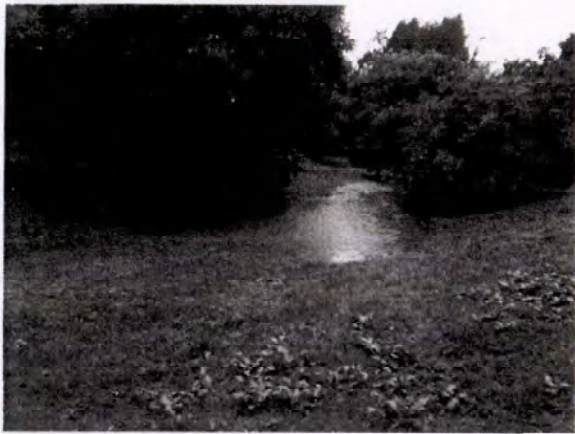
Figure 4: Existing drainage easement in proposed Lot 2 for conveying surface water

The subdivision site accepts surface water runoff from adjacent properties (golf course) and beyond via concentrated flows following the natural contours of the land. The overland flow path in the north of the subdivision site is designated via an easement passing through the property, allowing surface water to be conveyed from west to east. The concentrated flow is piped under the formed ROW access on the northeast boundary via a DN600 culvert.

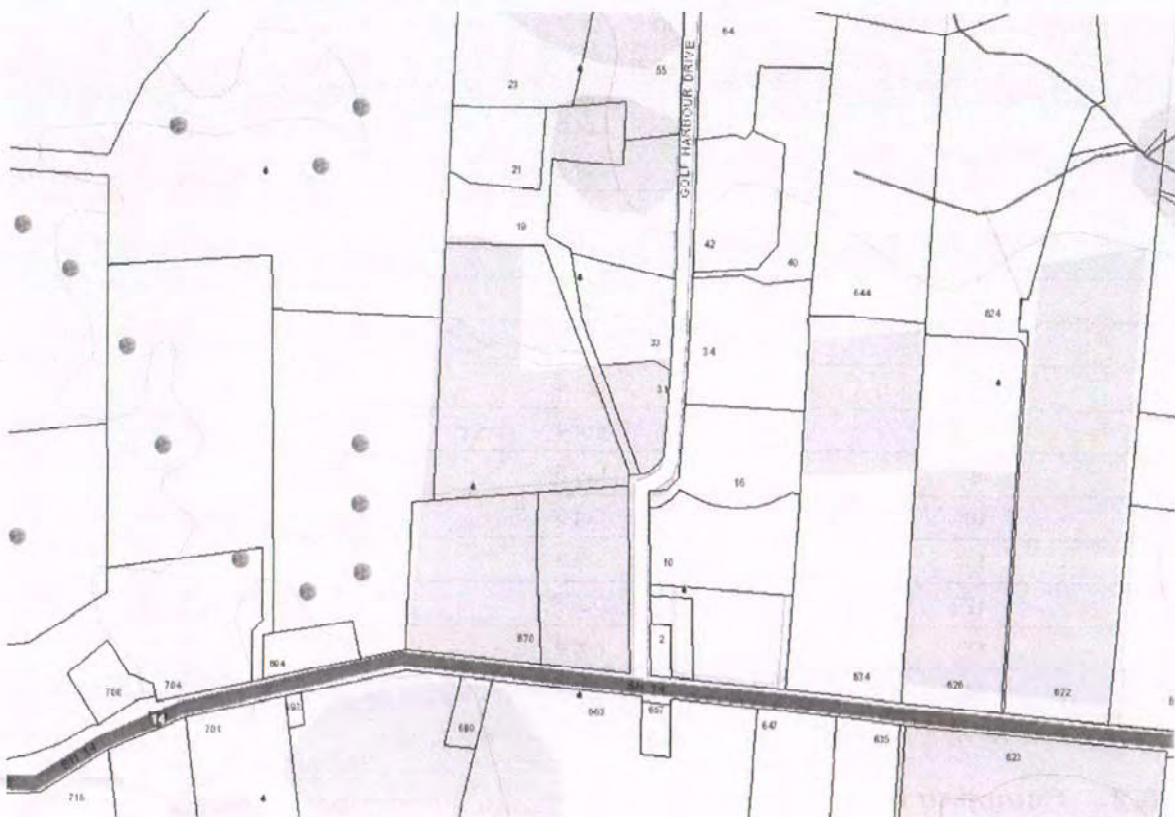
Figure 6: NRC GIS aerial image

Northland Regional Council GIS maps indicate the site is being positioned within the Maunu aquifer which is classified as a semi unconfined Principal Aquifer in Taheke Basalt overlying sandstone/mudstone with a saturated thickness of 8-58m. Ground water collection is common in the area and several water bores are mapped in proximity to the subdivision site, with one positioned within proposed Lot 2.
