# Your Building Inspection Report

CONFIDENTIAL REPORT FOR  
Kate Forsyth  
ID 174425  
Thursday, September 24, 2026

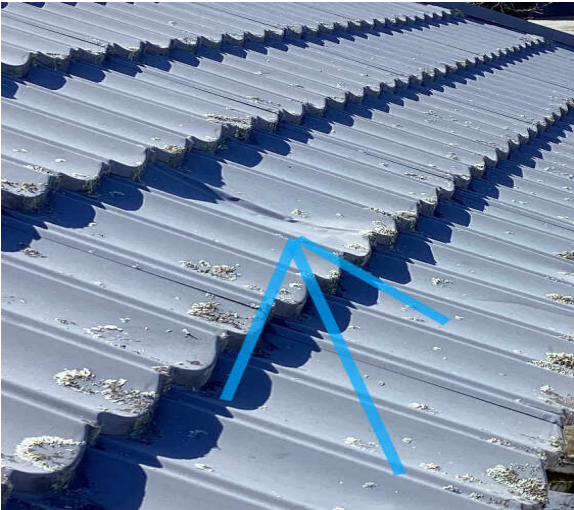
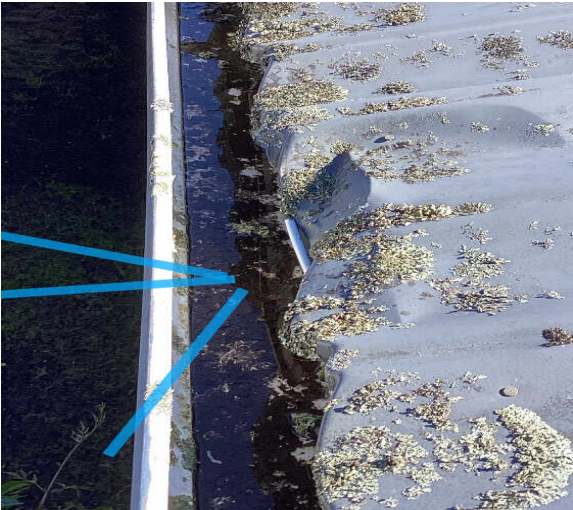
Impact damage noted to left-hand elevation as shown.

We recommend the tile and the guttering are fixed back into the correct position. The tile is bent over and has pulled the guttering with it. This is to the left-hand elevation as shown.

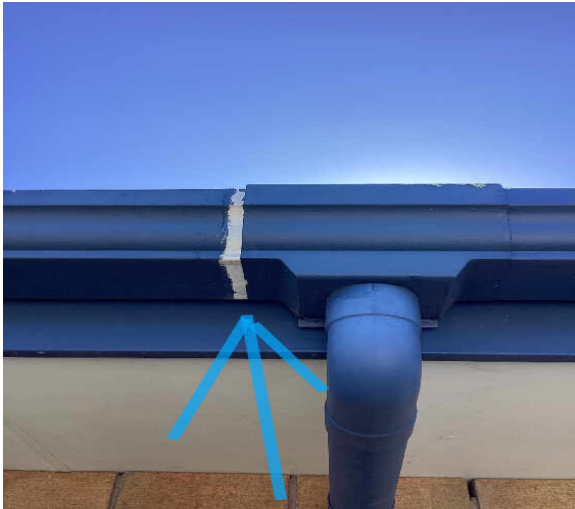
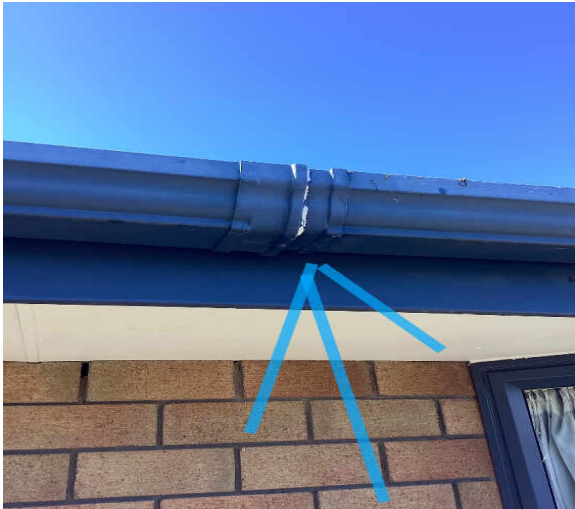
PVC gutters are prone to becoming brittle due to the high sunshine hours and UV in New Zealand's climate. The gutters have vegetation in areas. This will lead to the inadequate discharge of rainwater. We recommend these are cleaned. Guttering requires repairs as noted below. Allow to constantly monitor and maintain as required.

Left-hand elevation. The guttering has moved to the expansion gutter joiner.

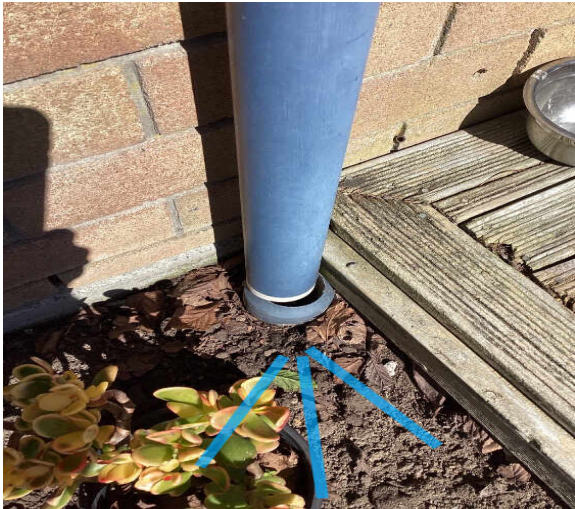
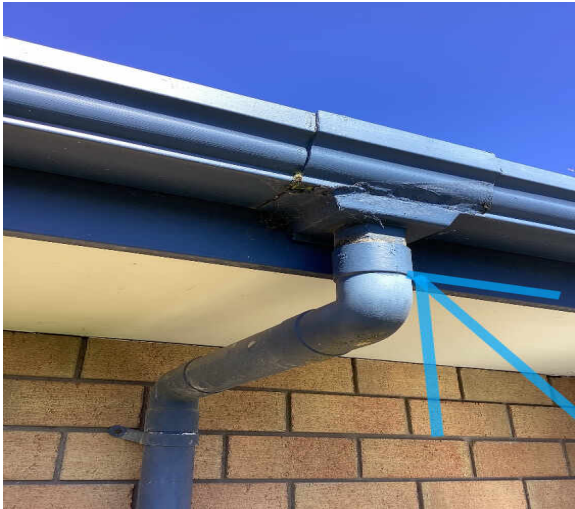
We recommend the leak is fixed to the guttering to the rear of the property as shown.

We recommend clipping downpipe back into outlet at ground level. This was noted to the right hand rear corner elevation.

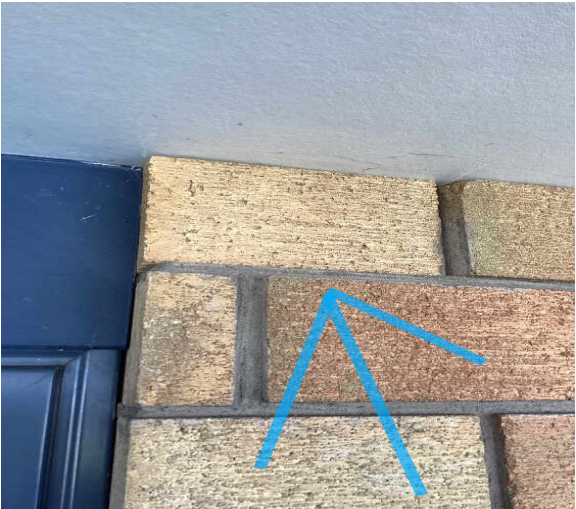
Please see comment below relating to the loose brick . This is a minor maintenance issue , hence why we have kept this section of the report green. Allow to constantly monitor and maintain as required.

Loose brick noted to left-hand elevation master bedroom window right hand side as shown.

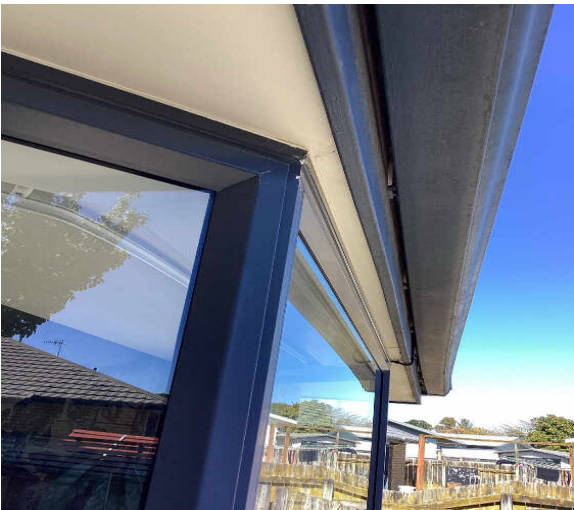
There is a narrow soffit noted to the lounge bay window.

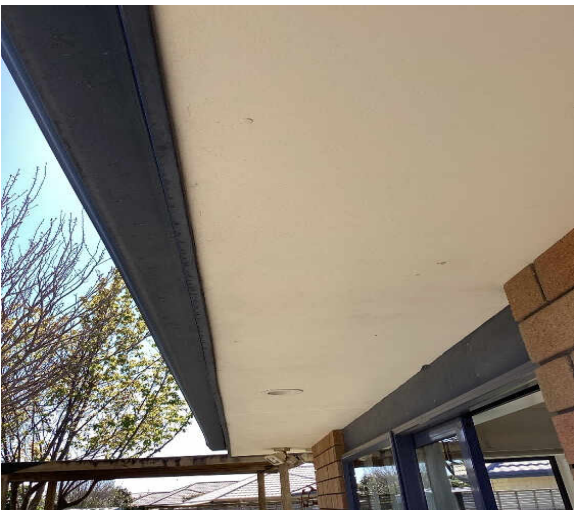
Due to the narrow soffit the cladding and flashings around the lounge bay window are relied on more heavily to keep water from penetrating the building envelope. We suggest that a thorough examination is completed bi-annually (ideally at the end of winter and end of summer), and any deterioration in the cladding or flashings are investigated by a weather tightness specialist. Conventional pitched roof shapes extend beyond external wall lines. This traditional design feature effectively shelters the top of the wall cladding and window heads that are close to the soffit. This reduces the risk external moisture ingress. Allow to constantly monitor and maintain as required.

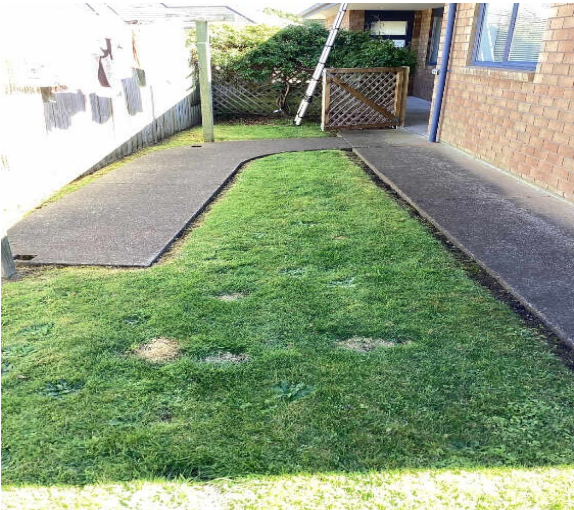
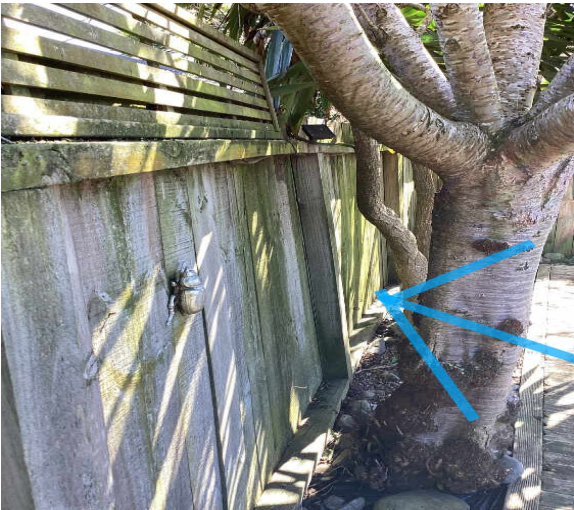
The site is reasonably flat and therefore stormwater may pond in areas. The site was dry during the inspection so we were unable to confirm. We are unable to comment on the stability of the land. Likewise, we cannot determine what areas are filled or what material is underneath. We recommend further investigation of the council files to ensure any documented evidence is discovered. If limited information is available, investigation of the land by a geotechnical engineer is advised if you have concerns following a council file check. Some fences are leaning, indicating the post foundations are not adequate to support the fence. This will deteriorate further if not repaired. Allow to constantly monitor and maintain as required. Please see comments below relating to gates.

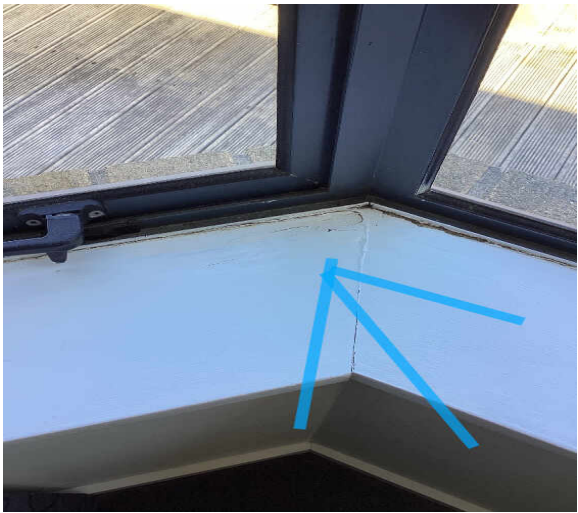
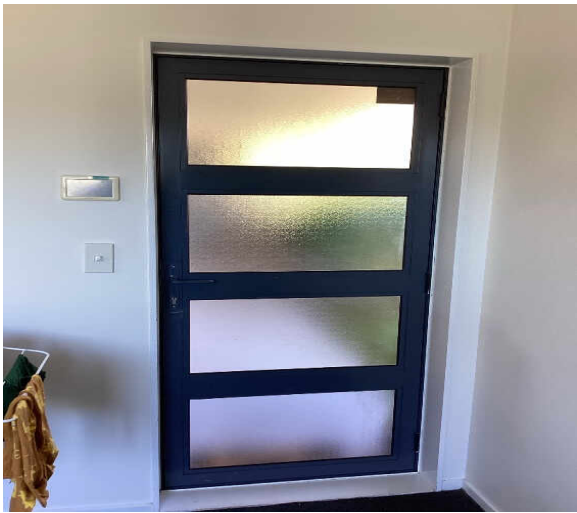
Please see comment raised relating to the lounge bay window sill. Allow to constantly monitor and maintain as required.

Moisture damage noted to lounge bay window sill as shown.
