Lubrication Failures in Large Excavators

Reliability and maintenance issues relating to mechanism lubrication.

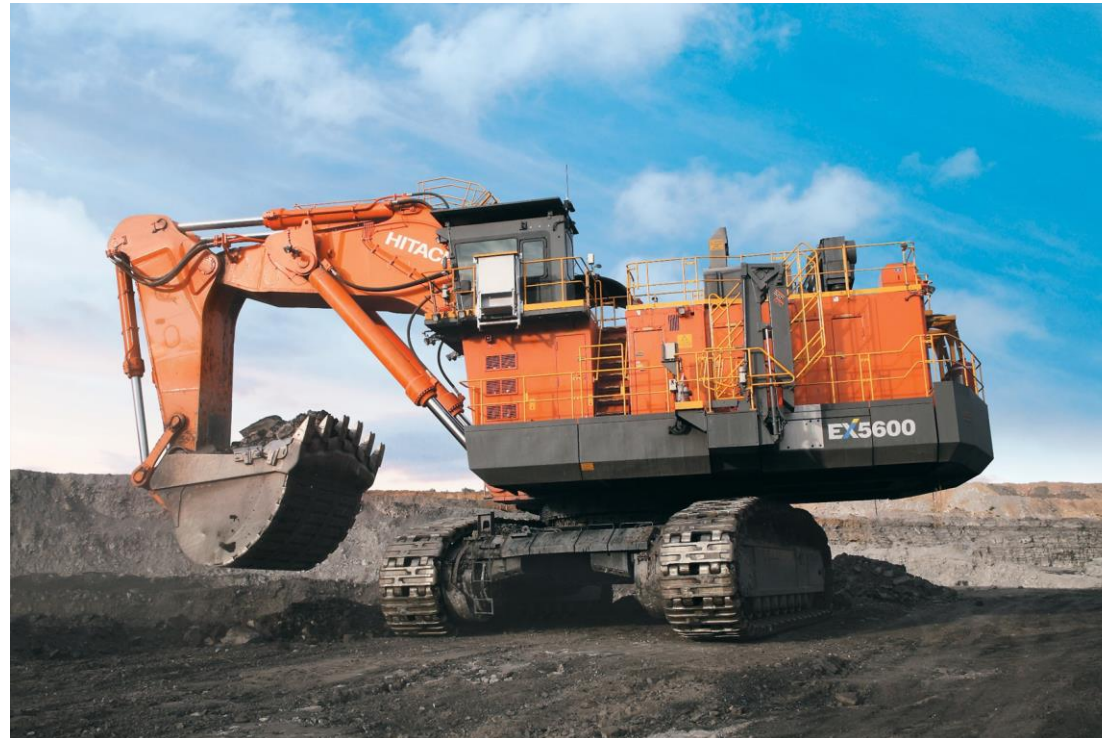
- Grease lines and injectors on H-links commonly damaged
- Grease leaks and spills

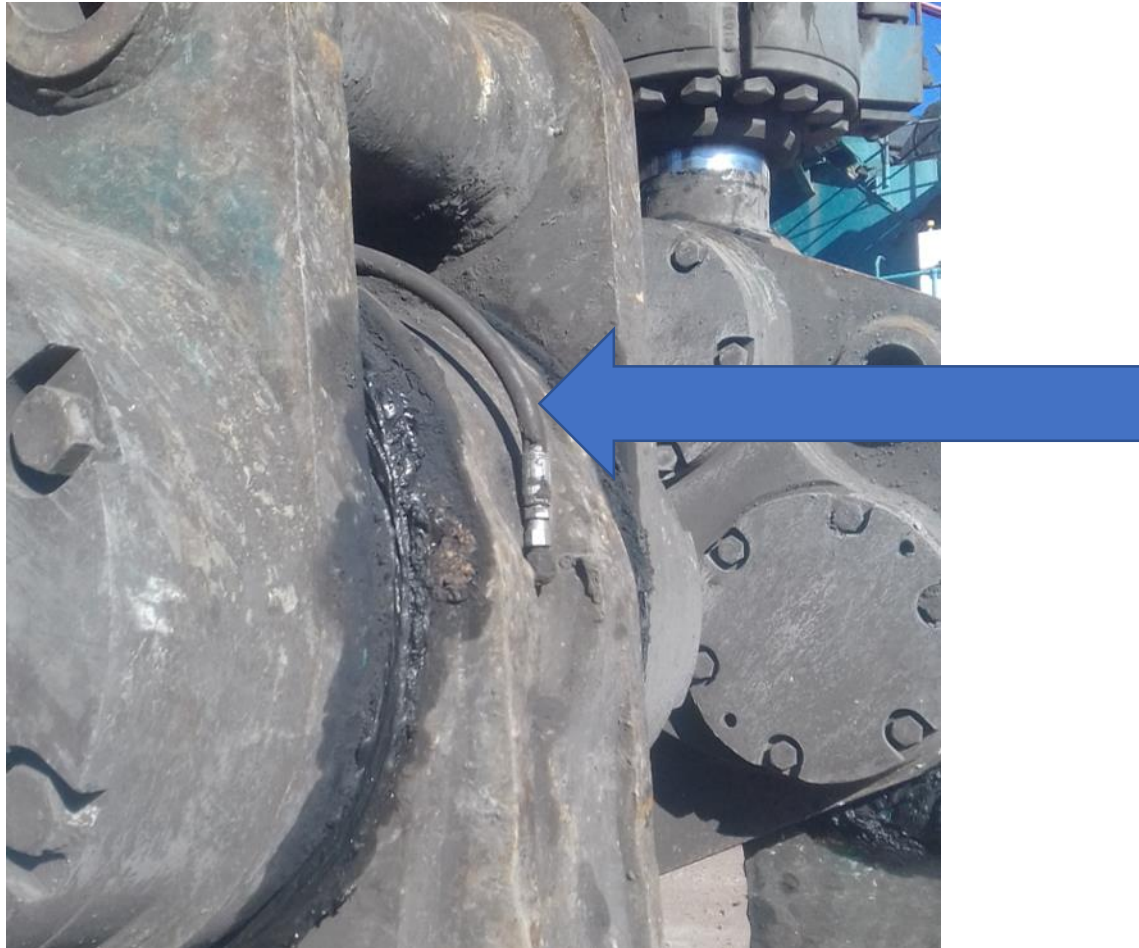
Grease still required in these areas.

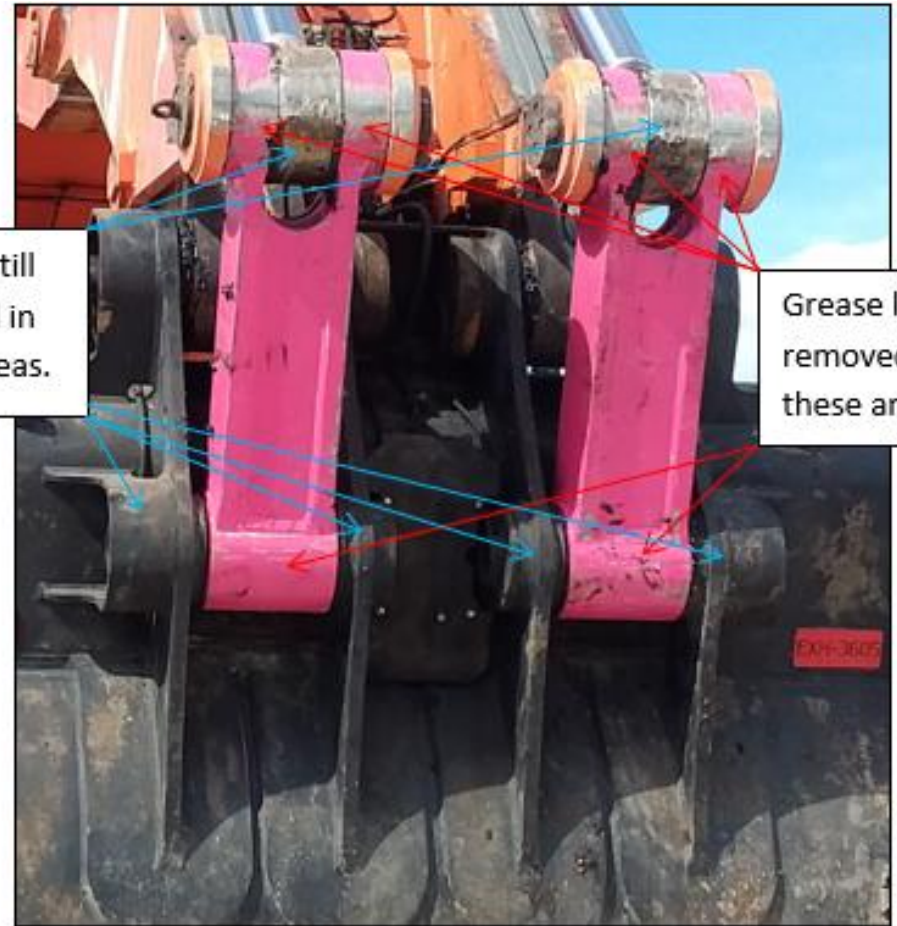
Grease lines removed from these areas.

- Remove lines and injectors from linkages

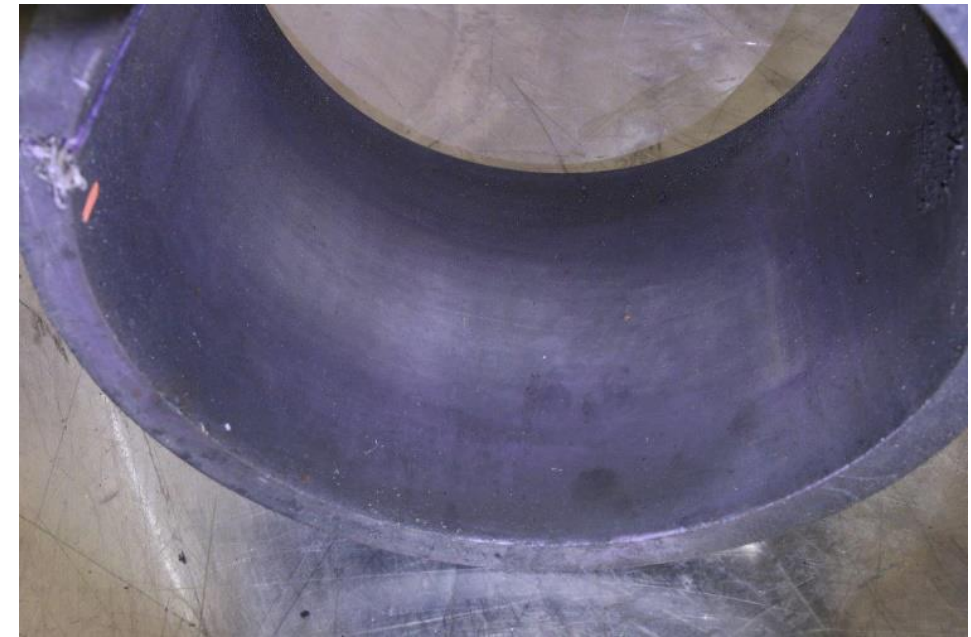
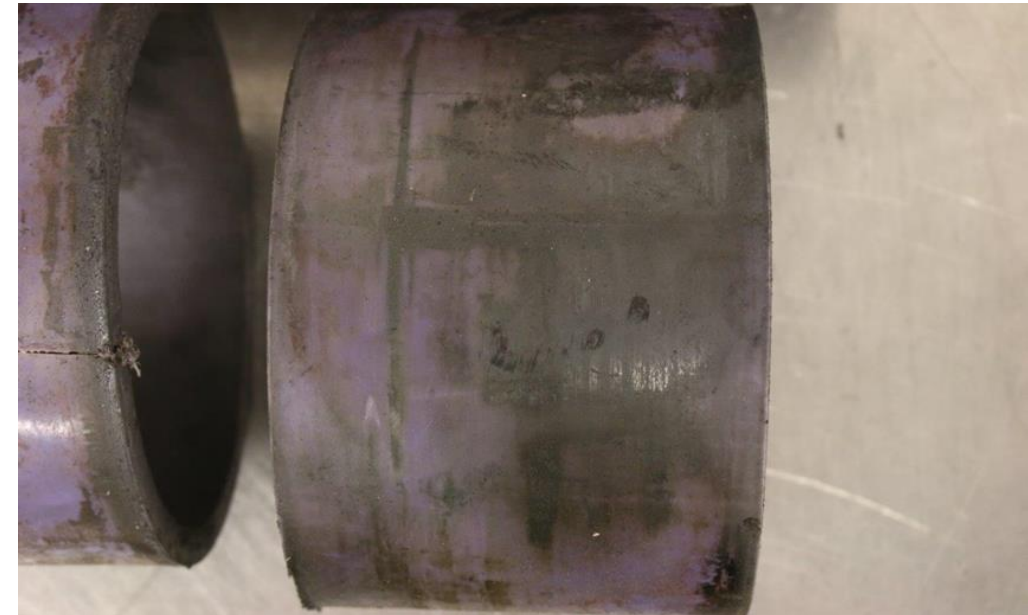
- Bushes in service on EX3600 and EX5600 H-Links since 2017
- No grease lubrication
- No service issues in this period
- Service life 10,000 hours
- UQMP report on used bushes October 2019

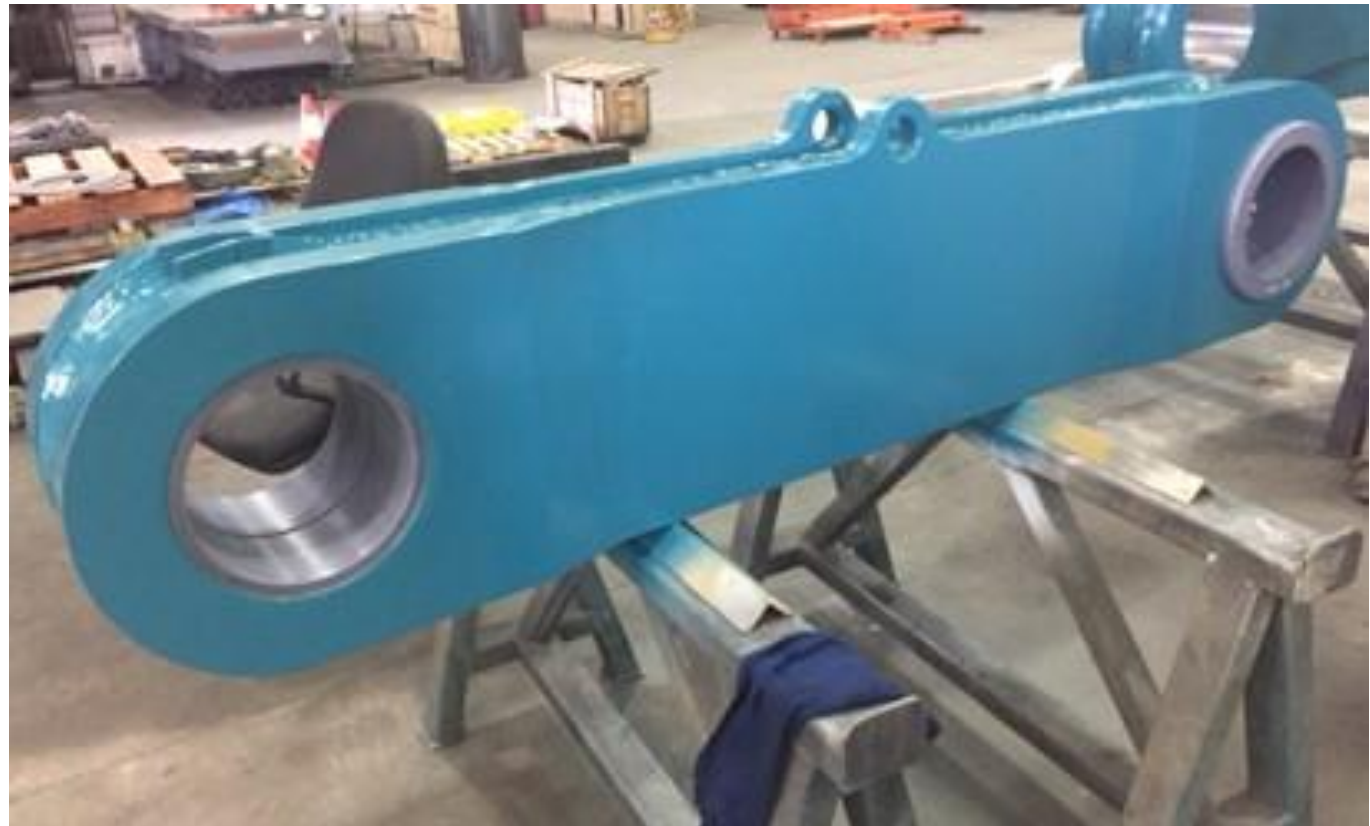
- Liebherr 996 connecting links.
- Bushes installed July 2016, replaced June 2018
- No grease lubrication
- No service issues
