INVENTORY AND CONDITION ASSESSMENT

PHASE II REPORT

Insular ABCs Insular Schools Assessment of Buildings and Classrooms

August 2013

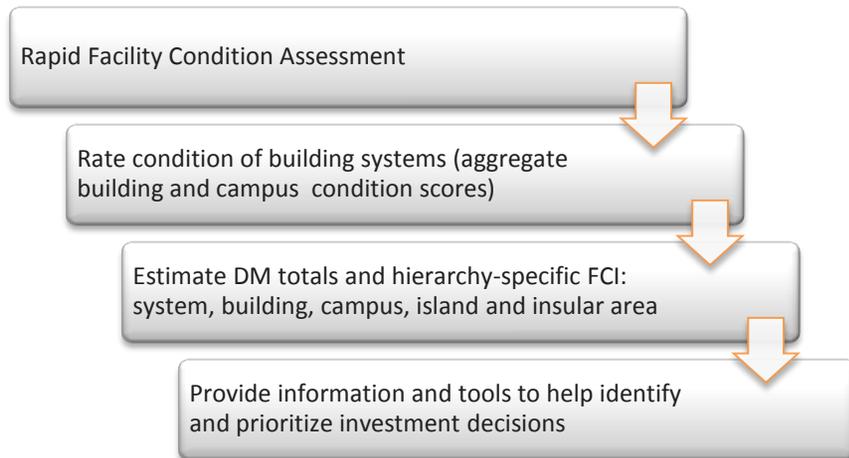
Schematic of overall approach

The Insular ABCs used a rapid condition assessment model following a standard set of assessment procedures, a simple condition score range, and score-based DM calculations. Data summaries were then provided by composite system and building level score, DM, and FCI.

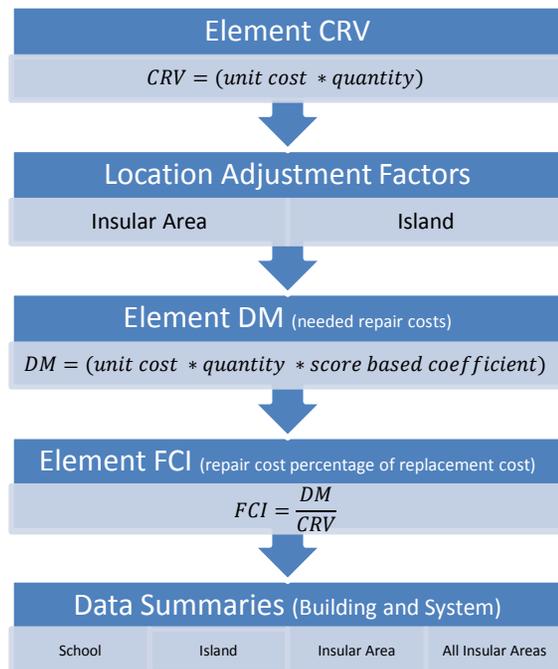
Key components of the cost model (identified in the schematic diagram to the right) include estimating element-level CRV, applying location adjustment factors, estimating DM based on a score coefficient (shown on the System Condition CRV Percentages table), calculating FCI to assist in data interpretation, and reporting data summaries through the system

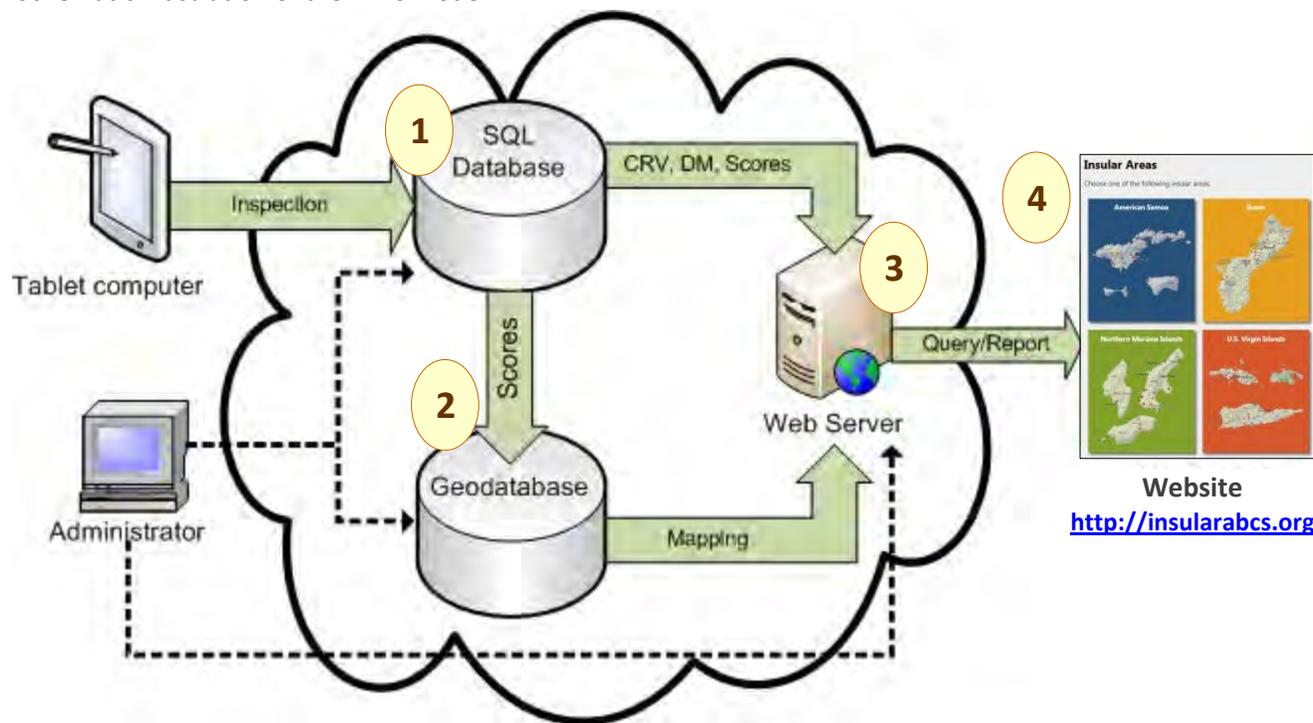
Schematic Illustration of the FIMS model

1. Assessment data and other available facility data was gathered and uploaded to the SQL database via tablets and laptops.
2. Facility data was geo-referenced for map-based data viewing.
3. Query and reporting tools were developed to provide data summaries.
4. Data was made accessible to authorized users through a web interface.

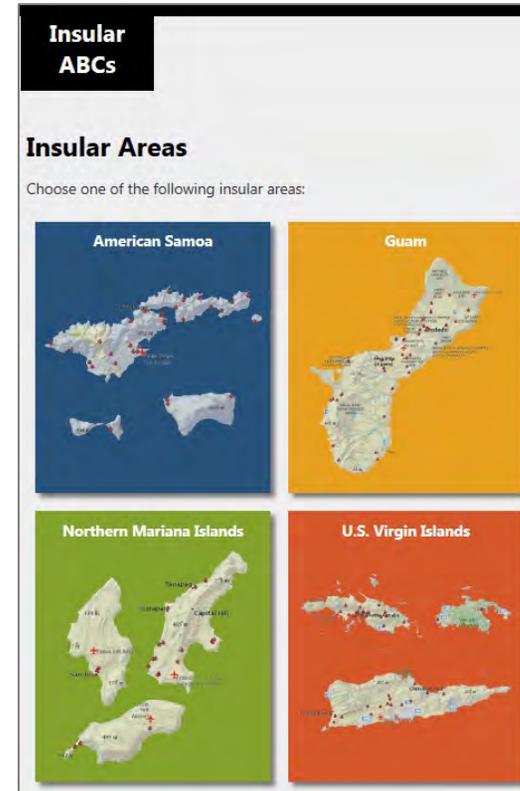
Home page view

The home page (left) provides a roll-up of all the insular area data for OIA use. Each insular area has access to its own page with associated data roll-ups at the school district, school (below), building and building system level.

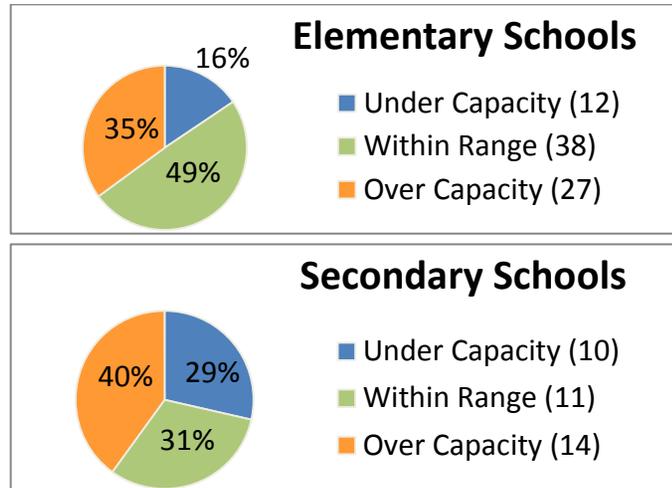
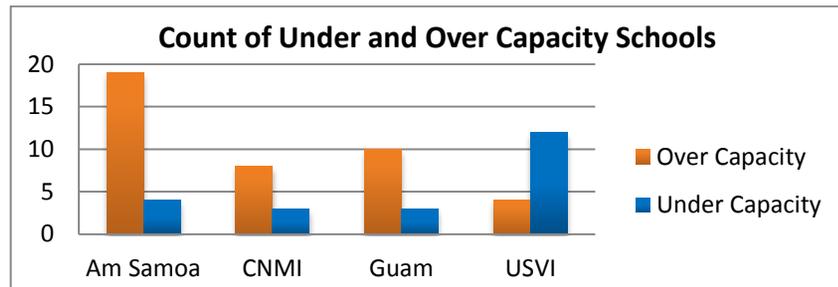
School Capacity Metrics³

Thirty-five percent of elementary schools (27 schools) and 40 percent of secondary schools (14 schools) were considered over capacity based on national gross area per student average ranges (Council of Educational Facility Planners).⁴ Fewer were considered under capacity (see accompanying charts).
