CONTRACT No. DOL-ETA-16-C-0043

EXTERIOR FAÇADE WALL BRACING GULFPORT JOB CORPS CENTER GULFPORT, MISSISSIPPI

REFERENCE: CONTRACT NO. DOL-ETA-16-C-0043
ARCHITECTURAL AND ENGINEERING SERVICES FOR THE STRUCTURAL
FORENSIC ENGINEERING ANALYSIS REPORT AT THE GULFPORT JOB
CORPS CENTER LOCATED IN GULFPORT, MISSISSIPPI

ADDITIONAL SERVICES – EXTERIOR FAÇADE WALL BRACING

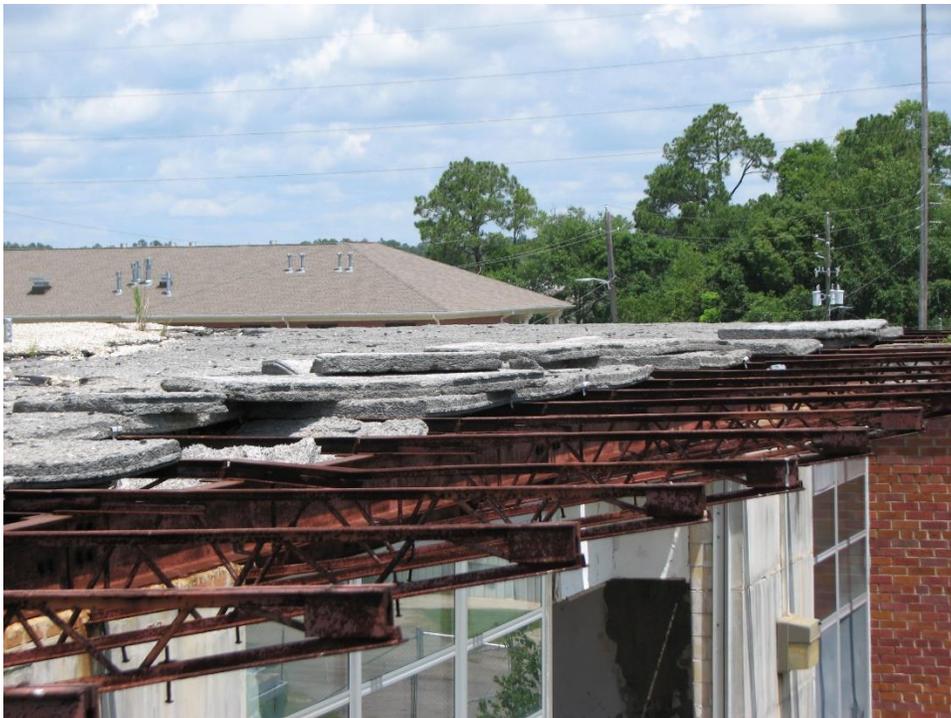
Picture No. 6 – Cantilever Roof Joist, Typical Eyebrow Structure at Second Floor and Roof

For the preservation of the exterior façades of the south and west walls of the Main Building, roofing and soffits must be repaired. Given that the eyebrow profile at the second floor and roof levels are an integral part of the exterior façade, the roof and soffit for these areas must be replaced. The new roof will be comprised of Creteplank, or equal, as outlined in the *Structural Forensic Engineering Analysis Report*. The new roofing will be a membrane material. The soffit will be constructed of plywood, similar to the current construction.

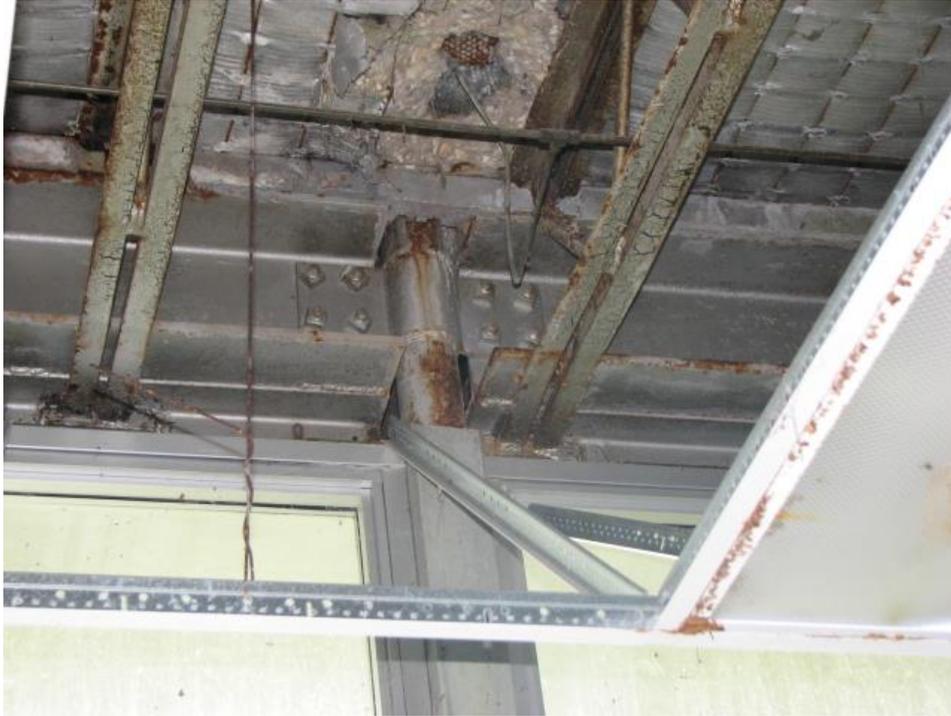
Picture No. 7 – Interior View of Joist Connection to Exterior Wide Flange Beam at Second Floor Level

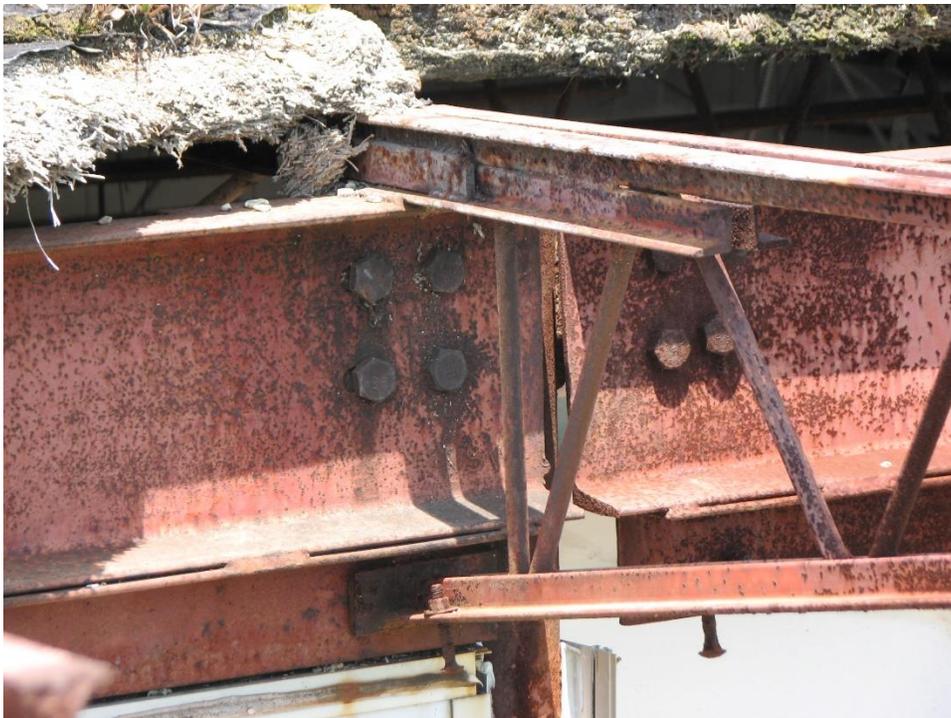
Picture No. 8 – Exterior View of Joist Connection to Exterior Channel Beam at Roof Level

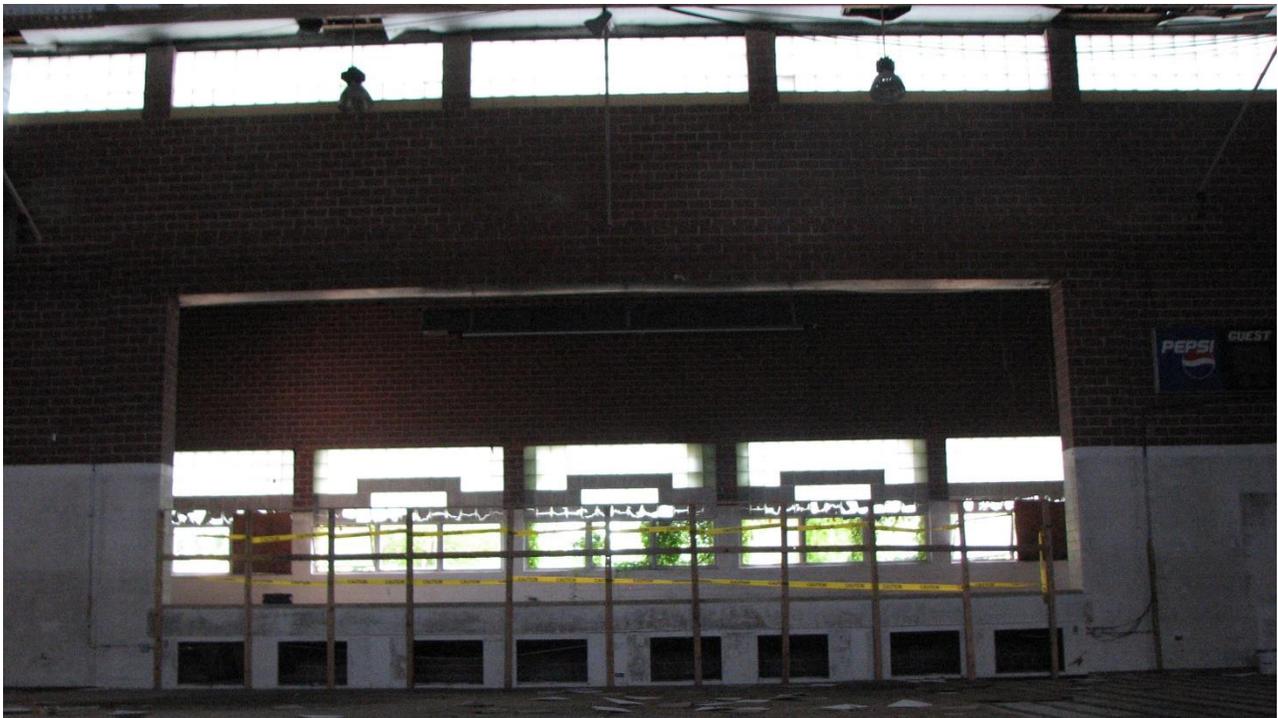
Picture No. 10 – Interior Elevation of Building 2 – Gymnasium, South Elevation
South Wall Between Main Area and Stage Area

Bracing of the existing Gymnasium building walls to a new building structure located behind the tall elevated façade wall located between the gym and stage area of the Gymnasium is not a cost-effective solution for bracing of the existing south walls of the Gymnasium. A bracing system similar to the one provided for the independent bracing system must be provided for the south wall of the building, regardless if the tall wall is braced to a new building structure. Using an independent bracing system, these braces can also be utilized to brace the tall wall located between the gym and the stage area of the Gymnasium without interfering with space used for future buildings. We recommend using the independent bracing system shown in Appendix C to brace the south walls of the Gymnasium, and not attaching to a new building structure.

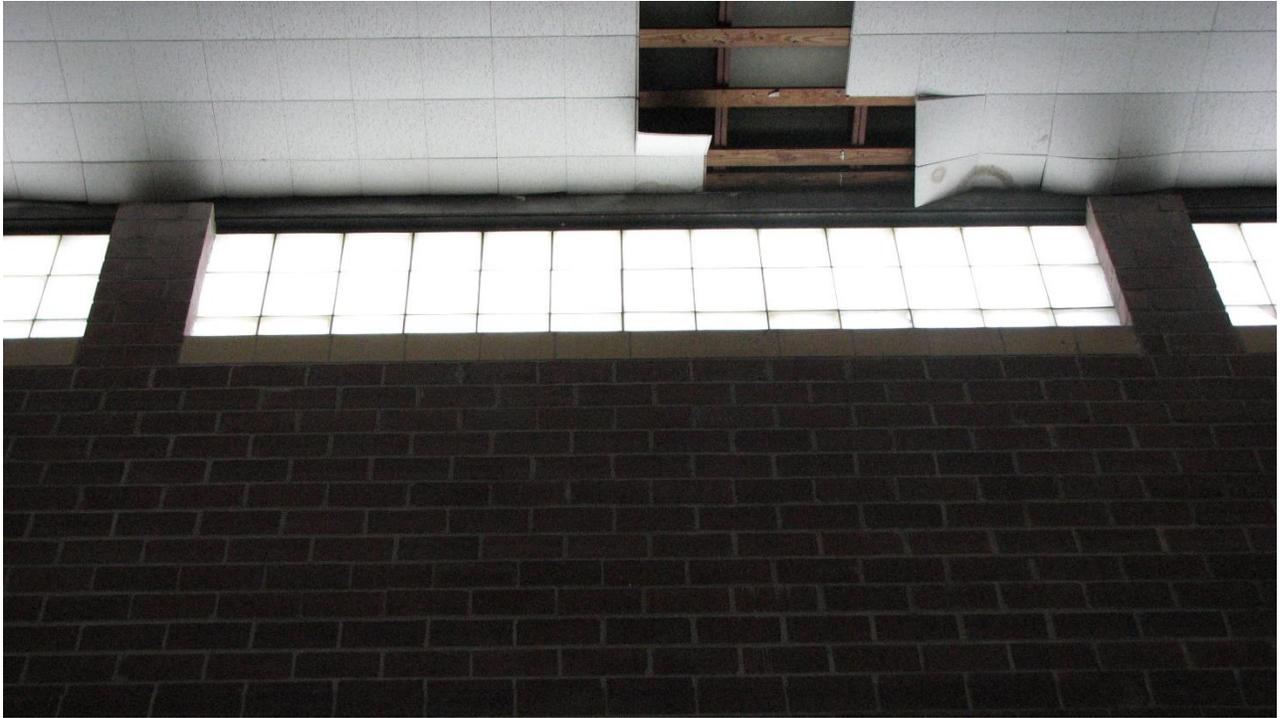
Picture No. 11 – Opening in Wall between Main Area and Stage Area

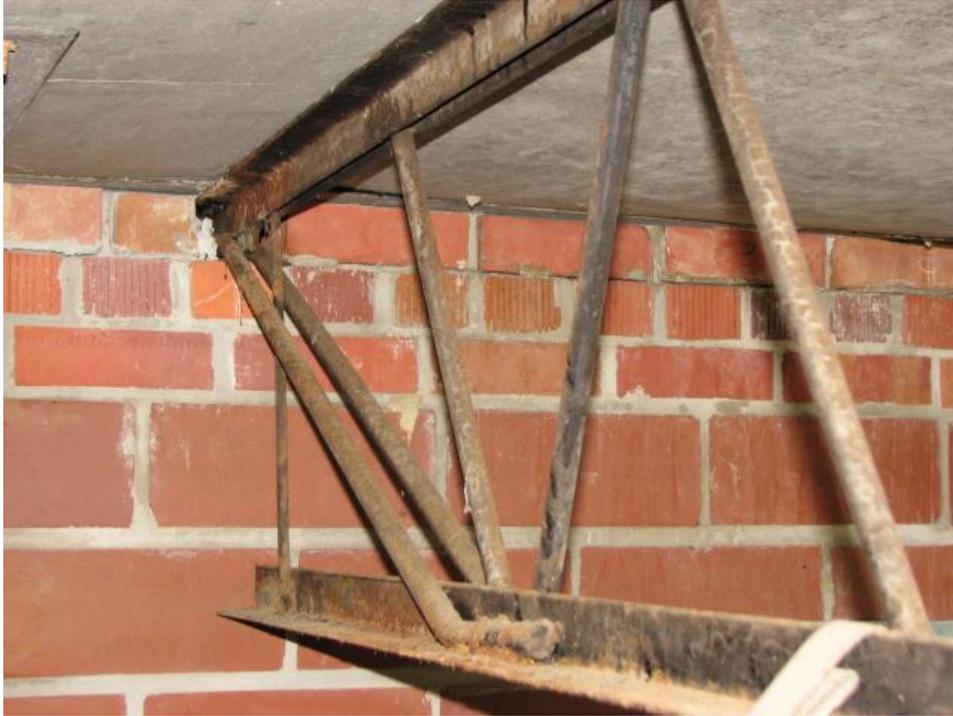
Picture No. 13 – Typical Connection of Roof Joists to Clay Tile Wall in Stage Area

The roof structure of the stage and gym areas currently provide lateral support to the top of the façades to remain. Because these roof structures will be demolished, a continuous channel will be attached to the existing clay tile walls to transfer the wind loads to the new braced frames. The vertical load of the wall will remain supported by the existing concrete foundation below the wall.

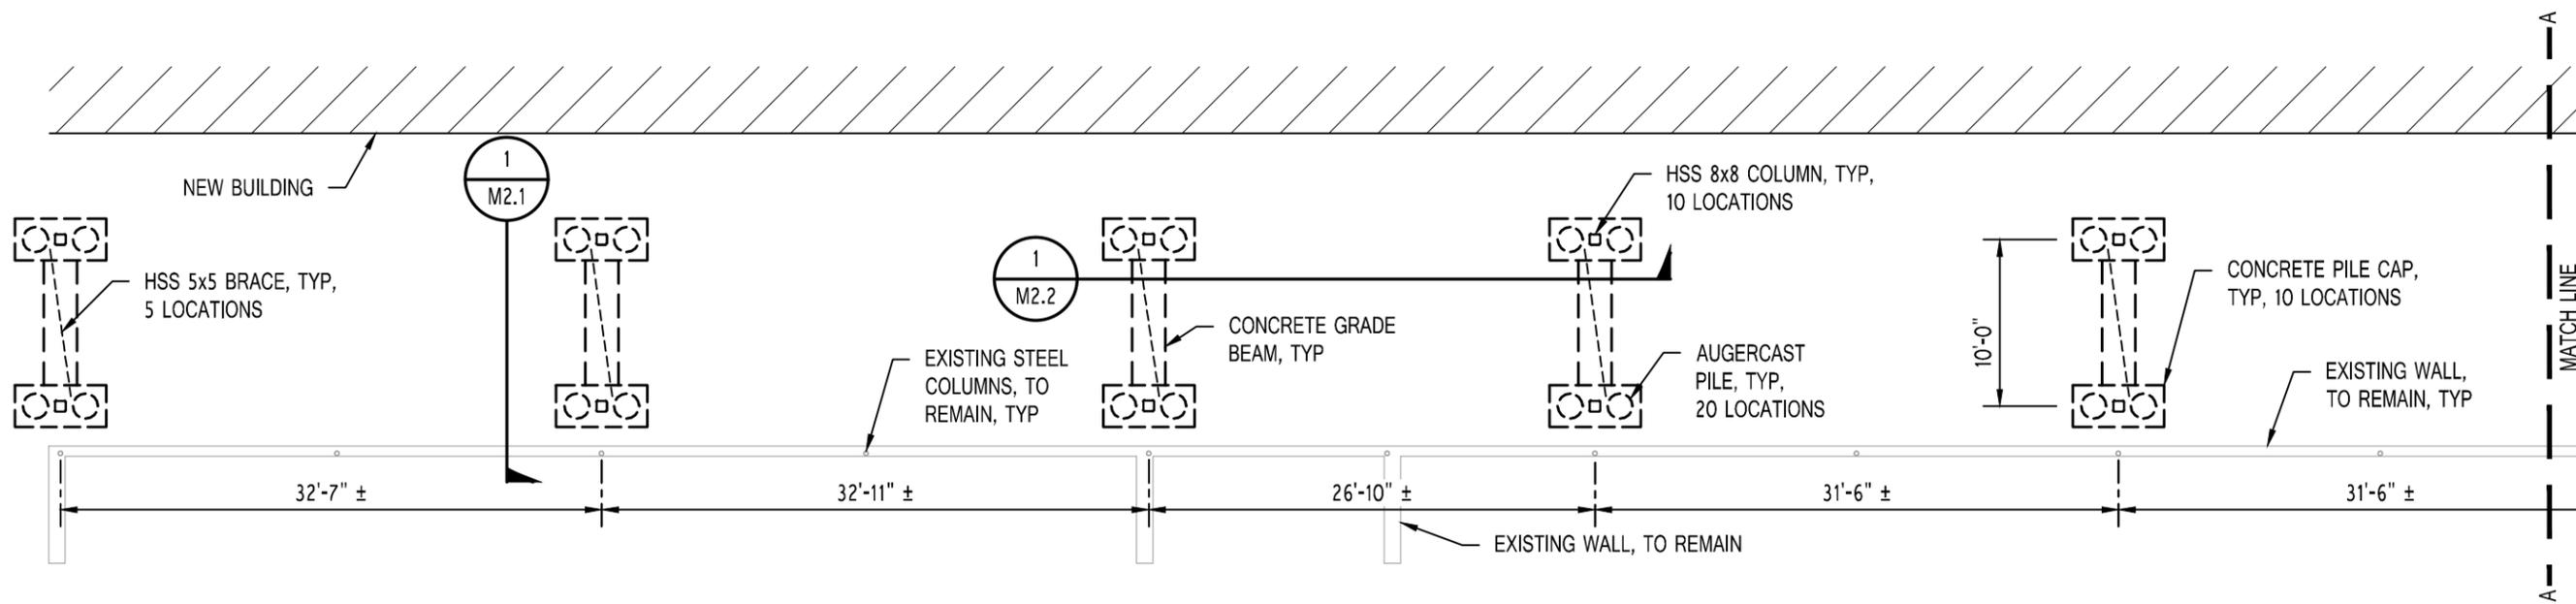
MAIN BUILDING - FOUNDATION WALL BRACING PLAN
 OPTION 1 - INDEPENDENT BRACING SYSTEM
 SCALE: 3/32" = 1'-0"

between the columns, in order to provide lateral stability to the braced frames in the longitudinal direction. A new deep foundation system for the new braced frames will be required to withstand the lateral and overturning loads of the frames due to wind loads. In our opinion, an augercast pile foundation, with an approximate depth of 50 feet, is suitable for this situation, but a geotechnical engineer should provide final foundation design recommendations. Schematic drawings and details of the proposed bracing system for the south and west walls of the Main Building are shown in Appendix C.

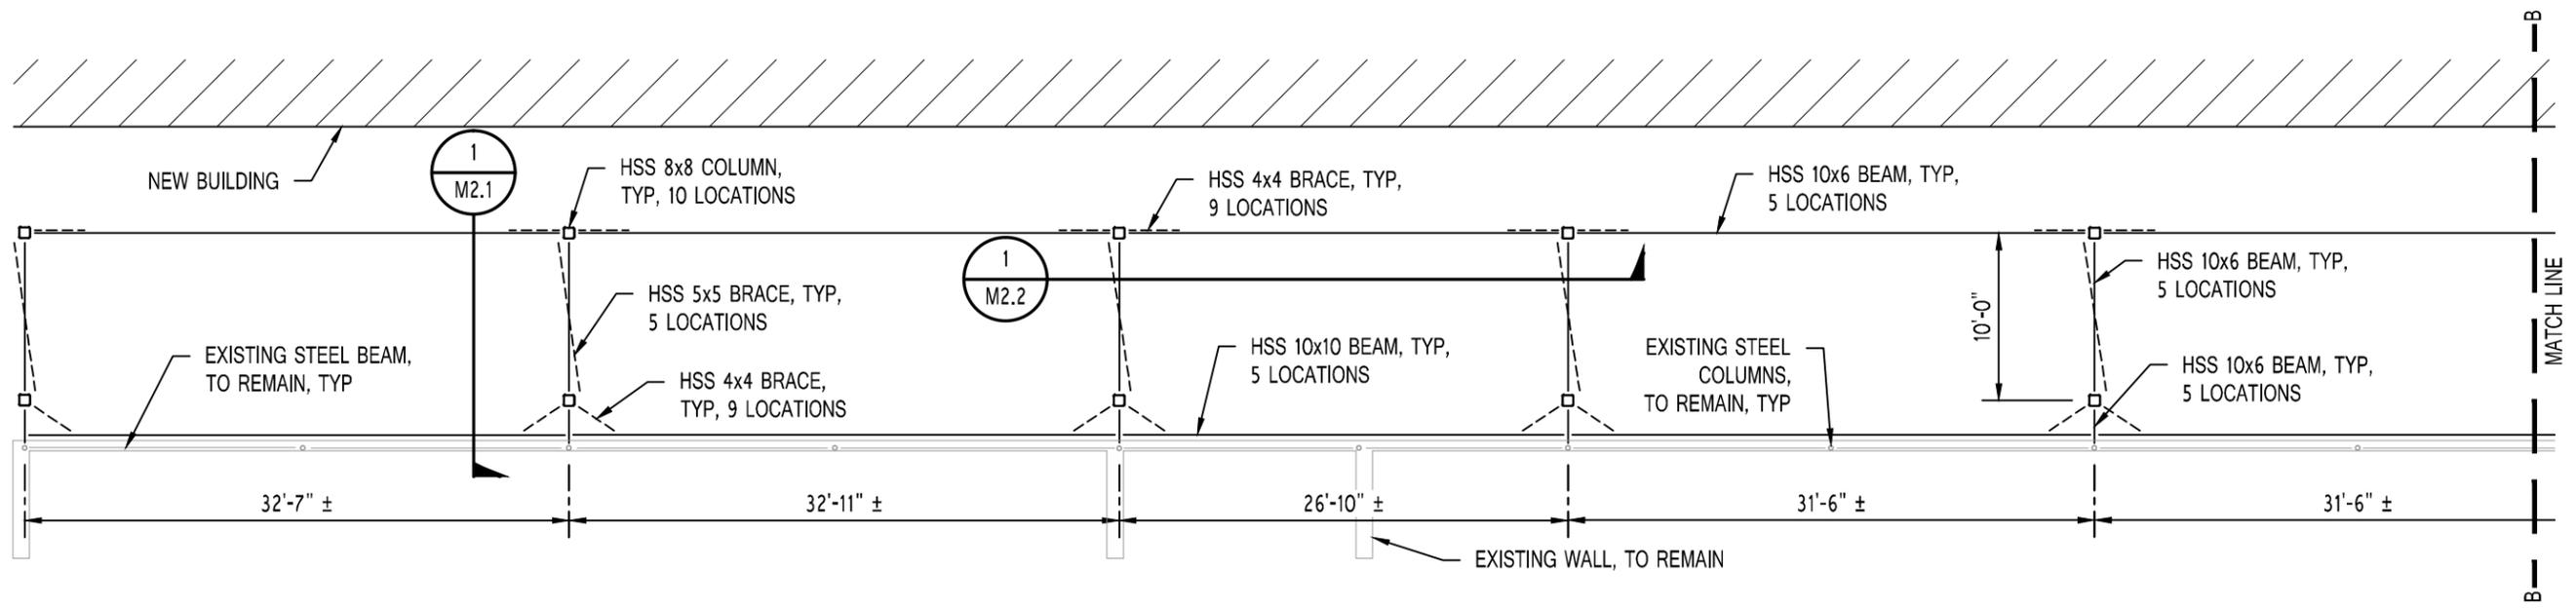
MAIN BUILDING - SECOND FLOOR WALL BRACING PLAN
 OPTION 1 - INDEPENDENT BRACING SYSTEM

Since the second floor and roof joists will be removed as part of the building demolition, except the exterior joists at the eyebrow, a new beam will be provided along the exterior walls at the second floor and roof levels between the new braced frames. This new HSS 10x10 beams will support the wind load induced on the façade and the eccentricity induced by the gravity load of the eyebrow structure. The vertical load of the wall will remain supported by the existing steel beam at the second floor level and the existing concrete foundation below the wall.

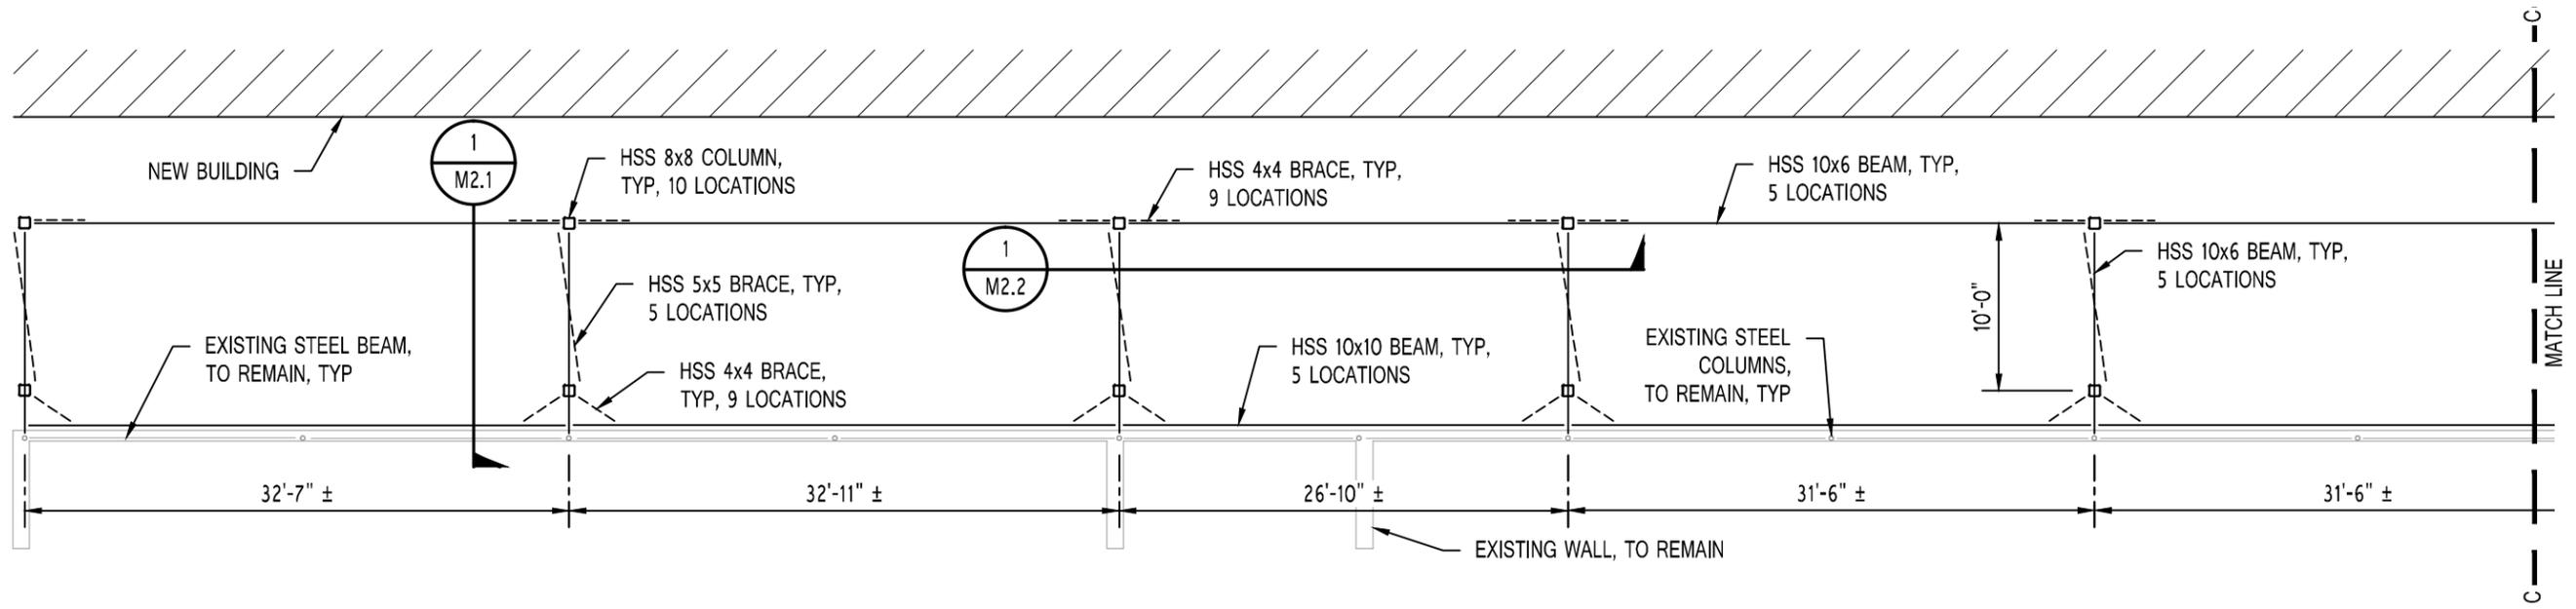
MAIN BUILDING - ROOF WALL BRACING PLAN
 OPTION 1 - INDEPENDENT BRACING SYSTEM
 SCALE: 3/32" = 1'-0"

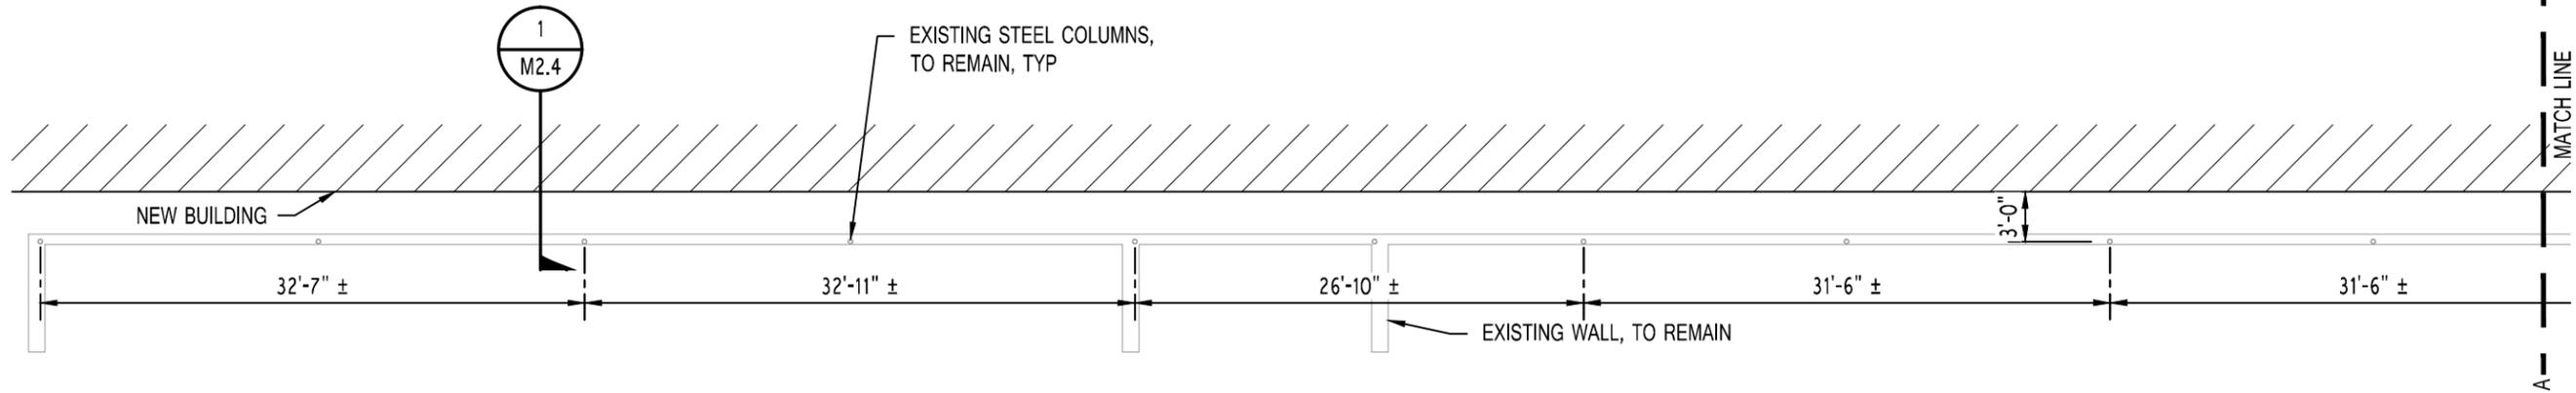
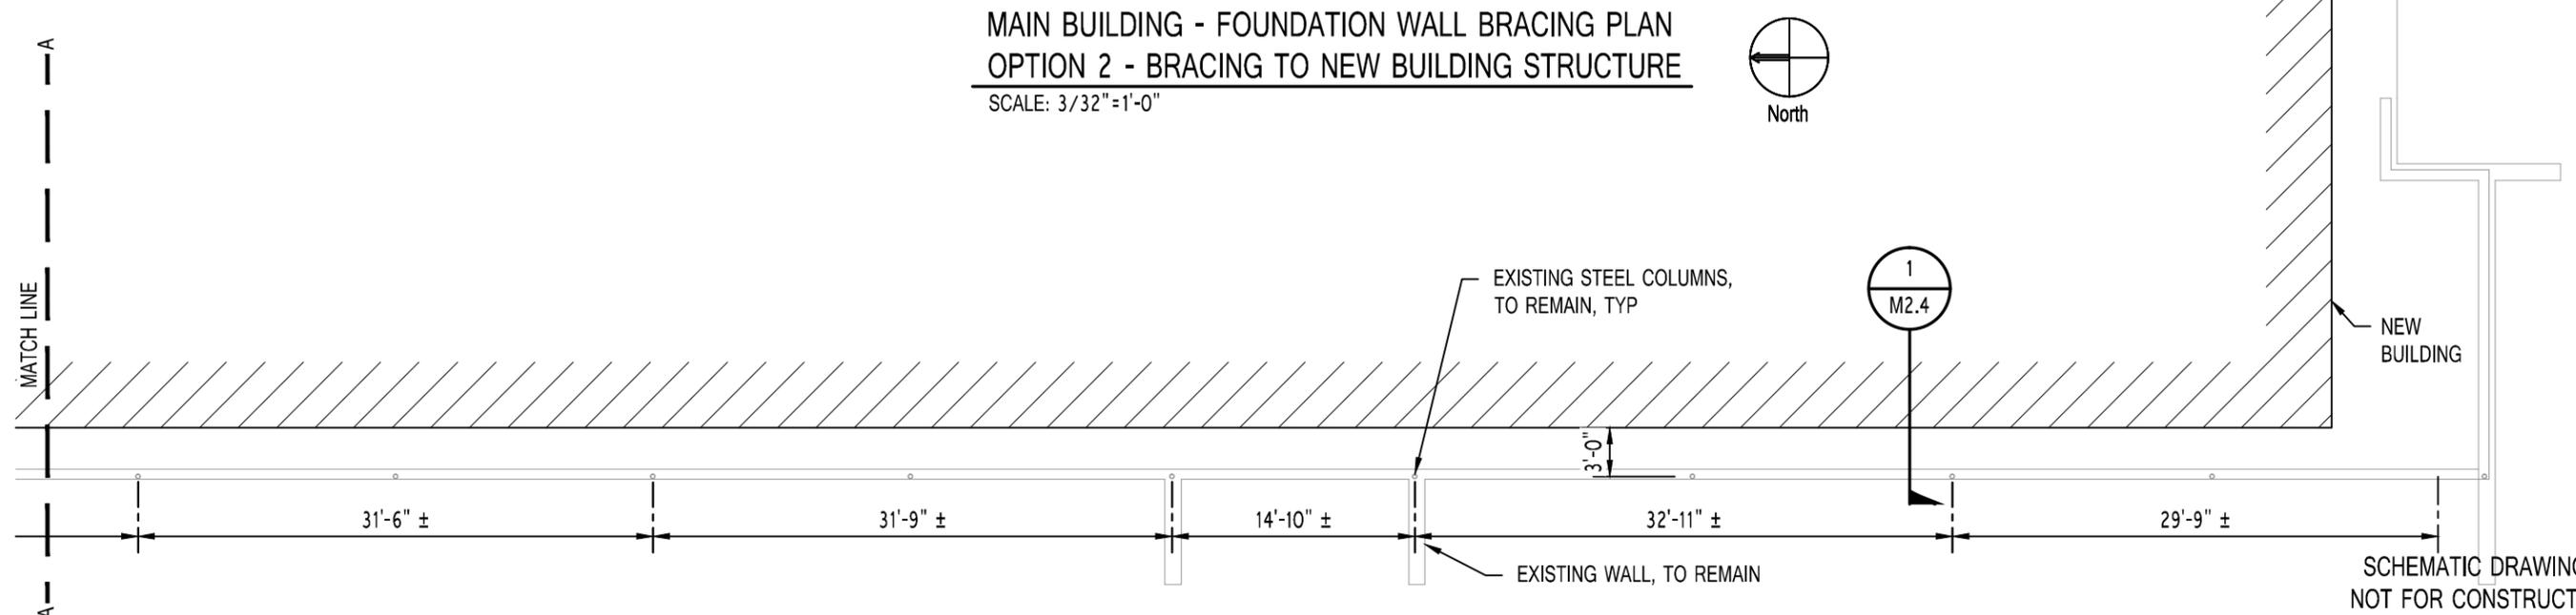
**MAIN BUILDING - FOUNDATION WALL BRACING PLAN
OPTION 2 - BRACING TO NEW BUILDING STRUCTURE**
SCALE: 3/32" = 1'-0"

The second option of wall bracing includes bracing the existing façades of the Main Building to a new building structure located behind the existing façades. This bracing system will be very similar to the independent bracing system regarding the attachment to the existing façade. The locations of attachments to the new building structure will be at the same locations and spacing mentioned previously, at every other existing column. The HSS 10x10 beams mentioned above will be similar, but the beam will attach to a new cantilevered beam attached to the new building structure and designed by the new building designer. The cantilevered beam will support the HSS 10x10 vertically and serve as a strut for wind load transferred from the existing façade to the lateral load resisting system of the new building.

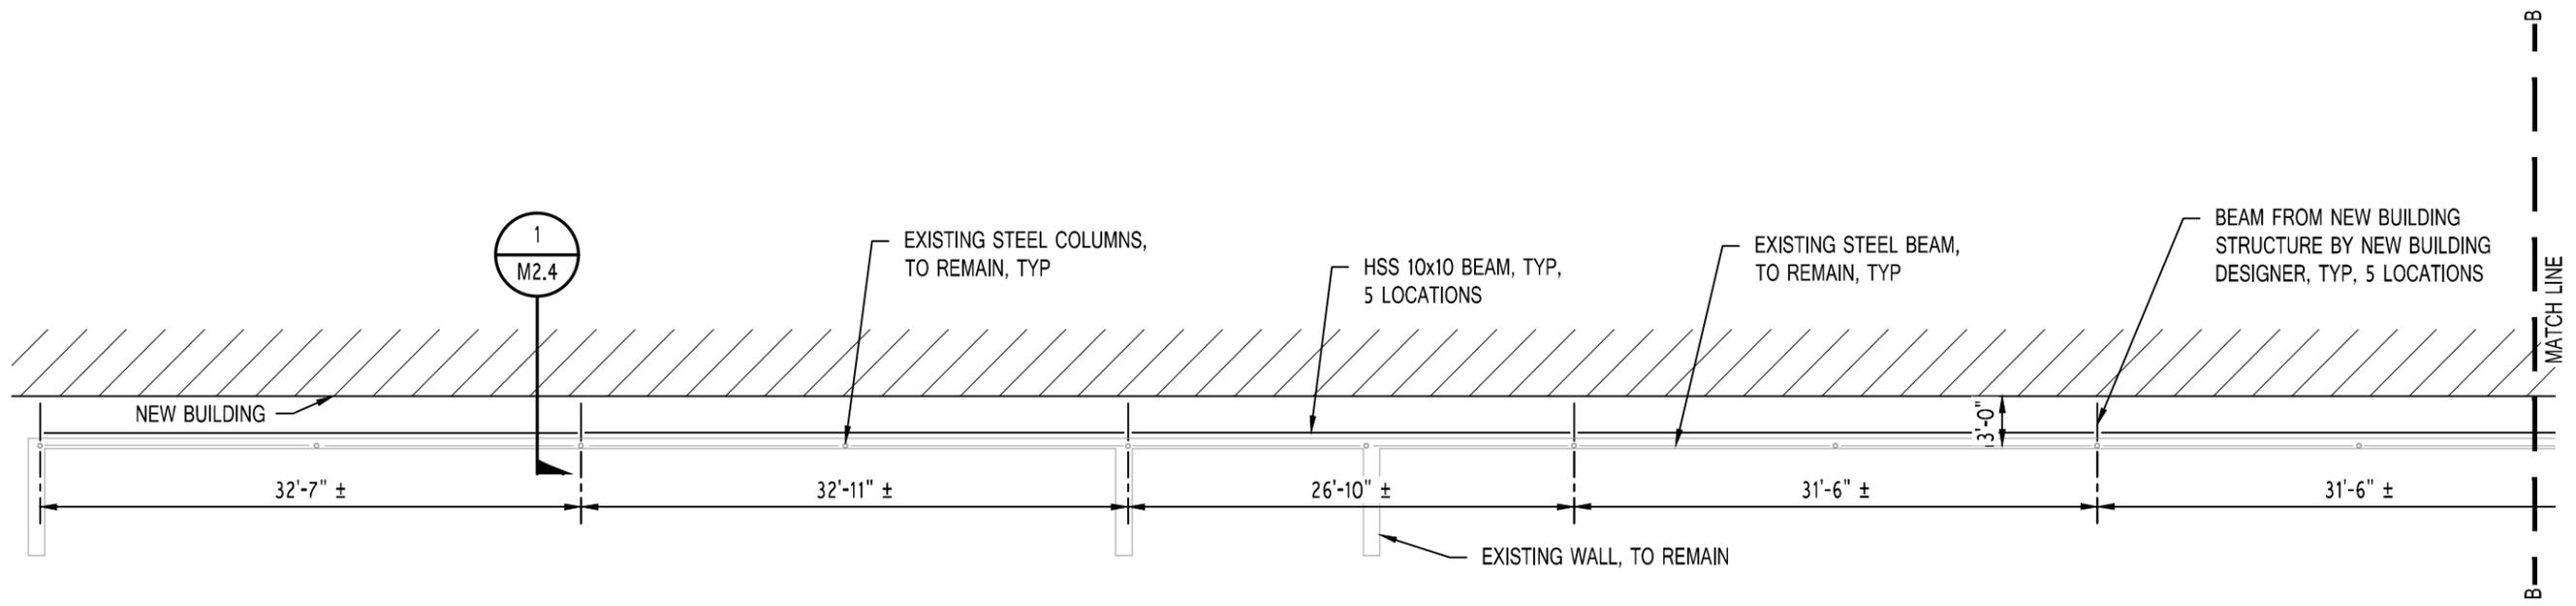
**MAIN BUILDING - SECOND FLOOR WALL BRACING PLAN
OPTION 2 - BRACING TO NEW BUILDING STRUCTURE**
SCALE: 3/32" = 1'-0"

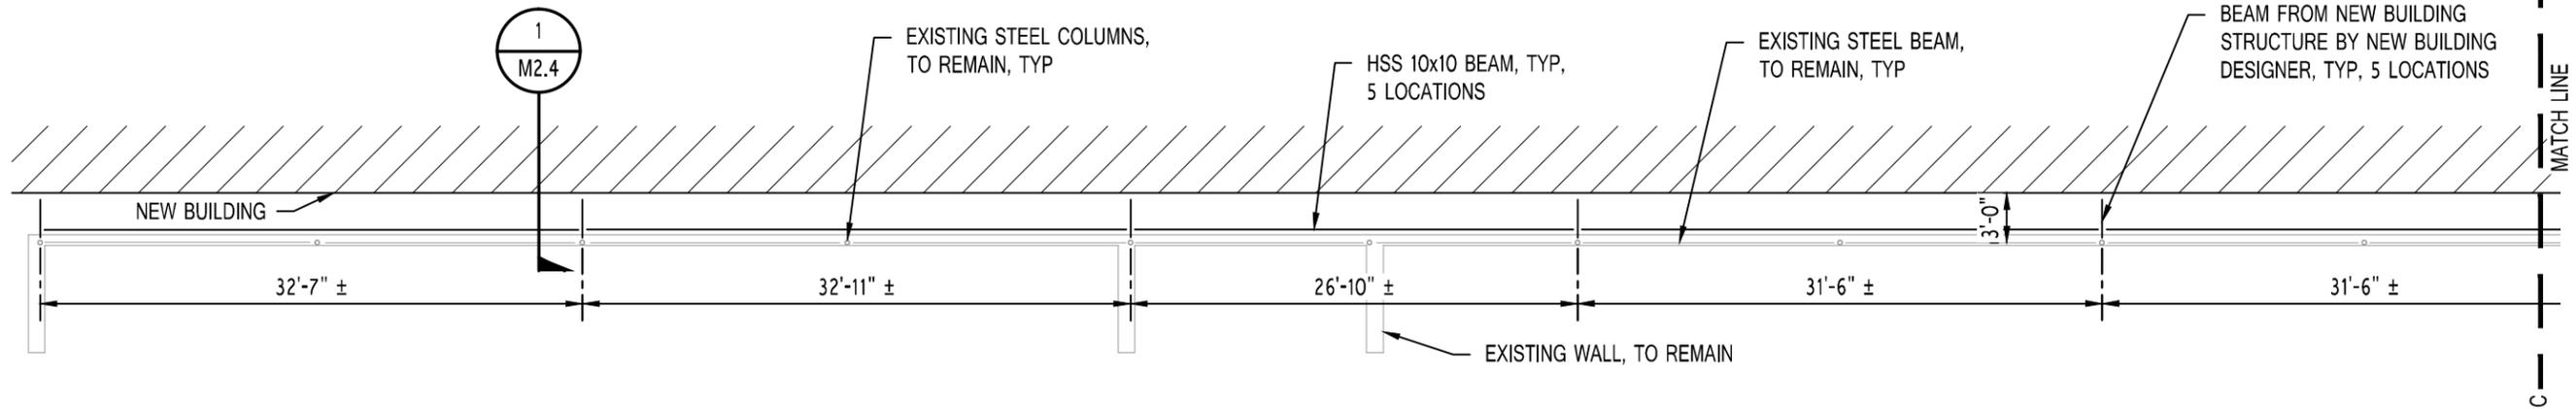
MAIN BUILDING - ROOF WALL BRACING PLAN
 OPTION 2 - BRACING TO NEW BUILDING STRUCTURE
 SCALE: 3/32"=1'-0"

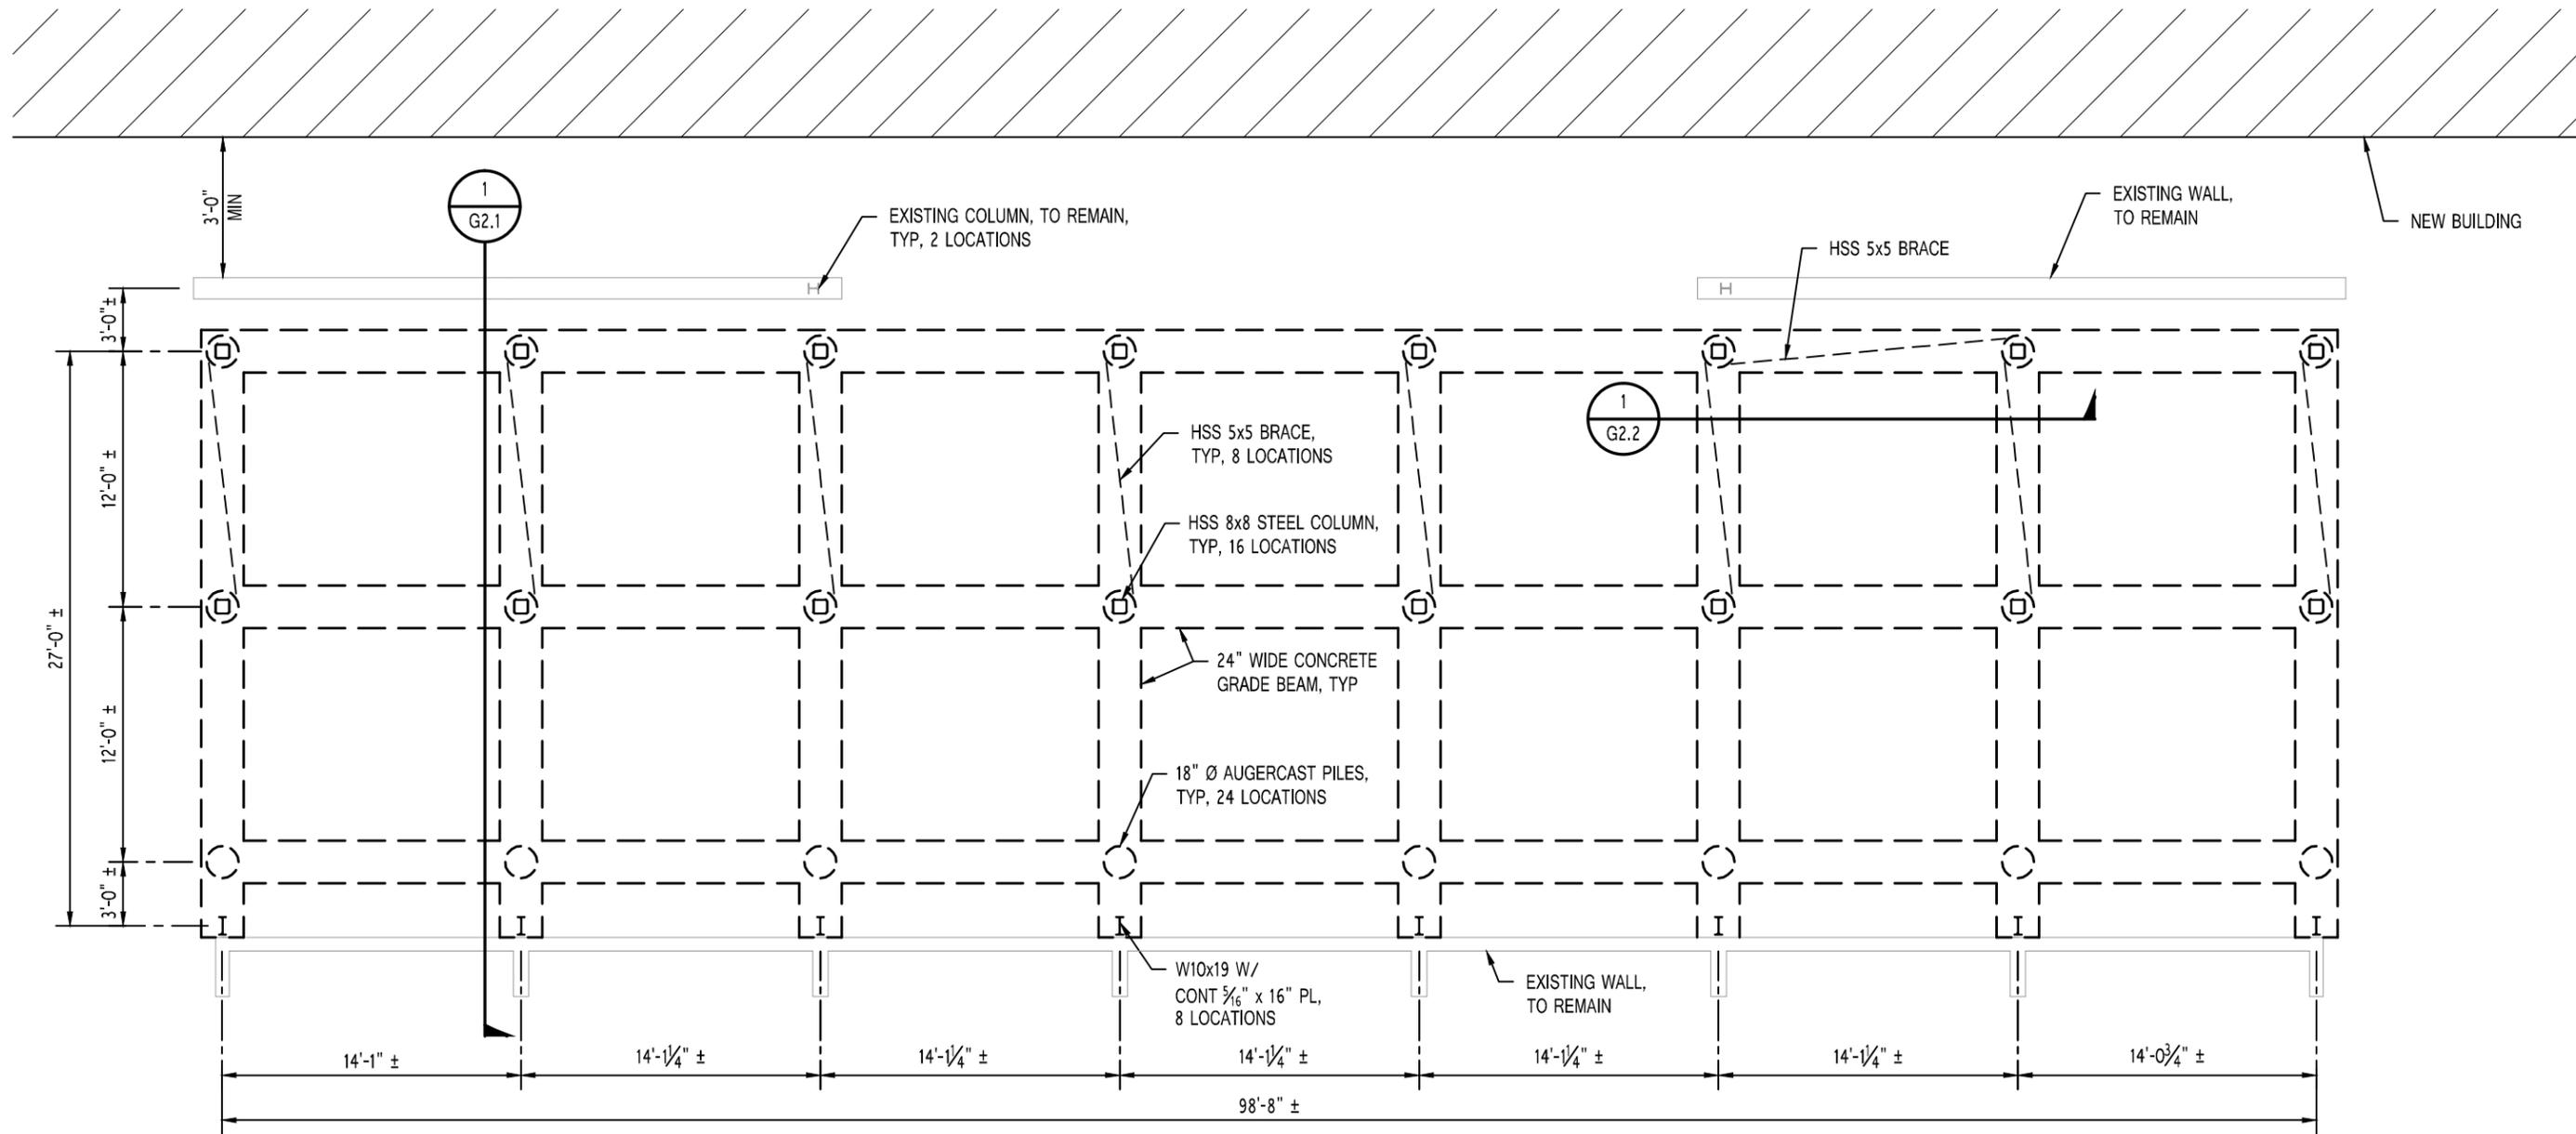
GYMNASIUM - FOUNDATION WALL BRACING PLAN
SCALE: NOT TO SCALE

In order to brace the exterior walls, a new steel bracing system will be provided behind the existing exterior walls. The braced frames will be provided at the locations of the brick clad columns along the south wall of the stage area, in order to minimize the visibility of the frames in the windows of the existing façade.

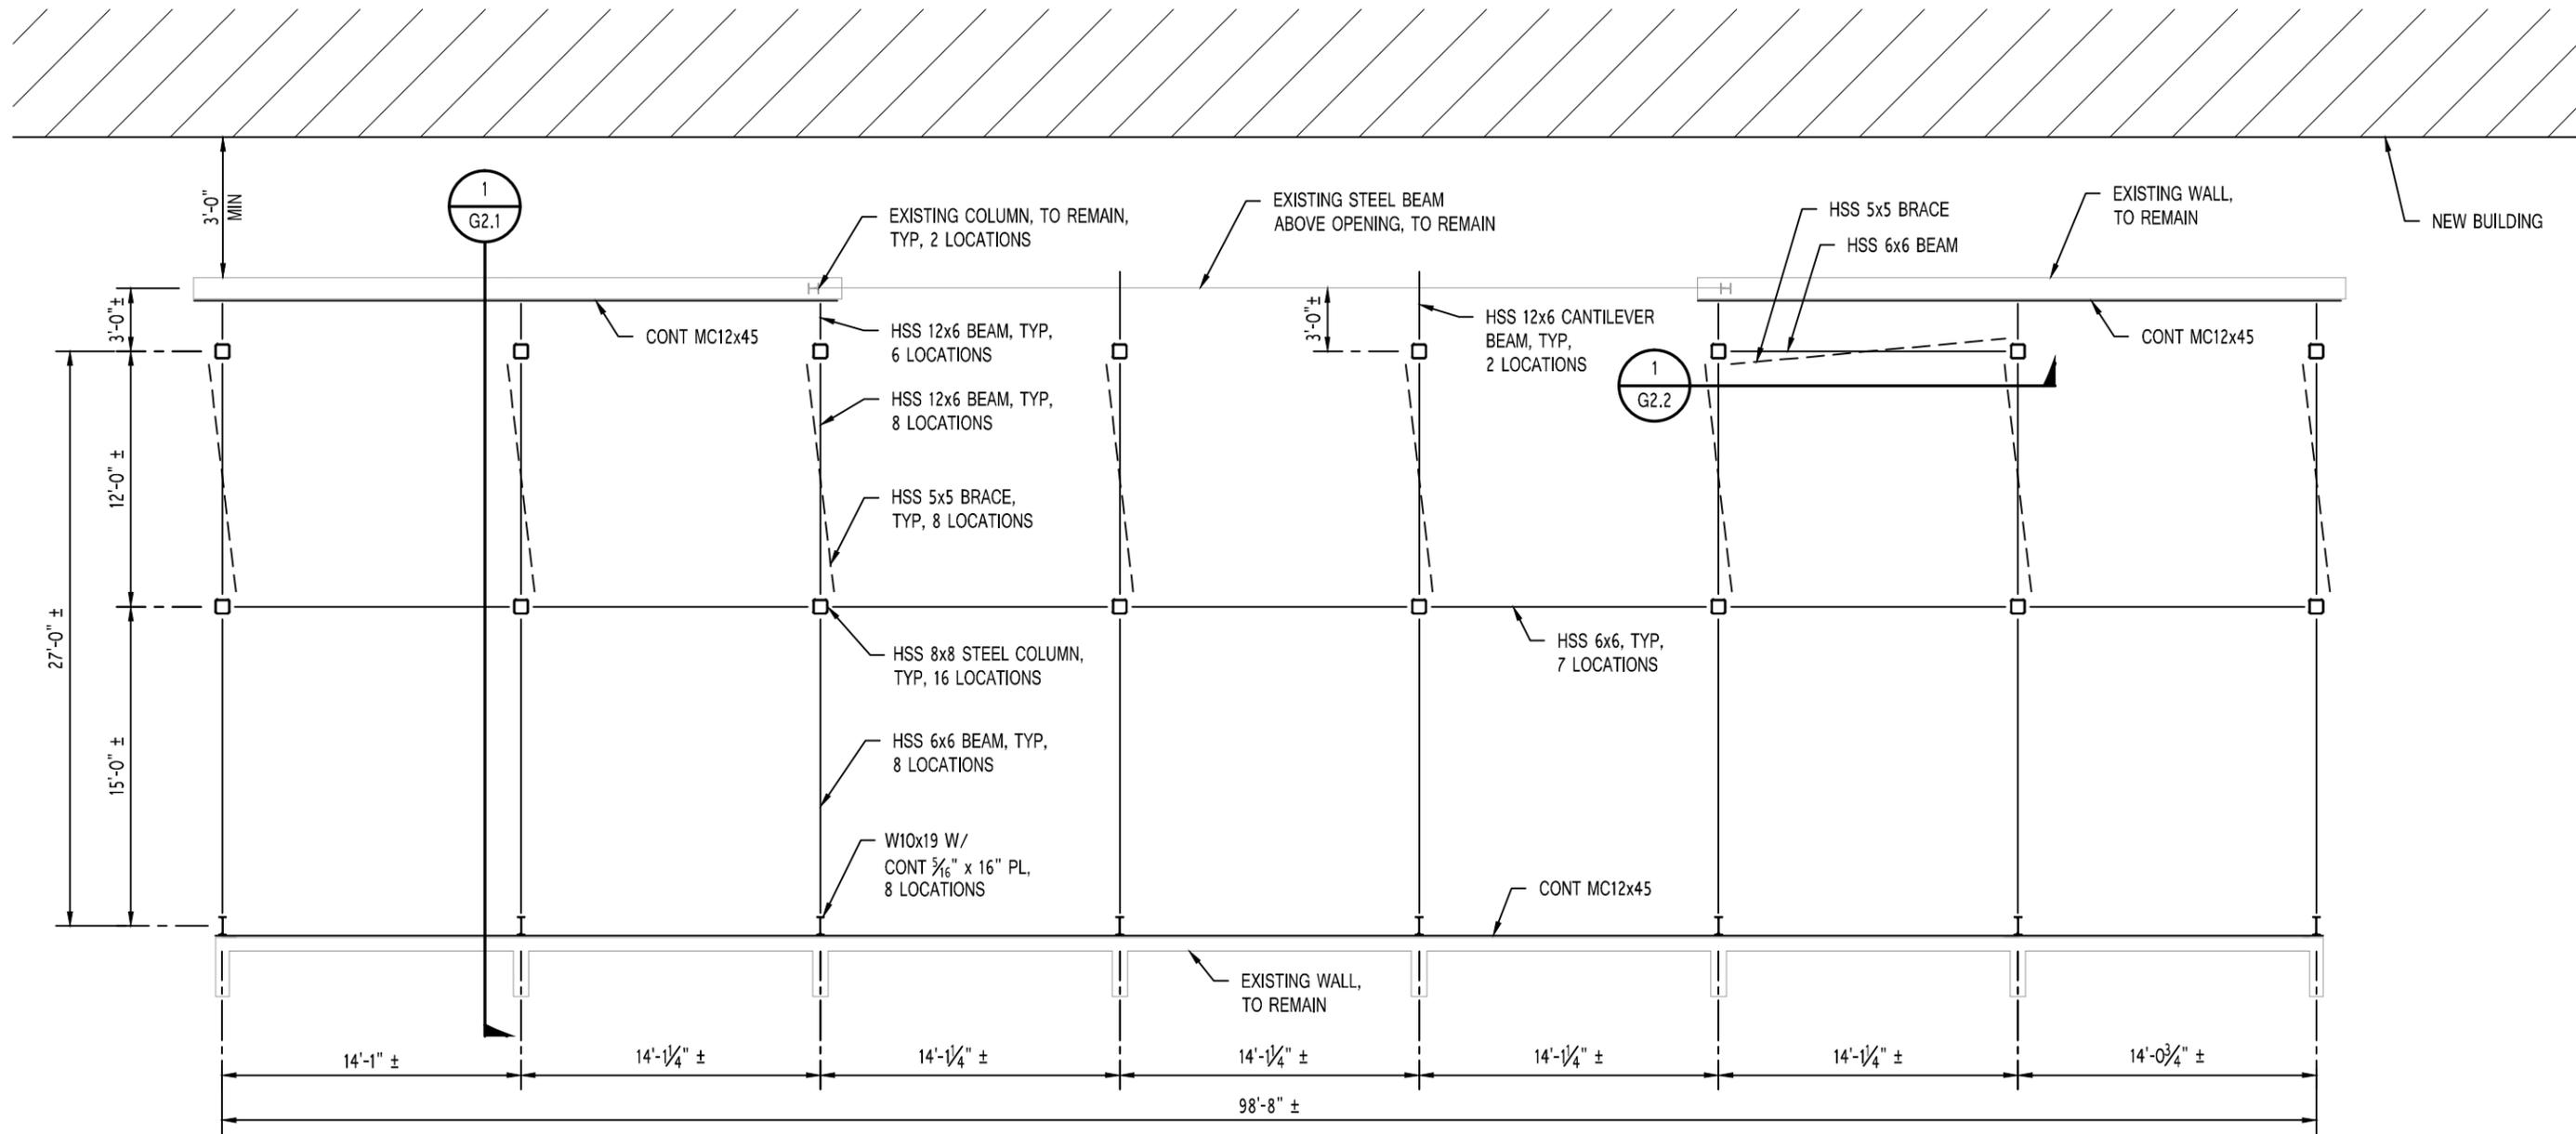
GYMNASIUM - WALL BRACING PLAN - ELEVATION +16'-9"± A.F.F.
SCALE: NOT TO SCALE
