CONTRACT No. DOL-ETA-16-C-0043

EXTERIOR FAÇADE WALL BRACING GULFPORT JOB CORPS CENTER GULFPORT, MISSISSIPPI

REFERENCE: CONTRACT NO. DOL-ETA-16-C-0043
ARCHITECTURAL AND ENGINEERING SERVICES FOR THE STRUCTURAL
FORENSIC ENGINEERING ANALYSIS REPORT AT THE GULFPORT JOB
CORPS CENTER LOCATED IN GULFPORT, MISSISSIPPI

ADDITIONAL SERVICES – EXTERIOR FAÇADE WALL BRACING

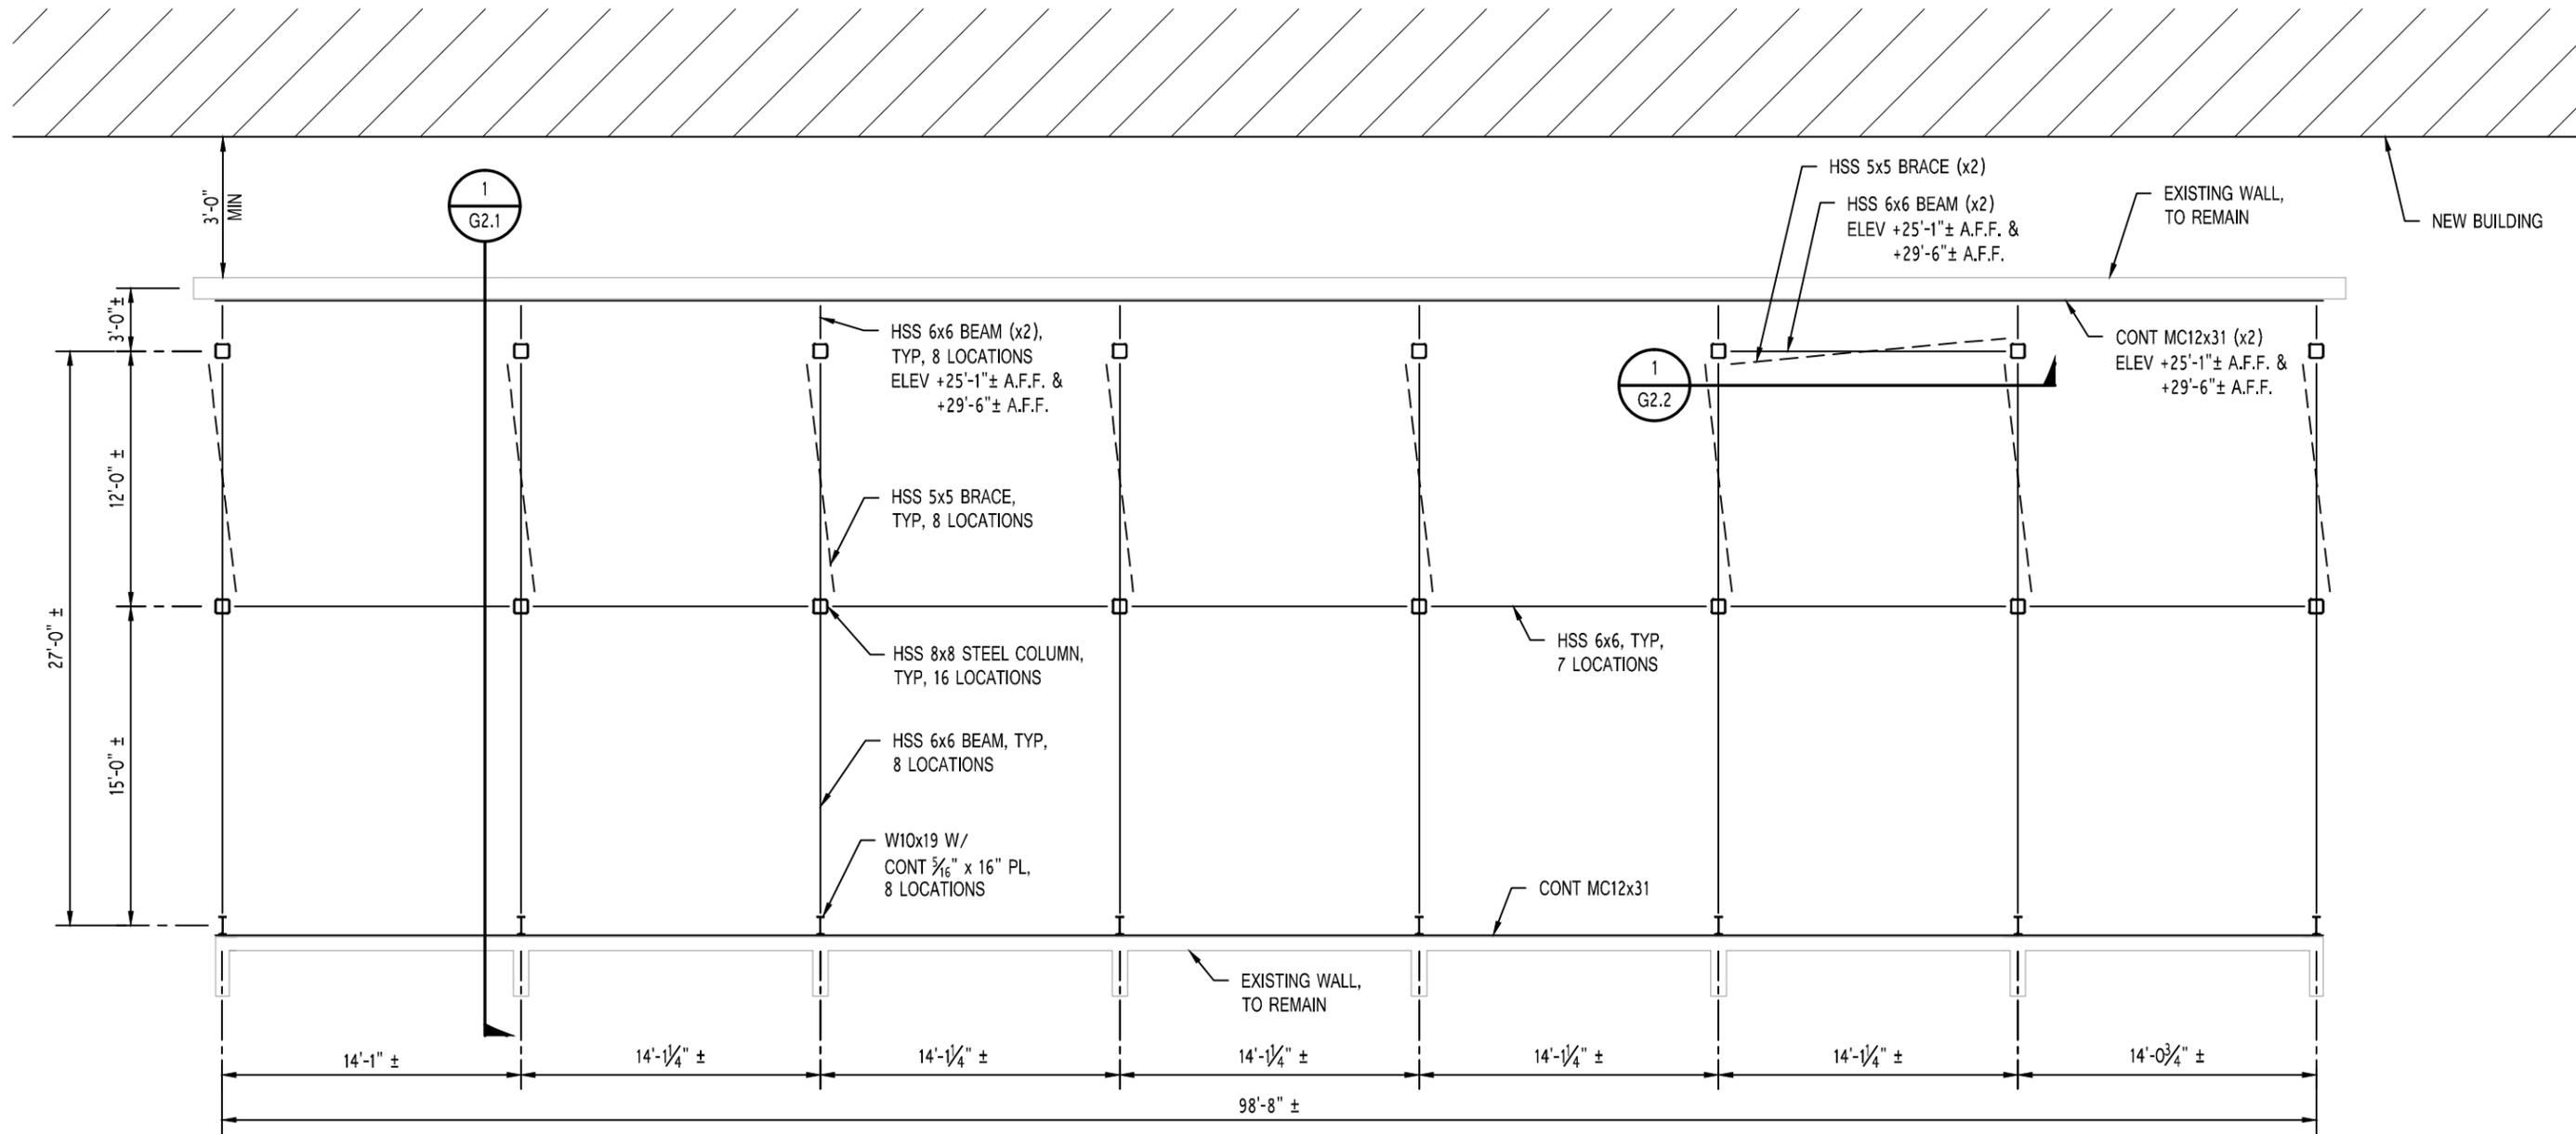
GYMNASIUM - ROOF WALL BRACING PLAN - ELEVATION +25'-1" ± A.F.F., U.N.O.

The roof structure of the stage and gym areas currently provide lateral support to the top of the façades to remain. Because these roof structures will be demolished, a continuous channel will be attached to the existing clay tile walls to transfer the wind loads to the new braced frames. The vertical load of the wall will remain supported by the existing concrete foundation below the wall.

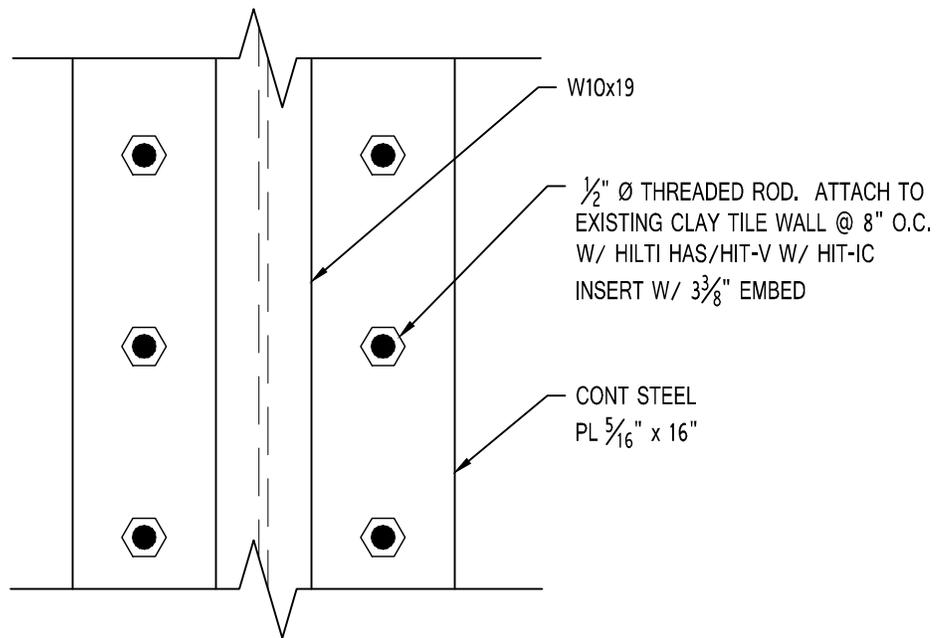
1 SECTION
G2.3 SCALE: 1 1/2" = 1'-0"

NOTE: EXISTING CLAY TILE PILASTER BEYOND STEEL PL.

1/2" Ø THREADED ROD. ATTACH TO EXISTING CLAY TILE WALL @ 8" O.C. W/ HILTI HAS/HIT-V W/ HIT-IC INSERT W/ 3 3/8" EMBED

MC12, SEE PLANS & 1/G2.1
