2006 EAST END BEACH RESTORATION PROJECT
KIAWAH ISLAND SOUTH CAROLINA

Survey Report No 9
February 2016

SURVEY REPORT NO 9
Annual Beach and Inshore Surveys

[CSE 2446 YR1]
February 2016

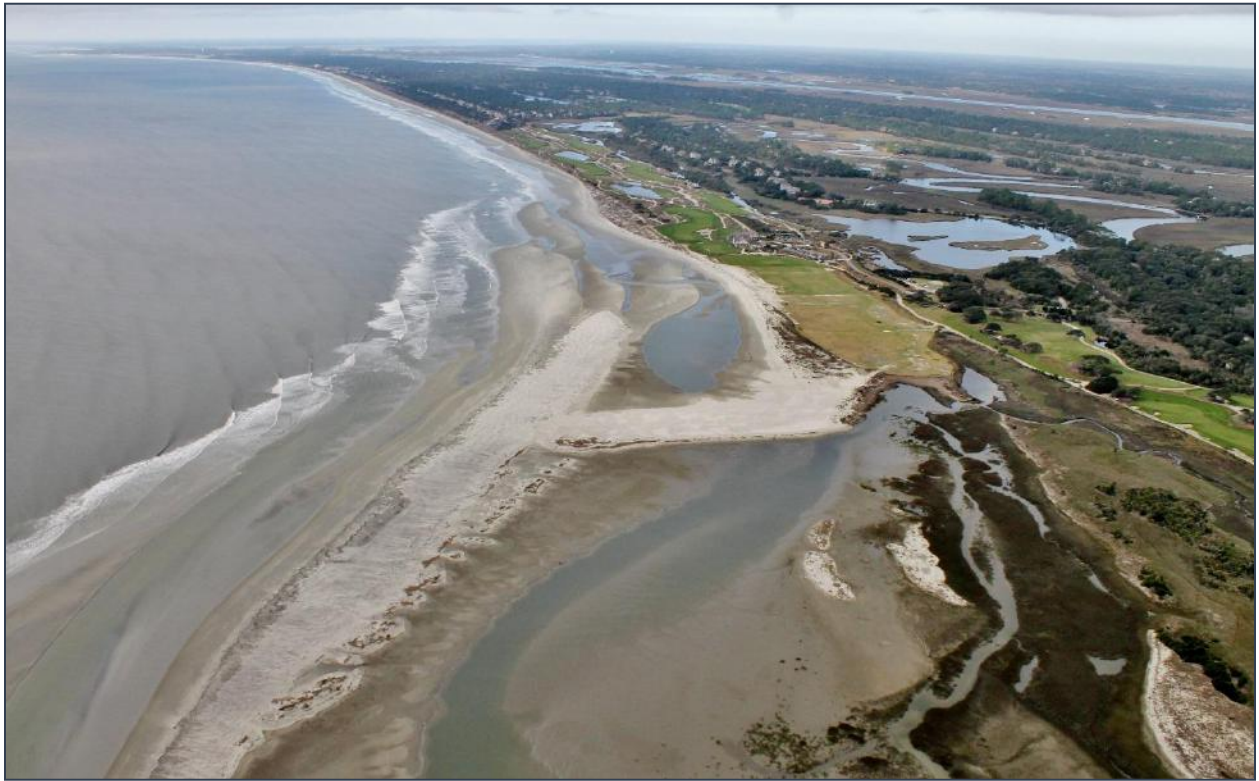
FIGURE A. View west from the lagoon on the eastern end of Kiawah Island in January 2016.

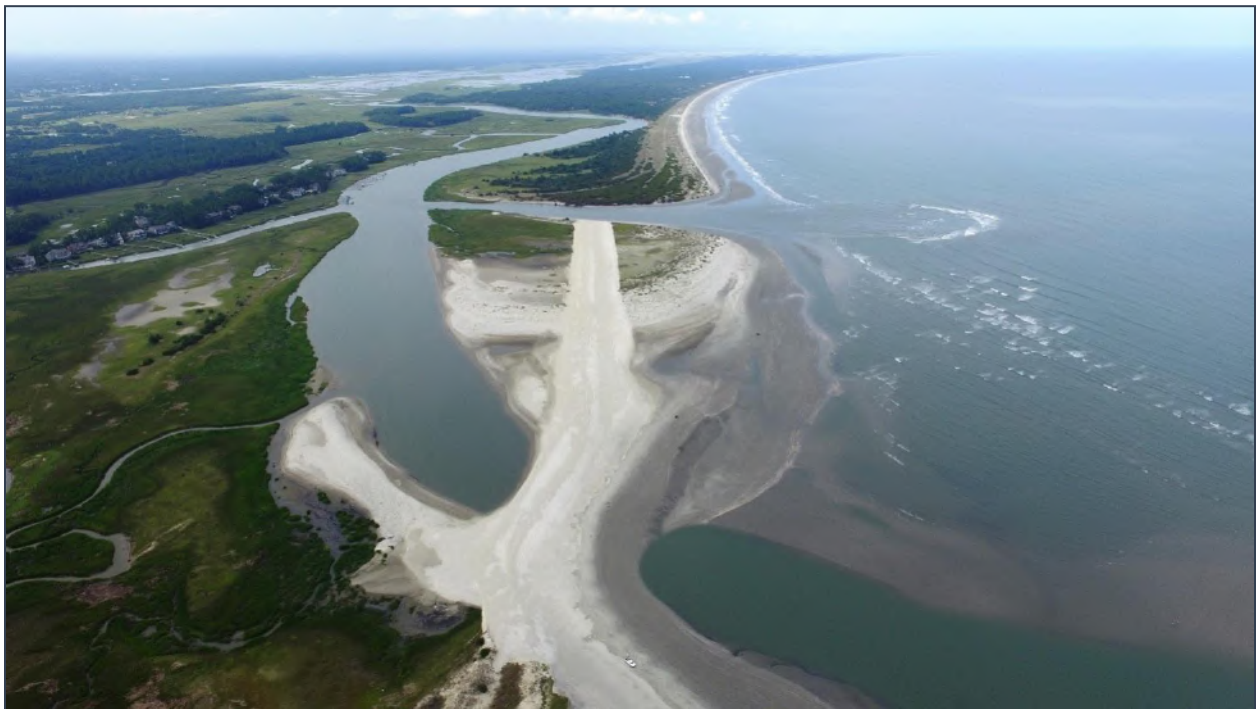
FIGURE B. July 2015 view of the west end of Kiawah Island following the third relocation of Captain Sams Inlet, which was completed in June 2015 by the Seabrook Island Property Owners Association.

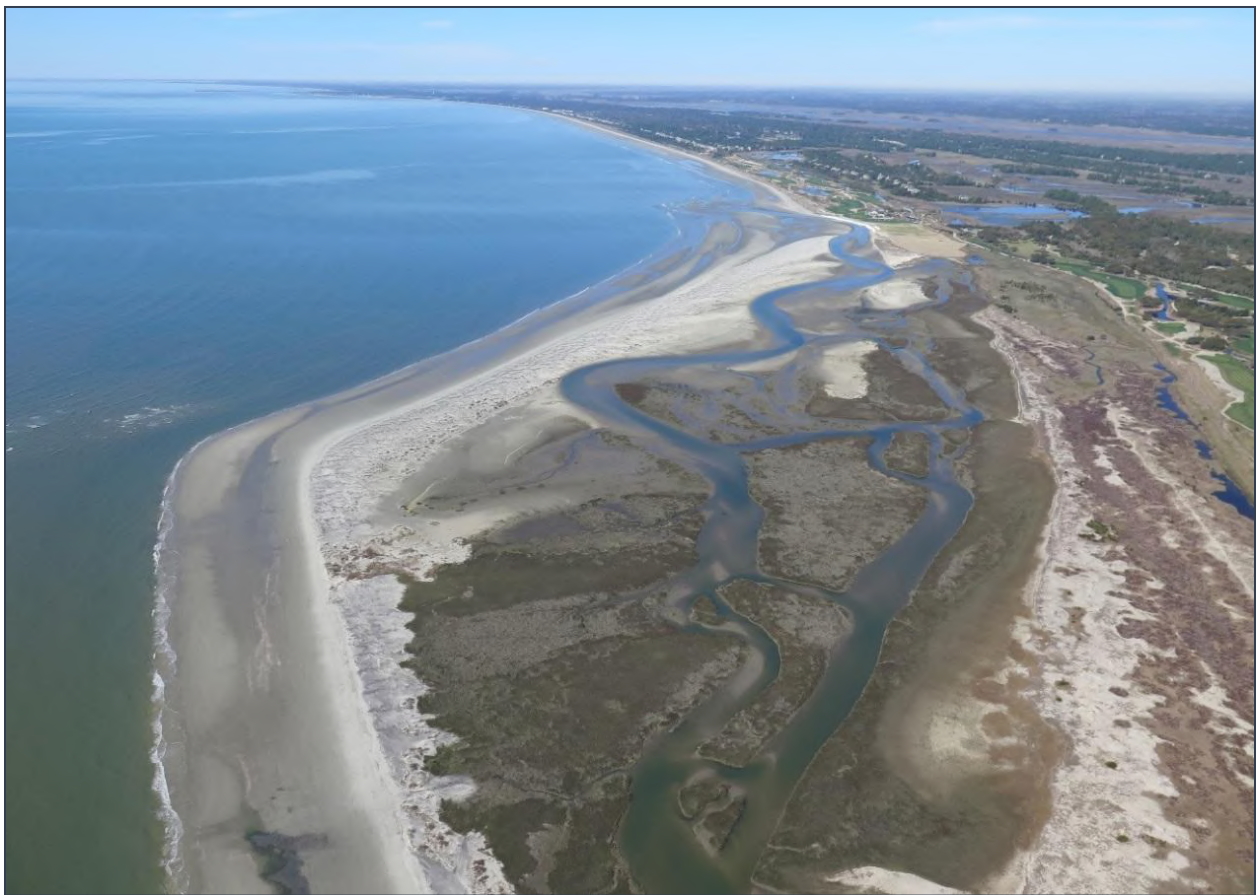
FIGURE 2.1. Kiawah Island in March 2015. Sand from Stono Inlet attaches to the island at the east end, then migrates west, nourishing the beach.

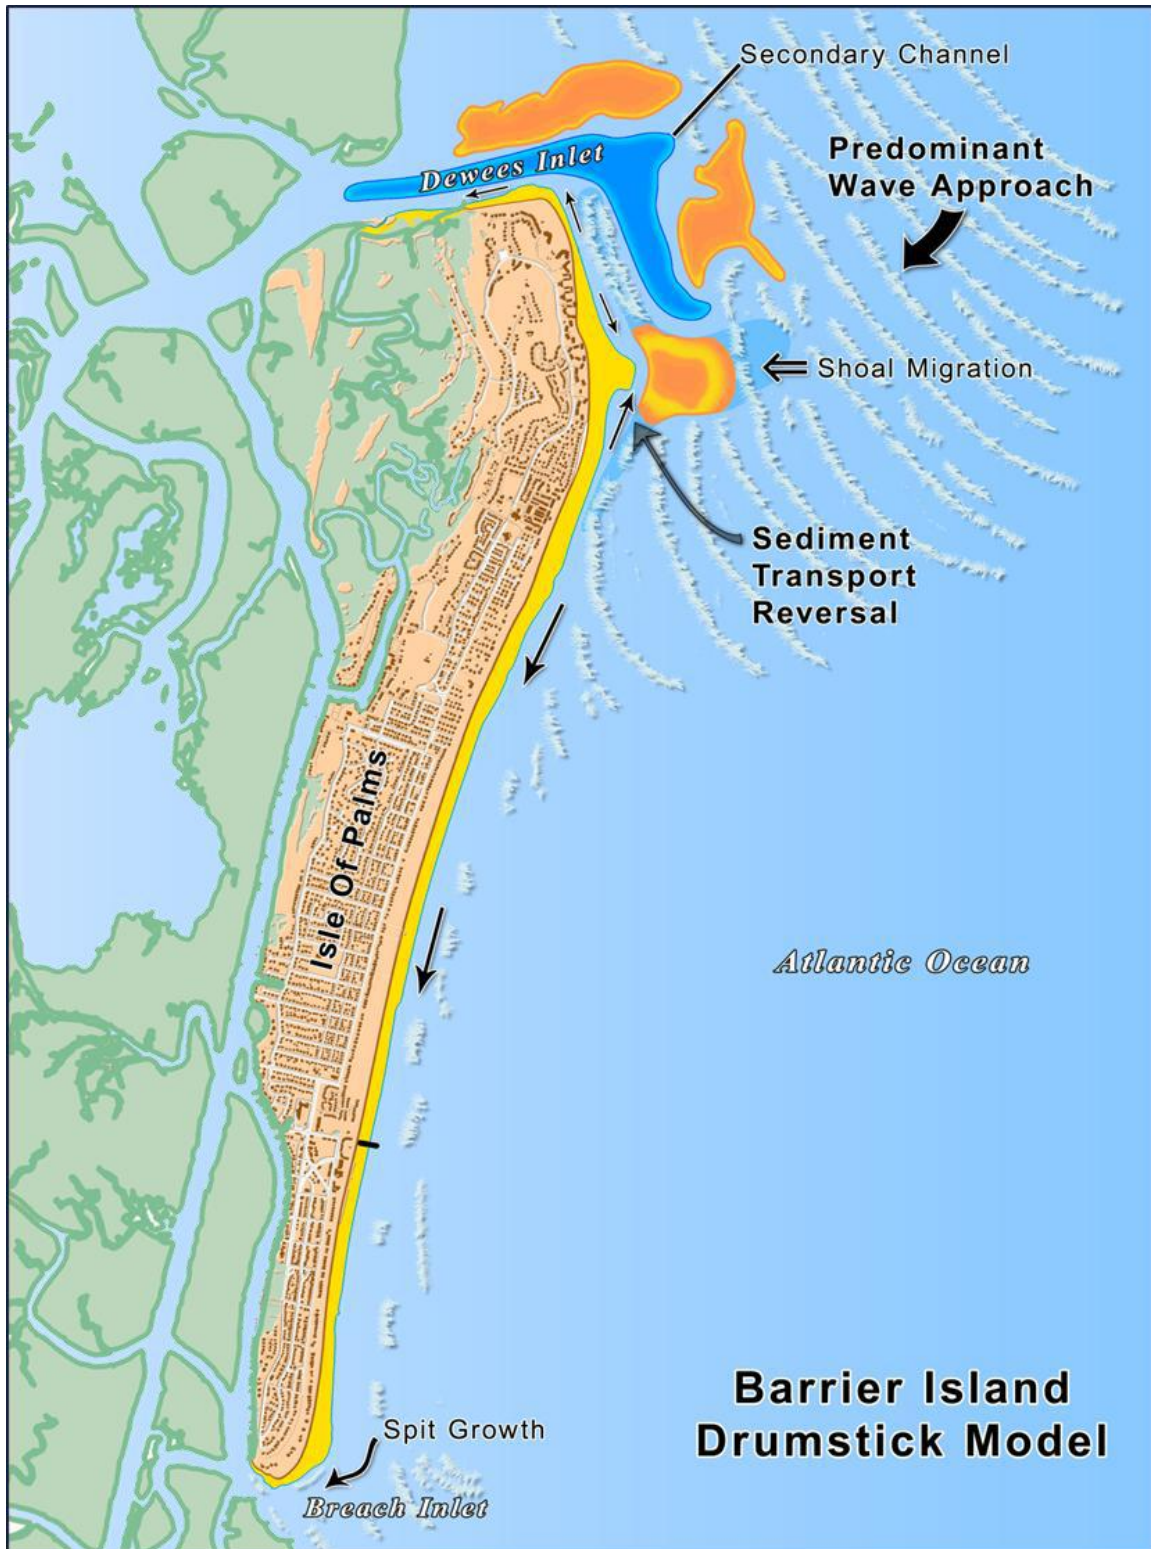
FIGURE 2.2. Barrier island drumstick model (after Hayes 1977) using Isle of Palms as an example. The upcoast end is wider due to additions of sand from shoal-bypass events in the inlet. Net transport to the south builds a spit at the downcoast end of the island.

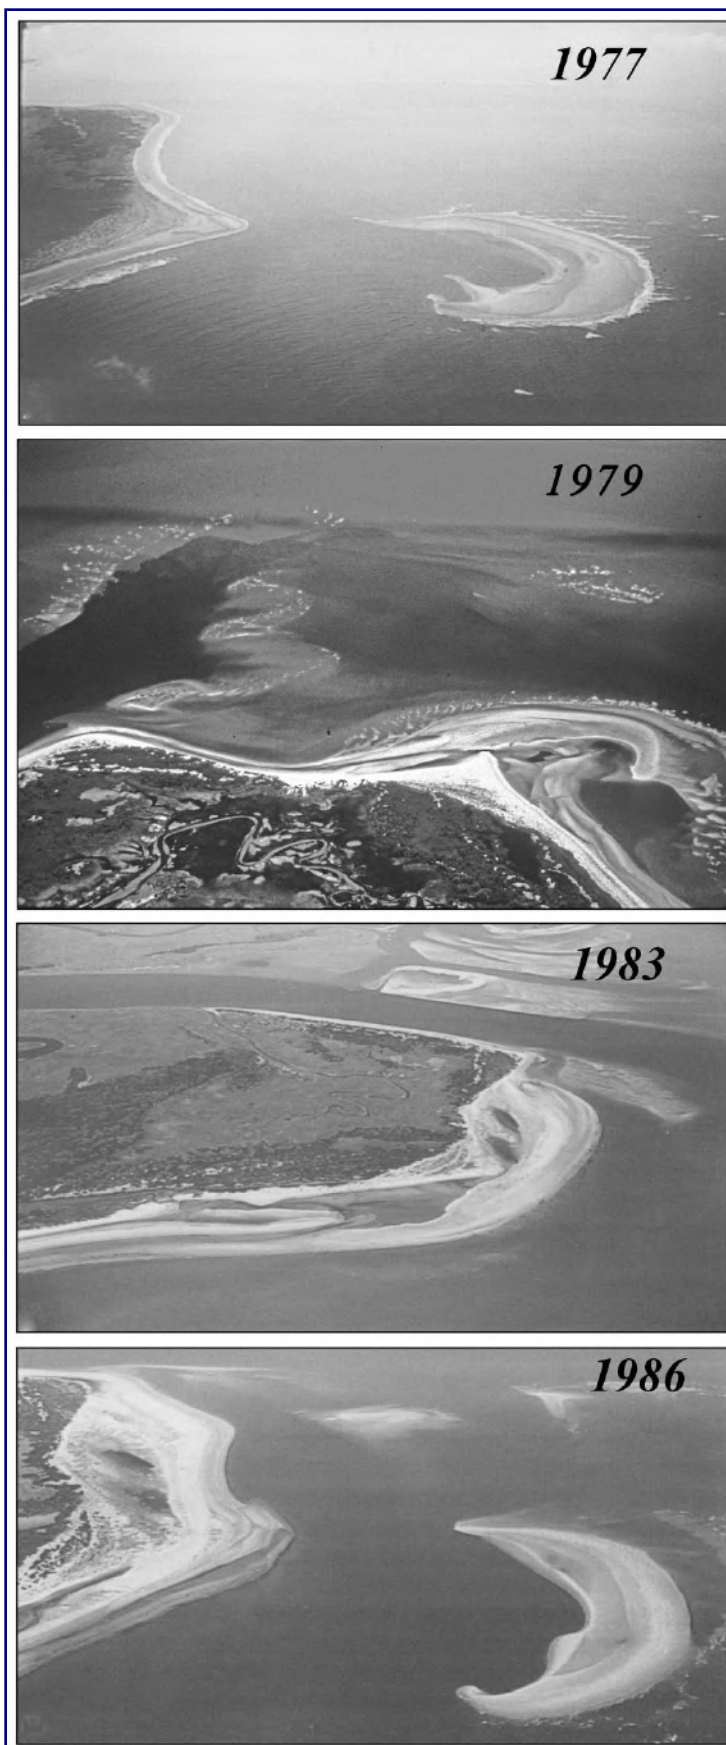
Shoal bypassing at the east end of Kiawah Island.

Stage 1 in 1977 (upper). Stage 2 in January 1979 (upper middle) (courtesy of Research Planning Institute Inc). Stage 3 in 1983 (lower middle). Stage 1 in 1986 (lower). Note the similarity between the 1977 shoal and the 1986 shoal, but the additional sand accumulated on Kiawah in 1986. [After Kana et al 1999]

The time between release of the shoal by the inlet, and attachment and spreading depends on the size of the inlet and its ebb tidal delta. Large inlets, such as Stono Inlet, tend to initiate shoal-bypassing events every 7–8 years with individual shoal volumes often exceeding 0.5 million cubic yards (Gaudio & Kana 2001).

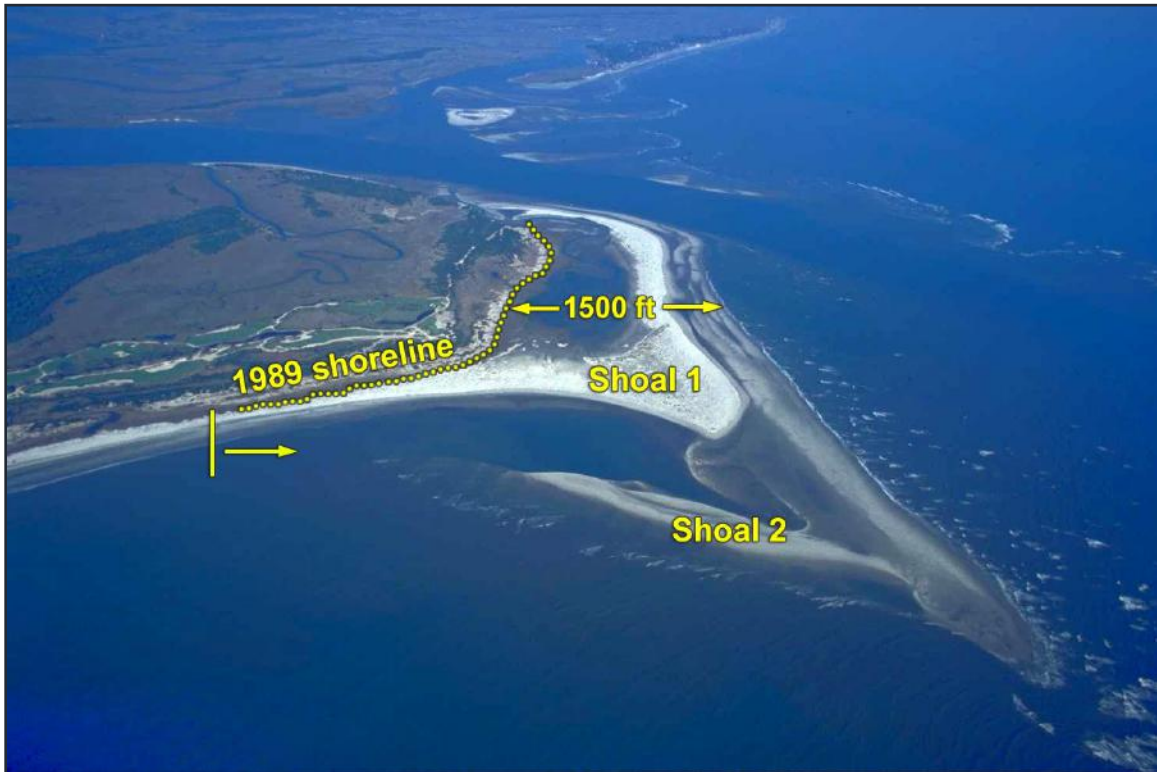
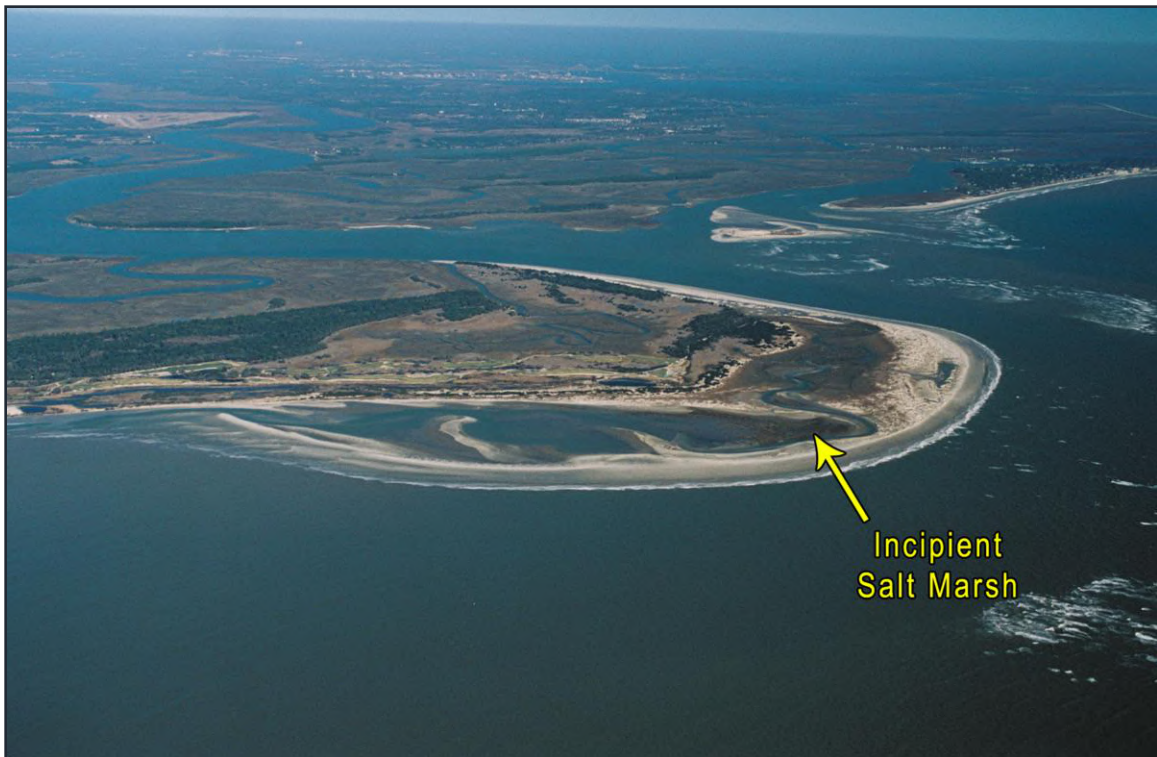
By 2004, the shoals had completely attached at the eastern end but remained offshore at the western end as sand migrated westward, reaching near the (old) Ocean Course Clubhouse (Fig 2.7). The shoals had not completely attached at the western end due to a natural channel maintained by tidal flushing of the lagoon. CSE (2005) estimated the two shoals added ~5 million cubic yards to Kiawah Island. Due to the overwhelming quantity of sand added at the eastern end, the shoreline near the Ocean Course jumped seaward and changed orientation. This protrusion altered the direction of approaching waves and caused focused erosion along the Ocean Course.

As longshore transport moved the shoal westward, the flushing channel migrated with the shoal, encroaching on the Ocean Course, specifically the 16th and 18th holes. The beach at the original Ocean Course Clubhouse (near OCRM monument 2775) retreated over 500 ft between 2000 and 2005. The magnitude of the bypassing event was so great, it was apparent that severe erosion would continue for several years before the cycle would be complete (Gaudio & Kana 2001). The Ocean Course remained vulnerable to erosion as the shoal and flushing channel migrated westward. This led to the plan for beach restoration by CSE (2005).

FIGURE 2.7. The eastern end of Kiawah Island in December 1998 (upper) and February 2005 (lower). Note the 1989 shoreline situated well inland from the outer beach. Shoals 1 and 2 added upward of 5 million cubic yards to Kiawah in the 1990s. As waves pushed the new sand shoreward, an incipient barrier island/lagoon/marsh formed. The new lagoon was flushed via a channel at the western end of the accreted beach. [From CSE 2007]

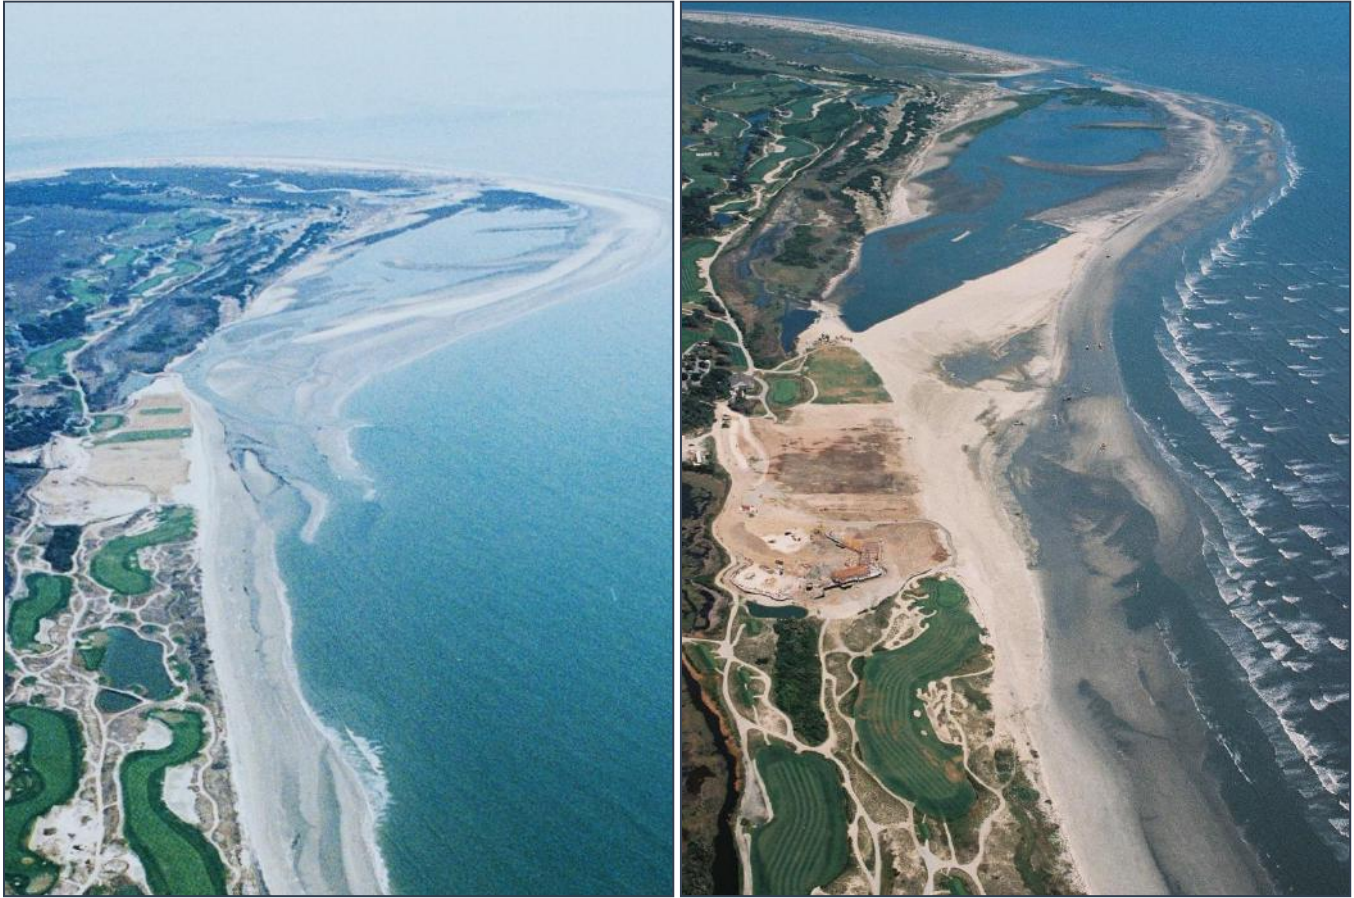
FIGURE 2.8. Before (February 2006) and after (July 2006) aerial photos of the 2006 east end beach restoration project.

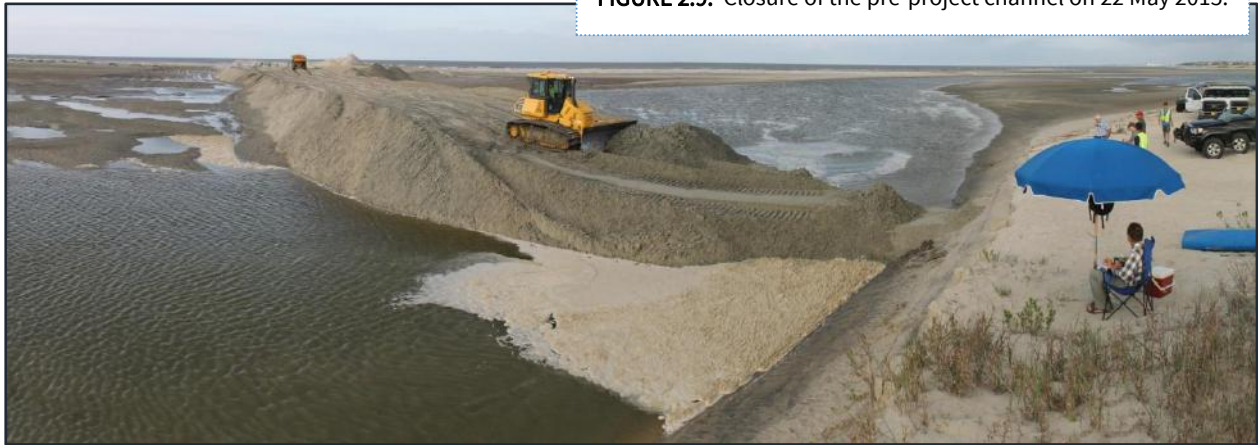
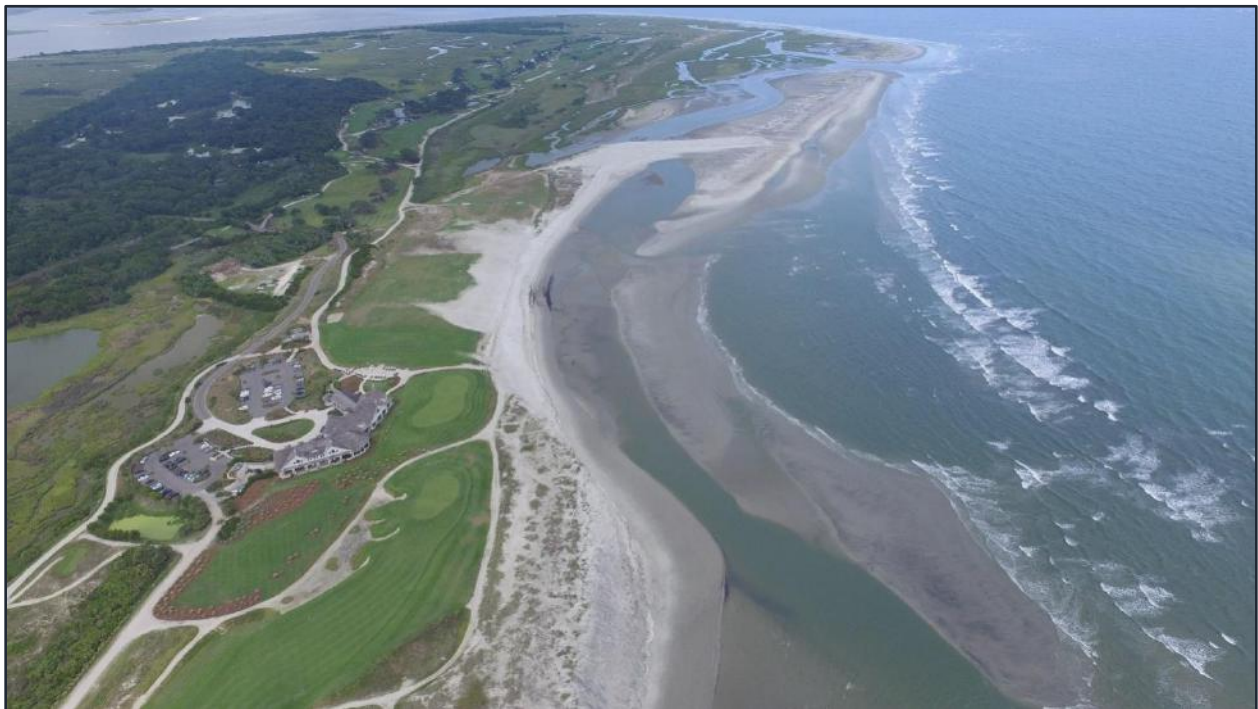
The 2015 project was constructed between May and June 2015 by Lake Moultrie Construction Company Inc DBA Lake Moultrie Water Company and Ashridge Inc, A Joint Venture (St. Stephen, SC), at a cost of \$538,000. A total of 100,000 cy of sand was transferred, and the new inlet was opened ~3,000 ft to the east. A closure dike was built across the original channel, connecting to the remaining portion of the 2006 closure dike (Fig 2.9). Excess sand was placed along the seaward edge of the driving range to facilitate recovery of the eroded areas and protect the range. The completed project accomplished the goal of eliminating the cause of erosion along the Ocean Course while minimizing the construction impacts through lower volumes and limited manipulation of the beach area (Fig 2.10).

FIGURE 2.10. Aerial image of the completed 2015 channel relocation project in July 2015. The new inlet was opened ~3,000 ft east of the old channel.

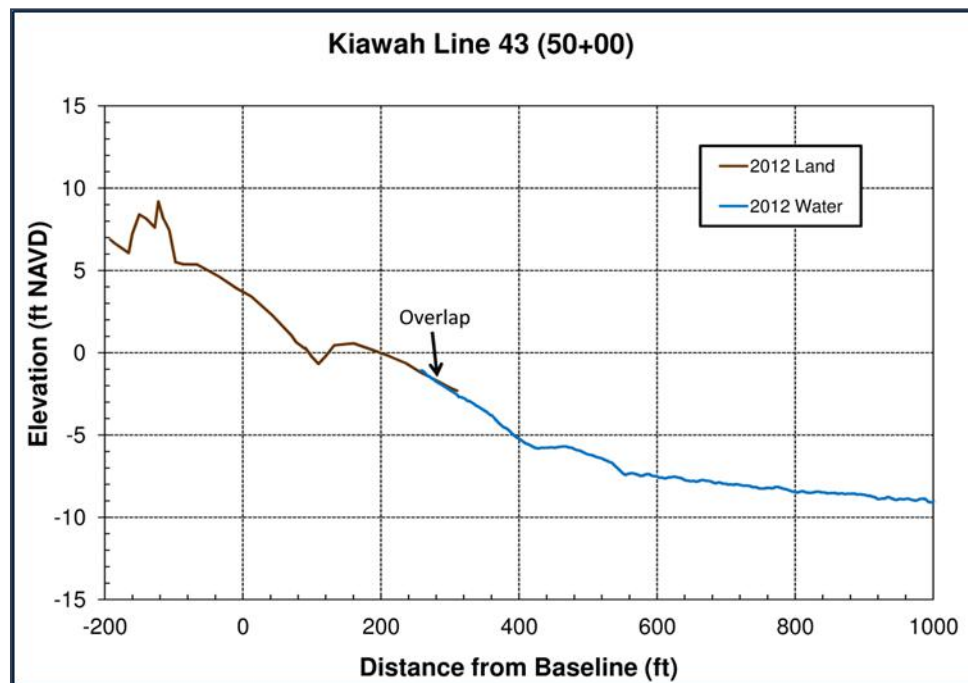
FIGURE 3.2. CSE combines land-based and hydrographic data collection to produce continuous profiles of the beach. Land-based work is accomplished at low tide, while hydrographic work is performed at high tide. This allows for overlap of the two data collection methods and ensures quality data and a complete profile.

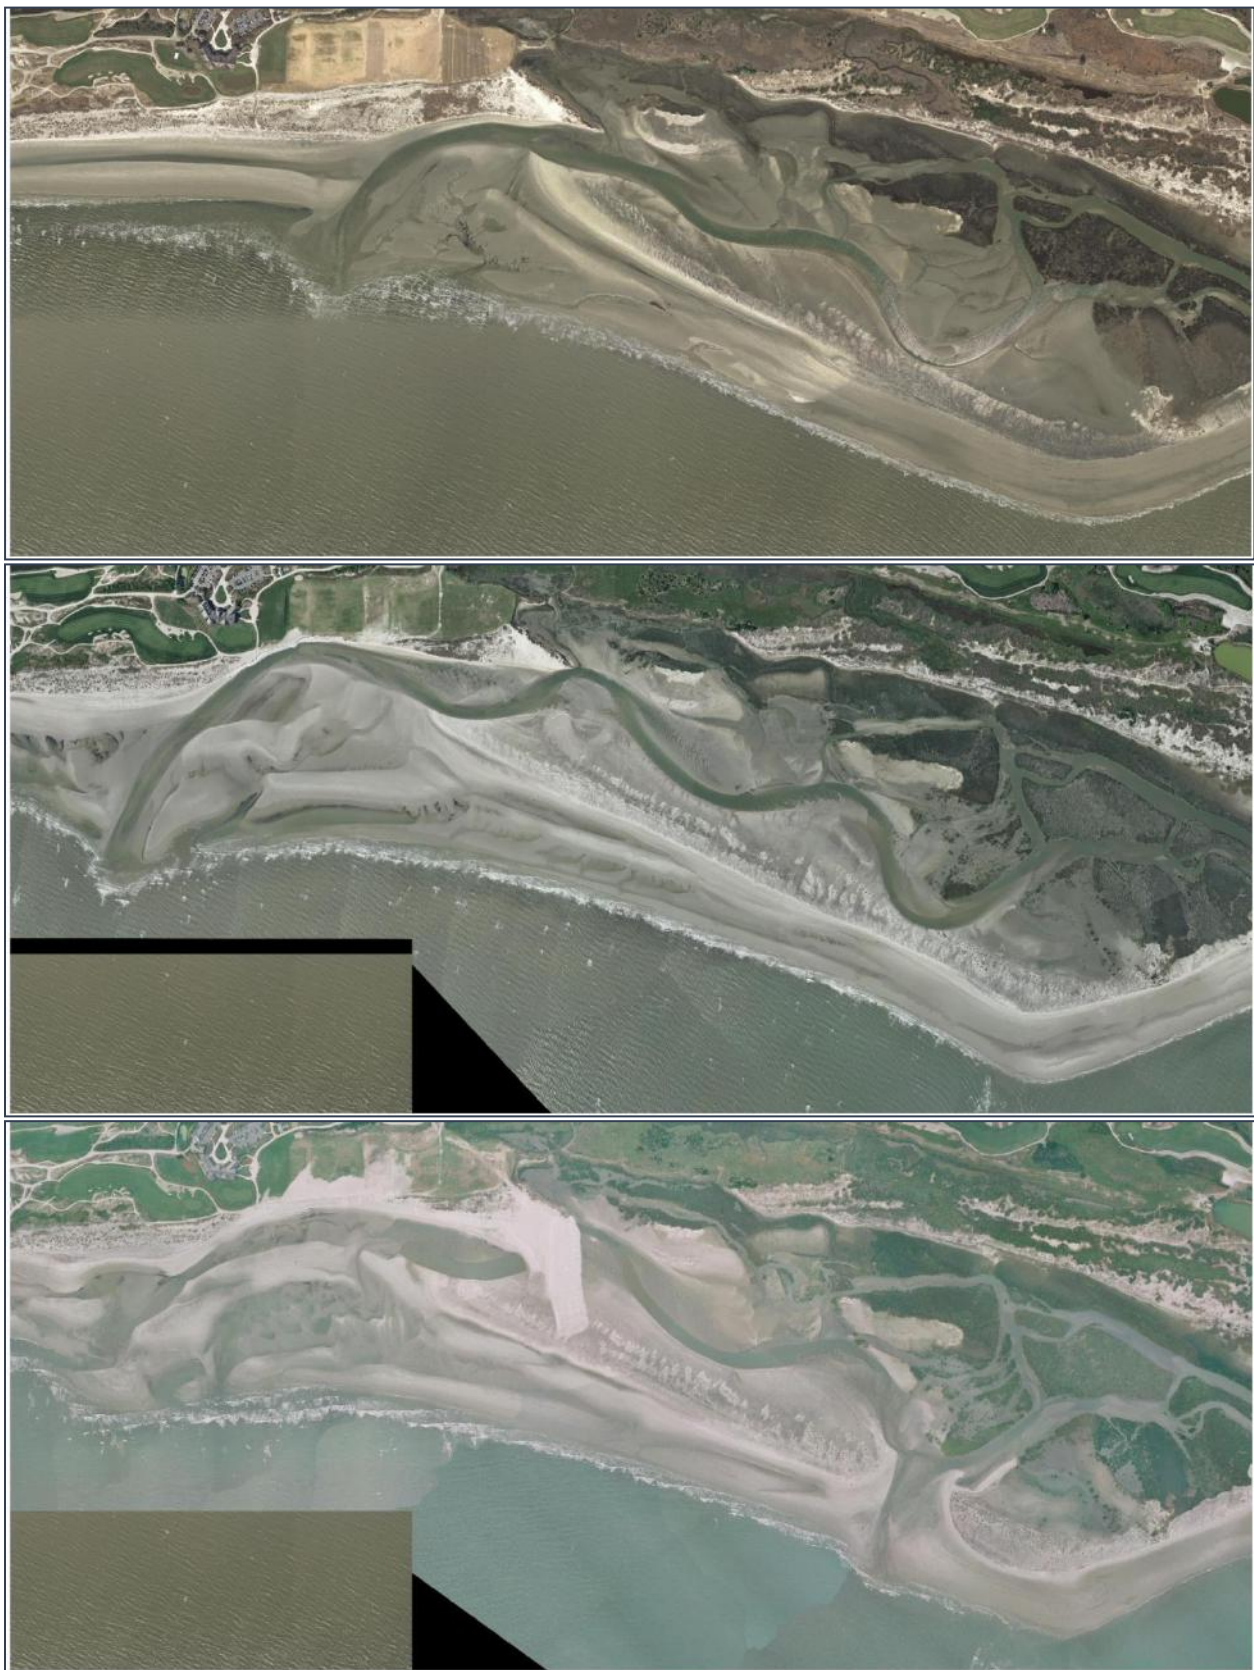
FIGURE 4.1. Aerial images of the east end project area from February 2014 (upper), April 2015 (middle), and July 2015 (lower).

A general description of the 2015 Kiawah Island east end channel realignment project was provided in Section 2. This section focuses on the impacts of the project on the physical condition of the beach. As part of project planning and design, CSE completed a detailed survey of the east end between the Ocean Course Clubhouse and the location of the proposed new channel in April 2014. Another (less detailed) survey was completed in October 2014 as part of the regular annual monitoring effort. Detailed final design (pre-construction) and as-built (post-construction) surveys were performed in February and June 2015 (respectively).

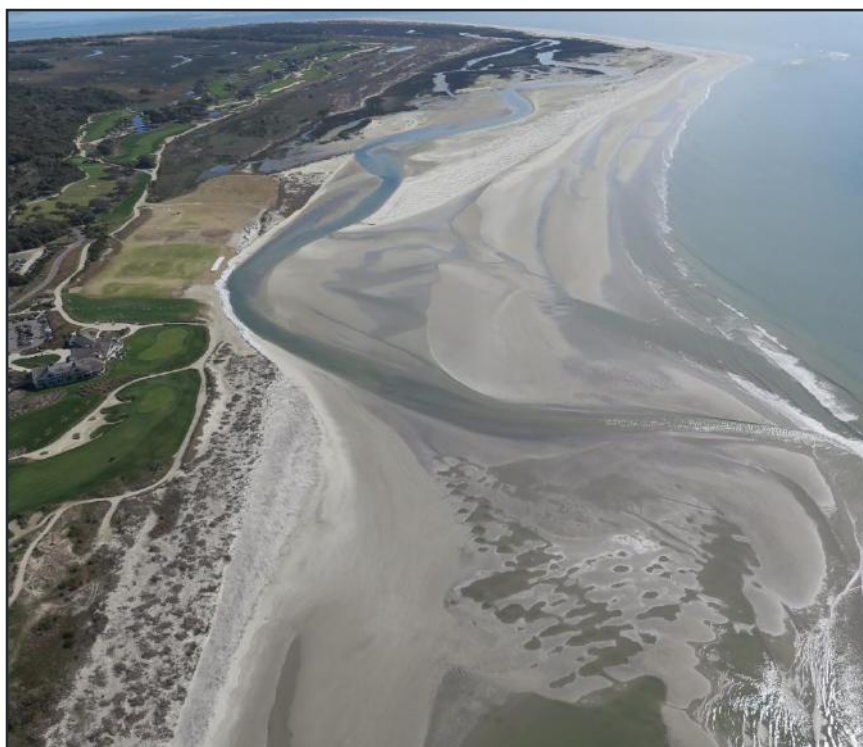
March 2015 aerial image of the east end of Kiawah Island.

Note the sandbag revetment at the driving range and practice green, the remnants of the 2006 closure dike, and the extensive sand flats that will migrate onshore after the channel is closed.

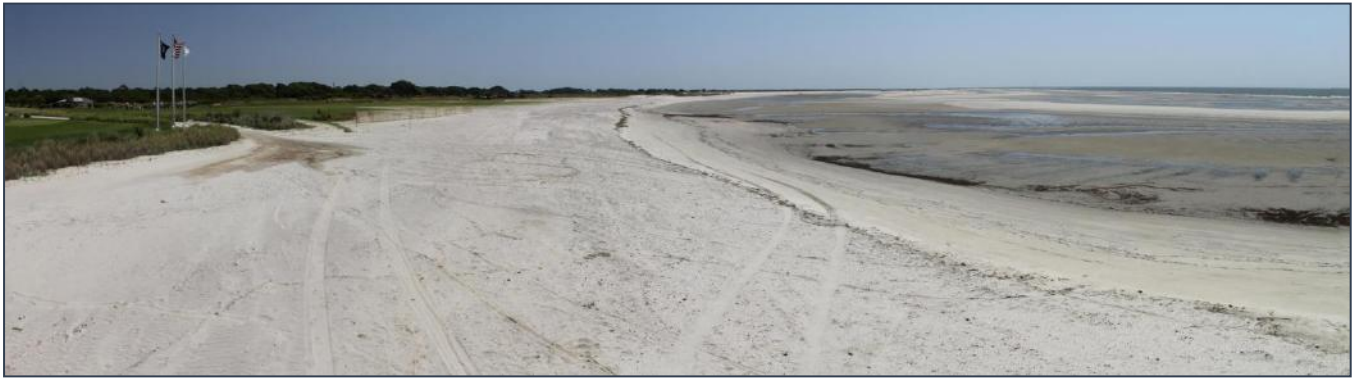
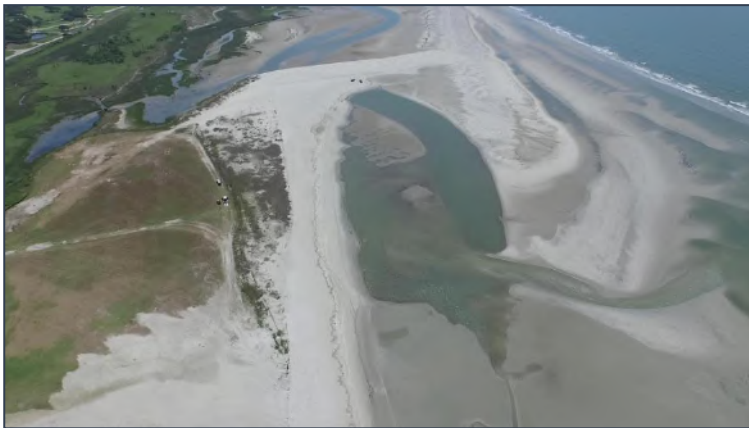
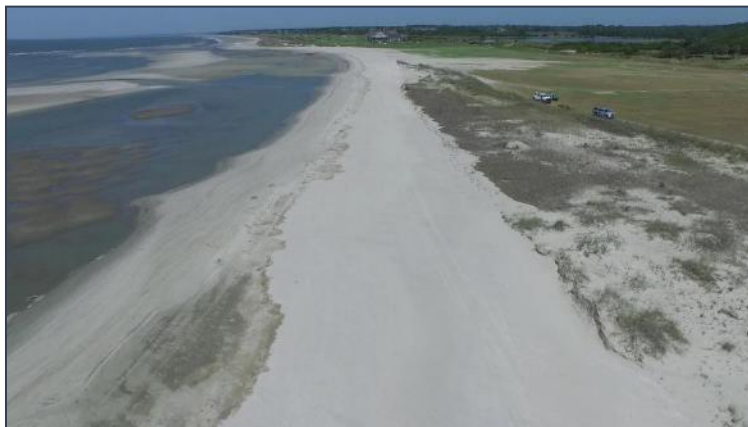
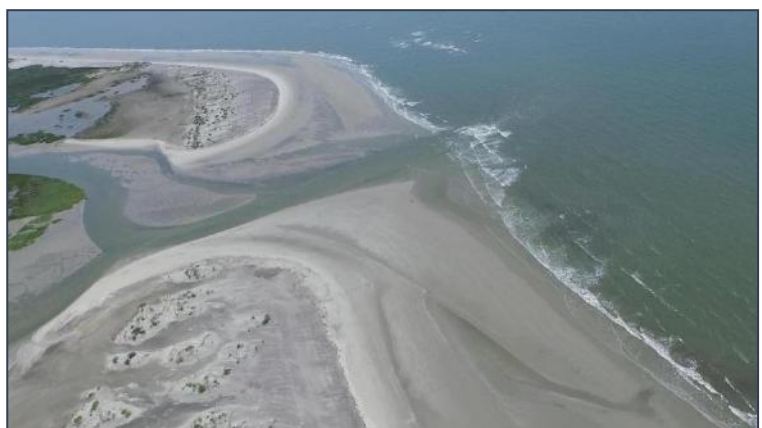
FIGURE 4.5. Photos from June 15 (above) and June 16 (aerials) showing the condition of the beach immediately after project construction.

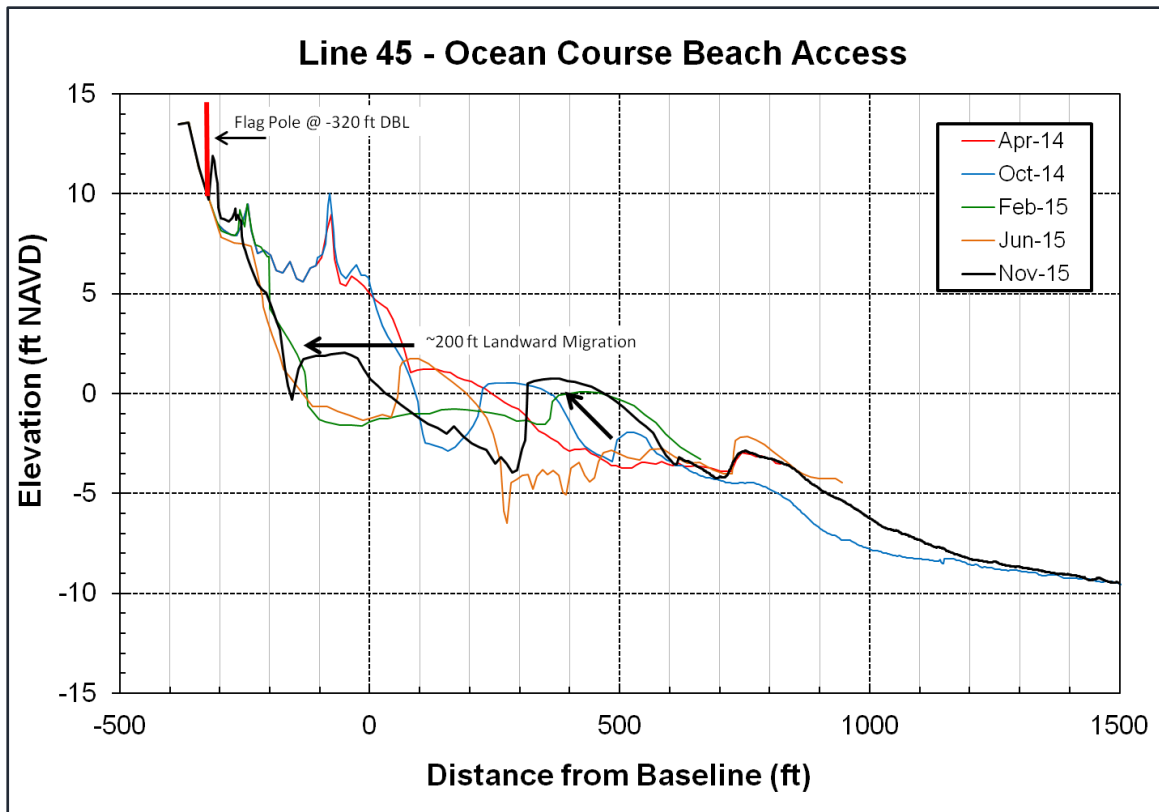
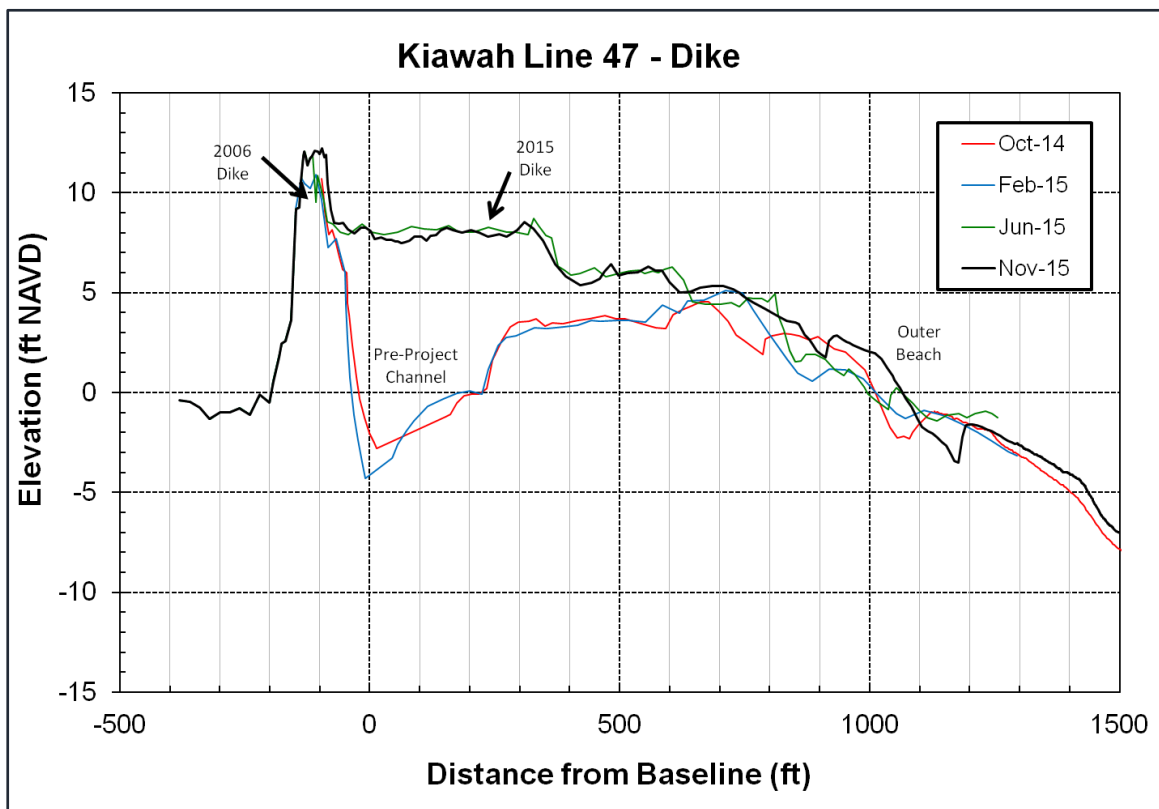
FIGURE 4.6. Profiles from Lines 45 (Ocean Course Beach Access) and Line 47 (closure dike). See text for additional information.

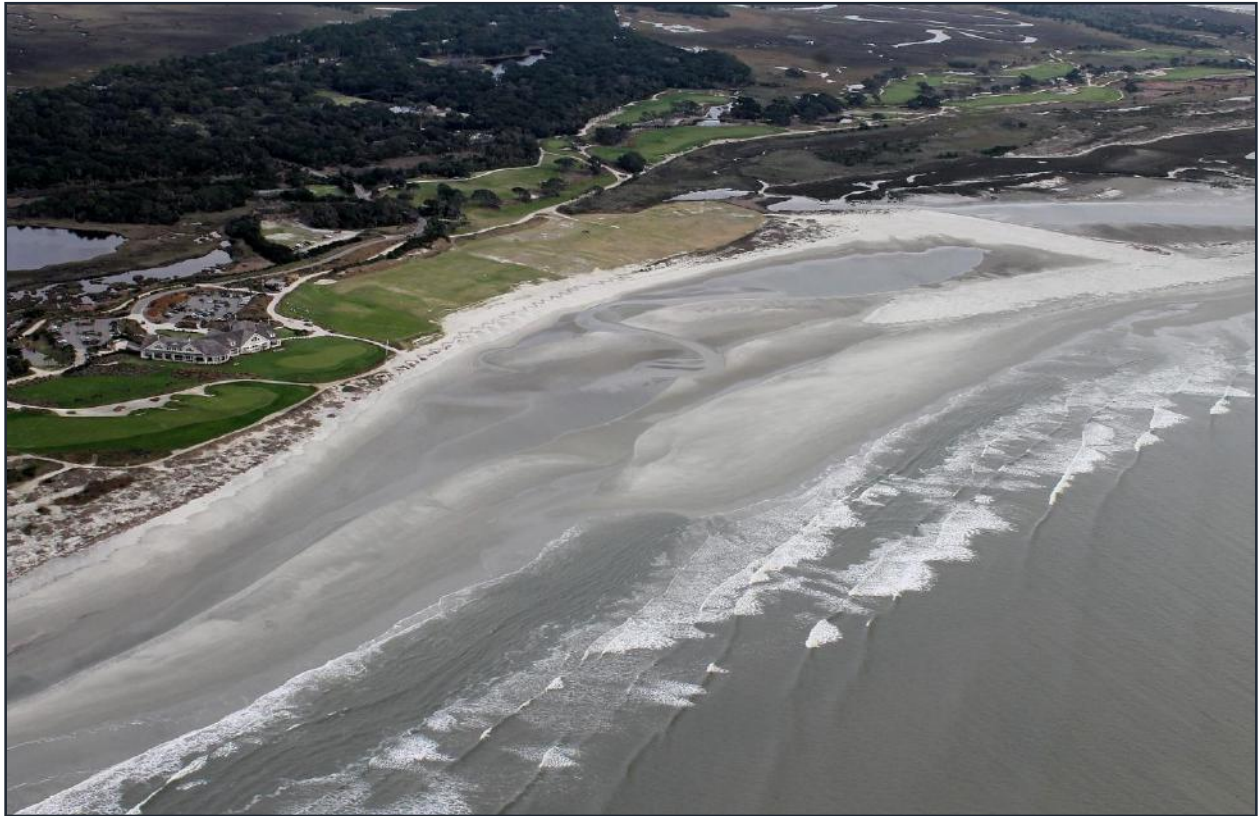
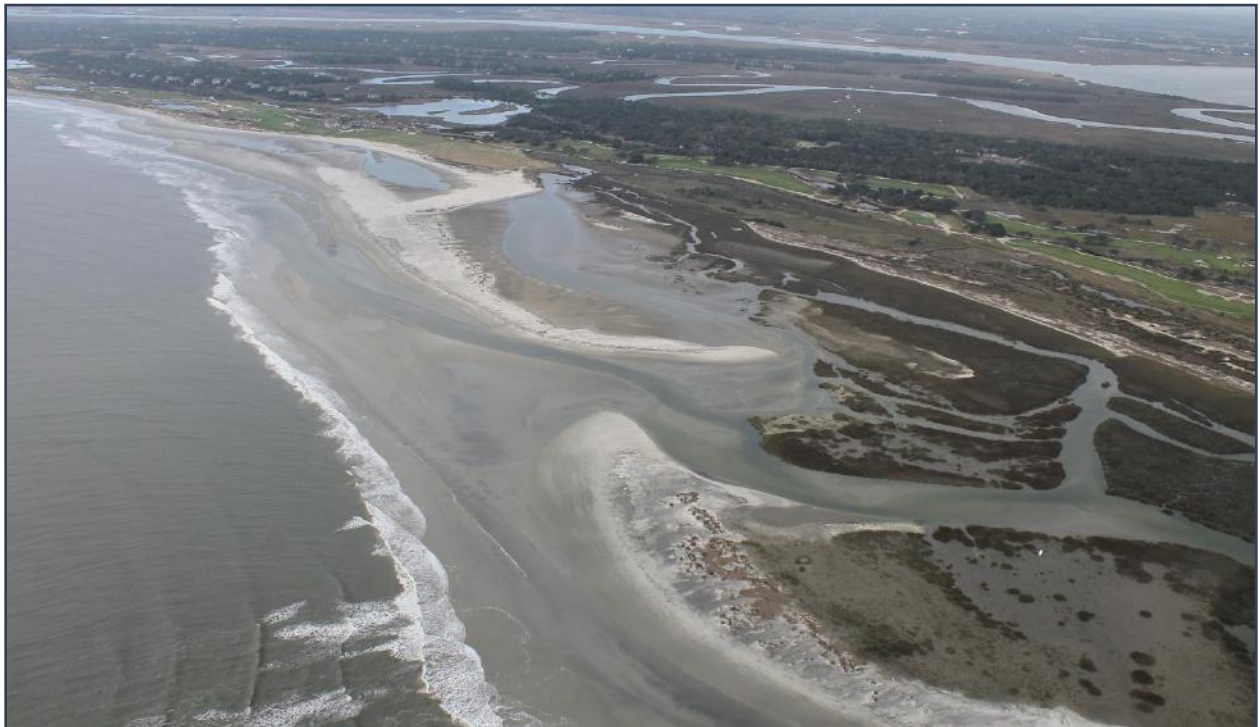
Figure 4.7 shows aerial views (7 January 2016) of the project area. West of the dike, the old channel has filled in between the clubhouse and vehicle access path along the middle of the driving range. Between the access path and the dike, an area of standing water remains, flushed by a very small channel. A large, intertidal ridge extends to the west from the area of dry beach seaward of the dike. This sand will eventually merge with the shoreline in front of the driving range. Hurricane *Joaquin* (early October 2015) likely contributed to onshore migration of the intertidal sand, and additional winter storms will be effective at moving detached shoals and bars landward.

FIGURE 4.7. Aerial images from 7 January 2016 showing the project area ~7 months after project completion. Note the infilling of the old channel and the merging intertidal sandbars on the top image. The bottom image shows the new inlet, which has deflected to the west since the project. Hurricane *Joaquin* impacted this area in early October 2015, creating washovers of the lagoon outer berm further east (see later sections).

CSE anticipates that the dry beach fronting the driving range will continue to accrete sand along the upper profile over the next several months. Sand fencing should be used to facilitate dune development in strategic places, while the intertidal flats and washover areas east of the dike should be left to natural processes for habitat conservation.
