2006 EAST END BEACH RESTORATION PROJECT
KIAWAH ISLAND SOUTH CAROLINA

Survey Report No 9
February 2016

SURVEY REPORT NO 9
Annual Beach and Inshore Surveys

[CSE 2446 YR1]
February 2016

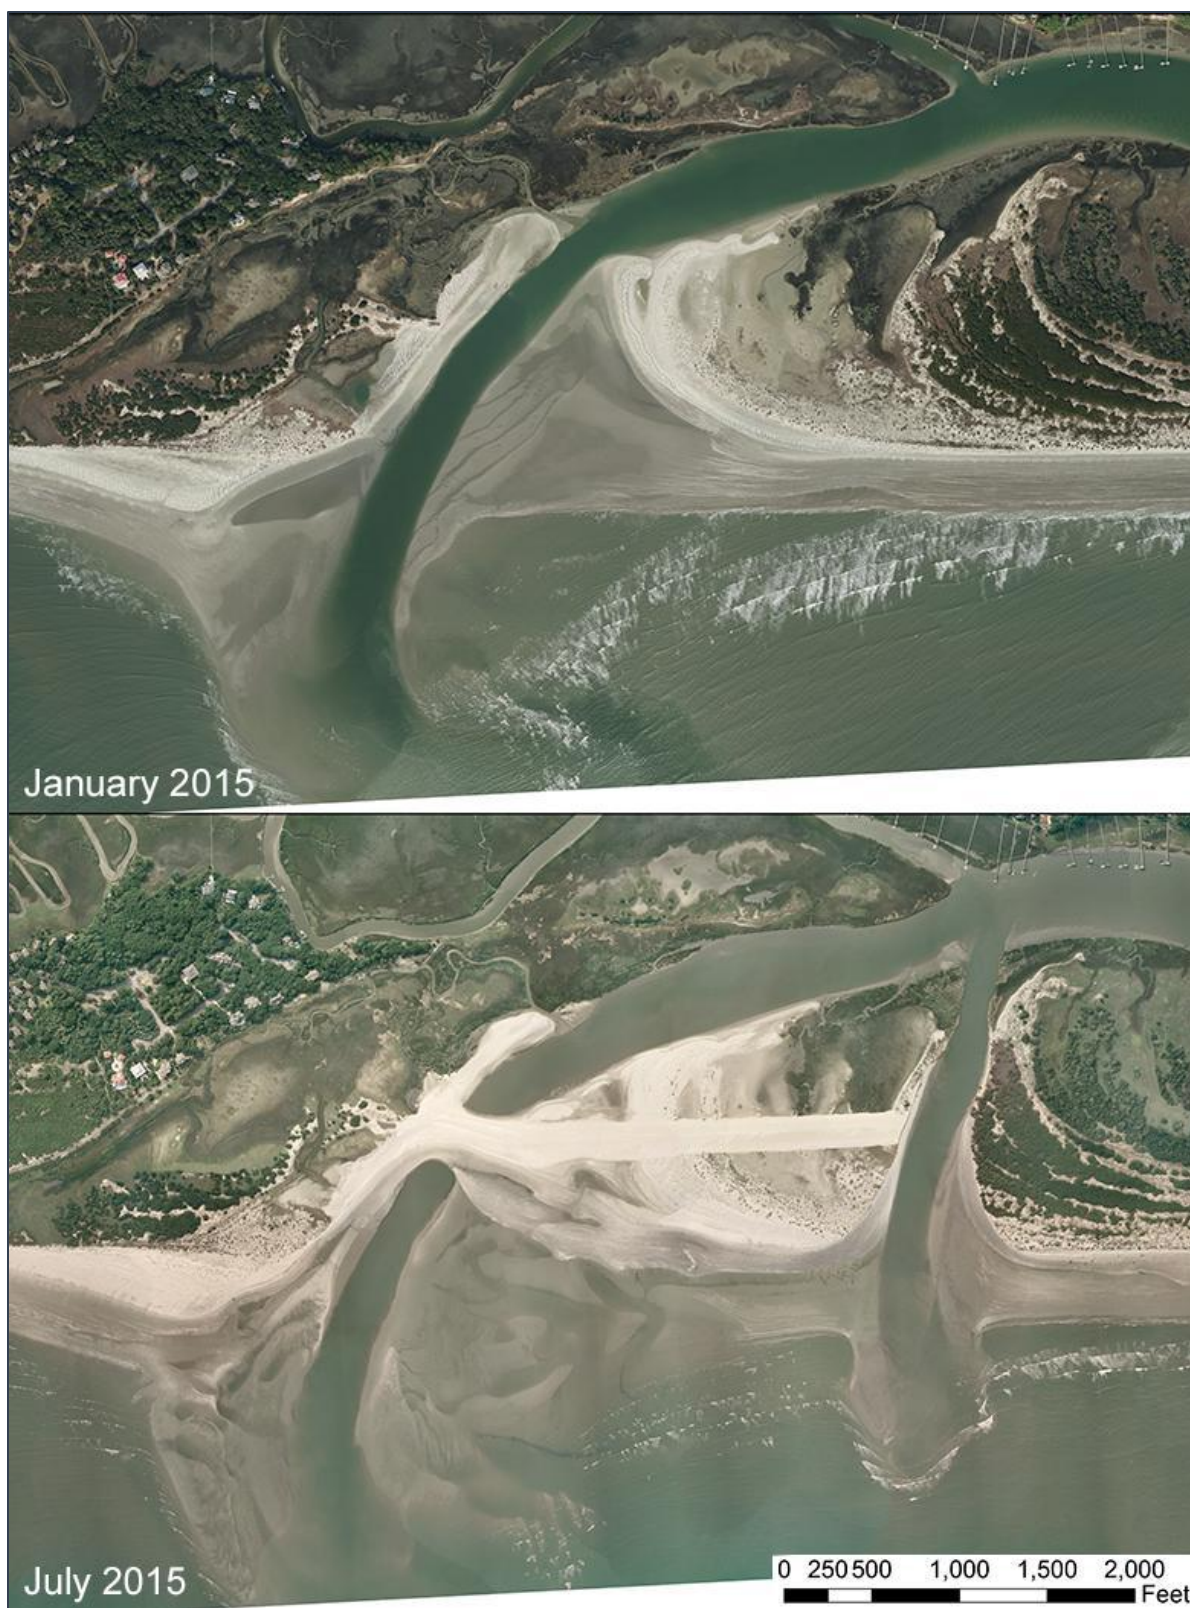
FIGURE 4.9. January 2015 (top) and July 2015 (bottom) aerial images of Captain Sams Inlet, which was relocated ~3,000 ft to the east by SIPOA in May-June 2015.

The project resulted in the western 2,800 ft of Kiawah Island (a portion of Captain Sams Spit) being temporarily lost to Seabrook. Figure 4.10 shows the post-construction photo and locations of monitoring stations. Profile Line 1 is now on the Seabrook side of Captain Sams Inlet; Line 2 is essentially in the inlet channel. For volume analysis, any volume associated with these profiles is excluded from computations. As the inlet migrates over time, the lines will be reincorporated into the volume measures as applicable. CSE anticipates the spit returning to near its pre-project condition in the next 12–15 years.

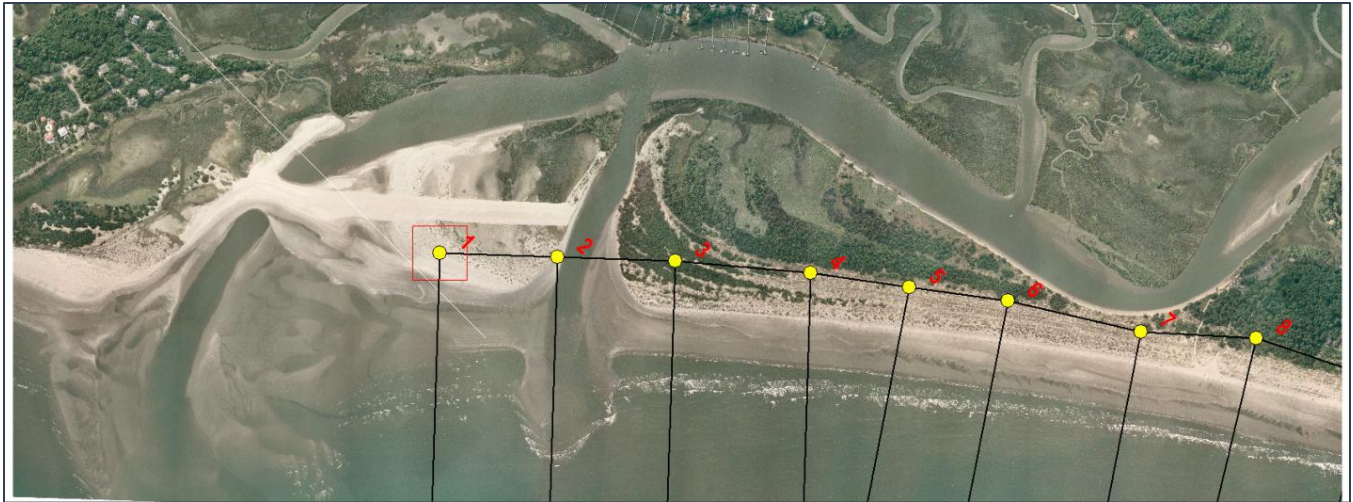
FIGURE 4.10. Post-project map of the west end of Kiawah Island and TOKI beach monitoring stations. Lines 1 and 2 are now located on the Seabrook side of the new inlet.

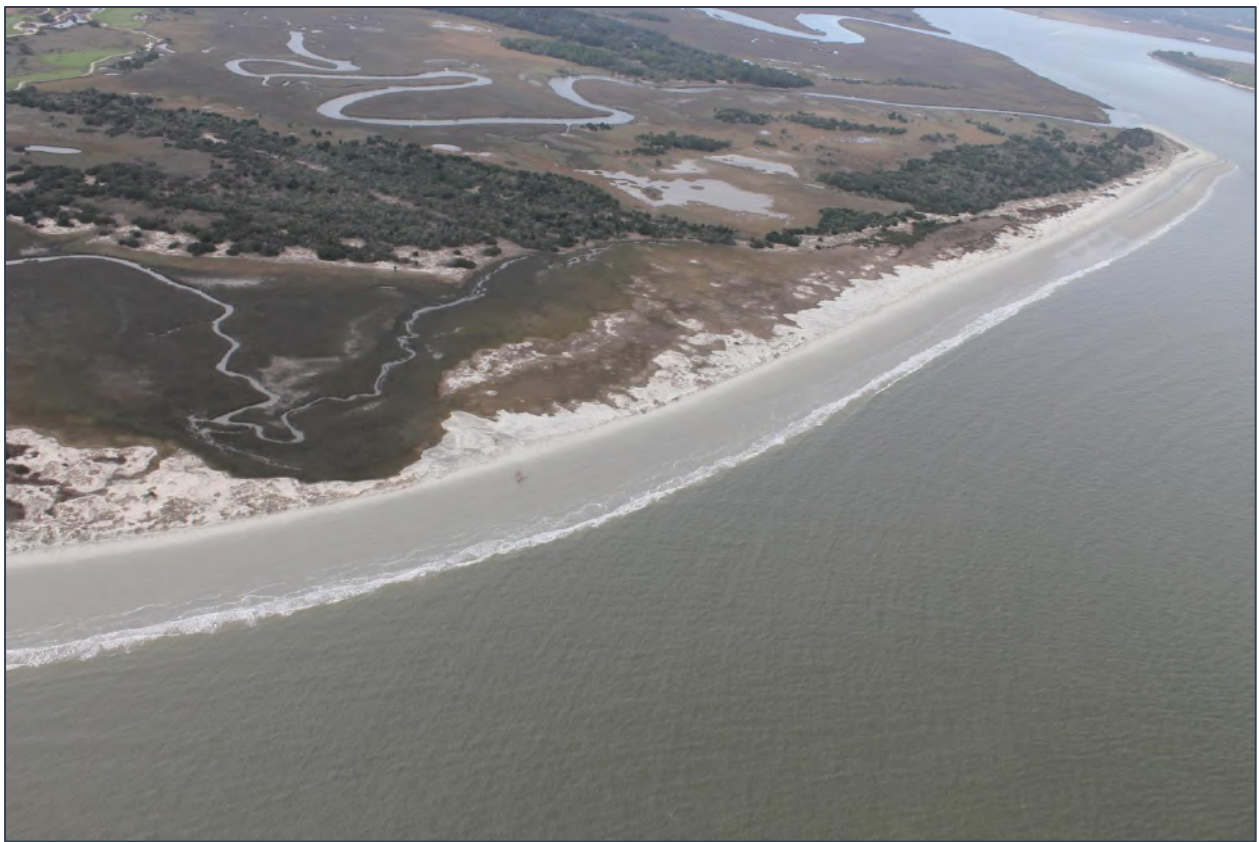
Photos (Fig 4.12 and Fig 4.13) from the November 2015 survey and January 2016 overflight show there was severe erosion along the southern end of the reach (Lines 56–57) with a large dune escarpment and signs of an overwash event (likely occurring during Hurricane *Joaquín*). A very thin strip of dune separates the ocean from the lagoon marsh between Lines 56 and 57 (foreground of Fig 4.12). Continued erosion of this area may lead to the formation of a new breach inlet at the site. Profiles show the primary dune was completely eroded at Lines 57 and 58, leaving a low dune area susceptible to overwash during storms (Fig 4.14).

FIGURE 4.12. January 2016 aerial image of the Stono Inlet Reach.

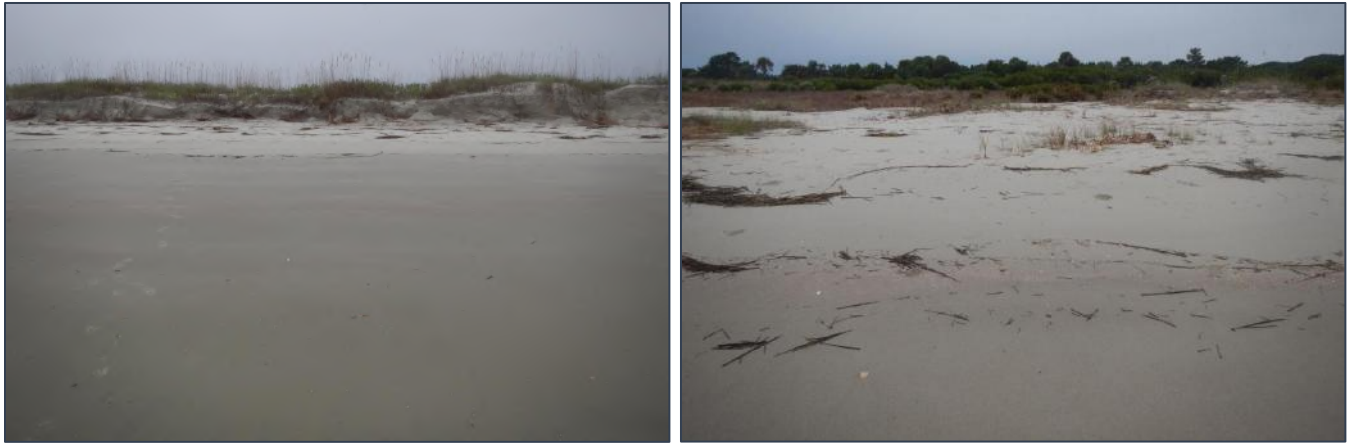
FIGURE 4.13. Ground photos from Line 56 (left) and Line 58 (right). The primary dune was lost at Line 58, leaving the potential for overwash during storms.

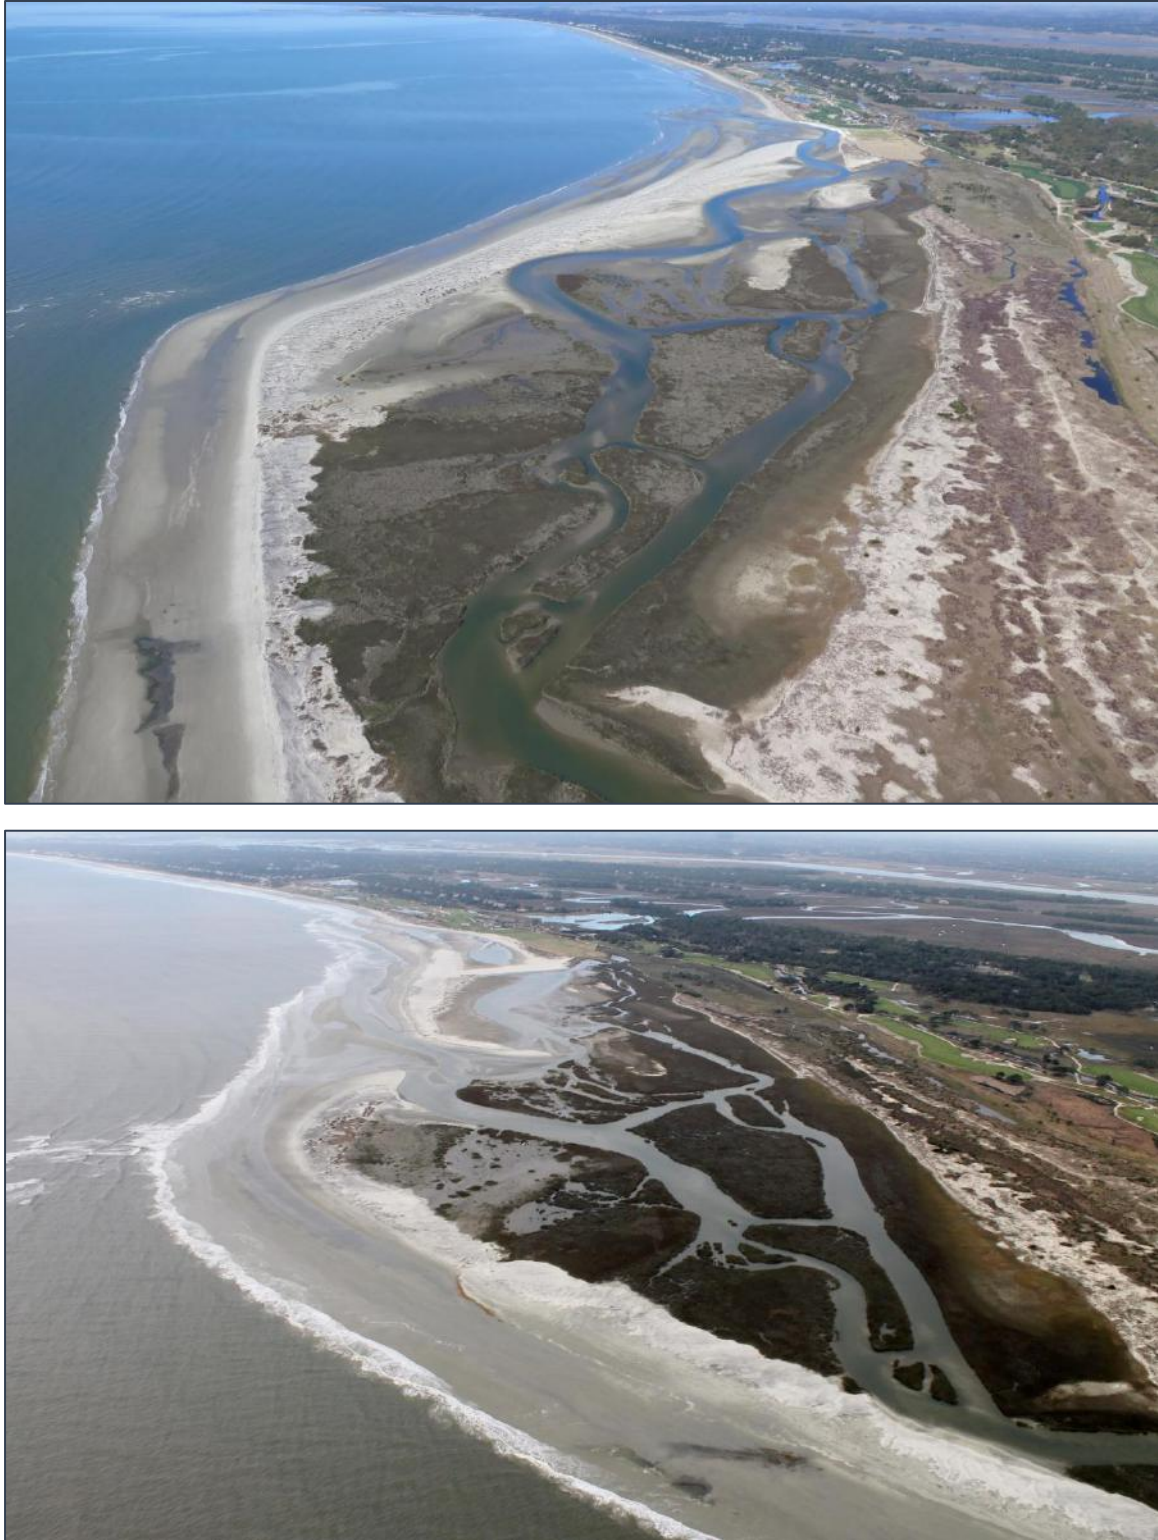
Figure 4.16. March 2015 (top) and January 2016 (bottom) aerial images of the Lagoon Reach.

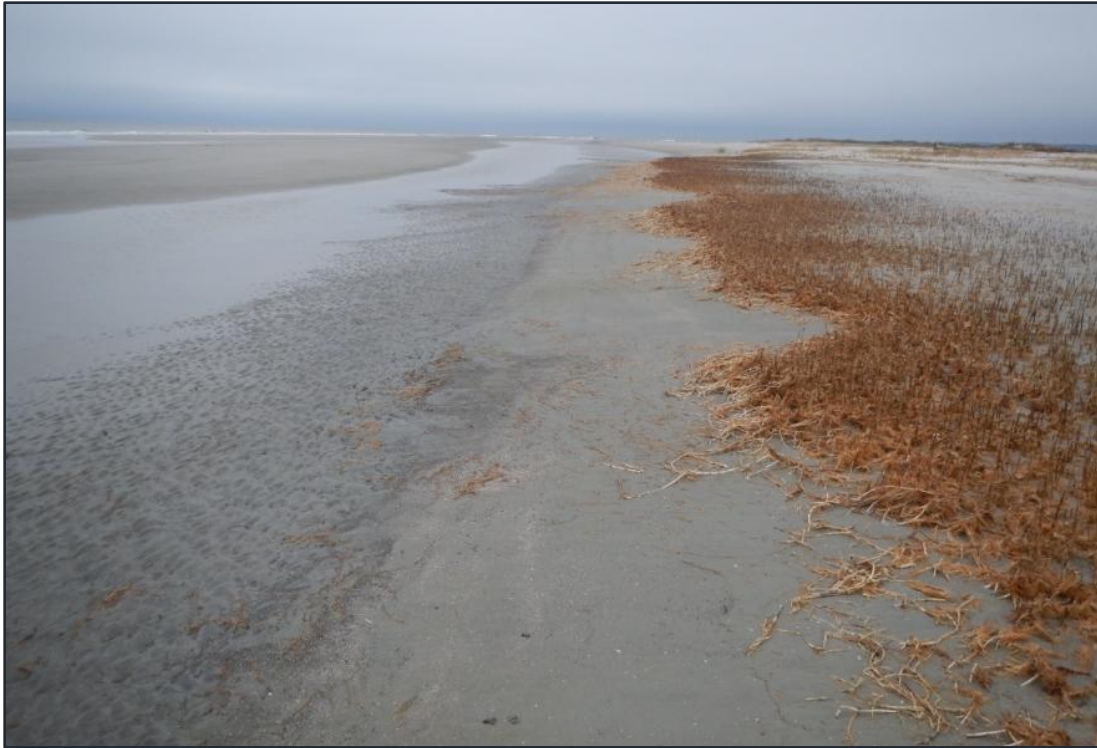
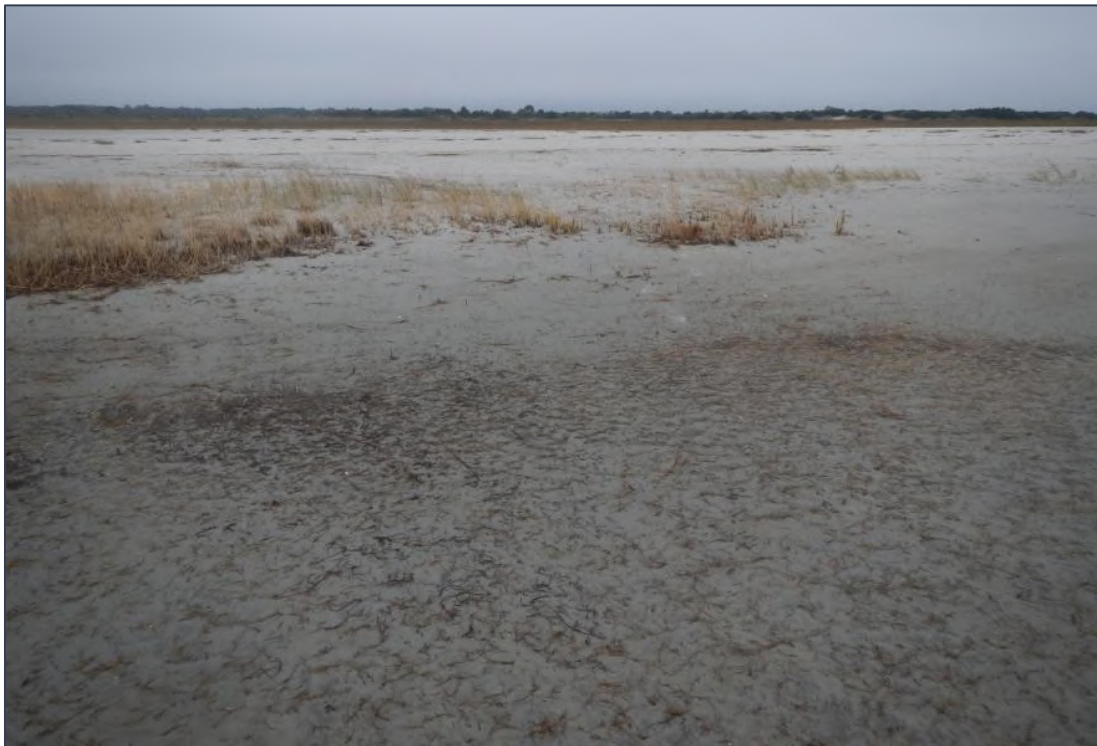
Other than the relocation of the inlet channel, the most significant change along the lagoon area was erosion and overwash of the berm along the eastern half of the reach. Lines 51–54 all showed complete loss of the dune and significant recession of the shoreline due to overwash (Fig 4.18). Up to 300 ft of landward recession was observed between 2014 and 2015. Much of the area is now susceptible to overwash during storms or extreme tides, as the maximum elevation along the stretch is (~)-5 ft NAVD, which near the typical elevation of a unvegetated dry sand beach. Photos from November 2015 confirm that nearly the entire span of the lagoon reach was overwashed by a recent tide (Fig 4.19 and Fig 4.20).

FIGURE 4.19. November 2015 ground photos from Line 53 (right) and 51 (left) showing overwash conditions and exposed marsh on the active beach.

Overall, the Lagoon Reach lost 270,200 cy (33.8 cy/ft) of sand over the past year. This is the highest total loss of sand observed during any previous monitoring interval. Volume change was complicated over the past year due to the 2015 project, which removed upwards of 40,000 cy of sand from the outer berm when the new inlet was excavated. Despite the erosion over the past year, the reach holds 320,000 cy (40 cy/ft) more sand than the 2007 condition with all the gain from natural processes. CSE expects continued erosion of the eastern portion of the lagoon due to limited sand supply and overwash effects. The attaching shoal is relatively small, and does not likely contain sufficient sand to restore the stable beach. It is important to note that the entire lagoon system is an ephemeral feature, created from two large shoal bypass events beginning in the 1990s. The sand from those events continues to attempt to merge with the earlier shoreline through washovers and spreading to downcoast areas. Additional sand continues to periodically attach to the east end, which may temporarily halt the landward retreat of the outer berm and extend the life of the lagoon further into the future.

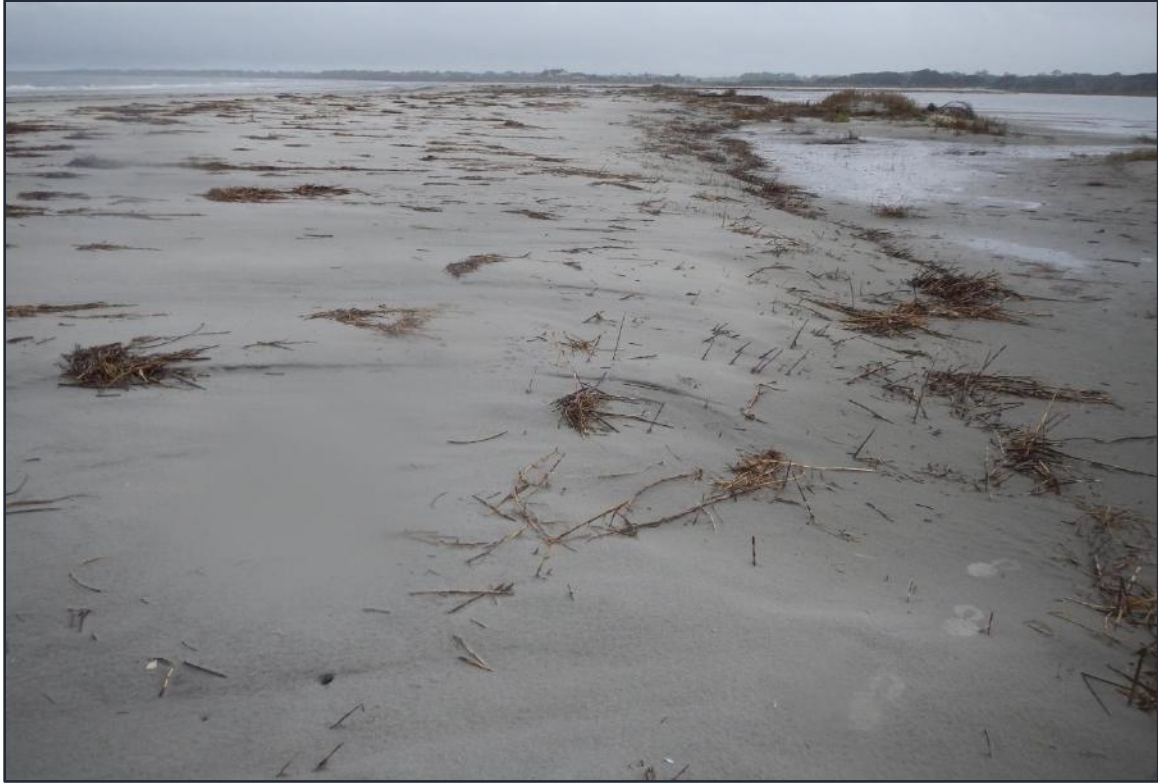
FIGURE 4.20. Photo looking west from Line 48 showing evidence of a recent washover event along the outer berm of the lagoon, east of the constructed dike.

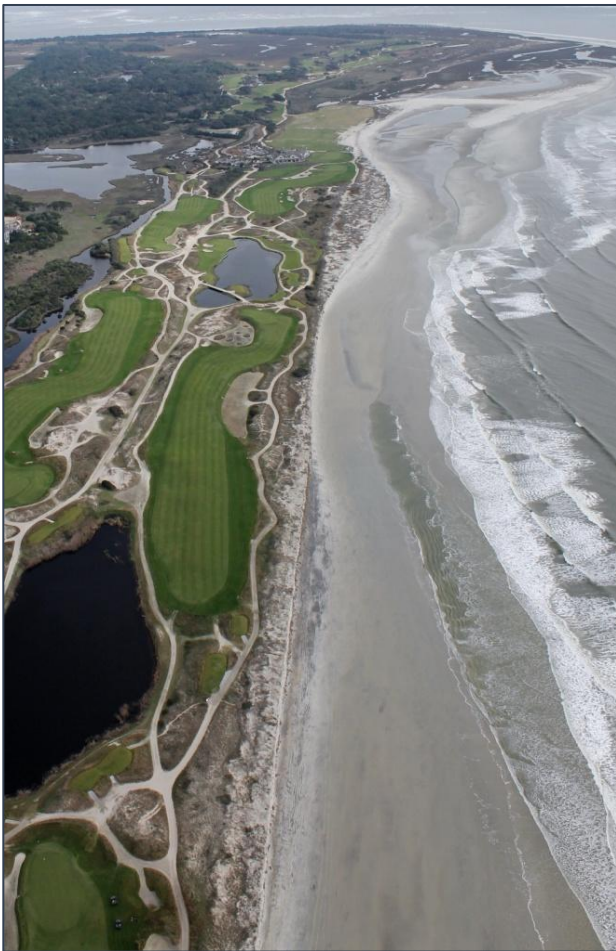
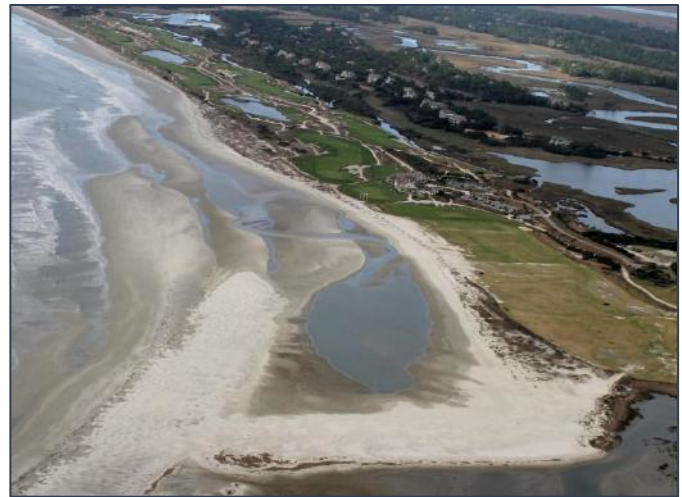
FIGURE 4.21. January 2016 aerial images of the Ocean Course Reach.

The Ocean Course Reach has consistently accreted since 2008, and totals 660,000 cy (73.5 cy/ft) more sand than the 2007 condition. The reach gain 122,500 cy of sand between 2014 and 2015, which is a nearly identical gain as the previous year; however, the gains are skewed by the east end of the reach, which gained a significant amount of sand during the 2015 project. Unit volumes for each profile in the reach are shown in Figure 4.22 and reveal that the western end of the reach was erosional and the eastern end accretional. Erosion along the western end was a result of sediment trapping in the delta of the inlet channel, which forced sand to be deposited in the nearshore zone near the inlet rather than continuing downcoast and feeding the beach.

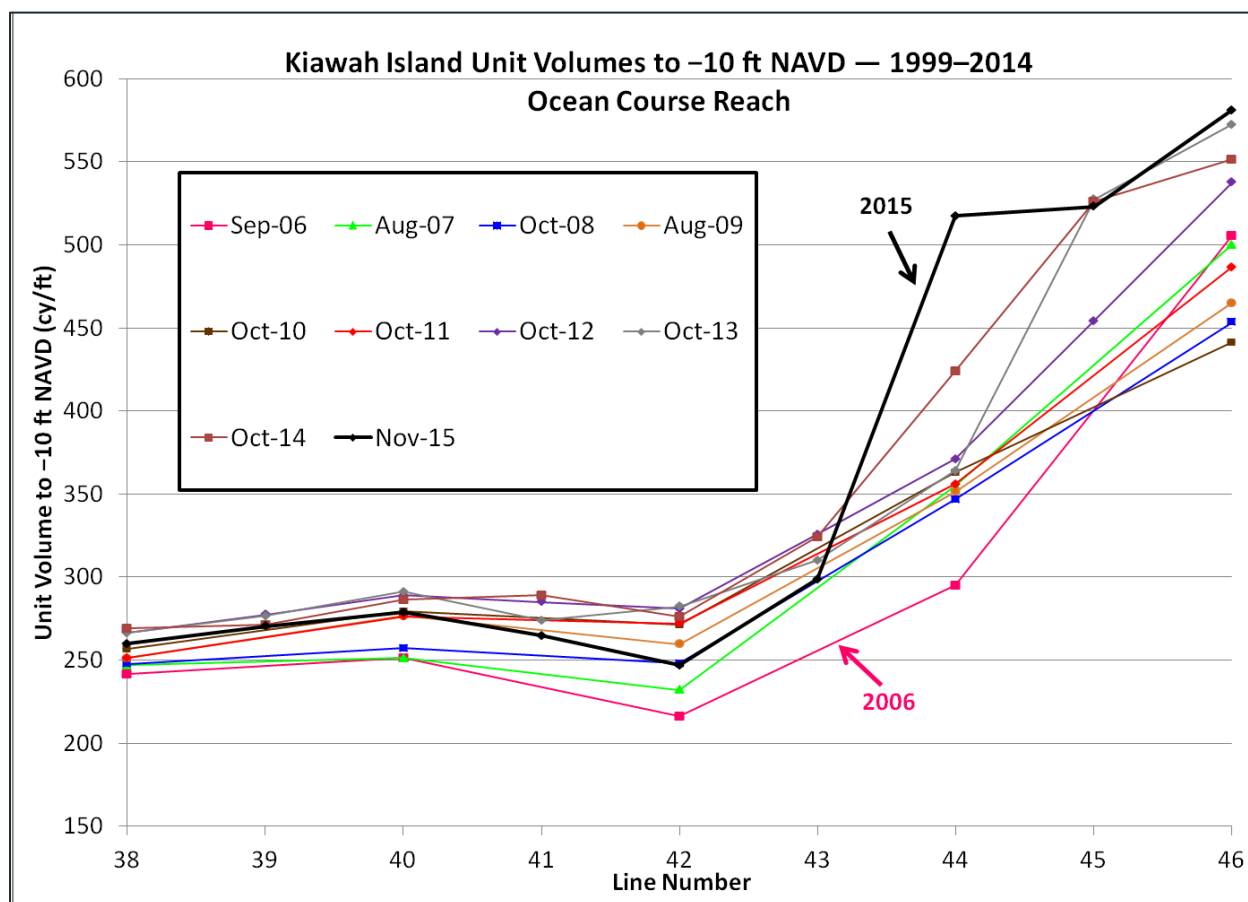
FIGURE 4.22. Unit volumes for the profiles of the Ocean Course Reach.

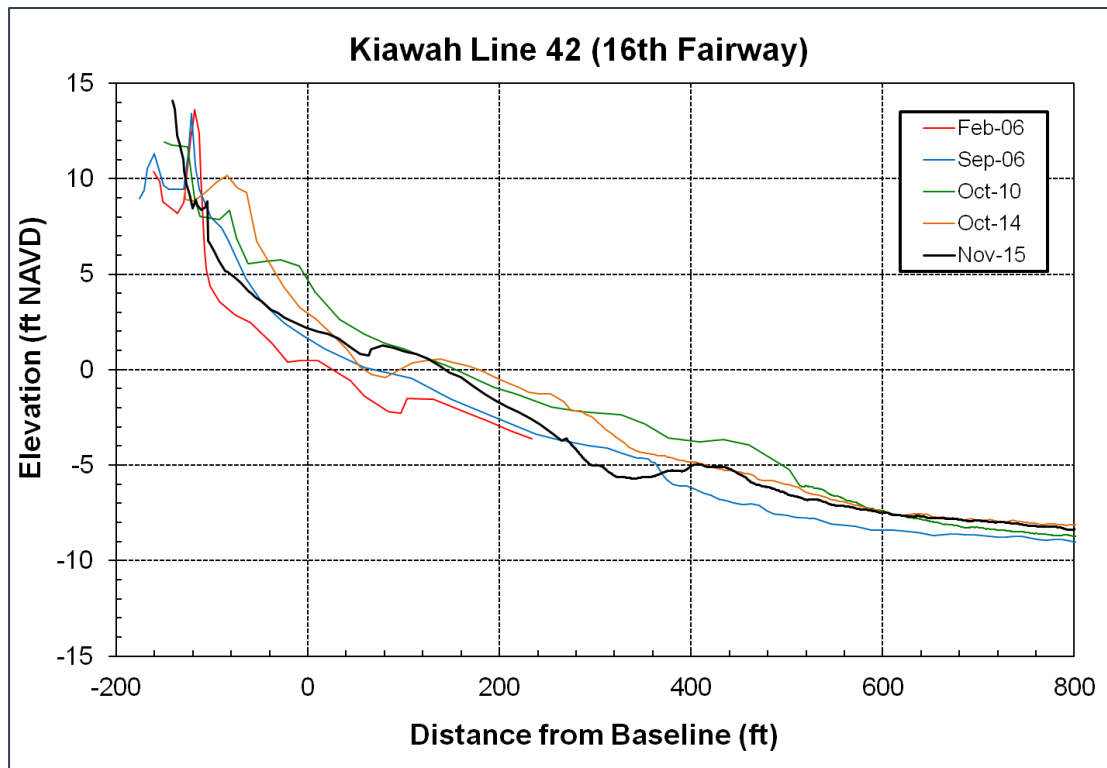
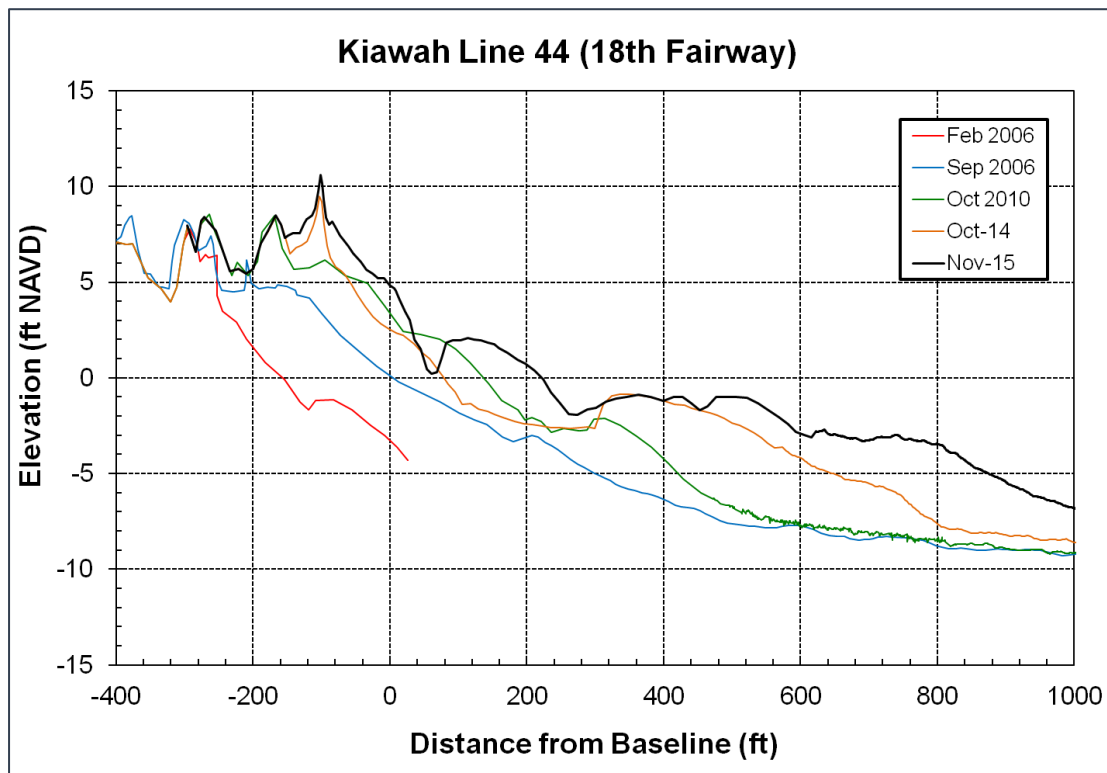
FIGURE 4.23. Profiles from Lines 42 (upper) and 44 (lower) highlighting the influence of the channel delta. At Line 42, the beach eroded over the past year due to sand trapping at the inlet further east. At Line 44, the beach grew as this area is directly adjacent to the inlet, and the delta extends from the beach. Profiles for Line 46 are presented in FIGURE 4.2.

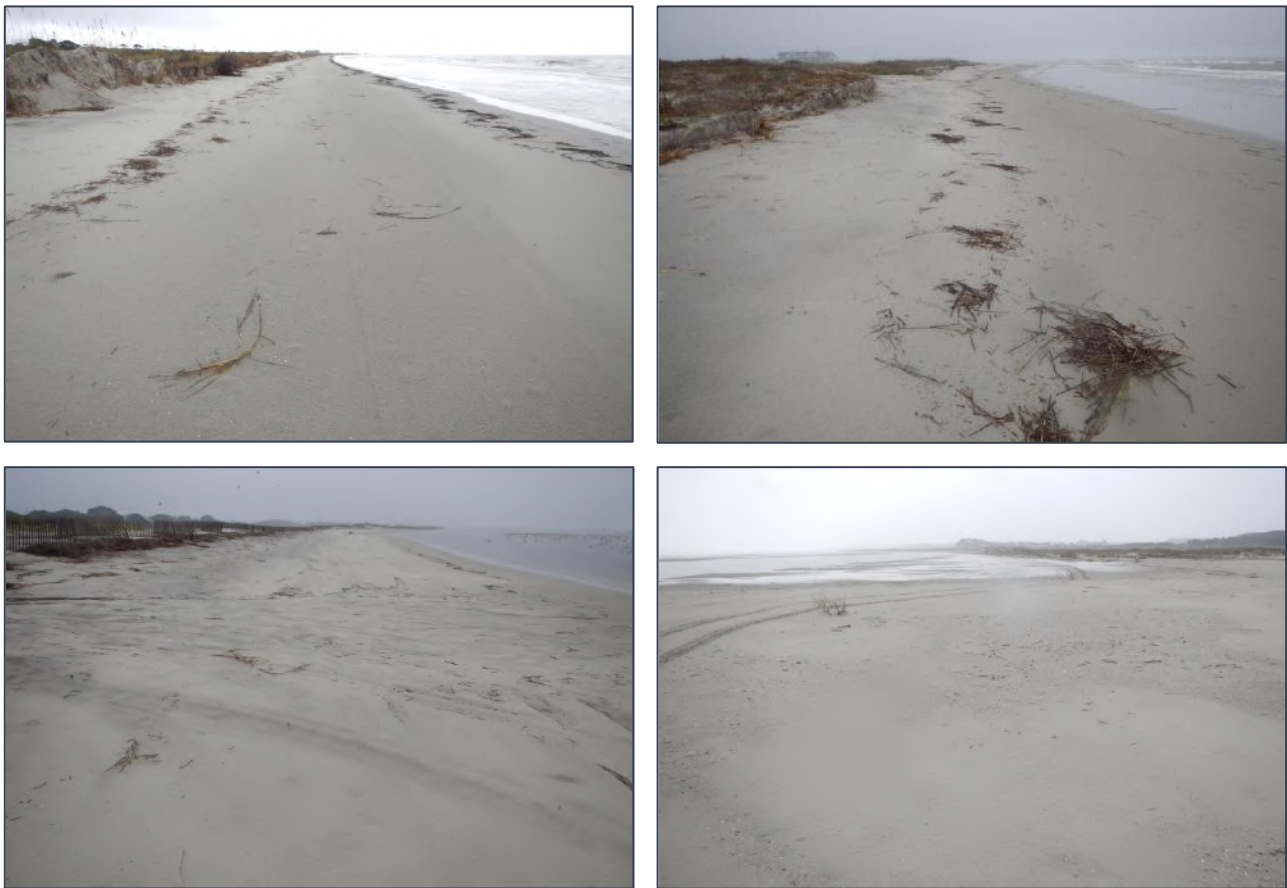
Ground photos (Fig 4.24) show the downcoast erosion (Line 39) and adjacent accretion (Line 43). Line 44 gained nearly 90 cy/ft of sand between 2014 and 2015. This excess sand will migrate onshore and downcoast now that the inlet has been relocated, as the channel currents are no longer capable of maintaining the delta. Much like the sediment transport patterns observed following the previous relocations of Captain Sams Inlet (CSE 1996–2004), CSE expects the old channel delta to collapse and migrate onshore as a series of sandbars over the next several months up to three years. This sand will restore the eroded portions of the reach before continuing downcoast and feeding the remainder of the island. A similar process is expected to take place along the eastern portion of the reach with sand moving landward by wind and wave action eventually filling the remnant channel and restoring the dry sand beach. Presently, the remnant of the old channel remains intact, creating a low area ~300 ft wide separating the upland shoreline from the outer berm (see Fig 4.2).

FIGURE 4.24. Clockwise from top left. (1) Line 39 looking east. An erosion escarpment was present in November 2015 between Lines 38 and 43. (2) View east from Line 43 towards the accretional area downdrift of the old inlet channel. (3) View east from Line 45 at the Ocean Course clubhouse. This beach was restored during the 2015 project and remained stable as of November 2015. (4) View west from Line 47 at the closure dike. The wet area in the background is the designed berm for the 2015 project, which was intentionally left at a low elevation to allow periodic washovers.

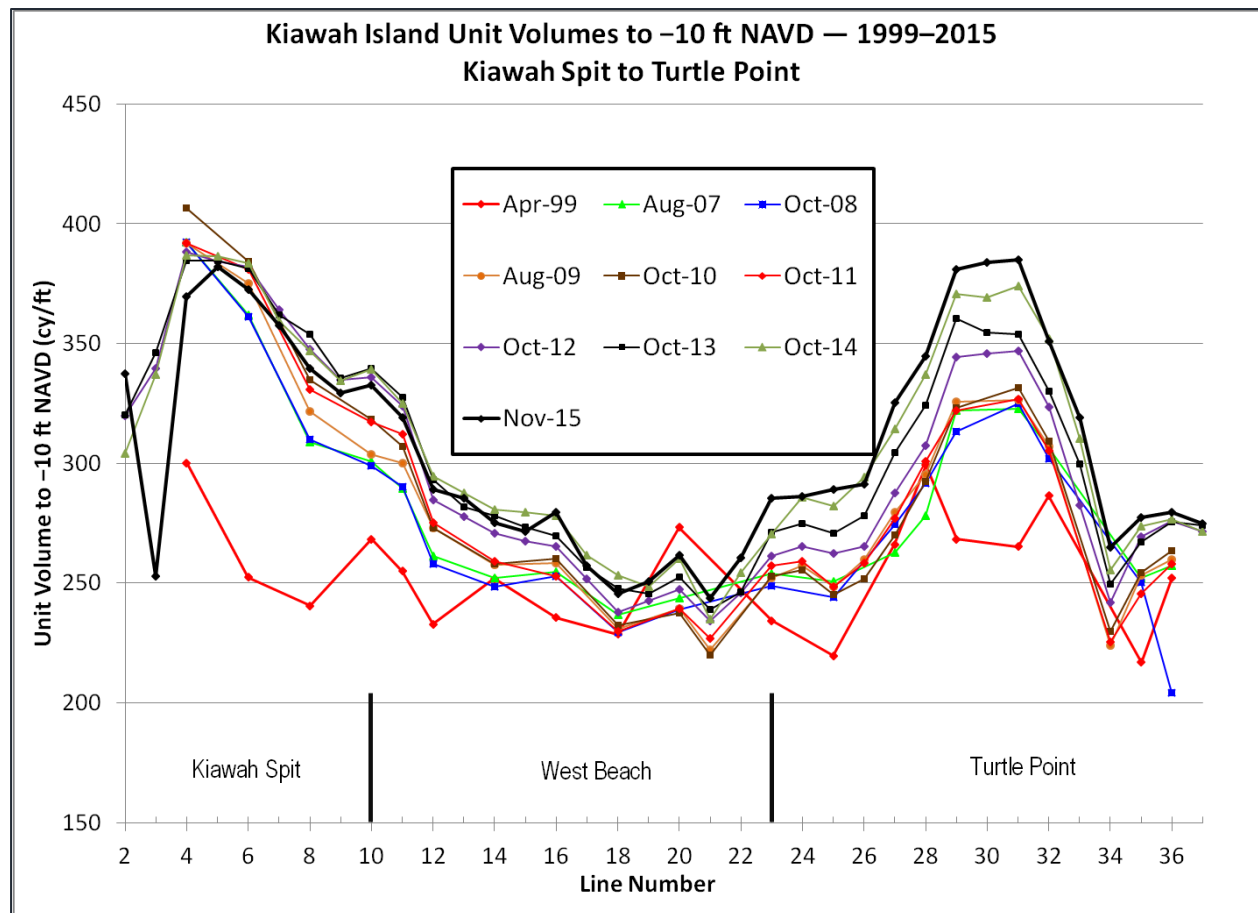
Figure 4.25 shows unit volumes for each station in the downcoast reaches. It is apparent that the present condition along the majority of the beach is much healthier than it was in 1999. Only at Line 20 (OCR 2675 near Sea Forest Drive) does the current condition have less volume than in 1999. Overall, the downcoast reaches have gained 1.6 million cubic yards of sand since 1999 (despite the loss of ~743,600 cy at Captain Sams spit this past year), which is equivalent to an average annual accretion rate of 2.9 cy/ft/yr over the ~6-mile beach length.

FIGURE 4.25. Unit volumes in the downcoast reaches between 1999 and 2015. Only Line 20 shows a volume presently lower than the 1999 condition. (Lines 1 and 2 are on the Seabrook side of Captain Sams Inlet following the 2015 relocation project.)

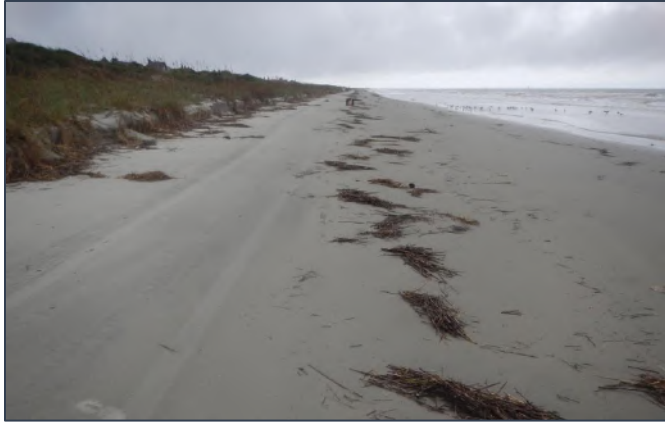
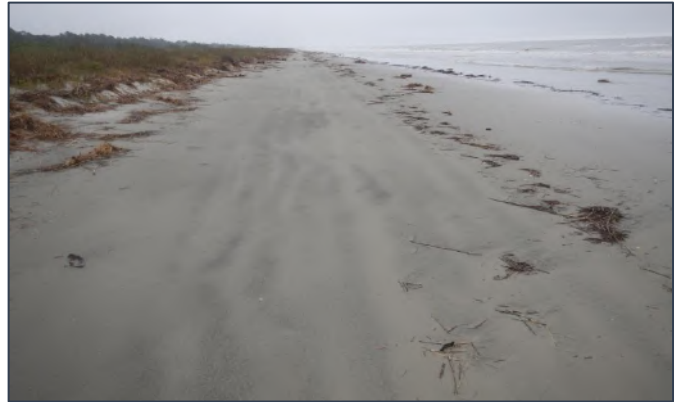
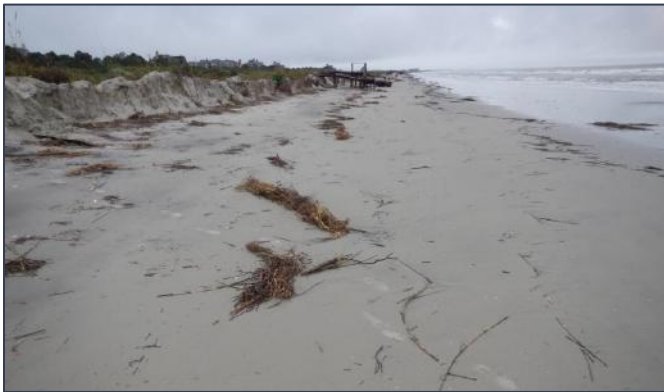
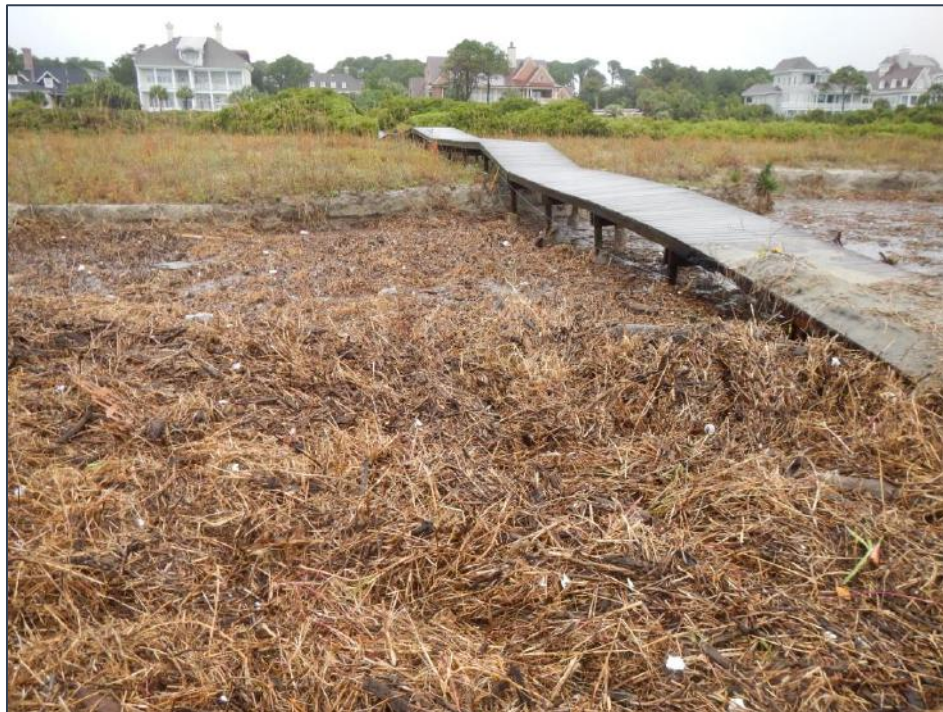
Ground photos (Fig 4.27) show an escarpment 2-3 ft high along the eastern and western ends of the reach, and a smaller scarp along the central portion of the reach. The Town reported a small breach in the primary dune line between boardwalks 38 and 39 that occurred during Hurricane *Joaquin* in early October 2015 (Fig 4.27). CSE advised the Town that the area will infill naturally over time, though sand from an upland source could be placed along the dune line to facilitate faster recovery should the Town elect to do so.

FIGURE 4.27. Ground photos from November 2015 of the Turtle Point Reach. Line 24 looking east (upper left). Line 30 looking east (center right). Line 35 looking east (center left). The dune breach between Lines 33 and 34 (lower).

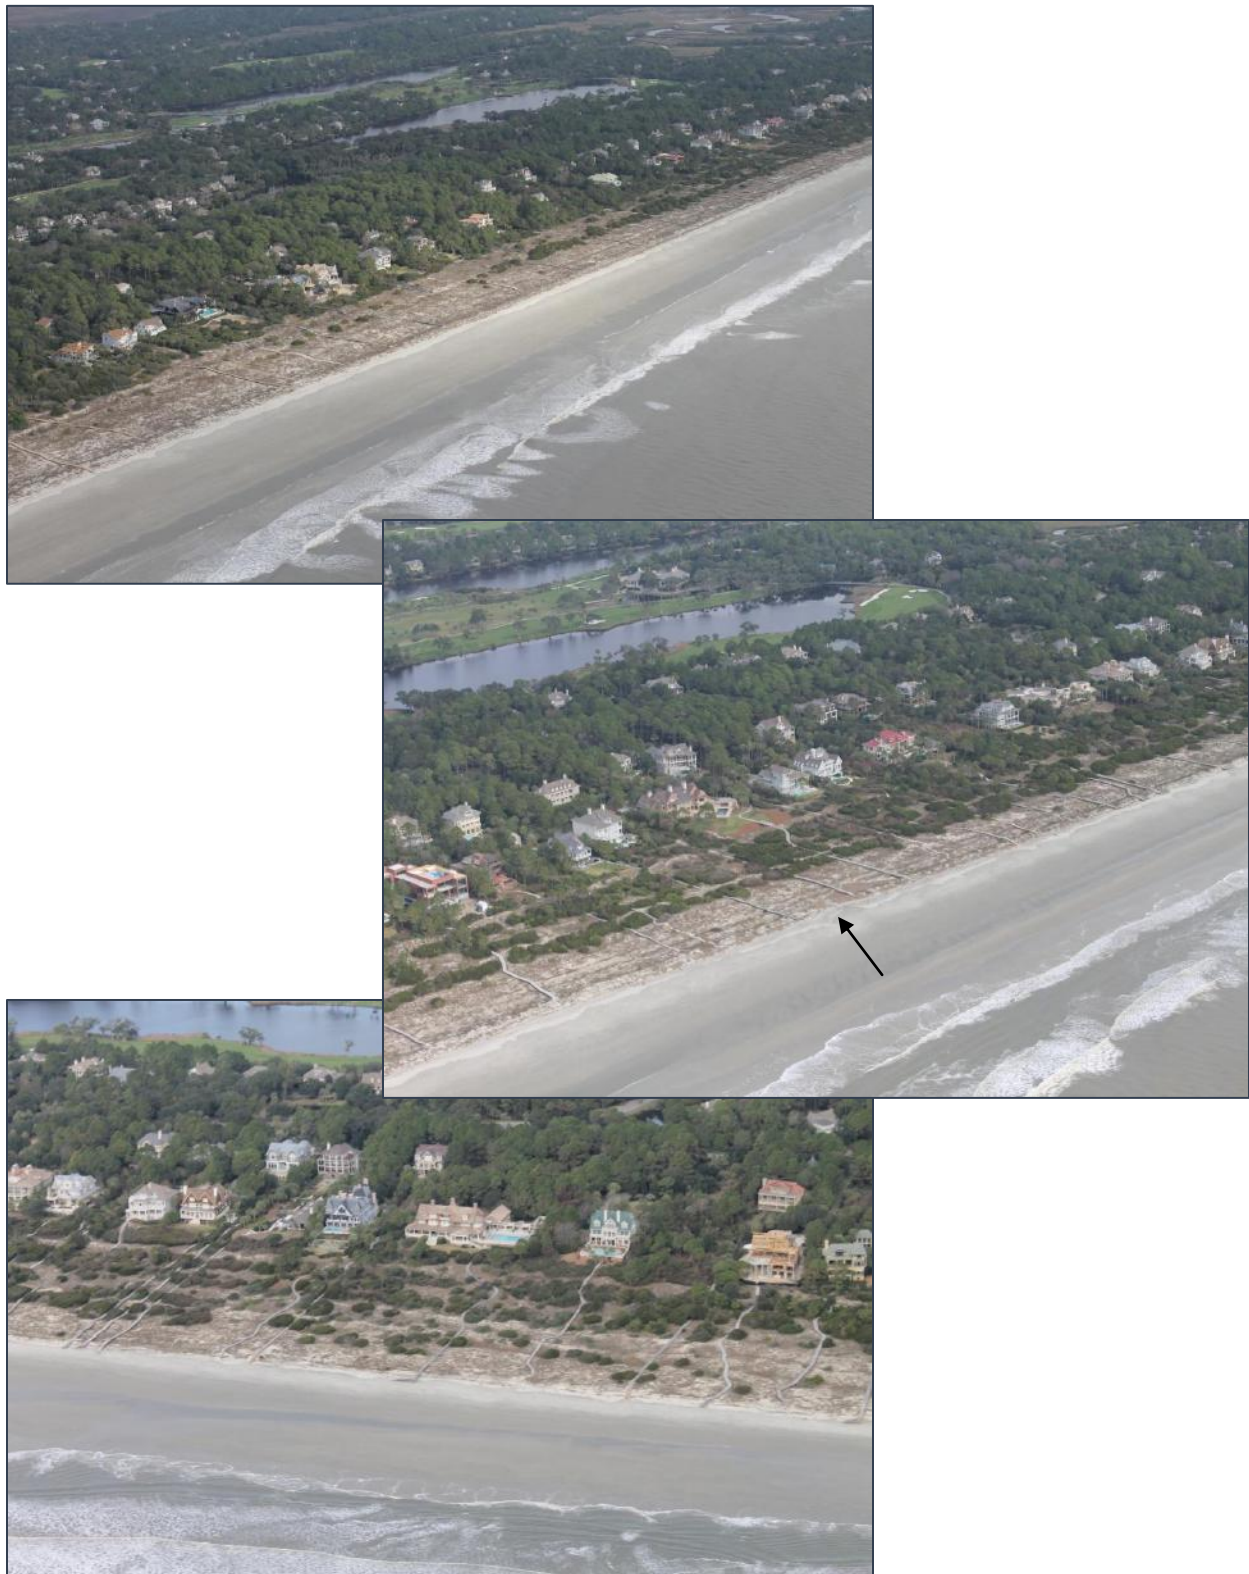
FIGURE 4.28. January 2016 aerial images of the Turtle Point Reach. **[UPPER]** The west end of the reach, just north of the Turtle Point golf course. **[CENTER]** The central area of the reach with the arrow showing the location of the Hurricane *Joaquin* dune breach, which has filled in with dead marsh grass and sand. **[LOWER]** The area just west of the Kiawah Beach Club.

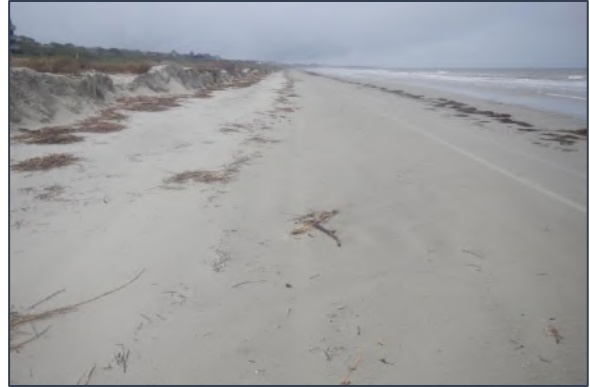
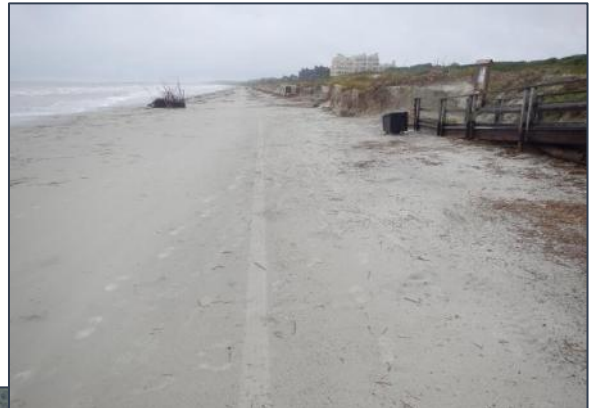
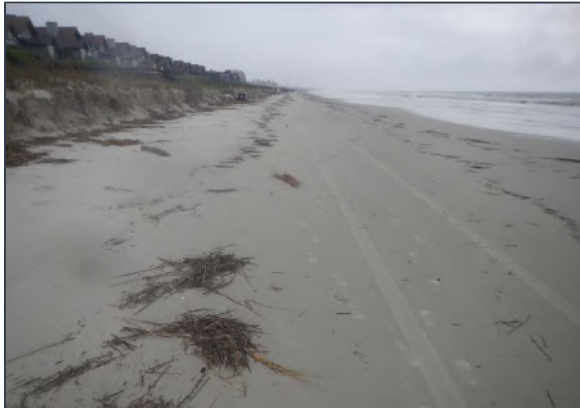
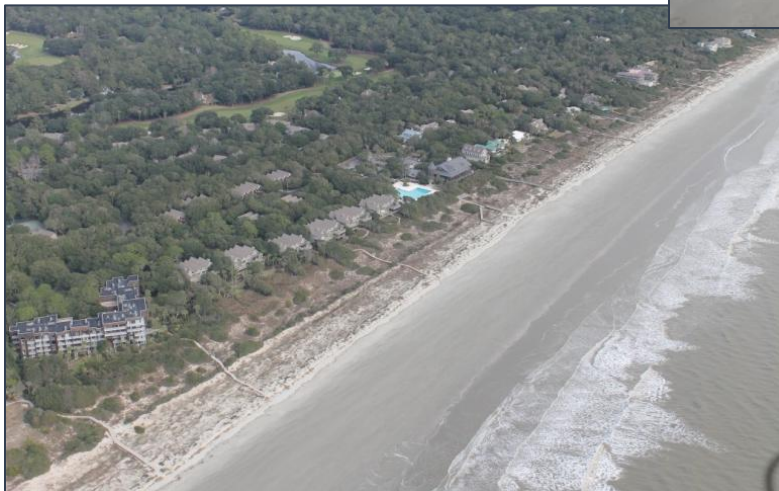
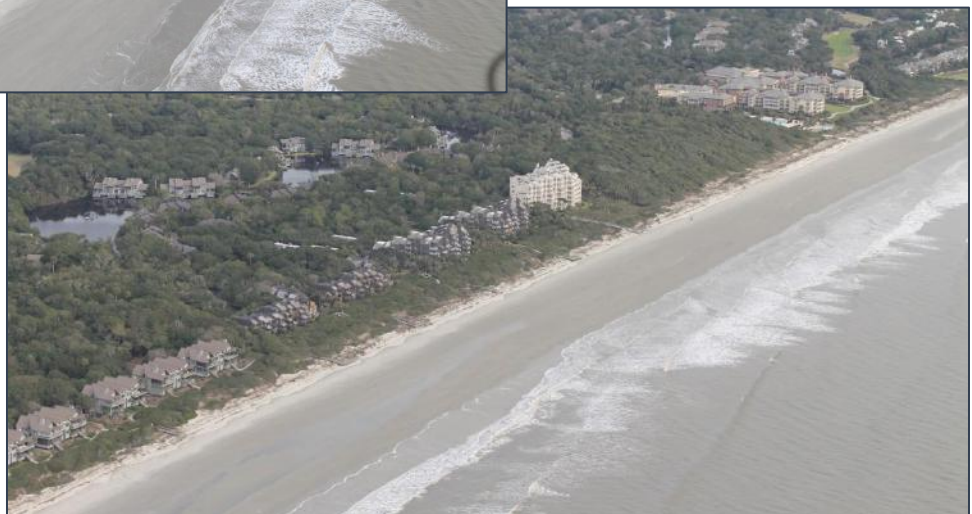
November 2015 ground photos and January 2016 aerial photos of the West Beach Reach.

Clockwise from top right – (1) Line 11 looking east. (2) Line 22 near the Sanctuary looking west. (3) Aerial of the eastern end of the reach. (4) Aerial of the western end of the reach. (5) Line 18 looking east.
