2006 EAST END BEACH RESTORATION PROJECT
KIAWAH ISLAND SOUTH CAROLINA

Survey Report No 9
February 2016

SURVEY REPORT NO 9
Annual Beach and Inshore Surveys

[CSE 2446 YR1]
February 2016

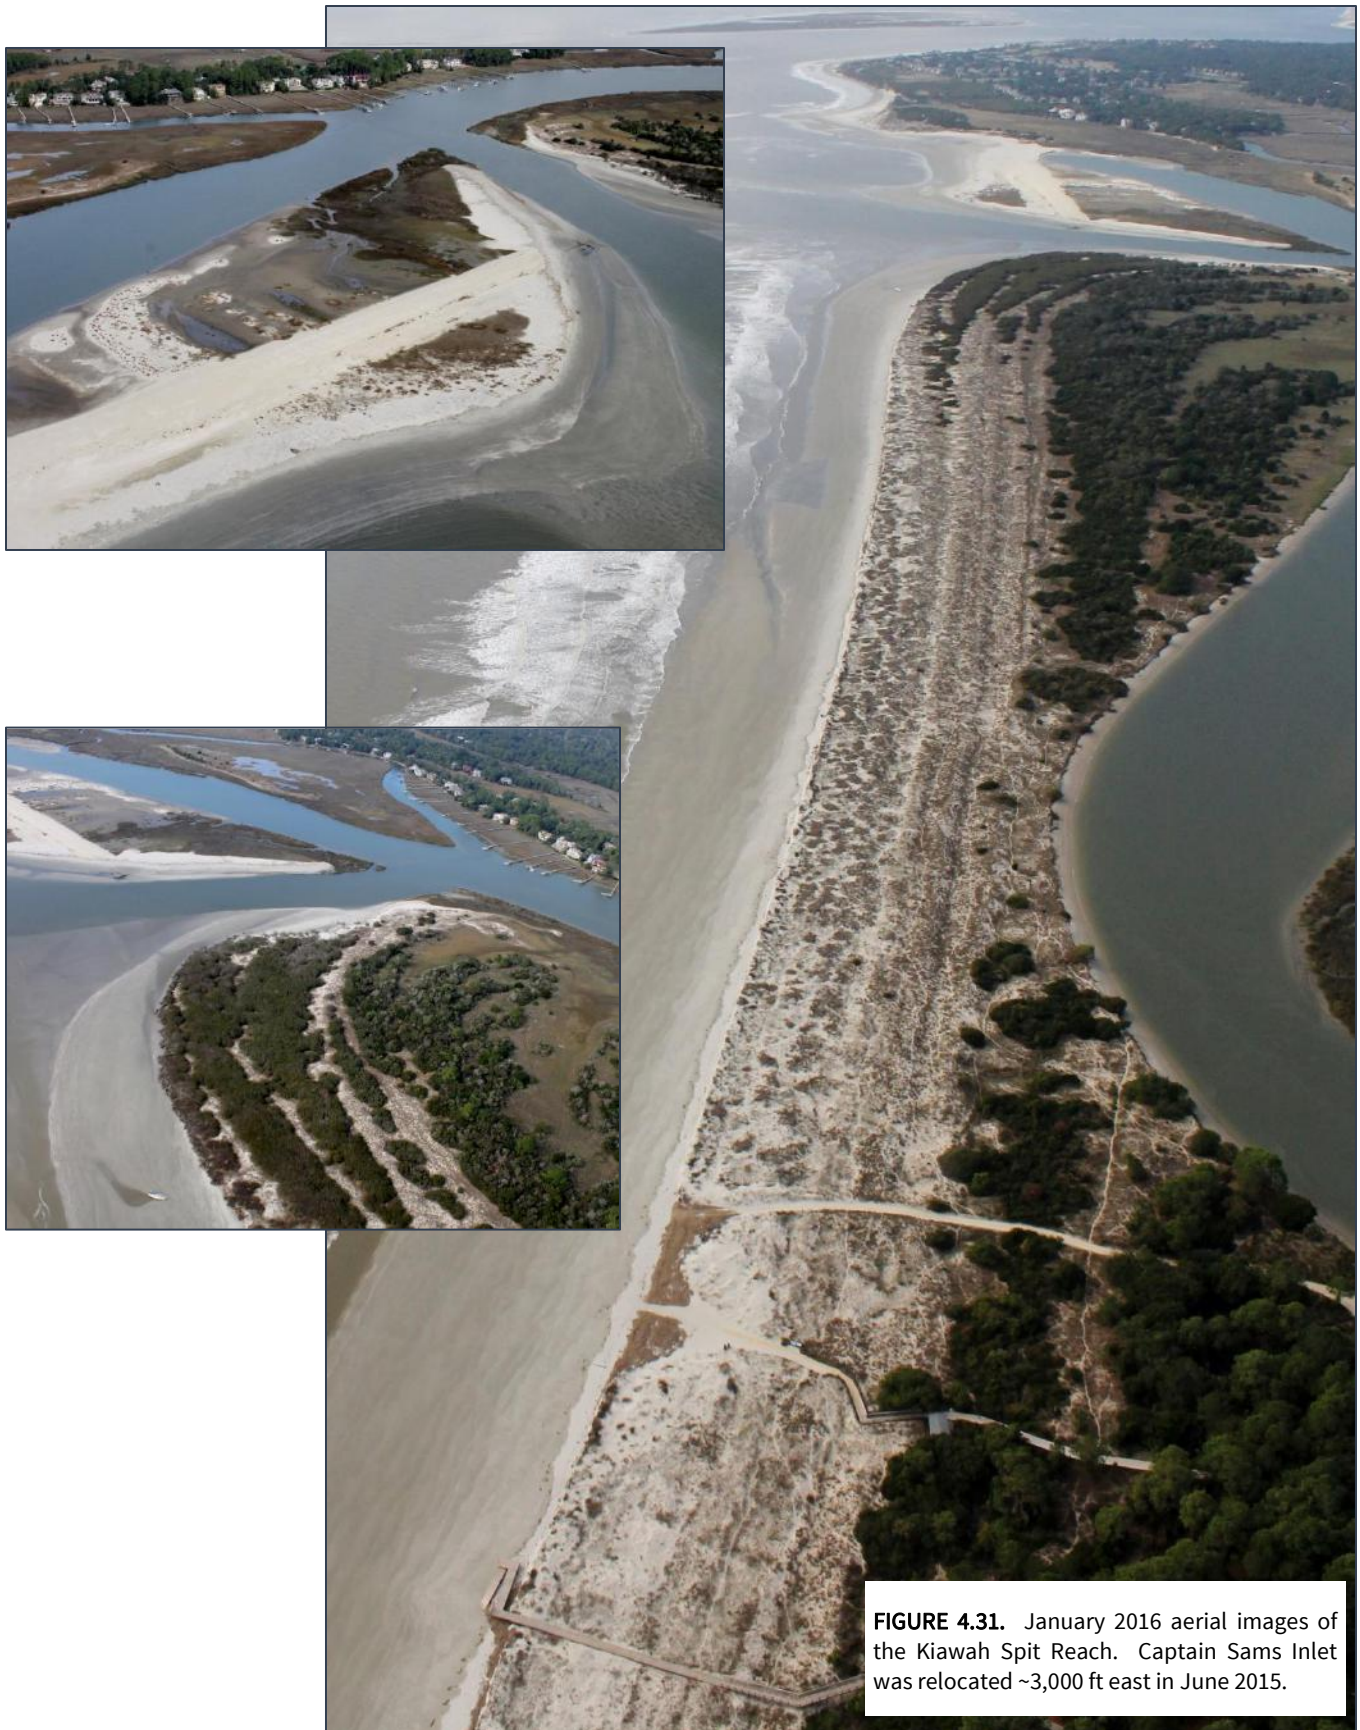
Between October 2014 and November 2015, the reach lost a total of 743,600 cy (84.3 cy/ft) of sand (Fig 4.31). The majority of the loss was due to the inlet recut; however, all lines on the Kiawah side of the channel lost sand, averaging 7.6 cy/ft from Line 4 to Line 10. The erosion observed over the past year continues an erosional trend along the reach which began in 2013. Overall, the reach gained 166,500 cy between 2007 and 2012, then lost 33,700 from 2012 to 2014. Despite the erosion associated with the inlet recut, the reach holds 158,000 cy (17.9 cy/ft) more sand than the 1999 condition, which was three years after the last inlet relocation in 1996.

FIGURE 4.31. January 2016 aerial images of the Kiawah Spit Reach. Captain Sams Inlet was relocated ~3,000 ft east in June 2015.

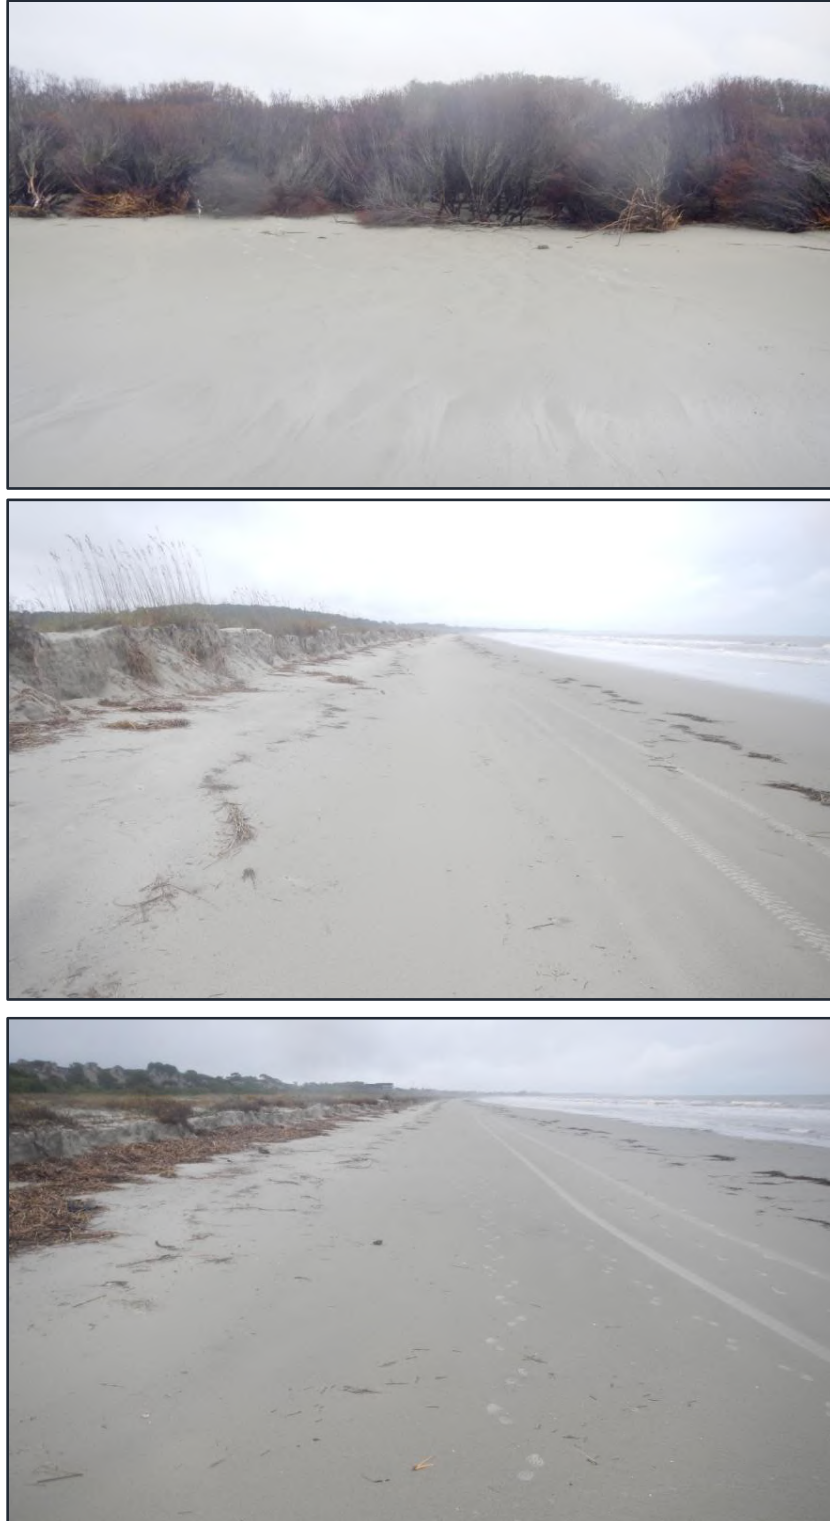
and dead myrtle bushes are visible. Once the inlet returns to a natural cross-section, CSE expects sand to accumulate on the Kiawah side of the channel and begin to rebuild the spit. Line 4 also lost a measurable width of dune, but by Line 5, erosion was more associated with supply from upcoast rather than the inlet. The dune east of Line 5 was scarped much like the rest of the front beach; however, little loss was observed to the crest of the dune (Fig 4.32).

FIGURE 4.33. Ground photos from November 2015 of the Kiawah Spit Reach. **[UPPER]** Adjustment of the new inlet channel has resulted in erosion of the beach into the myrtle thicket at Line 3. **[CENTER]** Line 6 looking east. **[LOWER]** View east from Line 8 near Beachwalker Park.

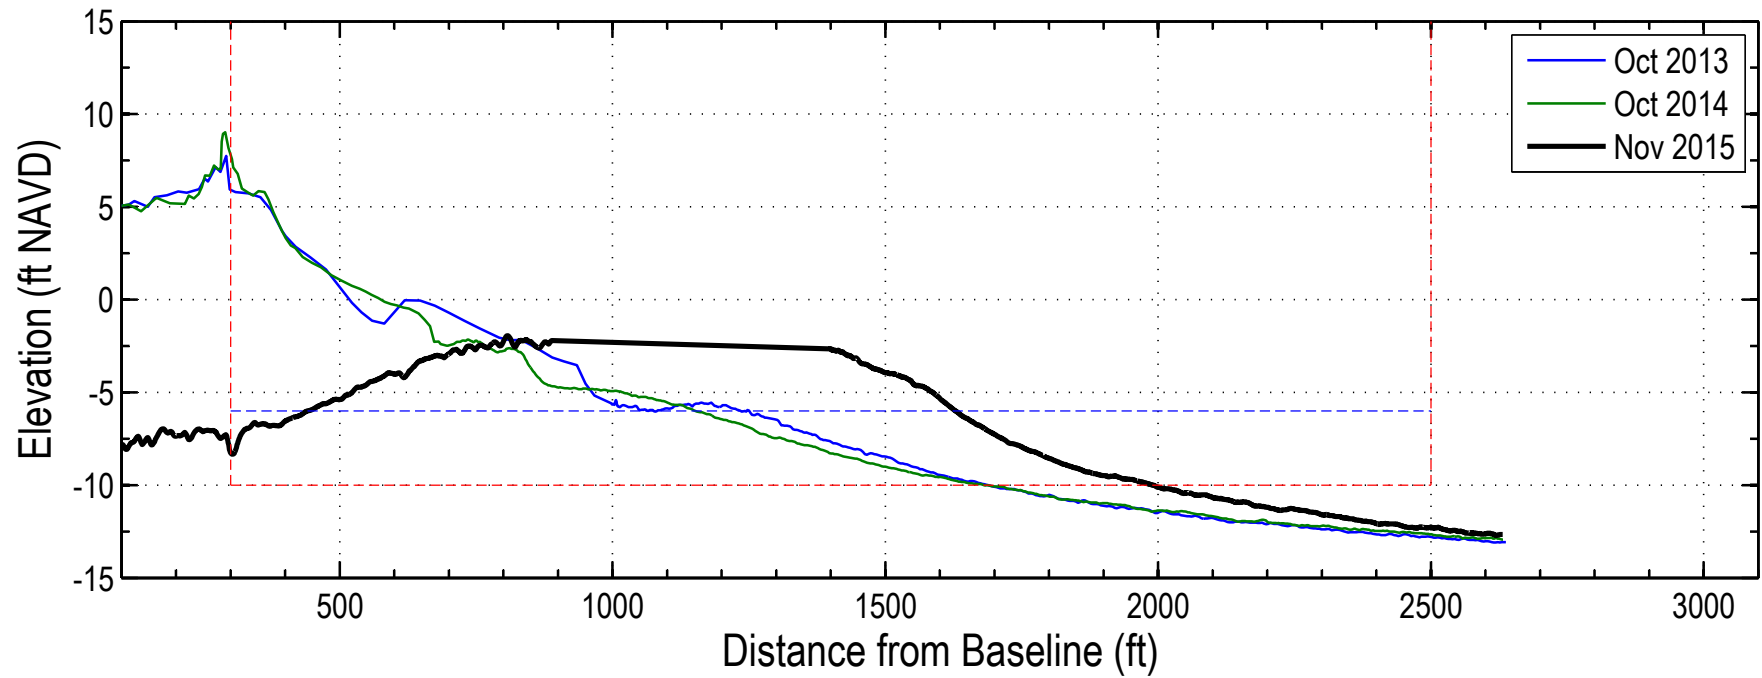
Kiawah Line 02

Date	Vol to -6	Vol -6 to -10	Vol to -10
Oct 2012	140.1	179.7	319.8
Oct 2013	150.3	169.9	320.2
Oct 2014	143.7	160.5	304.2
Nov 2015	123.9	213.5	337.4

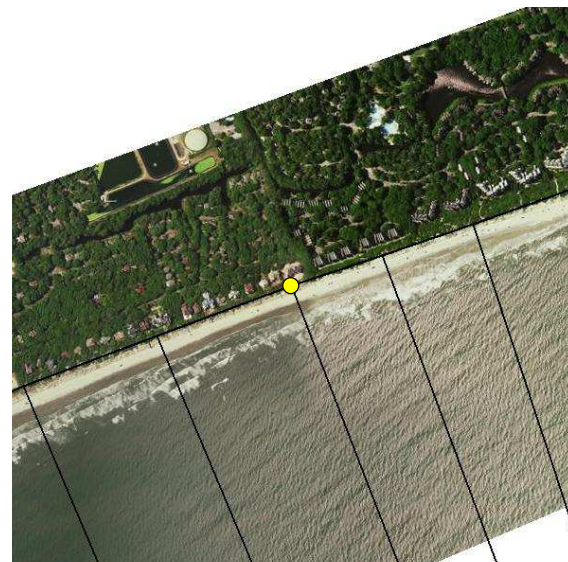
Kiawah Line 19

Date	Vol to -6	Vol -6 to -10	Vol to -10
Aug 2007	125.7	111.2	236.9
Oct 2008	120.1	109.6	229.7
Aug 2009	121.3	109.8	231.1
Oct 2010	124.9	107.7	232.6
Oct 2011	112.4	117.6	229.9
Oct 2012	127.5	110.4	237.9
Oct 2013	131.1	116.8	247.9
Oct 2014	140.1	113.1	253.2
Nov 2015	133.1	112.5	245.7

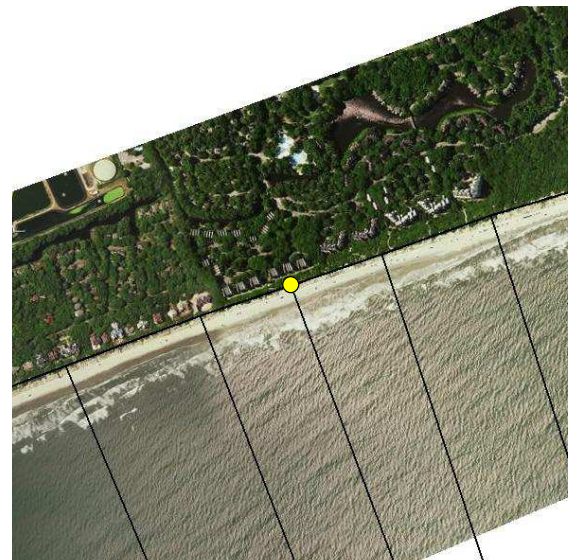
Date	Vol to -6	Vol -6 to -10	Vol to -10
Oct 2012	128.9	113.8	242.8
Oct 2013	127.4	118.1	245.5
Oct 2014	136.2	112.1	248.4
Nov 2015	137.3	114.8	252.1

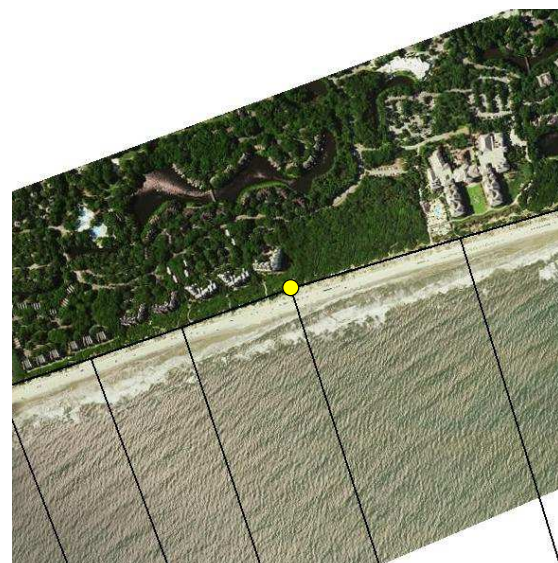
Kiawah Line 22

Date	Vol to -6	Vol -6 to -10	Vol to -10
Aug 2009	113.5	108.5	222.0
Oct 2010	113.2	106.8	220.0
Oct 2011	108.3	118.6	226.8
Oct 2012	120.5	113.6	234.1
Oct 2013	121.5	117.4	238.9
Oct 2014	121.8	113.3	235.1
Nov 2015	128.7	115.1	243.8

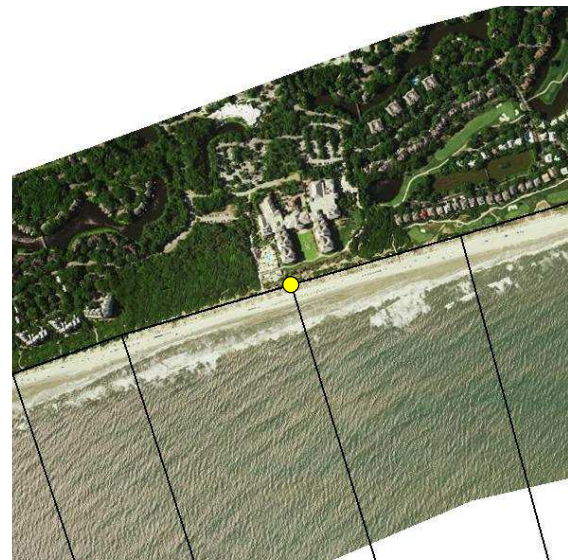
Kiawah Line 23 (OCRM 2685)

Date	Vol to -6	Vol -6 to -10	Vol to -10
Oct 2012	128.4	117.6	246.0
Oct 2013	126.8	119.6	246.4
Oct 2014	135.6	118.9	254.5
Nov 2015	140.2	119.3	259.4

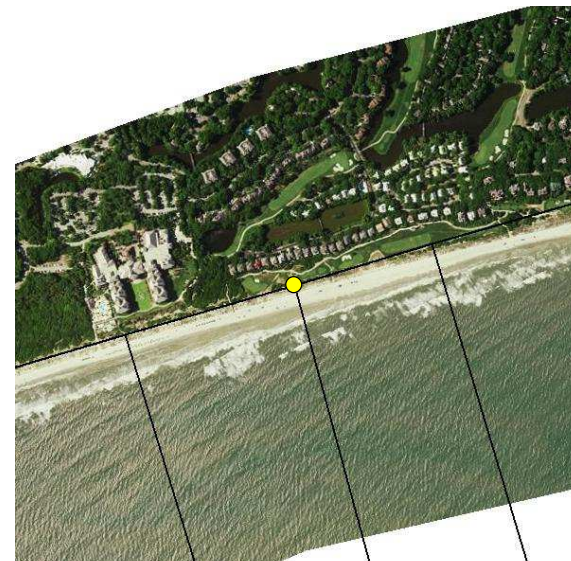
Kiawah Line 24 (OCRM 2687)

Date	Vol to -6	Vol -6 to -10	Vol to -10
Aug 2007	138.8	115.0	253.9
Oct 2008	133.1	115.9	249.0
Aug 2009	133.6	118.6	252.2
Oct 2010	137.9	115.0	253.0
Oct 2011	131.3	126.0	257.3
Oct 2012	139.2	122.1	261.3
Oct 2013	144.5	126.8	271.2
Oct 2014	148.6	121.9	270.5
Nov 2015	160.0	125.5	285.4

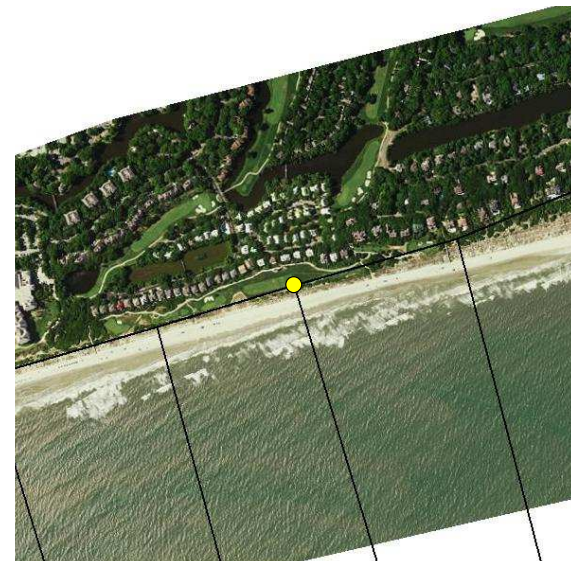
Kiawah Line 25 (OCRM 2690)

Date	Vol to -6	Vol -6 to -10	Vol to -10
Aug 2009	136.2	120.9	257.1
Oct 2010	138.8	116.6	255.3
Oct 2011	133.4	125.6	259.0
Oct 2012	142.0	123.4	265.4
Oct 2013	148.4	126.3	274.7
Oct 2014	159.5	126.3	285.8
Nov 2015	162.4	129.2	291.6

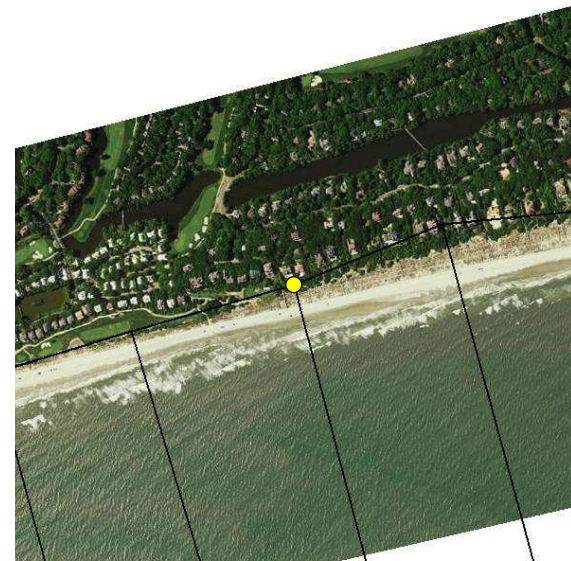
Kiawah Line 26 (OCRM 2692)

Date	Vol to -6	Vol -6 to -10	Vol to -10
Aug 2007	130.8	119.9	250.7
Oct 2008	126.2	118.1	244.3
Aug 2009	129.5	119.2	248.7
Oct 2010	128.9	116.4	245.3
Oct 2011	120.9	127.5	248.4
Oct 2012	138.5	123.8	262.3
Oct 2013	142.6	128.3	270.9
Oct 2014	155.5	126.5	282.1
Nov 2015	161.0	128.9	289.9

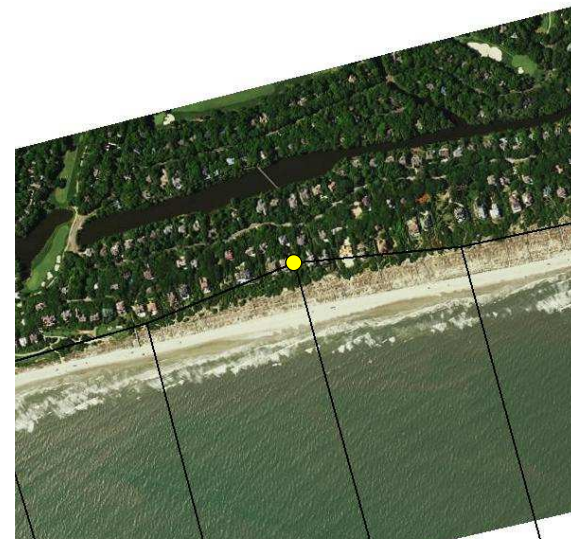
Kiawah Line 27 (OCRM 2695)

Date	Vol to -6	Vol -6 to -10	Vol to -10
Aug 2009	137.1	122.8	259.9
Oct 2010	133.0	118.7	251.7
Oct 2011	127.3	131.0	258.3
Oct 2012	140.7	124.5	265.2
Oct 2013	146.2	132.0	278.2
Oct 2014	163.7	130.5	294.2
Nov 2015	160.5	130.6	291.1

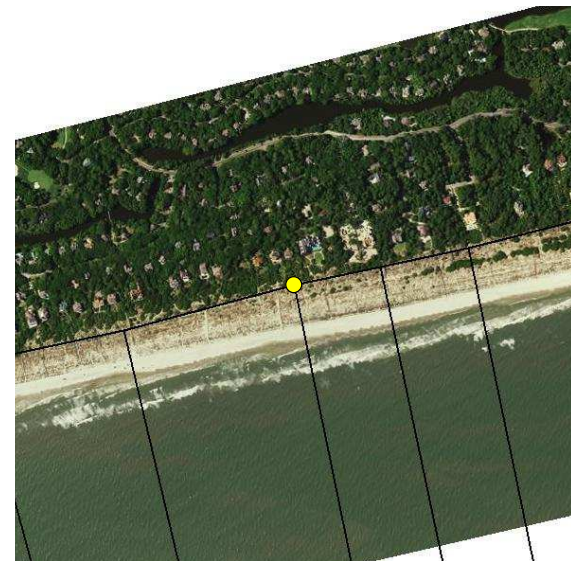
Kiawah Line 30

Date	Vol to -6	Vol -6 to -10	Vol to -10
Aug 2007	184.9	137.1	321.9
Oct 2008	175.8	137.6	313.4
Aug 2009	185.3	140.5	325.8
Oct 2010	186.8	136.4	323.1
Oct 2011	176.1	146.0	322.1
Oct 2012	200.7	143.8	344.5
Oct 2013	208.6	151.8	360.4
Oct 2014	216.6	153.9	370.5
Nov 2015	225.9	155.8	381.7

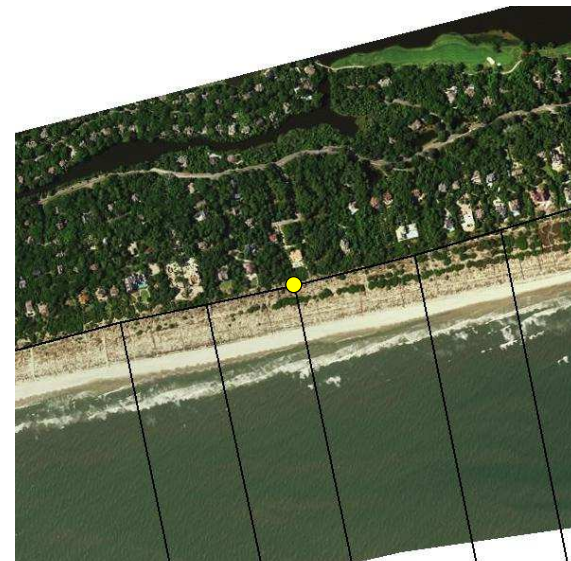
Kiawah Line 32 (OCRM 2720)

Date	Vol to -6	Vol -6 to -10	Vol to -10
Aug 2007	183.4	139.2	322.6
Oct 2008	186.6	138.5	325.1
Aug 2009	184.0	142.4	326.4
Oct 2010	193.4	138.2	331.6
Oct 2011	178.3	148.5	326.8
Oct 2012	201.1	146.0	347.1
Oct 2013	203.3	150.6	353.9
Oct 2014	218.2	155.8	374.1
Nov 2015	227.8	155.2	383.0

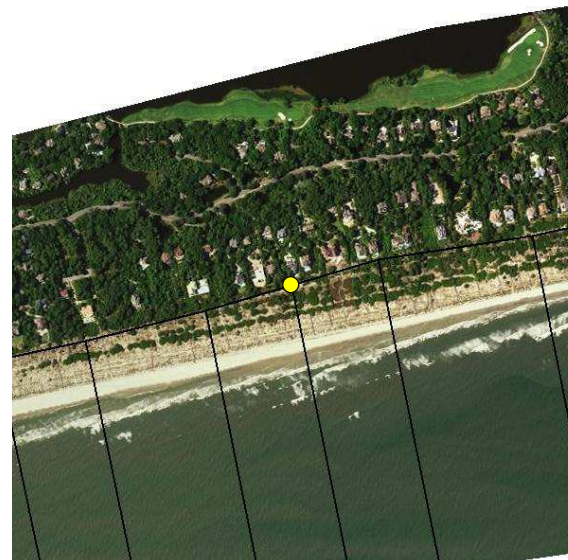
Kiawah Line 34 (OCRM 2722)

Date	Vol to -6	Vol -6 to -10	Vol to -10
Oct 2012	148.4	134.0	282.4
Oct 2013	158.1	141.5	299.6
Oct 2014	165.9	144.4	310.3
Nov 2015	174.2	144.4	318.6

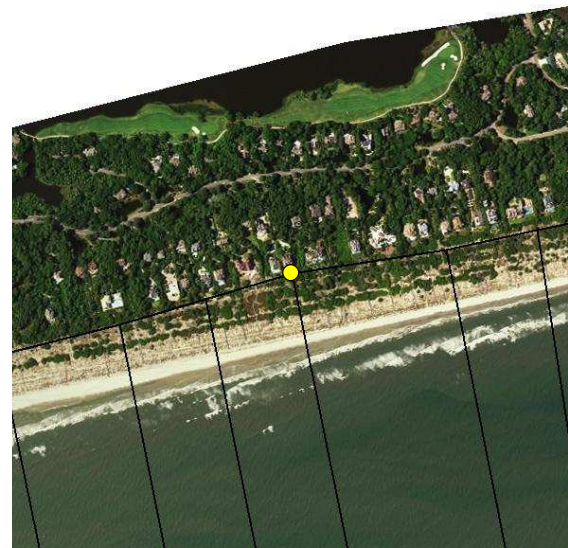
Kiawah Line 35 (OCRM 2725)

Date	Vol to -6	Vol -6 to -10	Vol to -10
Aug 2009	105.5	118.6	224.2
Oct 2010	113.6	116.2	229.8
Oct 2011	103.5	122.1	225.6
Oct 2012	115.6	126.2	241.8
Oct 2013	120.7	128.7	249.5
Oct 2014	124.4	130.9	255.3
Nov 2015	133.7	131.2	264.9

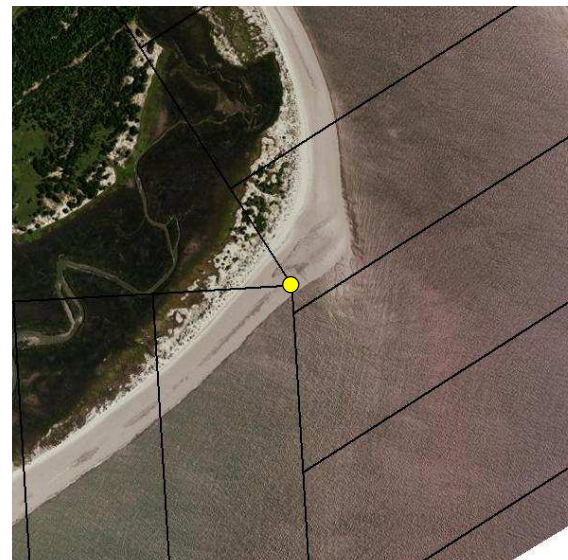
Kiawah Line 56 (Inlet 0+00)

Date	Vol to -6	Vol -6 to -10	Vol to -10
Oct 2012	341.9	246.6	588.4
Oct 2013	358.1	263.0	621.0
Oct 2014	340.5	261.8	602.3
Nov 2015	317.0	262.0	579.0

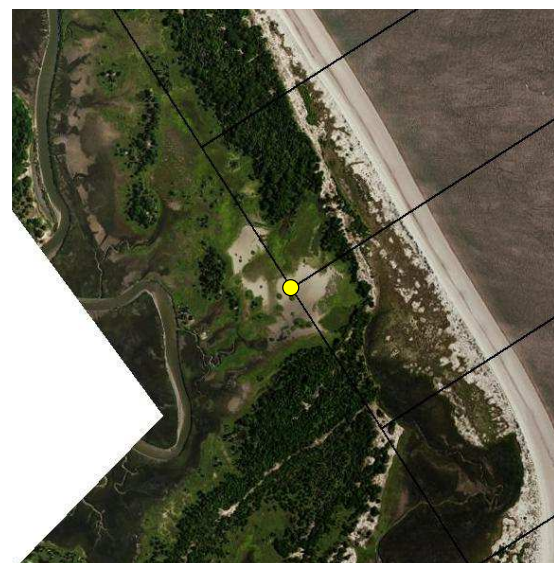
Kiawah Line 59 (Inlet 36+00)

Date	Vol to -6	Vol -6 to -10	Vol to -10
Sep 2006	91.8	54.5	146.2
Aug 2007	89.2	54.2	143.4
Oct 2008	89.7	50.9	140.7
Aug 2009	85.6	51.5	137.1
Oct 2010	104.9	51.7	156.6
Oct 2011	110.5	53.2	163.7
Oct 2012	117.5	51.9	169.4
Oct 2013	107.6	50.9	158.5
Oct 2014	91.2	50.4	141.5
Nov 2015	64.0	48.2	112.2

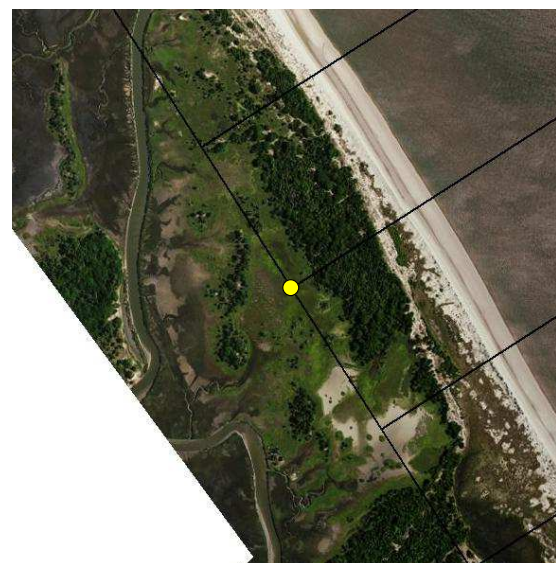
Kiawah Line 60 (Inlet 48+00)

Date	Vol to -6	Vol -6 to -10	Vol to -10
Sep 2006	109.8	57.8	167.6
Aug 2007	109.2	57.7	166.9
Oct 2008	108.0	57.4	165.4
Aug 2009	110.4	57.7	168.1
Oct 2010	122.4	58.3	180.7
Oct 2011	121.0	57.6	178.6
Oct 2012	116.4	57.3	173.7
Oct 2013	105.8	56.2	162.1
Oct 2014	89.8	55.5	145.3
Nov 2015	86.5	54.1	140.6
