**2006 EAST END BEACH RESTORATION PROJECT  
KIAWAH ISLAND SOUTH CAROLINA**

**Survey Report No 7  
February 2014**

**2006 EAST END BEACH RESTORATION PROJECT**  
**Kiawah Island – South Carolina**

**SURVEY REPORT NO 7**  
**Annual Beach and Inshore Surveys**

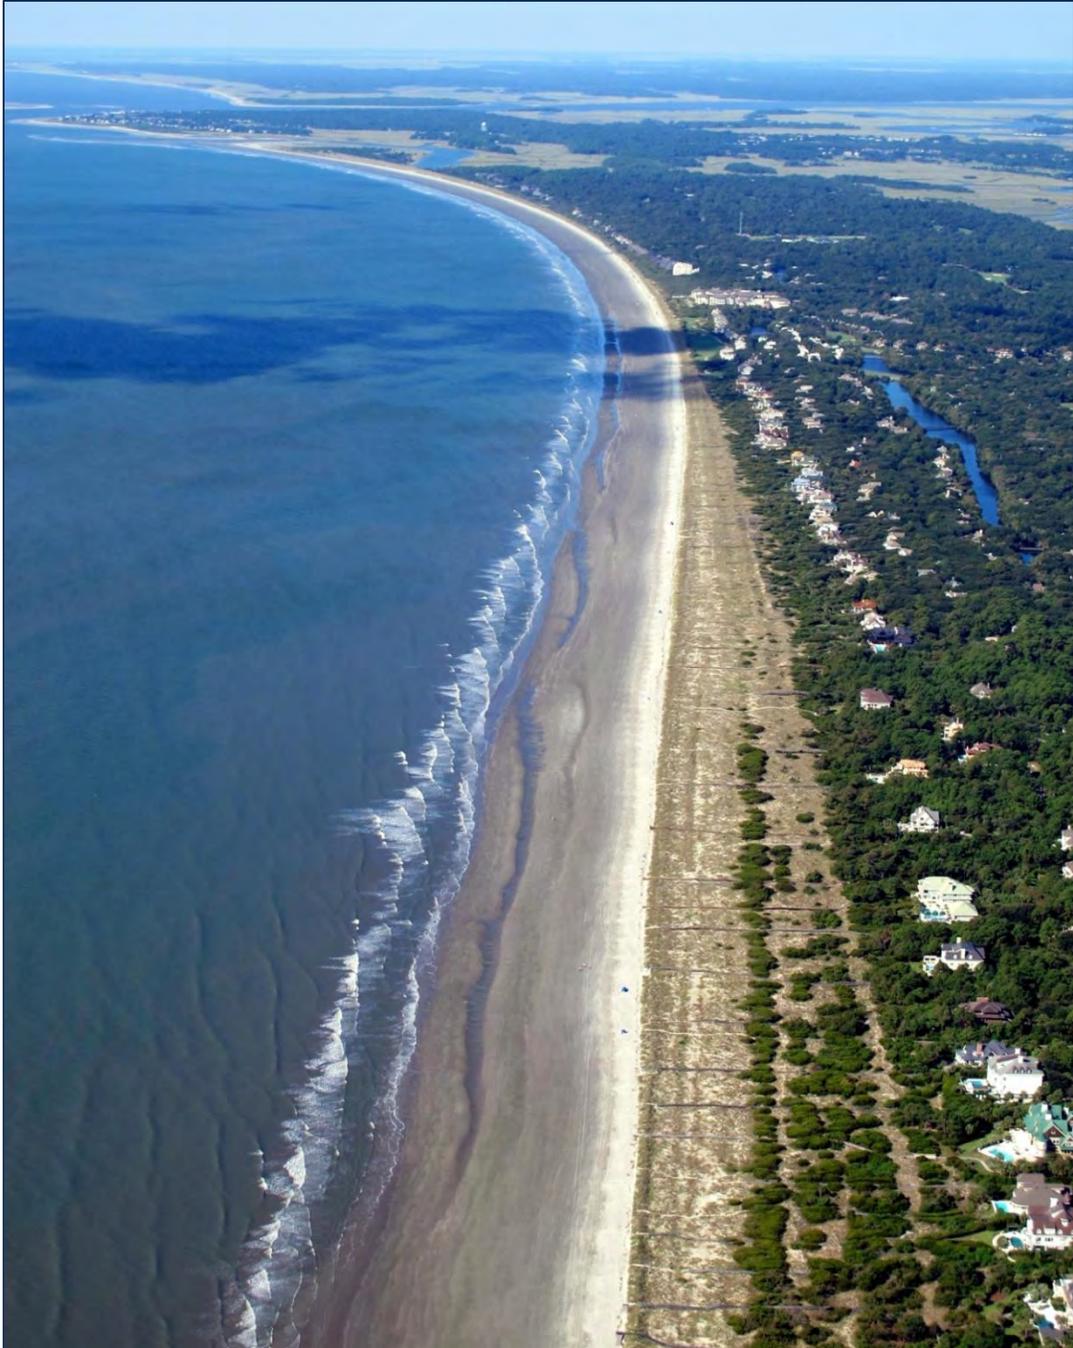
**FIGURE A.** Kiawah Island remains one of the healthiest beaches in South Carolina (September 2012 aerial).

Kiawah Island remains one of the healthiest beaches in South Carolina (Fig A). The results of shoreline monitoring and tracking the sand supply have provided new insight into the formation of barrier islands and rates of evolution of important habitats. Based on the results herein, the prognosis for the future is favorable for Kiawah's beach.

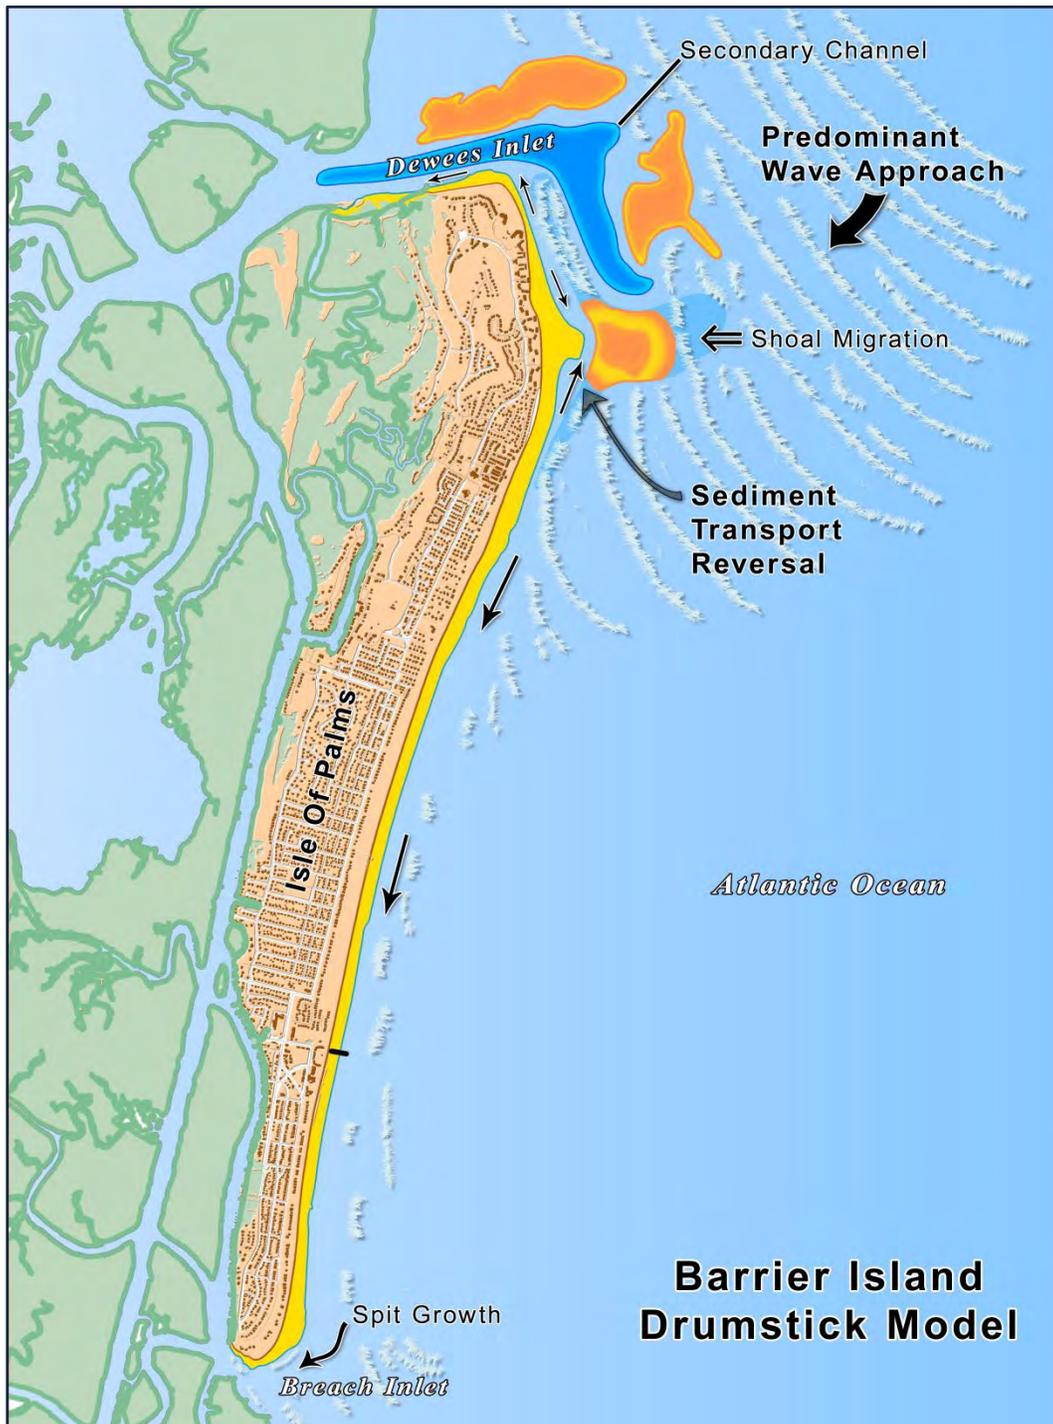
**FIGURE 2.2.** Barrier island drumstick model (after Hayes 1977) using Isle of Palms as an example. The upcoast end is wider due to additions of sand from shoal-bypass events in the inlet. Net transport to the south builds a spit at the downcoast end of the island.

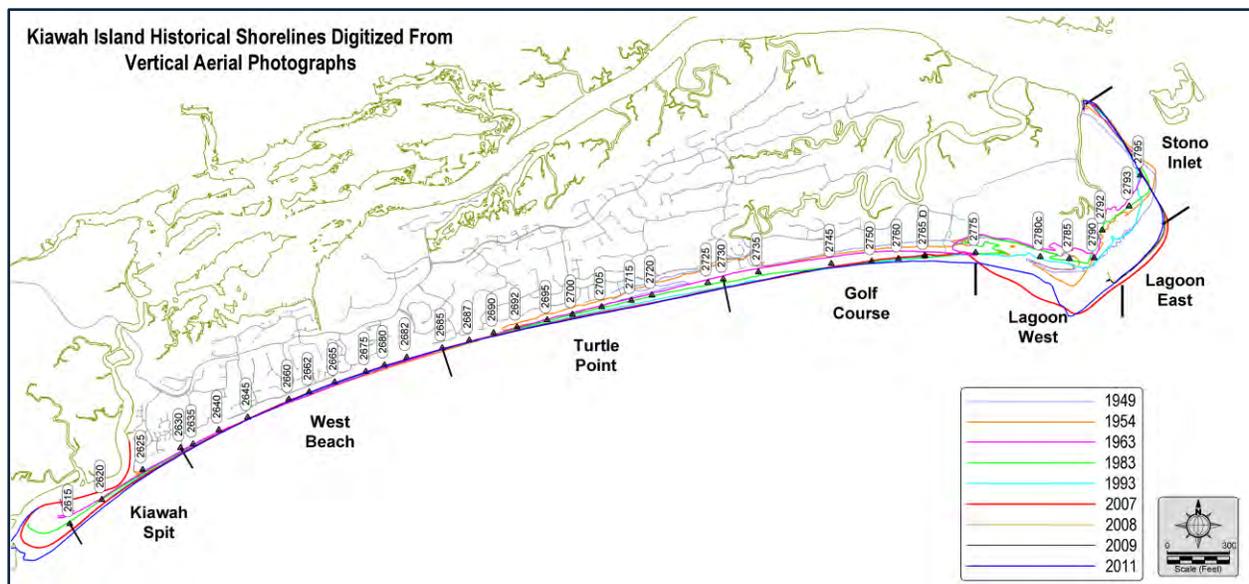
**FIGURE 2.4.** Historical shorelines (seaward vegetation lines). West Beach has been slightly erosional whereas all other reaches have been accretional since 1949. [Updated from CSE 1995]

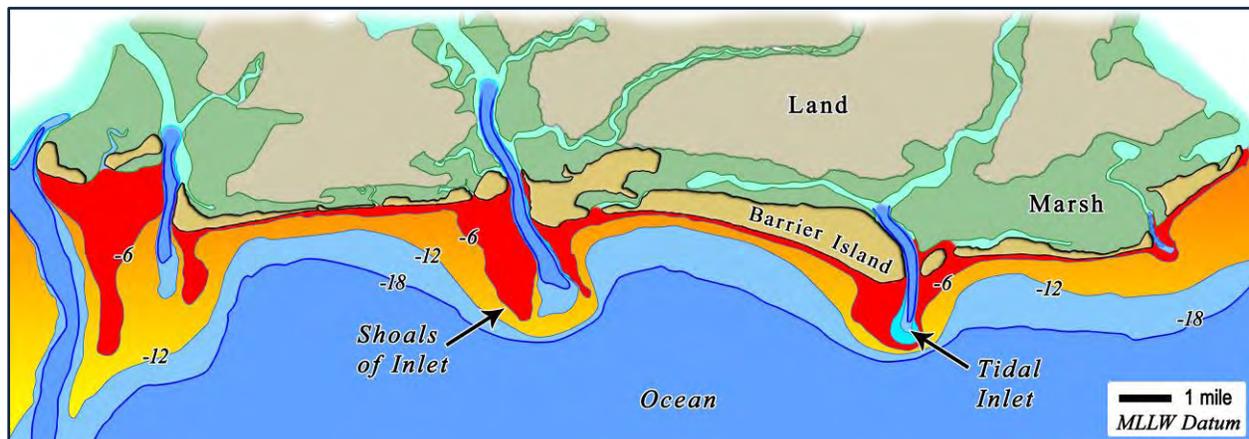
**FIGURE 2.5.** Nearshore bathymetry for a typical section of the central and southern South Carolina coast. Ebb-tidal deltas contain large amounts of sand, which alter the local bathymetry. This in turn directs wave energy and sediment transport patterns along the adjacent beaches. [From *Coastal Erosion and Solutions — A Primer* (Kana 2011) — CSE]

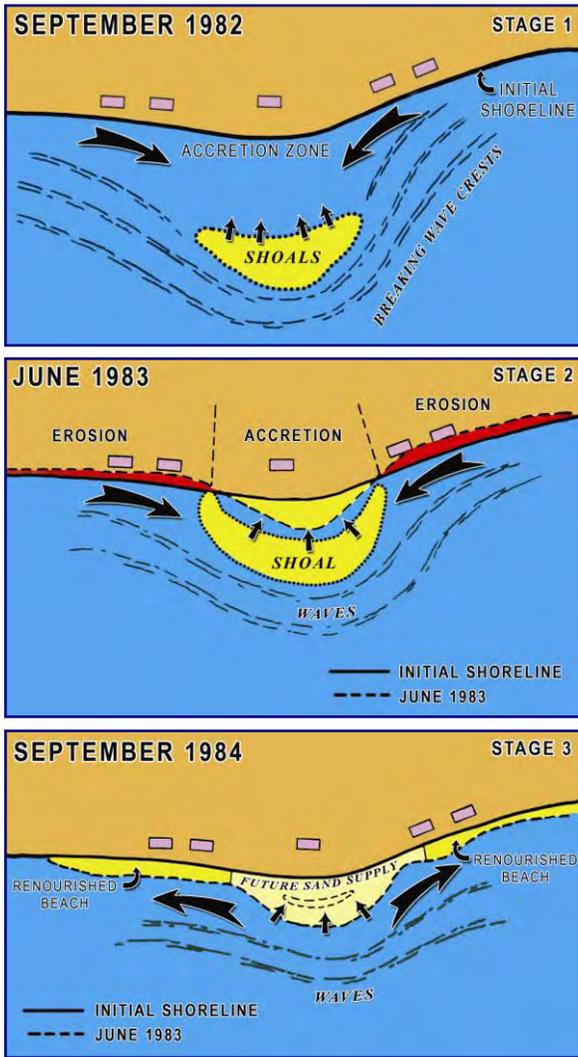
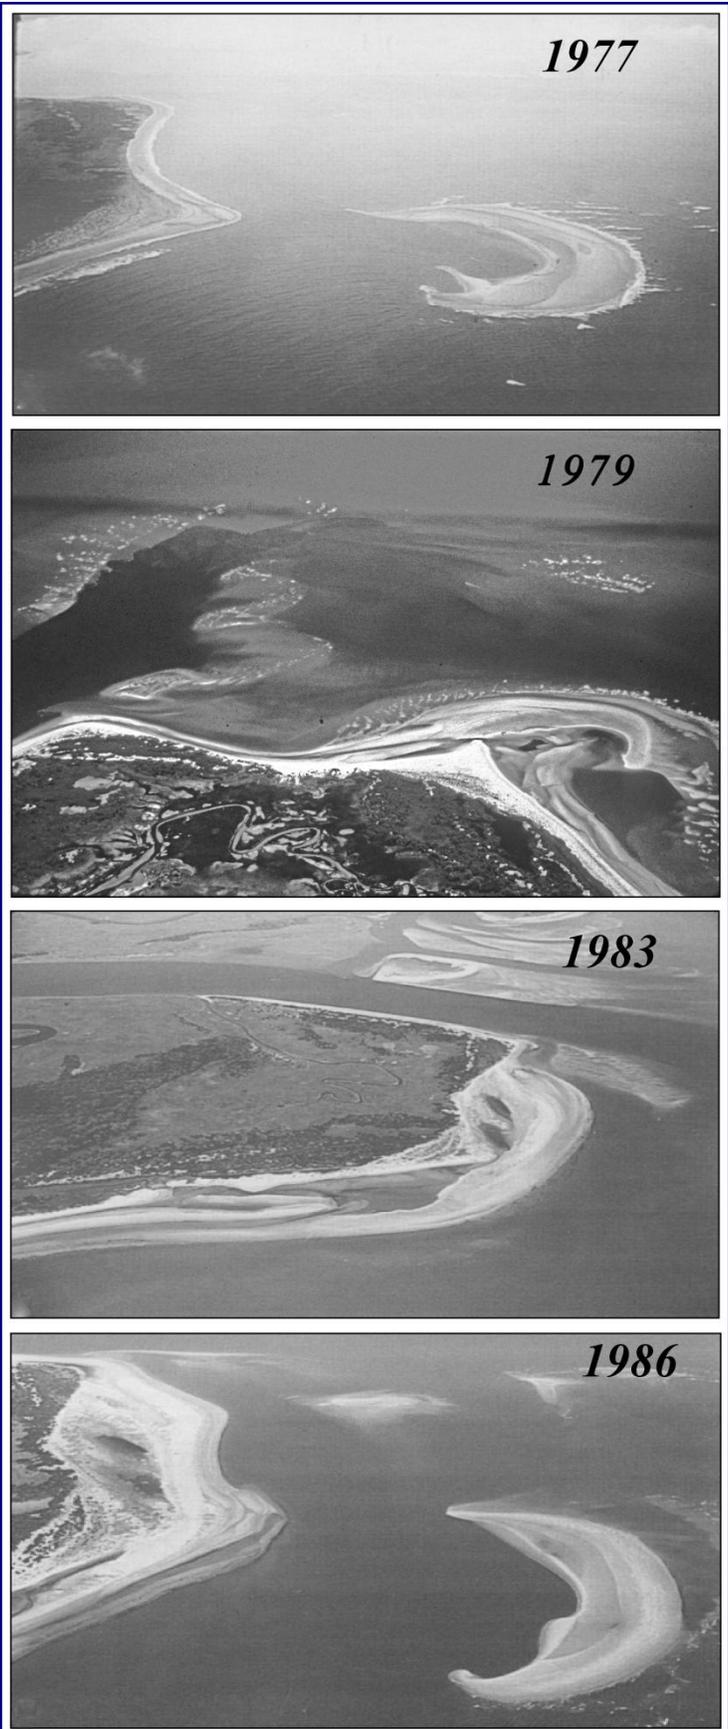
**FIGURE 2.6**

**[LEFT]**  
Schematic of the shoal-bypass cycle originally modeled from a bypass event at Isle of Palms (SC). During Stages 1 and 2 of the cycle, accretion in the lee of the shoal is accompanied by erosion on either side of the attachment site. (After Kana et al 1985)

**[RIGHT]**  
Shoal bypassing at the east end of Kiawah Island.

Stage 1 in 1977 (upper). Stage 2 in January 1979 (upper middle) (courtesy of Research Planning Institute Inc). Stage 3 in 1983 (lower middle). Stage 1 in 1986 (lower). Note the similarity between the 1977 shoal and the 1986 shoal, but the additional sand accumulated on Kiawah in 1986. [After Kana et al 1999]

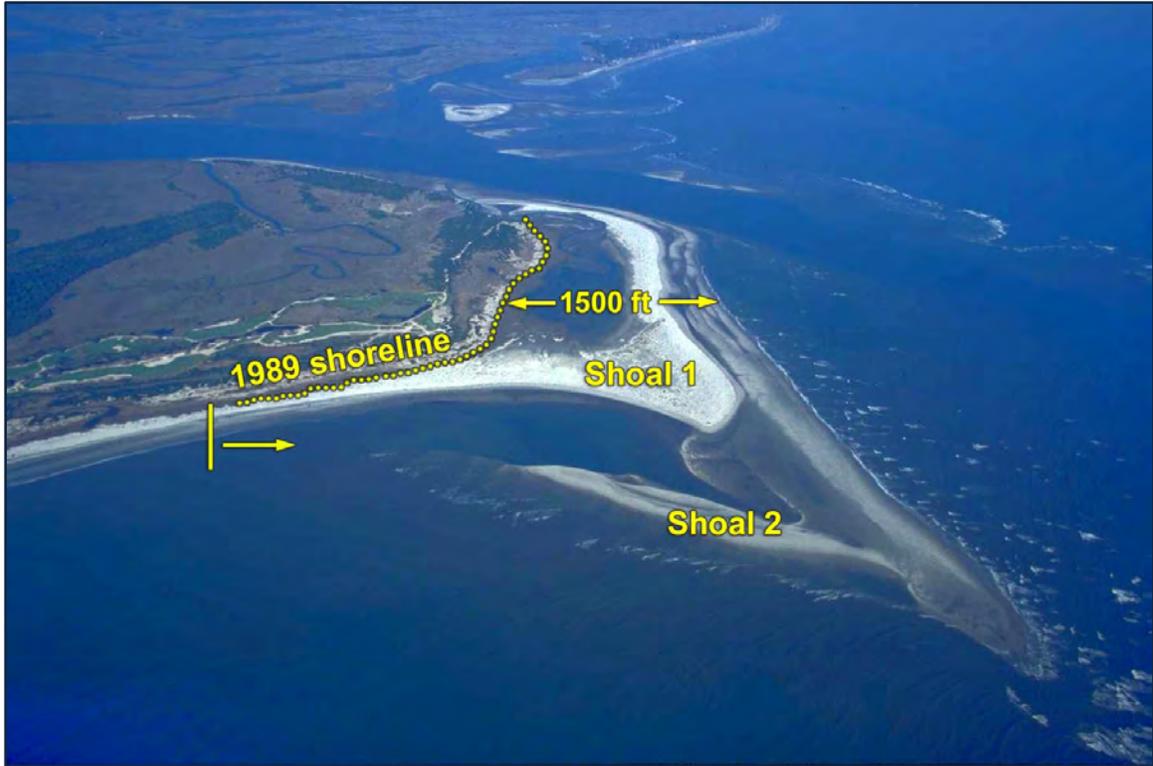
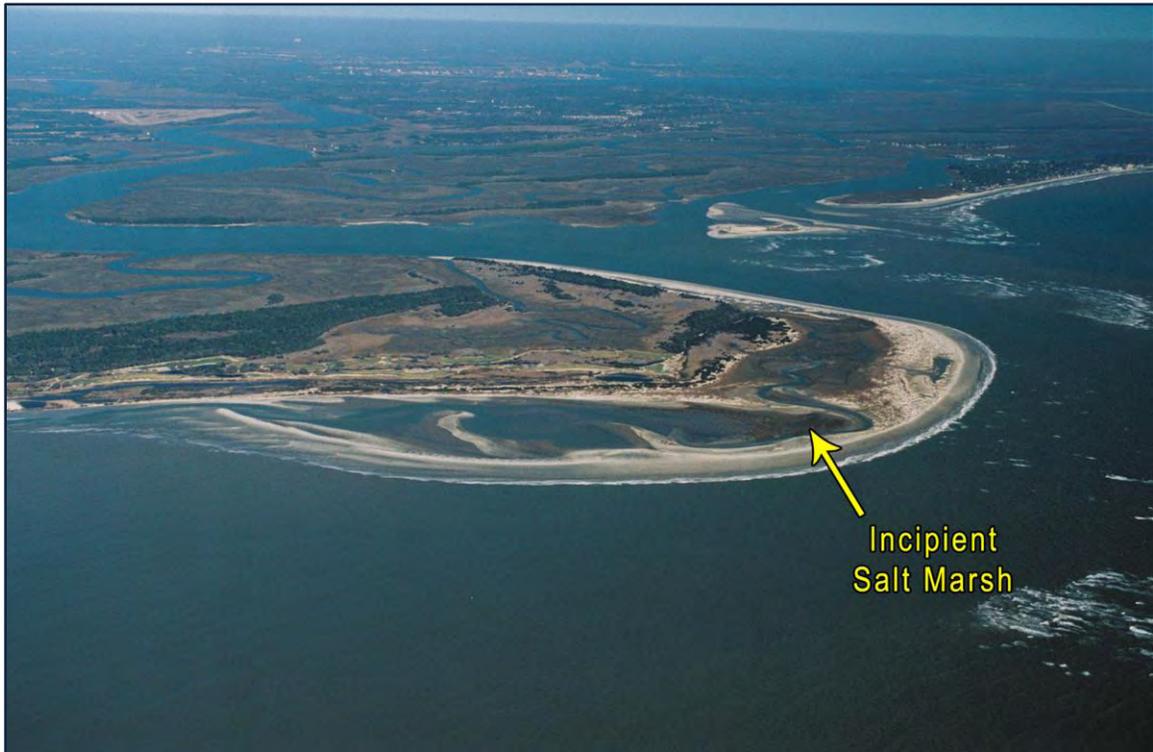
**FIGURE 2.7.** The eastern end of Kiawah Island in December 1998 (upper) and February 2005 (lower). Note the 1989 shoreline situated well inland from the outer beach. Shoals 1 and 2 added upward of 5 million cubic yards to Kiawah in the 1990s. As waves pushed the new sand shoreward, an incipient barrier island/lagoon/marsh formed. The new lagoon was flushed via a channel at the western end of the accreted beach. [From CSE 2007]

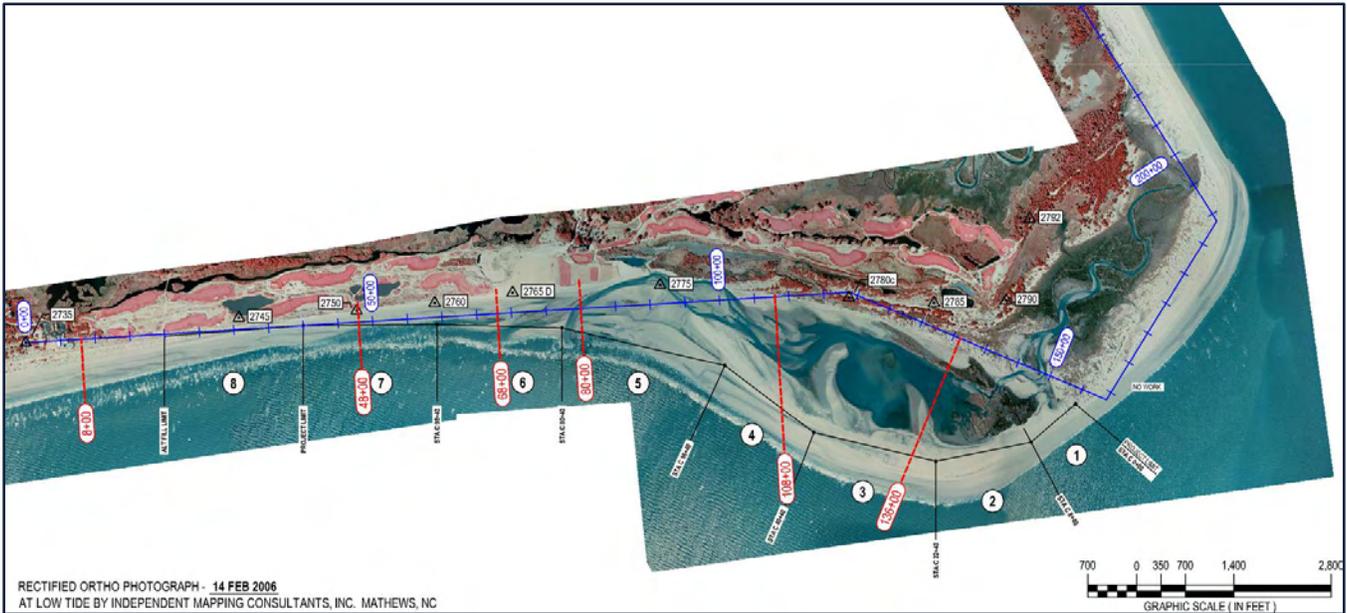
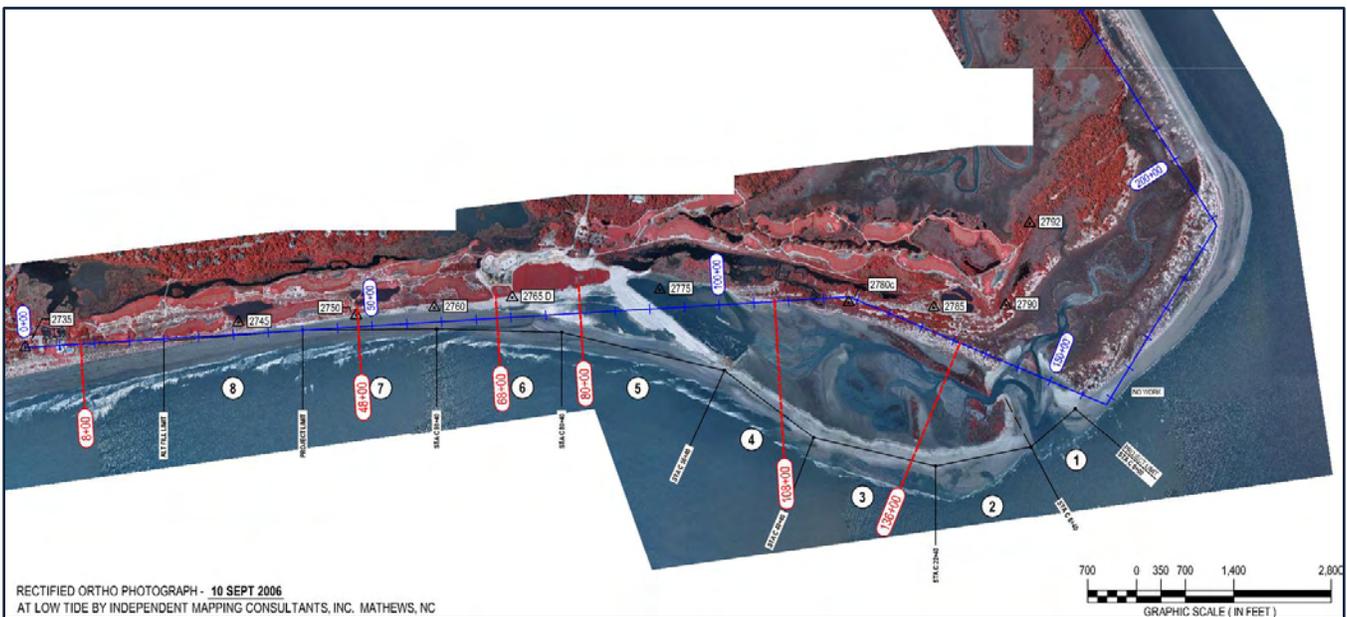
**FIGURE 2.8.** Rectified aerial photos of the project area showing pre-construction (February 2006, upper) and post-construction (September 2006, lower). The channel in Reach 5 was closed, and a new channel was constructed in Reach 1. Sand from Reach 1 to Reach 4 was excavated and transferred to Reaches 5–7.

The project consisted of closure of the existing flushing channel, creation of a new channel to maintain the tidal environment of the lagoon, and excavation and transfer of nourishment sand from the new inlet and accreted shoal areas to eroded downcoast areas. These actions were designed to provide a smoother transition between Kiawah's main beach and the accreted shoal. The contracted volume for the project was 550,000 cubic yards (cy), the majority of which was placed between the new clubhouse and just west of the old flushing channel. The new flushing channel was positioned at the apex of the attached shoal in Reach "1" (Fig 2.8).

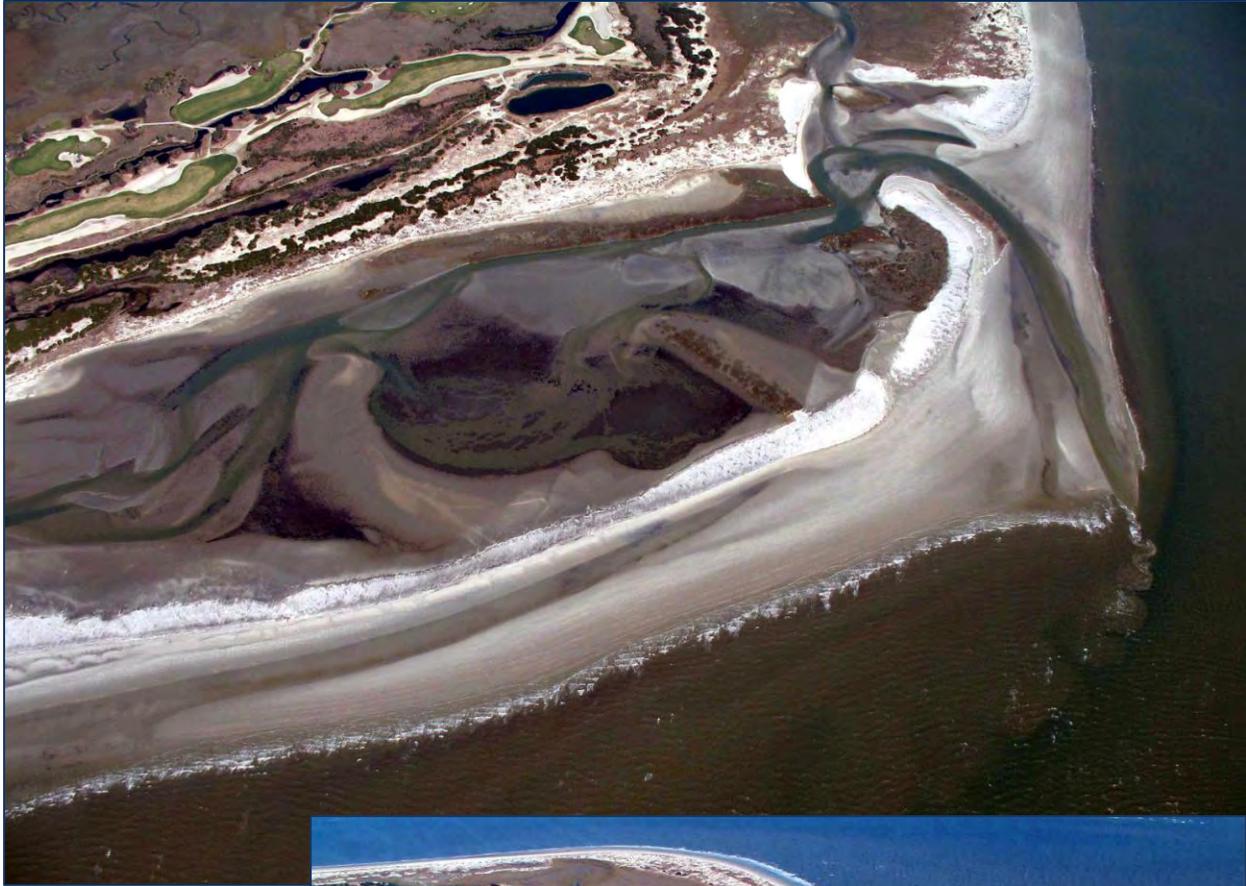
**FIGURE 2.9.**

The same area at low tide on 5 December 2007 after formation of a breach channel in Reach 4 and natural closure of the constructed channel.

In 2007, the constructed flushing channel naturally closed while a new flushing channel opened in Reach 4 (Fig 2.9). Several factors potentially led to the closure of the original flushing channel. The emergence of an offshore shoal to the west of the channel caused wave-focusing and significant erosion to the shoreline in the vicinity of the constructed channel. Sand lost from the dunes adjacent to the channel was deposited in and behind the channel. By September 2007, the constructed channel had completely infilled, and a new flushing channel had opened in Reach 4 (see Fig 2.8 for construction reach boundaries). The low elevations of the outer beach in Reaches 2–4 (intended to maintain washover habitat) left that reach susceptible to a breach. The new channel location provided a more efficient path for tidal flow. The emergent shoal off Reach 2 also increased the likelihood of a breach in Reach 4 because of wave-focusing around the sand bar.

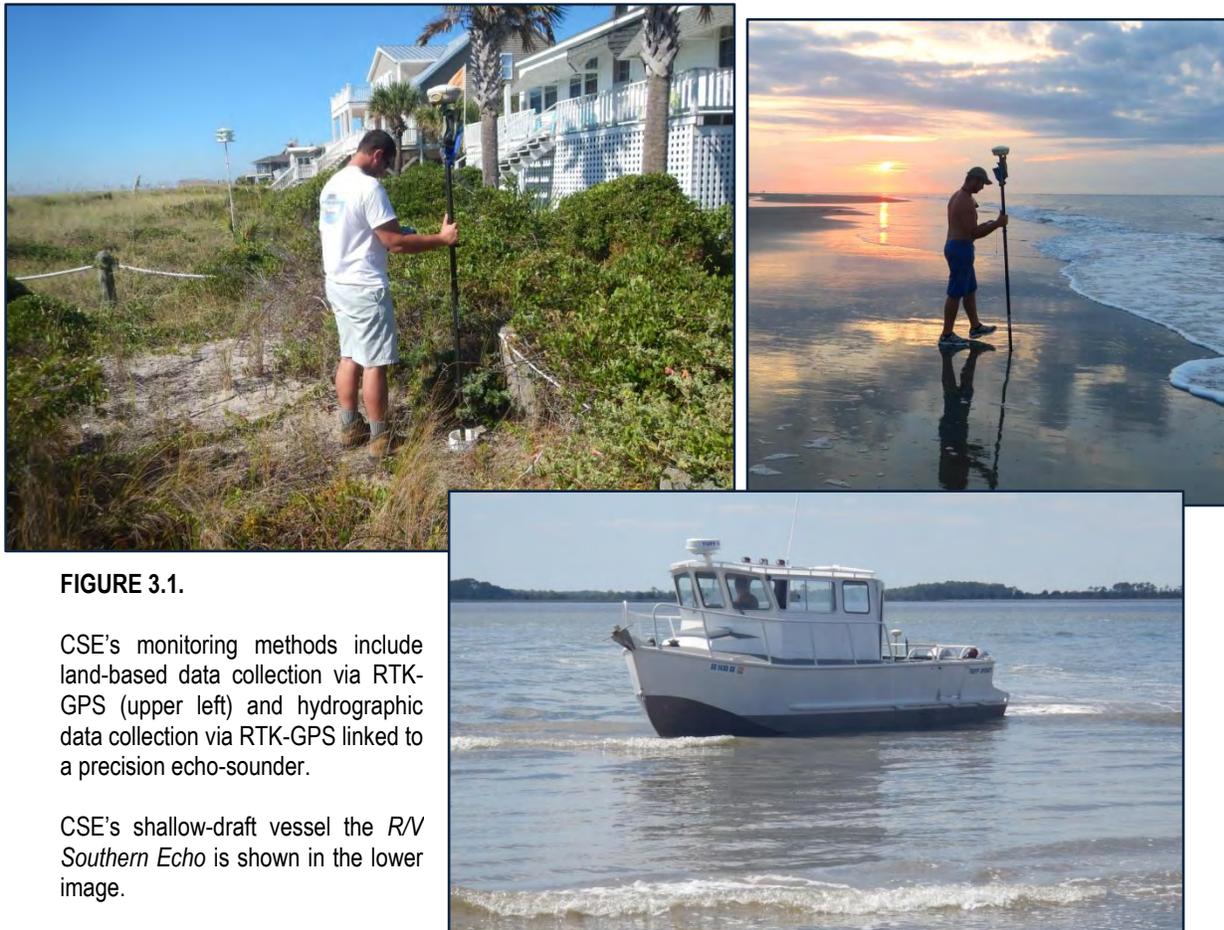
**FIGURE 3.1.**

CSE's monitoring methods include land-based data collection via RTK-GPS (upper left) and hydrographic data collection via RTK-GPS linked to a precision echo-sounder.

The present survey was conducted by RTK-GPS\* (Trimble™ R8 GNSS system) in late October 2013. Profiles along Kiawah Island were surveyed perpendicular to the local shoreline (CSE baseline) azimuth from the control points to a minimum of -12 ft NAVD (the depth equal to the normal limit of sand movement in this setting) or at least 3,000 ft from the dune. Surveys were conducted by combining a land-based survey and a bathymetric survey (Fig 3.1). Land surveys were accomplished using an RTK-GPS between the foredune and low-tide wading depth [(~)-6 ft NAVD], whereas overwater work was accomplished via RTK-GPS combined with a precision echo-sounder mounted on CSE's shallow-draft boat, the *RV Southern Echo*.

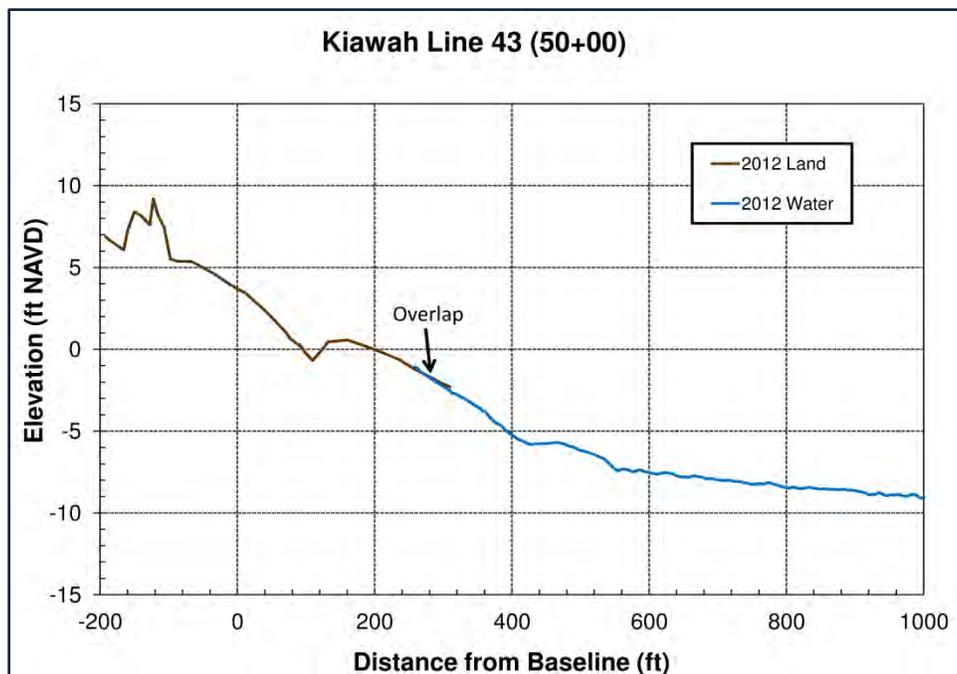
**FIGURE 3.2.** CSE combines land-based and hydrographic data collection to produce continuous profiles of the beach. Land-based work is accomplished at low tide, while hydrographic work is performed at high tide. This allows for overlap of the two data collection methods and ensures quality data and a complete profile.

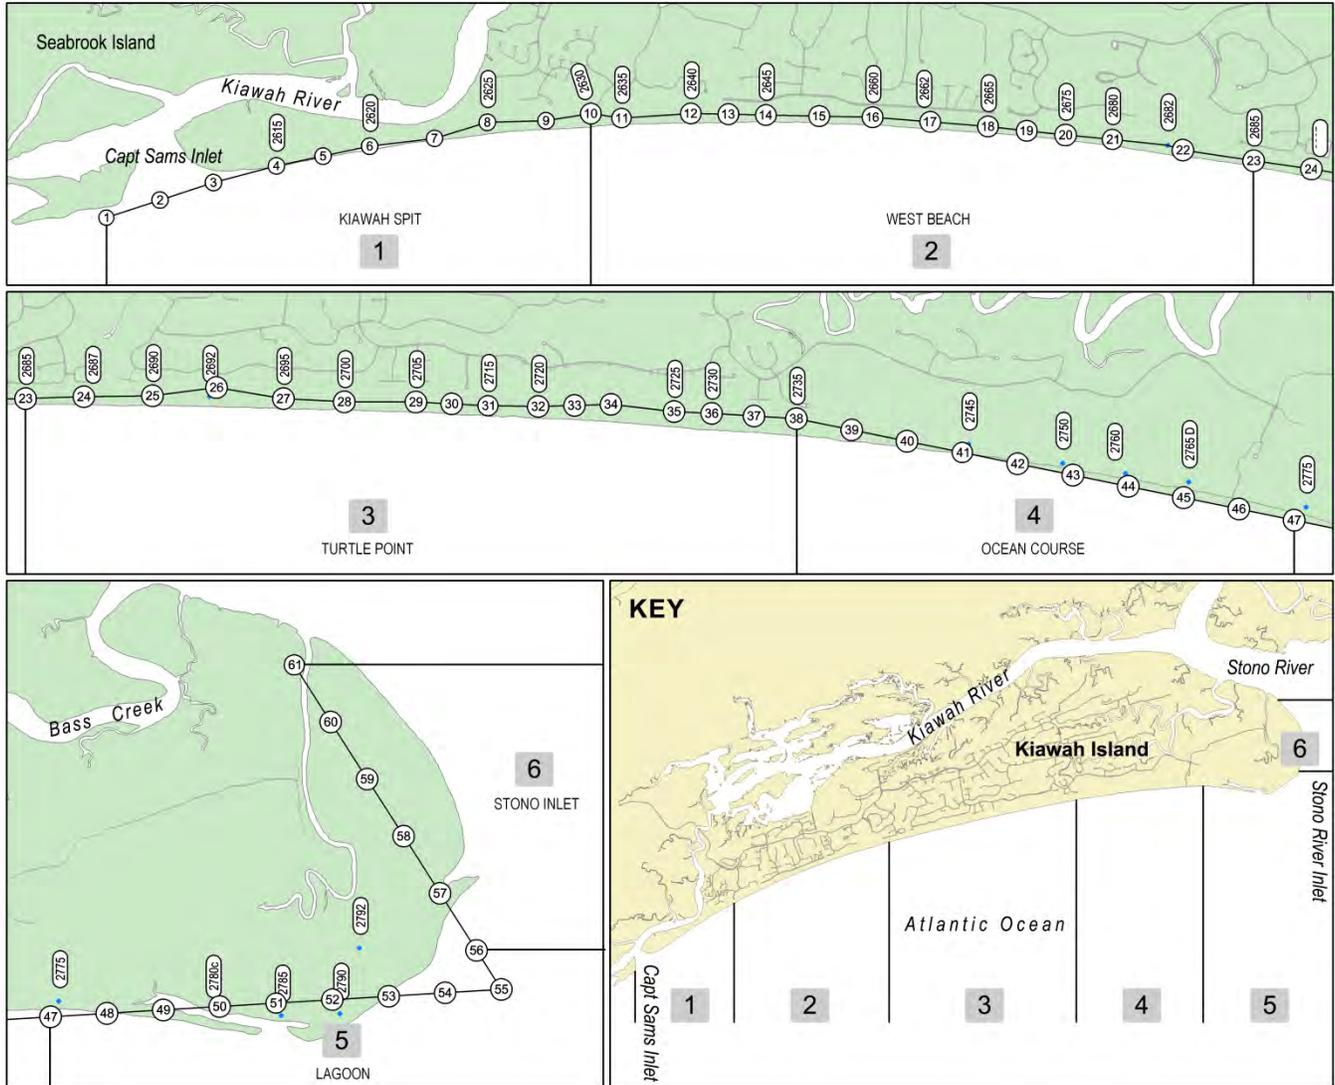
**FIGURE 3.3.** General location of beach stations and reaches monitored for the present report. Line numbers are shown in circles.

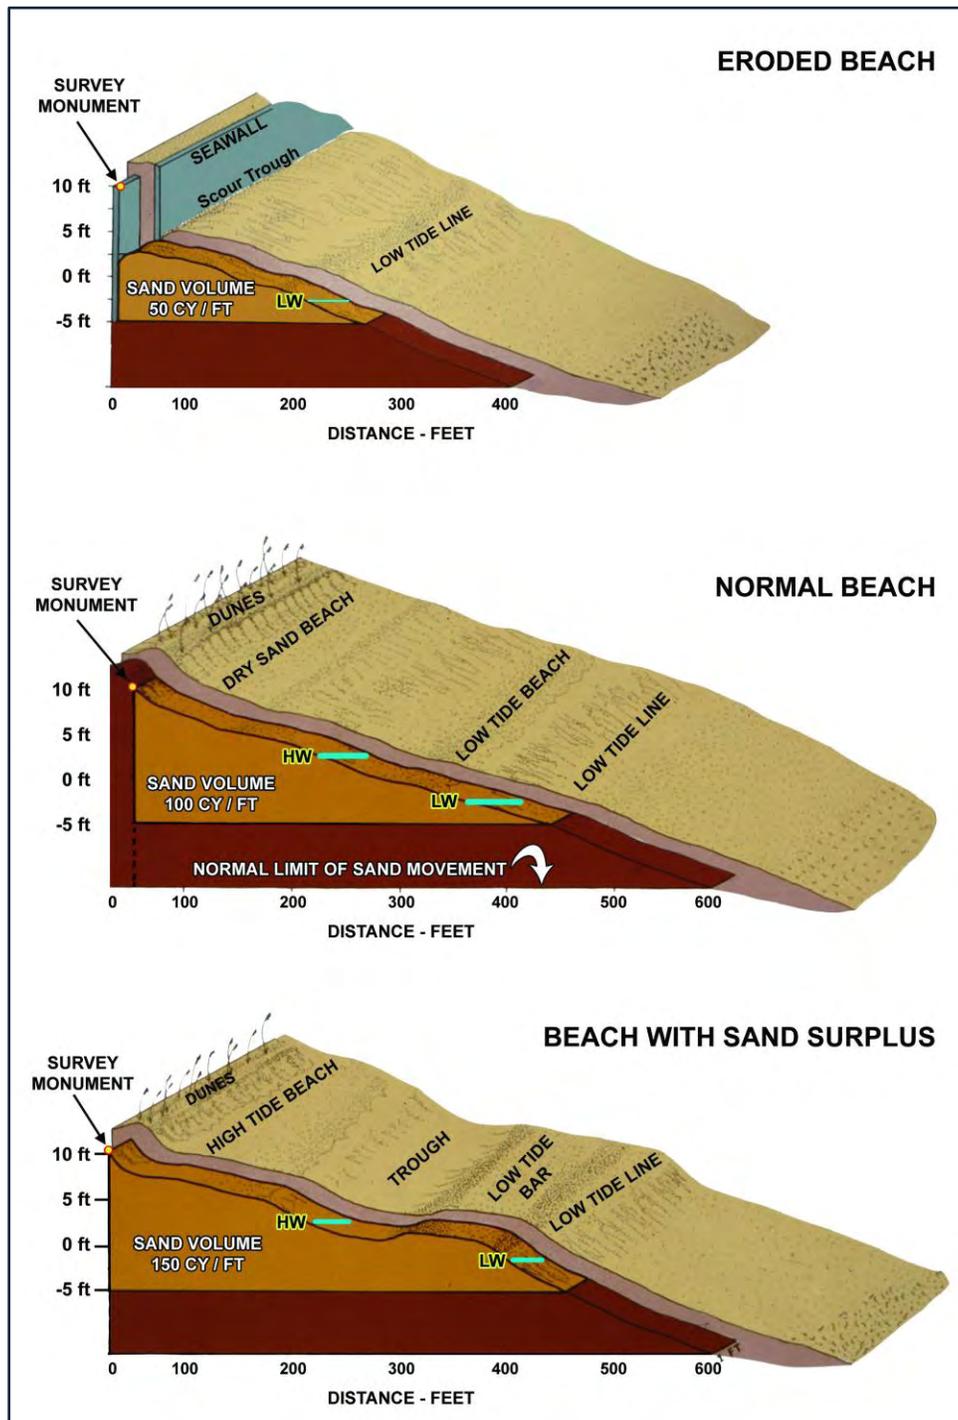
**FIGURE 3.4.** The concept of profile volumes – the volume of sand between defined contours over a 1-ft (unit) length of beach. [After Kana 1990]

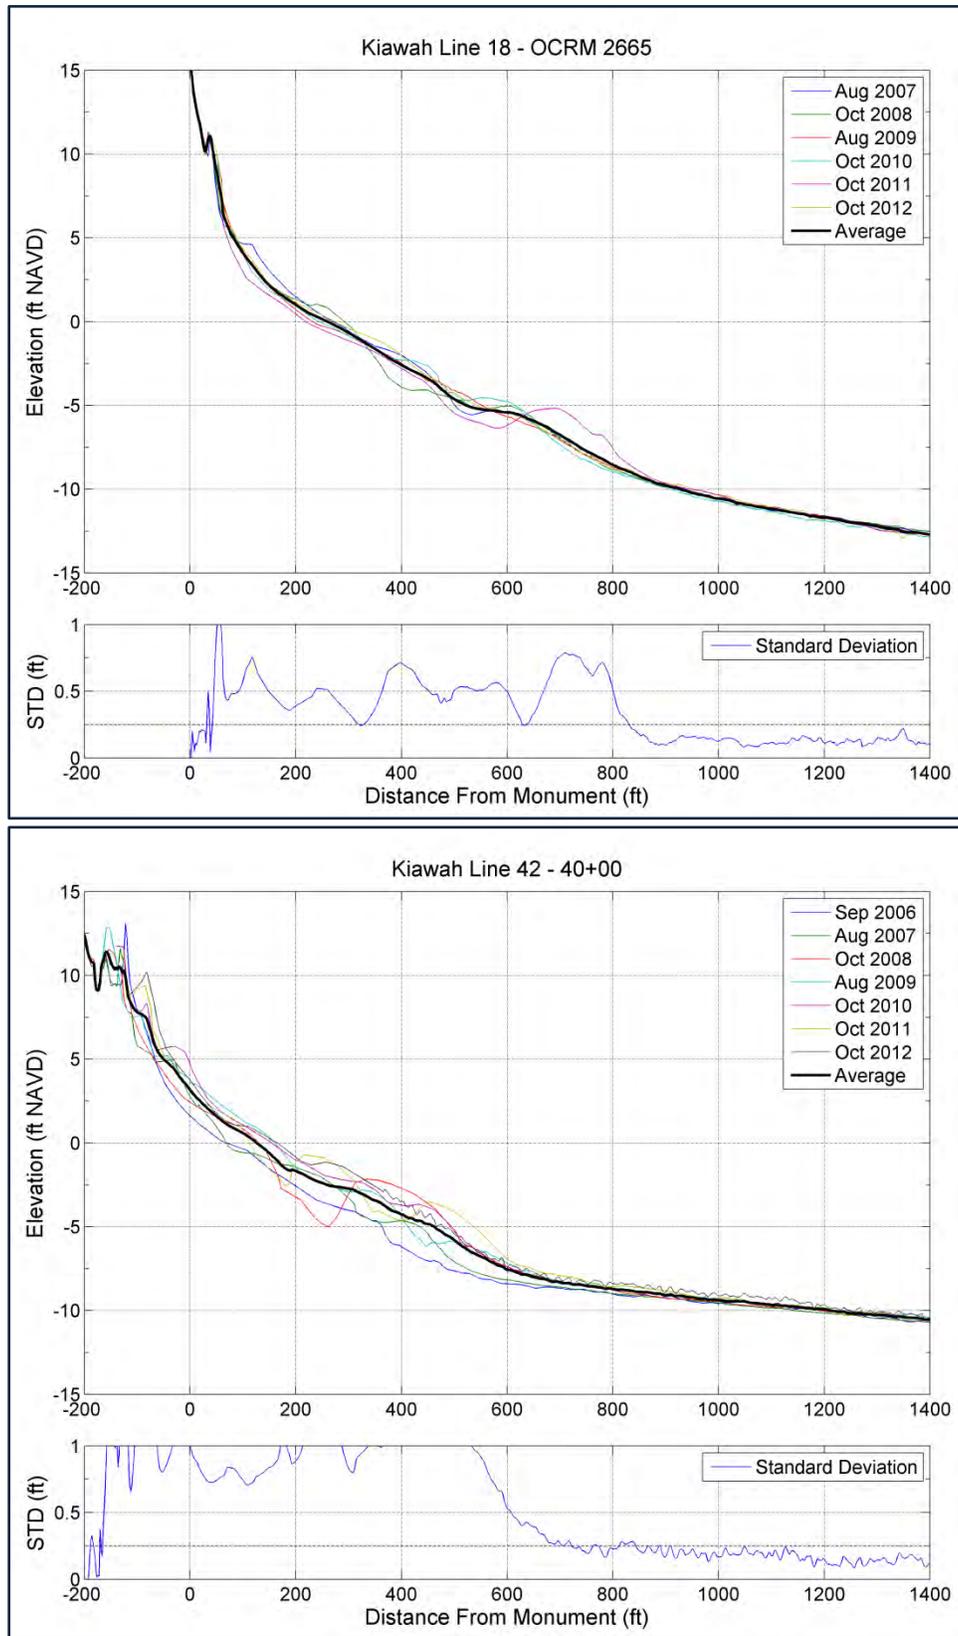
**FIGURE 3.5.** The lower portion of each graph tracks the standard deviation (variation from the average elevation) at any given point along a set of profiles. A standard deviation of <0.25 ft over several hundred feet is evidence of little change (ie – approximate depth of closure).

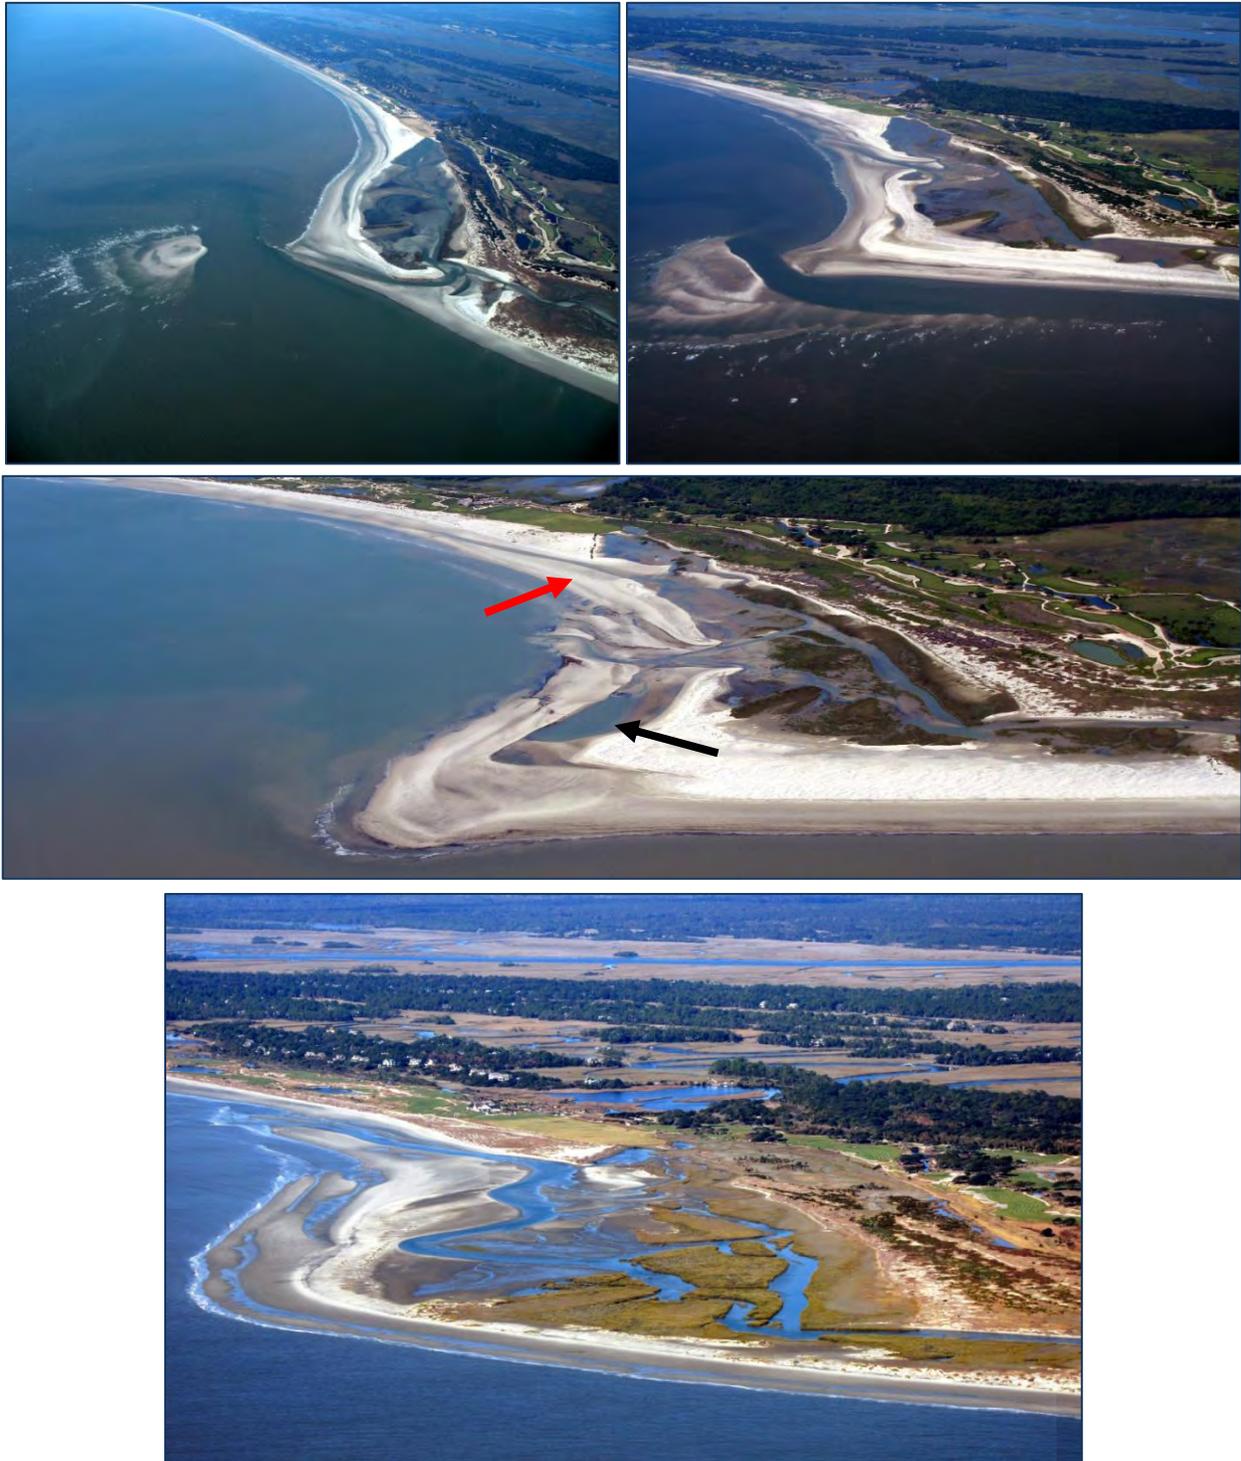
**FIGURE 4.1.** Oblique aerial photos of the west lagoon at the northeastern end of Kiawah Island. In December 2006 (upper left), an incipient shoal was present offshore of the eastern end of the lagoon. By May 2008 (upper right), the shoal was nearing attachment. A shoreline salient had formed on the outer barrier, as sand eroded from adjacent areas was deposited behind the shoal. The flushing channel had also relocated to the west and migrated westerly into the closure dike. The shoal had attached by April 2010 (middle), creating a small lagoon (black arrow) seaward of the original outer barrier. The flushing channel again relocated from the closure dike area (red arrow) to the central portion of the lagoon. Erosion of the shoal attachment site and downcoast spreading of sand rounded off the point of land from 2010 to November 2013 (bottom). Note formation and expansion of salt marsh in the west lagoon over the seven-year period represented by the photos.

Rapid and large-scale volume changes led to closure of the original (constructed) flushing channel and the opening of a new channel in the summer of 2007 (cf — Fig 2.6). The new flushing channel was located near the center of the west lagoon and migrated west between 2007 and 2009. It began to encroach on the constructed dike as it continued to migrate west. During this time (2007–2009), the outer barrier eroded via overtopping and sand spreading to the lee of the shoal, leaving it low, narrow, and susceptible to another breach. A new breach occurred between August 2009 and April 2010, and the old channel closed naturally. The new inlet was again located near the central portion of the west lagoon near the attachment site of the western edge of the incipient shoal. The seaward end of the channel meandered between 2010 and 2012; however, the channel throat remained in the same general location. The channel migrated further west from 2012 to 2013, encroaching on the 2006 closure dike and emptying in front of the Ocean Course clubhouse.

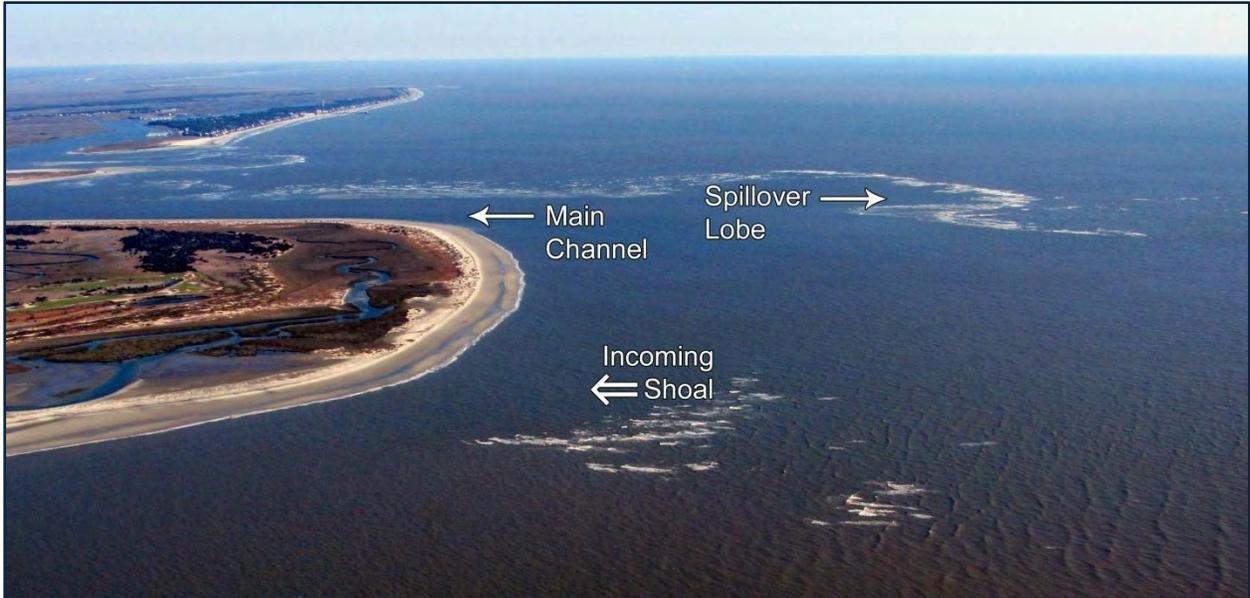
**FIGURE 4.2.** Seaward aerial view of the Stono Inlet delta in November 2013. While the main channel exits the inlet parallel to the interior inlet, a significant secondary channel is present. The attaching shoal is visible in the foreground. Measurement of the inlet shoals is outside the scope of CSE’s present monitoring agreement with the Town.

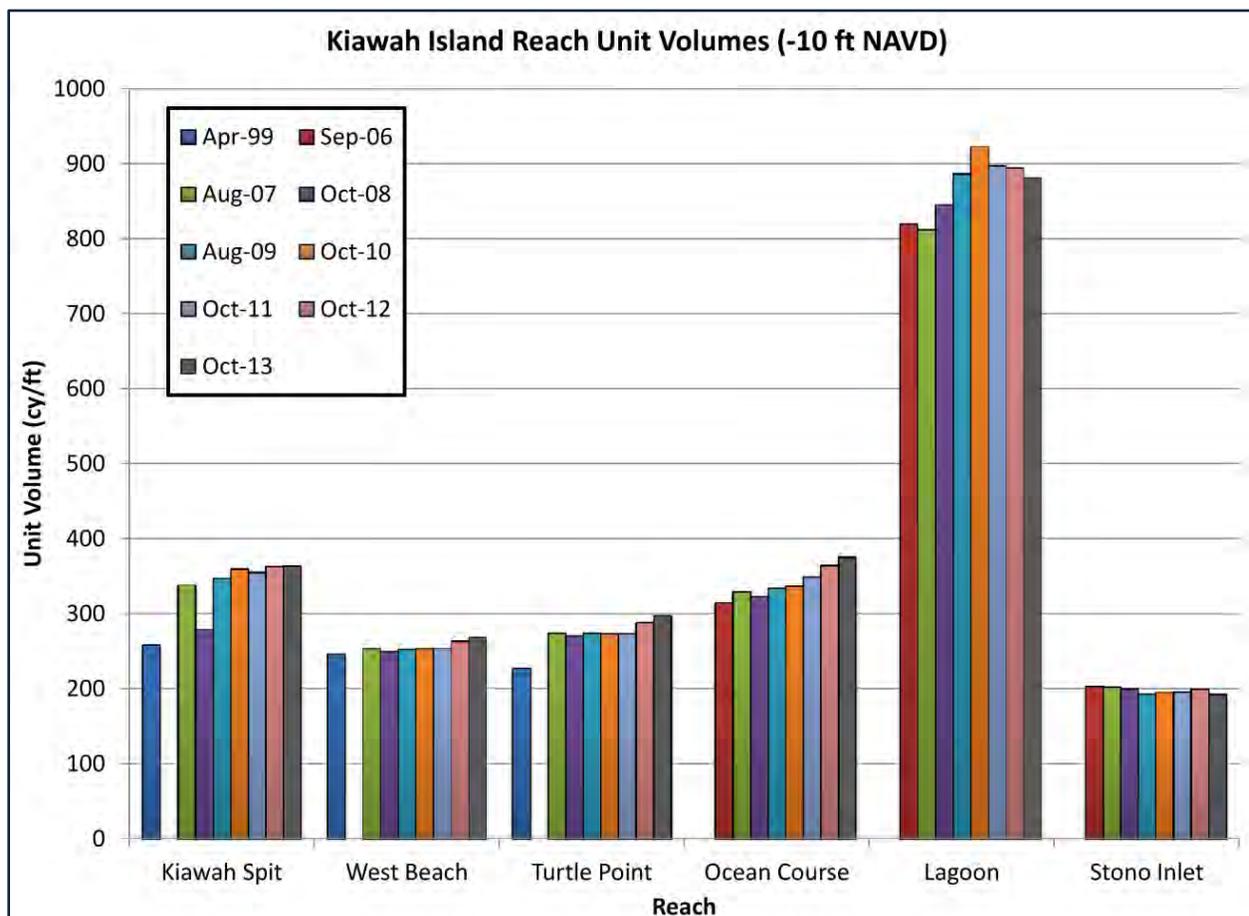
FIGURE 4.3. Reach unit volumes at Kiawah Island since 1999 measured to -10 ft NAVD.
