**2006 EAST END BEACH RESTORATION PROJECT  
KIAWAH ISLAND SOUTH CAROLINA**

**Survey Report No 7  
February 2014**

**2006 EAST END BEACH RESTORATION PROJECT**  
**Kiawah Island – South Carolina**

**SURVEY REPORT NO 7**  
**Annual Beach and Inshore Surveys**

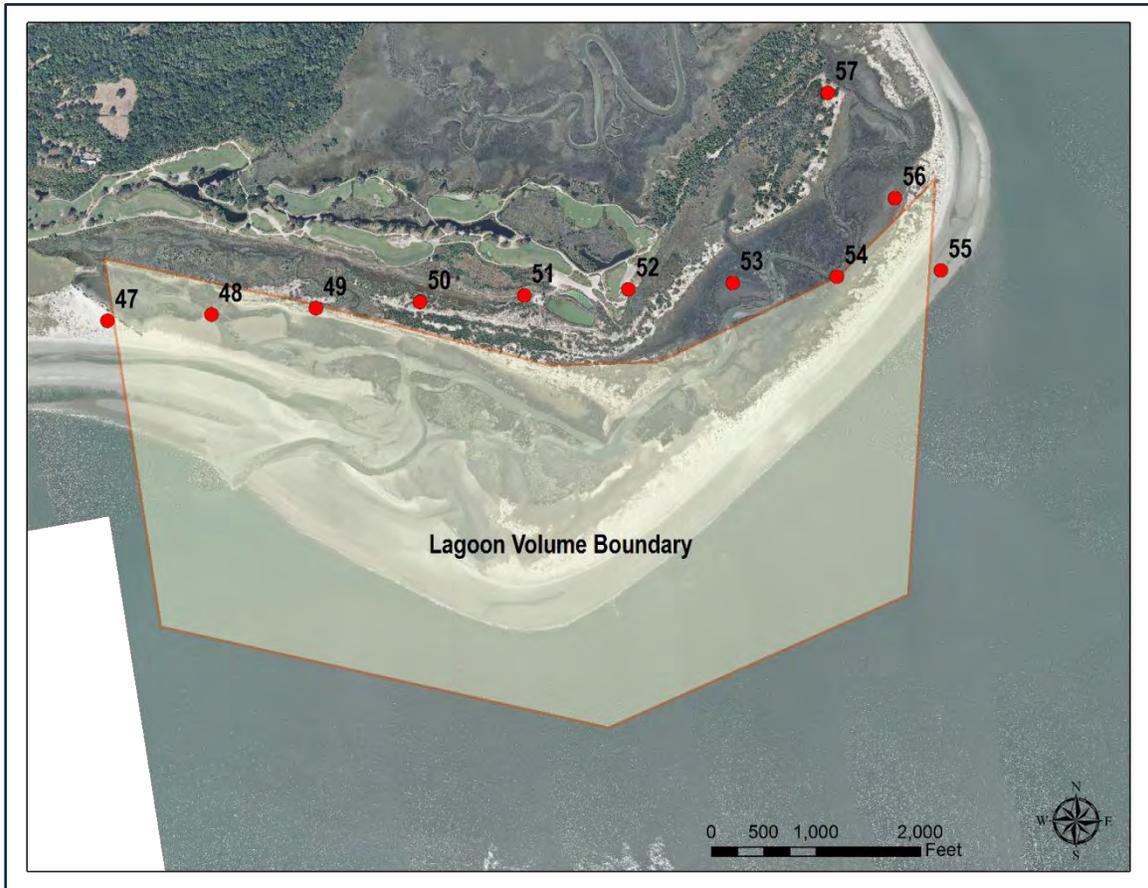
**FIGURE 4.4.** Boundary for the Lagoon Reach used to compute beach volumes for the present report. Elevation models were produced for surveys between 2006 and 2013, and total beach volume within the boundary was calculated to -10 ft NAVD. Coordinates below are in SC State Plane 3900 (ft).

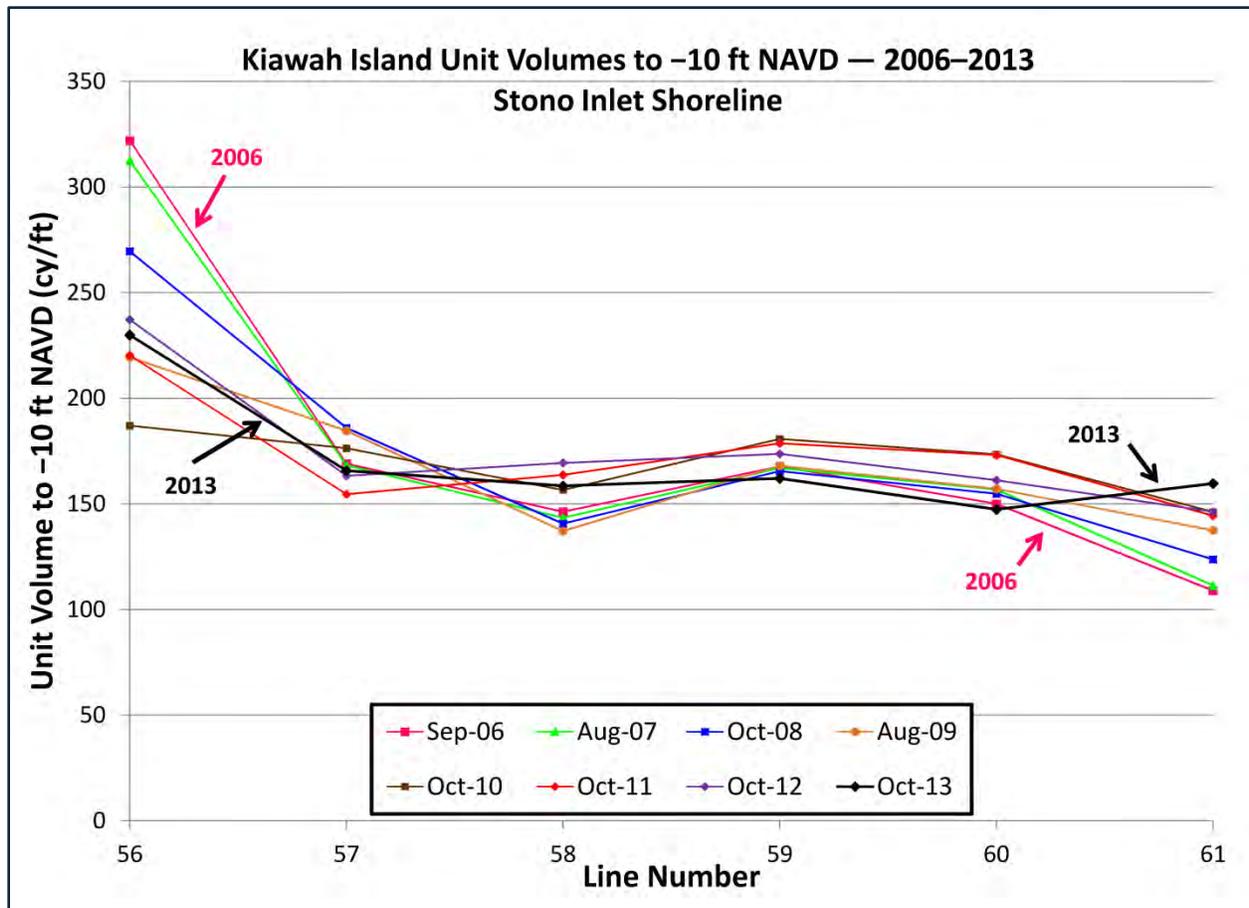
**FIGURE 4.5.** Unit volumes along the Stono Inlet reach. The seaward end of this reach (left side of graph) eroded from 2006 to 2010, but has since accreted. The central and inland areas have been more stable.

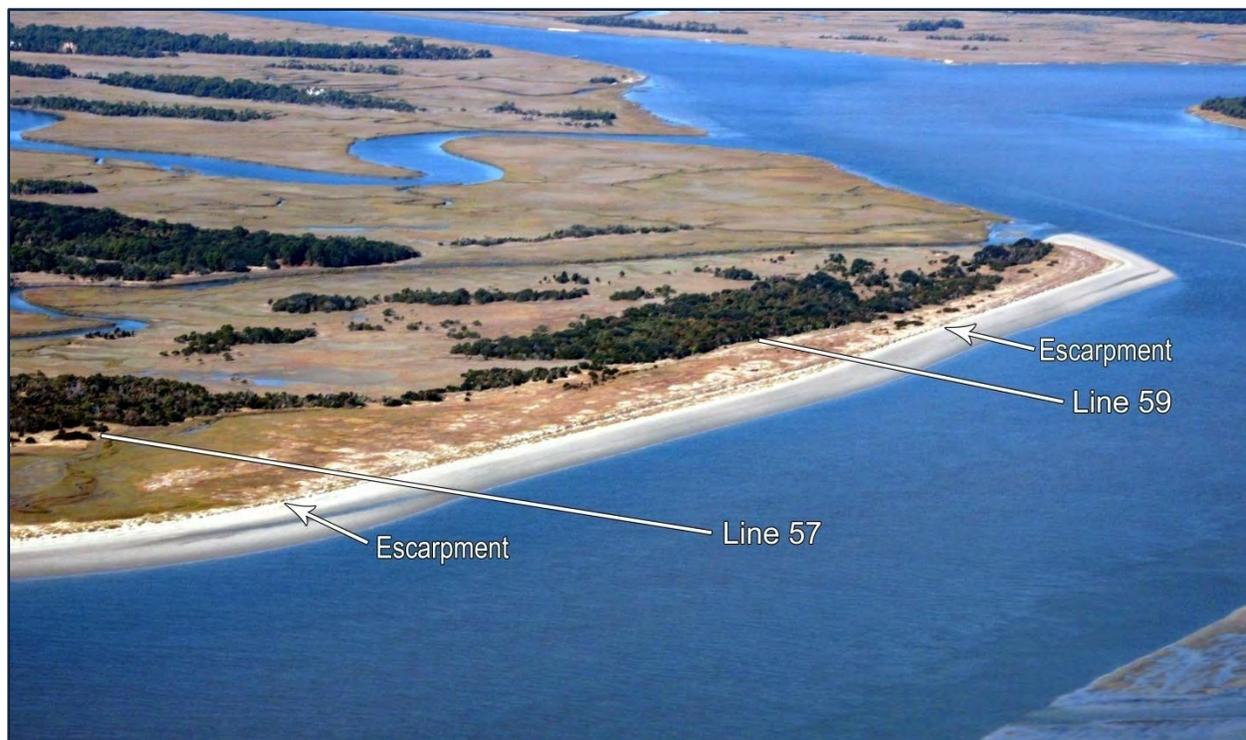
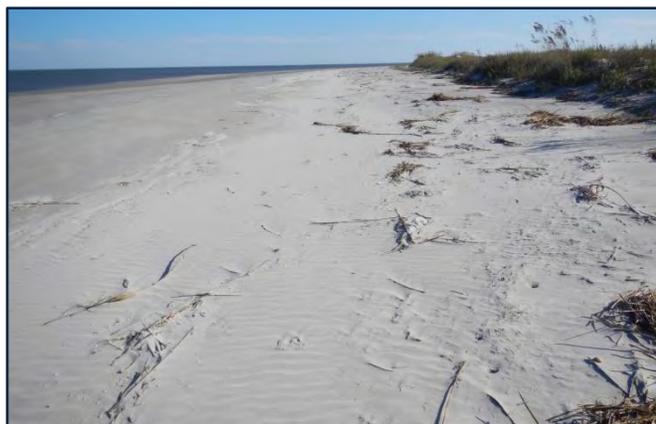
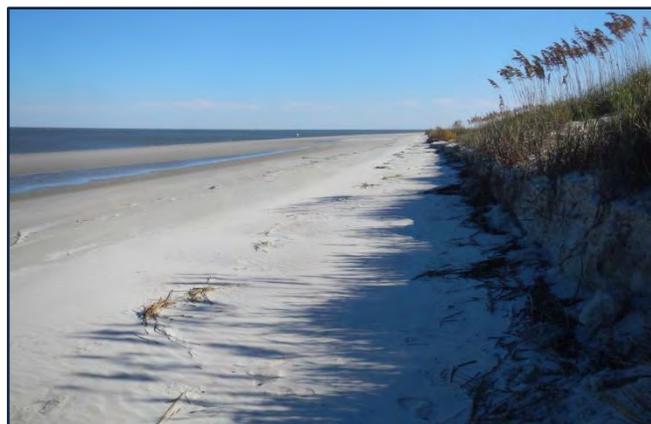
Erosion over the past year is evident in ground photos (Fig 4.6), which show an erosional escarpment in October 2013 spanning Lines 58–60, and was most significant at Line 59 (~2–3 ft high). If these ground photos are compared to the aerial image in Figure 4.6 (taken approximately two weeks after the ground photos), it appears that the beach near Lines 58 and 59 was recovering, while an escarpment had formed near Line 57. Profiles show the year-to-year variability in contour positions (Fig 4.7) with Line 56 the only profile showing significant dune recession since 2006. Rapid changes such as these are the result of recent storm occurrences or variable wave directions and sediment availability. Near the inlet, breaks in the shoals of the inlet delta can also cause shifts in sediment deposition under varying wave directions. Long-term monitoring averages out these short-term fluctuations to provide a better understanding of typical erosion patterns.

**FIGURE 4.6.** [UPPER] Aerial image (14 November 2013) of the Stono River inlet shoreline. Accumulation of wrack suggests this location was recovering during the first two weeks of November. [LOWER LEFT] Ground photo (29 October 2013) from Line 57. [LOWER RIGHT] Ground photo (29 October 2013) from Line 58 showing an escarpment present at the time of the photo.

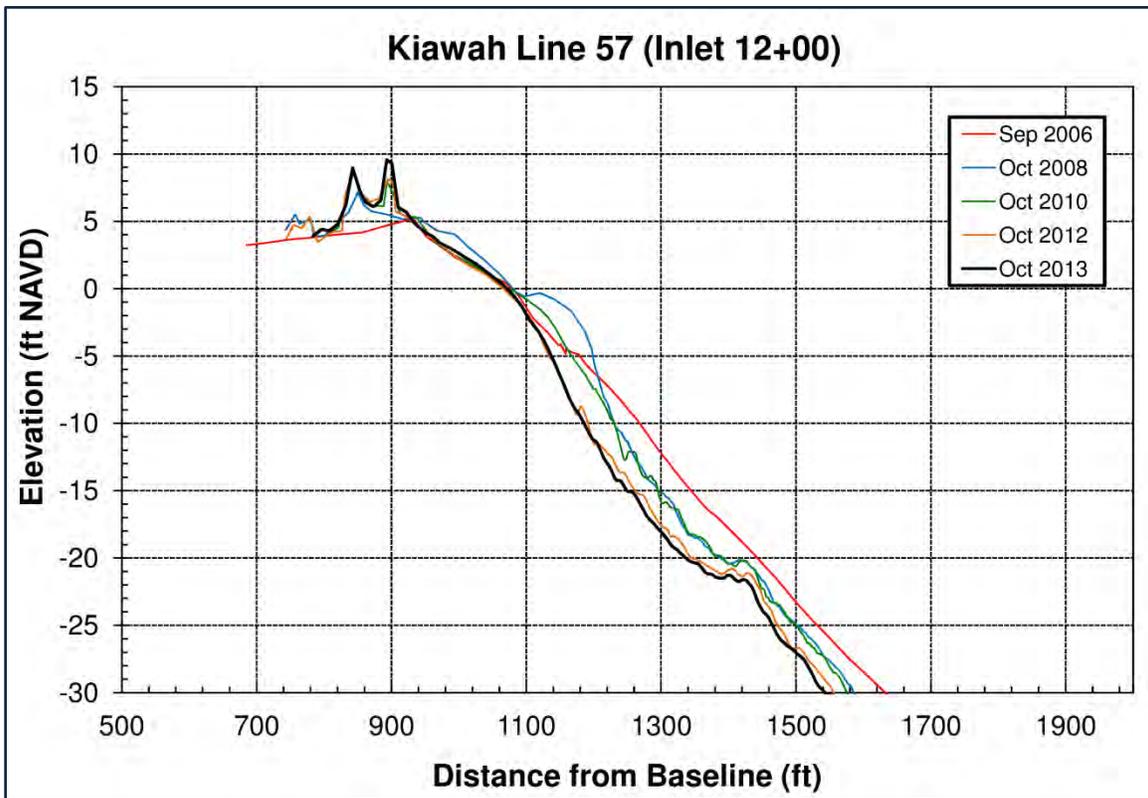
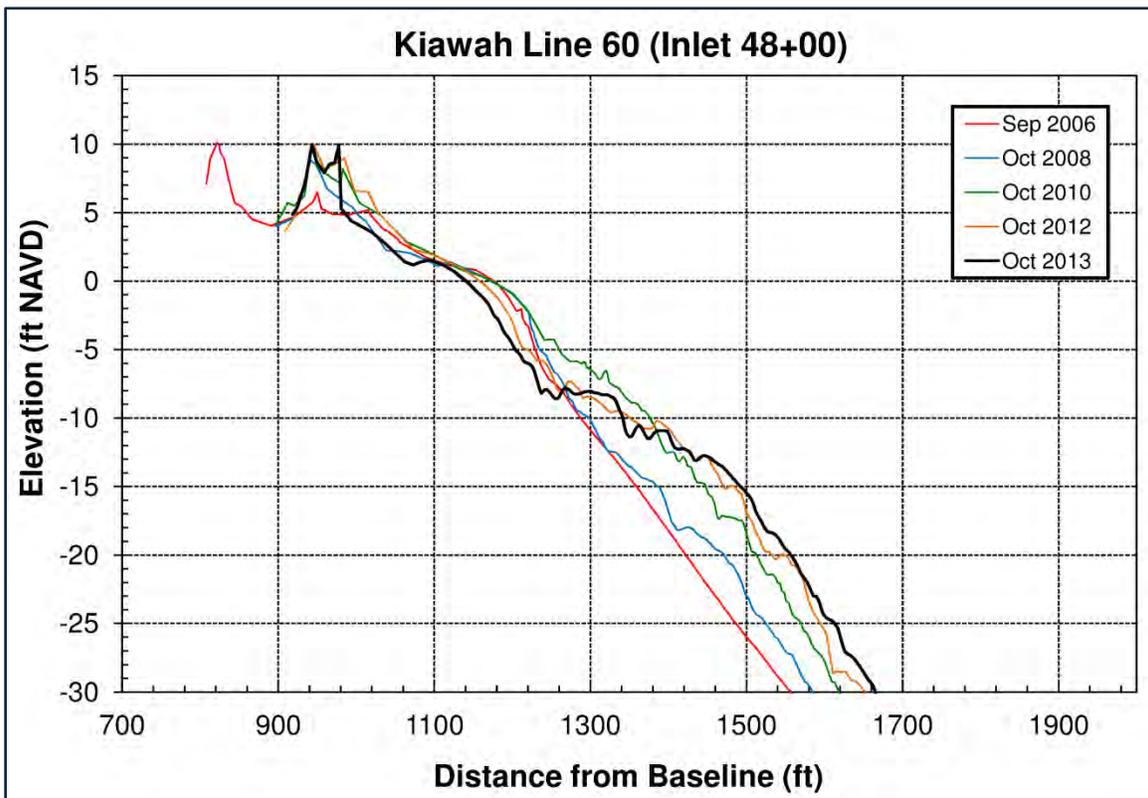
**FIGURE 4.7.** Beach profiles from Line 57 and Line 60 in the Stono Inlet Reach. Line 57 eroded from 2007 to 2011, but has since accreted. The central and inland portion (Line 60) of the reach has accreted since 2007, although most of the gain has been in the dune or underwater.

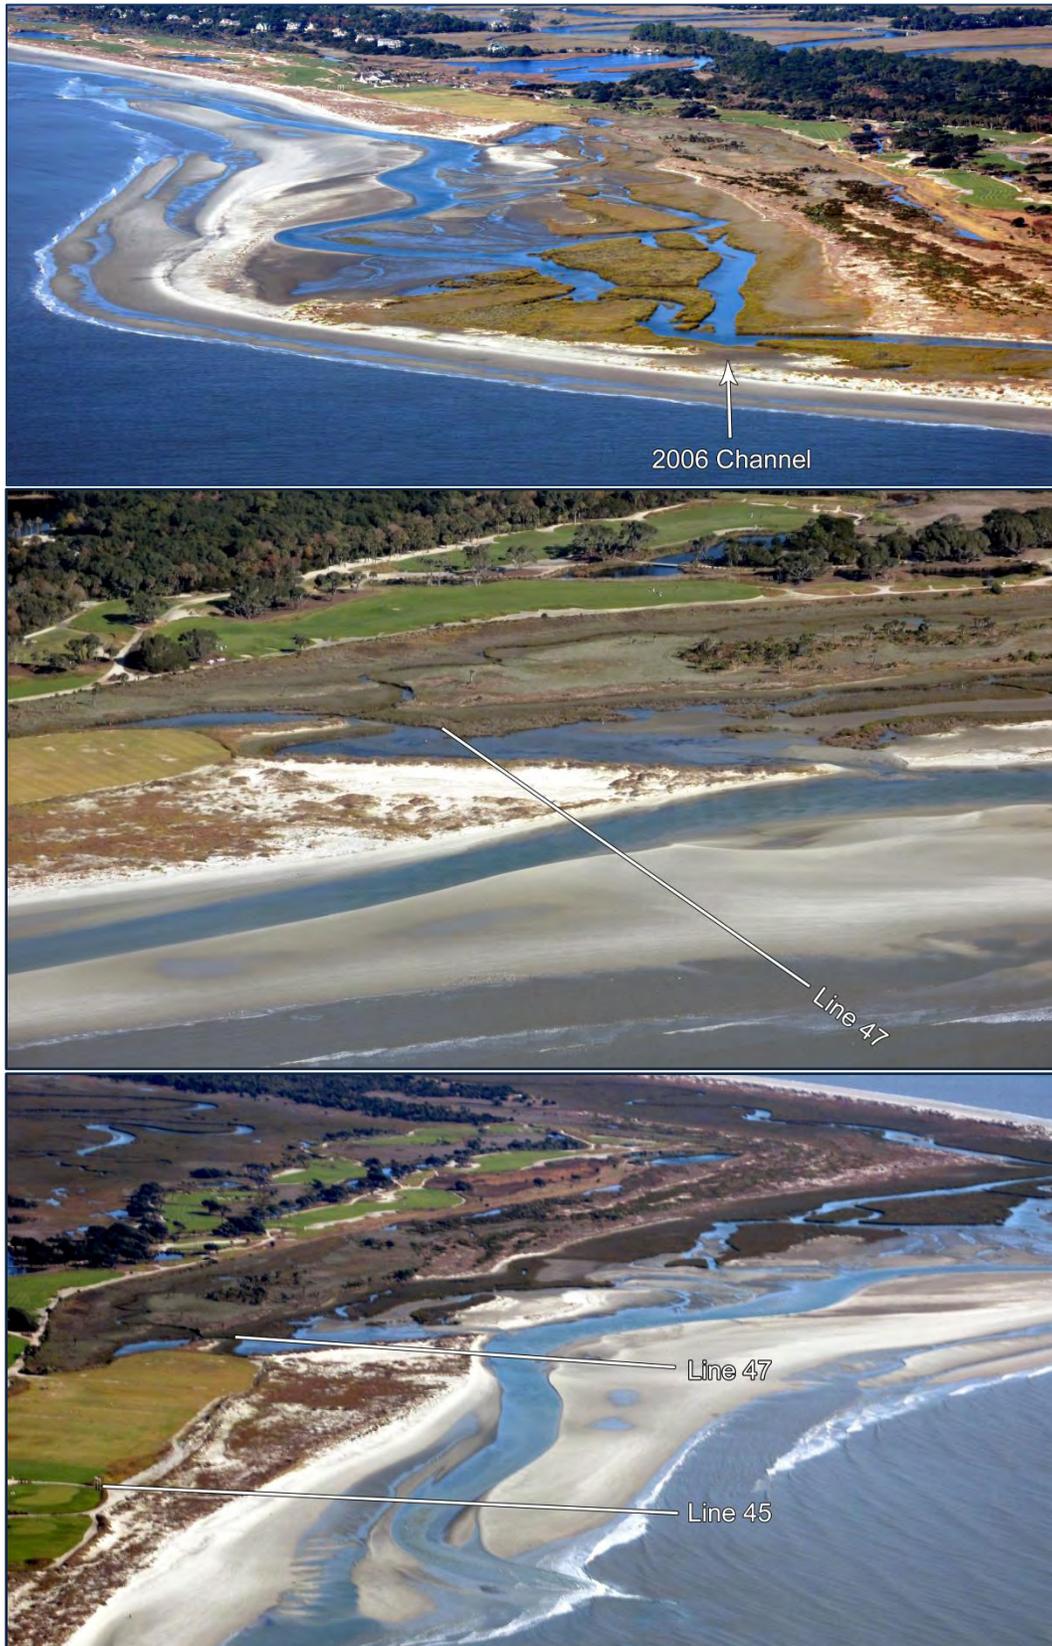
**FIGURE 4.8.** November 2013 aerial images of the Lagoon Reach. **[UPPER]** Westward view of the eastern lagoon area. The 2006 channel position is noted. **[MIDDLE]** At the time the image was taken, the flushing channel ran parallel to the beach and was causing dune erosion at Line 47. **[LOWER]** Eastward view of the flushing channel and fill berm.

The other significant event occurring over the past year was the migration of the flushing channel which has meandered across the western lagoon area over the past several years. Between 2012 and 2013, the channel moved further westward than it has at any point since the 2006 project (Fig 4.10). The migration caused erosion of the 2006 dike and fill area, up to ~150 ft at Line 47 (Fig 4.9 – Line 47). The eroded area consisted of dry berm and dune habitat which also serves as a shorebird roosting and nesting area.

The erosion of the habitat plus the potential for additional erosion of the fill berm is a concern for two reasons. The first is that loss of nesting habitat is obviously detrimental to shorebirds. The second is that continued erosion will eliminate the fill area placed in the 2006 project and could lead to loss of beach and dune protection fronting the Ocean Course. If left alone, the channel may eventually return to the pre-project location, causing erosion of the driving range and threatening certain holes on the golf course. The likelihood of this happening is uncertain, but CSE considers it low due to the large volume of sand currently present landward of the channel. Natural breaches in the outer lagoon berm have occasionally allowed the channel to relocate further east, a process which will likely continue into the future. However, the dynamic nature of the area leaves open the possibility of the channel's continued migration to the west. As of this writing, the Town is seeking to discuss this issue with regulatory agencies to determine the most appropriate course of action regarding the channel migration.

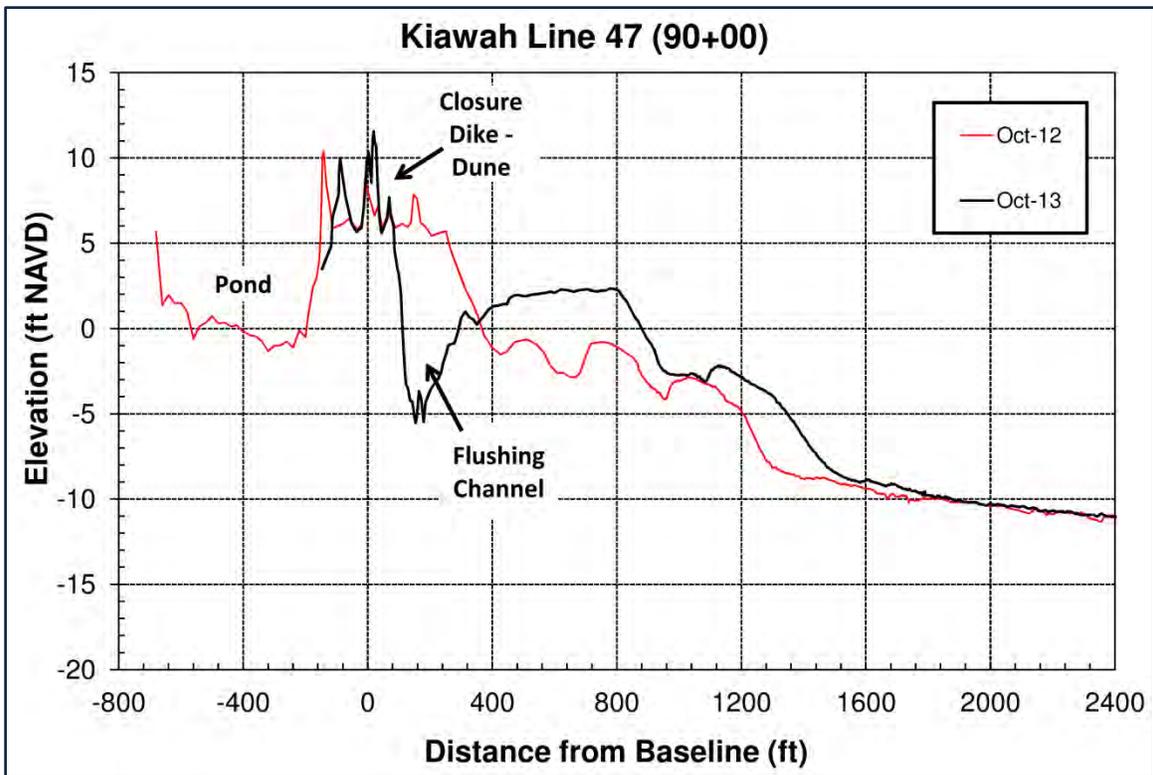
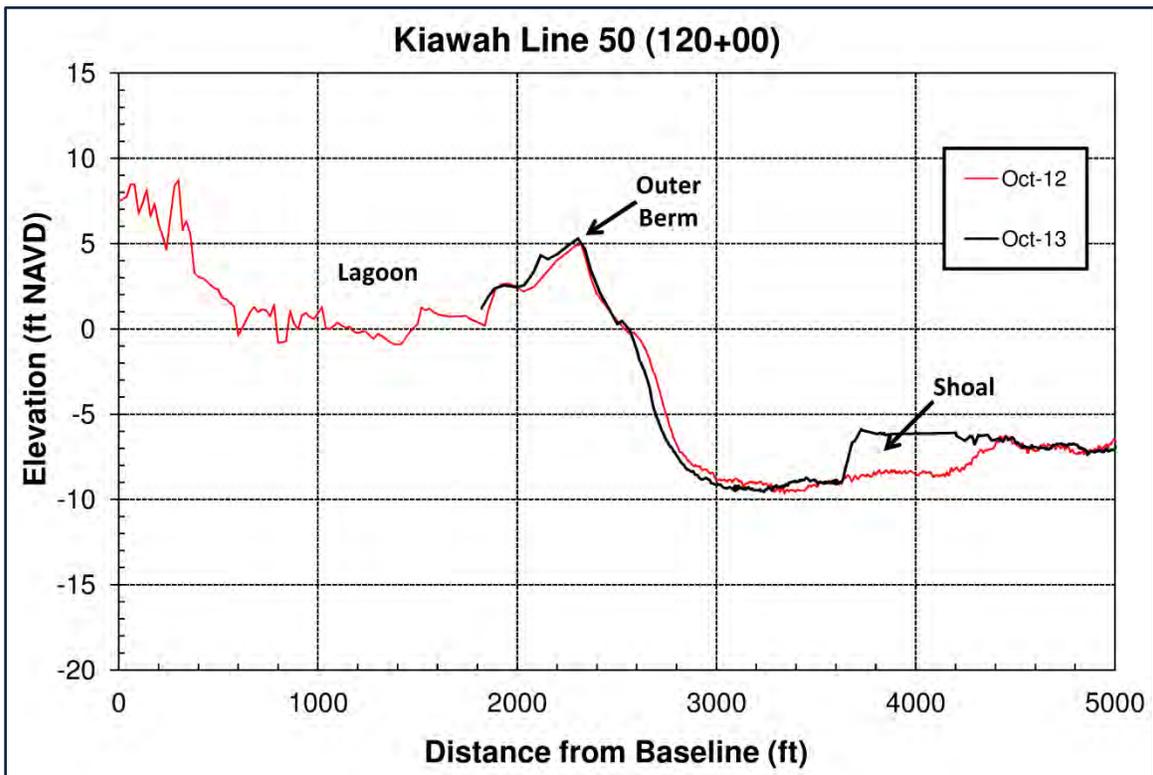
**FIGURE 4.9.** [UPPER] Profiles from Line 47 showing encroachment of the dune by the migrating flushing channel. [LOWER] Line 50 (near the southern apex of the east end) shows migration of the current shoal-bypass event which moved ~700 ft landward over the past year.

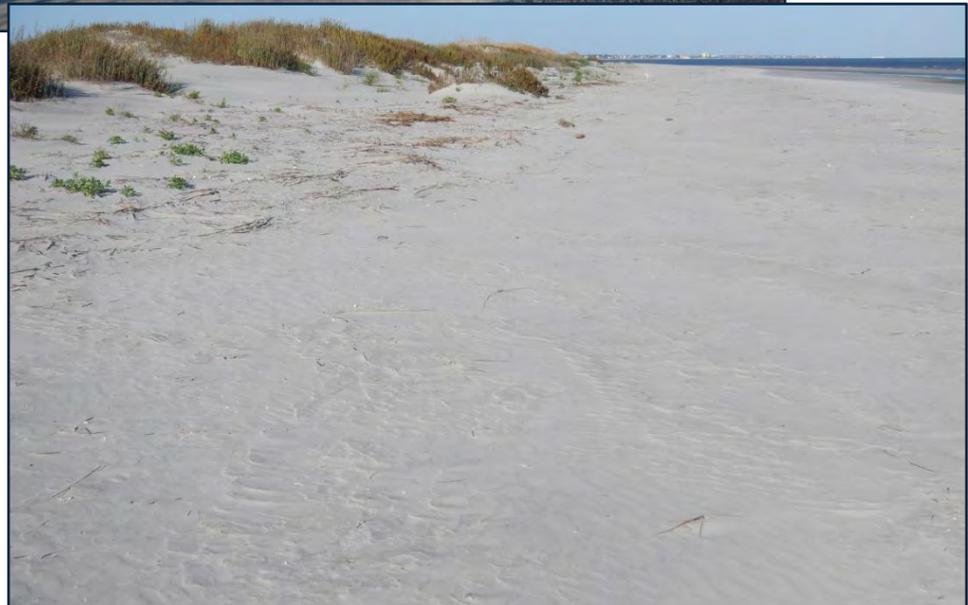
**FIGURE 4.10.**

October 2013 ground photos.

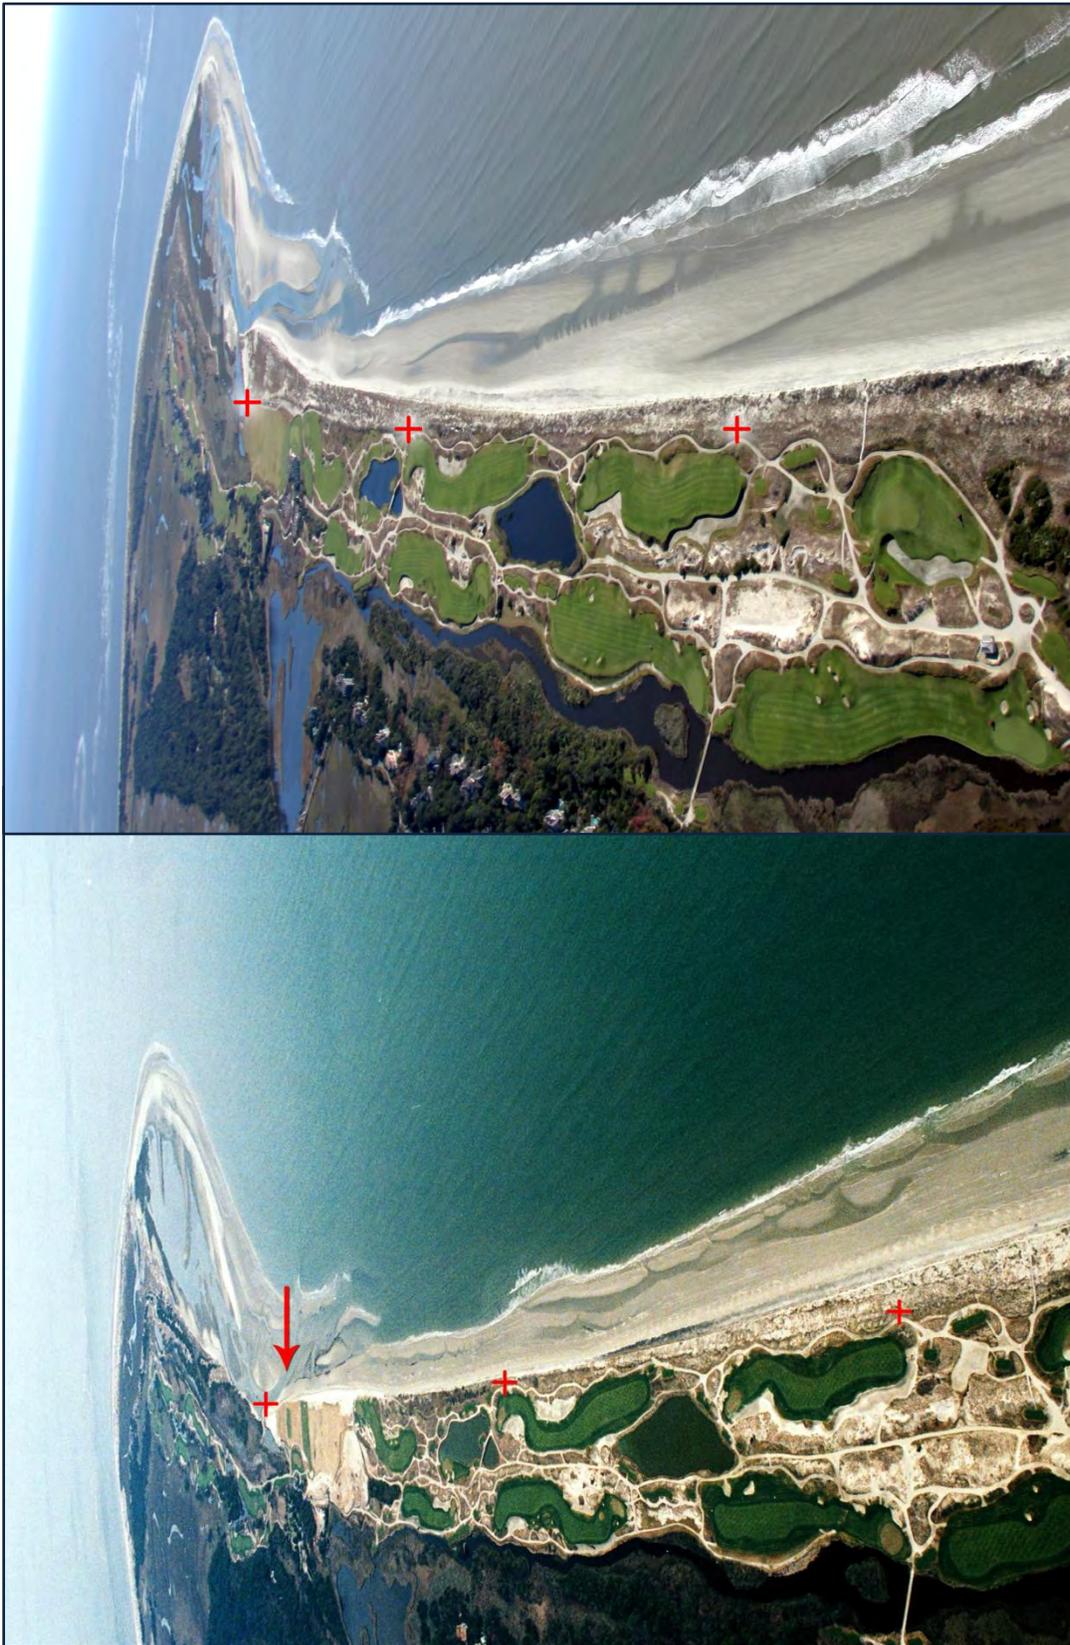
**FIGURE 4.11.** The Ocean Course Reach in February 2006 (left) and November 2013 (right). The 2006 restoration project relocated the flushing channel (arrow), which was eroding the driving range, and renourished the reach. Natural accretion following the project has led to dune growth and propagation of vegetation along all of the Ocean Course. While the configuration of the shoreline is remarkably similar for each date, there is a much wider dune/berm buffer seaward of the driving range and the 18<sup>th</sup> fairway. [Red "+" indicates the same position on the images.]

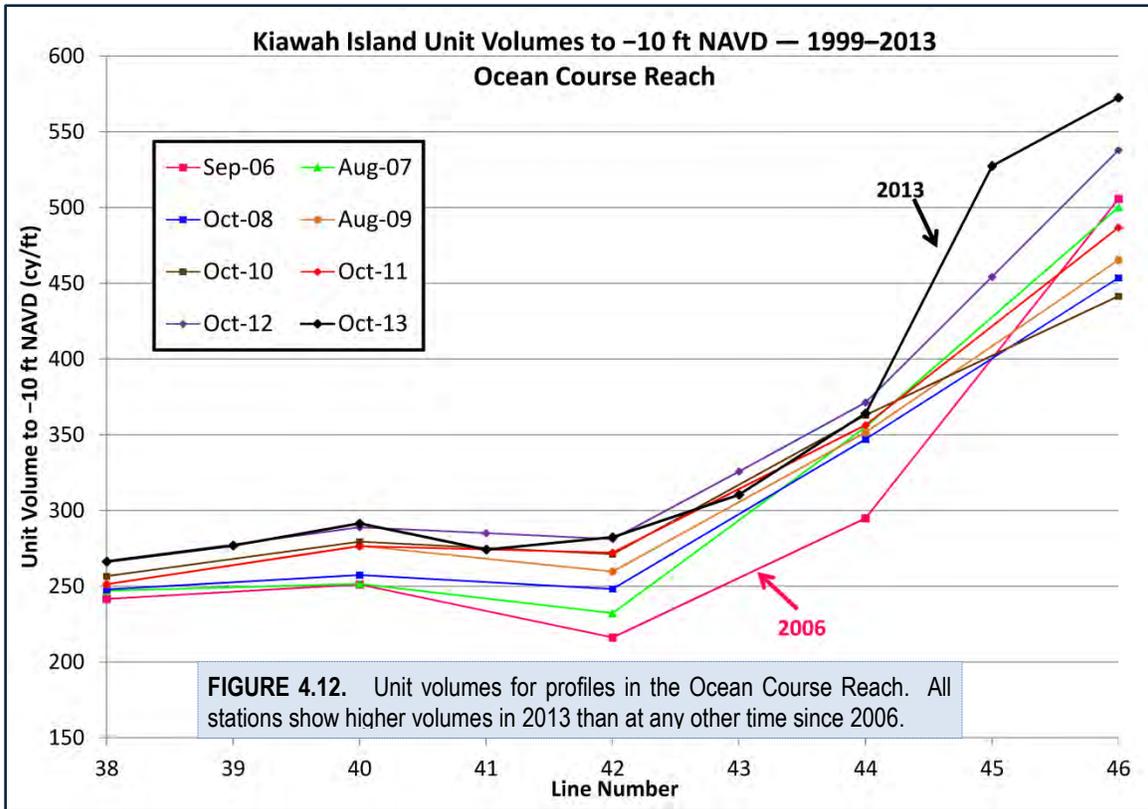
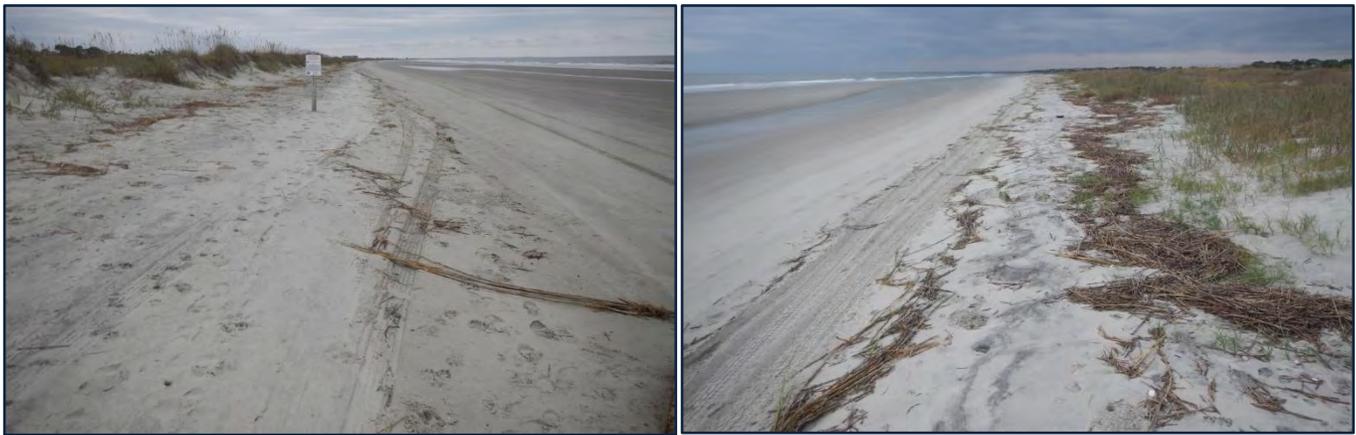
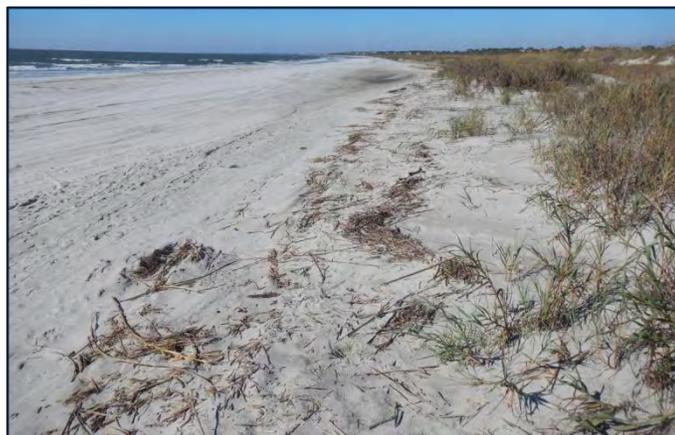
Individual lines showed unit volume changes ranging from -15.3 cy/ft to +73.2 cy/ft from 2012 to 2013. Ground photos from the reach are shown in Figure 4.13. Lines 45 and 46, at the east end of the reach (near the Clubhouse) were the most accretional, gaining 73.2 and 34.7 cy/ft (respectively). Most of the gain was in the intertidal and underwater portion of the profile and was due to sediment buildup at the seaward end of the flushing channel (Fig 4.14). The remainder of the reach showed lower volume change rates and varied between erosion and accretion (see Table 4.1). No dune erosion was evident at any of the lines in the Ocean Course Reach.

**FIGURE 4.13.**  
Ocean Course Reach in October 2013.

**[LOWER RIGHT]**  
View west from Line 45 (Club House).

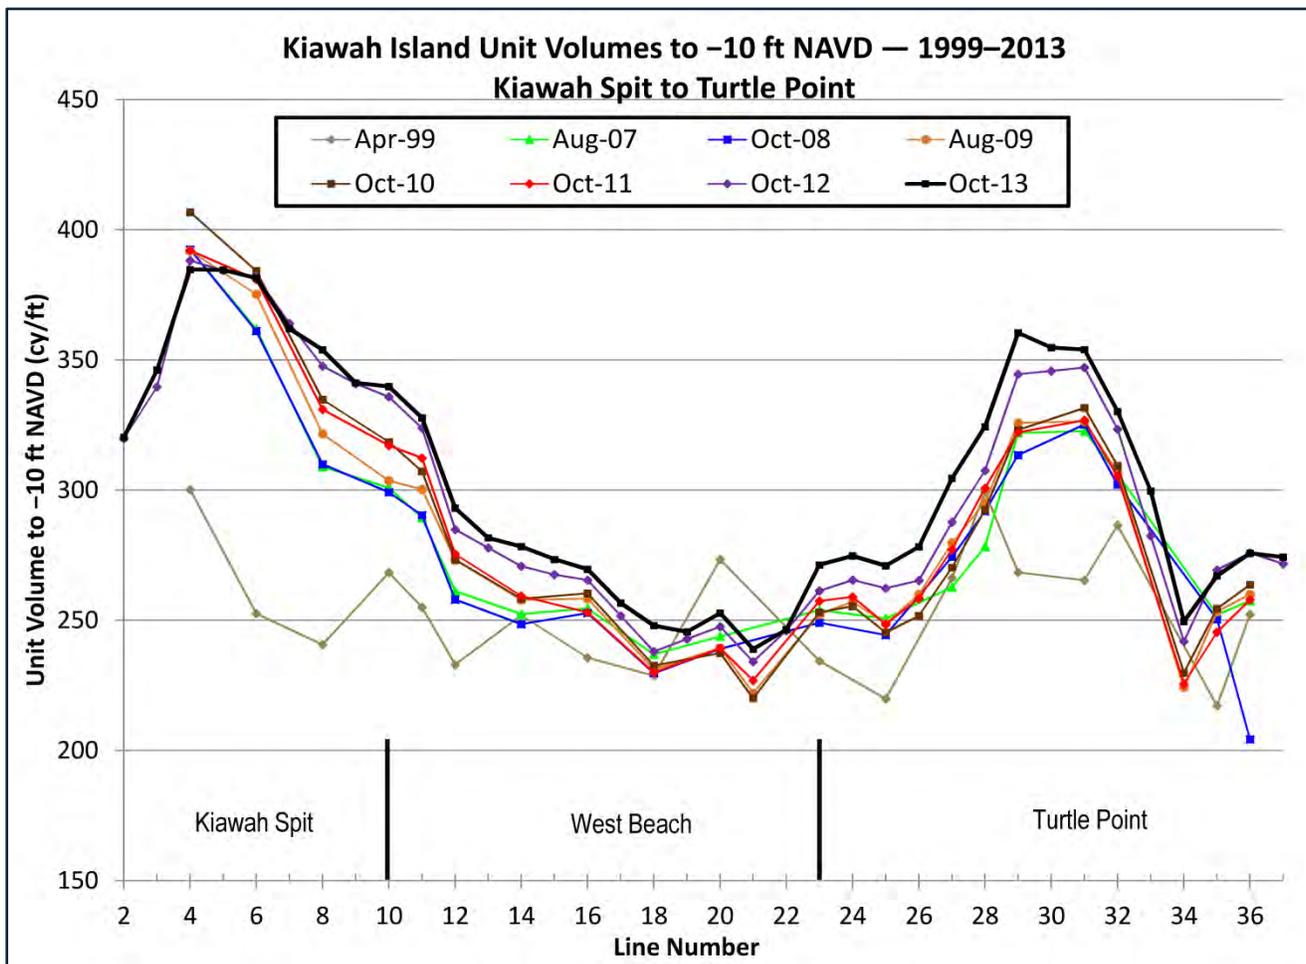
Figure 4.15 shows unit volumes for each station in the downcoast reaches. It is apparent that the present condition along the majority of the beach is much healthier than it was in 1999. Only at Line 20 (OCRM 2675 near Sea Forest Drive) does the current condition have less volume than in 1999. Overall, the downcoast reaches have gained 2.16 million cubic yards of sand since 1999, equivalent to an average annual accretion rate of 4.3 cy/ft/yr\* over the ~6-mile beach length. Over the past year, the downcoast beach was accretional, gaining a total of 188,000 cy (5.5 cy/ft) of sand. This compares to a gain of ~350,000 cy over the previous year. Since 2012, 32 of the 37 profiles in the downcoast reaches gained sand.

FIGURE 4.15. Unit volumes for each station in the downcoast reaches.

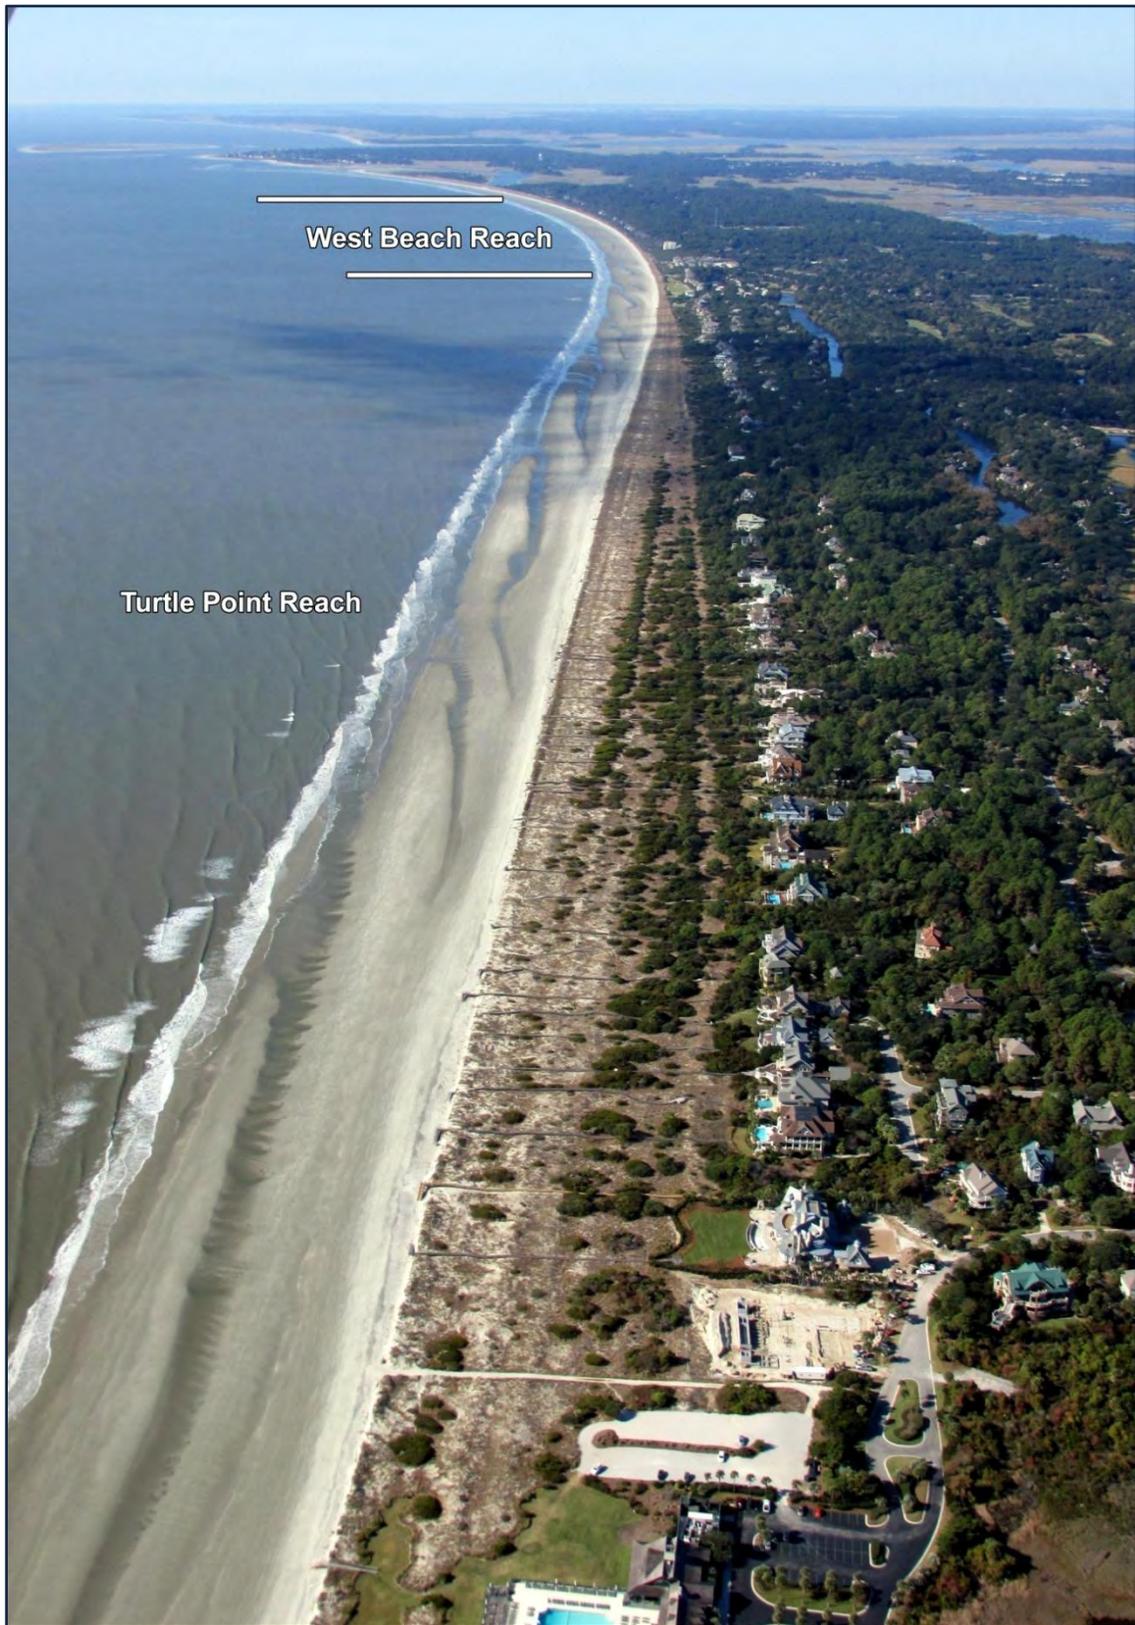
**FIGURE 4.16.** November 2013 aerial image of the Turtle Point Reach. Shrub vegetation (typically waxed myrtle) continues to propagate between sparsely vegetated foredunes. CSE expects the shrub zone to expand and eventually be transformed to forest vegetation.

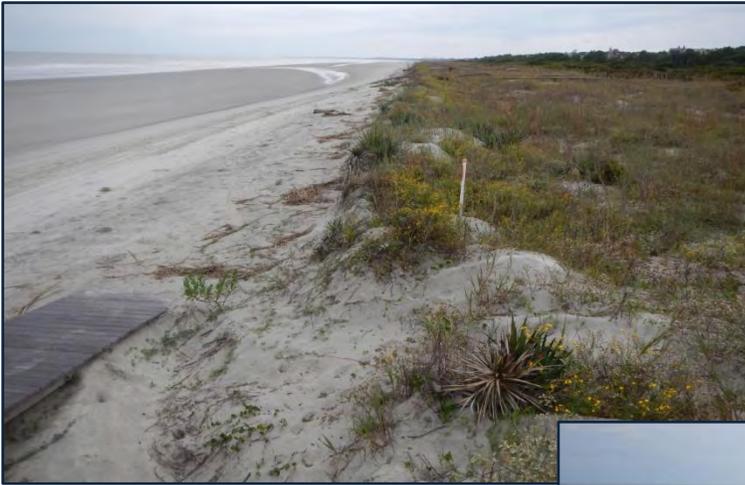
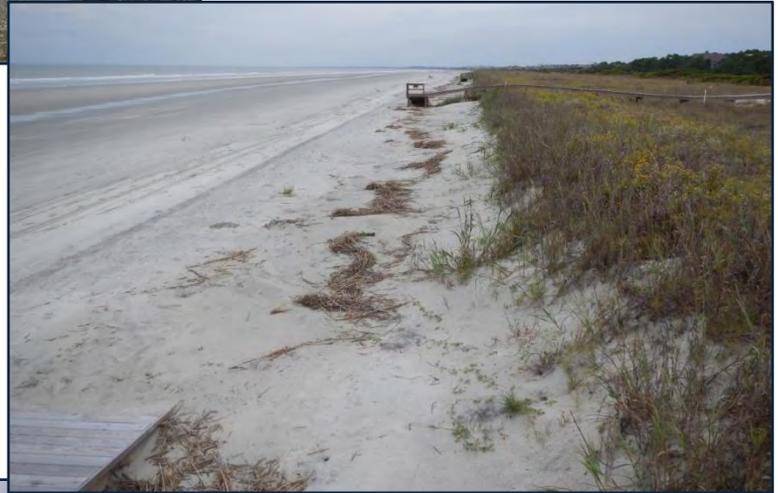
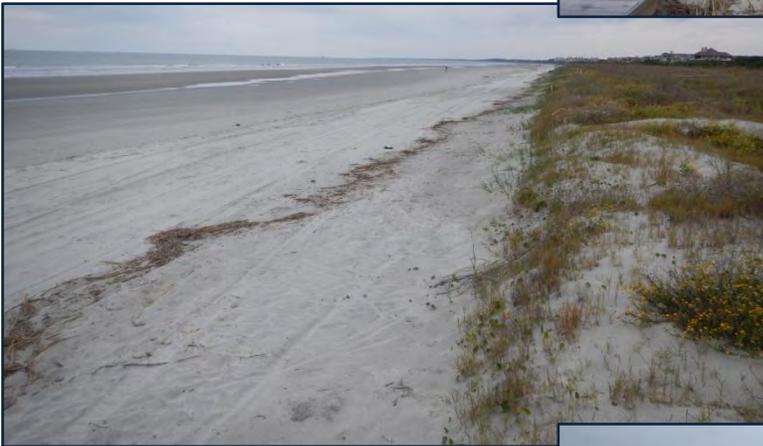
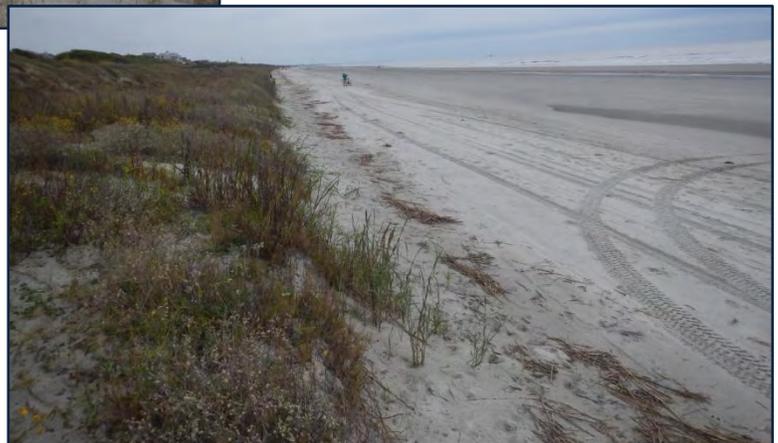
**FIGURE 4.18.** October 2013 ground photos of the Turtle Point Reach. Note the low, wide dune field and narrow dry berm.

**[LOWER RIGHT]** Line 23 near Turtle Point's 16<sup>th</sup> hole (east of The Sanctuary).

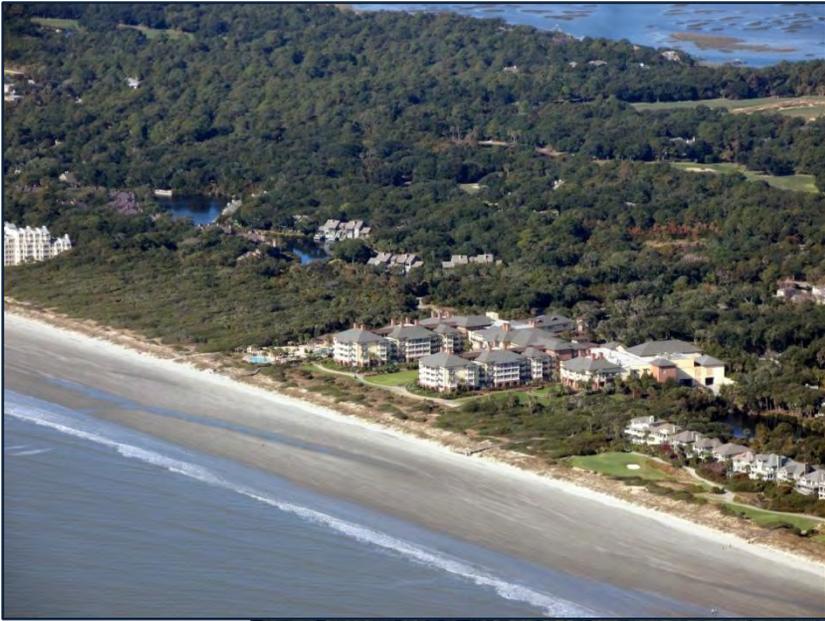
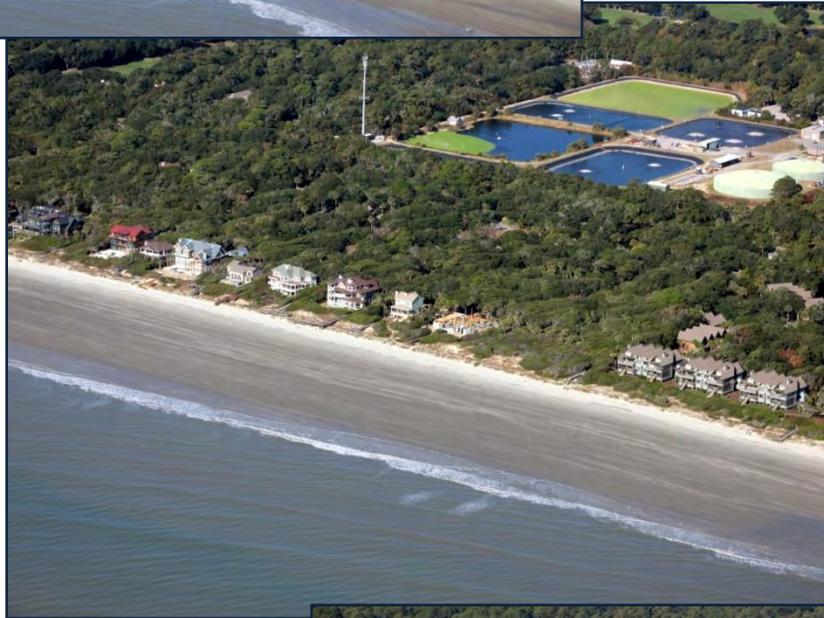
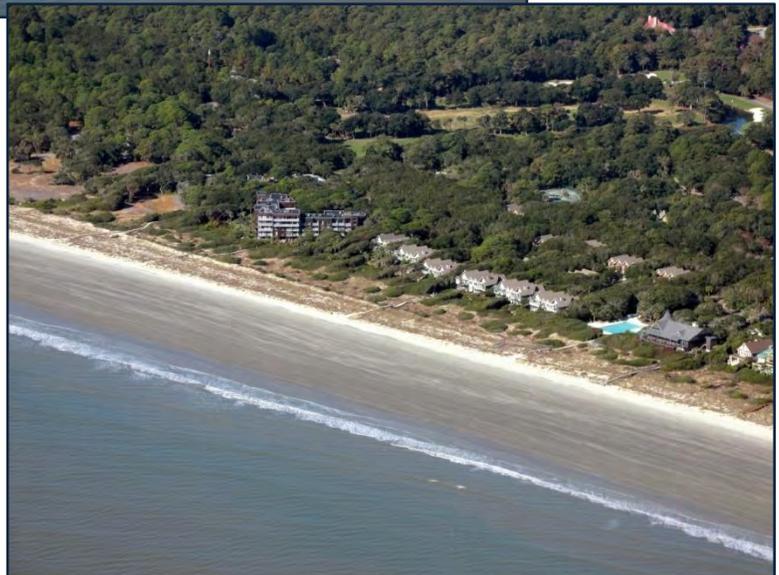
**FIGURE 4.19.** November 2013 aerial views of various areas in the West Beach Reach.

**[LOWER]** The western end of the reach near Shipwatch Drive.

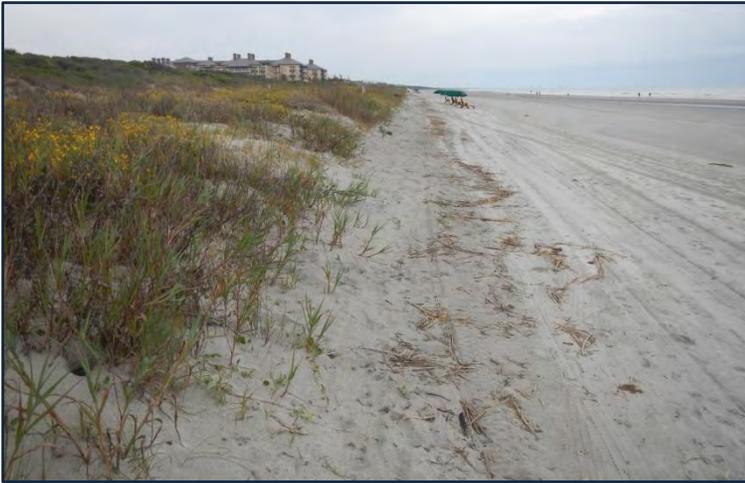
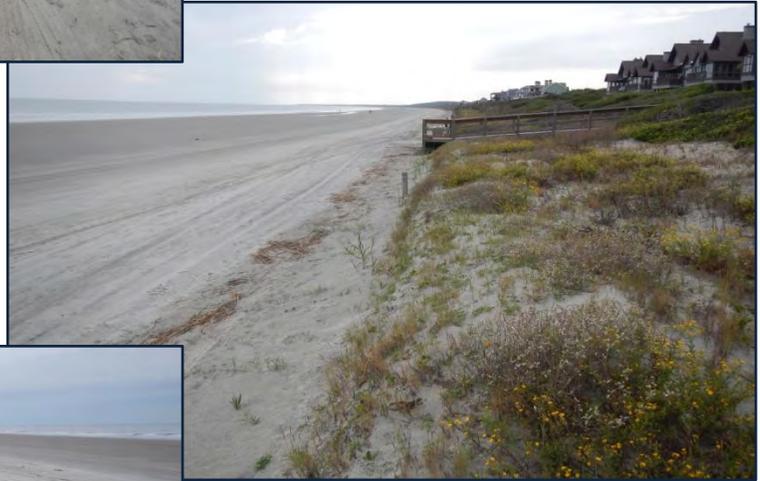
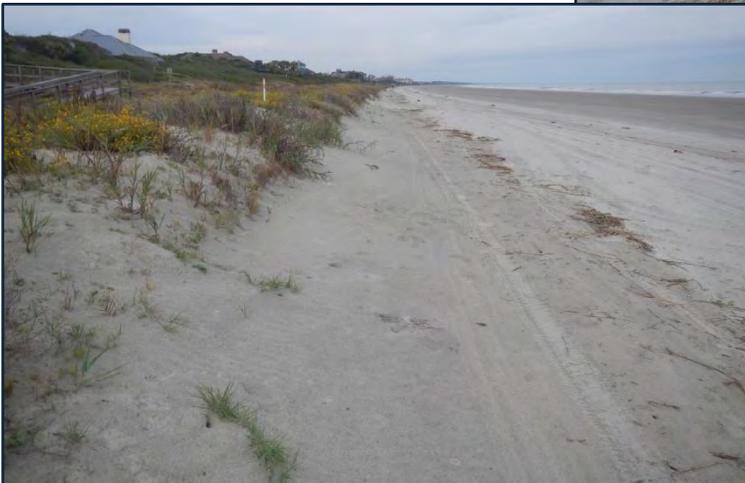
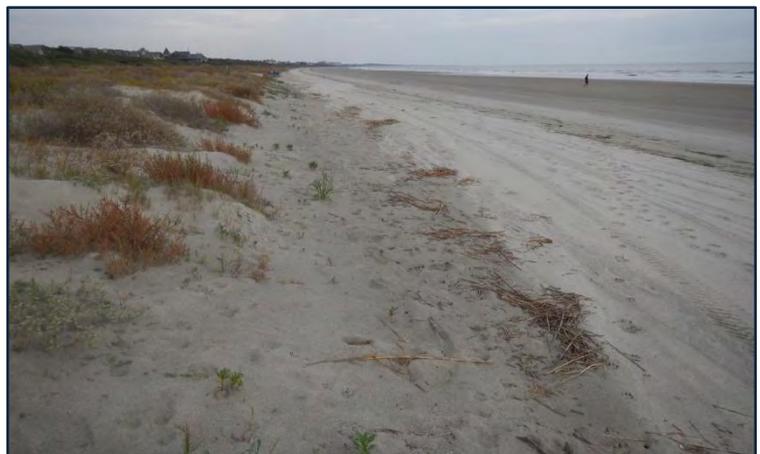
**FIGURE 4.21.** October 2013 ground photos of the West Beach Reach.
