**2006 EAST END BEACH RESTORATION PROJECT  
KIAWAH ISLAND SOUTH CAROLINA**

**Survey Report No 7  
February 2014**

**2006 EAST END BEACH RESTORATION PROJECT**  
**Kiawah Island – South Carolina**

**SURVEY REPORT NO 7**  
**Annual Beach and Inshore Surveys**

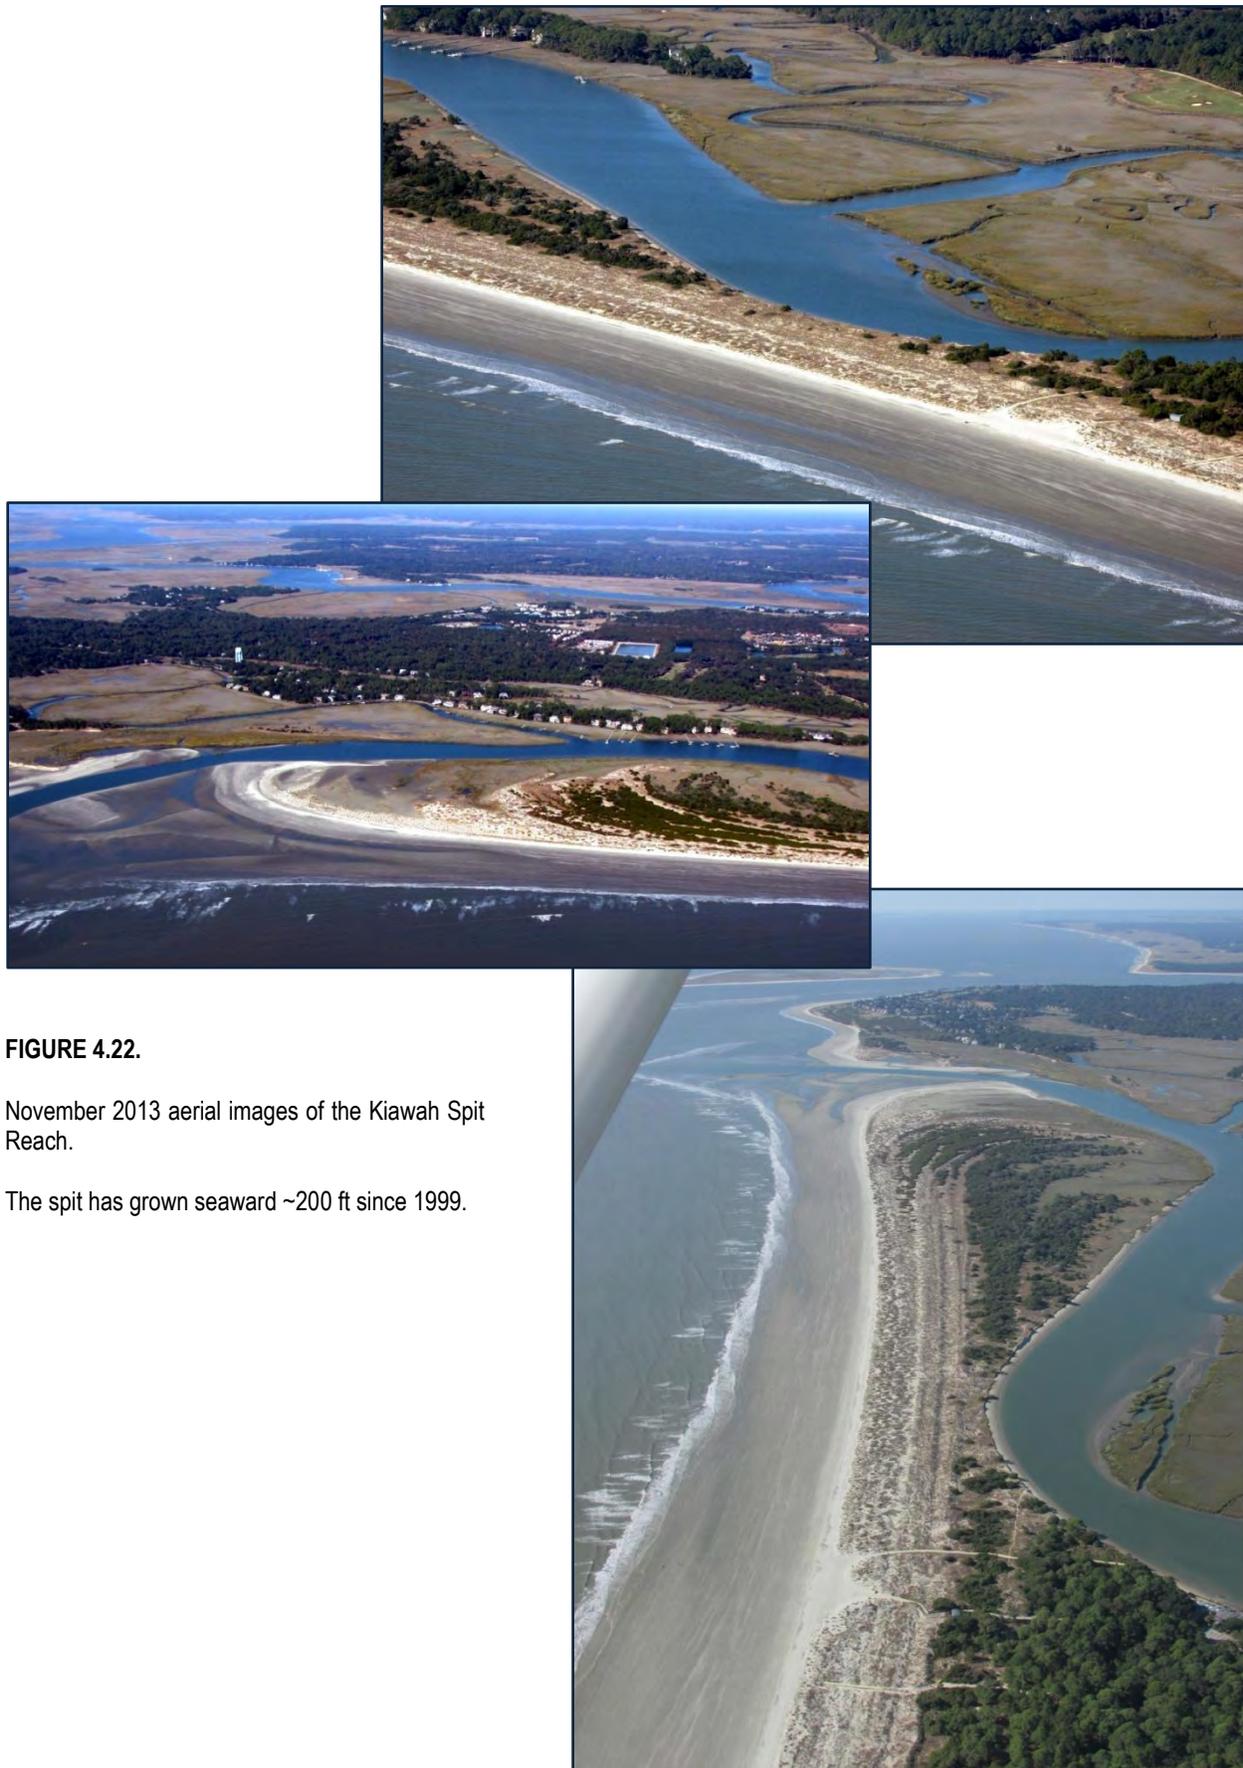
**FIGURE 4.22.**

**[MIDDLE LEFT]** View east from Line 15 near the center of Eugenia Avenue.

**[LOWER RIGHT]** View east from Line 11. The western end of the reach has a much wider, but low, dune field.

November 2013 aerial images of the Kiawah Spit Reach.

The Kiawah Spit Reach encompasses the downcoast end of the island (Fig 4.22). It acts as a collection site for sand transported by longshore currents from upcoast areas. As wave action transports sand to the west, it feeds the spit, causing growth into Captain Sams Inlet and forcing the inlet to migrate toward Seabrook Island.

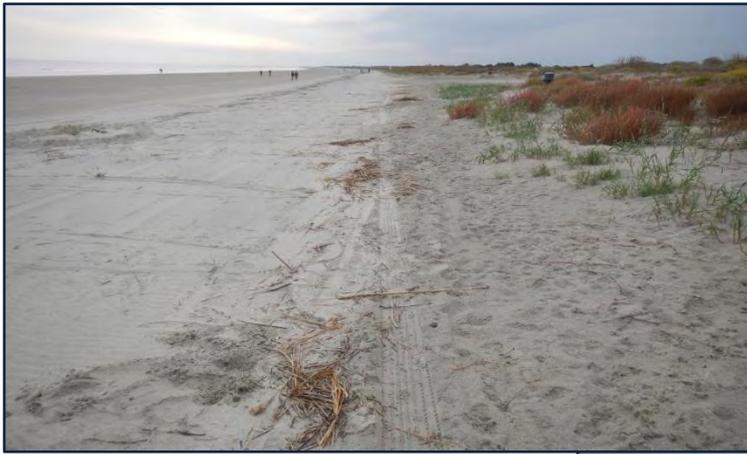
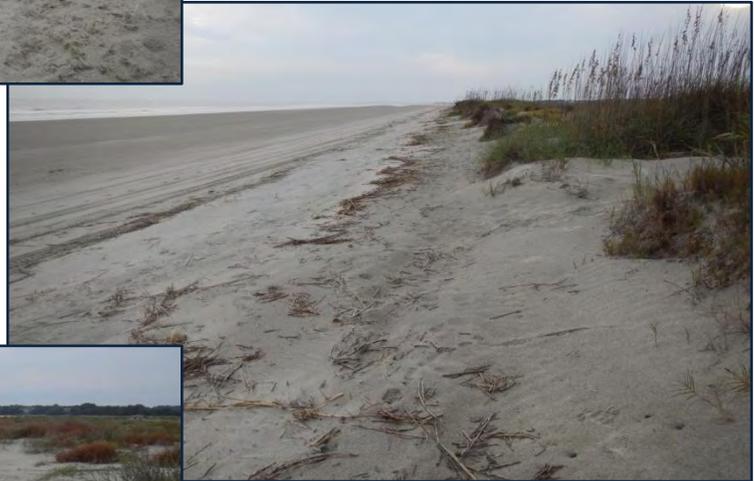
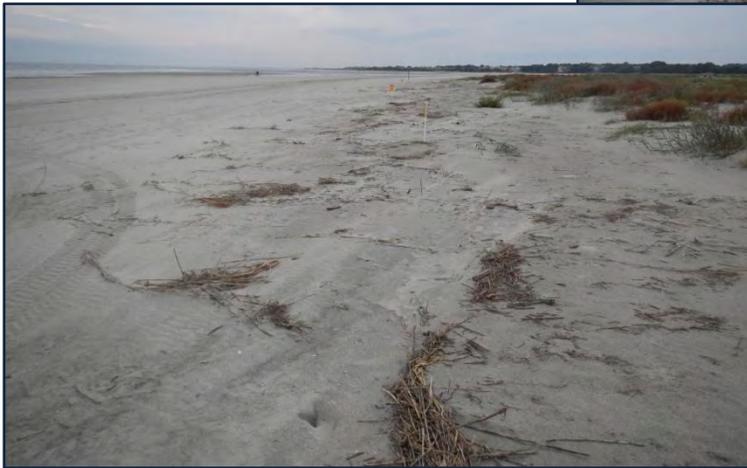
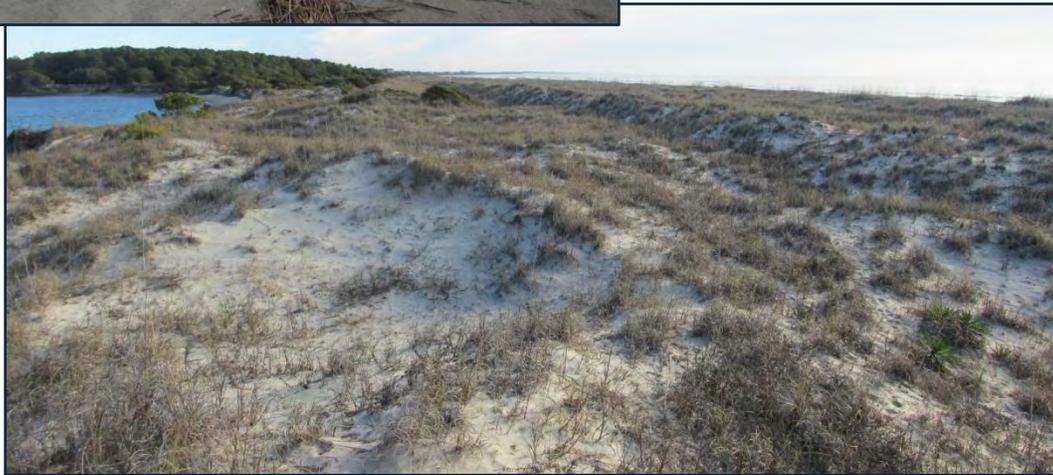
**FIGURE 4.24.** October 2013 ground photos of the Kiawah Spit Reach. **[UPPER LEFT]** Line 8 looking west (new Beachwalker vehicle access). **[MIDDLE RIGHT]** Line 4 looking west. **[MIDDLE LEFT]** Looking west near the end of the spit. **[LOWER]** January 2014 image of the dune field just west of Beachwalker Park.
