## How Do You Prevent Indented Buttonhole Sites?

Lynda K. Ball  
Stuart Mott

Ball, L.K., & Mott, S. (2010). How do you prevent indented buttonhole sites? *Nephrology Nursing Journal*, 37(4), 427-428, 431.

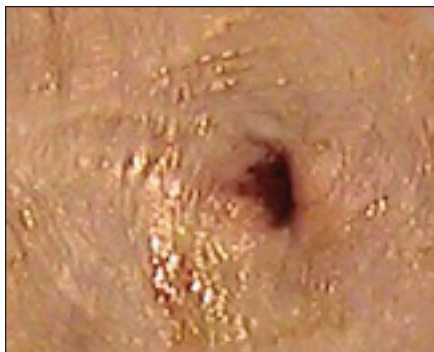
**Figure 1**

This illustrates the concave area, “hubbing,” caused by advancing the hub into the buttonhole.

The experience you have described is not unique to your facility. The authors have received reports of this occurrence from around the country. Because this technique does not require rotating cannulation sites, the constant pressure exerted by the needle hub pushing up against the skin with repeated cannulations can cause the mouth of the buttonhole site to enlarge. As cannulation continues, further deterioration of the entrance to the buttonhole sites occurs, creating a concave area (see Figure 1). This phenomenon is known as “hubbing.” The term hubbing is derived from the needle hub actually becoming buried in the entrance to the tunnel and cannot be

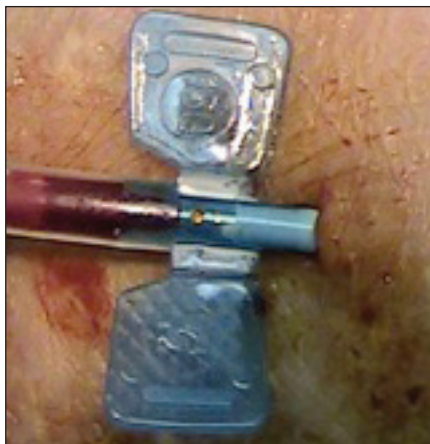
**Figure 2**

The hub of the needle is inserted into the buttonhole, leading to the development of “hubbing.”

seen (see Figure 2). Potential problems associated with hubbing may include:

- Inability to remove the scabs completely.
- Inability to clean the entrance site thoroughly.
- Increased trauma at the entrance of the buttonhole sites.
- Breakdown of the epithelial lining of the buttonhole tunnel.

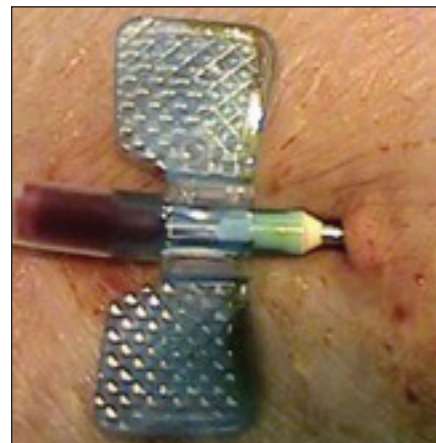
**Figure 3**

This image demonstrates correct needle placement with approximately 1/16 inch of the needle exposed, preventing the hub from entering the buttonhole that can lead to the development of “hubbing.”

What does that mean for nephrology nurses? First and foremost, we need to prevent hubbing from occurring. When inserting needles into the buttonhole tunnels, make

sure to leave approximately 1/16” of the needle exposed, which will prevent the hub of the needle from touching the entrance sites (see Figure 3).
