GEOMORPHIC ANALYSIS OF CACHE CREEK BETWEEN RUMSEY AND MADISON YOLO COUNTY, CALIFORNIA

GEOMORPHIC ANALYSIS
OF
CACHE CREEK
BETWEEN RUMSEY AND MADISON
YULO COUNTY, CALIFORNIA

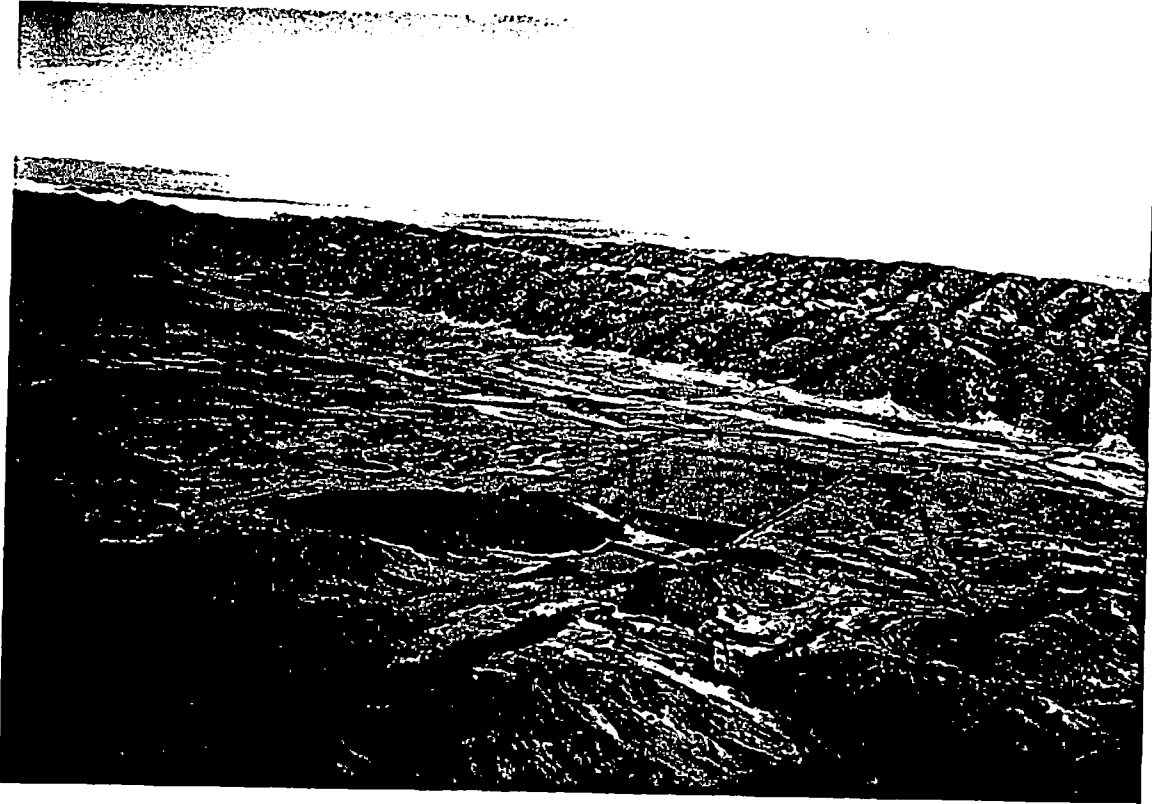
Figure 2.6. Upper valley along Bear Creek (looking east).

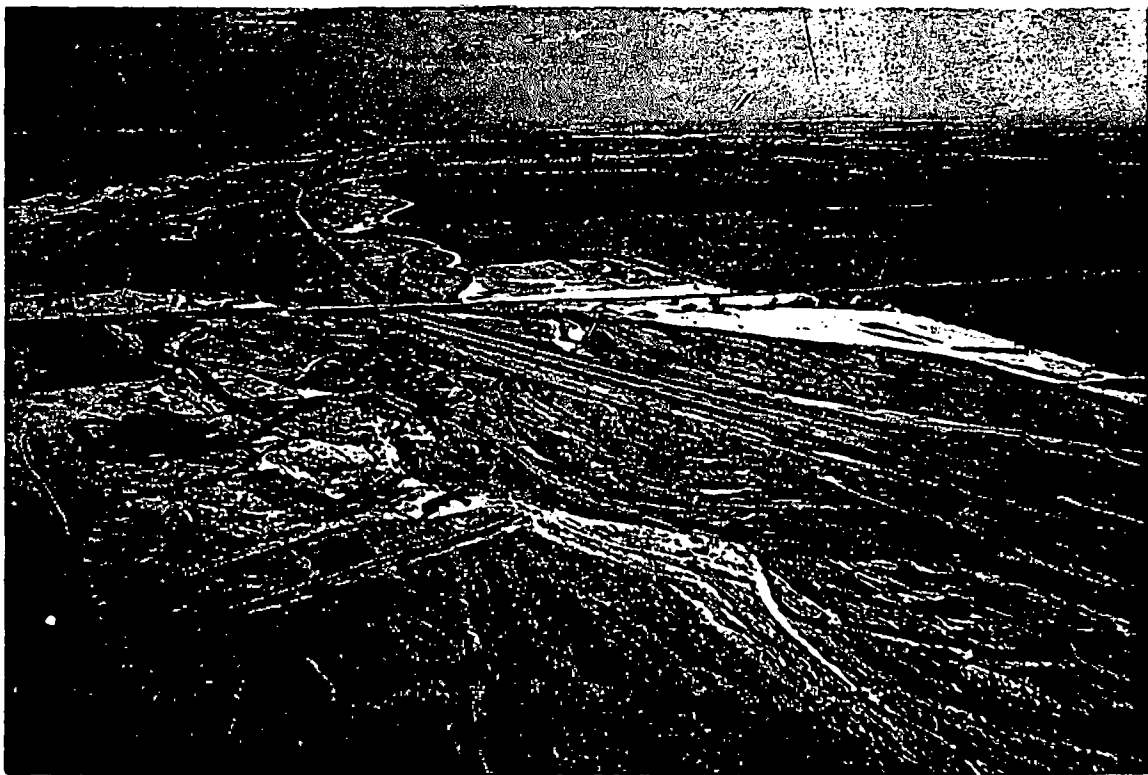
Figure 2.9. Cache Creek at Esparto Bridge (looking downstream).

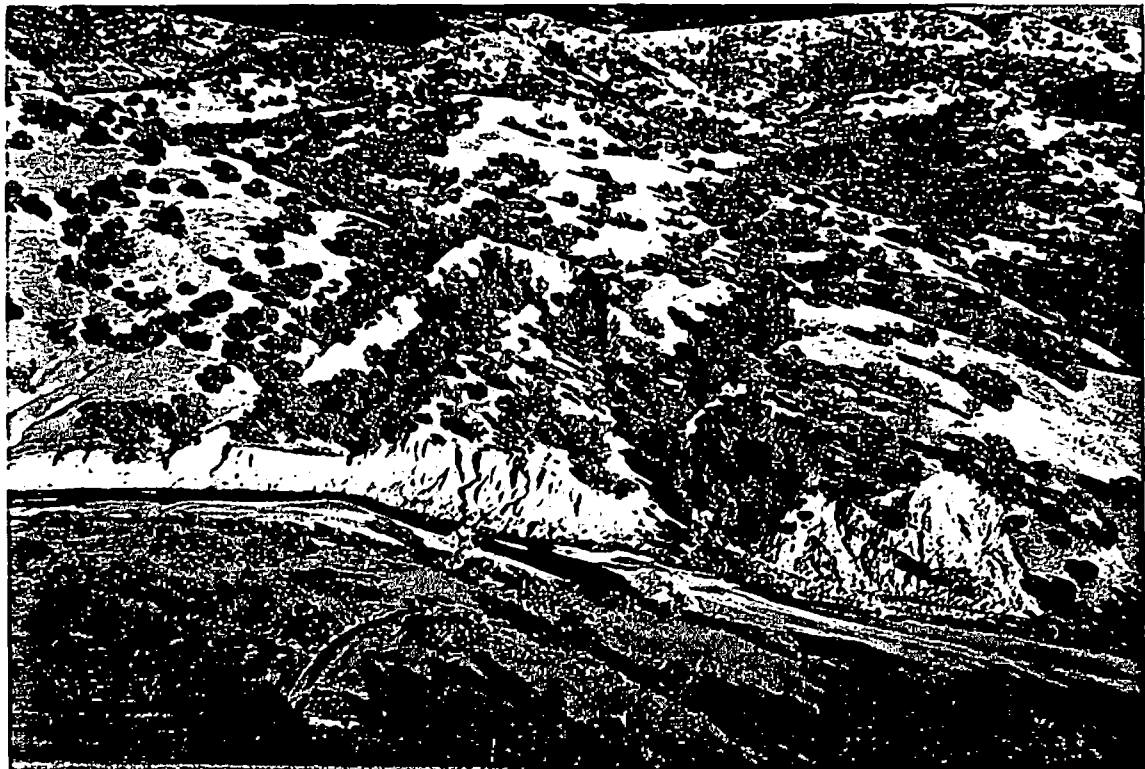
Figure 2.30. Landslide along left bank Cache Creek, River Mile 18.5.

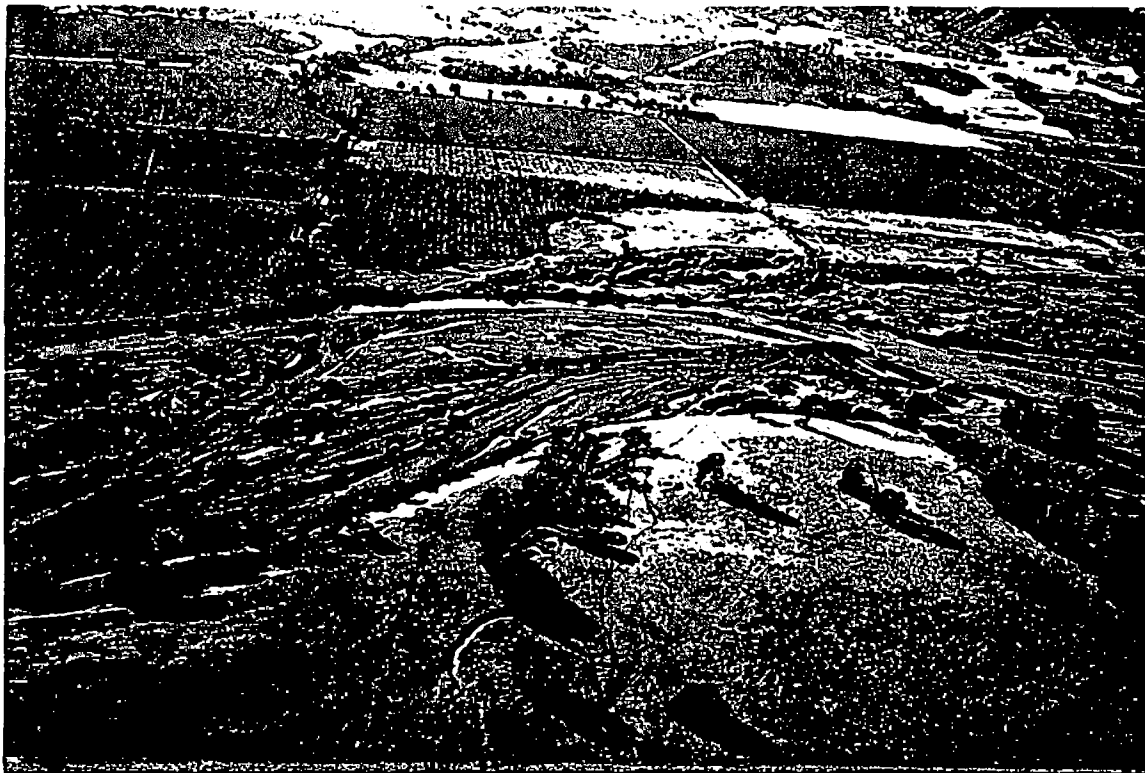
Figure 2.38. Excavated sand-and-gravel bar along Cache Creek, River Mile 17.2 (looking towards left bank).

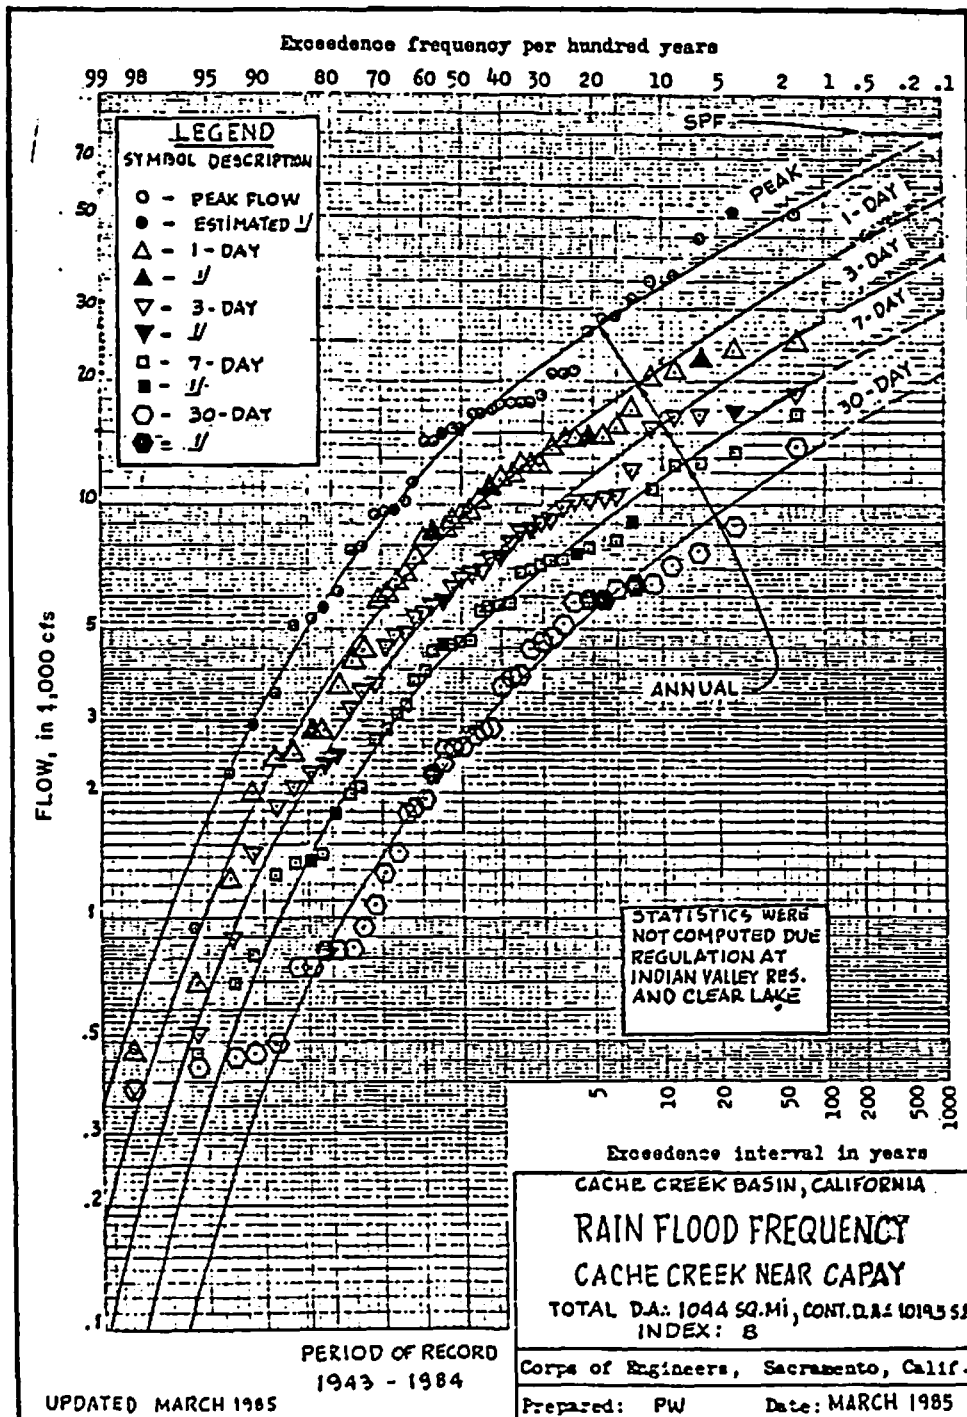
Figure 3.2. Flood frequency curves for Cache Creek near Capay (USCOE, 1985b).

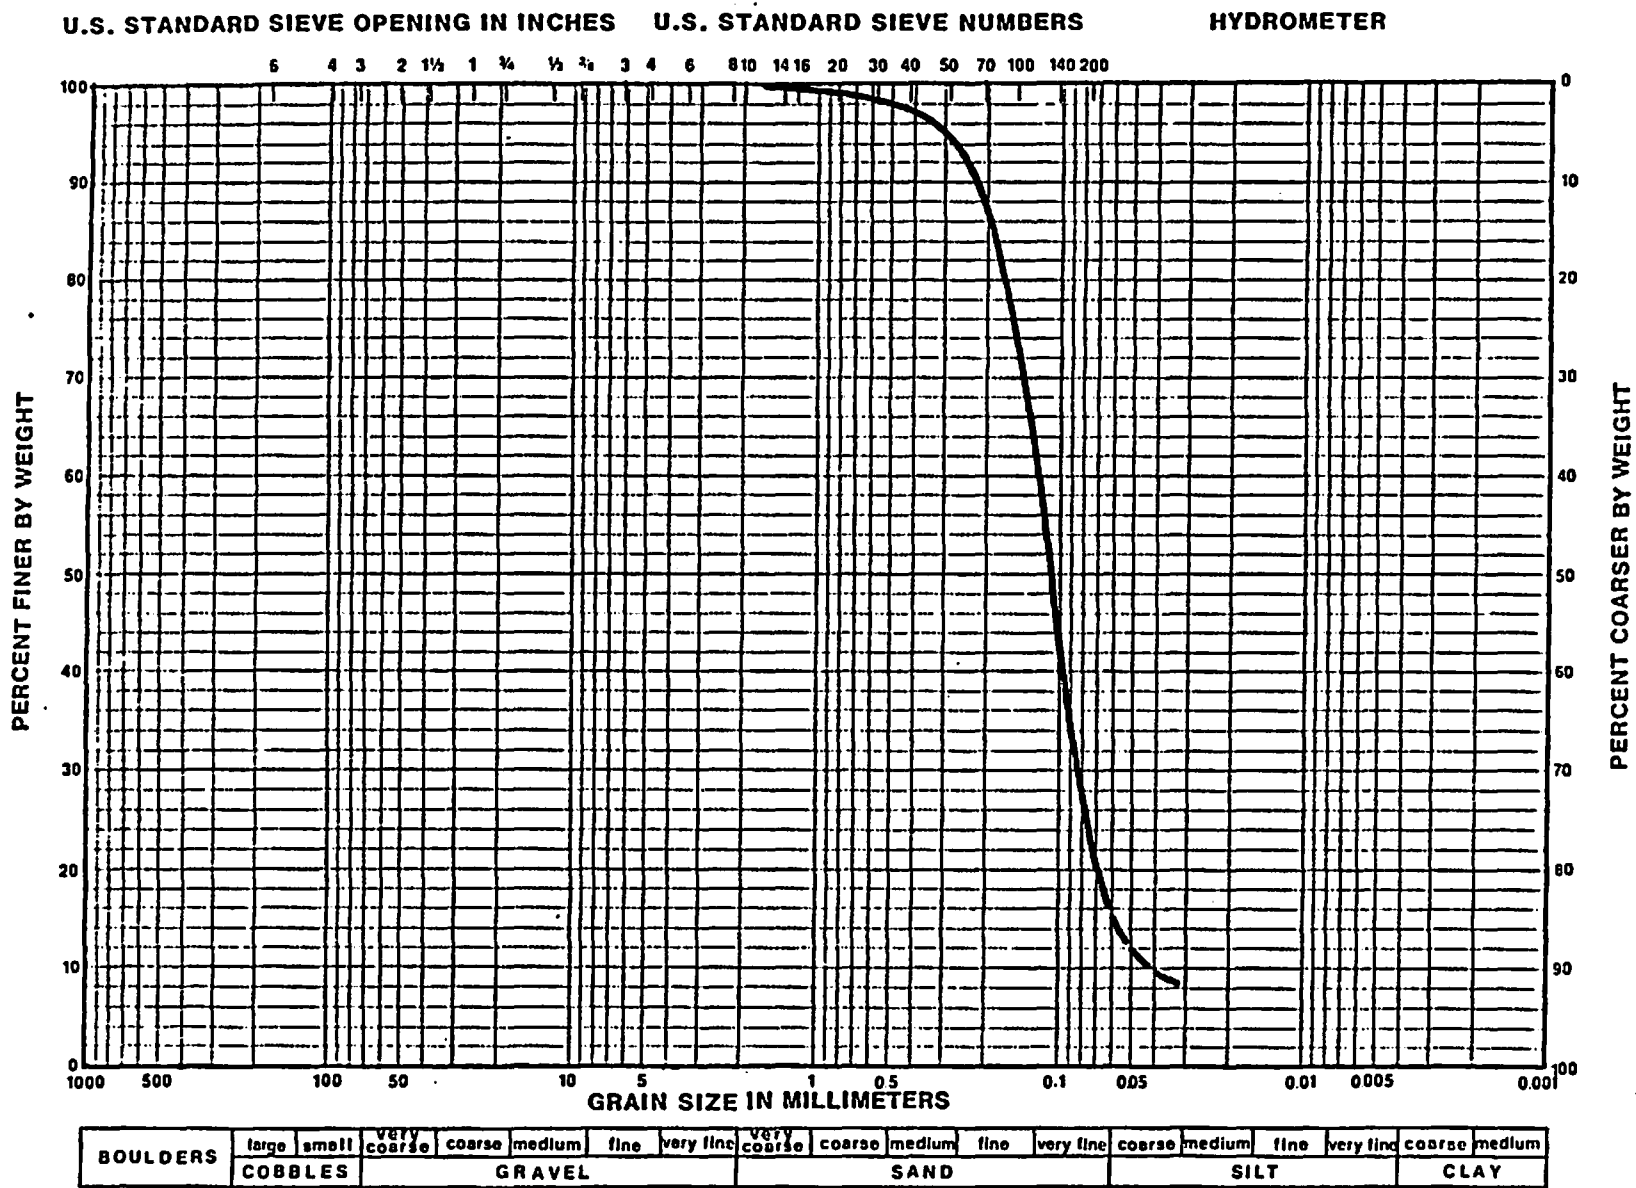
Figure 4.8. Representative bank-size distribution.

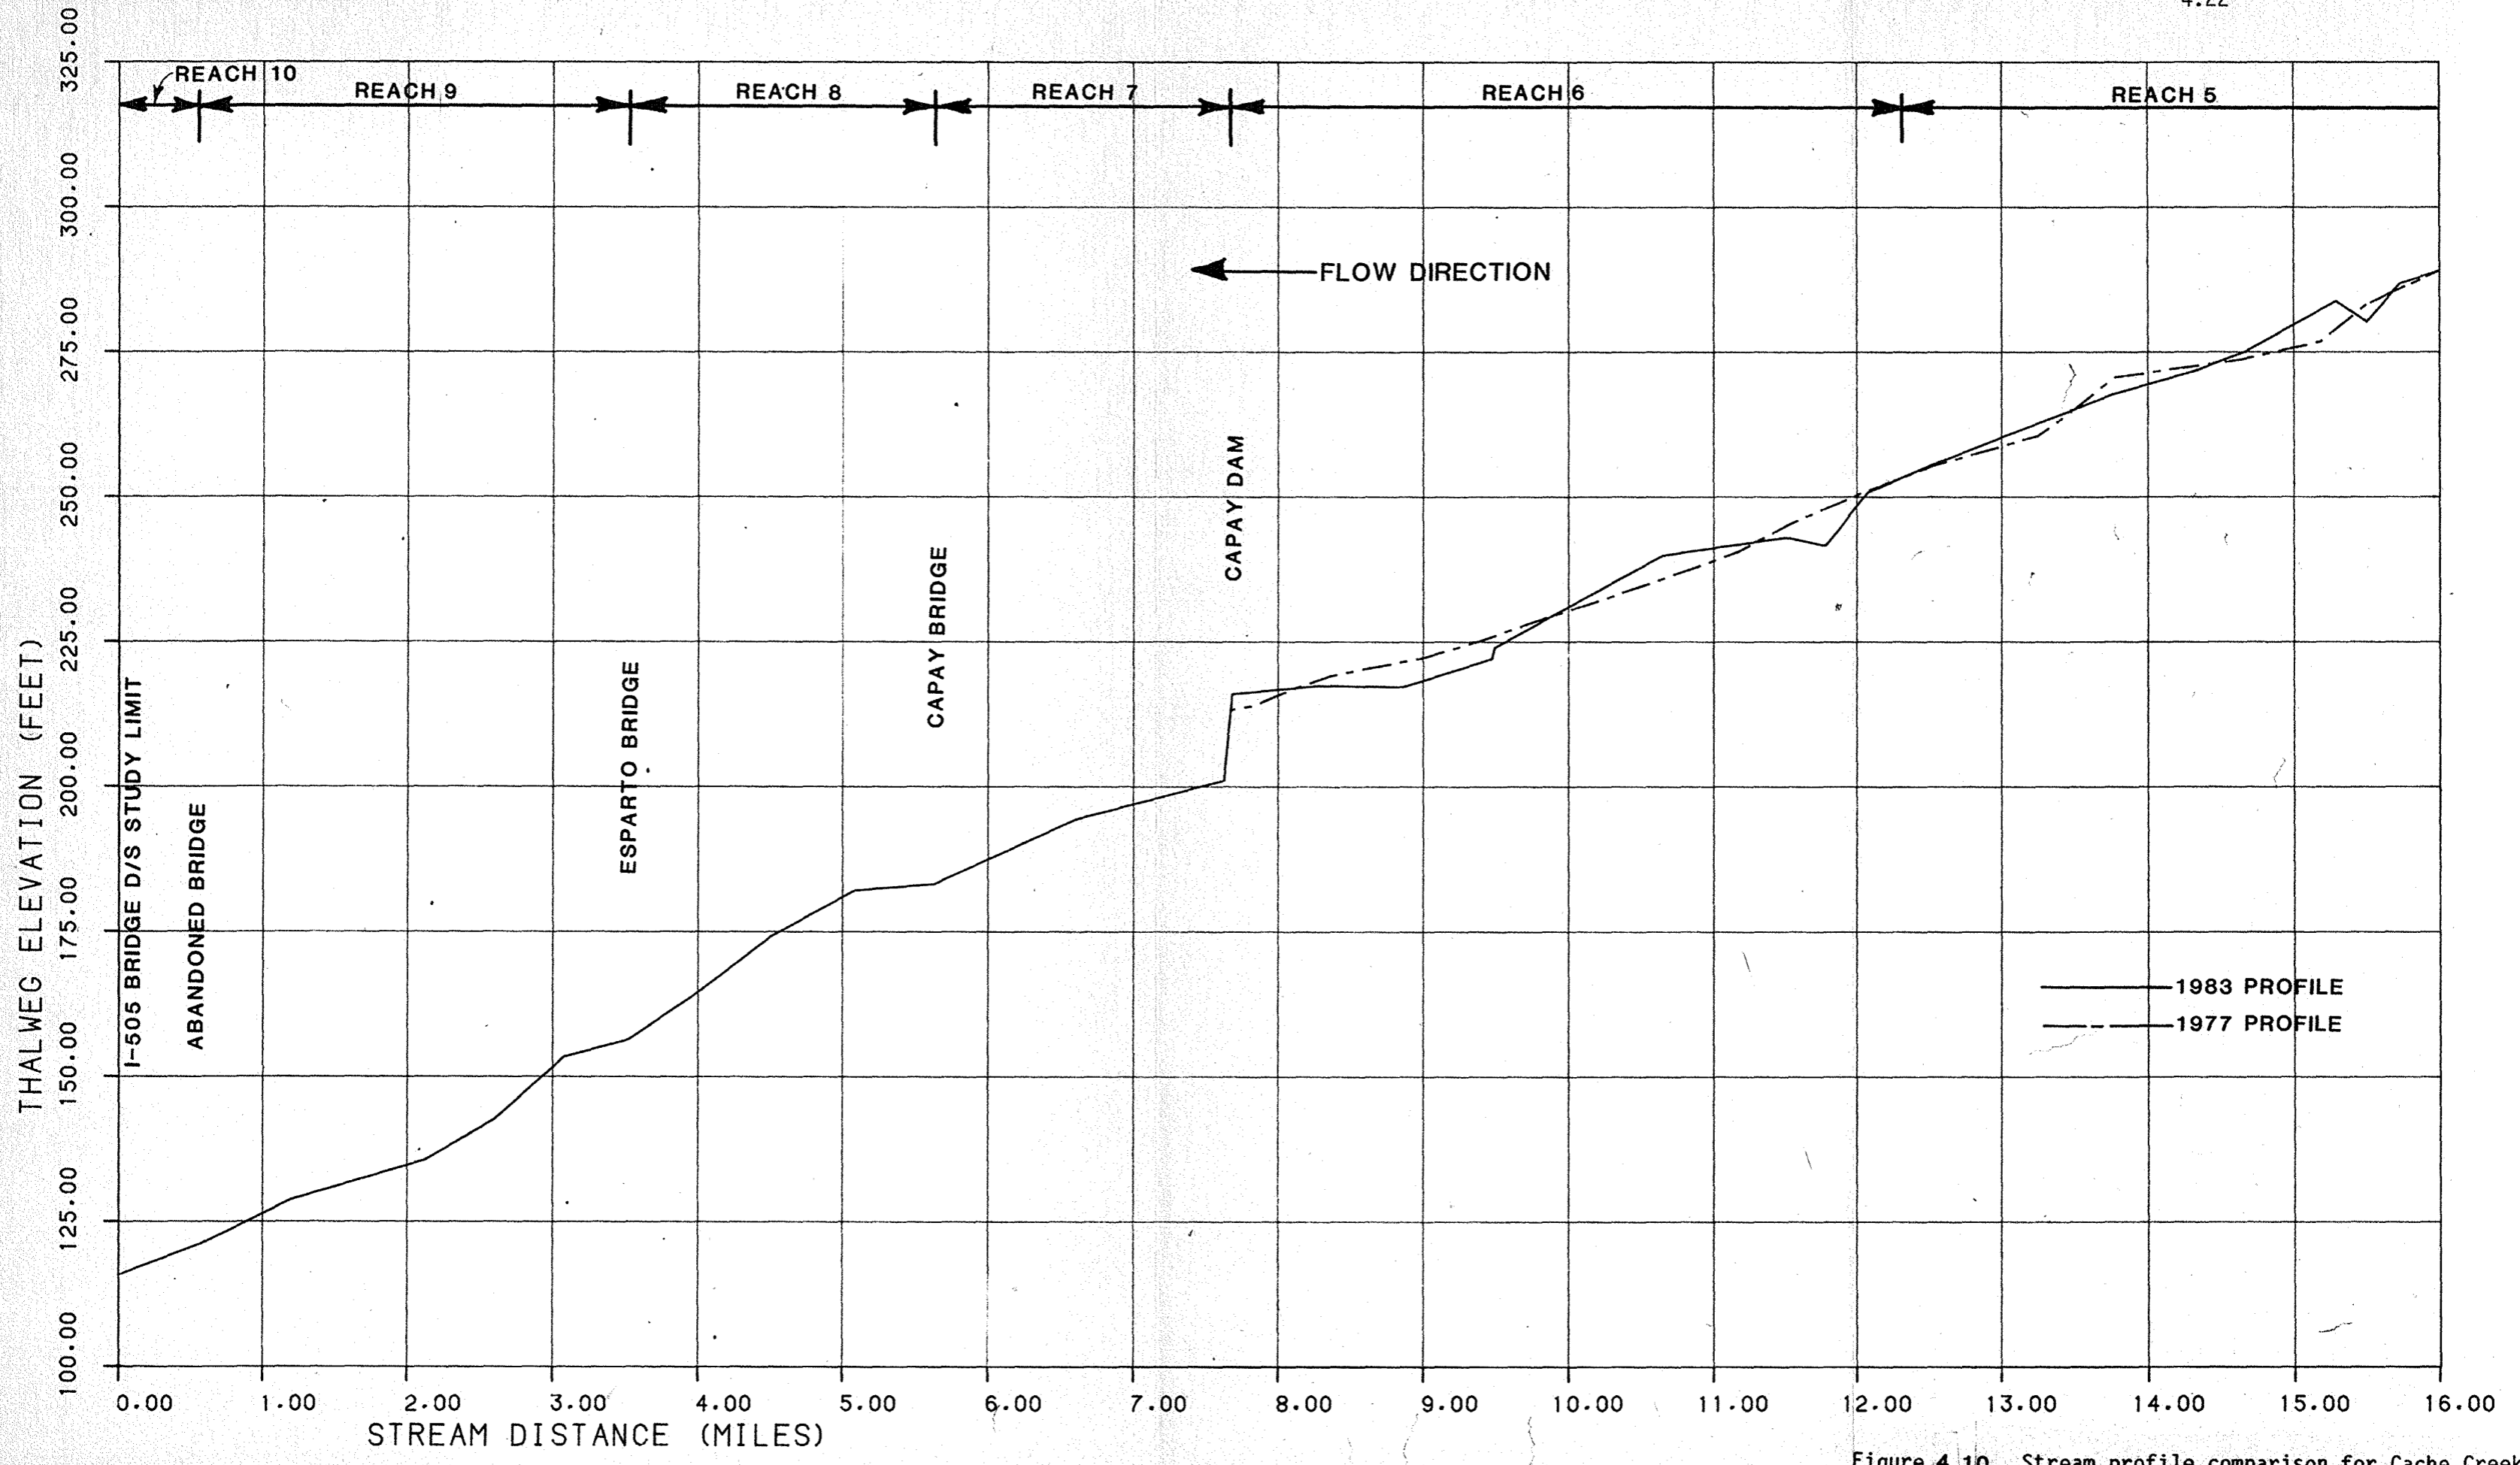
Figure 4.10. Stream profile comparison for Cache Creek

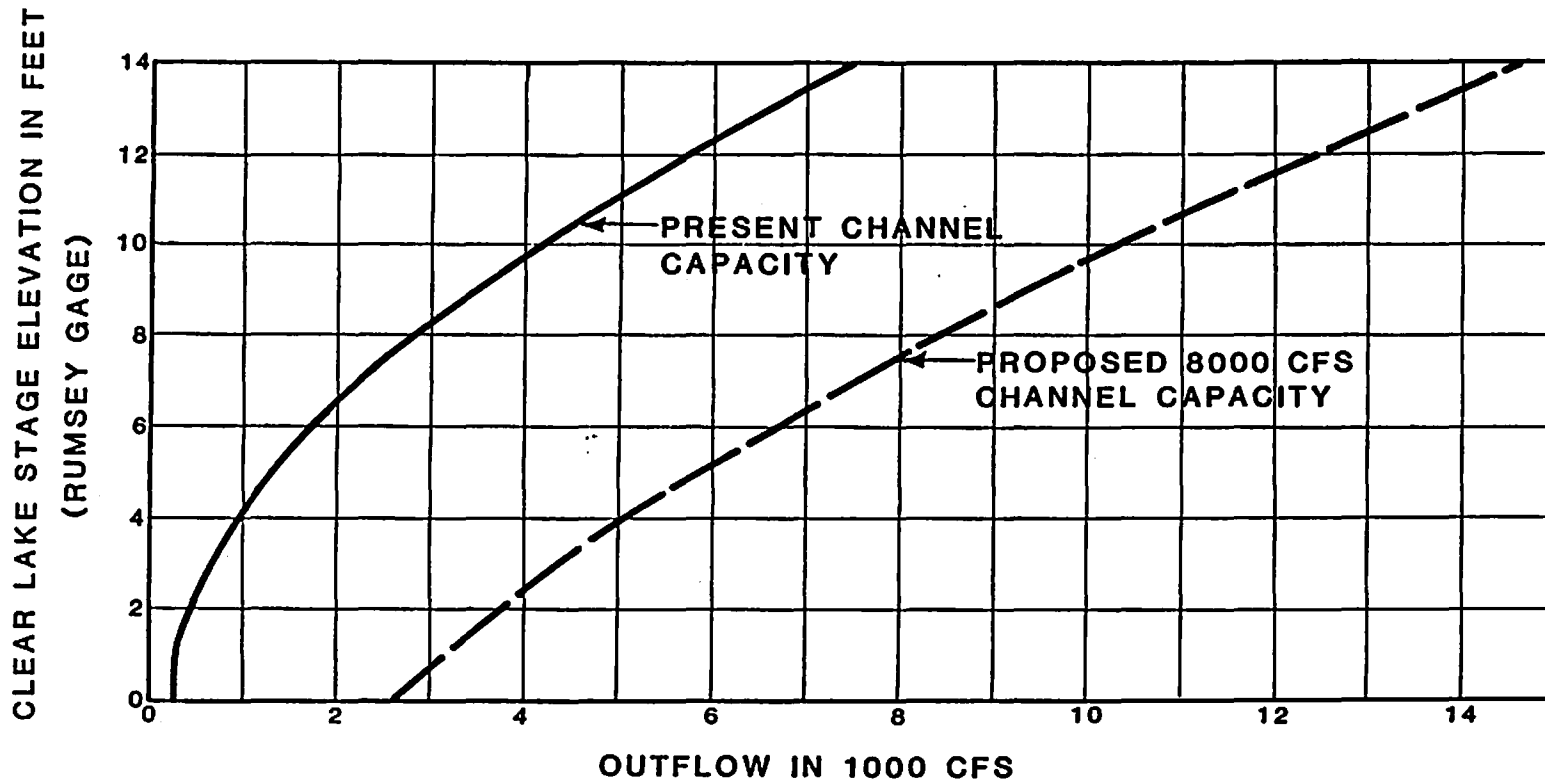
Figure 2.1. Clear Lake outlet channel rating curves proposed for the Clear Lake flood-control project.

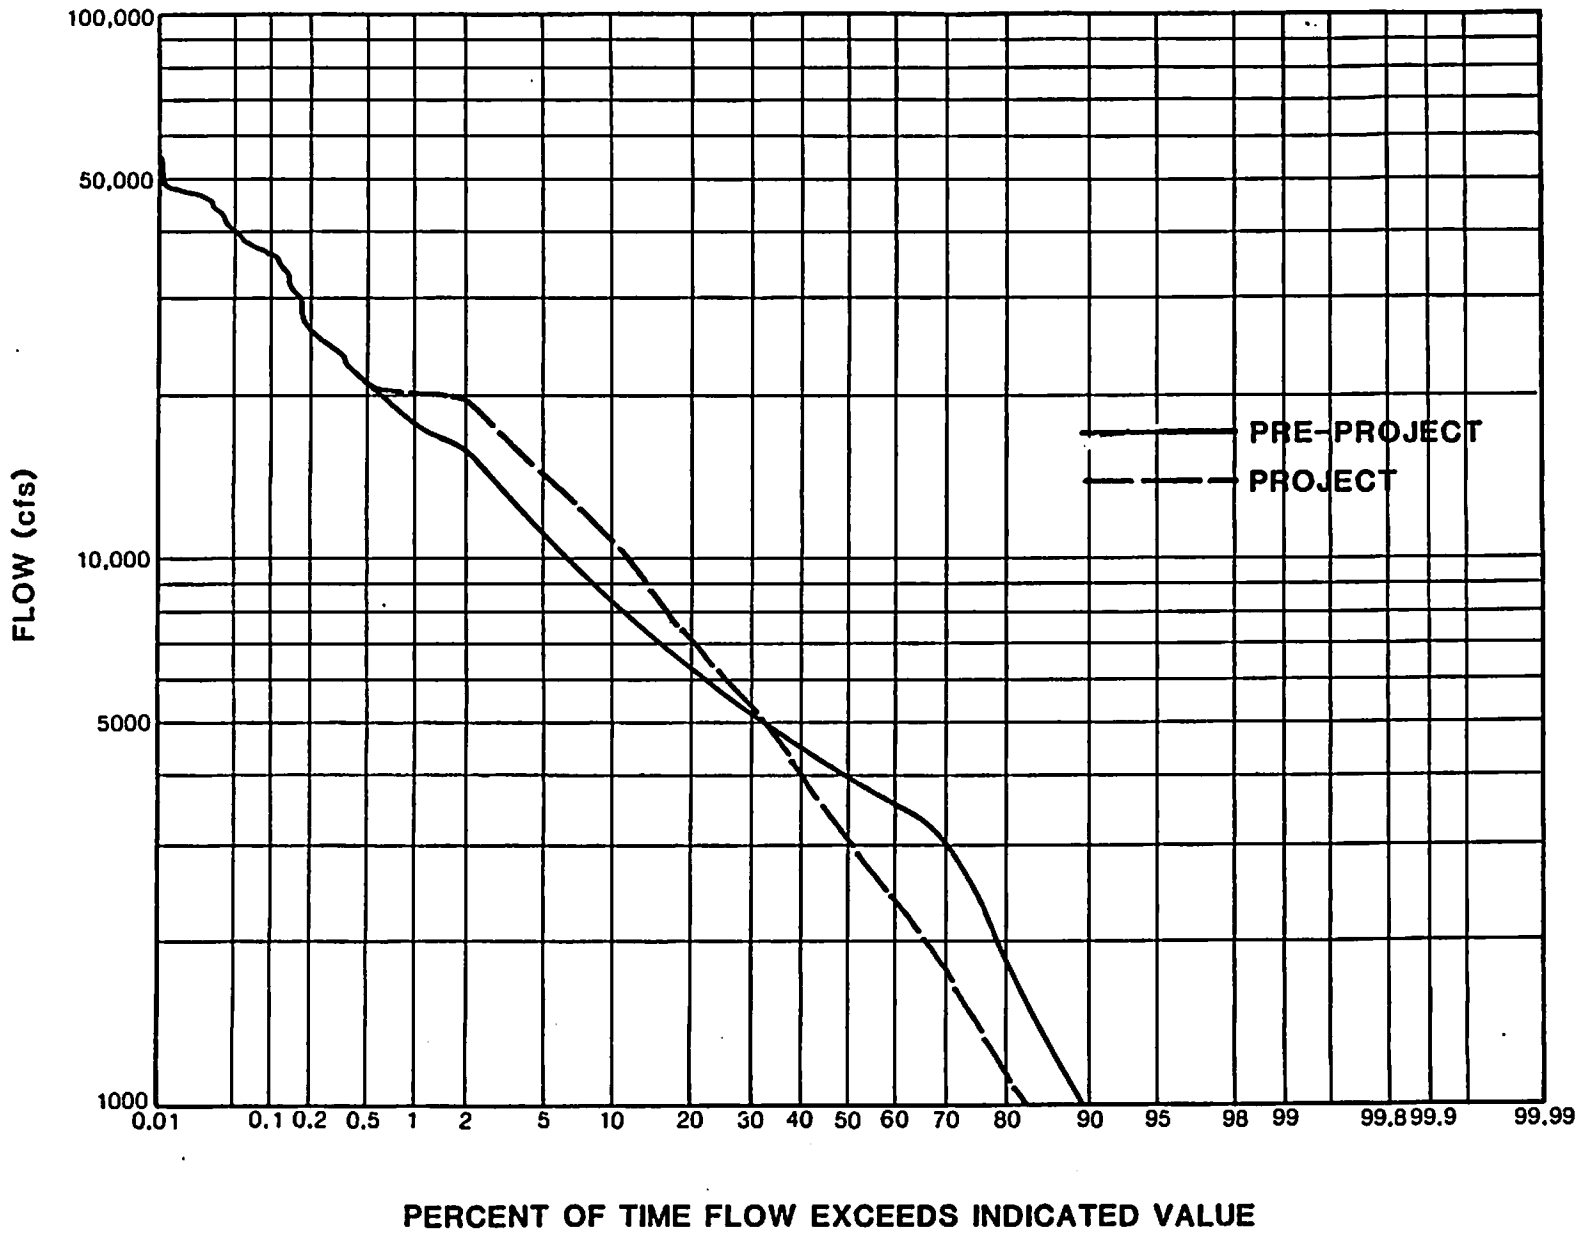
Figure 2.3. Pre- and postproject flow-duration curves computed at Rumsey for the entire period of simulated flows.

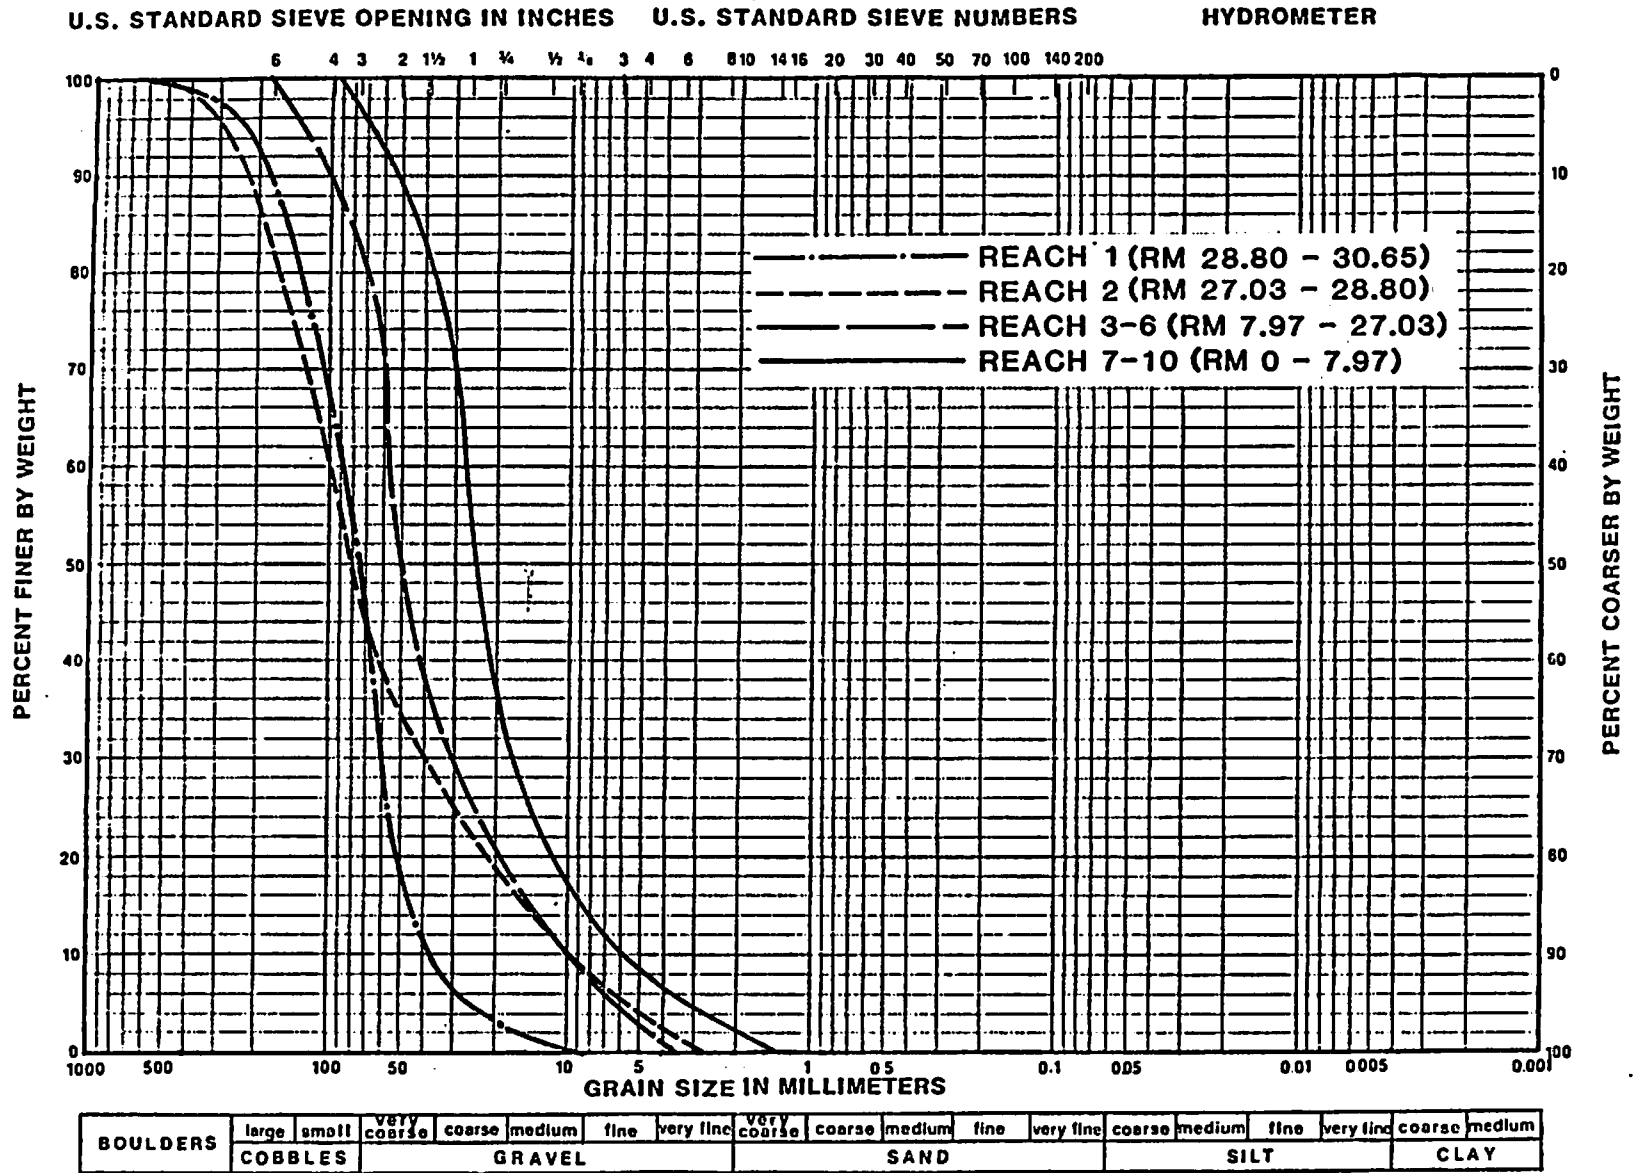
Figure 4.1. Average bed-material size distributions used to develop sediment-transport relationships along Cache Creek.

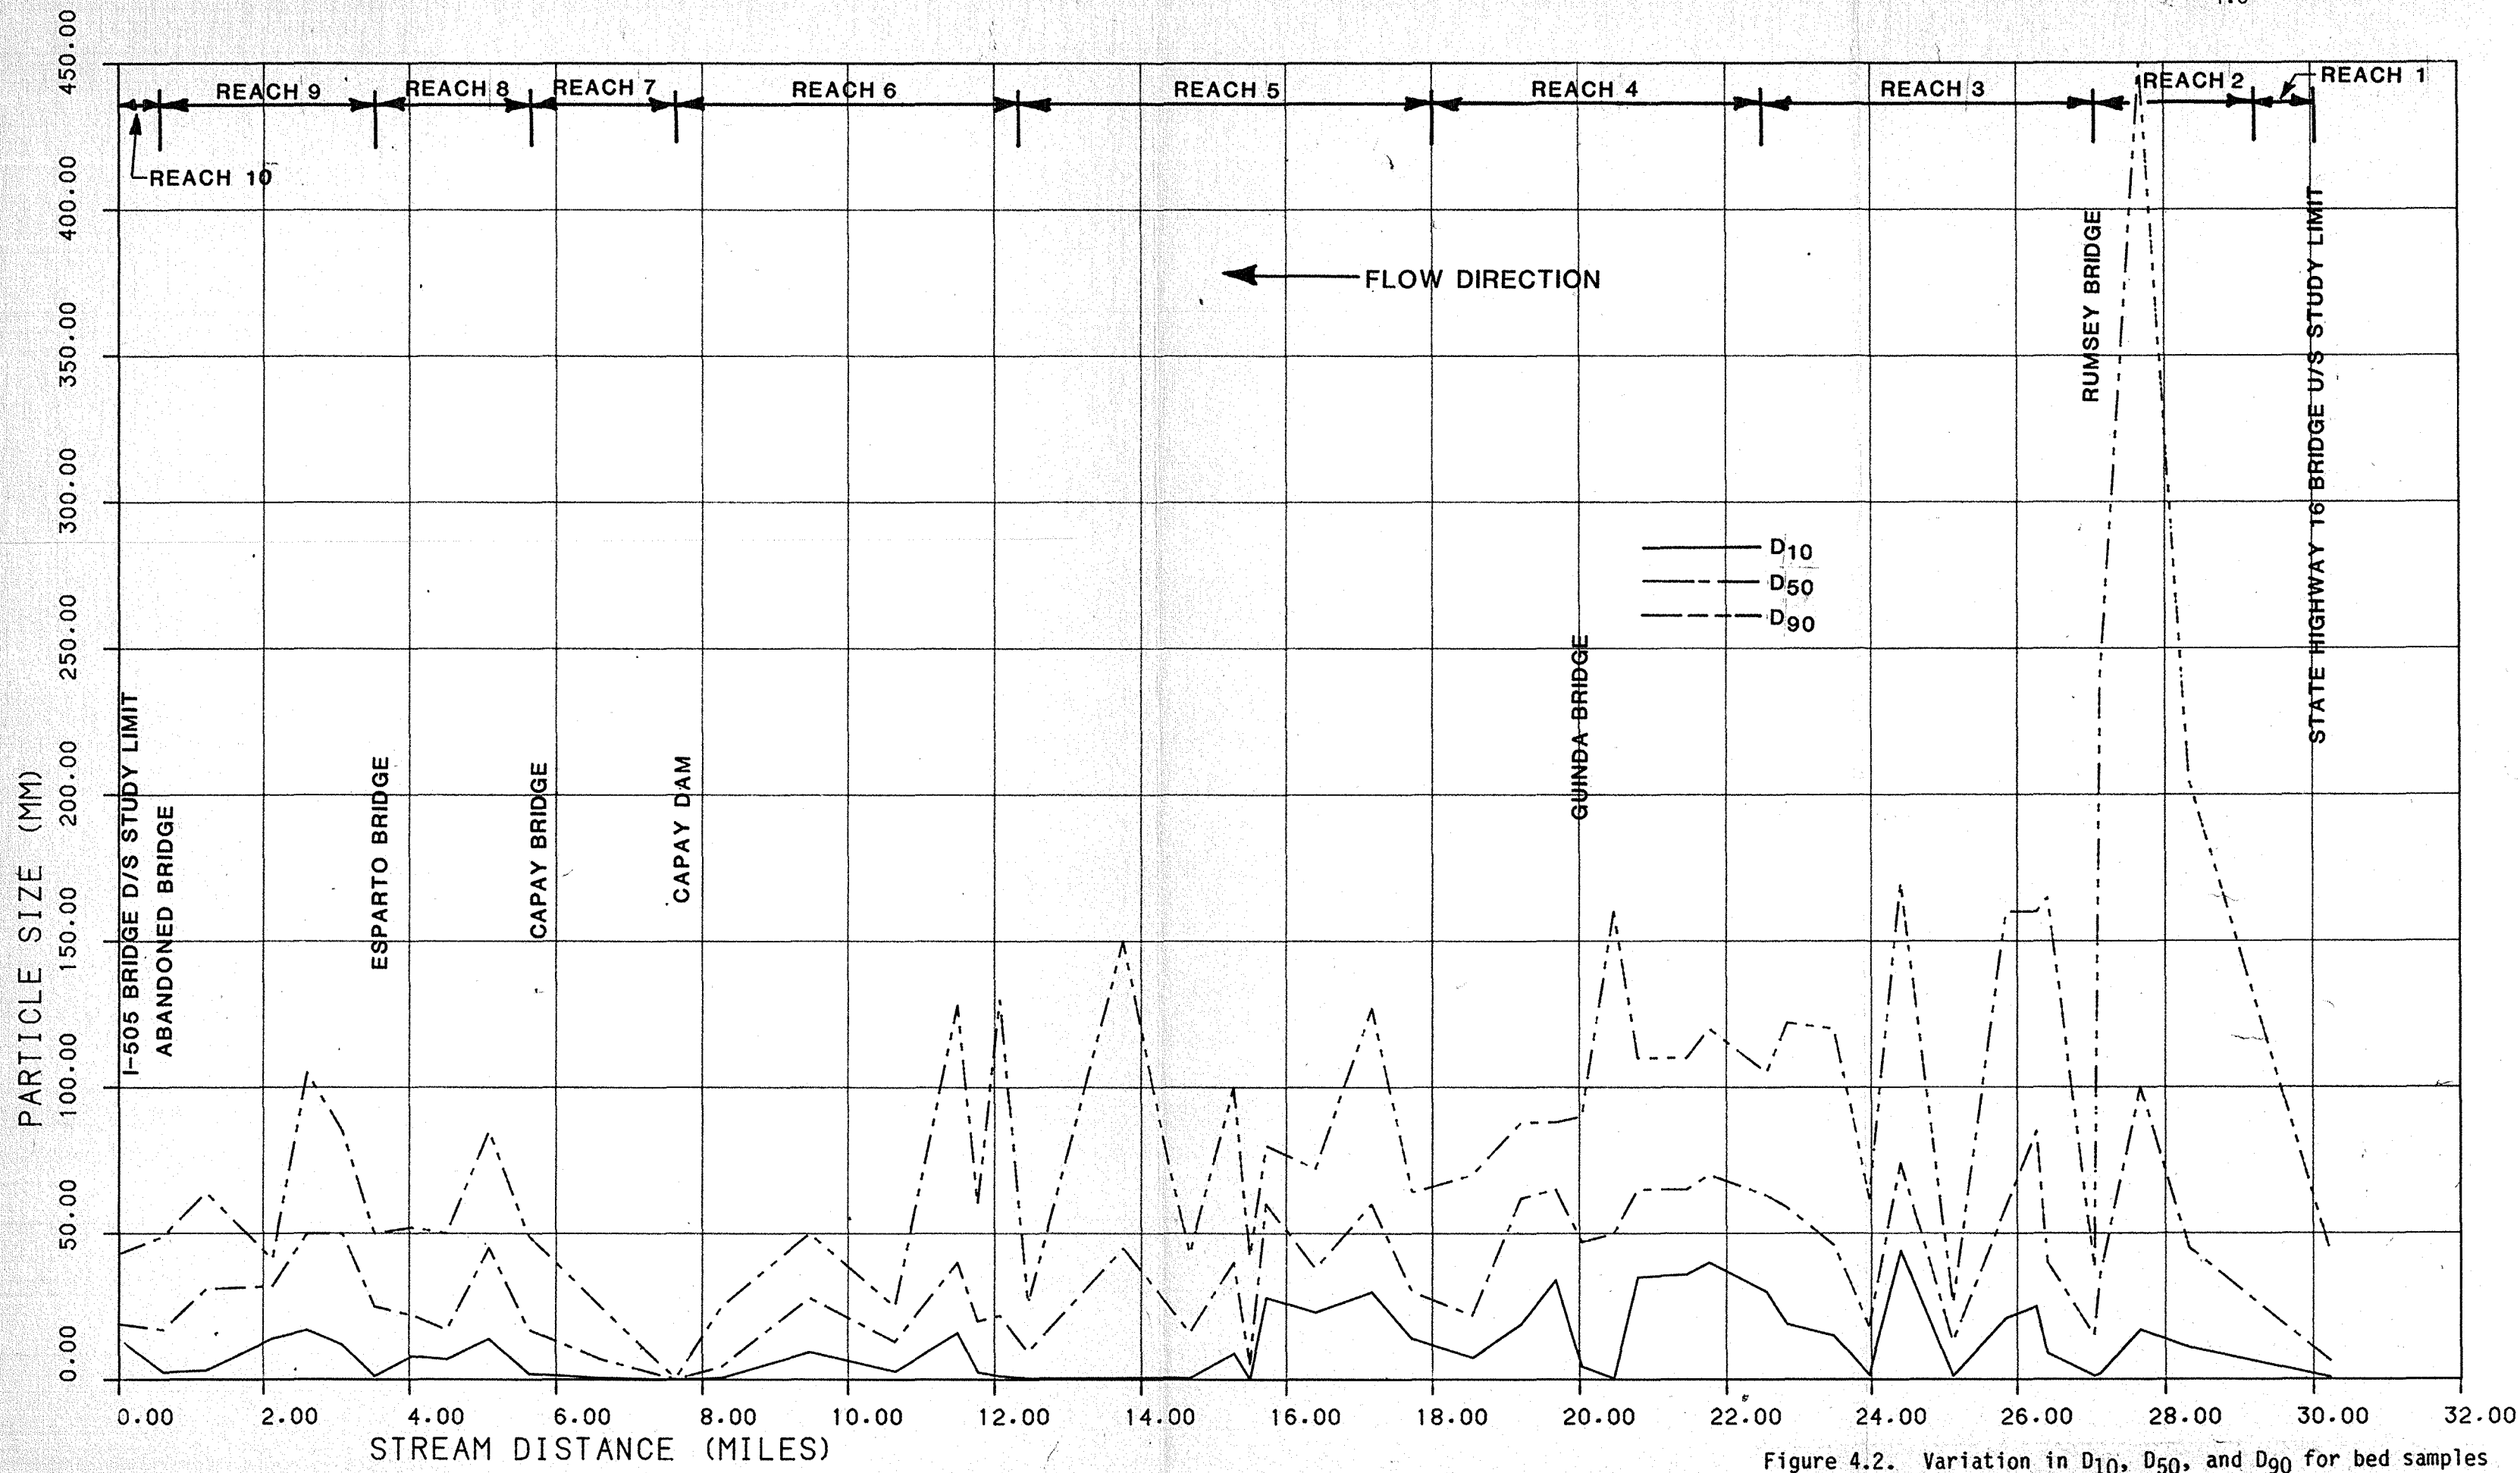
Figure 4.2. Variation in D₁₀, D₅₀, and D₉₀ for bed samples collected through the study reach

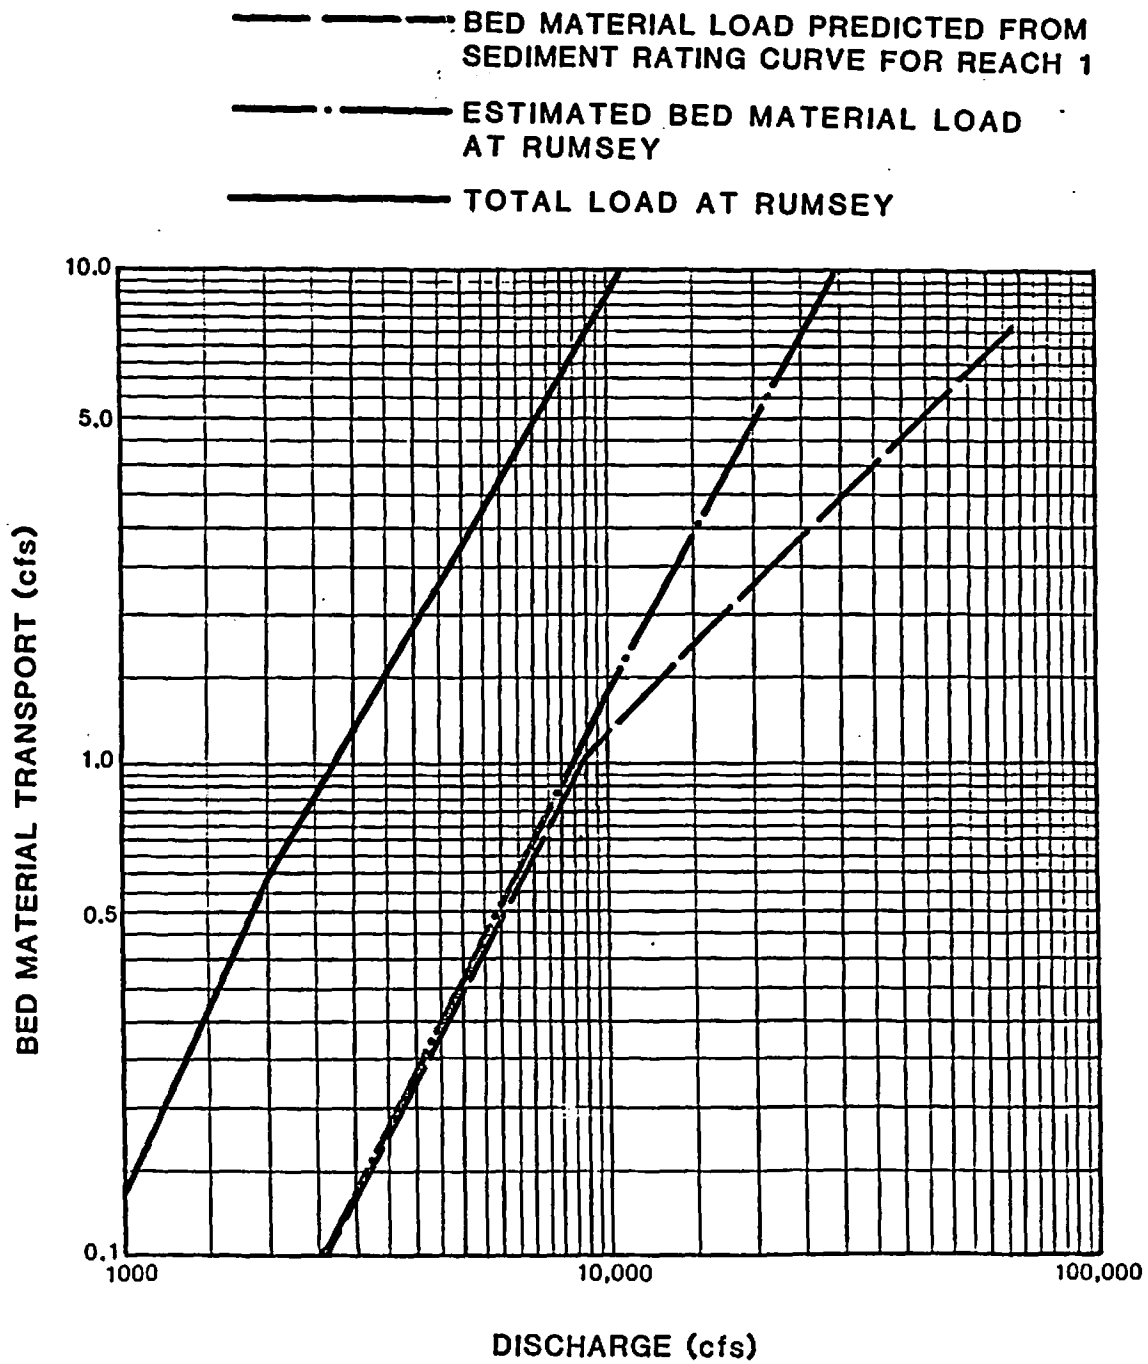
Figure 4.2. Comparison of bed-material load, derived from measured total load, and predicted bed-material load at the Rumsey gage.
