GEOMORPHIC ANALYSIS OF CACHE CREEK BETWEEN RUMSEY AND MADISON YOLO COUNTY, CALIFORNIA

GEOMORPHIC ANALYSIS
OF
CACHE CREEK
BETWEEN RUMSEY AND MADISON
YULO COUNTY, CALIFORNIA

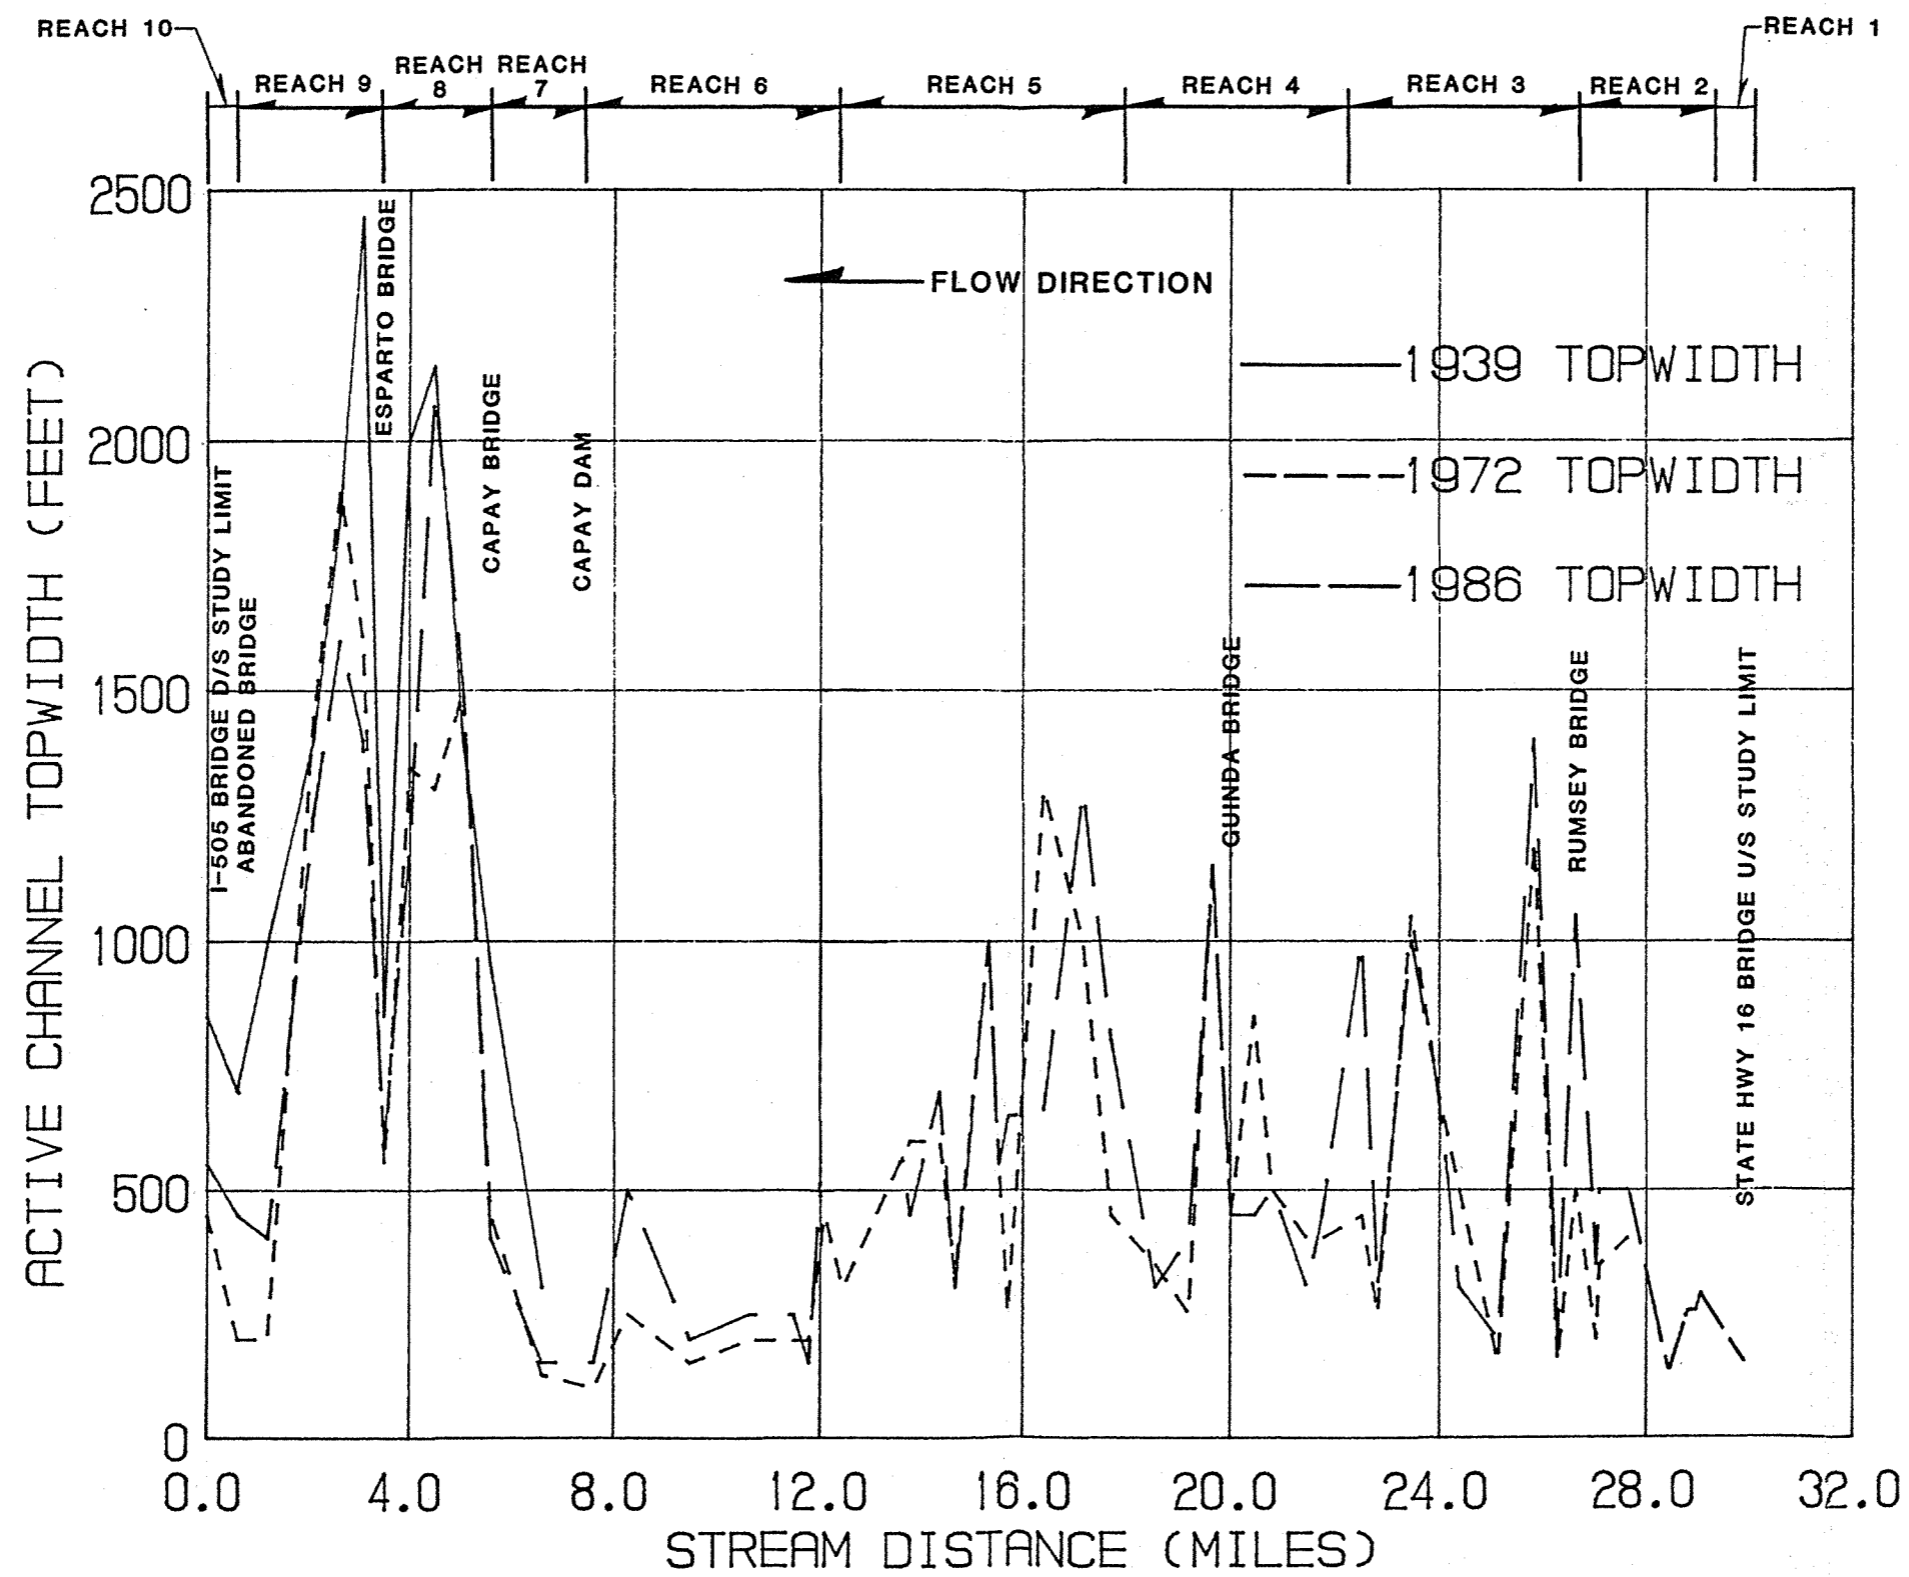
Figure 4.9. Variation in active channel topwidth along the study reach.

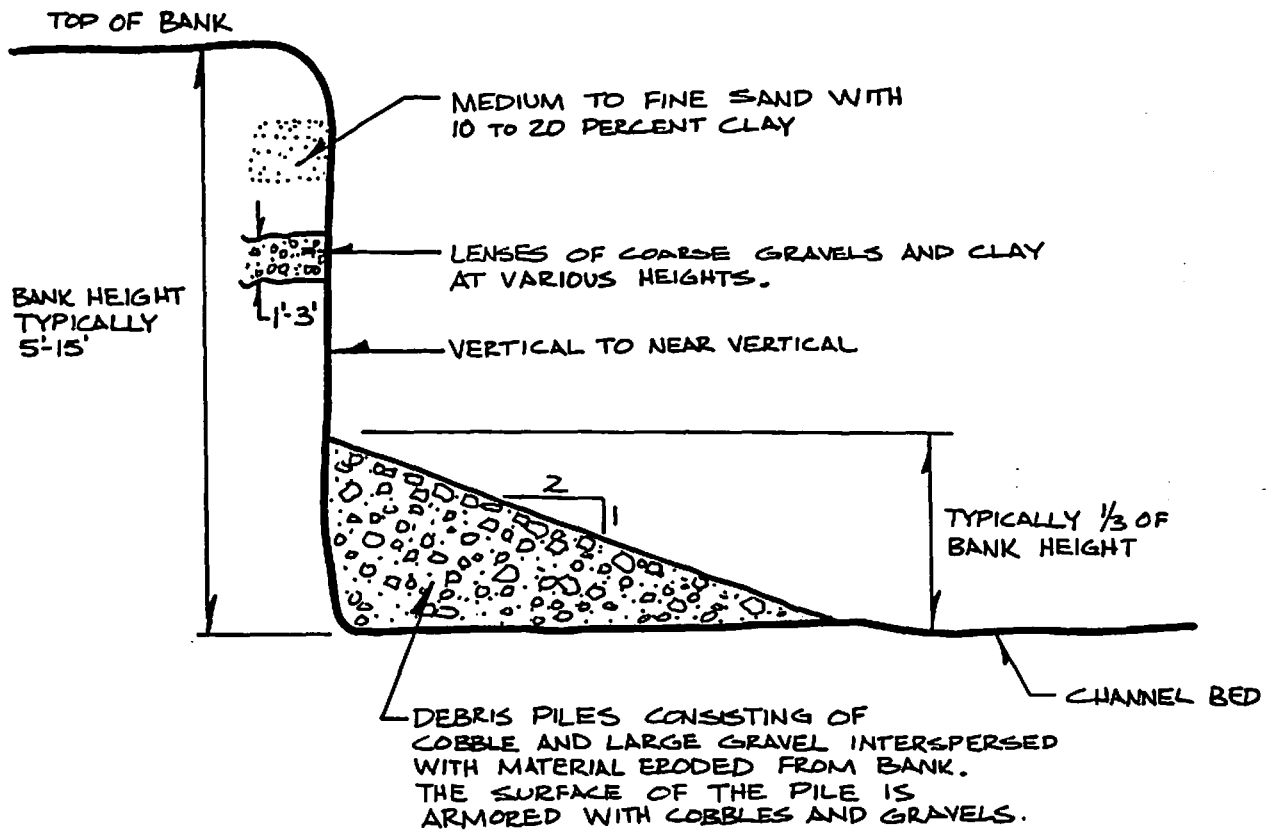
Figure 4.3. Typical bank configuration.

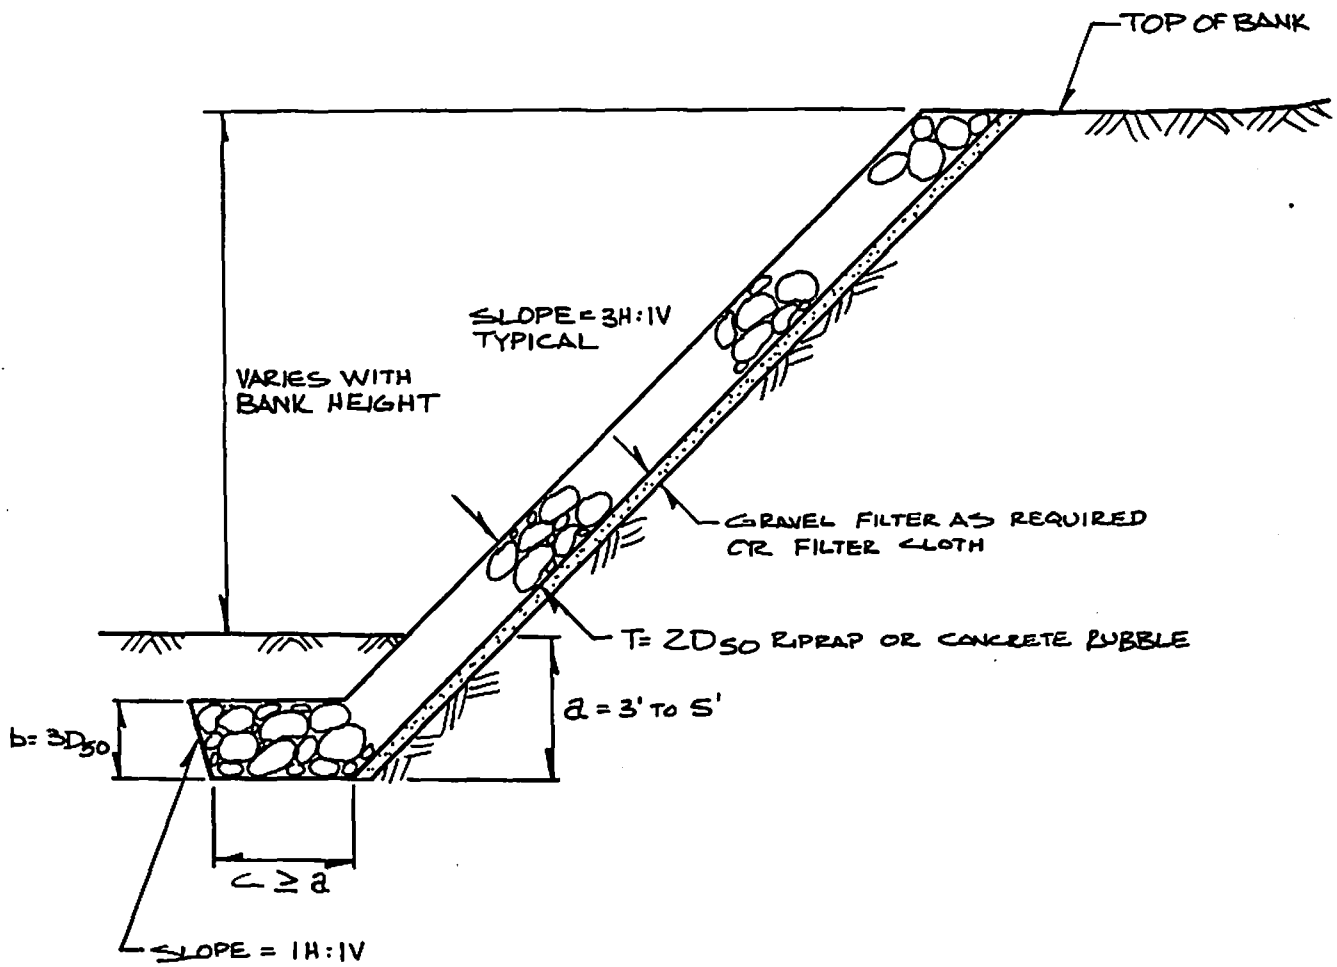
Figure 5.1. Typical riprap or concrete rubble bank protection.

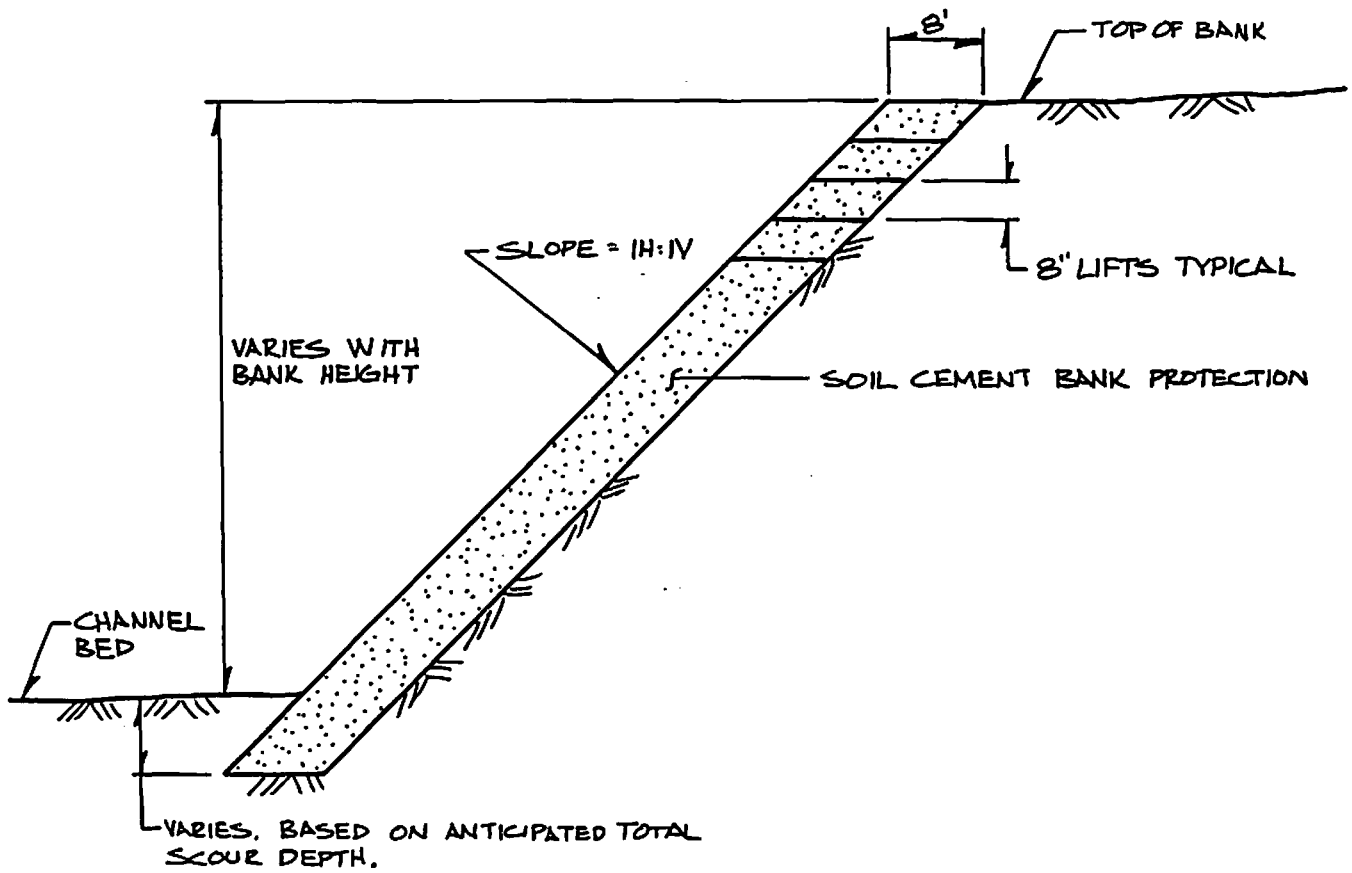
Figure 5.2. Typical soil cement bank protection.

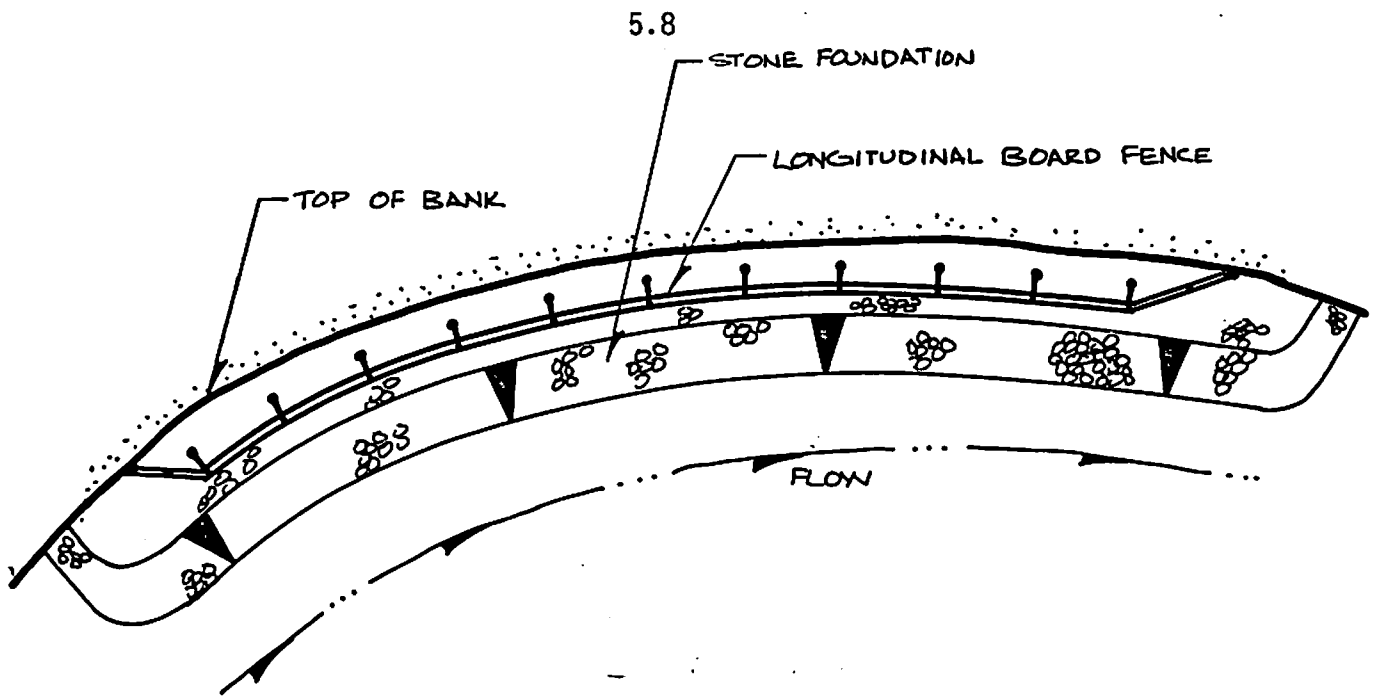
Advantages of windrow revetment include relatively simple construction procedures, the avoidance of construction problems and hazards within the channel, minimal impact on the hydraulic characteristics of the channel, and the ability to use less expensive quarry run material rather than a specified gradation. Disadvantages of this method of bank protection include the additional land area necessary for placement of the revetment, the bank loss which must occur for function of the revetment, and the periodic monitoring needed to insure adequacy of design quantities. Additionally, the "maximum" bank height for which windrow revetment should be utilized is thought to be approximately 15 feet (SLA, 1985).
