# Big Rapids Dam Removal

Big Rapids, MI

This booklet tells the story of the Big Rapids dam removal project in Big Rapids, MI. Contractors removed a dam remnant from the Muskegon River there in the summer of 2000 and completed the remainder of the project in 2001. The Muskegon is one of Michigan's largest rivers, and the Big Rapids dam passed an average flow of almost 9,000 gallons of water each second. Big Rapids officials and the Michigan Department of Natural Resources' (MDNR) Fisheries Division conceived the project in July, 1994.

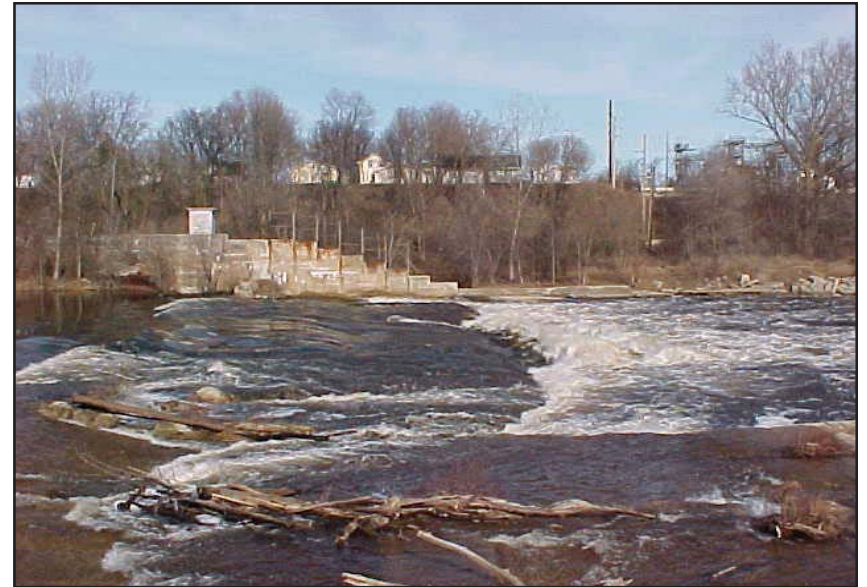
*The Big Rapids Dam remnant before removal.*

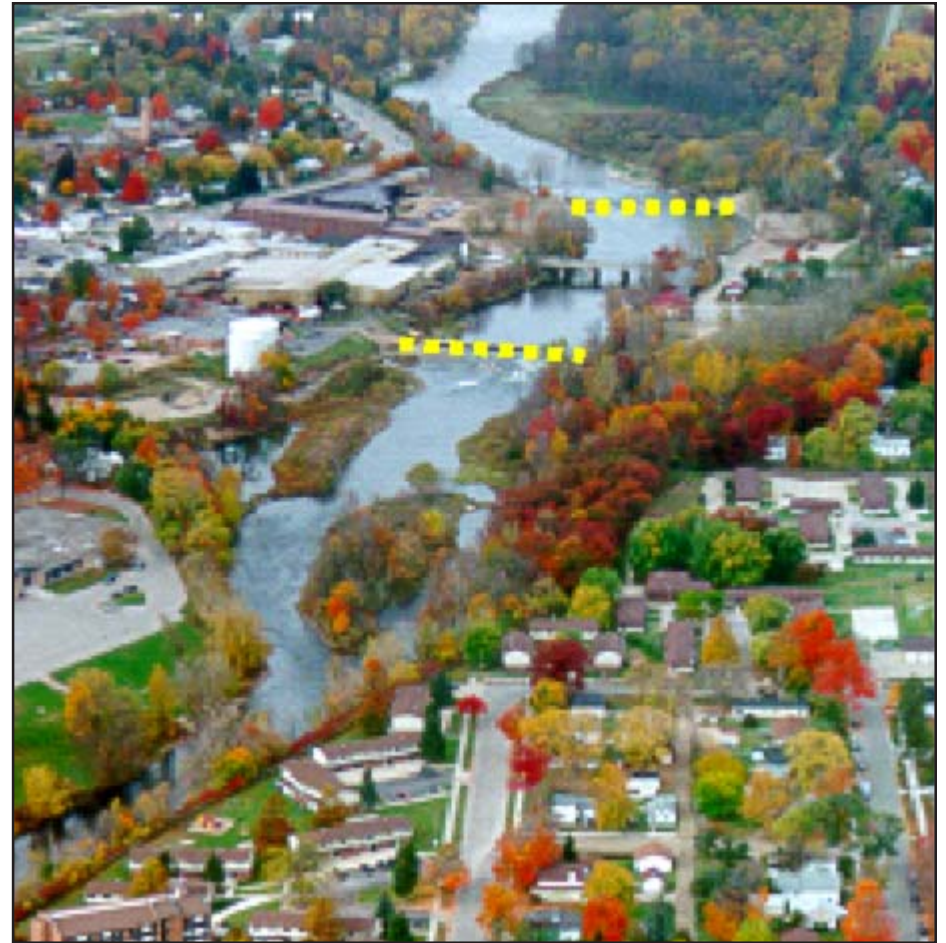
*This aerial photo was taken in October 2000 after the dam was removed. The yellow dashed line in the upper portion of the photo shows the dam remnant's location, while the lower dashed line shows the cofferdam that formed the sediment trap. The area between the two lines is where sediment settled while the dam was removed.*

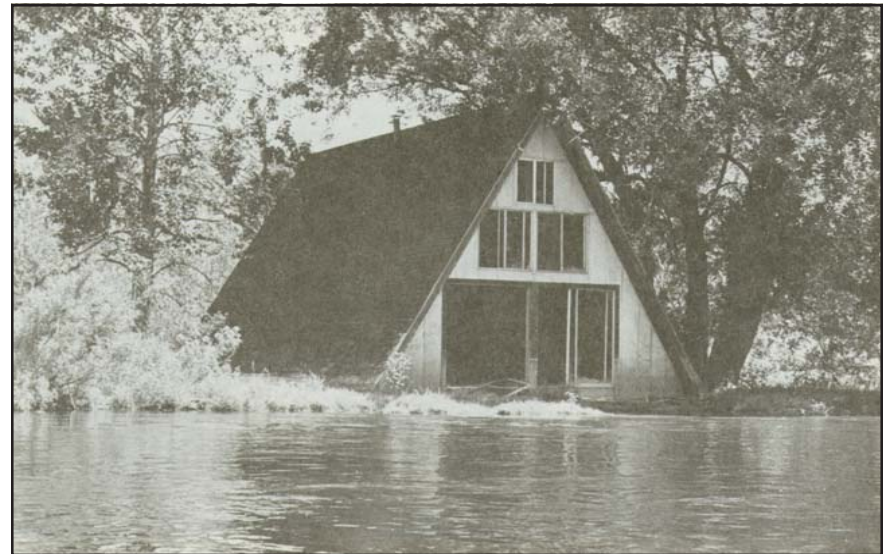
*The botched 1966 dam removal attempt released over 1,000,000 cubic yards of sand sediment downstream. This sediment formed new sand bars that backed up ice in spring, causing flooding to low-lying areas.*

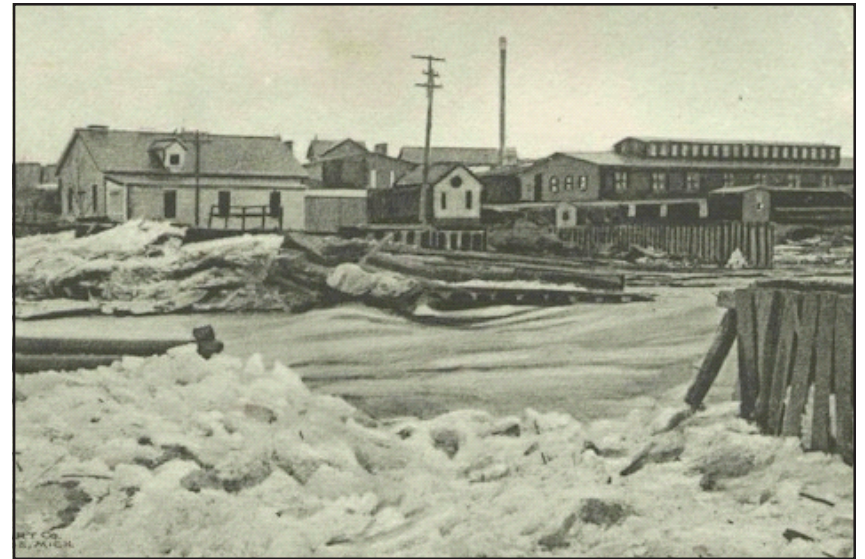
*The original Big Rapids Dam failed in 1912.*

The 1866 rock crib dam survived until 1912 when a flood breached it. At that time, dams were converting many rivers into hydroelectric power generators, and so, too, was the fate of the Muskegon River. A new, 17-foot-high concrete dam was built over the failed rock crib dam in 1914 and it soon began generating power. It operated until 1955 when Consumers Power Company and its partners de-activated it. In 1966 Big Rapids officials deemed the dam unsafe and contracted to have it removed. Unfortunately the demolition contractor hired to remove the Big Rapids Dam went bankrupt before finishing the project, leaving an ugly, five-foot-high foundation remnant in the Muskegon River.

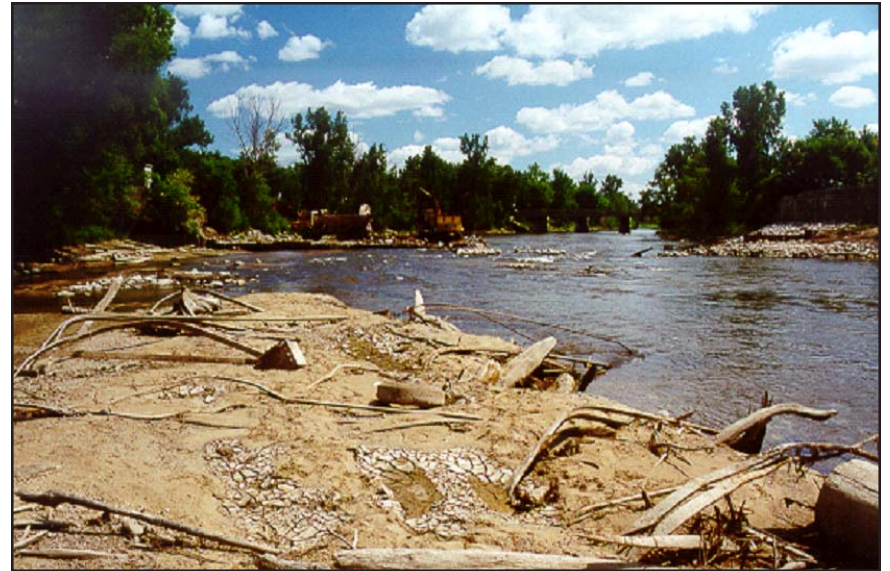
*This photo shows the impoundment of the Muskegon River behind the Big Rapids Dam's remnant. City officials originally wanted to build a new water intake pipe here.*

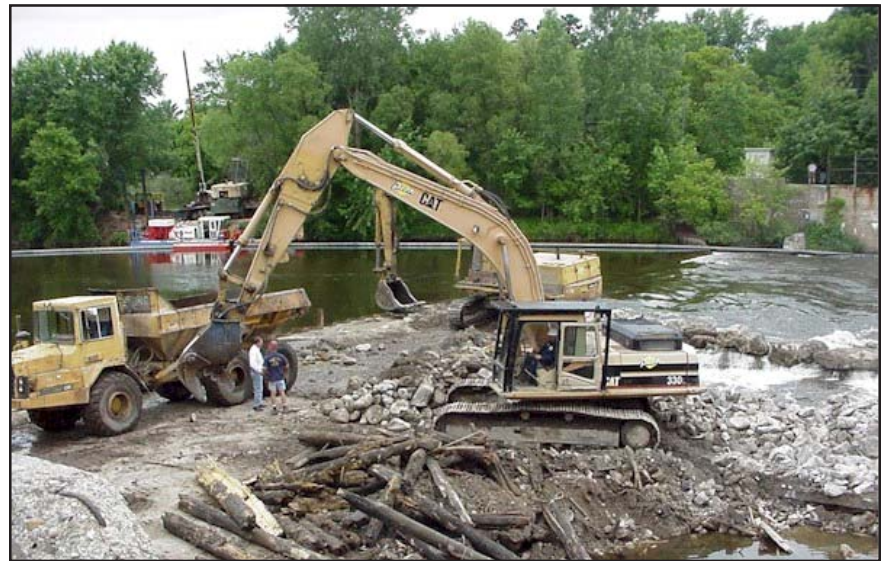
*The contractor is just beginning to remove the old dam.*

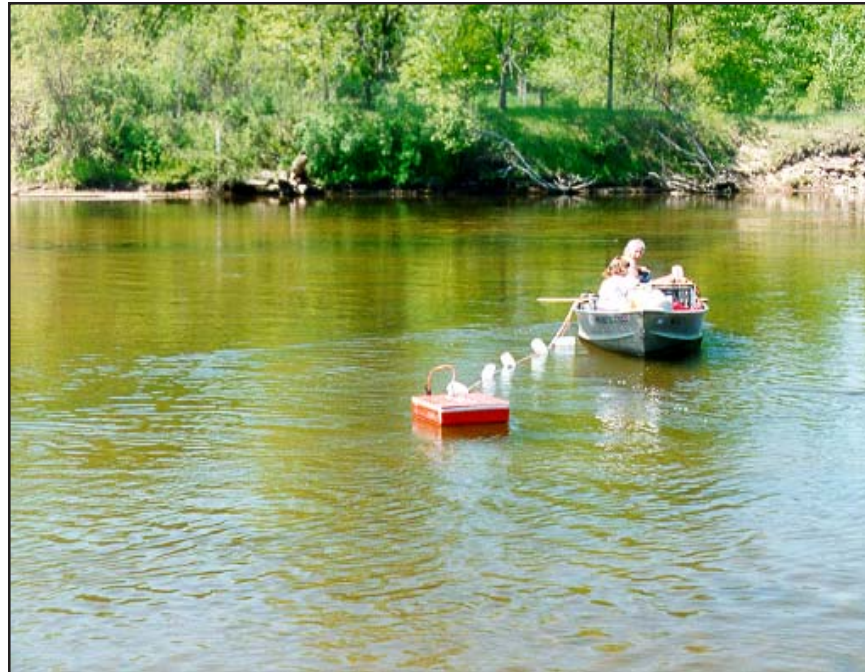
*Scientists from the United States Geological Survey used ground-penetrating radar to measure the depth and type of sediments trapped behind the dam remnant’s impoundment.*

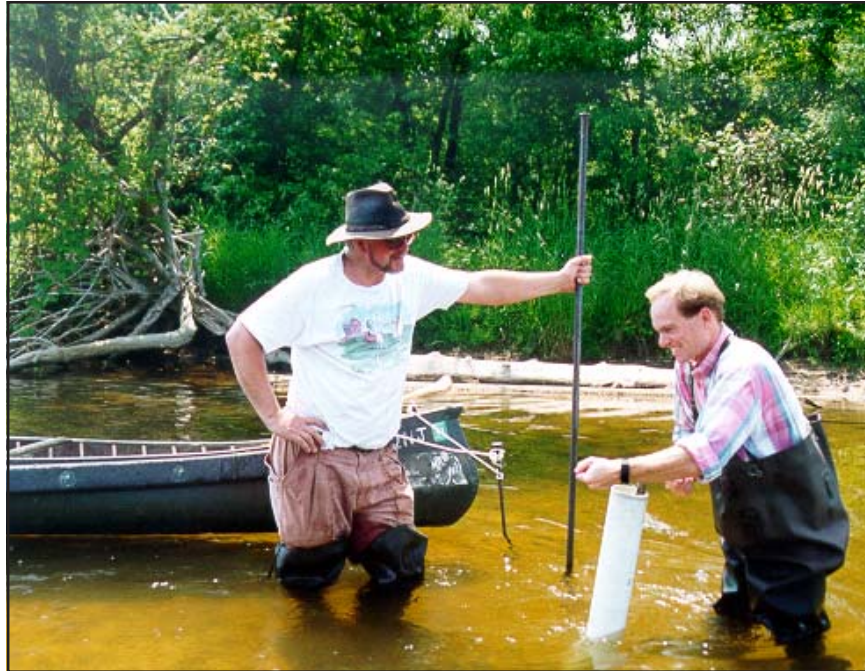
*Geologists verified the ground-penetrating radar's readings by coring through the bottom sediments and comparing results.*

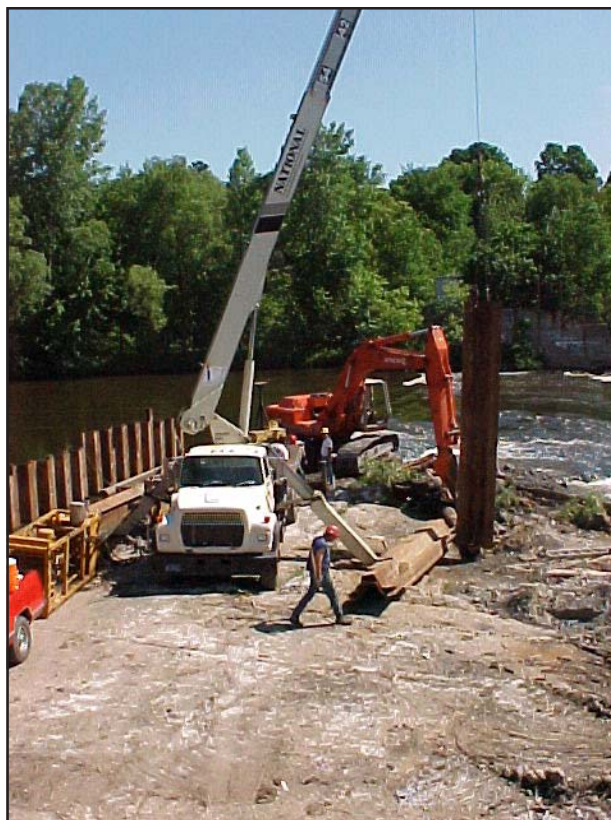
*The demolition process began with the contractor driving steel sheet piling upstream of the dam remnant's west side to divert flow over the east side during the demolition process.*

Pitsch and King crews started their work. King's crews drove steel sheet piles immediately upstream of the old dam's powerhouse foundation on the Muskegon River's west side. This diverted flow away from the area while Pitsch's machinery began the task of breaking up the dam's massive concrete foundation. It wasn't unusual to see exposed timbers left over from the original 1866 dam as Pitsch's equipment began to pick away at the old foundation.

pilings below the river's surface to divert flow away from the dam's east-side foundation. This allowed the river to run over the lowered sheet piles such that the river dropped an average of a couple inches a day over a two- to three-week period. King's crew eventually completed the drawdown process by simply pulling piles entirely out of the river after they could not be driven any further. Each method successfully effected the controlled draw-down required by the project's MDEQ permit. This process lowered the river surface by about four feet.

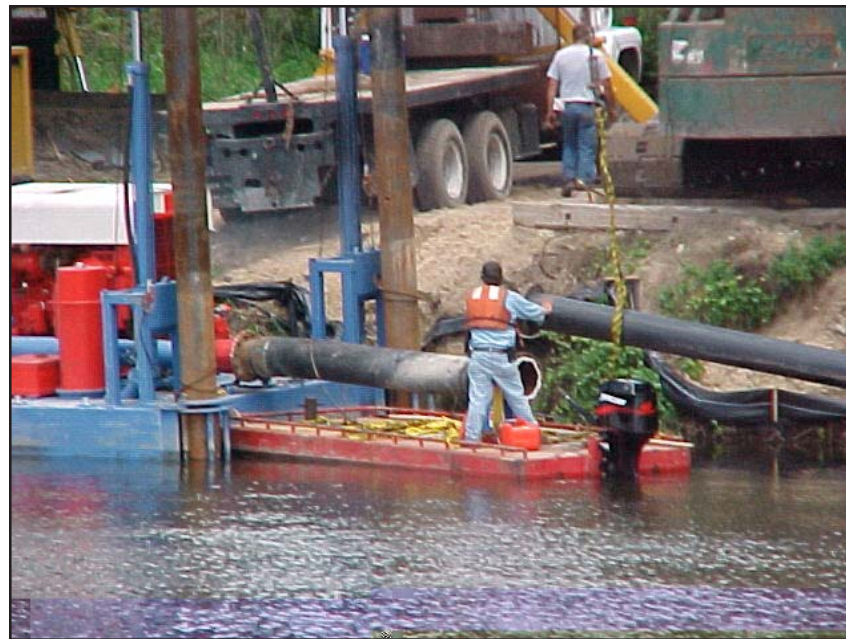
*Workers attach the polyethylene dredge discharge pipe to the dredge.*

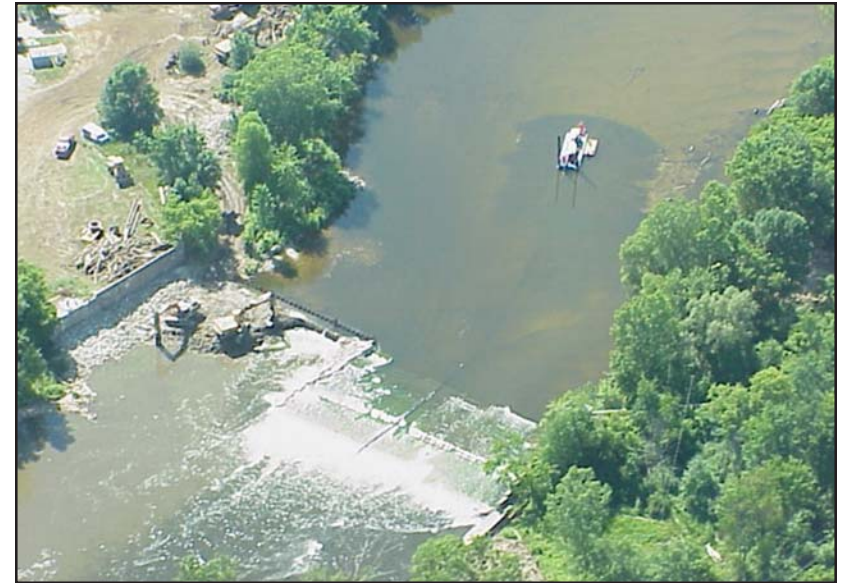
*On the left side of this photo, the contractor has diverted the river's flow over the east portion of the dam while demolishing the west portion. The dredging contractor has begun dredging the sand bars located just upstream of the dam remnant.*

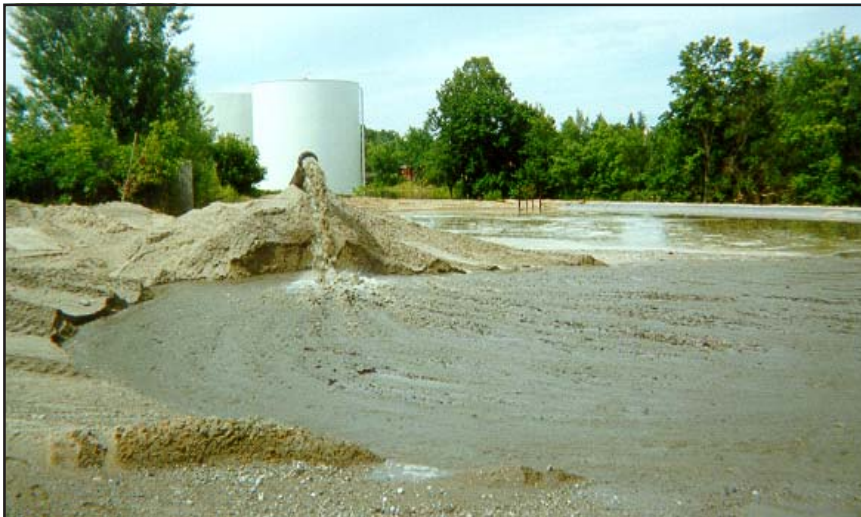
*The contractor created a holding basin and pumped dredged sediments to this city-owned property adjacent to the project site.*

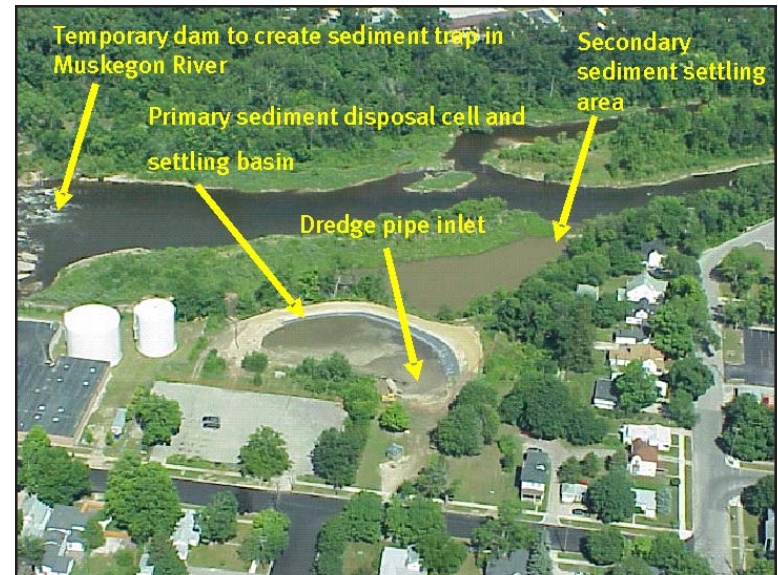
*Aerial view of the sediment disposal process.*

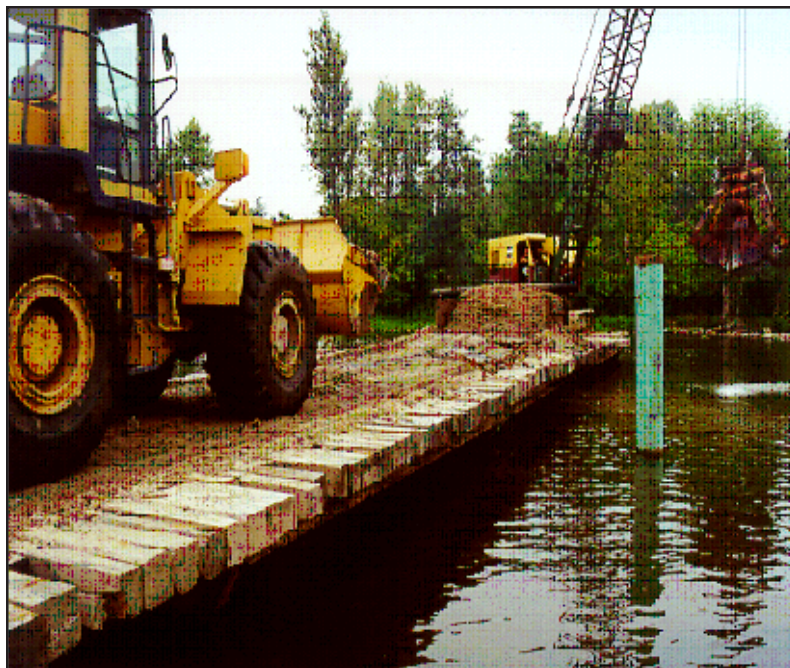
*The secondary sediment trap was located about 700 ft downstream of the dam remnant. It collected almost all of the sand that was scoured from the river bottom as its level dropped during the controlled drawdown. The contractor built a temporary bridge into the middle of the river so he could clean out the sediment trap. This photo shows the temporary bridge and the crane equipped with a “clam-shell” bucket. The crane dipped sediment out of the sediment trap and dumped it into the steel box on the bridge. Then, the front-end loader scooped the sediment and took it to an off-site stockpile.*

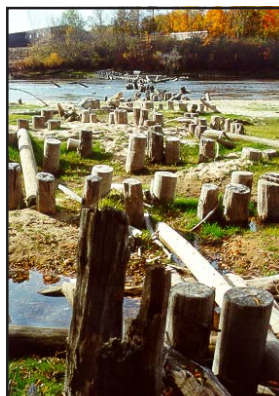
*These wooden pilings from an old railroad trestle became exposed in the river upstream of the old dam after the drawdown. The contractor removed them in the summer of 2001.*

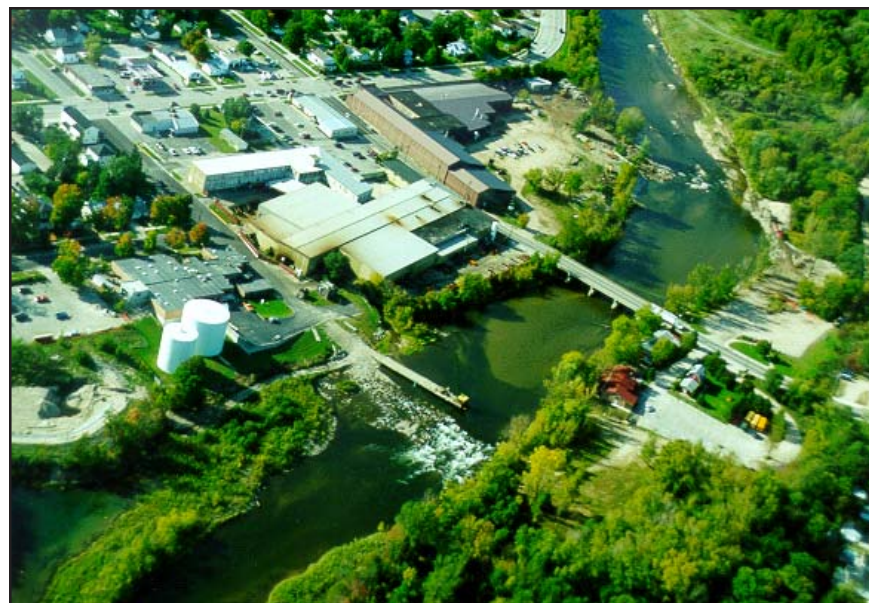
*This aerial photo was taken in late 2000, and it clearly shows the effectiveness of the sediment management plan. You can see the sand sediment that has settled into the river bottom in the sediment trap. The contractor excavated much of it from the river the following year.*

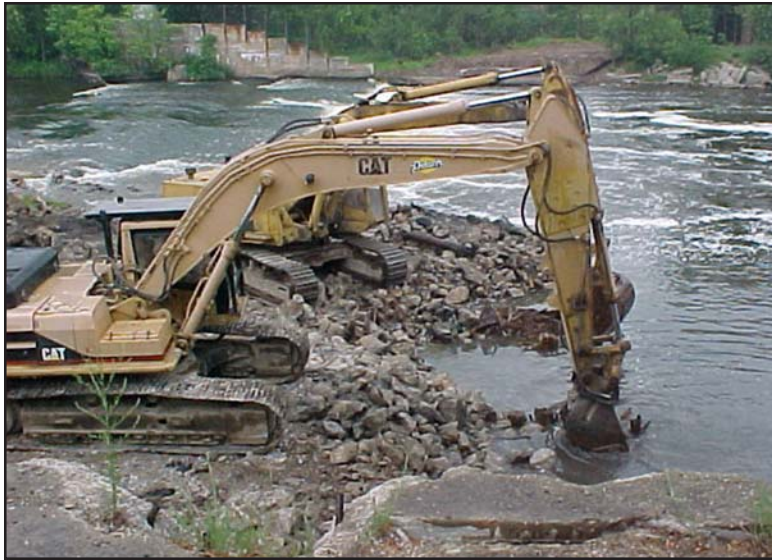
*The contractor utilized two excavators for the project. One was equipped with a jackhammer attachment, while the other had a hydraulic “claw.”*

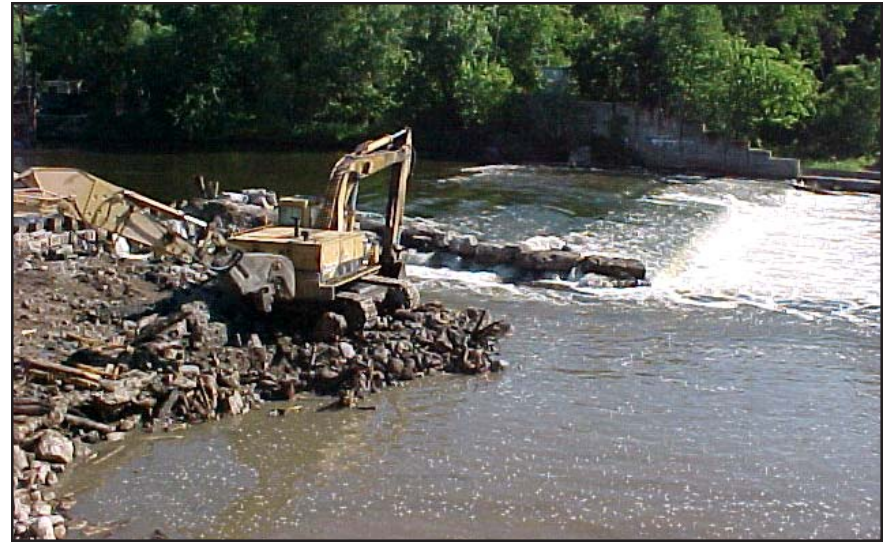
*The contractor eventually broke through the dam’s structure, allowing them to “peel it back” from the middle of the river toward the bank.*

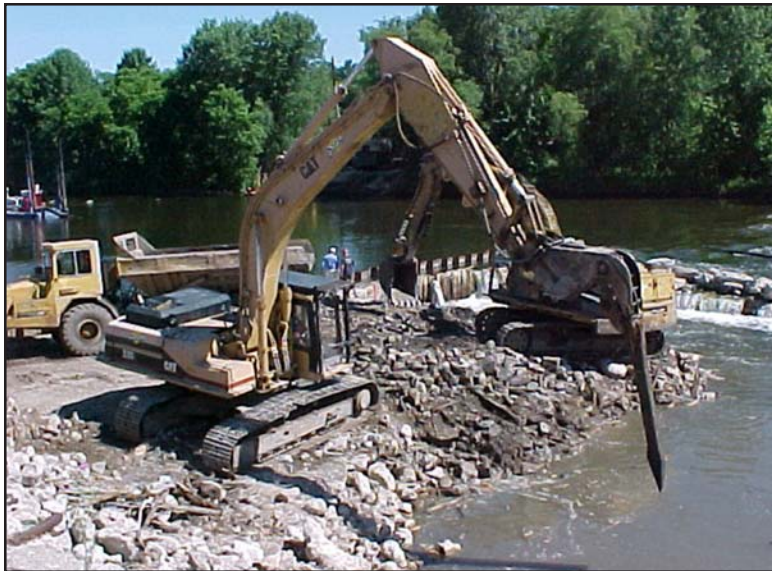
*Many vestiges of the old dam were discovered, such as this wooden piling.*

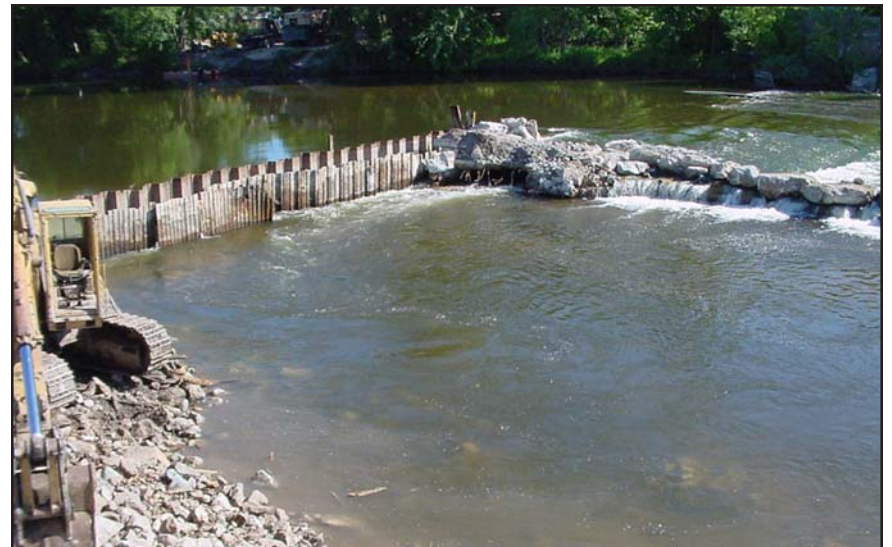
*After several weeks’ work, the west side of the old dam’s foundation had been removed. The old sheet pile from the dam remnant and the new sheet pile used to divert flow can be seen in the background.*

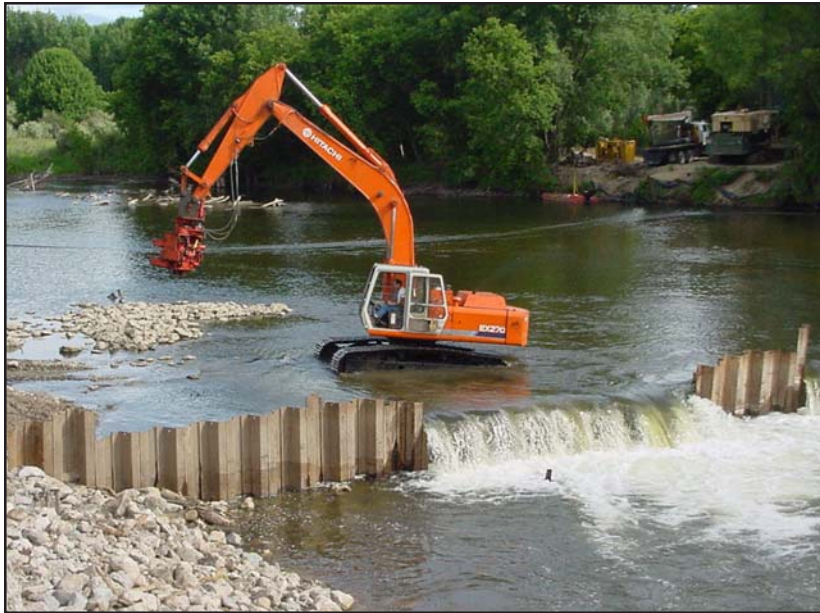
*Once the west side of the dam was taken out, the contractor began to lower the sheet piles used for flow diversion. He was able to control the lowering of the river's level in the impoundment to about 6 inches a day.*

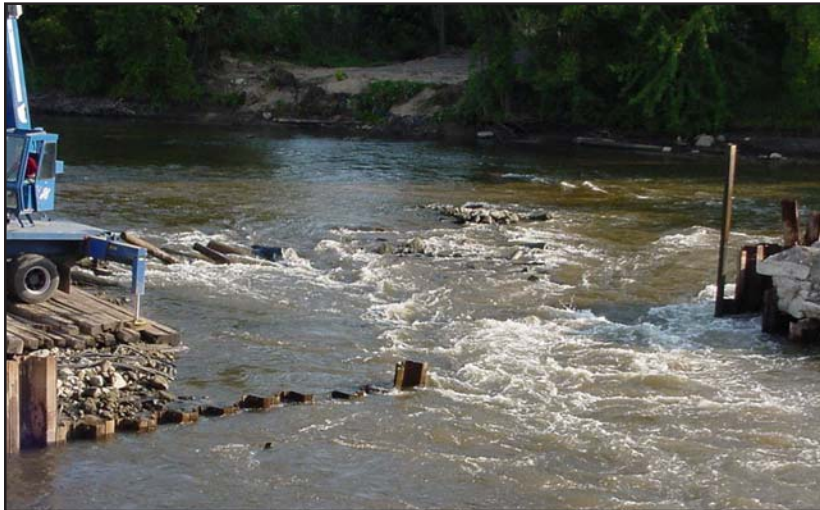
*Before long, the drawdown was complete, and the river's flow was diverted over to the west side.*

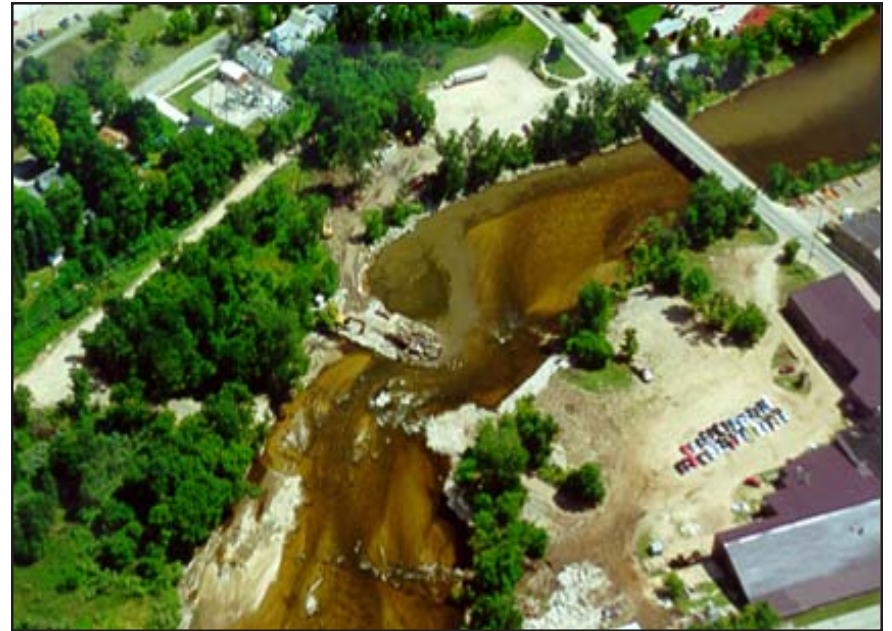
*This aerial photo was taken just as the contractor began demolition on the dam remnant's east side. You can clearly see the sand sediment beginning to settle into the sediment trap downstream of the old dam. The trail of muddy water leaving the site is not from sediment, but from earth remaining in the old dam's core.*

It was interesting to discover as much intact earthen fill within the dam’s structure as was found. When demolishing the dam, the biggest concern was for river-bottom sediment to flow downstream. Ironically, the earthen dam fill was released into the river and remained suspended beyond the project area. The sand moved as expected: like lava down a mountainside. Fortunately, the “muddy” river was short-lived, and the City fielded no complaints.

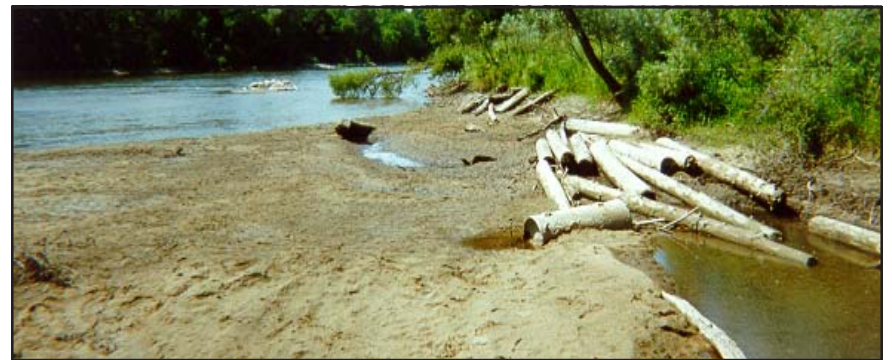
*Previously-submerged sand bars like this began to surface shortly after the controlled drawdown began. The timbers in this photo are remnants from Big Rapids' boom logging days of the 1800s.*

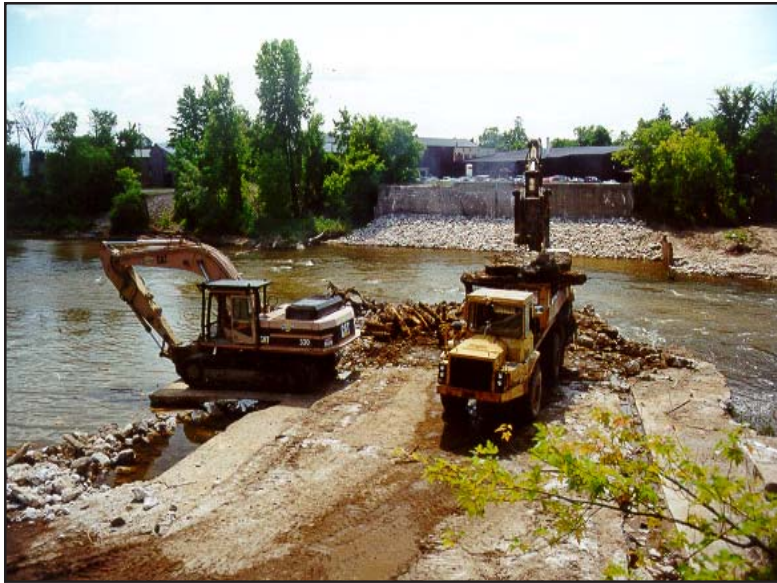
*This photo shows the former dam's site after it was demolished. The banks on either side of the river were cleaned up and seeded to beautify the area. The rapids you see in this picture are located just above the old dam, and are created by the remains of old timber and rock cribs. The smaller "rapids" further upstream is caused by pilings from a former railroad trestle.*

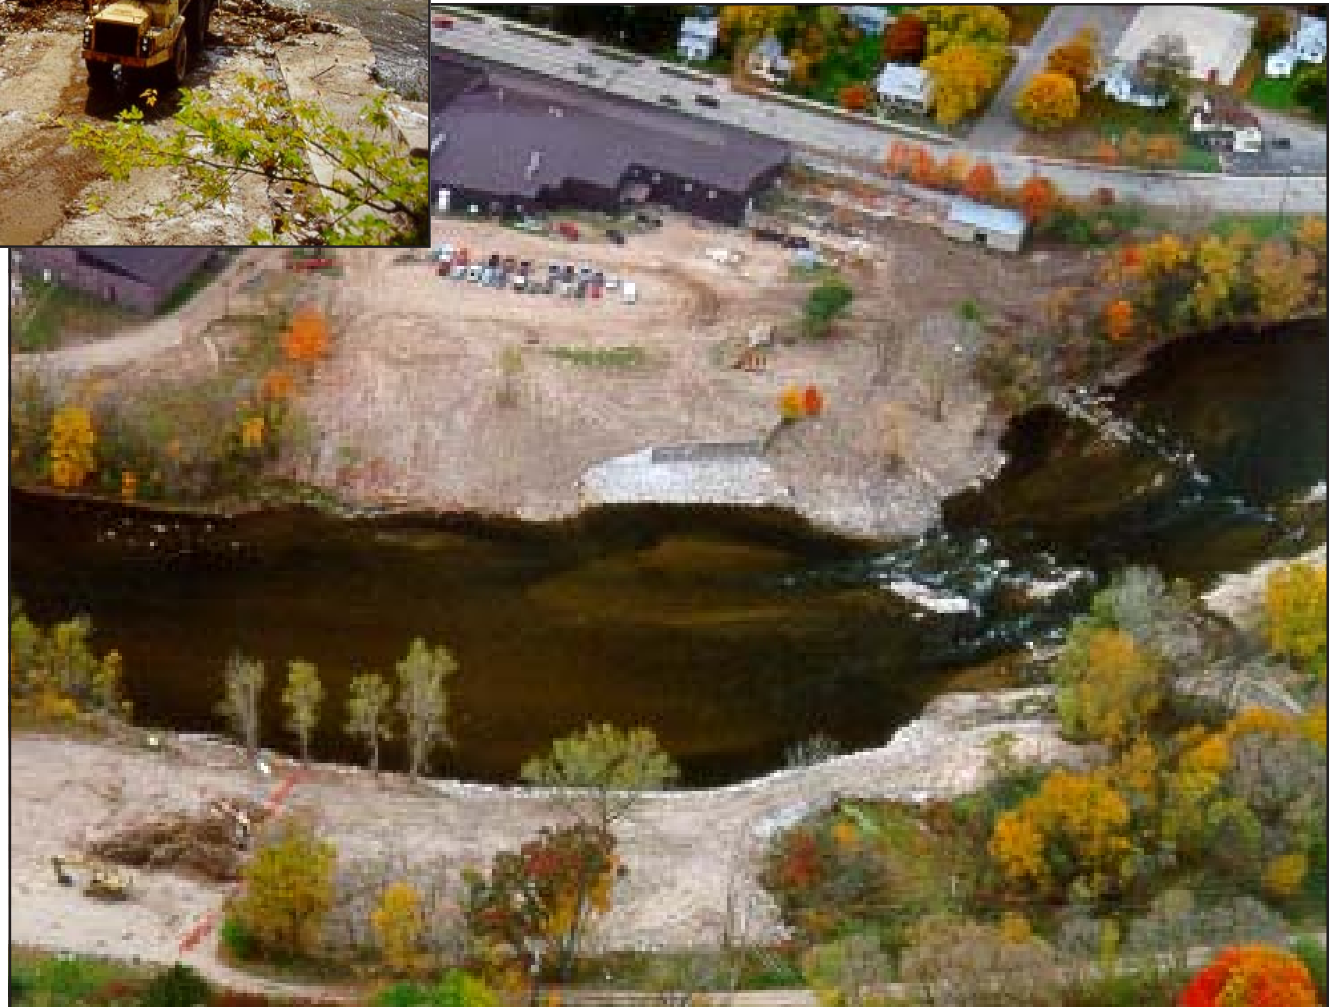
*With the flow diverted to the river's west side, the contractor simply "peeled" the dam back to the east side, beginning in the center of the river.*

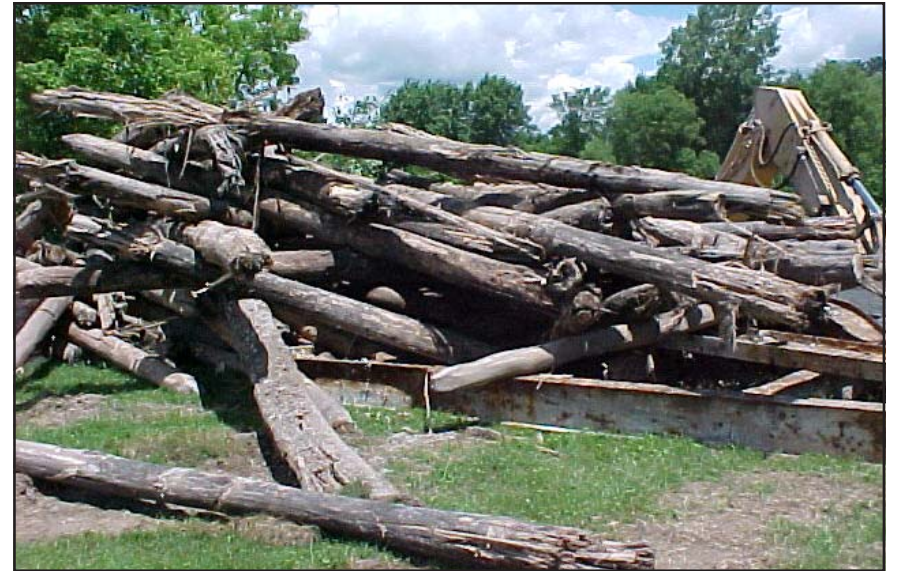
*Here are some of the many wooden timbers taken from the dam. They were part of the original 1866 dam.*

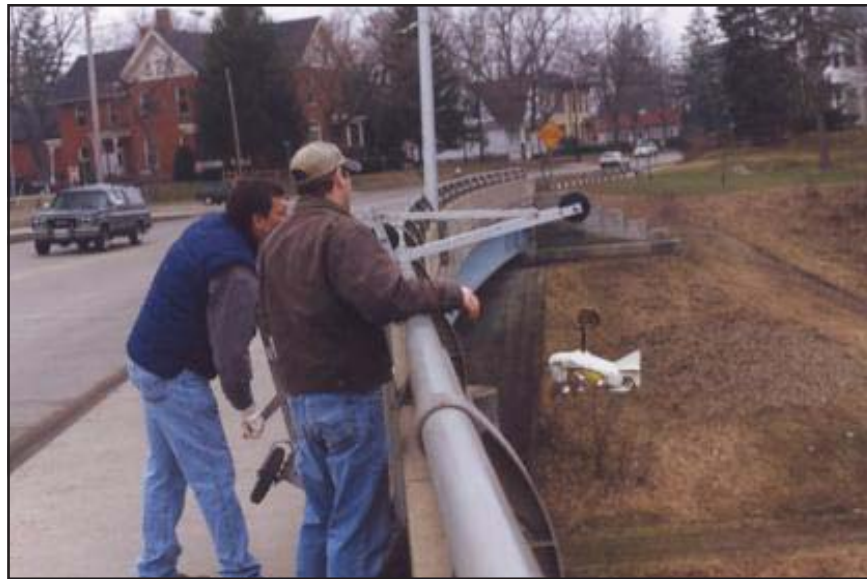
*USGS scientists sample sediments from the Maple Street (M-20) bridge.*

Water-quality, suspended-sediment, and bed-load samples are collected from White's Bridge and the M-20

Bridge (downstream of the dam) above the sewage treatment plant. The White's Bridge samples are used to establish a water-quality base line and to estimate the sediment load entering the study reach. The M-20 bridge samples are used to assess changes in water-quality and sediment load within the reach containing the dam remnant. The M-20 sediment samples are also used to calibrate the continuous suspended-sediment monitors.

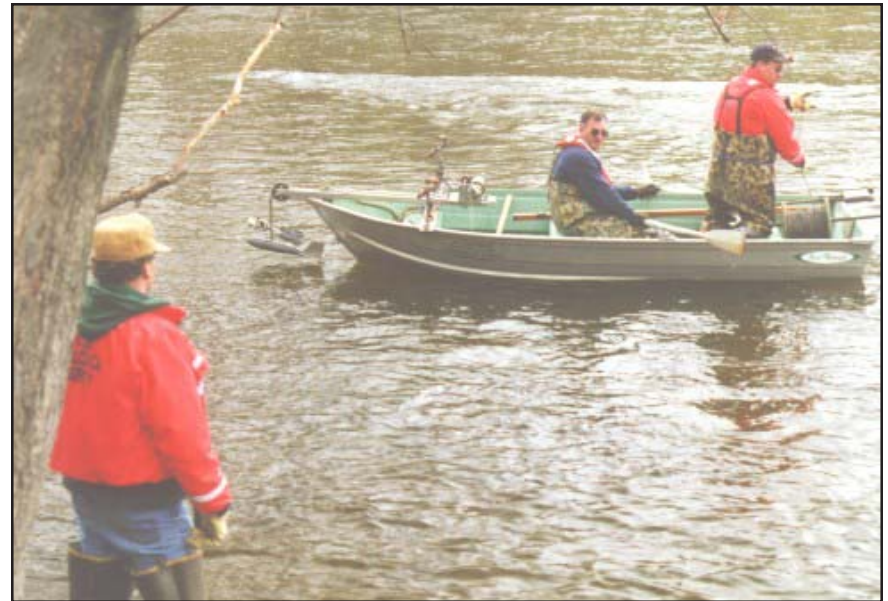
*For the study, the river bottom profile was checked before, during and after the dam removal to determine the sediment movement pattern.*

River-bottom transects were made prior to the dam remnant removal (prior), a few months after the removal (short-term), and one year later (one-year). This last set was made after the removal of the rock cofferdam in 2001. Two areas upstream of the dam remnant show erosion of sediments. One upstream area shows the annual deposition and erosion of sediments near the upstream end of the backwater from the dam remnant and that some erosion has occurred in this area since the dam remnant was removed. Immediately downstream, no erosional effects have been observed. The area upstream of the dam remnant has undergone significant removal of sediment. Some of this sediment was dredged during the dam remnant removal, the remainder was remobilized to be captured by the secondary sediment trap or to be transported down the river.

Downstream of the dam remnant, sediment deposition varies with the reach. At the first transect downstream of the sediment trap, there is little difference in the prior and short-term profiles. The one-year profile, however, shows substantial deposition in the deep channel there. Further downstream, there is little evidence of sediment deposition from the profiles. Here, the Muskegon River flows in a high-gradient reach with increased velocities. Farther downstream near the Big Rapids City limits, the one-year profile

shows deposition over the entire channel with the deeper sections completely filled in.

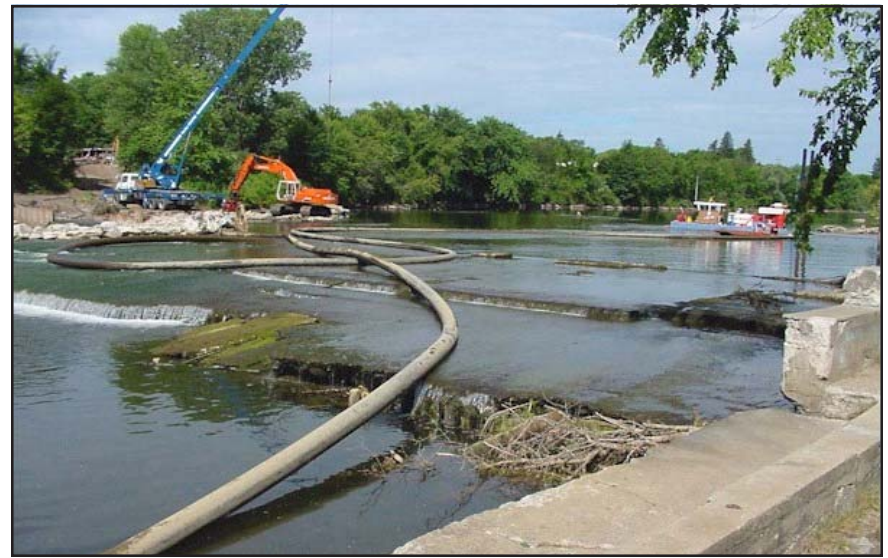
*The sediment management process used on this project will serve as a model for future projects.*

The Big Rapids Dam Removal project is of great value to both the engineering profession and that of environmental science. It is important first because of its method of sediment management. The innovative method conceived by Prein&Newhof and The King Company showed that it is possible to perform a dam removal while managing the mobilization of sediment that could potentially cause environmental damage and flooding. This project helped foster a national consciousness of the key role of sediment management for dam removals, as few previous dam removal projects have considered sediment mobilization a major issue.

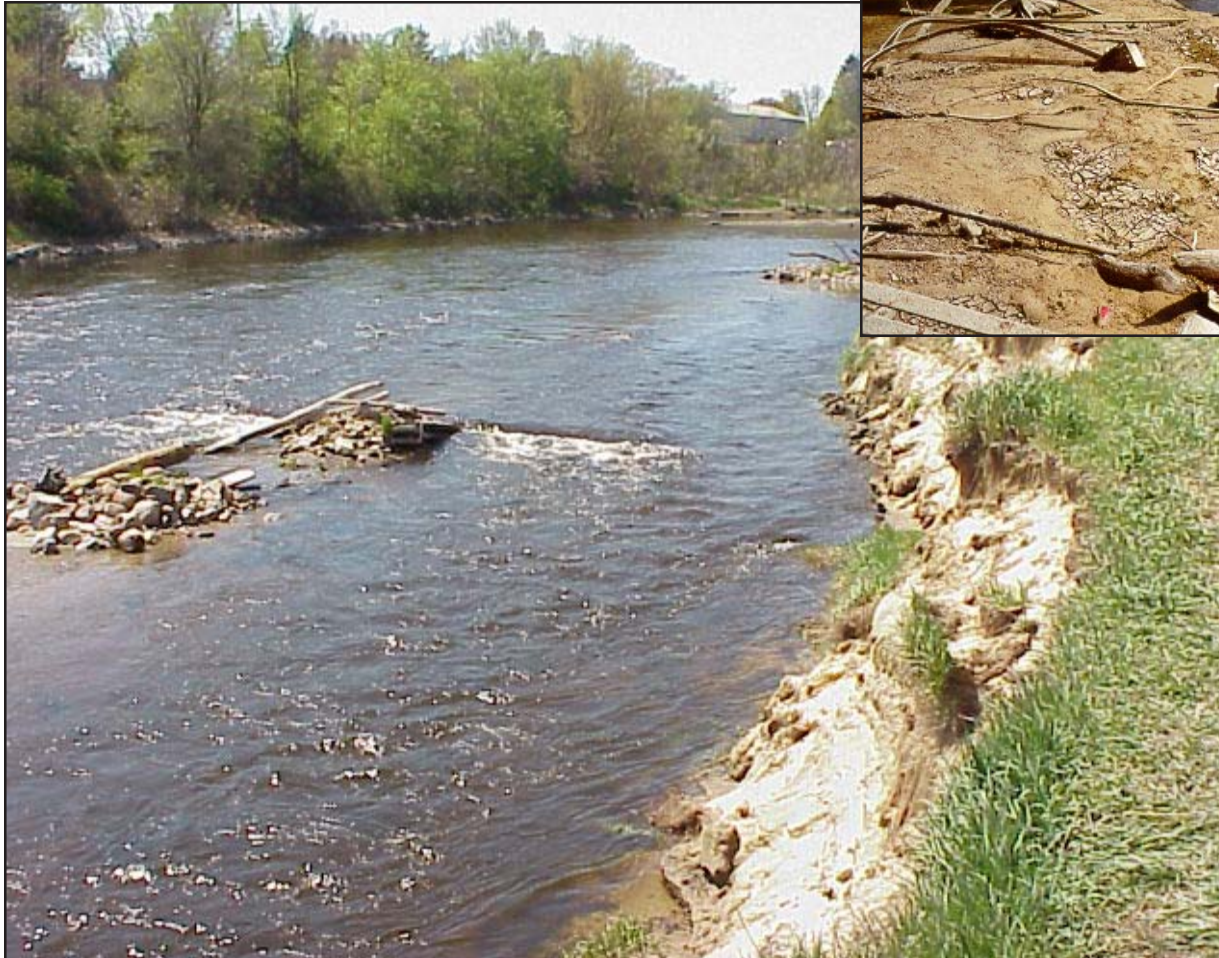
*In the 1800s, loggers used timber and rock cribs to corral logs in the river. This formerly inundated old timber and rock crib caused the river's flow to erode a nearby bank.*

There were relatively few surprises encountered during this project. The most significant visual surprise was the discovery of several timber and rock cribs near the middle of the river that became exposed as the river's level was drawn down. These cribs have been left in the river. It is expected that

the timber will gradually decay, and the rock inside the cribs will fall to the river bottom. Ice is also expected to assist in the process of “naturally” demolishing the cribs.

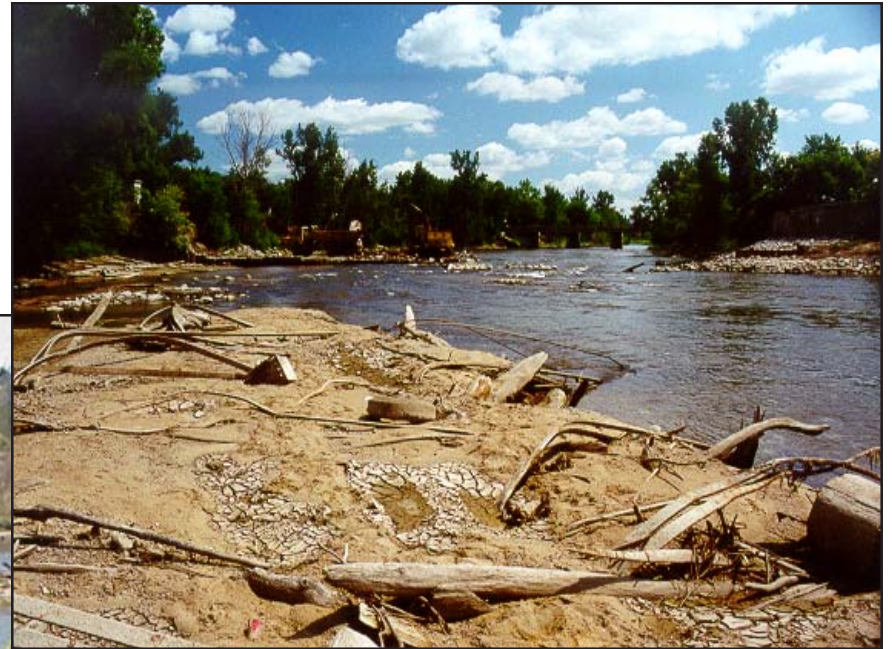
*Once the dam's impoundment was drawn down over four feet, many interesting relics became exposed. Just above the dam, the remains of the former steel superstructure for a railroad bridge was found embedded in sediment. The contractor removed the steel and disposed of it.*

The project team knew from historical photos that a railroad trestle crossed the impoundment just upstream of the dam remnant’s impoundment. While one of the contractor’s bid items was to remove the remnants of the trestle from the river’s flow channel, he did not anticipate finding 140 wooden pilings still in the river! The contractor also discovered the remains of the trestle’s former steel superstructure on the river bottom. It evidently was stripped from the trestle foundation and “dumped” into the river. By the time it was discovered, its twisted remains had become part of a large sand bar. The contractor was paid to cut the steel beams out of the sand bar, and haul all of the steel off-site.

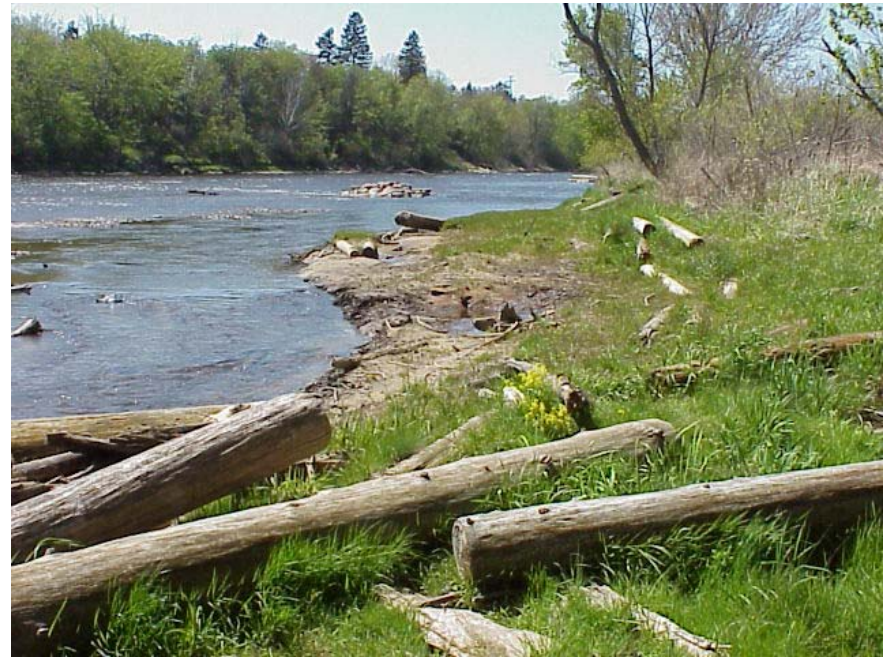
*Old logs lined the river’s banks and actually helped to prevent bank erosion when the water level dropped. The logs shown above and below settled on a sand bar. The green grass was planted along the bank by the contractor to reduce future erosion.*

Finally, there were hundreds of old timbers lining the river banks. While their existence was known during design, the number of timbers exposed during the drawdown was indeed a surprise. These timbers served a valuable erosion and sediment control function, in that they tended not to mobilize during the drawdown. They remained behind and either trapped sediment or protected the river’s former banks from sloughing into the river’s flow.

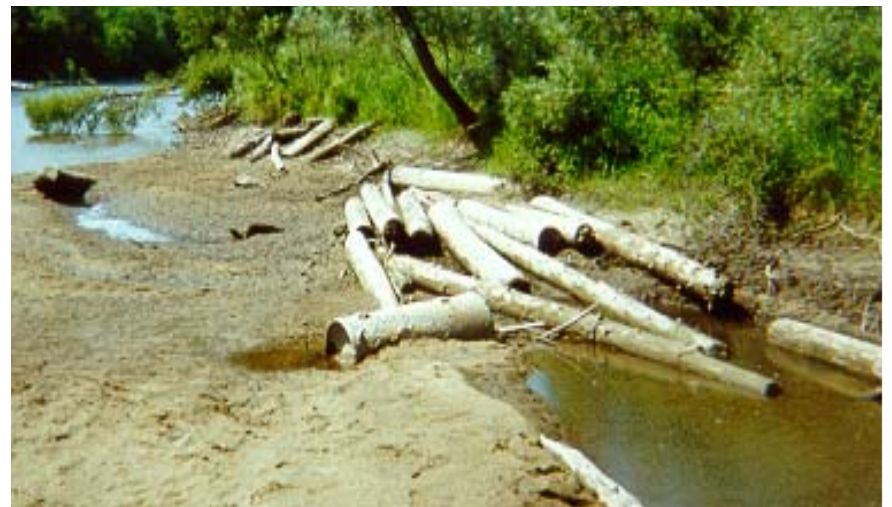
*A railroad trestle once crossed the Muskegon river immediately above the dam. Here you can see the timber pilings from the trestle emerging from the water. These piles were removed by the contractor.*
