# Big Rapids Dam Removal

Big Rapids, MI

This booklet tells the story of the Big Rapids dam removal project in Big Rapids, MI. Contractors removed a dam remnant from the Muskegon River there in the summer of 2000 and completed the remainder of the project in 2001. The Muskegon is one of Michigan's largest rivers, and the Big Rapids dam passed an average flow of almost 9,000 gallons of water each second. Big Rapids officials and the Michigan Department of Natural Resources' (MDNR) Fisheries Division conceived the project in July, 1994.

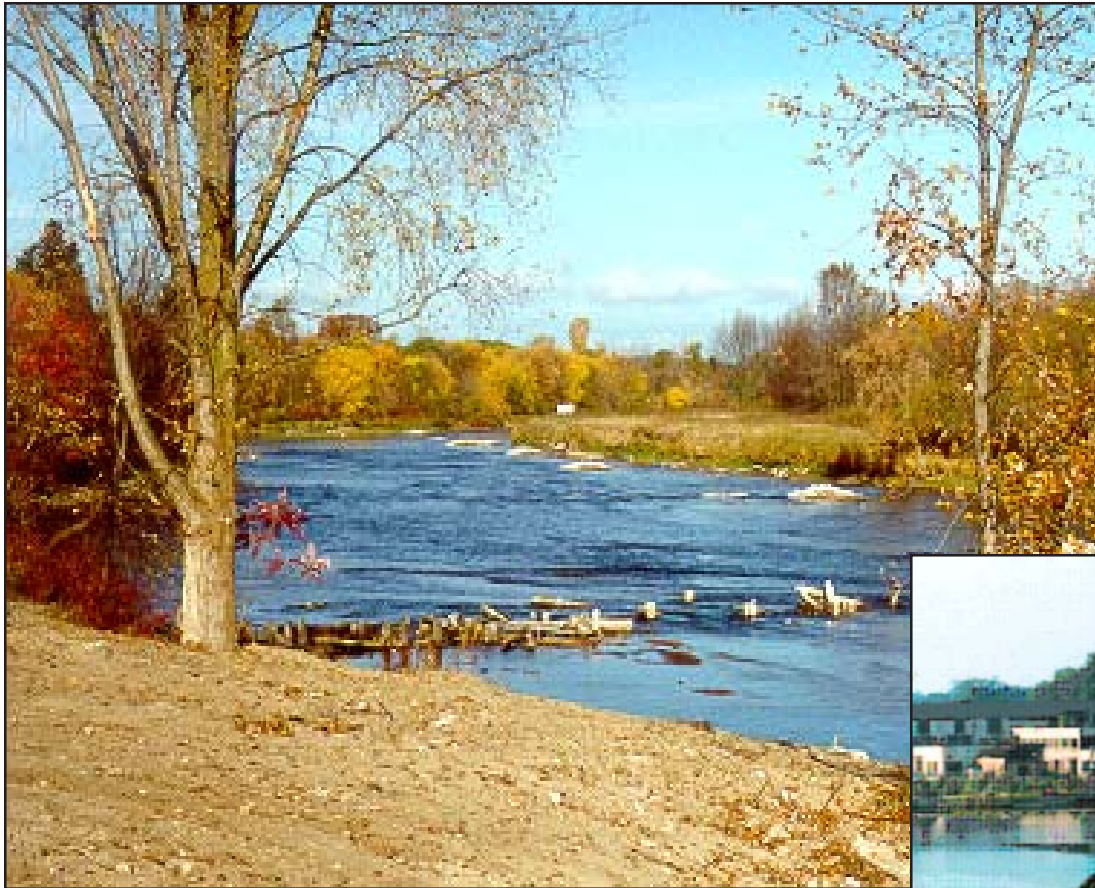
*A railroad trestle once crossed the Muskegon river immediately above the dam. Here you can see the timber pilings from the trestle emerging from the water. These piles were removed by the contractor.*

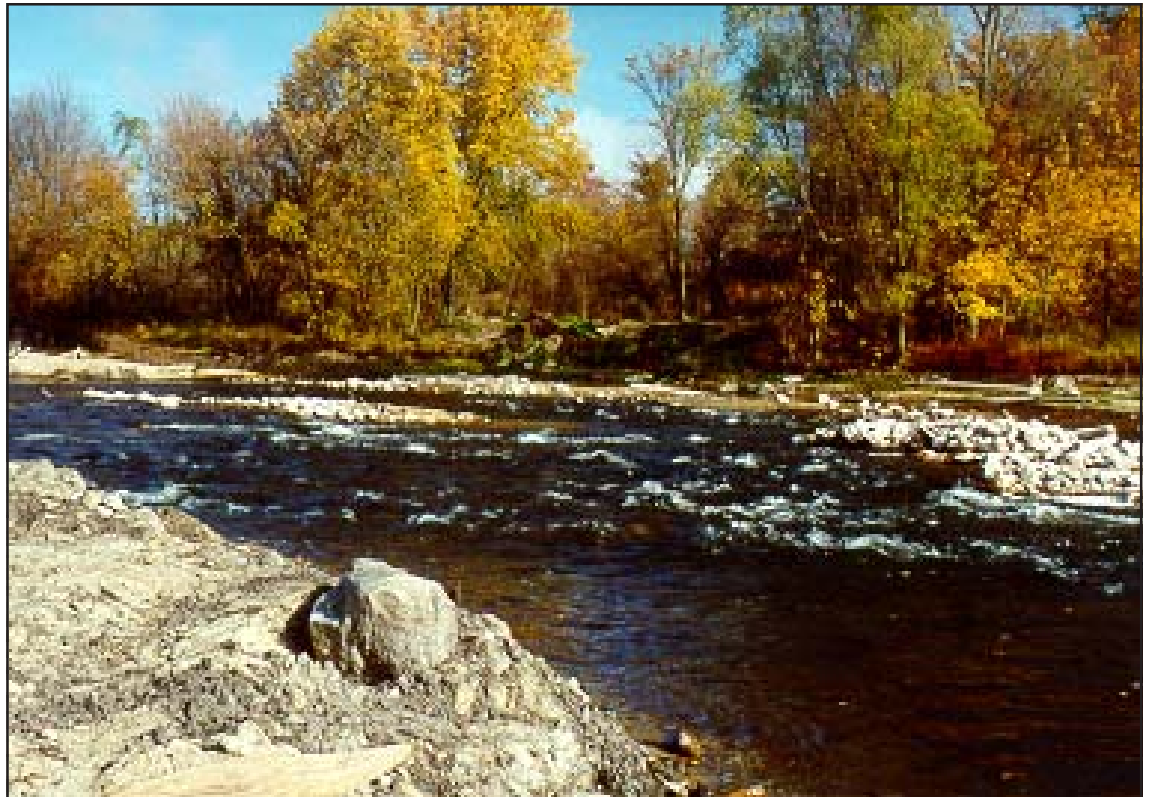
*By the autumn of 2001, the Muskegon River in Big Rapids had a new 'look.' The big rapids were back! Several timber and rock cribs, used in the 1800s to 'corral' lumber as it floated to local sawmills, became visible as the river's level dropped behind the dam.*
