# Gruendyke Dam Removal: Initial Step in Restoring the Musconetcong River

Geoff M. Goll, P.E.   Jacob Helminiak, P.E.   Paul M. Woodworth

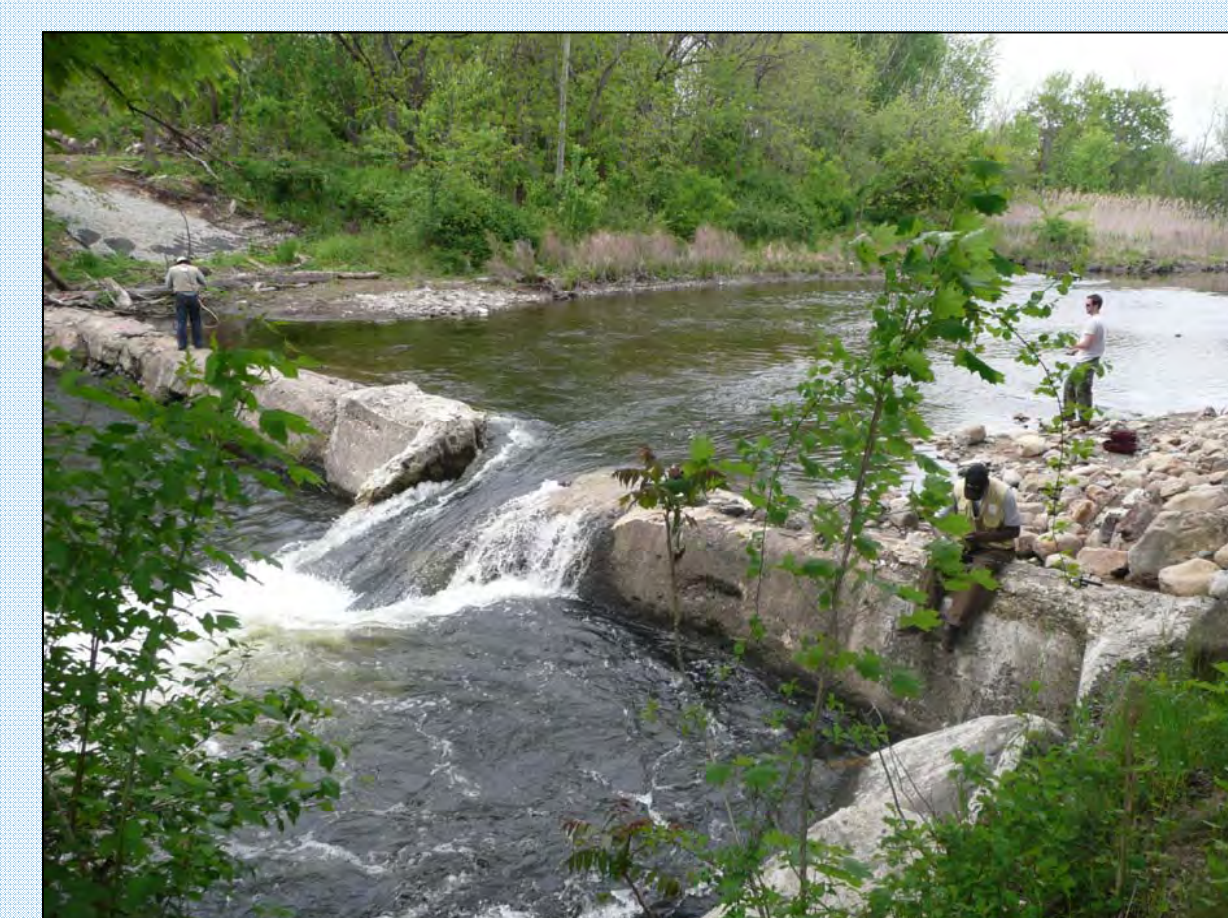
Dewatering the impoundment - 5/14/08

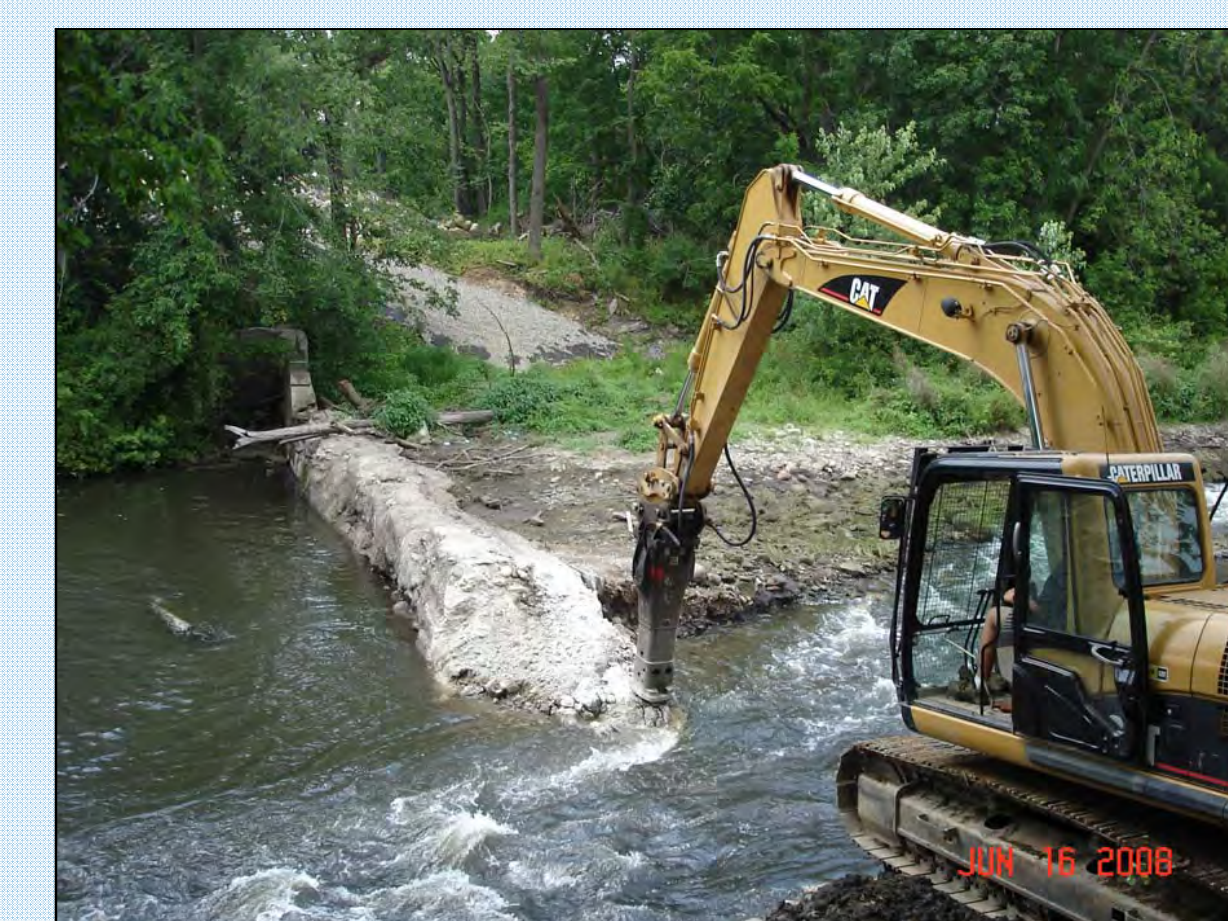
Removing river left half of dam to lower water levels and begin weir installation - 6/16/08

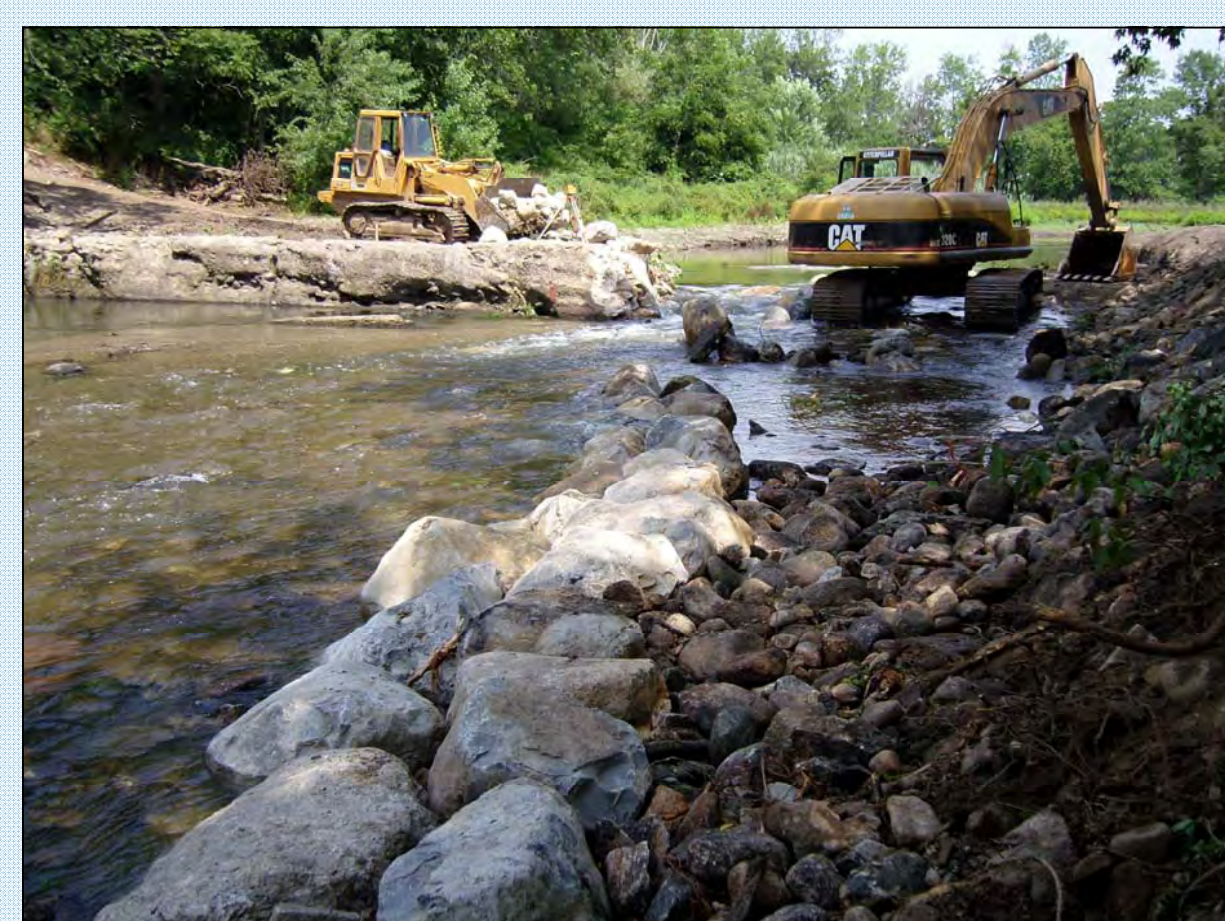
Installing lower weir on river left - 7/17/08

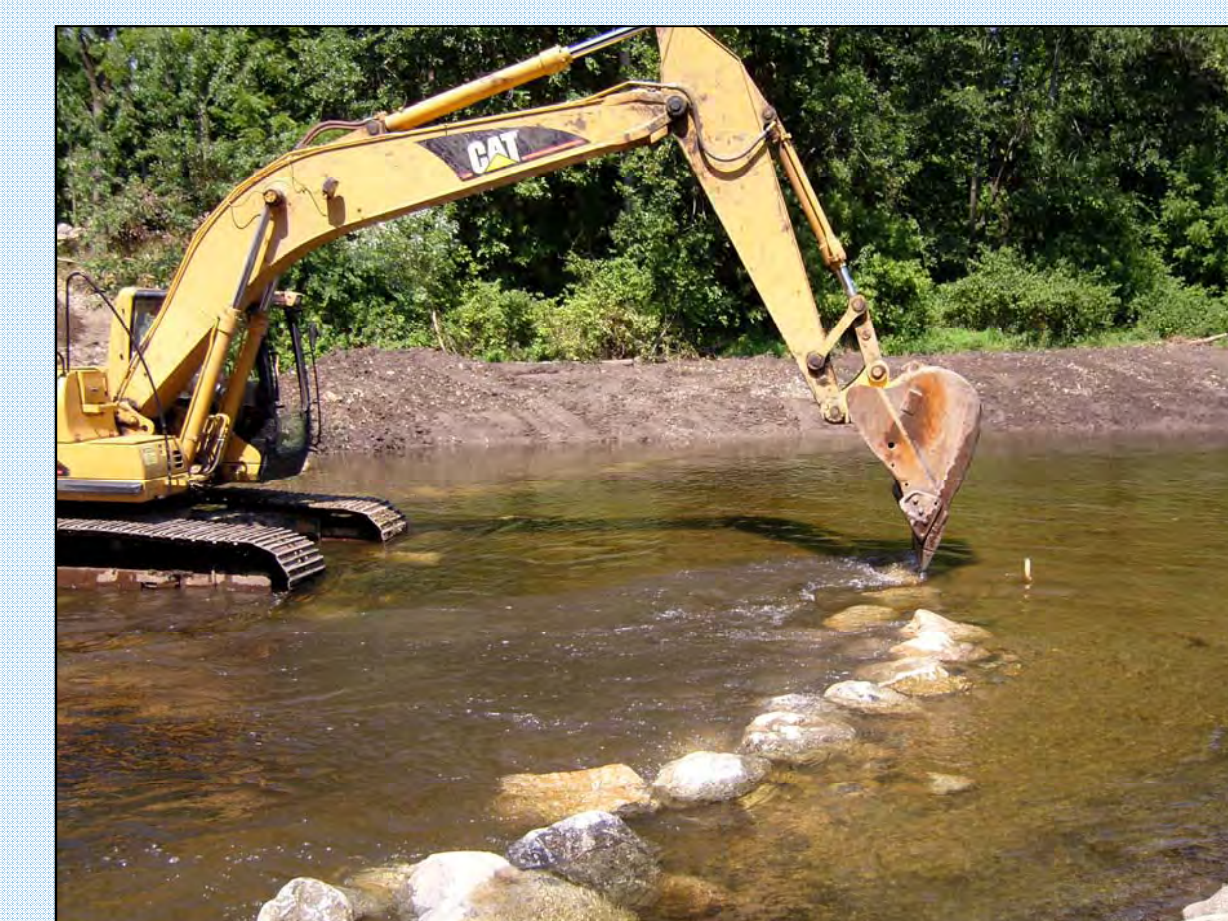
Modifying upper weir on river left - 7/25/08

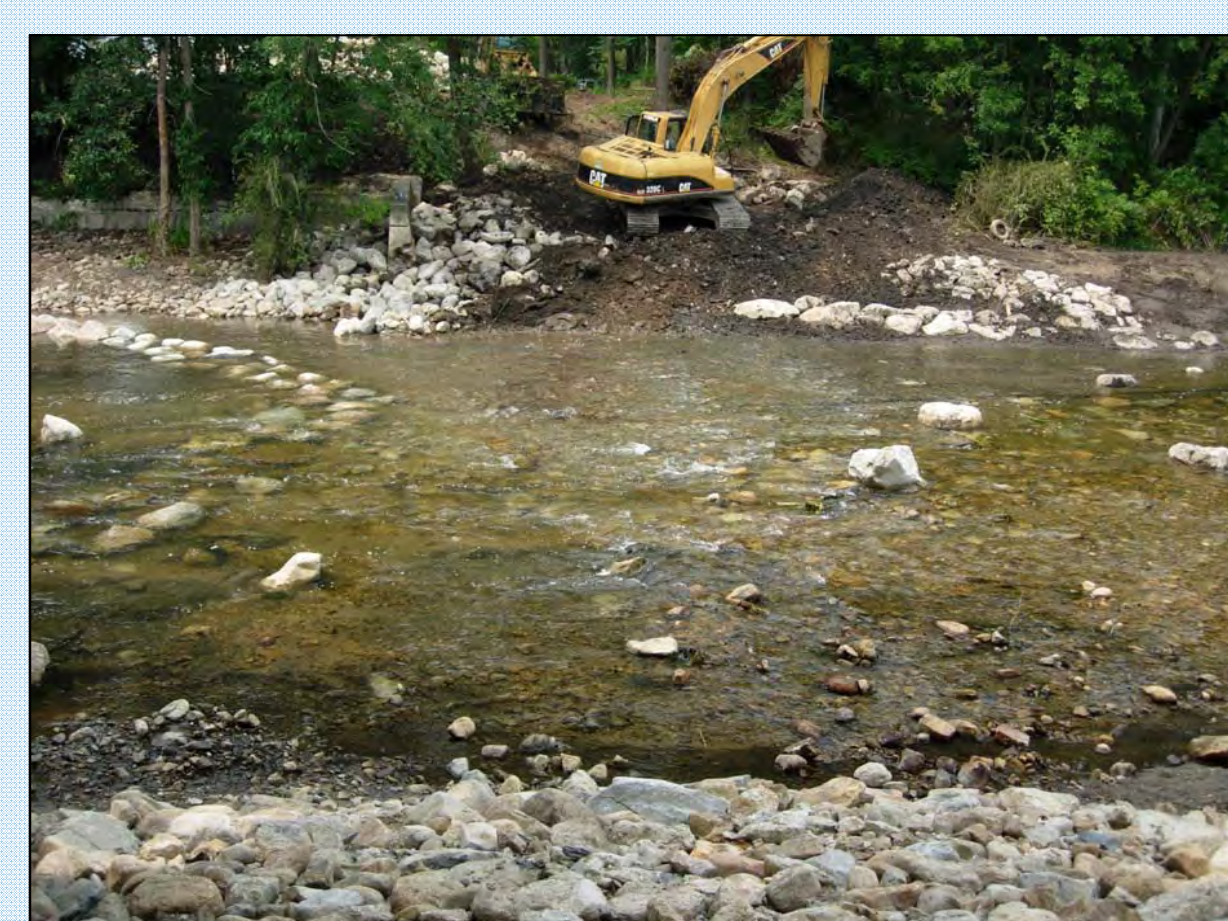
Installing upper weir on river right - 7/30/08

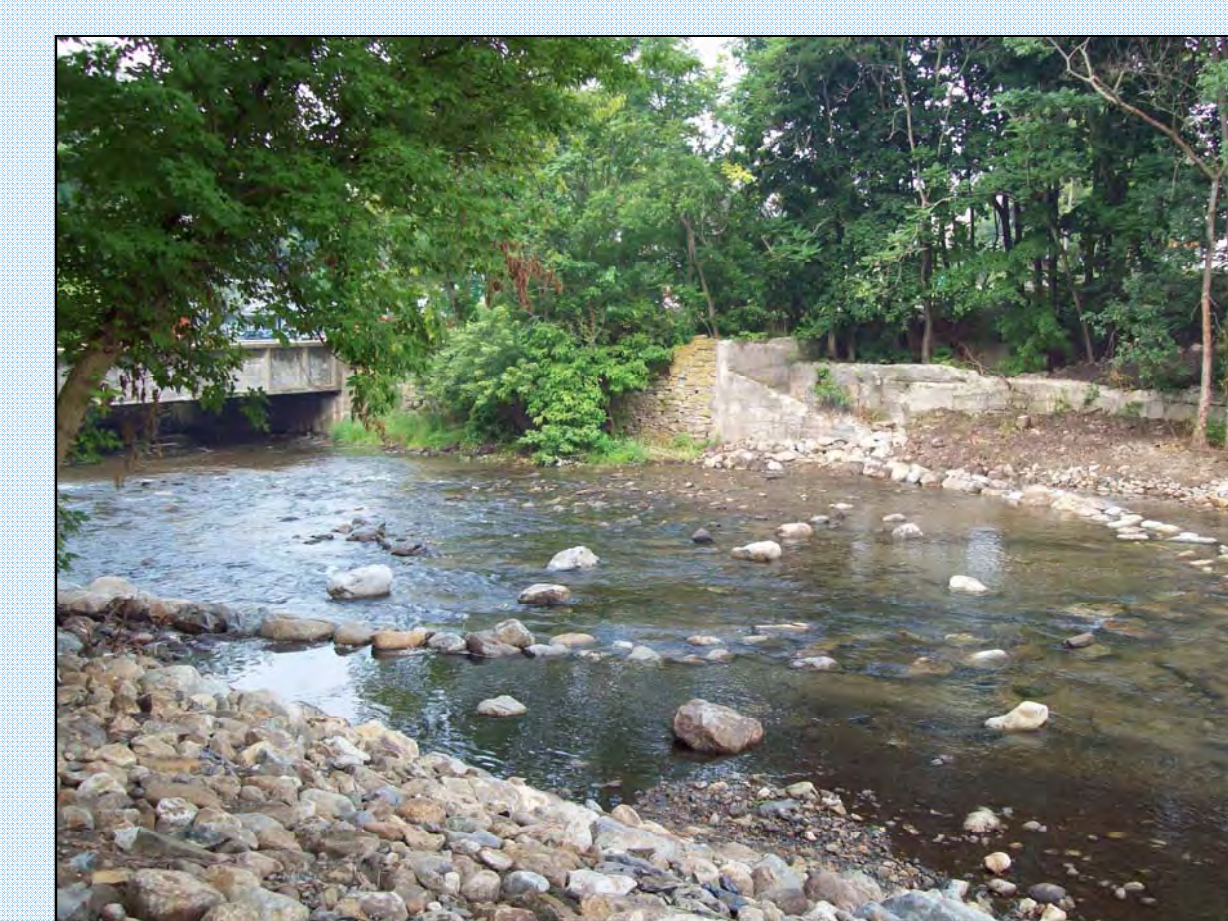
Completed lower weir - 8/6/08

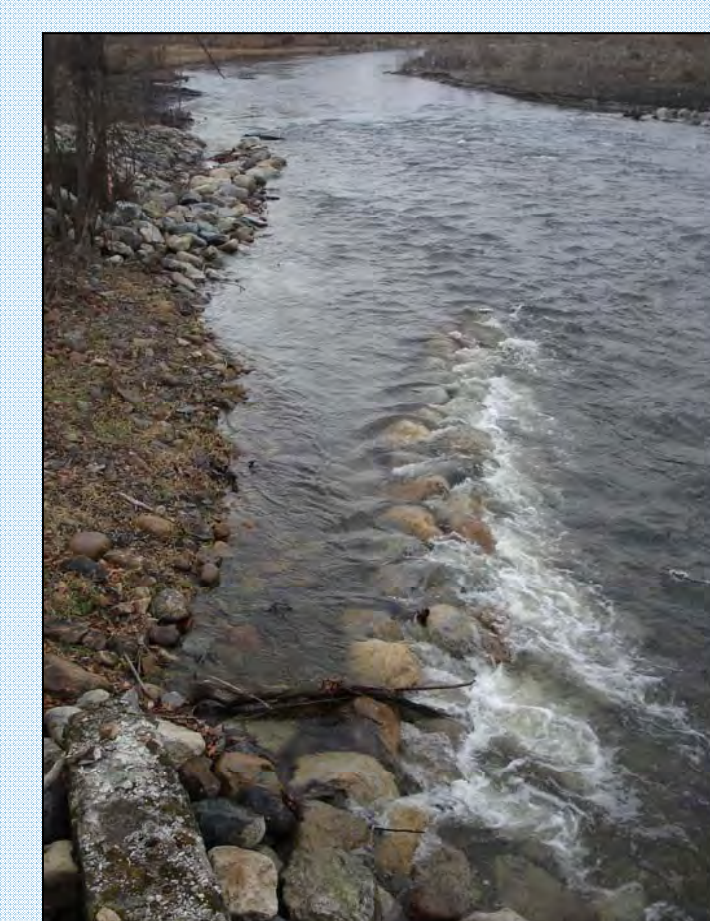
Reduction in near bank velocities - 12/2008

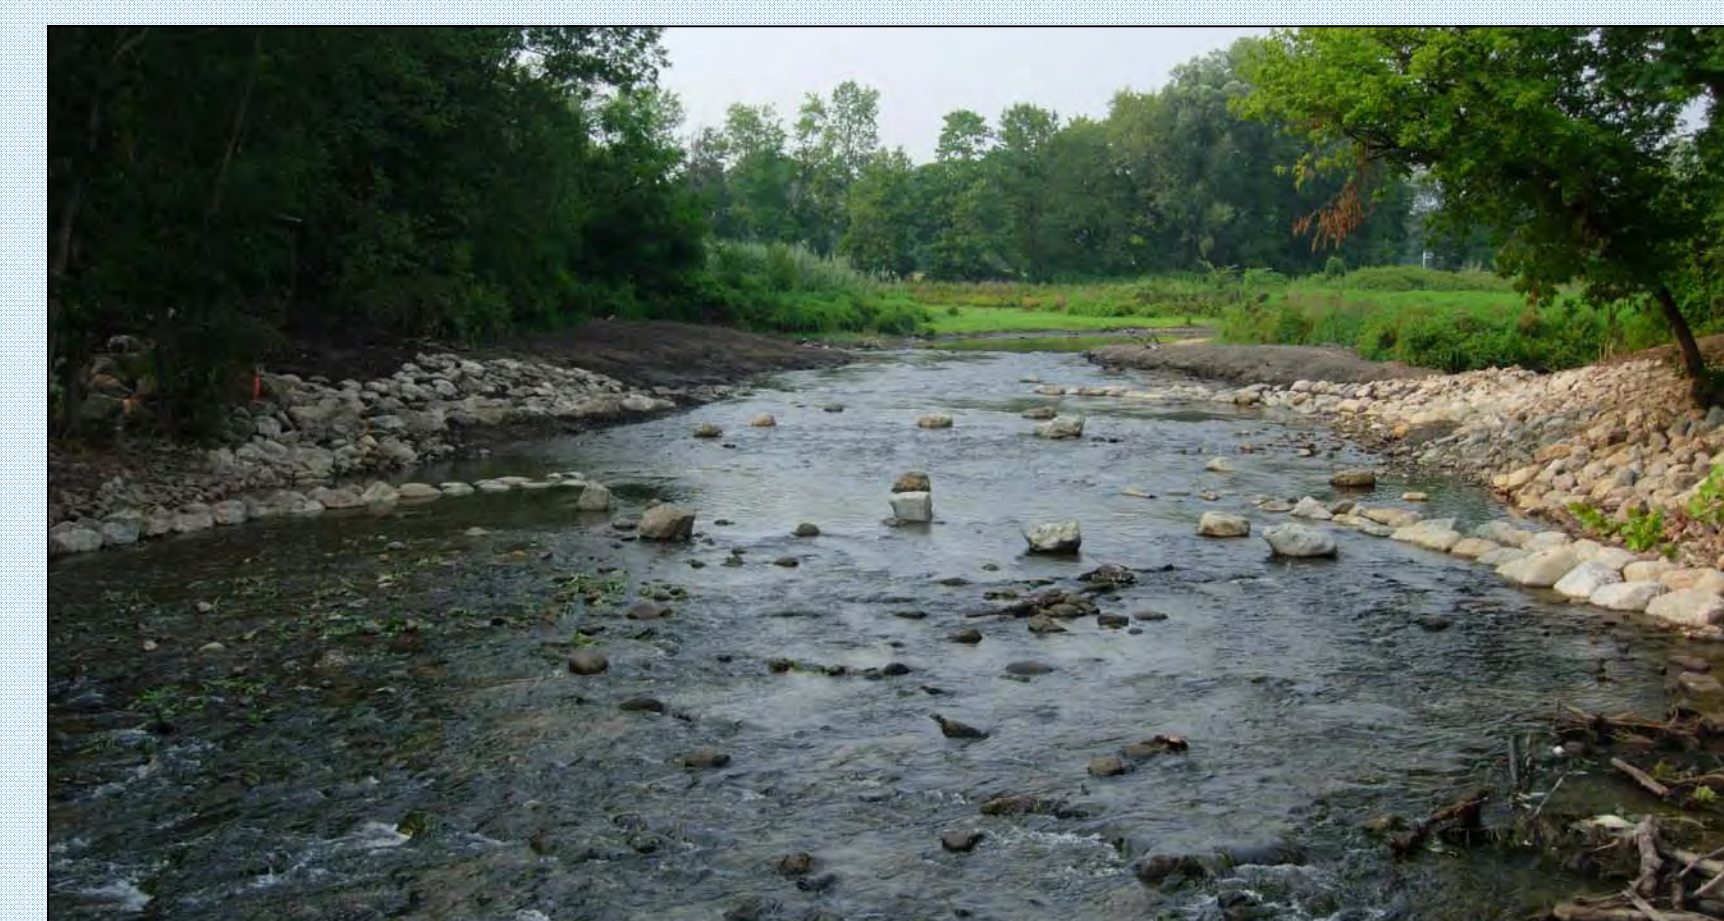
Completed Weirs - 7/30/08

- Used native boulder vortex weirs
- Created pool/riffle habitat
- Reduced near bank shear stress
- Redirected thalweg away from bridge pier
- Maintained desired riffle sounds & Improved river aesthetics for Pump House Restaurant

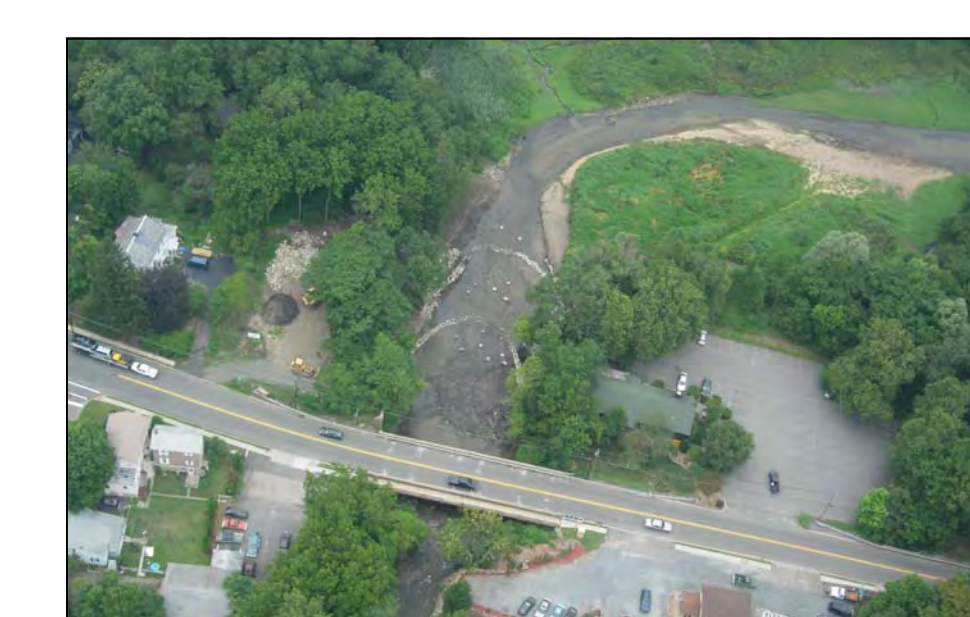
Completed Weirs - 7/30/08
