July 17, 2007

## **HORSE CREEK DAM REMOVAL - POST PROJECT SURVEY**

Matt Stoecker, Biologist, Stoecker Ecological

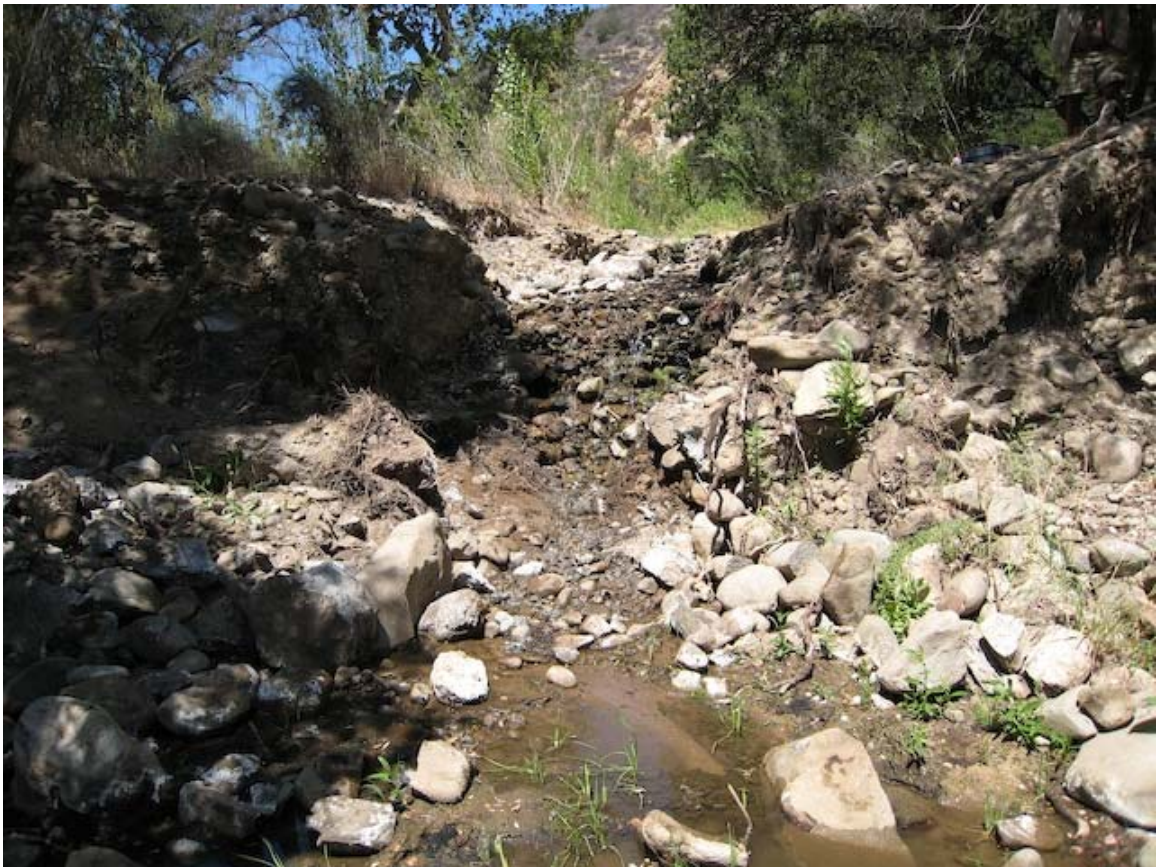
Upon returning to the dam site on June 26<sup>th</sup>, we observed similar conditions as described by Kevin, with a wedge measuring 7.5 feet wide and 4 feet deep extending 21 feet upstream to heavily mineralized pre-dam channel substrate. The mobilized sediment wedge had deposited immediately downstream of the dam creating a mound of substrate where the former scour pool occurred. The concrete footing was undercut with approximately 0.15 c.f.s. flowing underneath it. Using heavy boulders nearby, we were able to break the remaining concrete footing in half and remove it from the channel that was incising upstream through the sediment. Following removal of the footing, the wedge-shaped notch was measured to be 6.5 feet tall at the site of the former dam with the same width and upstream incision lengths stated above.

Looking upstream at incising channel from below former dam site.

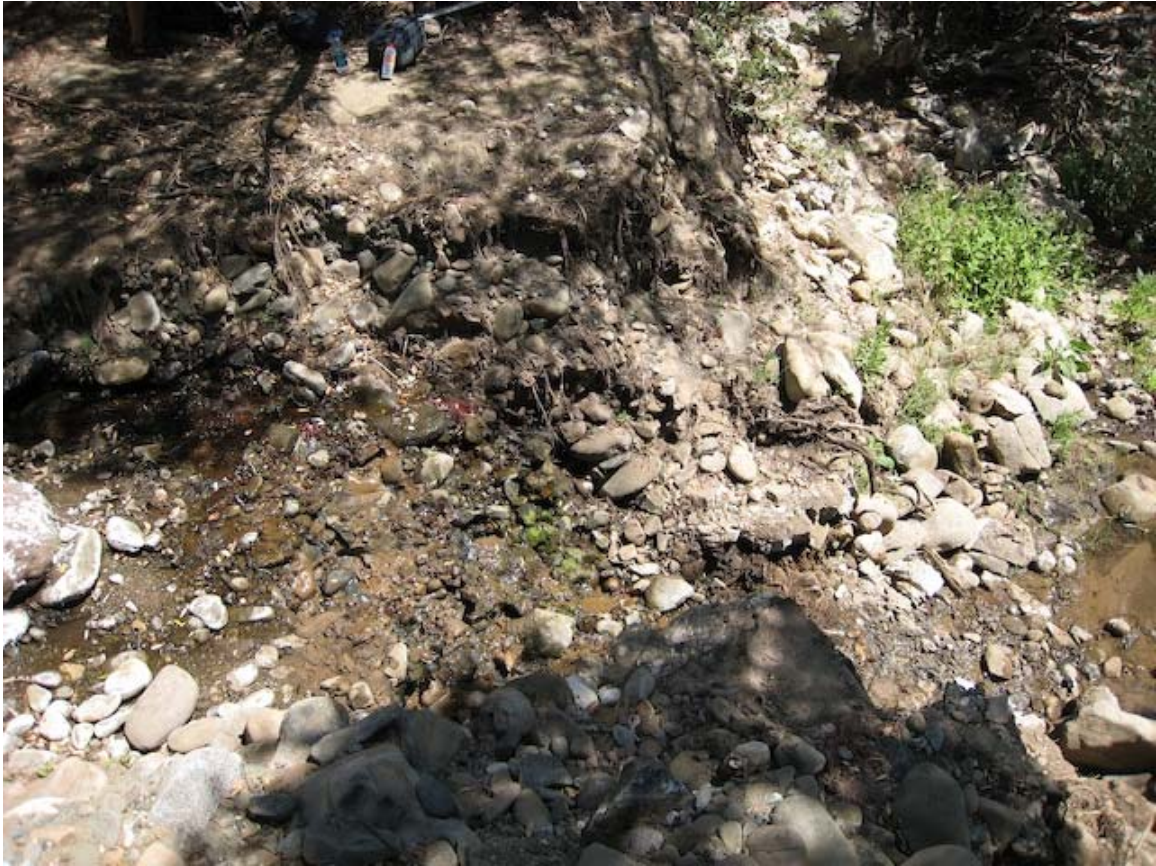
Looking across incision from river right side.

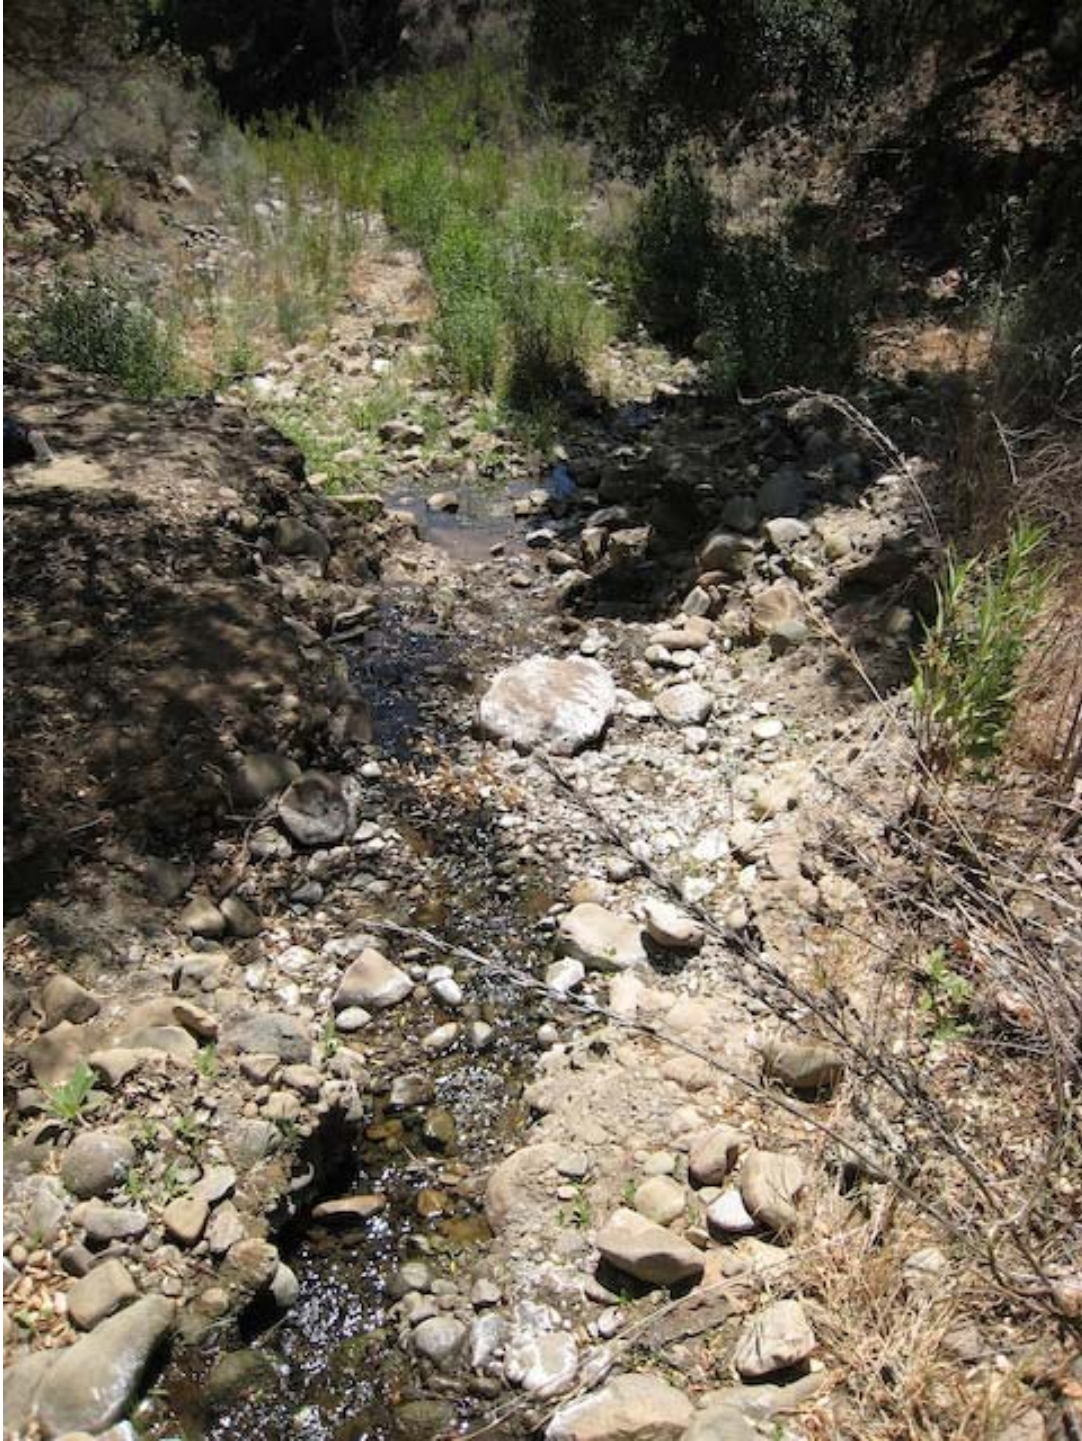
Looking downstream from the top of the incising channel.

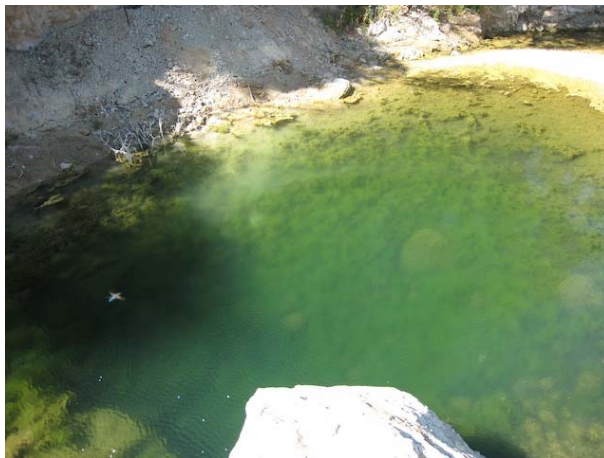
While hiking from Manzana Schoolhouse downstream to Horse Creek several large *O. mykiss* were observed in the Sisquoc River. During previous surveying efforts through this reach in 2001 and 2005 no *O. mykiss* were observed. Immediately downstream from the Manzana Schoolhouse campground outhouse and where the dry Manzana Creek channel enters the Sisquoc River, two *O. mykiss* with estimated lengths of 7 and 15 inches were observed while snorkeling in an isolated pool. The boulder scour pool measured over 7 feet deep with no surface inflow or outflow. Thousands of Arroyo chub were also present in this pool in addition to three Southwest pond turtles.

Pool with 7 and 15 inch *O. mykiss*.

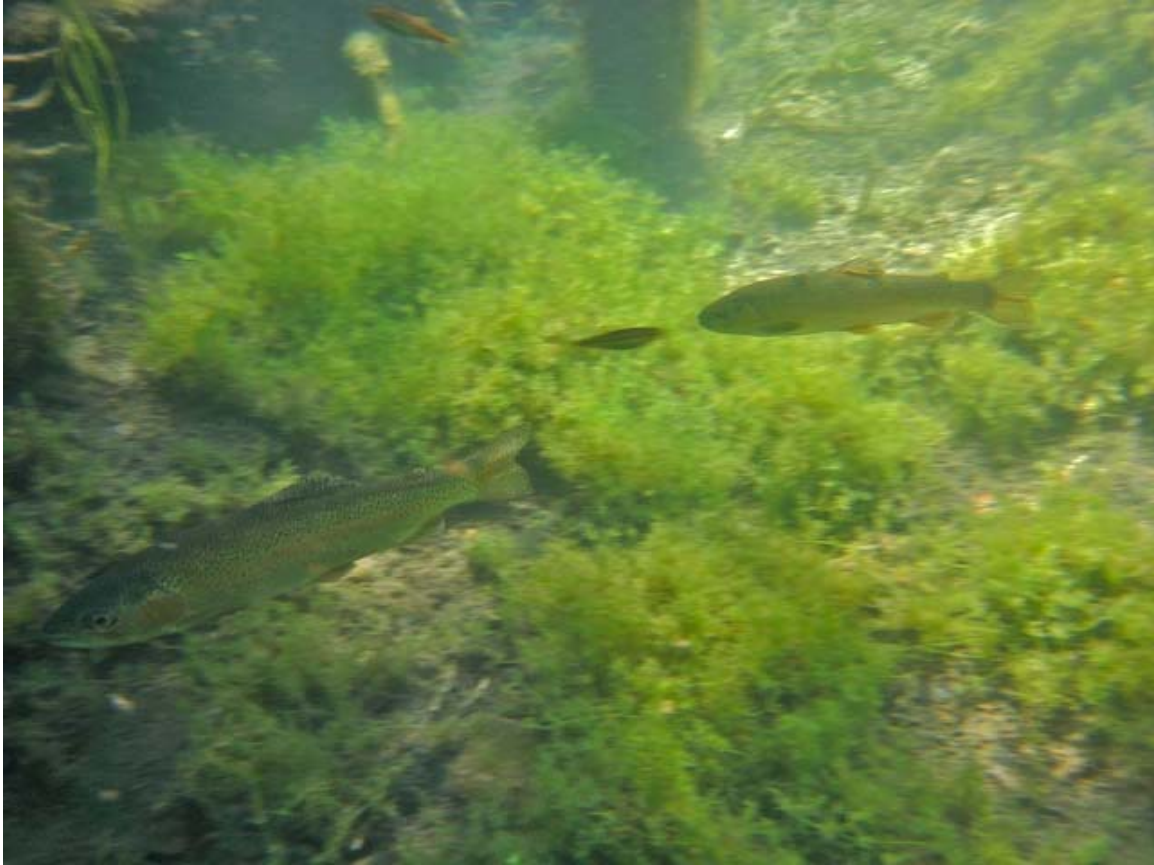
An additional 1000 feet downstream from the above mentioned scour pool surface flows resumed and a small pool measuring 4 feet deep occurred upstream of a small beaver dam and in association with adjacent undercut banks. Four *O. mykiss* ranging from 11 to 17 inches in length were observed while snorkeling this pool.

11 and 14 inch *O. mykiss* in beaver dam pool plus small Arroyo chub.
