Hydrology, Hydraulics, and Sediment Studies for the Matilija Dam Ecosystem Restoration Project, Ventura, CA – DRAFT Report

U.S. Department of the Interior
Bureau of Reclamation
Technical Service Center
Denver, Colorado

November 2006

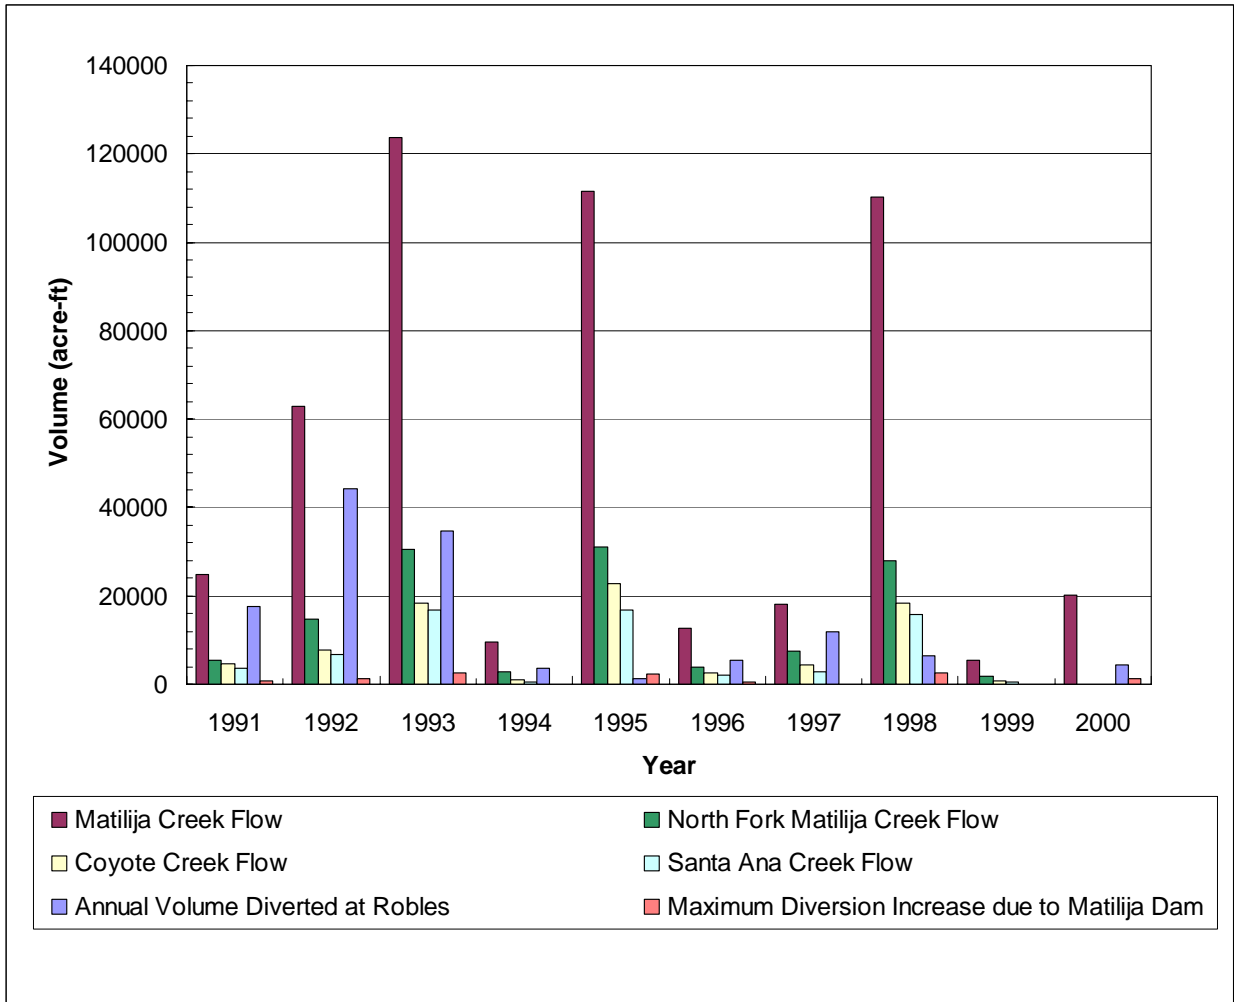
Figure 2.13. Annual Flow and Diversion Volumes for Period 1991 to 2000.

Based on the available diversion flow data for the years 1991 to 2000 there appears to be no set date for the diversion to be shut down each year. Diversions will occur as late as August 7 or July 16 in wet years such as 1992 and 1993. In normal years, the diversion appears to be shut down by the end of May. It appears that diversions can occur during all summer months if water is available for diversion.

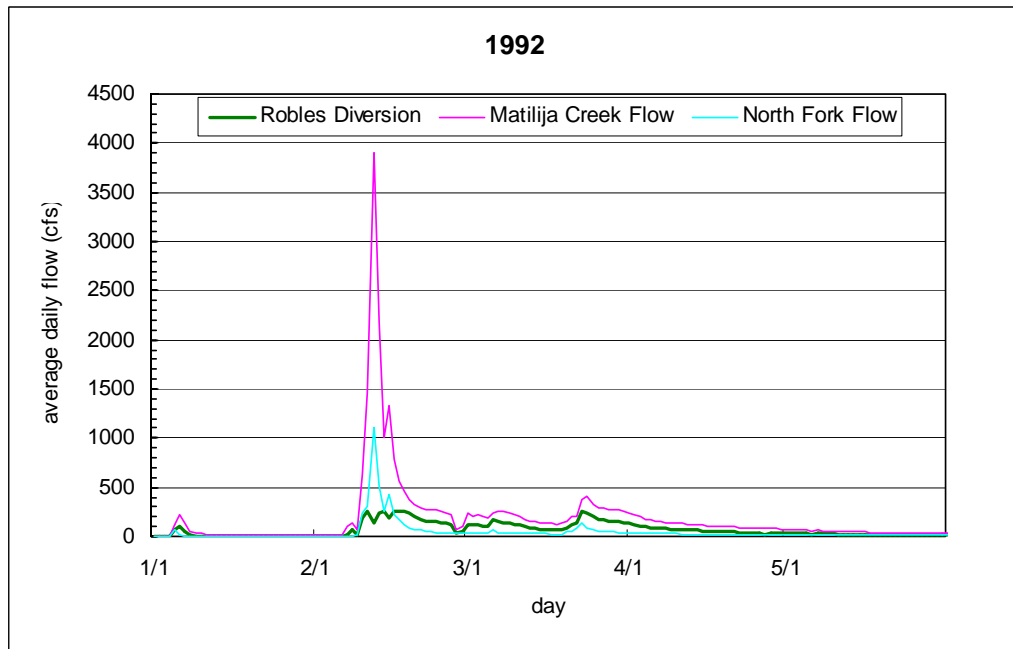
The actual daily average flow diversions for the period of 1991 to 1998 are shown on the following pages (Figure 2.14). It should be noted that there are large variations in the flow for a given year and as a result, there are large variations in the diversion at Robles. For example, in 1997, 47% of the flow of North Fork and Matilija Creek was diverted into Robles Canal.

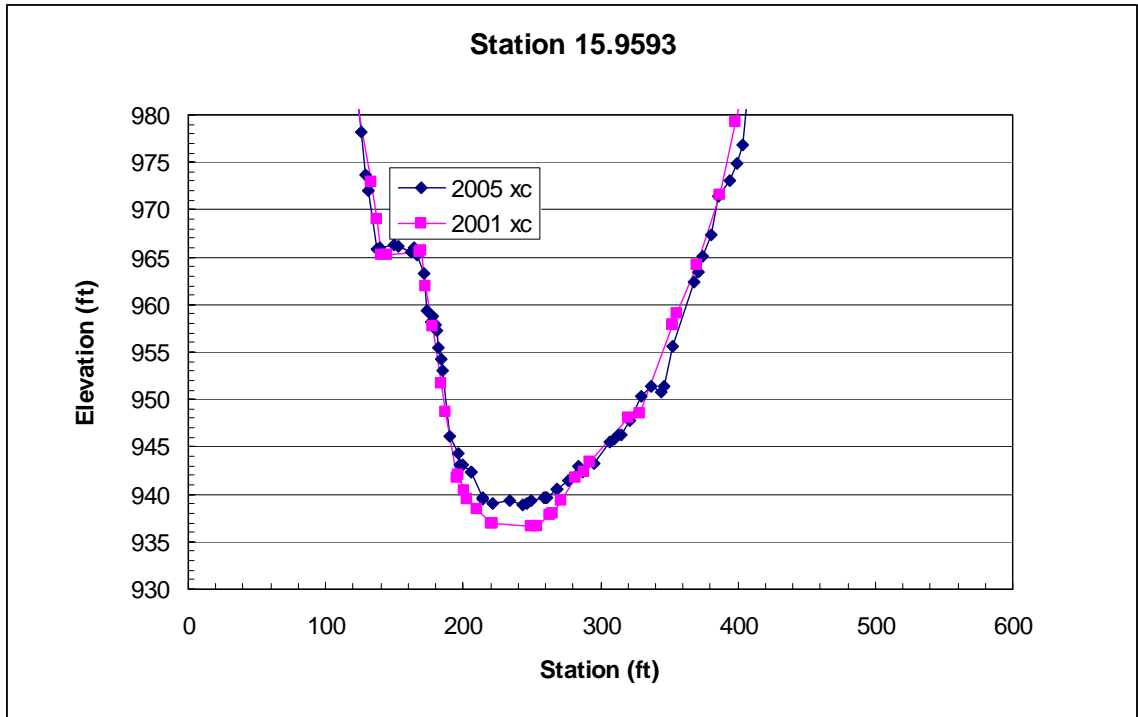
Figure 4.1. Comparison between 2001 and 2005 aerial surveys at Station 15.9593.

The 2005 LiDAR survey was compared against the 2001 Photogrammetry survey. In general, the comparison between the surveys found little inexplicable change. Major differences between the surveys could generally be explained by changes in river plan form, bank erosion or differences in the methods used to eliminate vegetation from the aerial survey. However, one important difference in the two surveys was found in the Hot Springs reach (RM 16). The 2005 survey showed the bed approximately 3 to 4 feet higher than the 2001 survey in this reach. Two example cross sections are shown in Figure 4.1 and Figure 4.2. However, subsequent ground surveys confirmed that the 2001 survey was more accurate in this reach and therefore the 2005 cross sections were corrected within HEC-RAS before the hydraulic computations were performed.

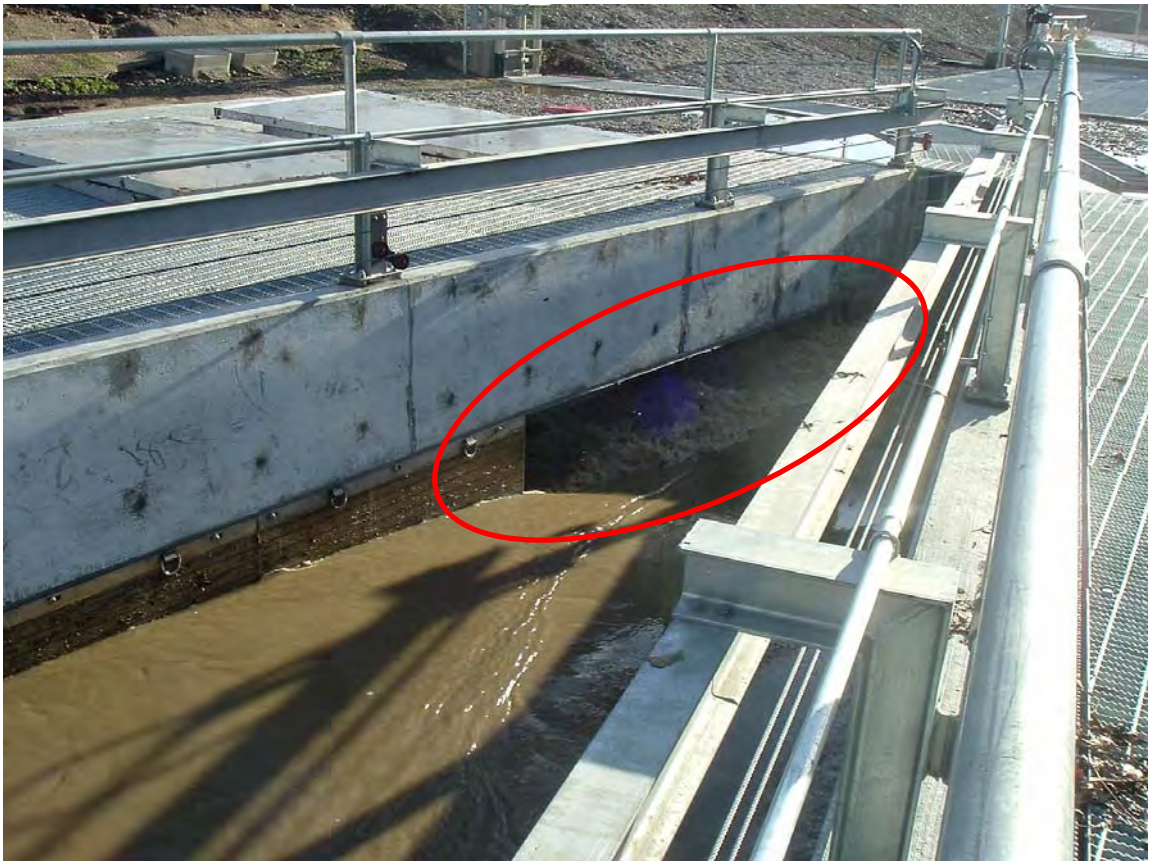
Figure 4.7. Picture Taken During January 2005 Flood Showing Fish Screens Removed in Robles Canal.

Floods can cause a variety of problems at Robles Diversion. One such problem is associated with the fish screens that were placed in the canal as part of the fish passage facility constructed in 2004. These fish screens can become plugged with sediment and debris and prevent flows from passing down the canal. The screen cleaning equipment in current use is not adequate to keep the screens clean during floods (see Figure 4.7).

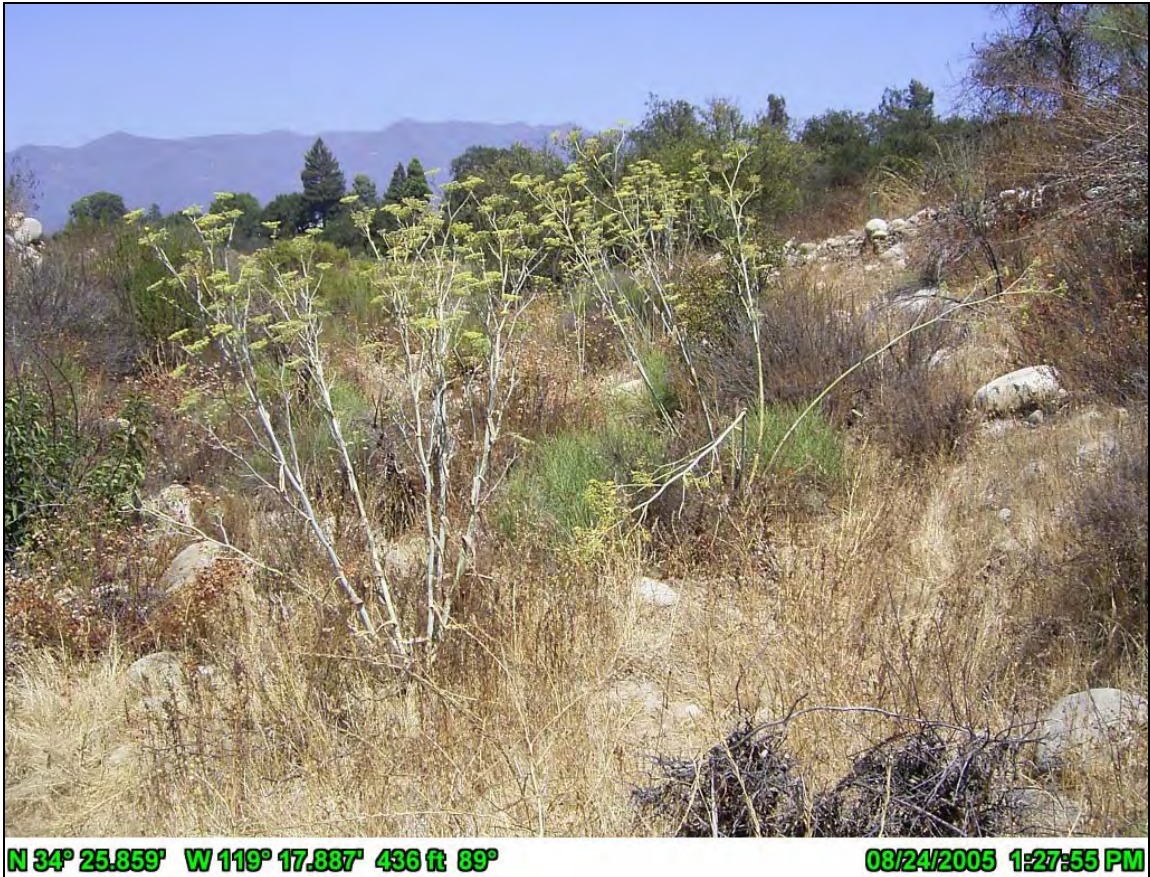
Figure 4.9. Levee located upstream of “Burn Dump” on east side of Ventura River at approximately RM 11.54.

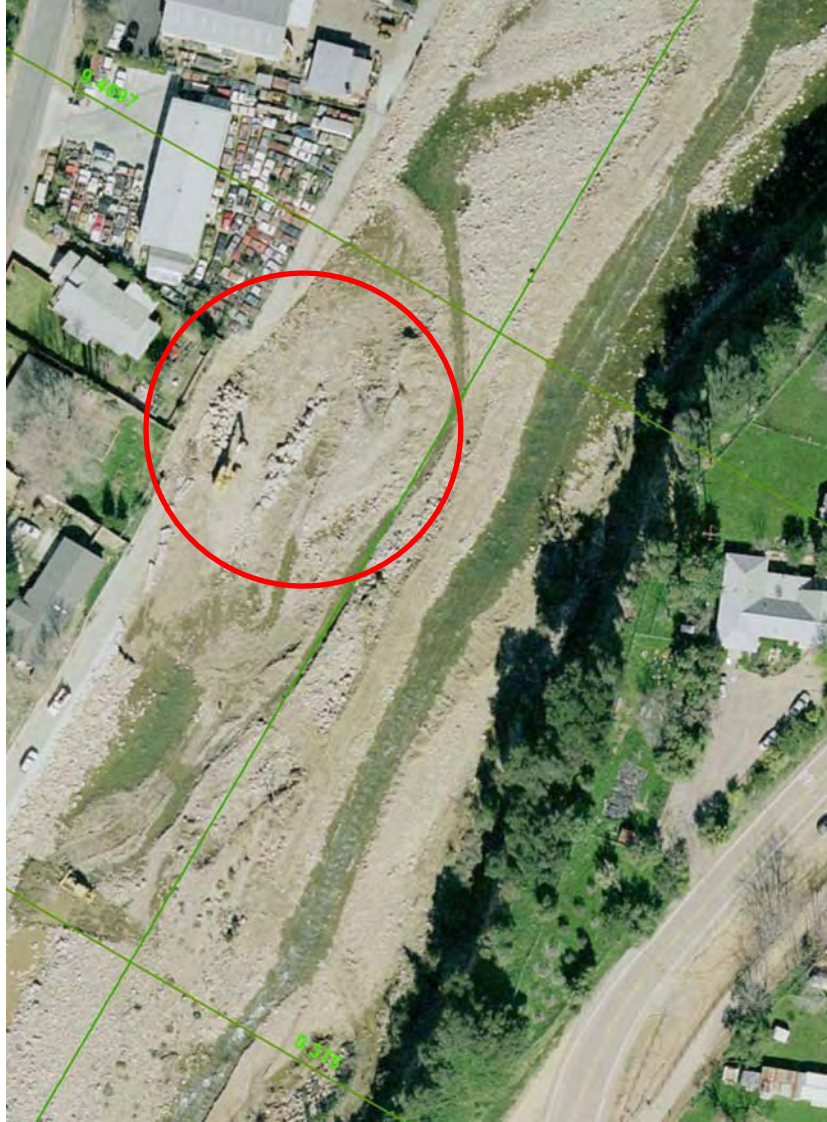
Figure 4.12. Aerial photo taken in February 2005 showing erosion of Live Oak Levee erosion between XC 9.375 and 9.4697.

The Live Oak levee may be subject to erosion as evidence by the damage caused by the Jan 2005 flood shown in Figure 4.12 at approximately RM 9.4. There is backhoe shown in the photo repairing the damage caused by the Ventura River eroding the riprap protection along the West bank. The riprap placed along the Live Oak Levee is approximately ½ ton based upon the County records. From the Santa Ana Bridge to RM 9.5, it is estimated that rock weighing at least 0.8 ton would be required to prevent erosion up to the 100-yr flood. The levee will continue to erode at flood flows with a return period of 20-yr and greater. Smaller flows may also erode the levee if the river is directed at the levee as occurred in 2005.

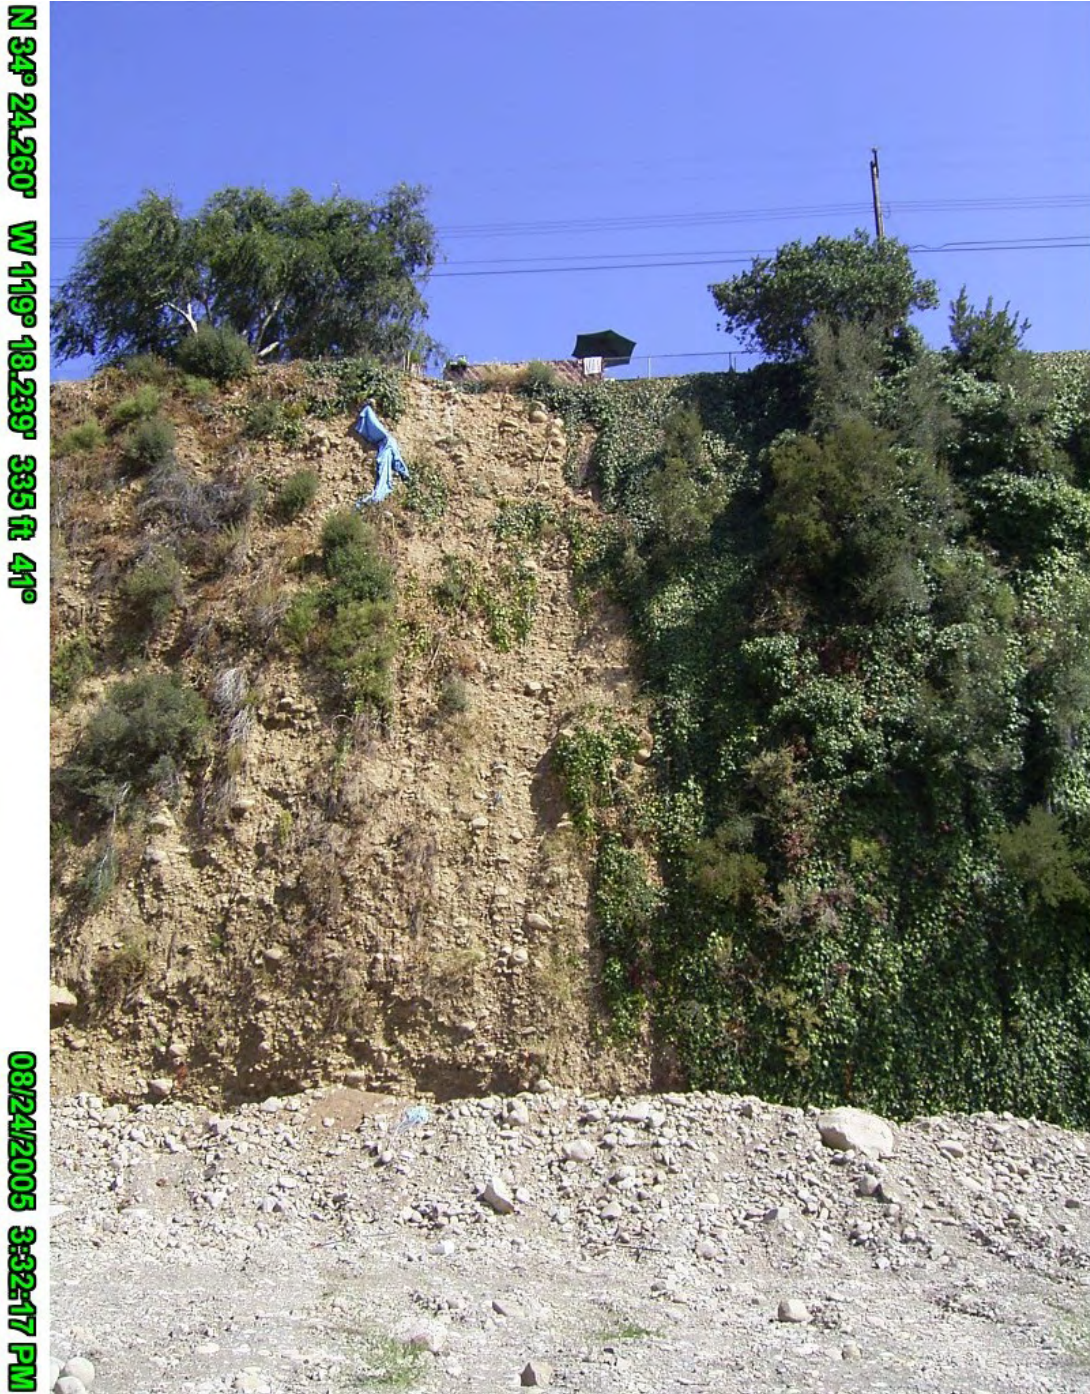
Figure 4.14. East Bank of Ventura River Located at RM 9.6 Showing Alluvial Material of Terrace and Some Recent Bank Failure.

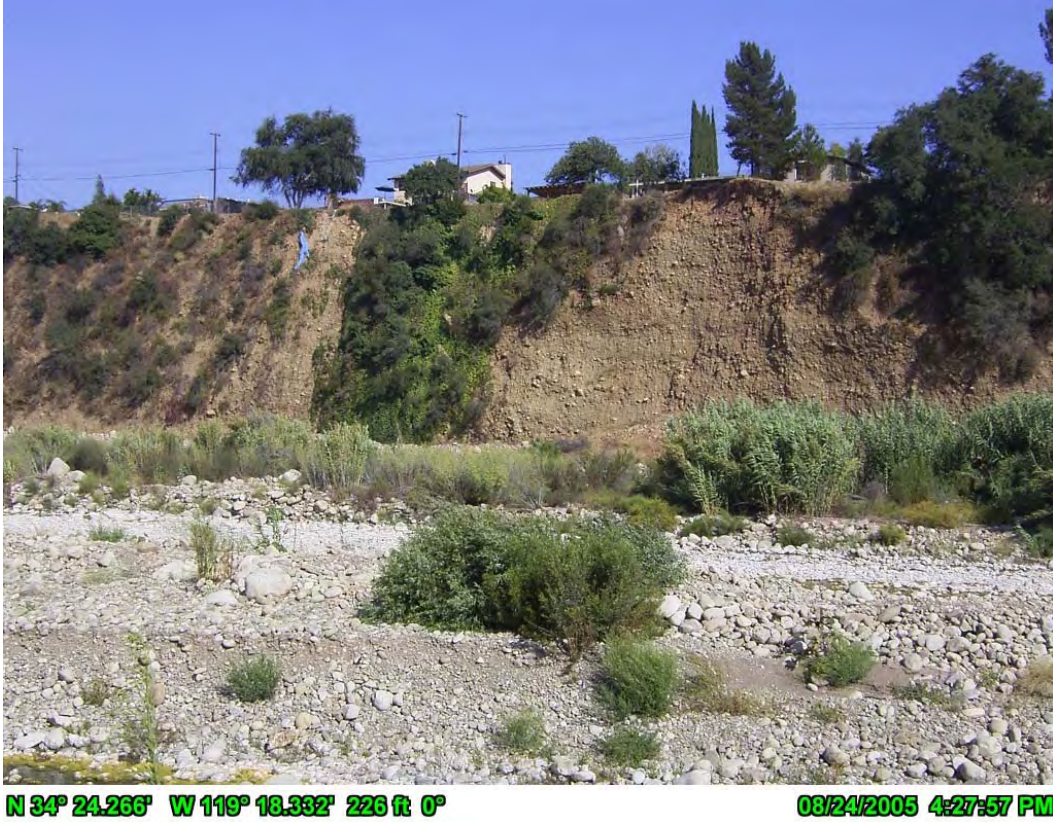
Figure 4.15. East Bank of Ventura River Located at RM 9.6 Showing Some Recent Bank Failure,

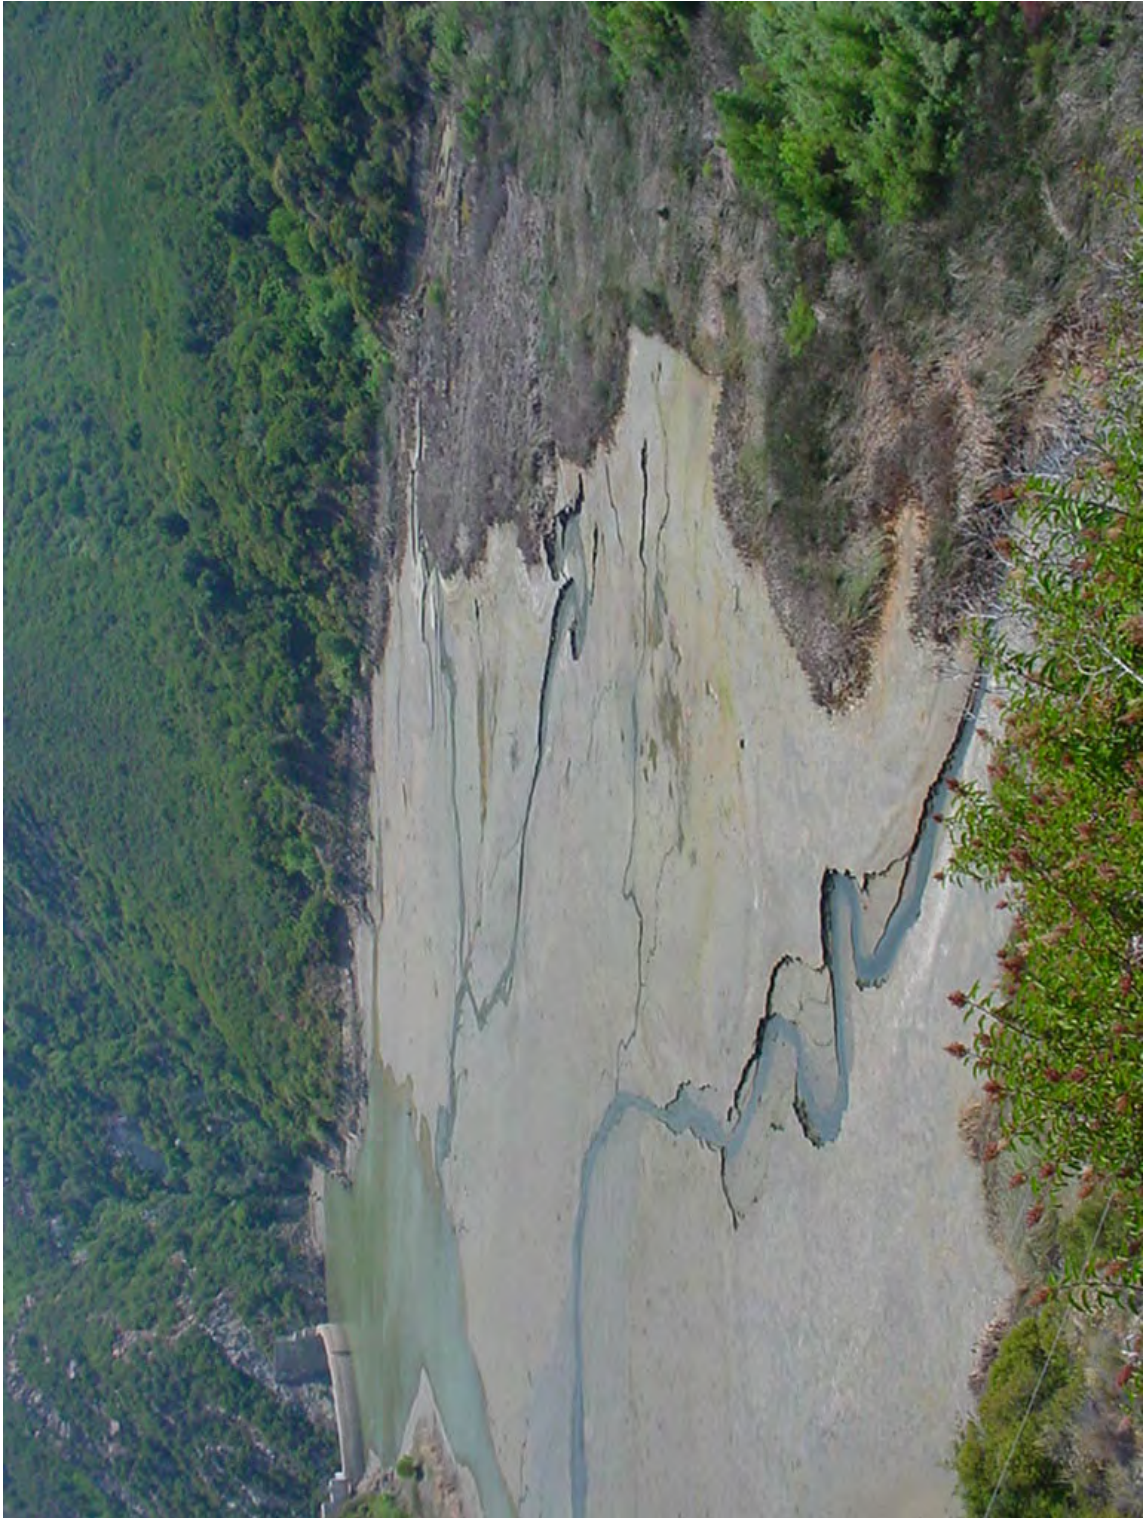
Figure 5.11. Picture of Sediment Trapped behind Matilija Dam While the Reservoir was Drawn Down. Picture was taken in July 2003 by Paul Jenkin of the Surfrider Foundation.

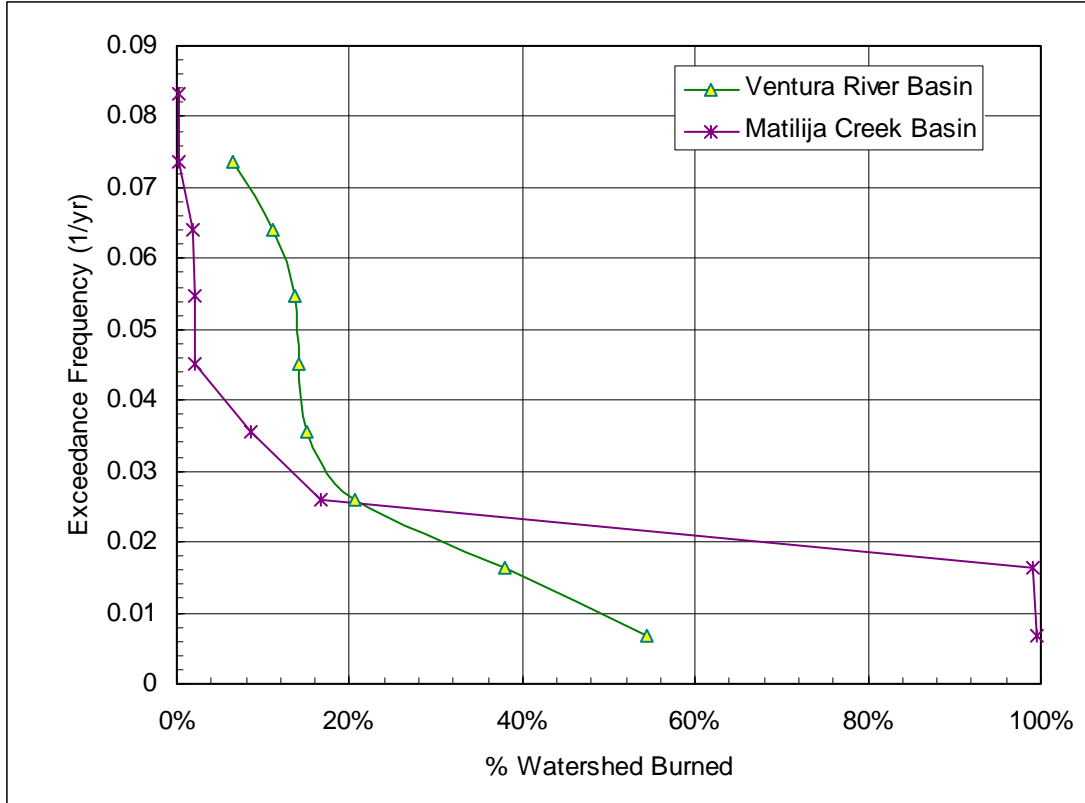
Figure 5.24. Fire frequency in the Matilija Creek and Ventura River Watersheds.

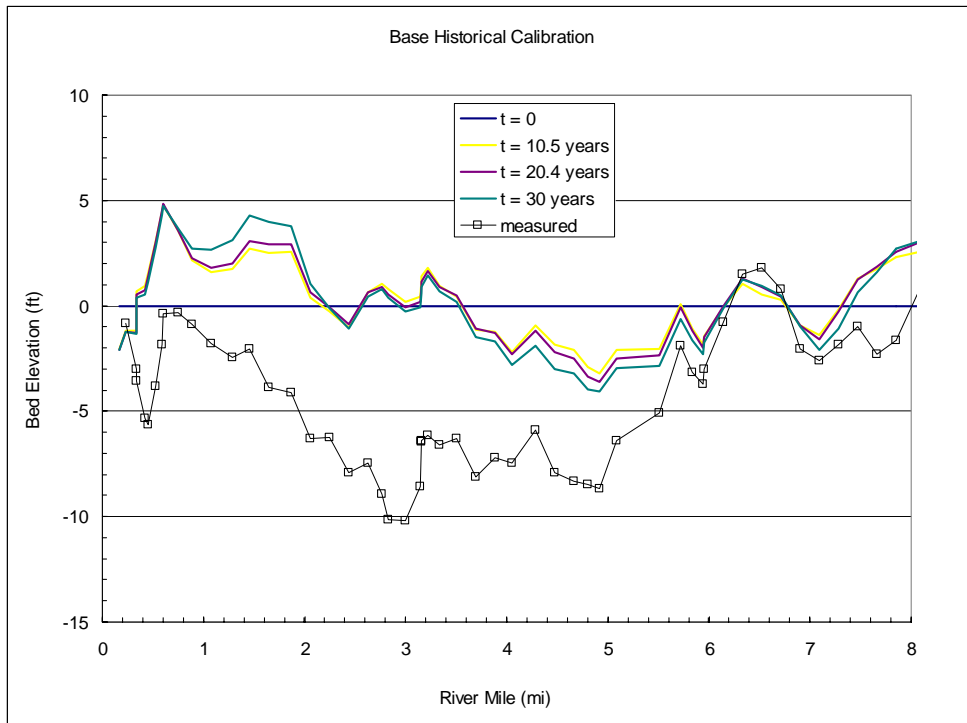
Figure 6.17. Computed Thalweg Elevation Change from 1971 to 2001, RM 0 – 8.

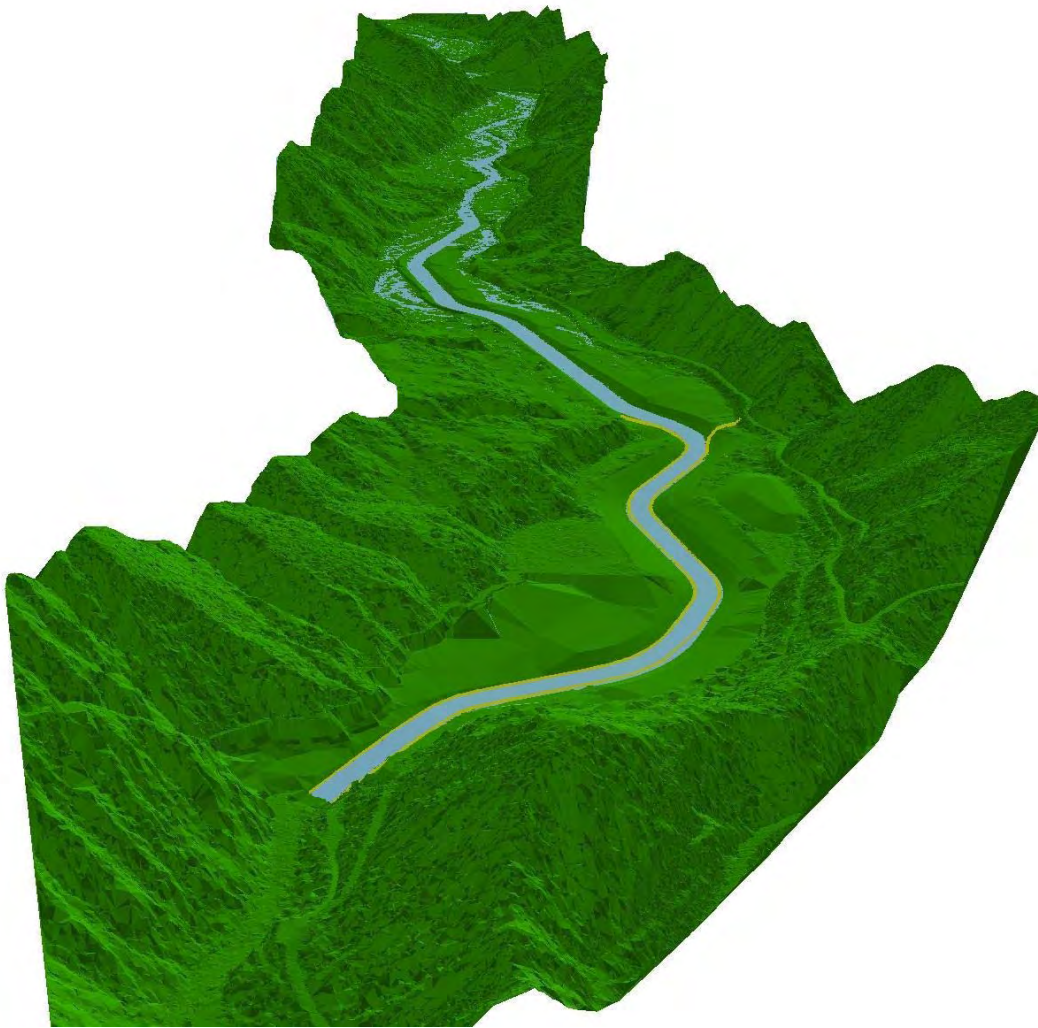
Figure 7.1. Oblique View of Channel Immediately after Dam Removal.

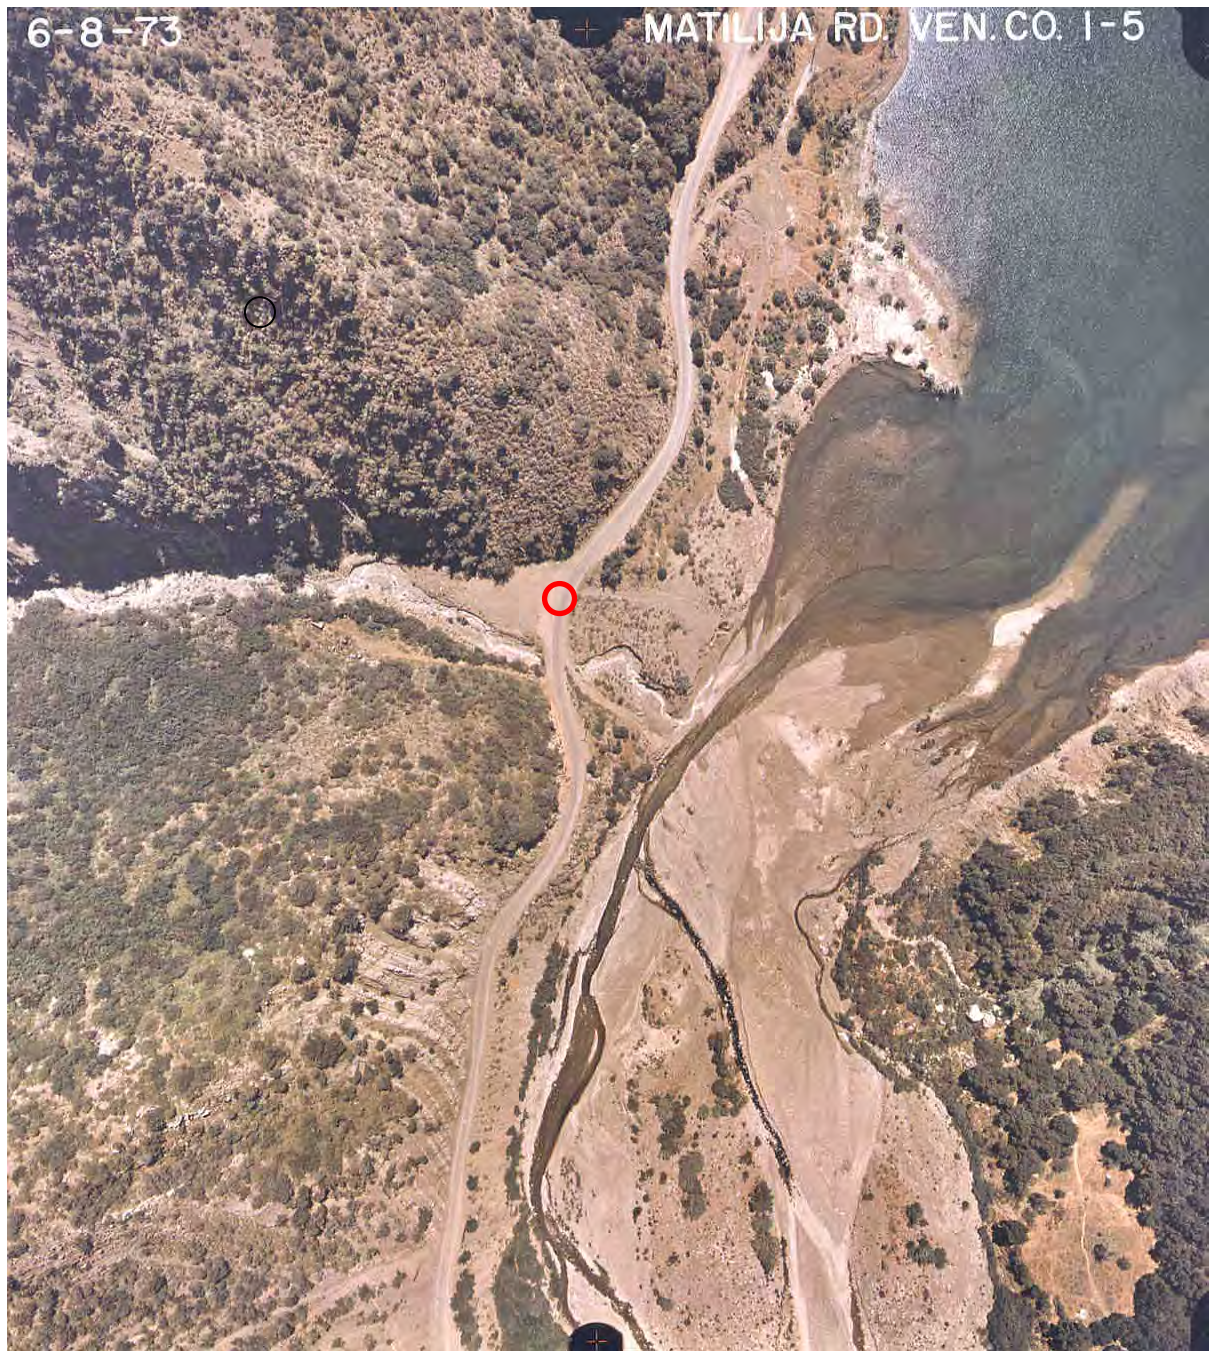
Figure 11.2. 1973 Photograph of Matilija Delta. Note: The red circle is located at the same location in the following pictures of the Matilija Reservoir.

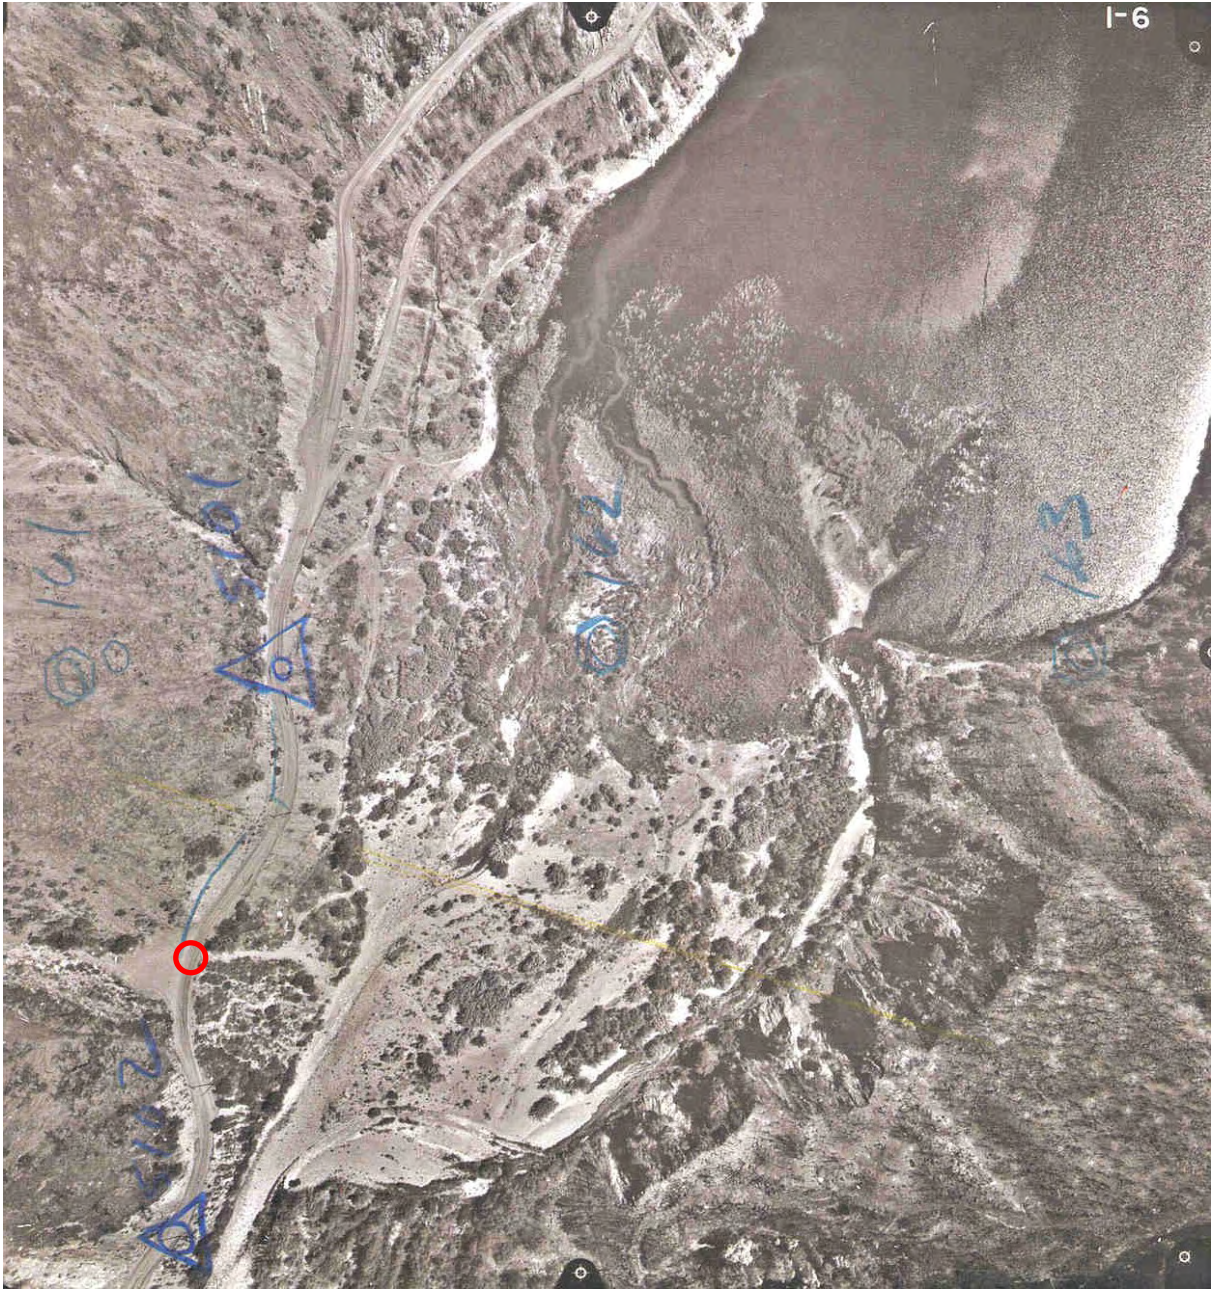
Figure 11.3. 1985 Photograph of Matilija Delta. Note: The red circle is located at the same location in each photo.

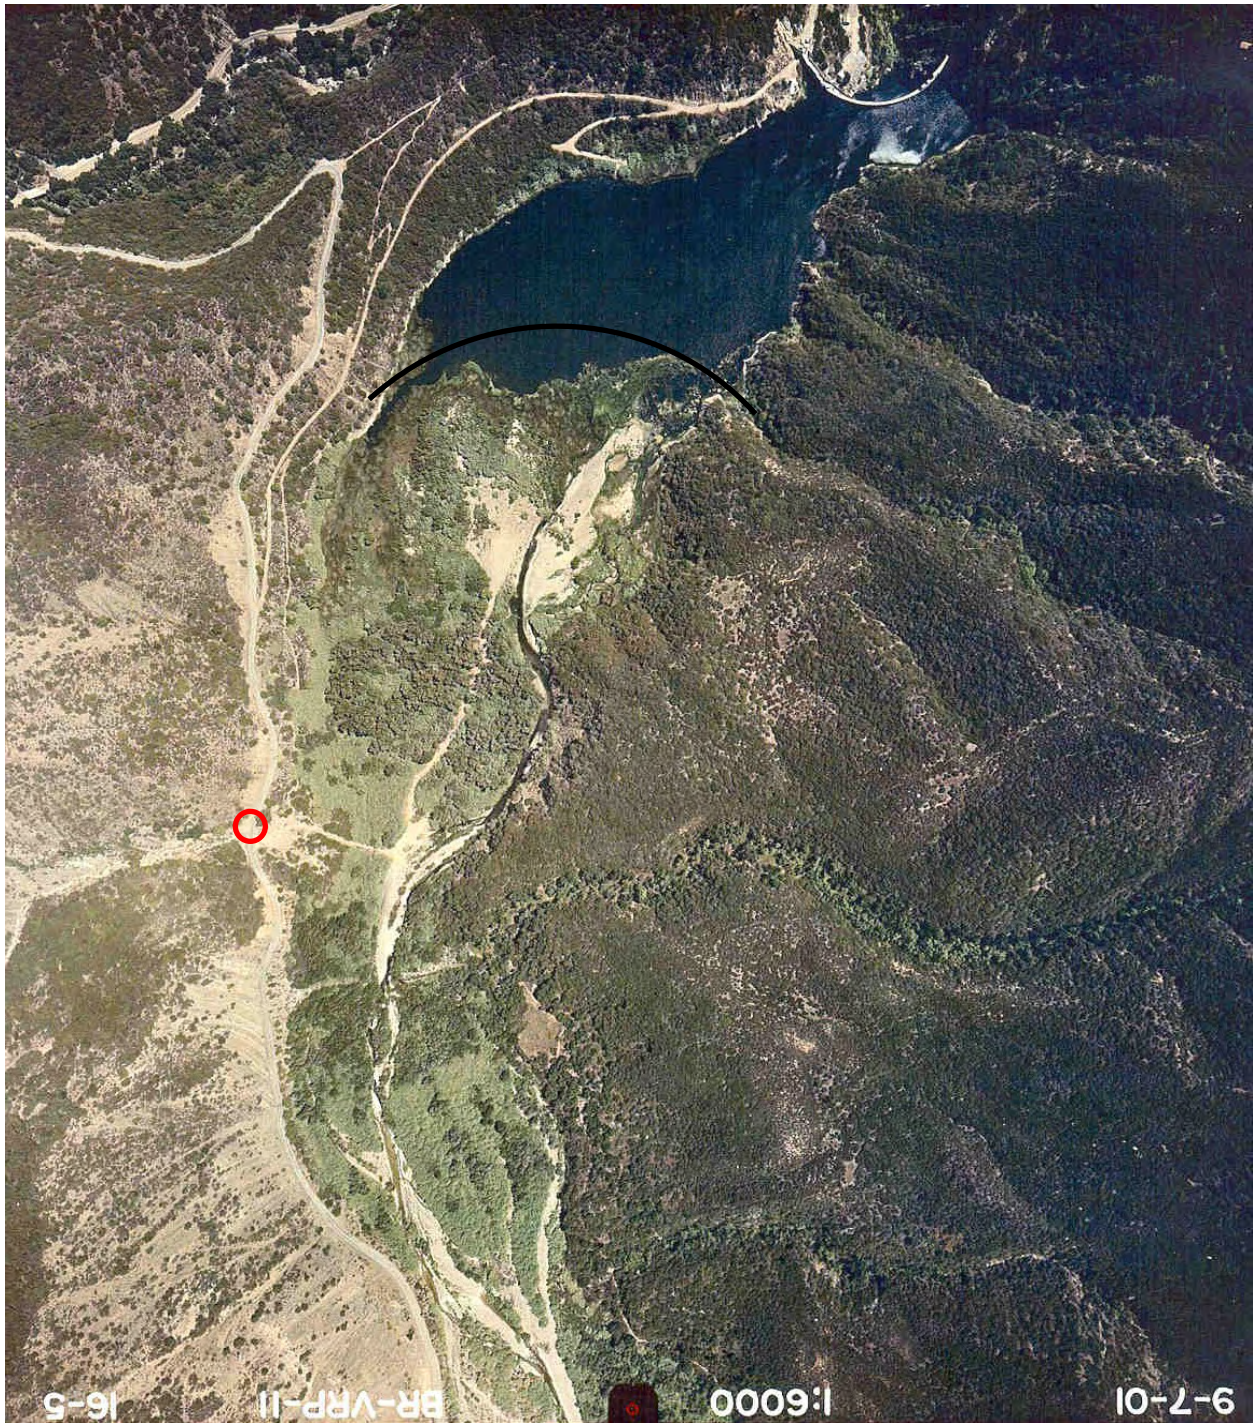
Figure 11.4. 2001 Photograph of Matilija Delta.

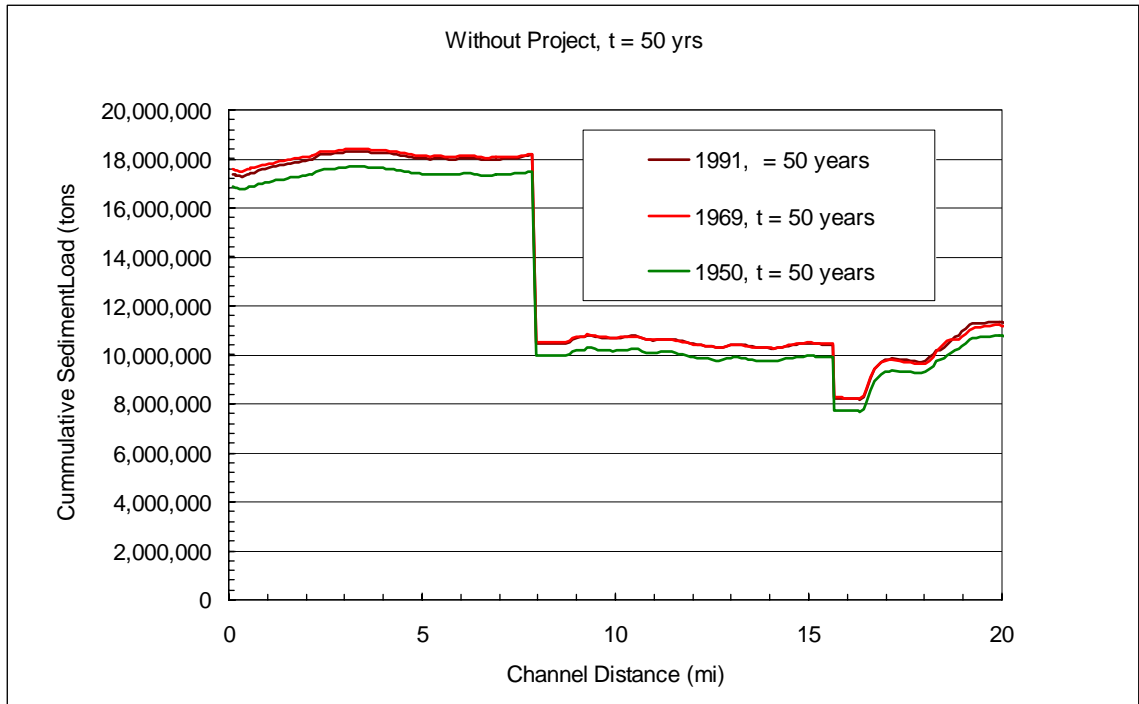
Figure 11.13. Cumulative Sediment Loads at end of 50 year Simulation for Without-Project Conditions for different hydrographs.

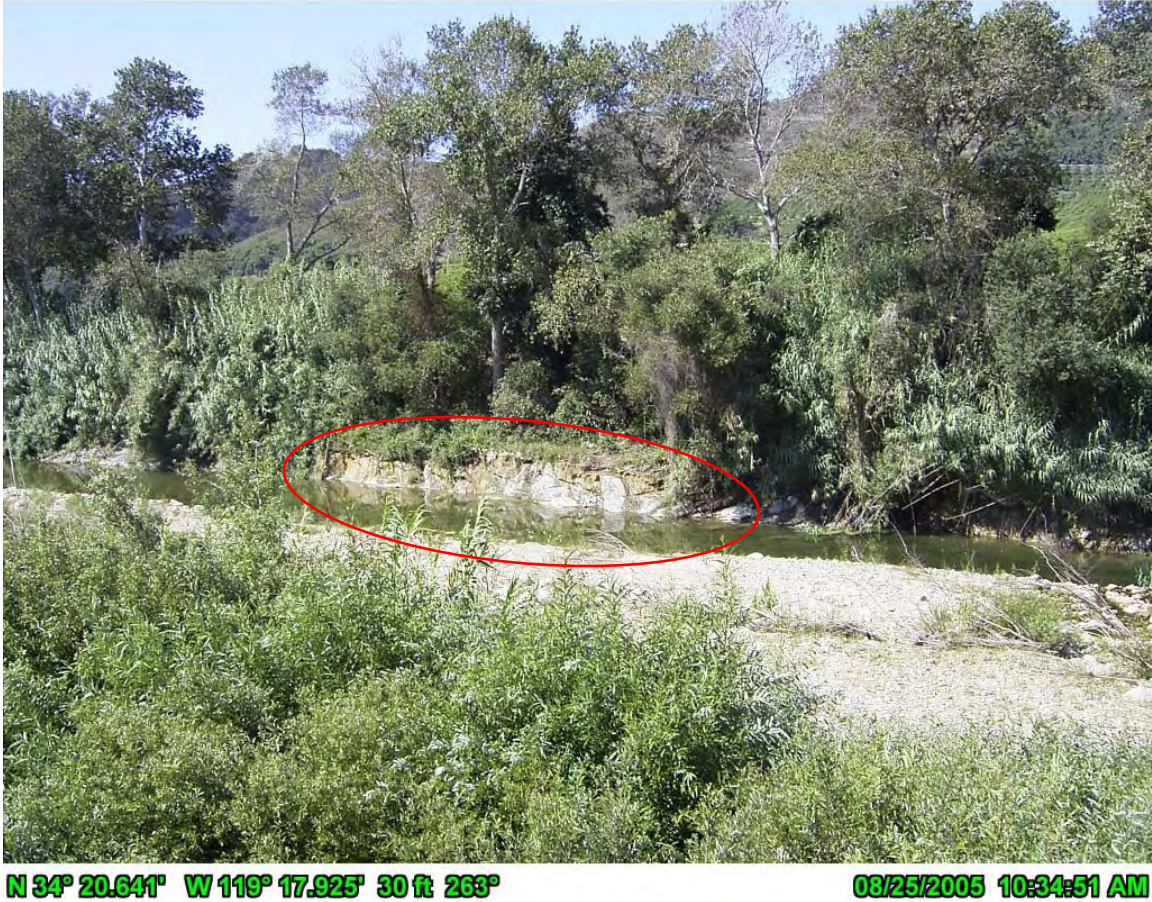
Figure 11.15. Exposed Bedrock along West side of Ventura River near OVSD Facility at RM 5.

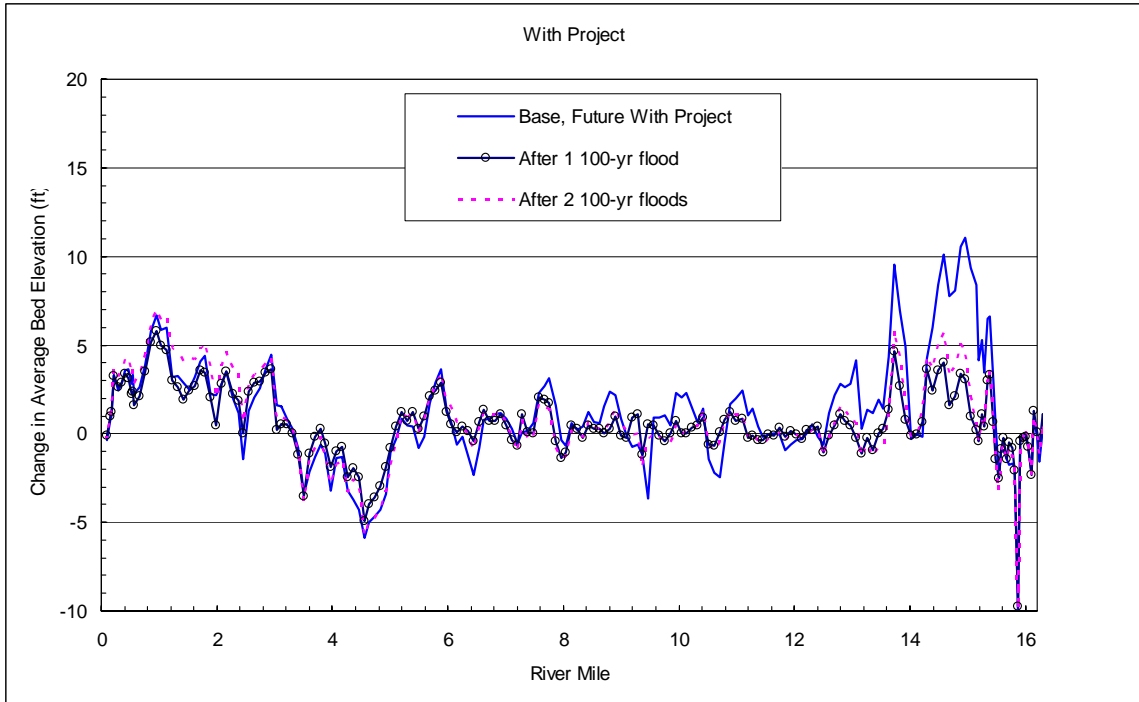
Figure 11.29. Average bed elevation changes at the end of the 100-yr storm and at the simulation end of the 1969 50-yr hydrograph.
