# Pursel Mill Dam Breach & Fish Passage Improvements

## Balancing Ecological Restoration & Historic Preservation

## History in the Making

HEAVY CONSTRUCTION APRIL 2006

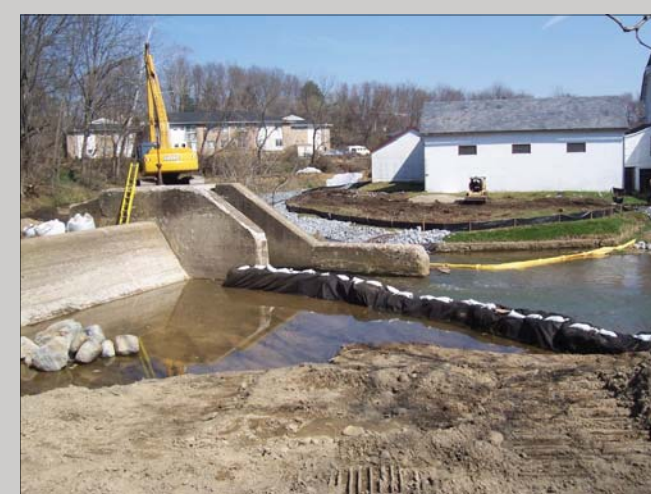
Setting up downstream cofferdam.

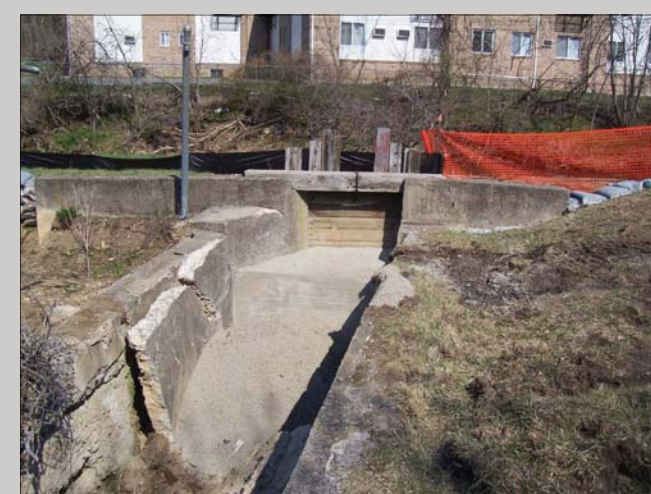
Plugging mill raceway with concrete.

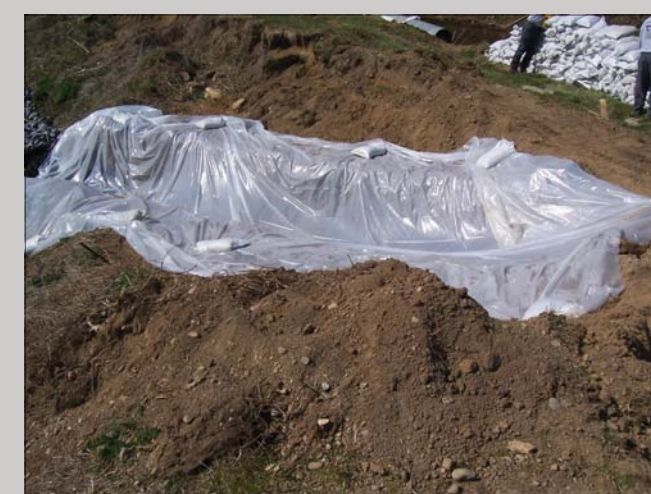
Excavation and lining of diversion channel at upstream end of project.

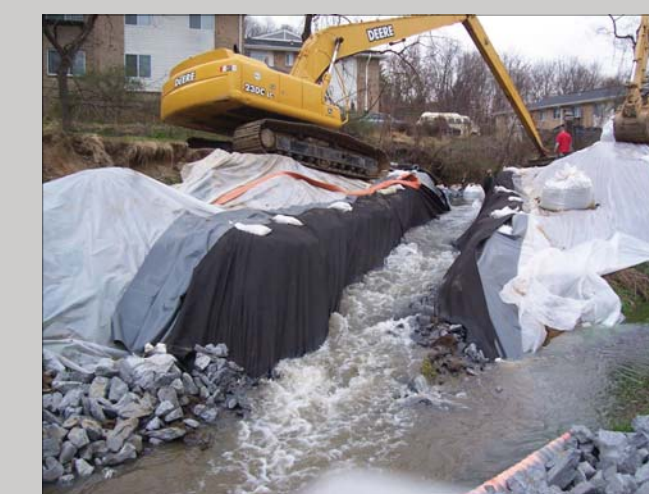
Diverting the Lopatcong Creek.

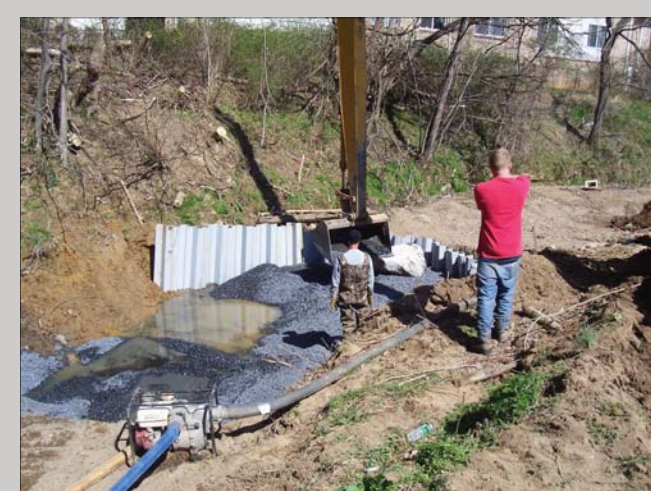
Installing sheetpile at upstream end to eliminate headcutting.

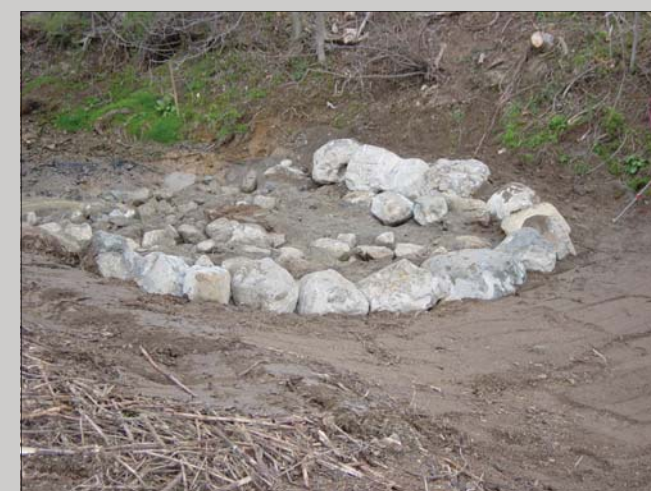
Installed rock vane (1 of 4).

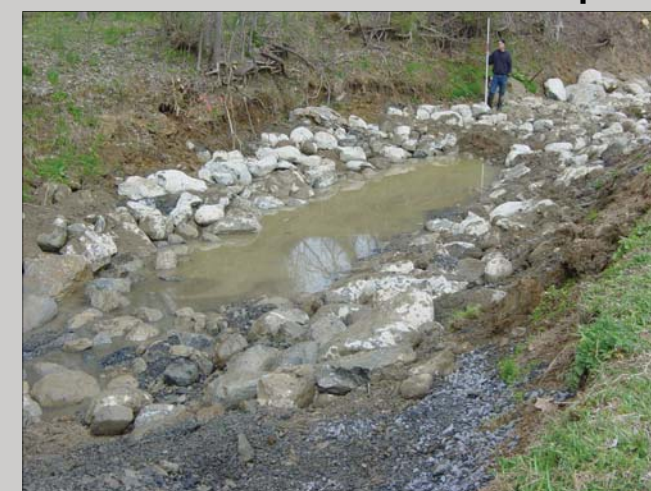
Installed deep pool.

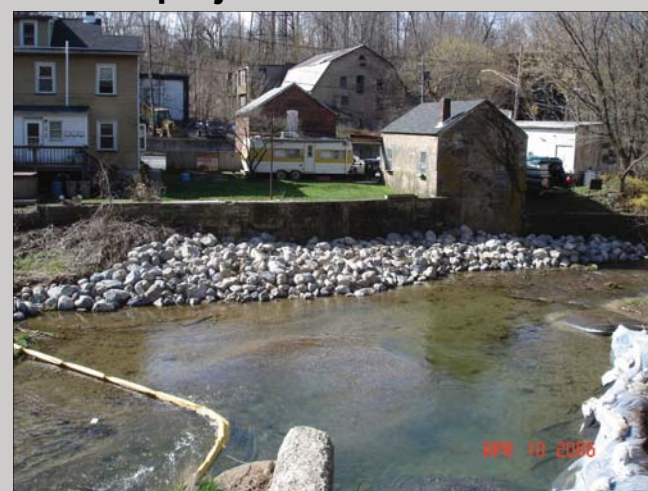
Armoring historic walls downstream of project with river stone

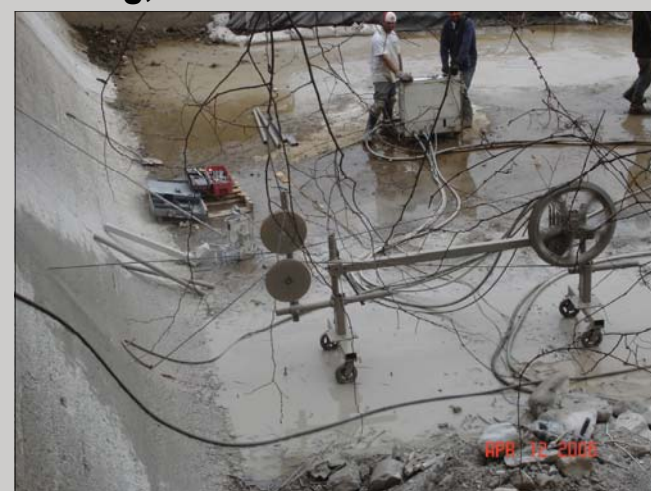
Diamond wire sawing of concrete spillway.

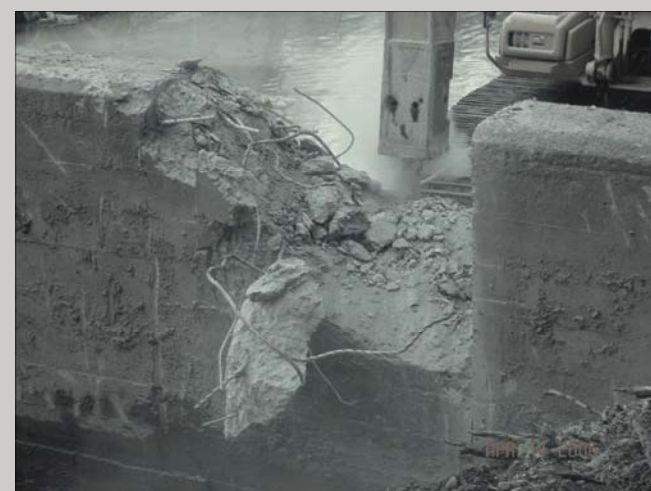
Demolition of spillway portion to be removed with hydraulic hammer.

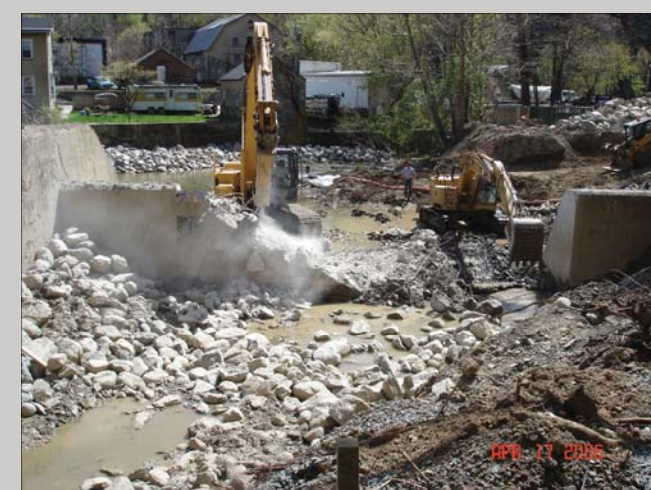
Continued demolition of spillway.

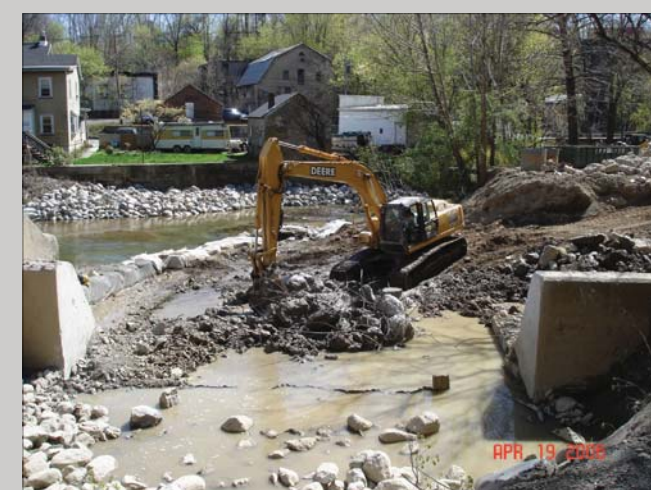
Breach of spillway almost complete.

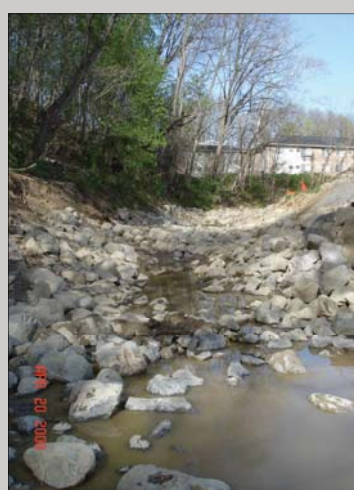
Finished channel looking upstream.

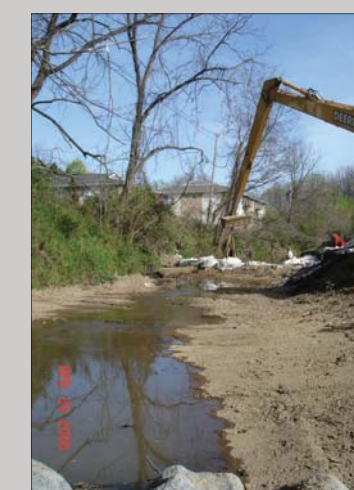
Releasing the Lopatcong to the finished channel and breach.

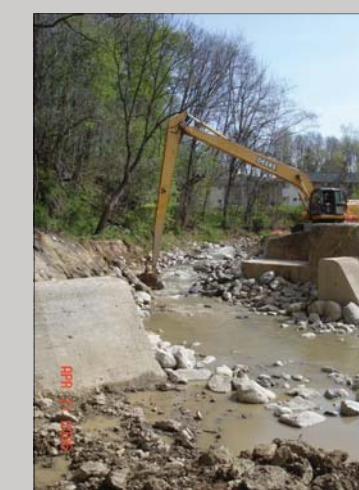
The final touches on the stream channel.

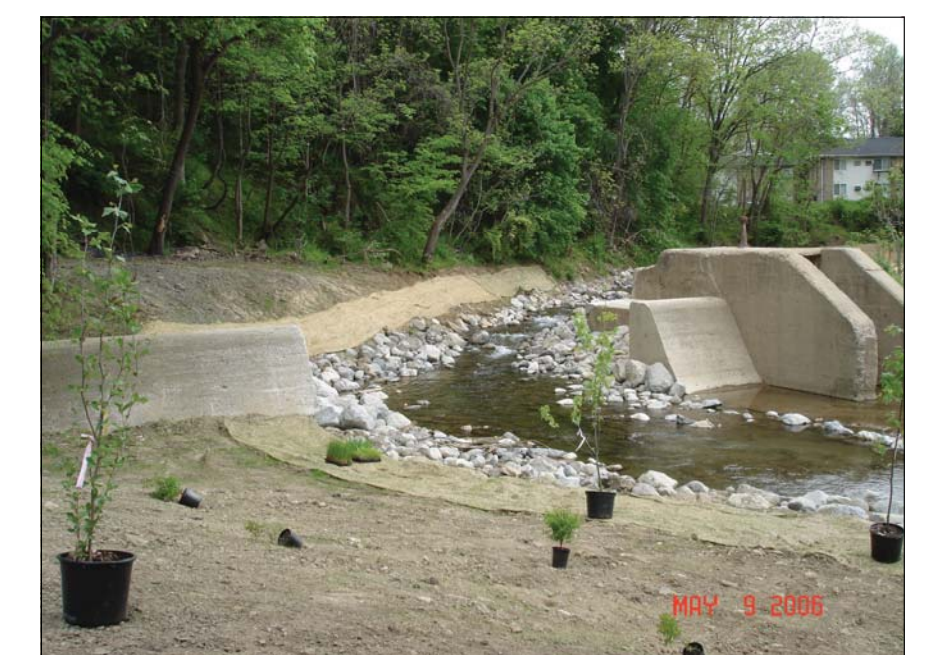
*The Completed Fish Passage And Preserved Spillway*
