# Utilizing lithologic identification and repeat photos to understand the potential bedload contribution of a prominent cut bank cliff

By Gabriel RiCharde (Wheaton College, IL), Chuck Podolak (Johns Hopkins University), and Dr. Peter Wilcock (Johns Hopkins University)

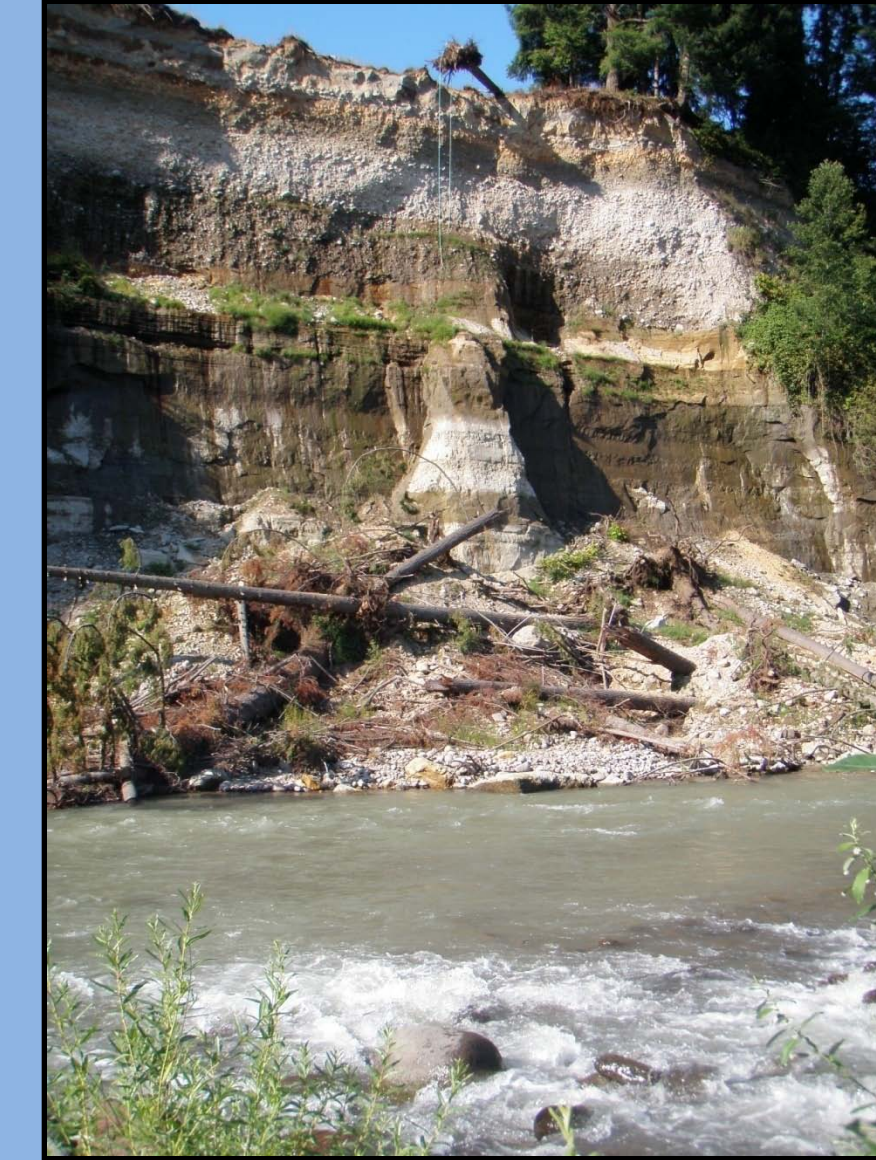
1660 m<sup>3</sup> landslide on cliff face

In 2008, the cut bank cliff contributed 840 cubic meters of sediment to the Sandy. Only 49% of this can be considered for bedload calculations, leaving roughly 400 cubic meters. Four hundred cubic meters is only 0.053% of the mobilized Marmot Dam reservoir sediment. In May of 2009, a landslide with a volume of 1660 cubic meters, nearly doubled the 2008 contributions, leaving 800 cubic meters of bedload sediment amounting to 0.106% of the Marmot Dam reservoir sediment.

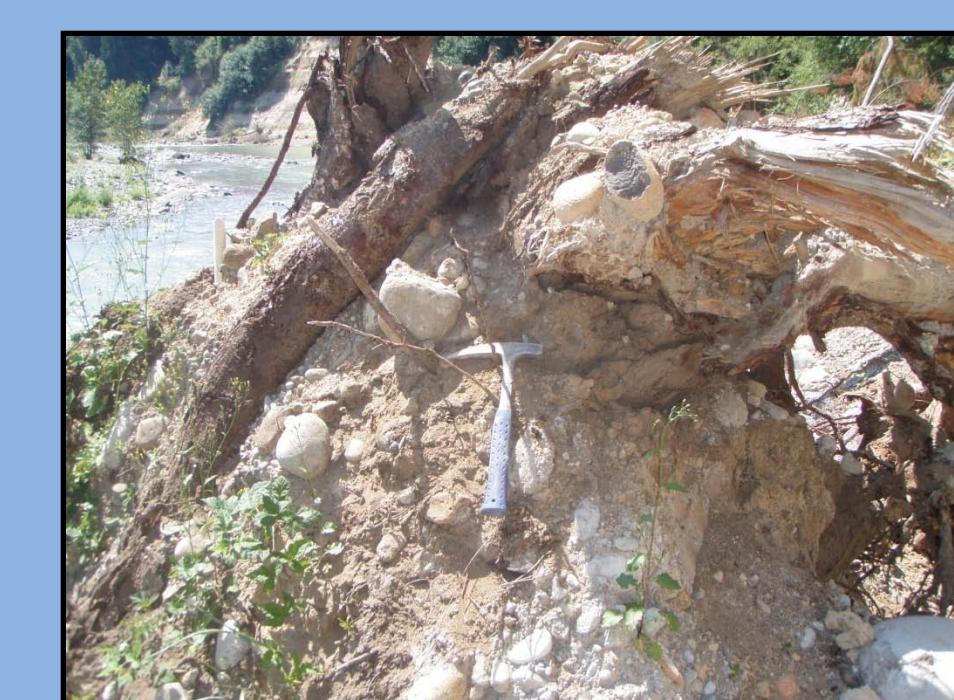
Fallen tree root system filled with sediment; hammer for scale

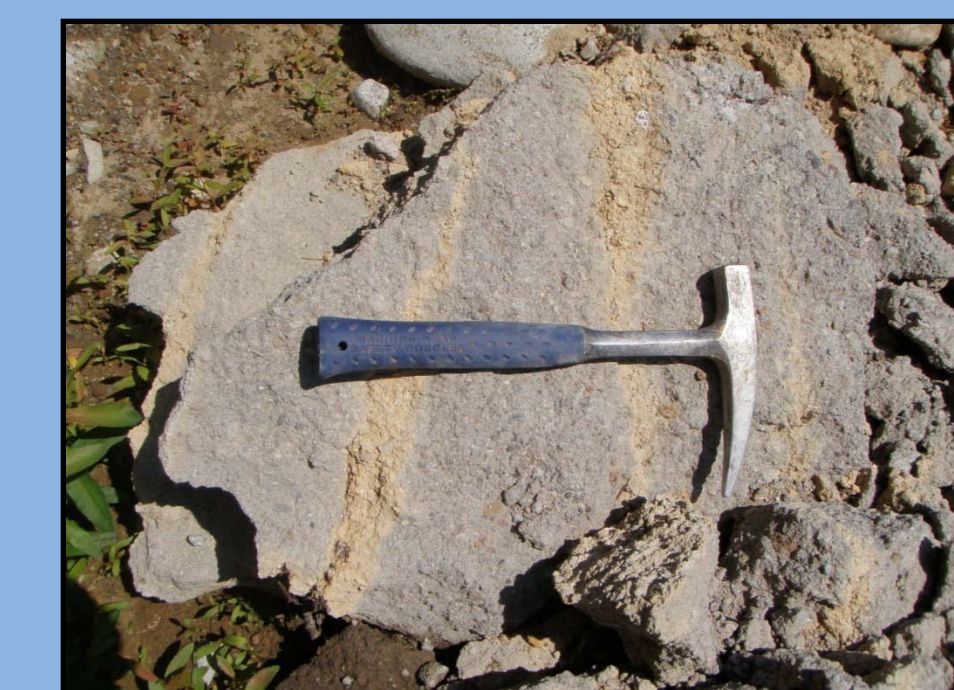
Glaciofluvial gravel-pebble conglomerate; hammer for scale
