# **MARMOT DAM REMOVAL GEOMORPHIC MONITORING & MODELING PROJECT**

## **ANNUAL REPORT June 2008 – May 2009**

**June 2010**

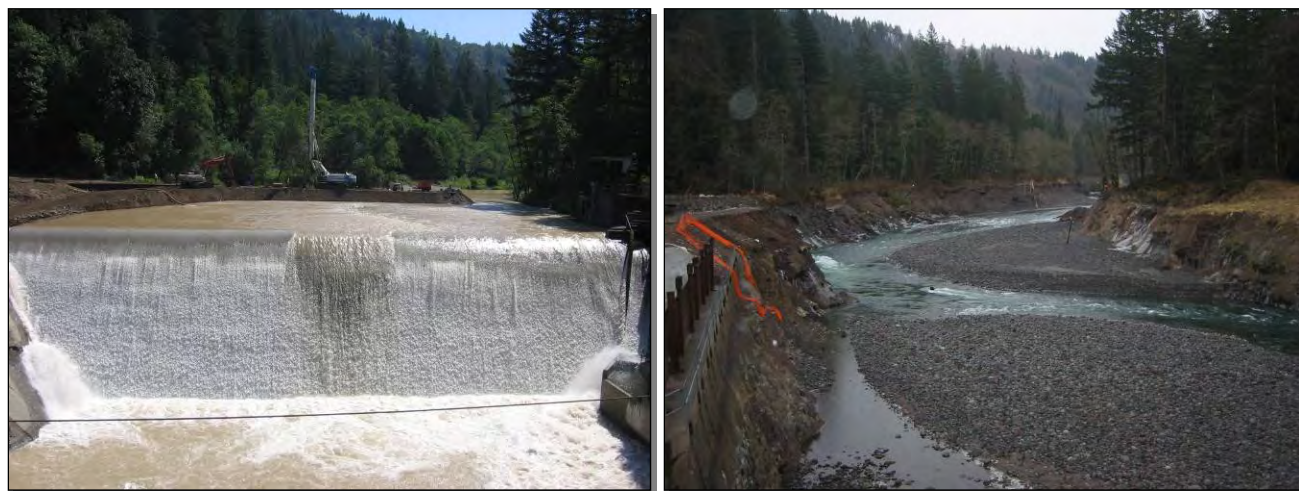
**Figure 3 - Marmot Dam Site in July 2007 (left) and January 2008 (right). Construction of the cofferdam is visible in the 2007 photograph.**

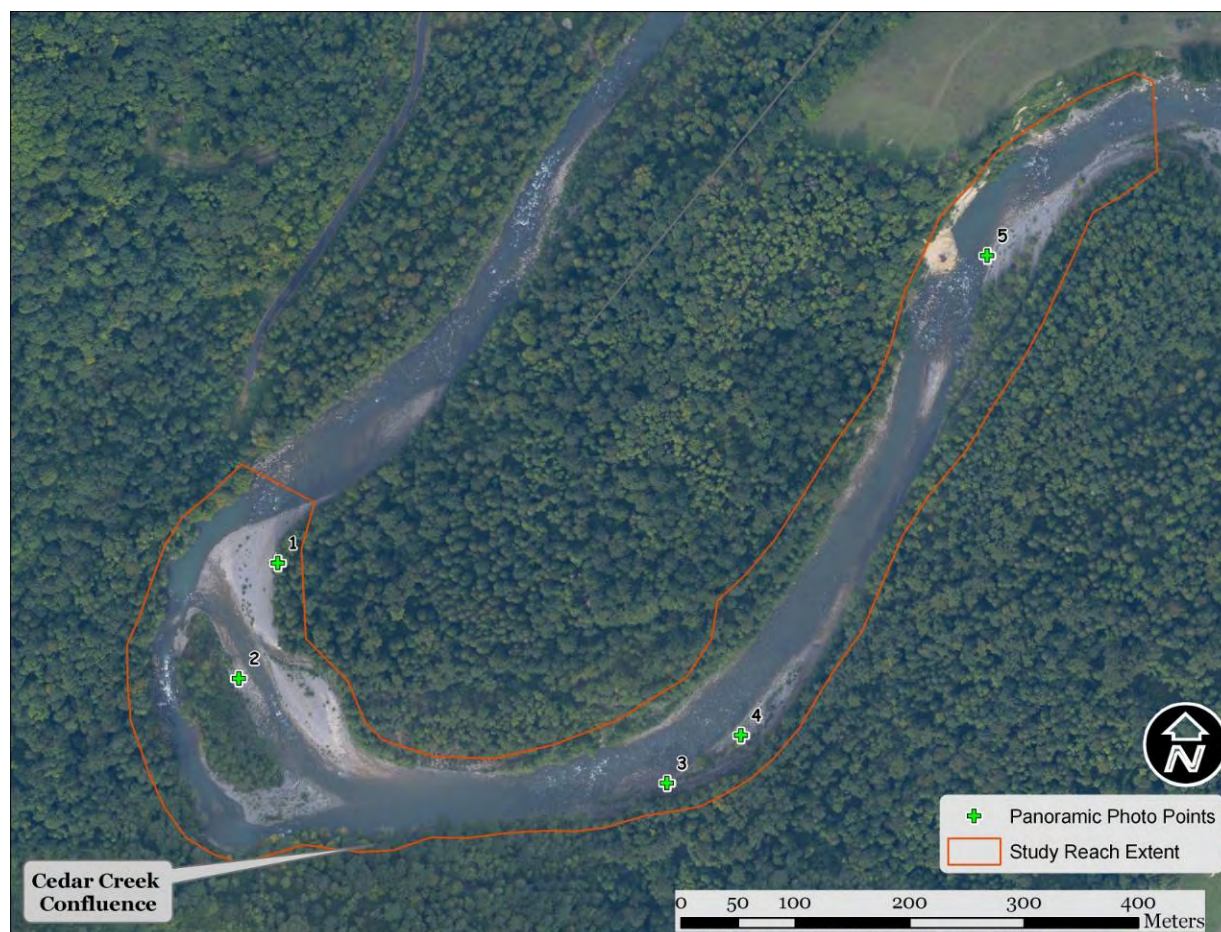
Figure 10 - Overview of Cedar Creek Reach (panoramic photo points shown in green)

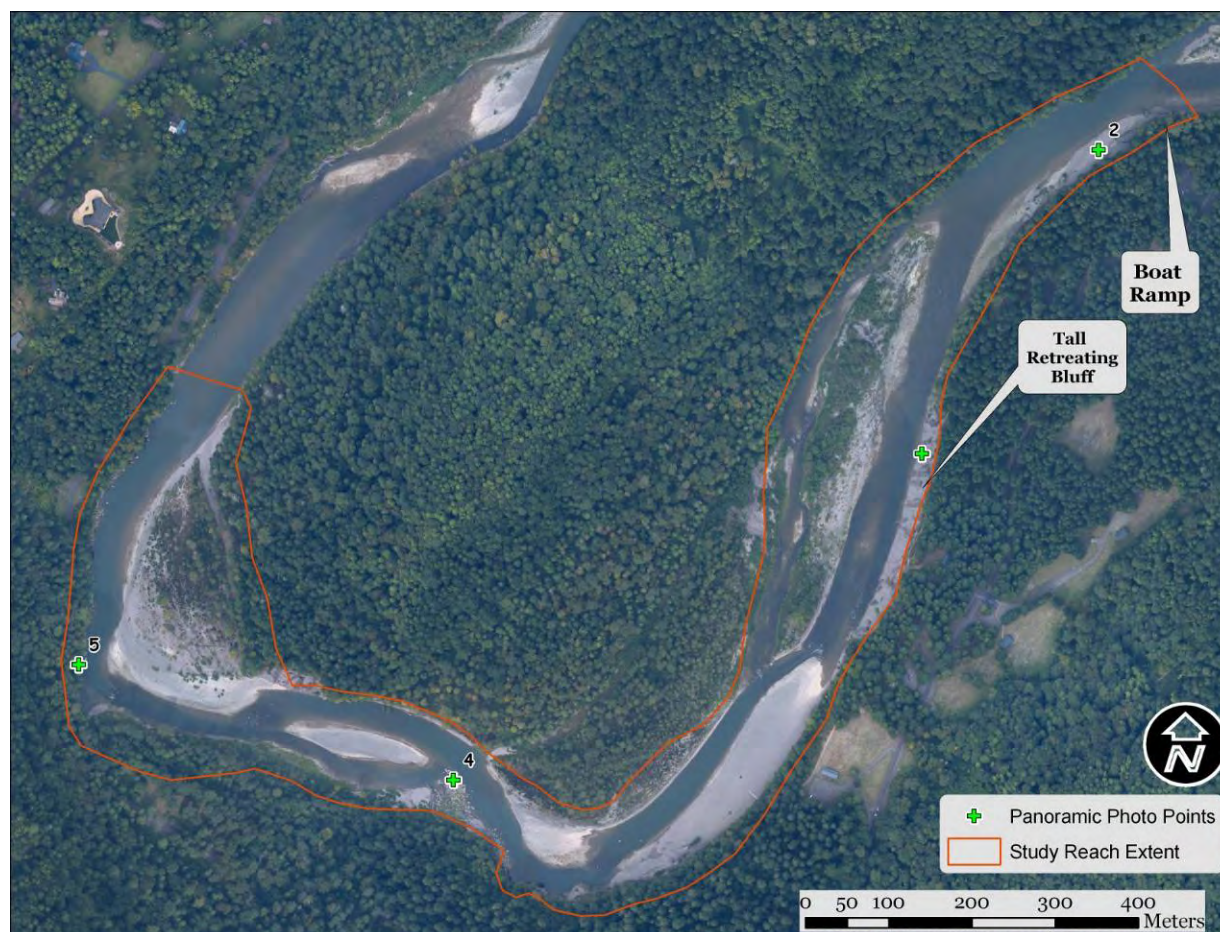
Figure 11 - Overview of Oxbow Reach (panoramic photo points shown in green)

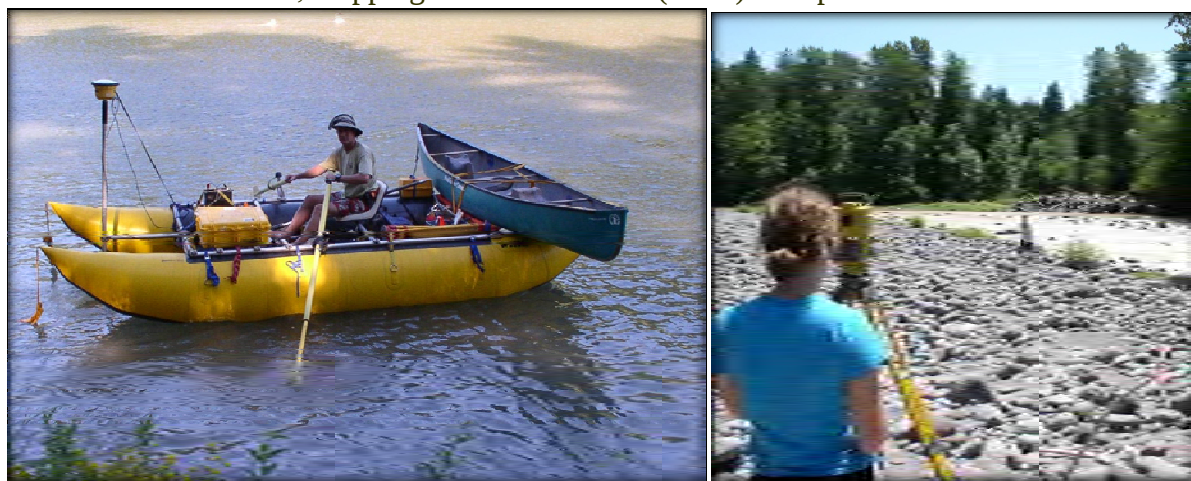
Figure 12 - Surveying Setups. Cataraft (left) with GPS antenna mounted on the mast. Total station (right).

1. Dry bars, riffles and shallow pools were surveyed by hand using a total station (Topcon APL-1A or Sokkia SET2110) (Figure 12 [right]) and conventional methods of mapping breaks in grade and significant features (water edge, bar top, etc...). In areas of uniform topography, a grid pattern (approximately 10m<sup>2</sup>) was utilized. Detailed, monumented cross section surveys supplemented topographic surveys.
2. Deep pools and riffles in the Oxbow reach were surveyed using a depth sounder integrated with an RTK GPS (Figure 12 [left]). Equipment was mounted to a 4.8m (16 ft) cataraft which traversed the rivers, mapping features > 0.43m (1.4 ft) in depth.

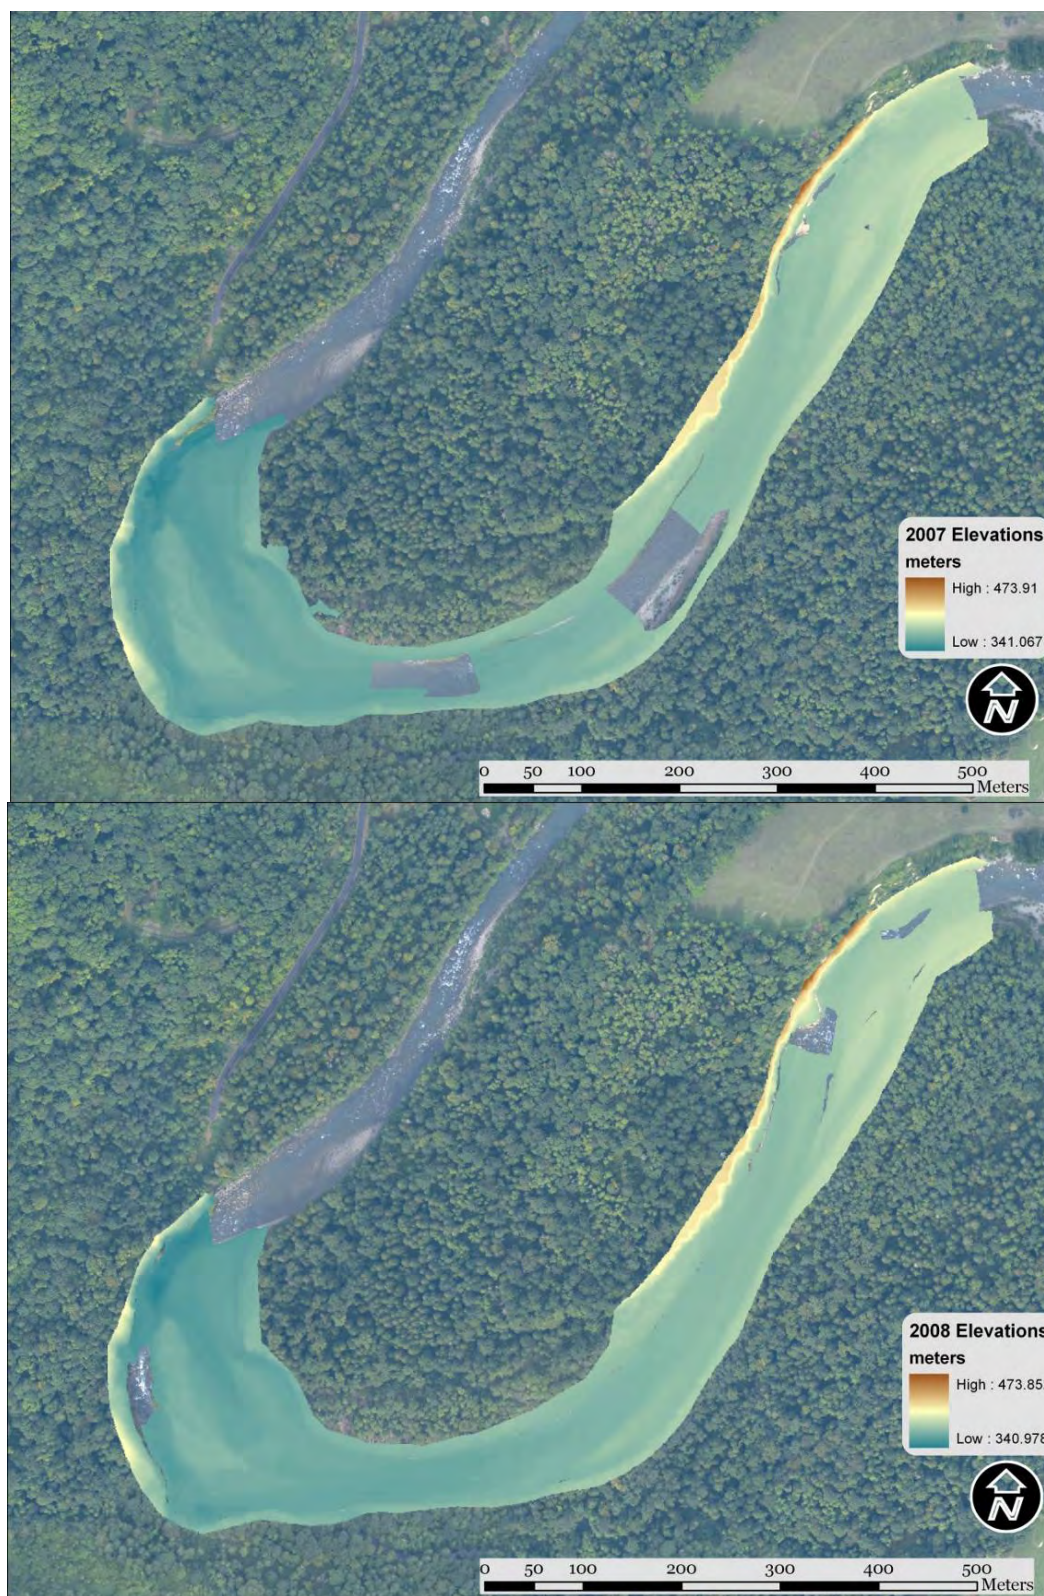
Figure 15 - DEM generated from survey & LiDAR for Cedar Creek Reach (2007 on top, 2008 on bottom)

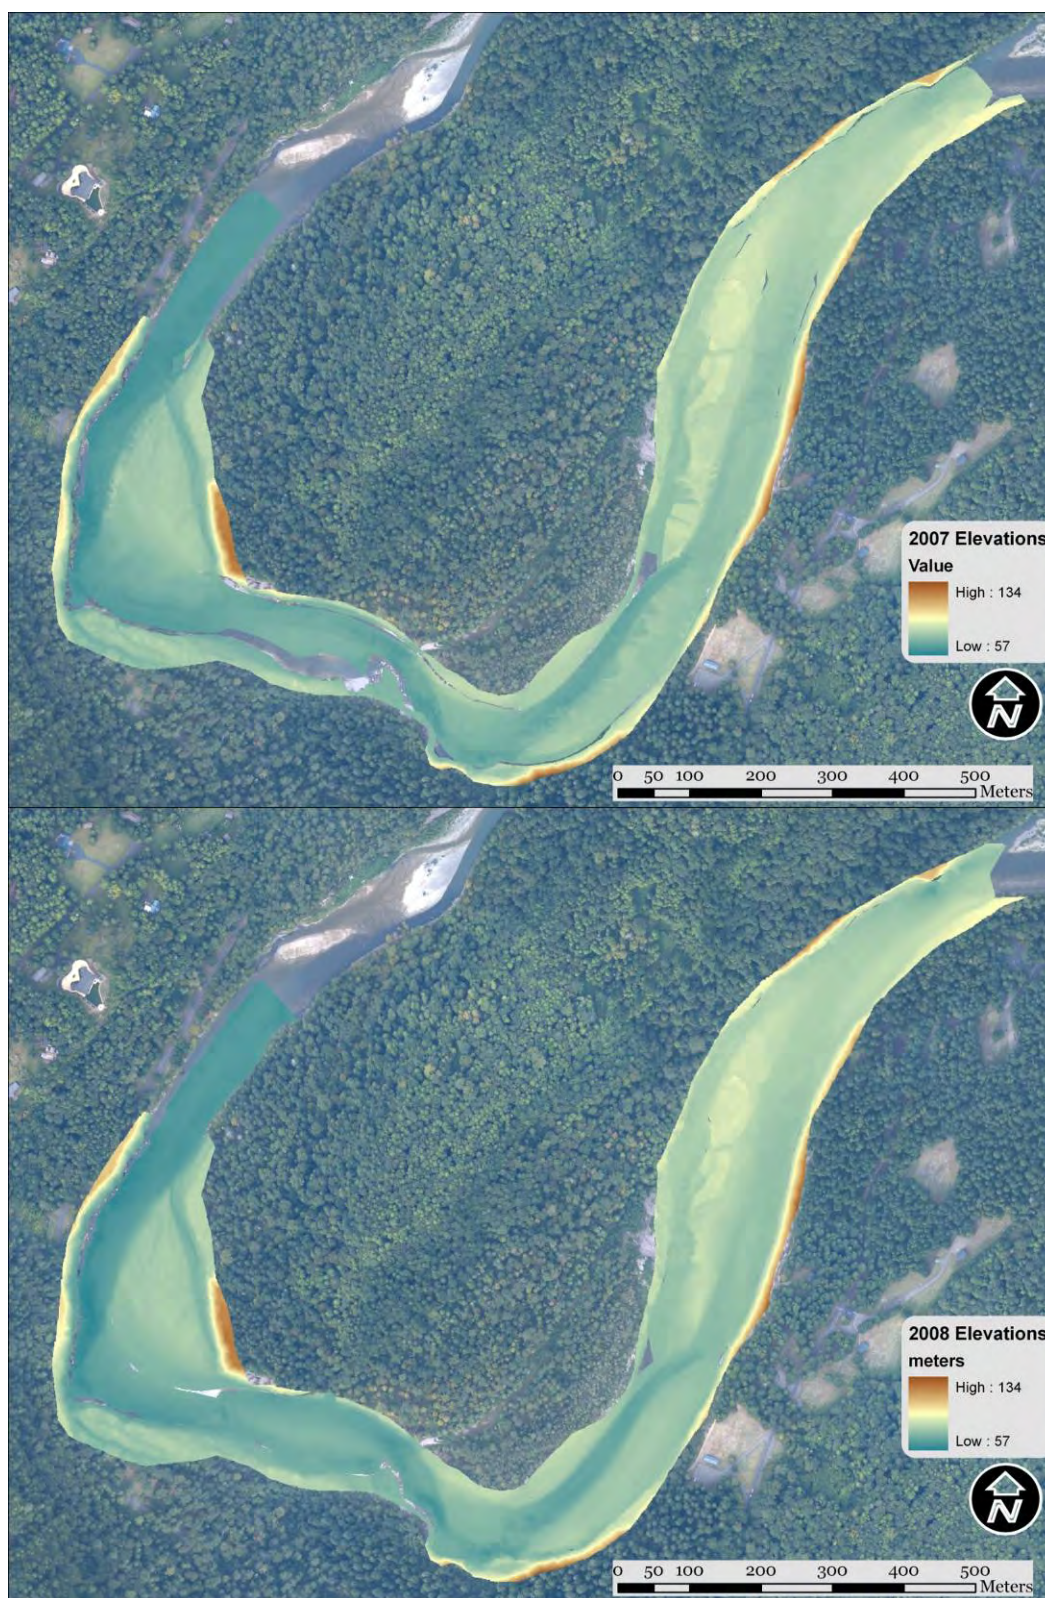
Figure 16 - DEM generated from survey & LiDAR for Oxbow Reach (2007 on top, 2008 on bottom)

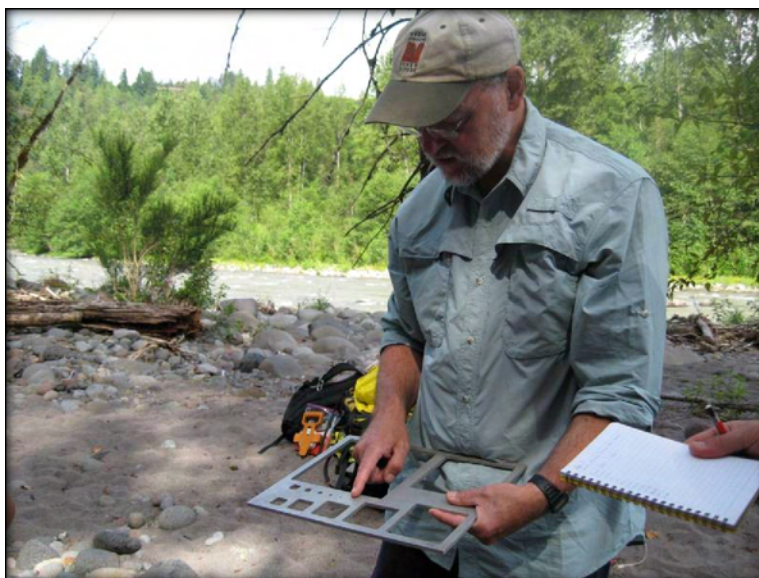
Figure 20 - Gravelometer (demonstrated by Dr. Peter Wilcock, JHU)

After classifying all exposed bars, lightly vegetated islands, and shallow submerged areas of sediment into distinct facies, pebble counts were made of the each facies. Grains were selected for measurement by laying out several 100-meter fiberglass tapes in a manner that they were evenly distributed throughout the facies (Figure 17 [lower]). At fixed intervals on the tapes, the grains that were under a mark on the tape were picked up and measured using a gravelometer (a metal plate with square openings of 2, 4, 5.6, 8, 11.25, 16, 22.5, 32, 45, 64, 90, and 128 mm) (Figure 20). For grains larger than 128mm, the intermediate axis was measured. For nearly all the pebble counts three 100-meter tapes were used and grains were measured every meter. For few large facies more than three tapes were used, and similarly for several small or homogeneous facies either fewer than 3 tapes were used or the interval was decreased. In any case, the spacing of the tapes and measurement intervals were selected to avoid measuring the same grain twice.

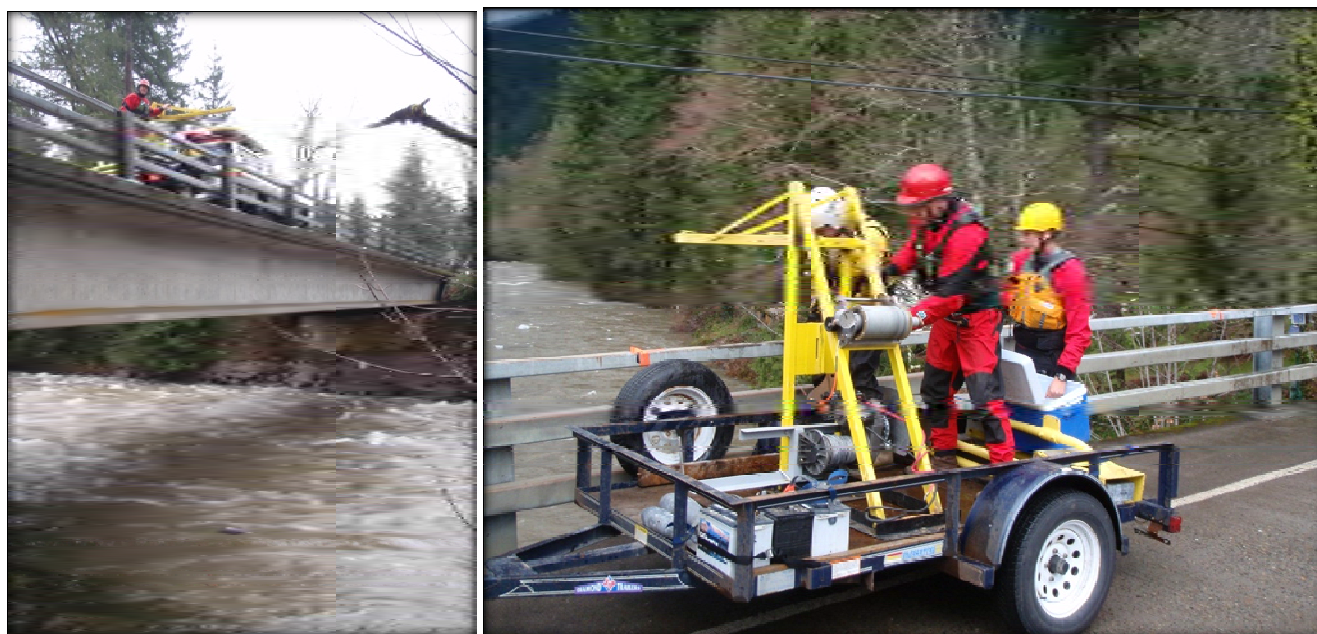
Figure 21 - Bridge Crane Sampling Setup

Depth-integrated suspended sediment sampling was performed using a US D-74 Depth-Integrating Suspended Sediment Sampler (cable-deployed from a bridge using a trailer-mounted crane) (Figure 21). Standard methods, as developed by the USGS and described in Edwards and Glysson (1998), were generally used for sampling. For each sample, the location, time, stage, number of verticals, distance between verticals, bottle #, and whether a field replicate was taken, were recorded. Suspended sediment concentrations were measured in the GMA sediment lab in Weaverville, California following USGS and ASTM D-3977 protocols. Samples were analyzed for concentrations at greater and less than 0.063mm. All sample data are stored together in a project notebook.

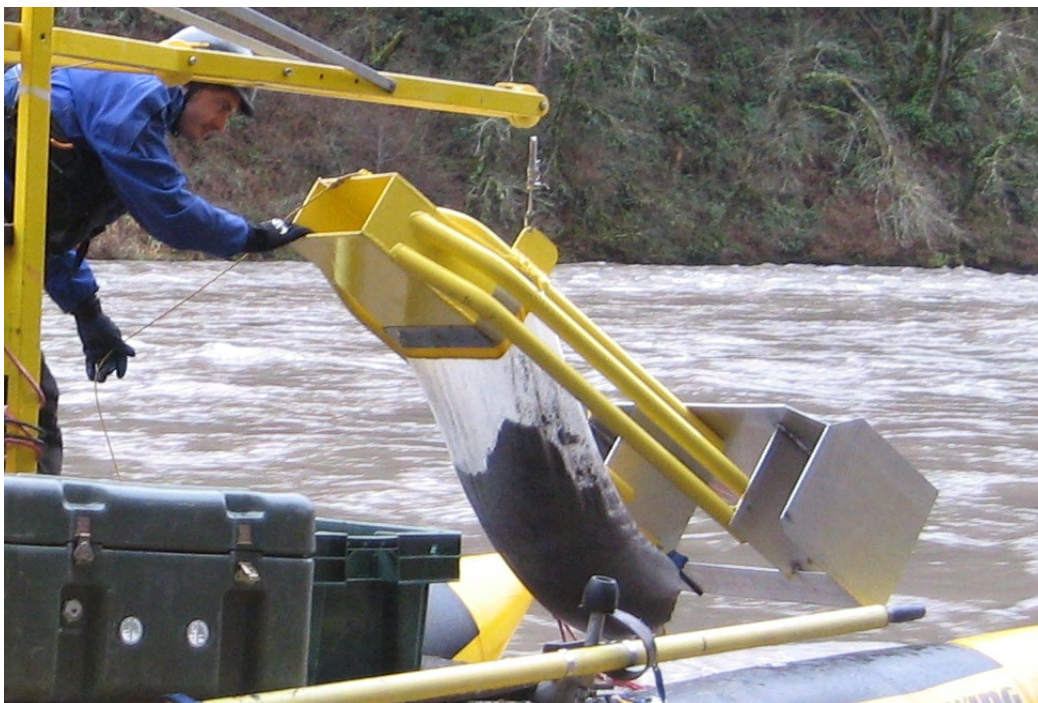
Figure 22 - TR2 Bedload sampler

The sampling section was located on the downstream side of the Brightwood Bridge (E. Barlow Trail Road bridge over the Sandy River, near the intersection with E. Sleepy Hollow Dr). An initial point (I.P.) was initially established on the right bank and used to anchor the tape for all measurements. A 15.2 x 30.5cm TR-2 bedload sampler (Figure 22) was lowered from the same crane assembly described in the methods for discharge and suspended sediment measurements. A stay-line was utilized to prevent the sampler from being swept too far downstream. Standard methods, as developed by the USGS and described in Edwards and Glysson (1998), were used. Beginning and end stations, sample interval, sample duration, start time and end time, beginning and end gage height, and pass number were recorded. All bedload sample data are stored together in a project notebook. Bedload samples were processed at the GMA coarse sediment lab in Arcata, California. Processing involves sieving and computing the percent retained in each sieve class as determined by weight. These data are entered into Excel spreadsheets for subsequent conversion to the cumulative percentage finer (by weight) than the corresponding sieve size.

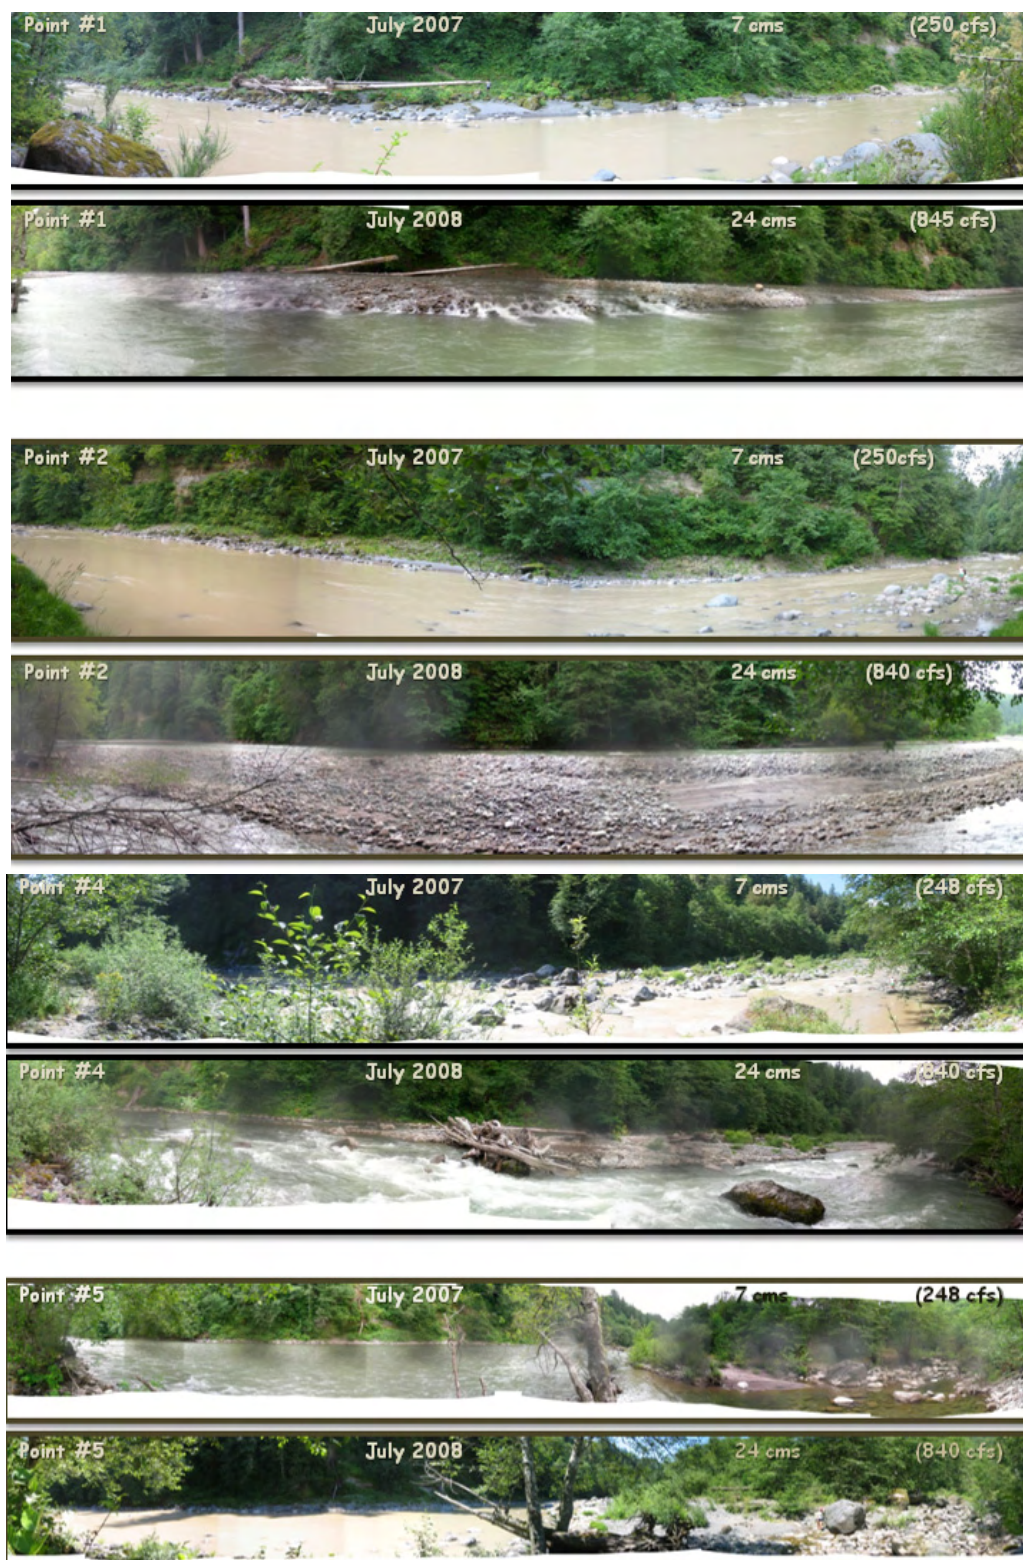
Figure 36 - Panoramic Photographs from Dam Reach. For photo locations see Figure 8.

Our upstream-most monitoring reach was located in the immediate vicinity of the dam site (RK 49.2 – 46.0 [RM 30.6 – 28.6]) (Figure 8). Since this portion of the monitoring effort was concerned with deposition, the upstream limit of this reach was the location of the cofferdam. For 2.2 km (1.4 mi) below the dam, the river flows through an alluvial reach. At the end of the alluvial reach is the head of a 6.9 km-long (4.3 mi) bedrock gorge. The wetted width in the alluvial reach at low flows is  $\approx 16\text{--}40$  m (50–140 ft). The floodplains, islands, and bars occupy the rest of the valley bottom width of  $\approx 120\text{--}140$  m (400–460 ft). This reach was predicted to receive the bulk of the sediment deposition, receiving between 1 and 4 m (3.2 – 13 ft) of average deposition (Downs et al, 2009).

In addition to the survey data capturing the shape of the surface each year and the grain size data characterizing the texture of the surface, repeated photographs were taken at monumented photopoints at least once per year. Nineteen locations were chosen throughout the four study reaches (Figure 8, Figure 9, Figure 10, & Figure 11). The locations were selected for their views of the reach, ability to be reoccupied for multiple years, and accessibility during times of high discharge. Where practical the locations were surveyed using a total station, and where this was infeasible, the photo points were located using a handheld GPS receiver (Garmin Legend HCx). Photographs were taken with a handheld digital camera (Cannon Powershot S200 Digital Elph with 2.0 megapixels) at a 1600 x 1200 resolution. To keep the panning motion level, the photographs were made from the top of a survey rod at a fixed height keeping the bubble level centered while panning the camera. Between 7 and 18 photographs were taken per panorama at each location. The photo points were reoccupied each summer (July 2007, and July 2008) and opportunistically throughout the winter. The photographs were stitched together (Figure 36, Figure 37, Figure 38, & Figure 39) into a single image using Cannon Utilities PhotoStitch (version 3.1.7.19).

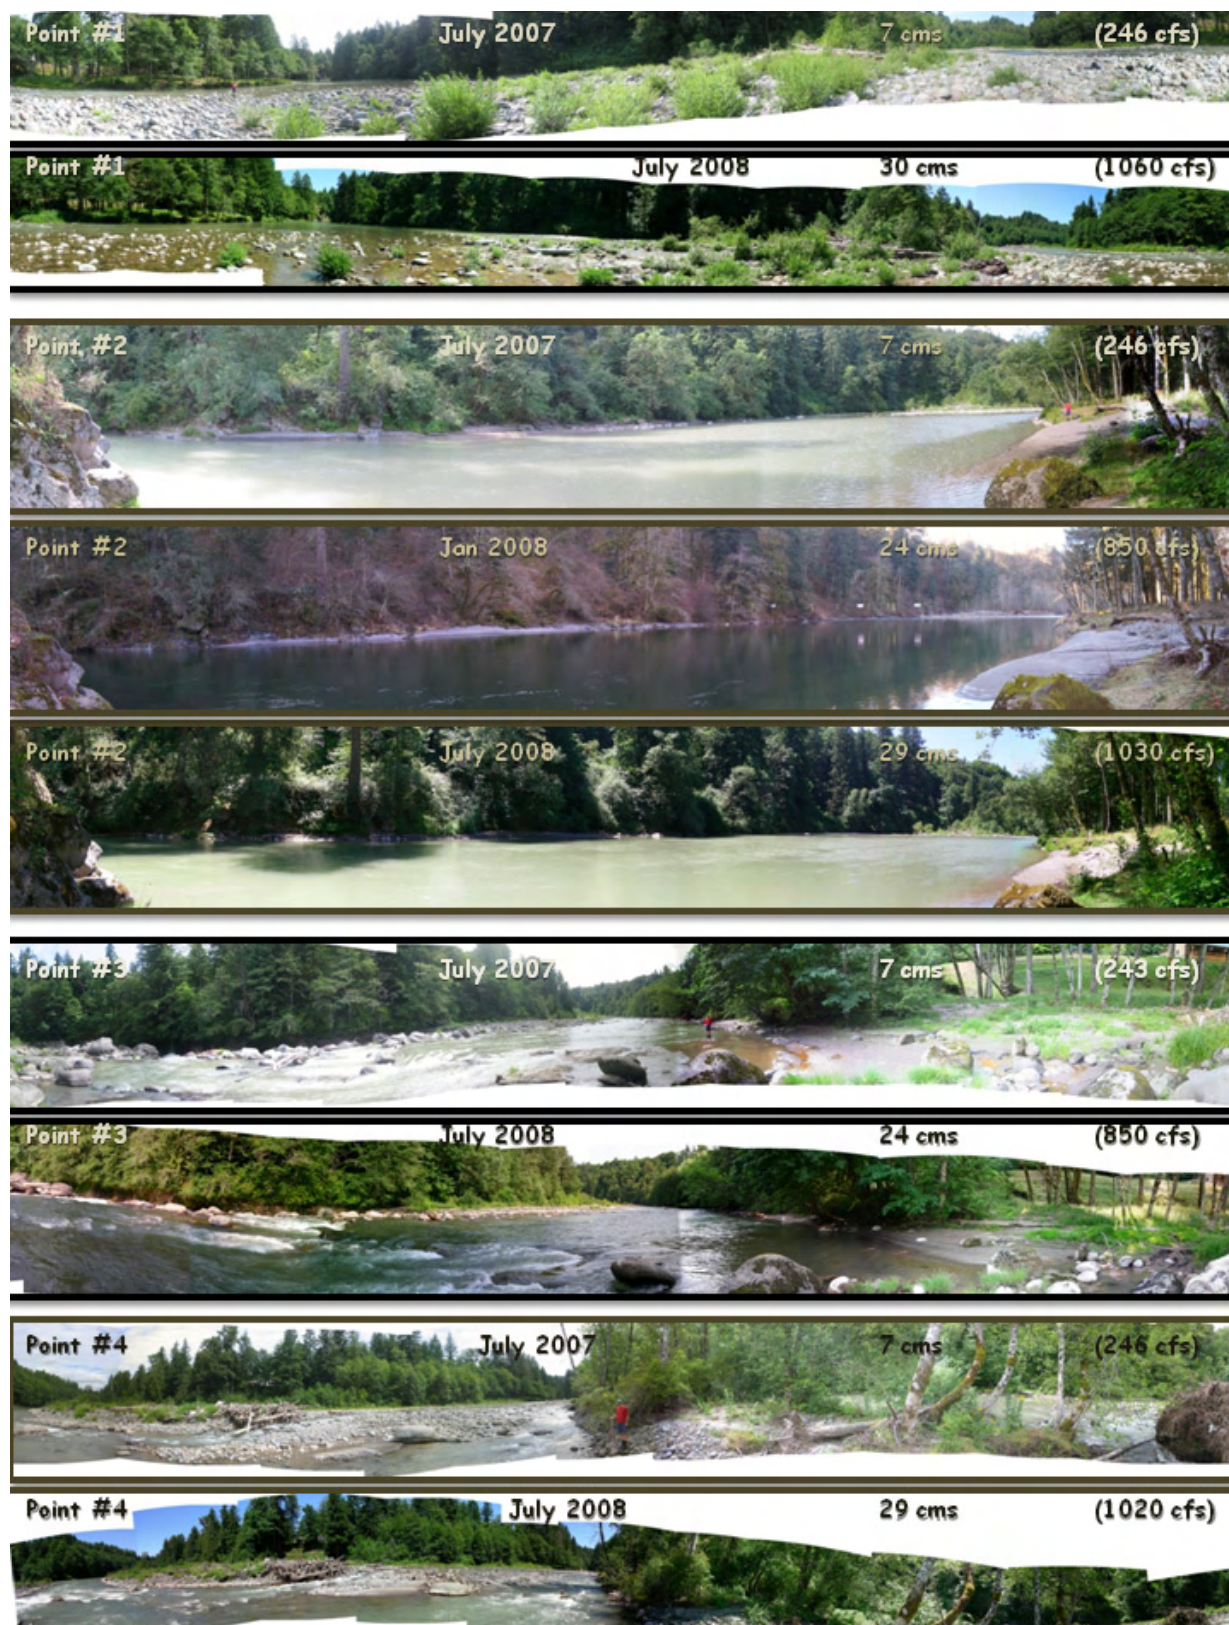
Figure 37 - Panoramic Photographs from Revenue Reach. For photo locations see Figure 9

The second study reach (RK 39.1 – 38.4 [RM 24.3 – 23.9]) lies immediately below the 6.9 km-long (4.3 mi) bedrock gorge, in which the river and valley are confined to 30-40 m (100-130 ft) wide. In the Revenue Bridge study reach, the river expands to as much as 70 m (230 ft) as the valley expands to nearly 300 m (980 ft) (Figure 9). Both the existence of bedforms such as mid-channel bars / islands and the Stillwater Sciences report suggest that this reach would receive deposition. The Revenue Bridge reach is short, bounded at the top by the gorge and at the lower end by Revenue Rapid.
