# New Hampshire's Innovative Approach to Dam Removals

**Grace Levergood, P.E**  
**NH Dept. of Environmental Services**  
**Anders Bjarngard, P.E**  
**GZA GeoEnvironmental, Inc.**

# **Champlin Pond and Champlin Farm Pond Dams Removed, Fall 2005**

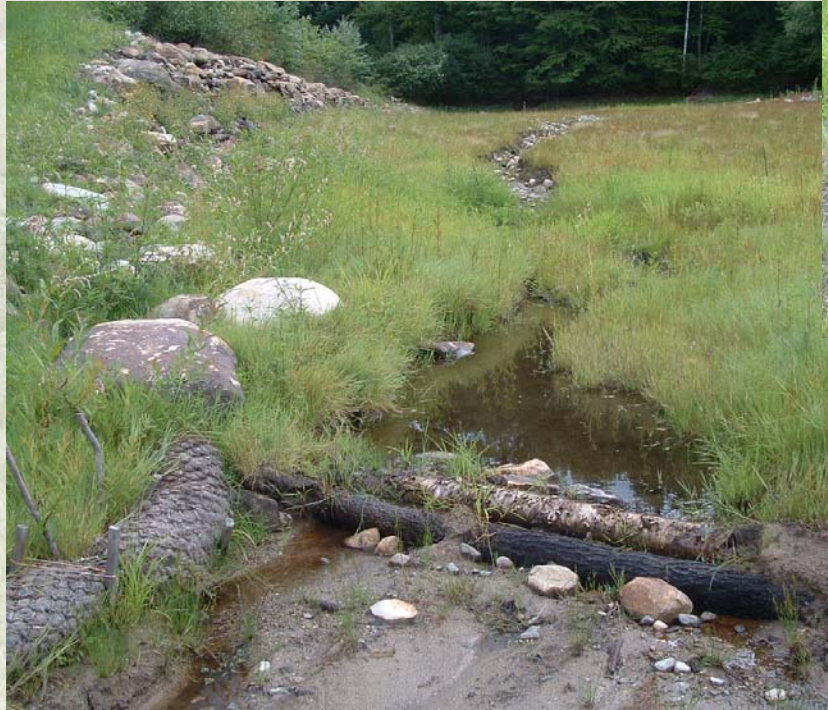
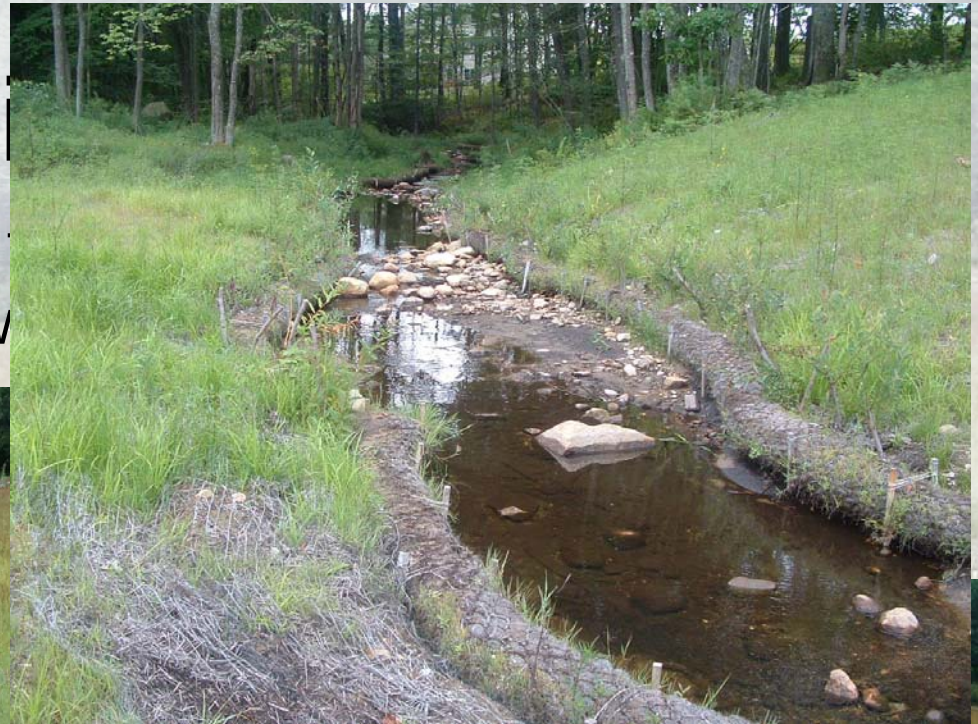
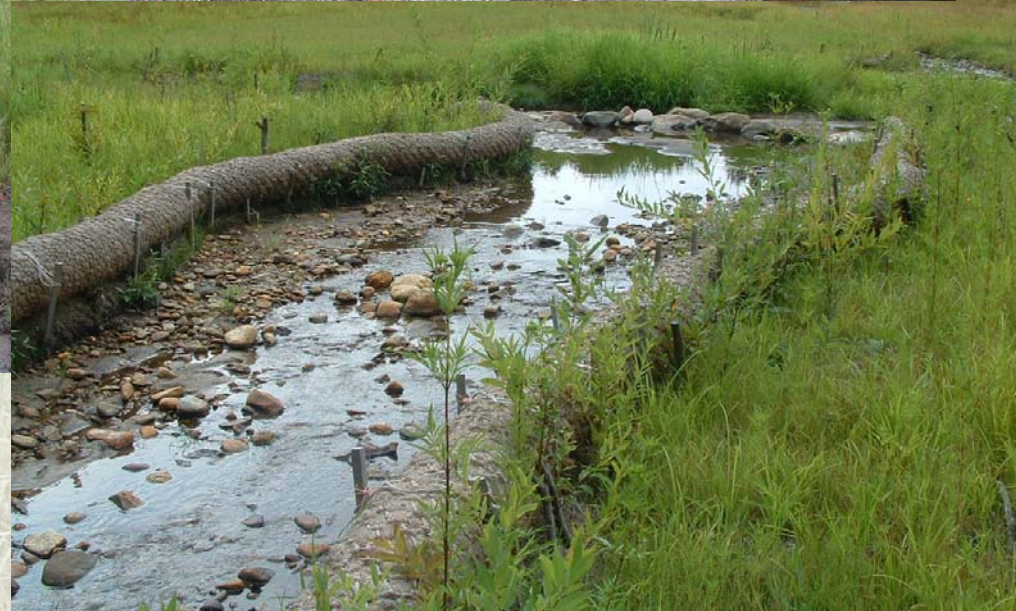
# “BioEngineering

- Natural Gravel channel clusters, coir logs, willow

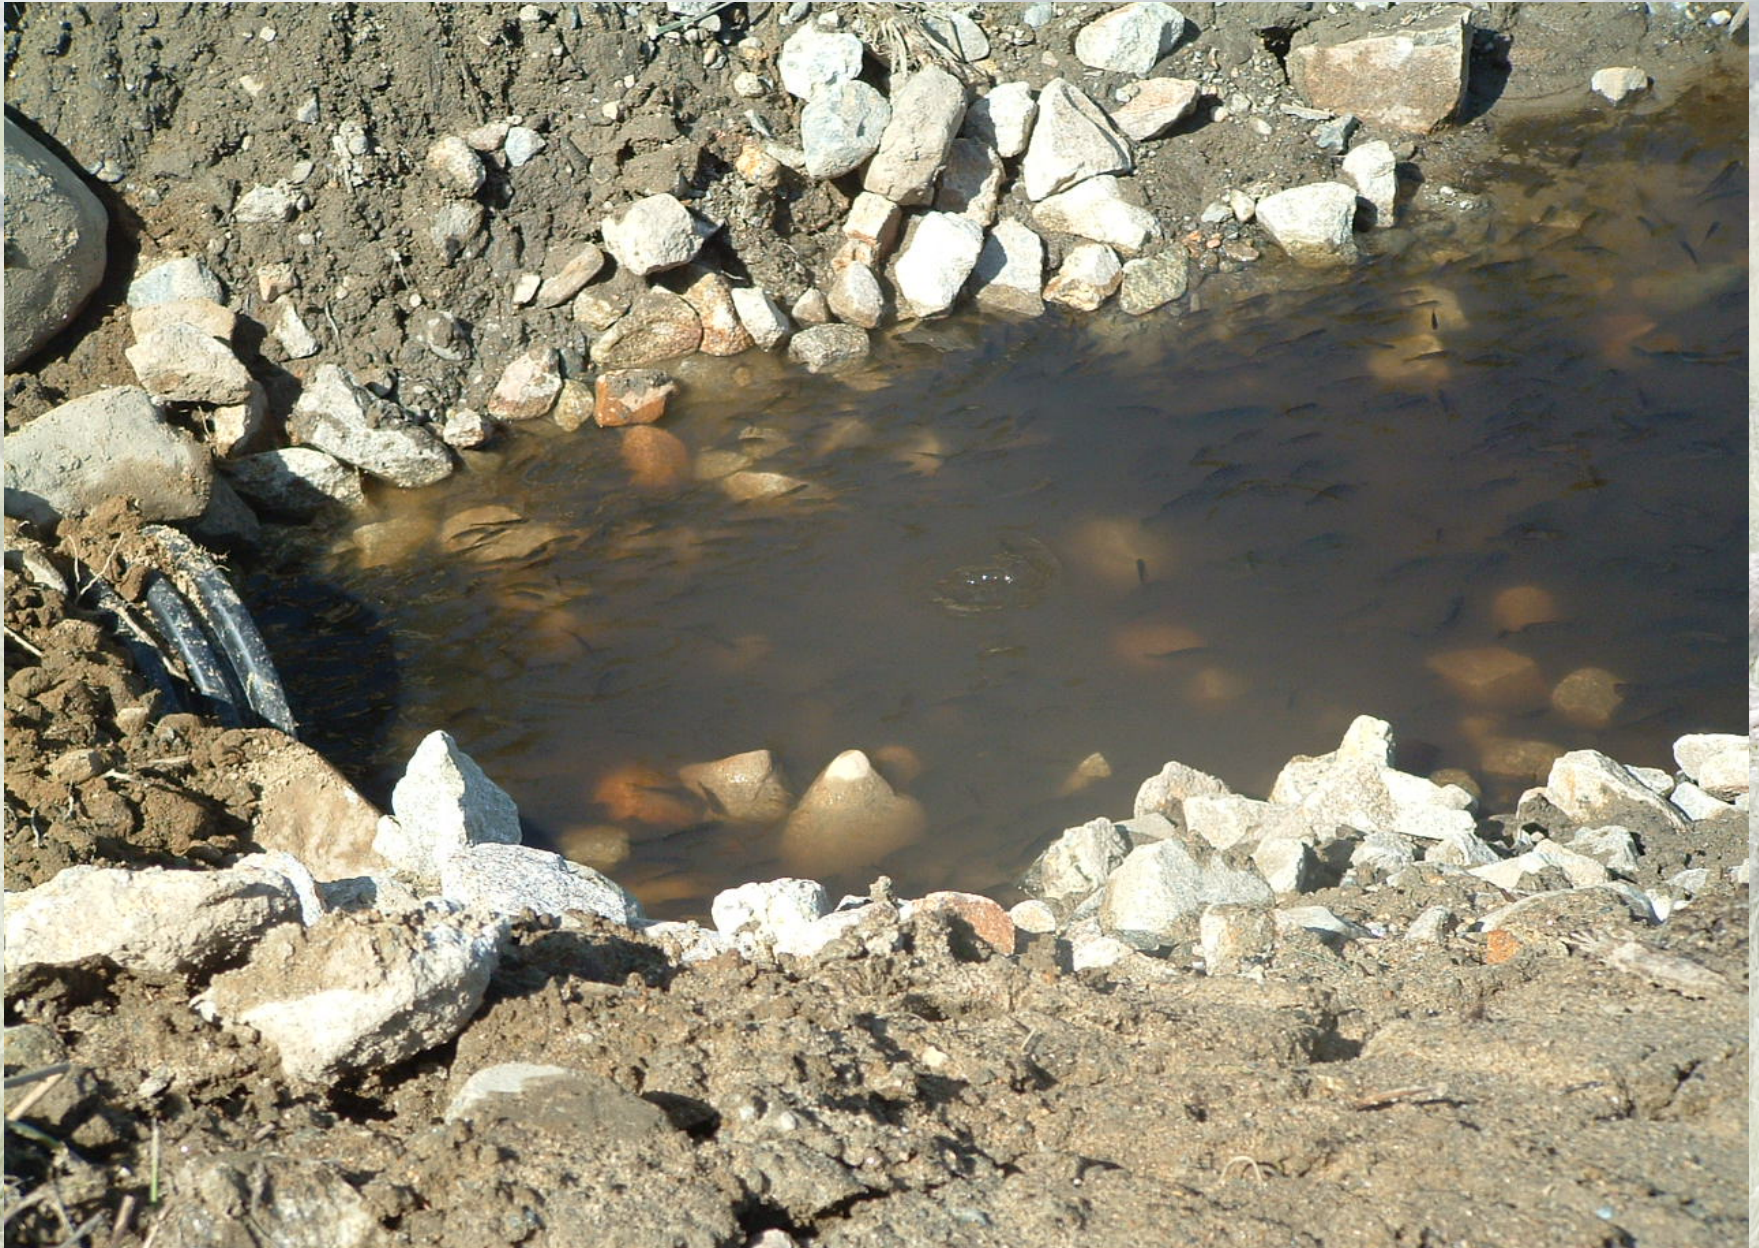
# Fish Pass Through Temporary Culvert

Most are Bluegill also Bass and Hornpout
