THE MATILJIJA DAM
A CASE STUDY IN
MANAGEMENT/DECOMMISSIONING OPTIONS

Prepared by:
Nina Marie Anderson
May 1998

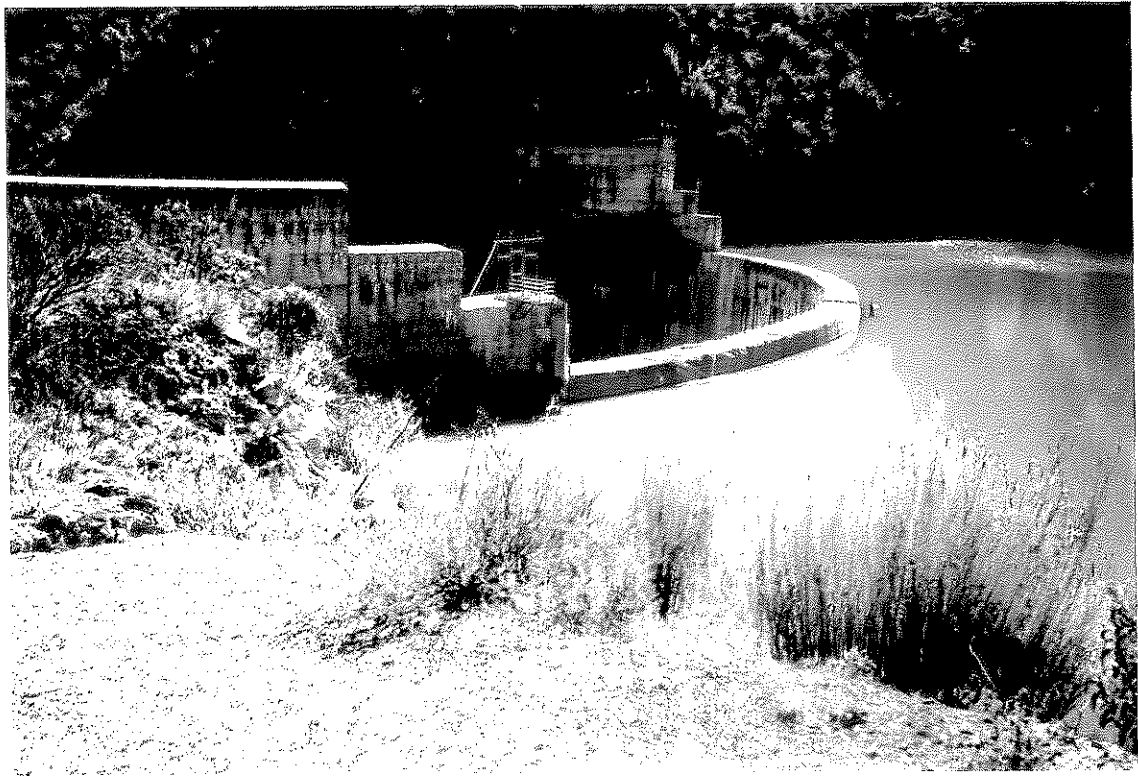
Figure II.1 –Upstream Matilija Dam

The Matilija Dam is a concrete arch structure, 190 feet high and 620 feet long. The arch section varies in thickness from 8 feet at the crest to 35 feet at the base. A horizontal slip joint in the concrete is provided at elevation 960 feet. Arch dams are structures limited to narrow canyons with strong rock walls. An arch dam is in form like a normal architectural arch pushed onto its back, with its curved head facing upstream and its feet braced against the sides of its canyon. The inherent strength of the arch form enables the relatively thin wall of an arch dam to hold back a reservoir with only a fraction of the concrete needed for a gravity dam of similar height.

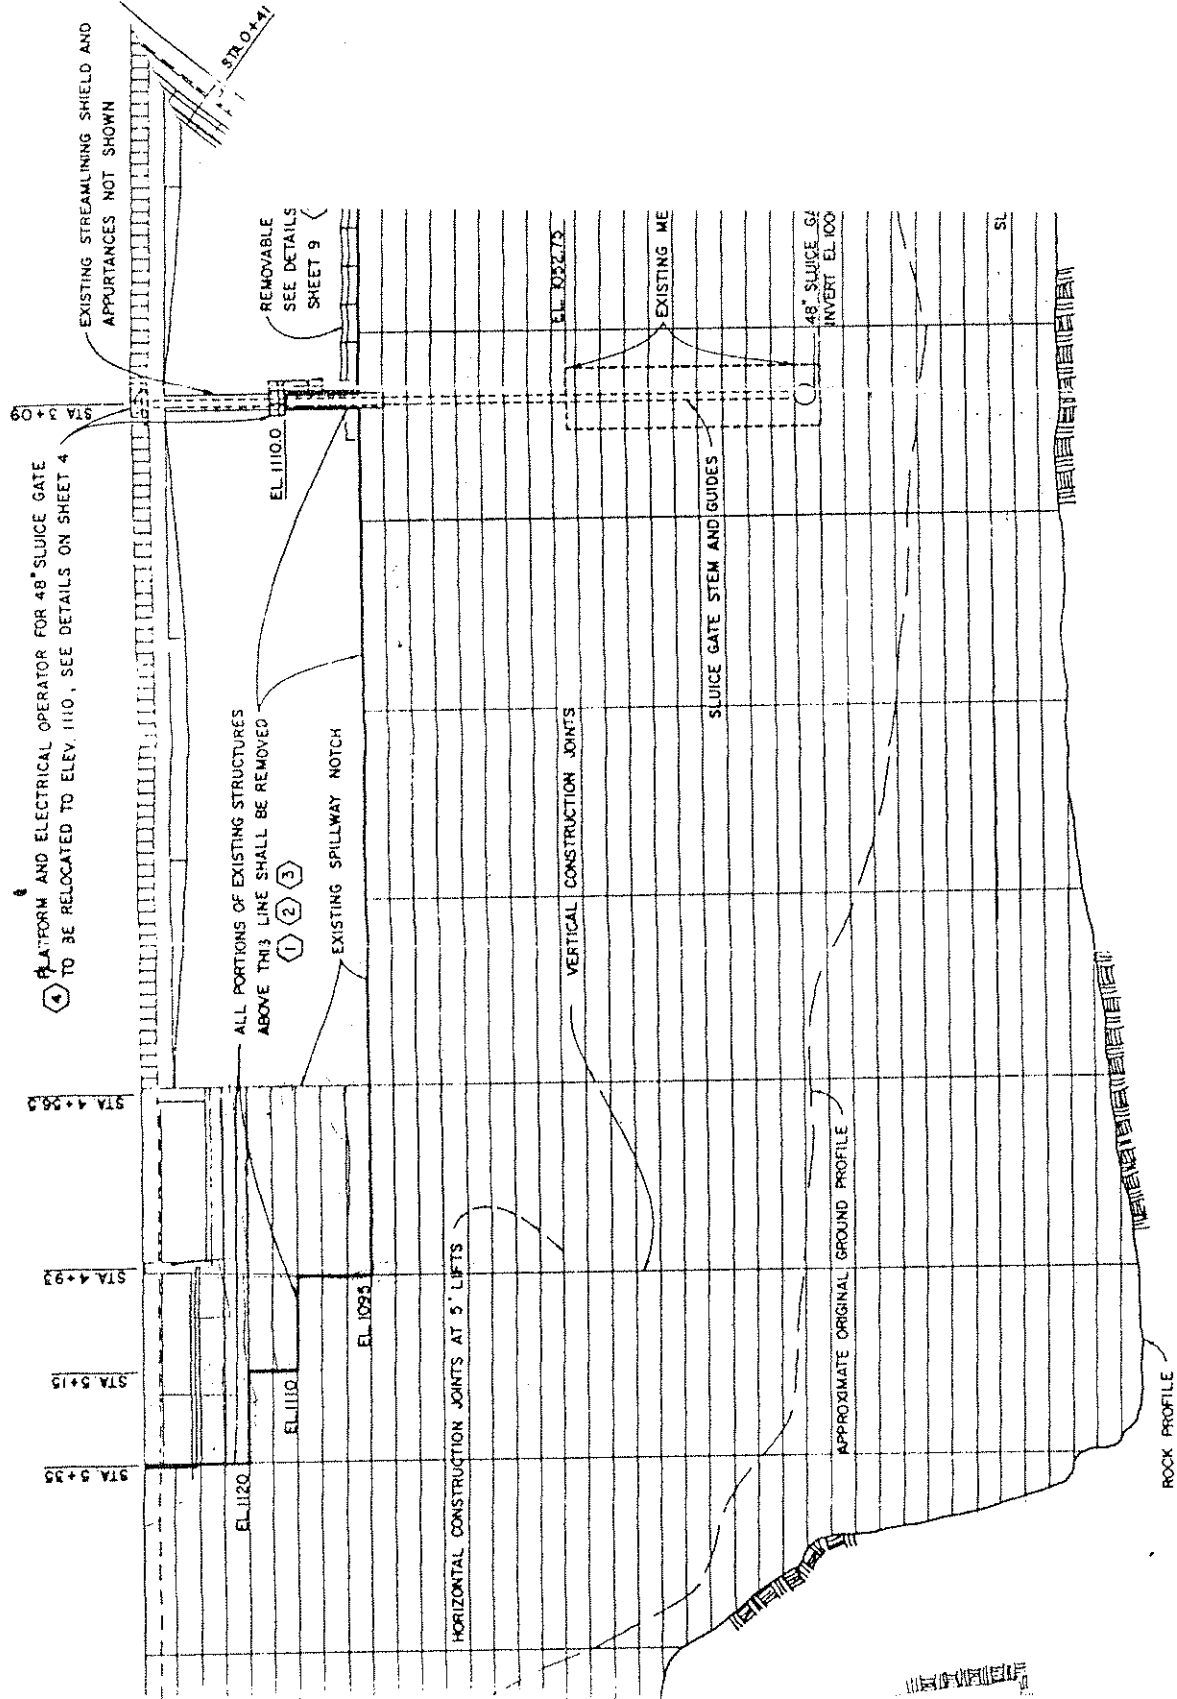
DAM ELEVATION

In 1964, Bechtel Corporation was contracted by VCFCO to determine the cause of cracks in the dam and structural integrity. Bechtel identified alkali-aggregate reactivity as the cause of the cracks and determined that expansion of the dam due to the cracks had lowered the safety factors of the dam to unacceptable levels. The decision was made to reduce the storage capacity behind the dam. In 1965, a 30 feet deep by 280 feet wide notch was cut into the central part of the top of the dam, lowering the elevation of the top of the dam from 1125 to 1095, and reducing storage capacity from the original 7020 to 3860 AF. The notch was expanded horizontally in 1978 to remove additional deteriorated concrete [Figure II.2 - diagram of Matilija Dam].

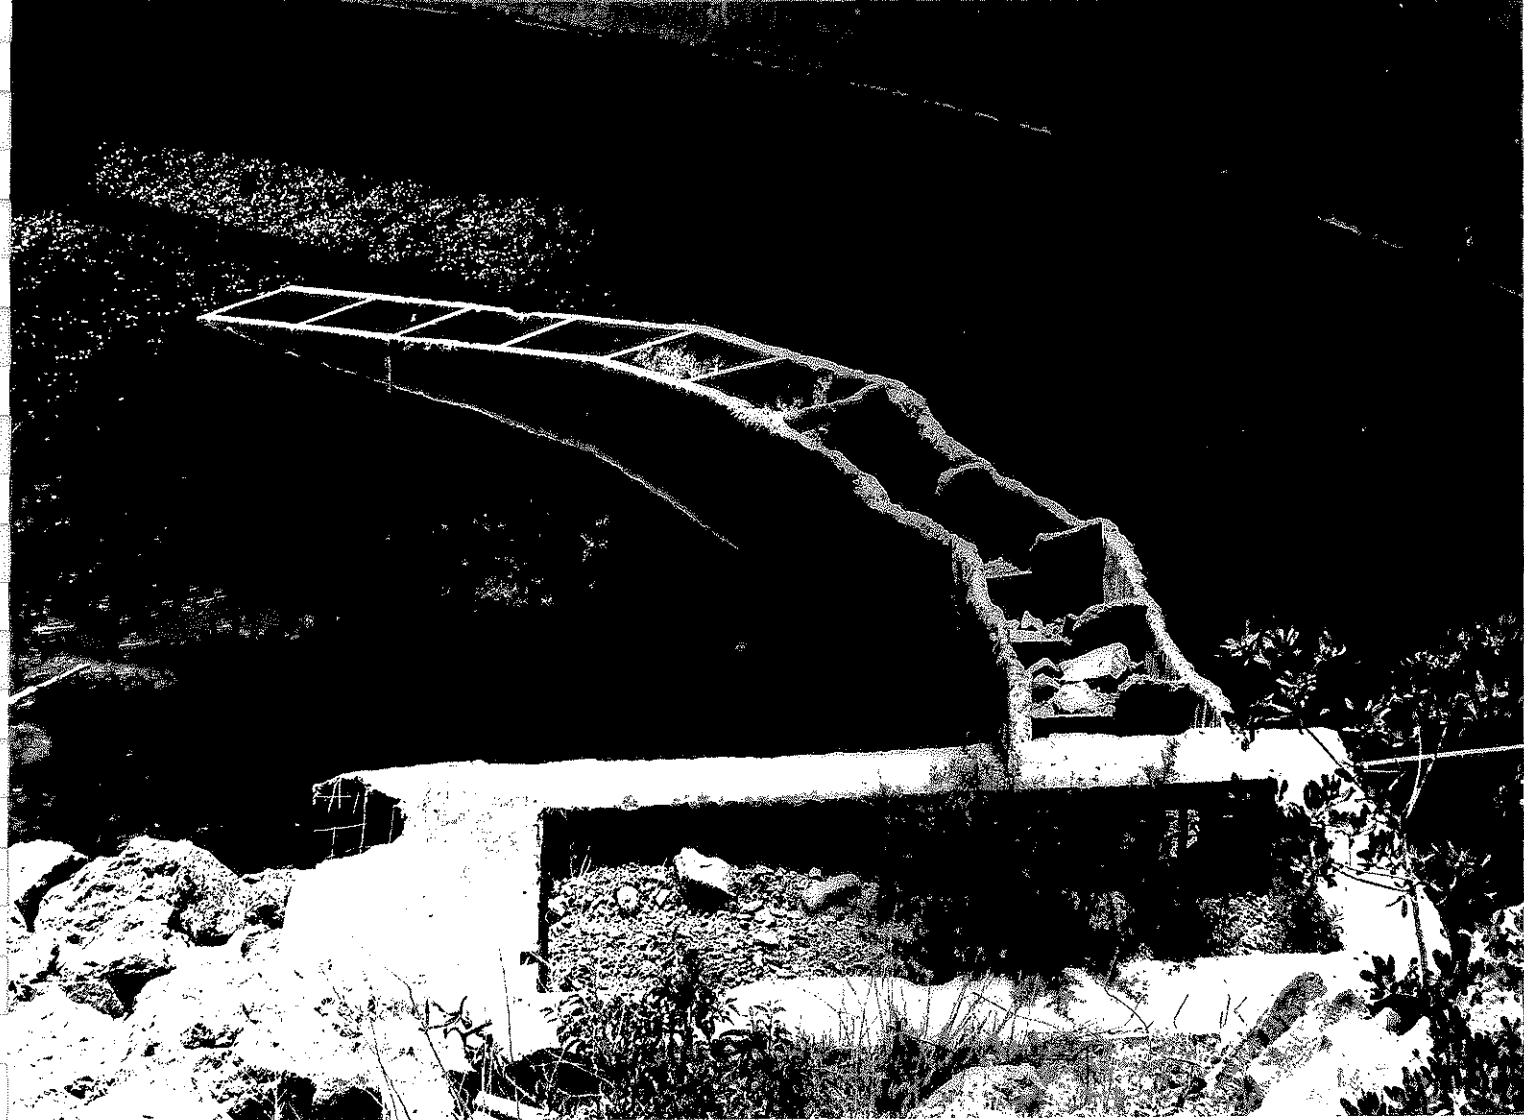
Figure II.3 The Fish Ladder

A fish ladder and holding facilities were constructed at the base of the dam [Figure II.3 - photo of fish ladder]. The plan was for adult migrant fish to be trapped at the base of the dam and trucked to the top. However, the slip pools of the fish ladder were built only a few yards out from the base of the dam, and subject to inundation by water cresting over the spillway. In addition, water was normally released down a side apron on the downstream face of the dam, and competed with the smaller flow of the ladder. Migrating fish tended to run up the heavier flow, which led to a dead end. The last county warden (retired in 1953) reported that the most fish he saw in the holding tank were "three confused adults." No provisions were made for the downstream transport of adults and smolts caught above the dam - the spillway was a straight drop from the crest of the dam. In 1965, the California Fish and Game Commission authorized deactivation of the fish trapping facilities. [Capelli, 1974].

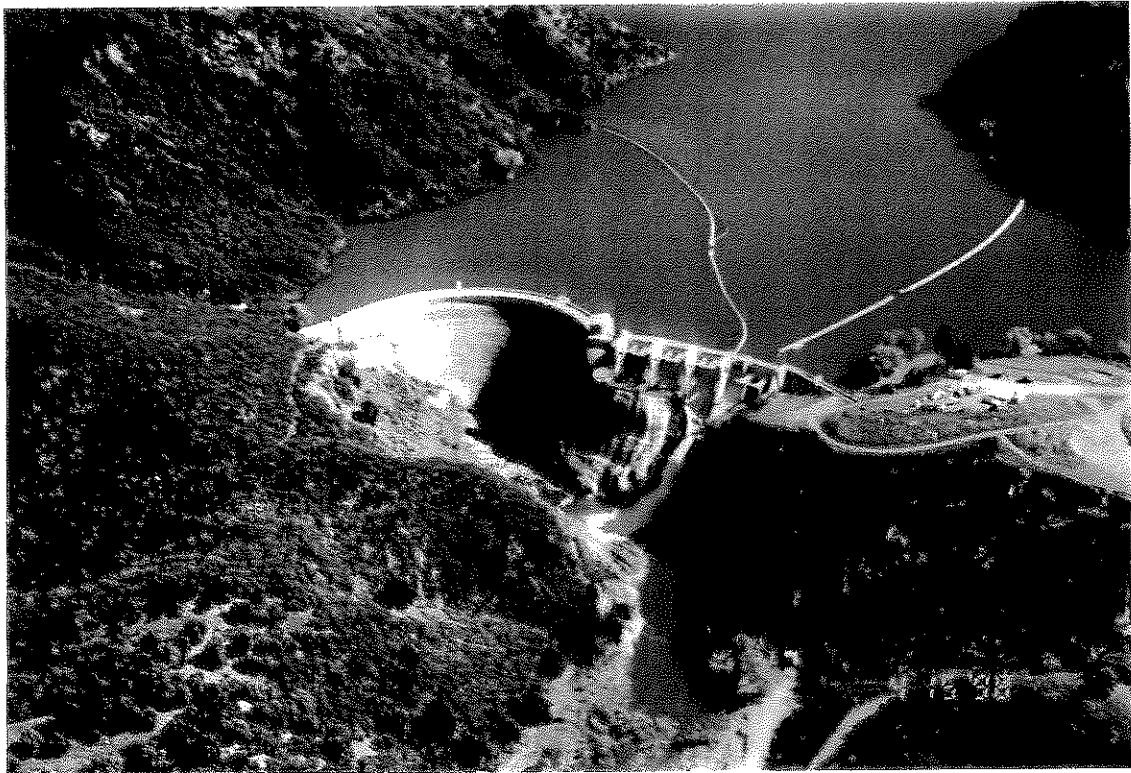
Figure III.1 Gibraltar Dam (stabilized)

The City and their consultants determined the best method for strengthening the dam would be to construct a roller-compacted concrete (RCC) buttress against the downstream face of the existing concrete arch dam. RCC is relatively dry concrete that can be put in place using earthmoving equipment, and is less costly than concrete placed using conventional construction technology.

The cost of design and construction of the project was approximately 10 million dollars, took one year to complete. The project is a good comparative study for a stabilization requirement for the Matilija Dam. Details regarding project description, alternatives, and environmental impacts can be found in the Gibraltar Dam Strengthening Project Final Environmental Impact Report/Environmental Assessment, SB-18-87, prepared for the City of Santa Barbara in 1988. A photograph of the dam taken 4/15/98 is provided.

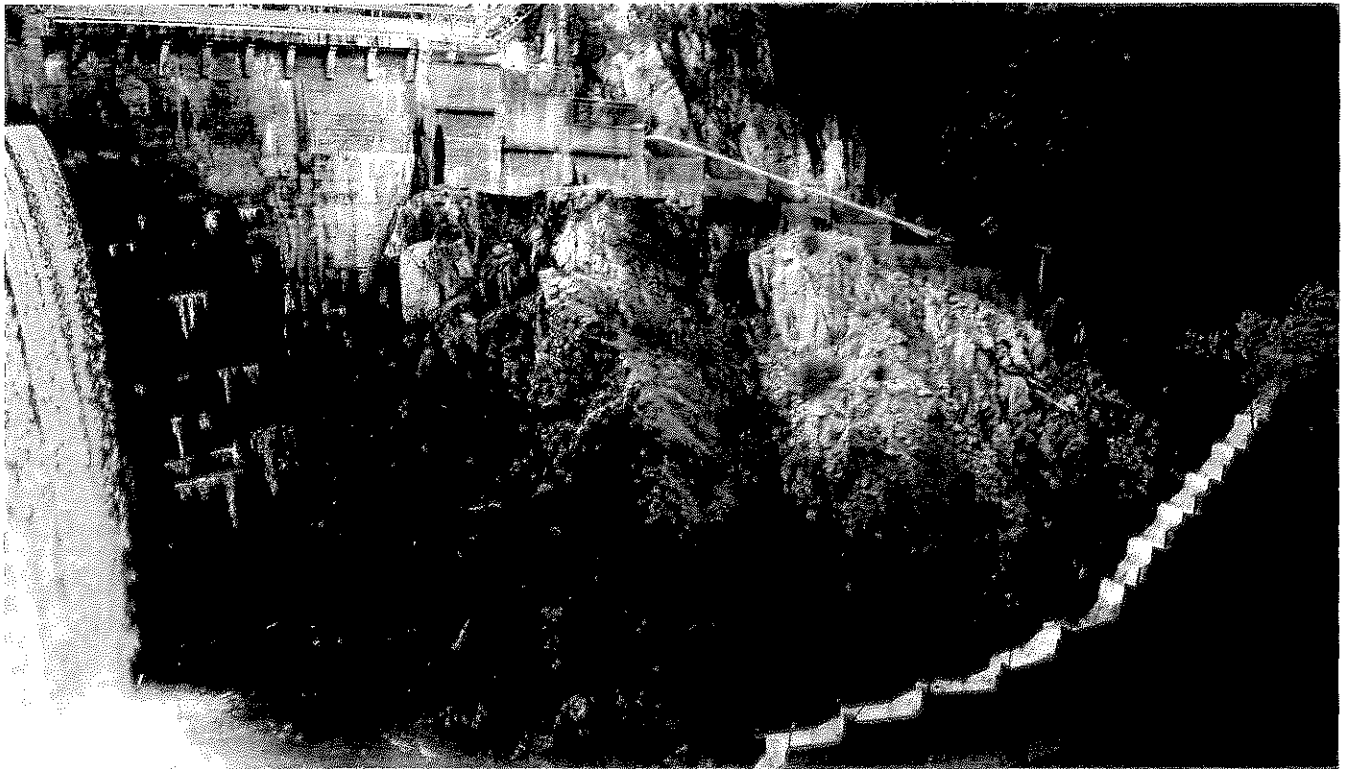
Figure III.3 Fish Ladder at San Clemente Dam

The fish ladder was built in 1922, at the time of dam construction. The design of the ladder incorporates one turn midway up the series of step-pools

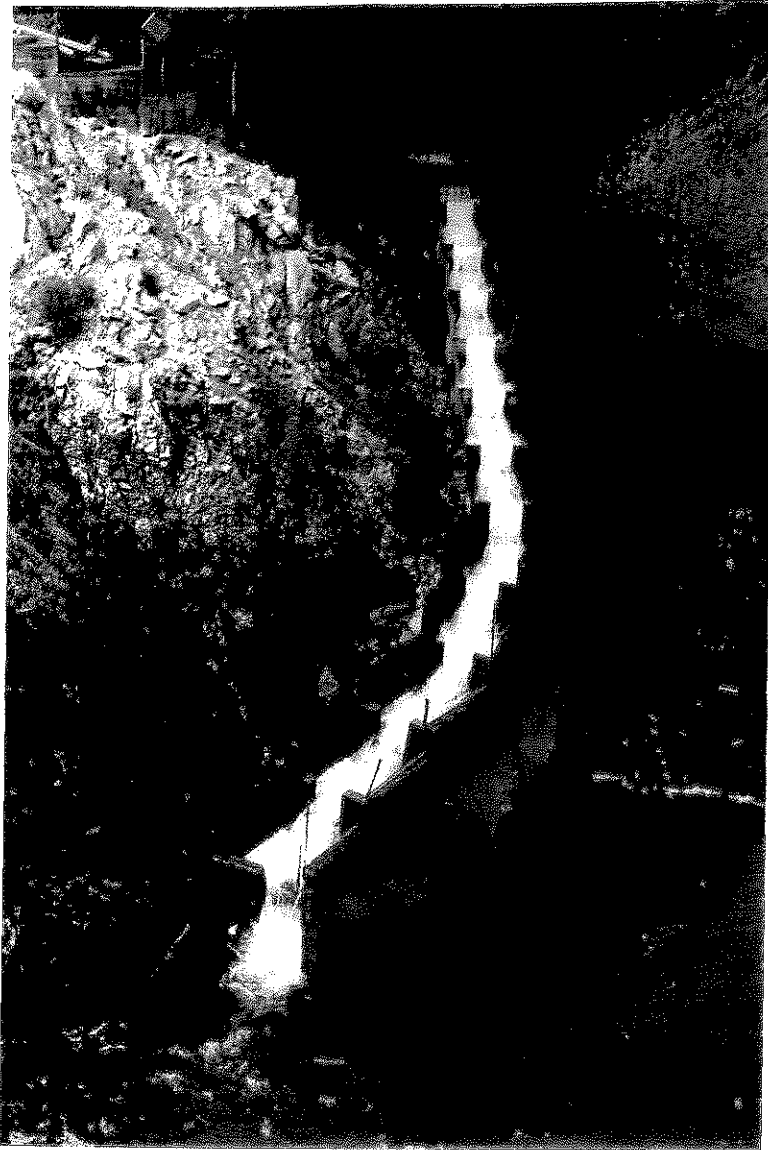
Figure III.4 Lower half of Step-Pool Fish Ladder at San Clemente Dam

Although fish ladder design was much less sophisticated in the early part of the century, the ladder does indeed provide access to the upstream habitat. In the 1996/1997 season, 775 steelhead were counted, and as of the date of the accompanying photographs (3/7/98), 650 steelhead had made the journey up the ladder. It was noted however, by Beverly Chaney, a fishery biologist with the Monterey Peninsula Water Management District, that the less than ideal design coupled with the large elevation change puts enormous stress on the fish. In her words, "the fish that make it up are exhausted and somewhat beat up." It is not known how successful these steelhead are at spawning and rearing, as there is no way to keep track of the numbers of fish that migrate back downstream, due the competition of the water flowing down the face of the dam with the upstream entrance to the ladder taking adult and juvenile fish.

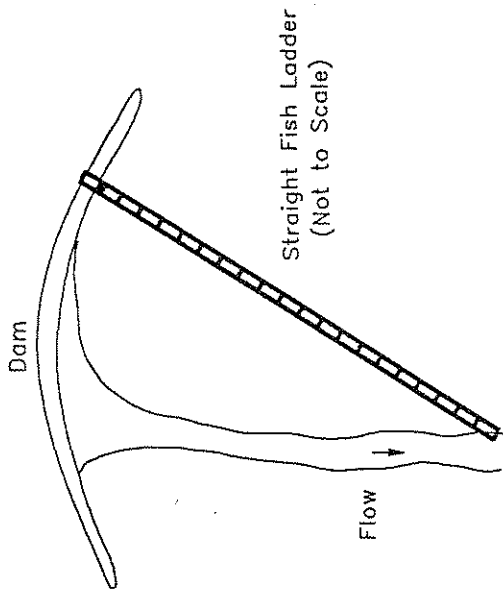
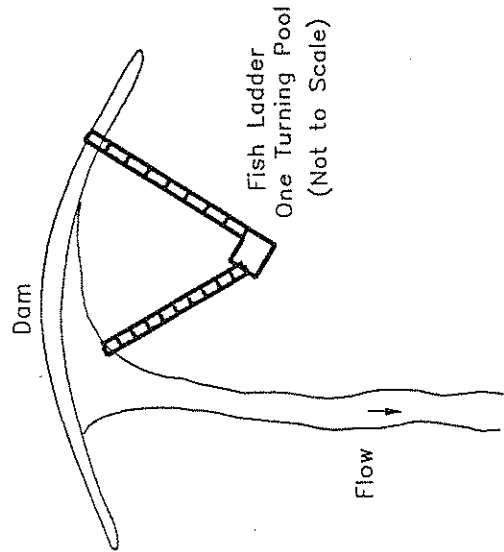
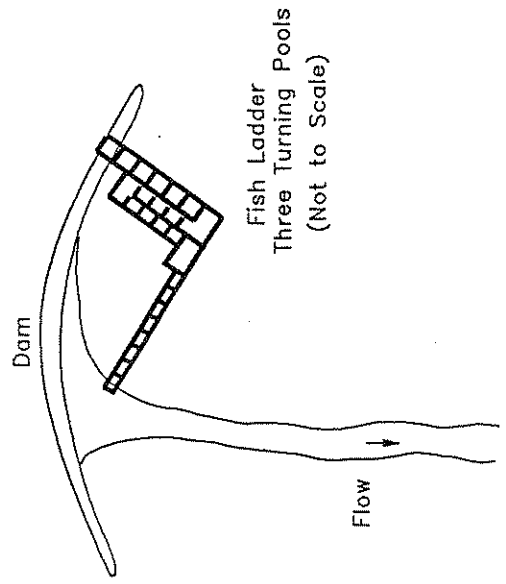
Figure III.5 Fish Ladder Options

Without notching the Matilija, a fish ladder must overcome an approximately 145' elevation differential. There is no height limit to fish ladders, since the step and pool design incorporates resting areas. However, the optimal design standards require 1'-1 ½' of rise per pool; therefore, a minimum of 97 pools would be necessary. Standard specifications for a step and pool ladder also require pools that are 6' to 10' long, 6' wide, and 4' deep. Using these specifications, a straight ladder would need to be between 580' to 1350' in length. It is possible to reduce the straight length of a ladder by including turning pools [Figure III.5 - diagram of Fish Ladder Options].

The steep and narrow Matilija Canyon is not a likely candidate for a straight ladder. An additional requirement for the ladder is that flows in and near the fishway entrance should be sufficient to attract fish. Again, the downstream topography at the Matilija would indicate that the entrance to a ladder would most likely be situated in the limited area of the pool at the base of the dam. It therefore seems unlikely that there is adequate space with which to design a ladder that would accommodate the 145' elevation differential.

Partial removal of the dam would reduce the length and cost of a fish ladder.

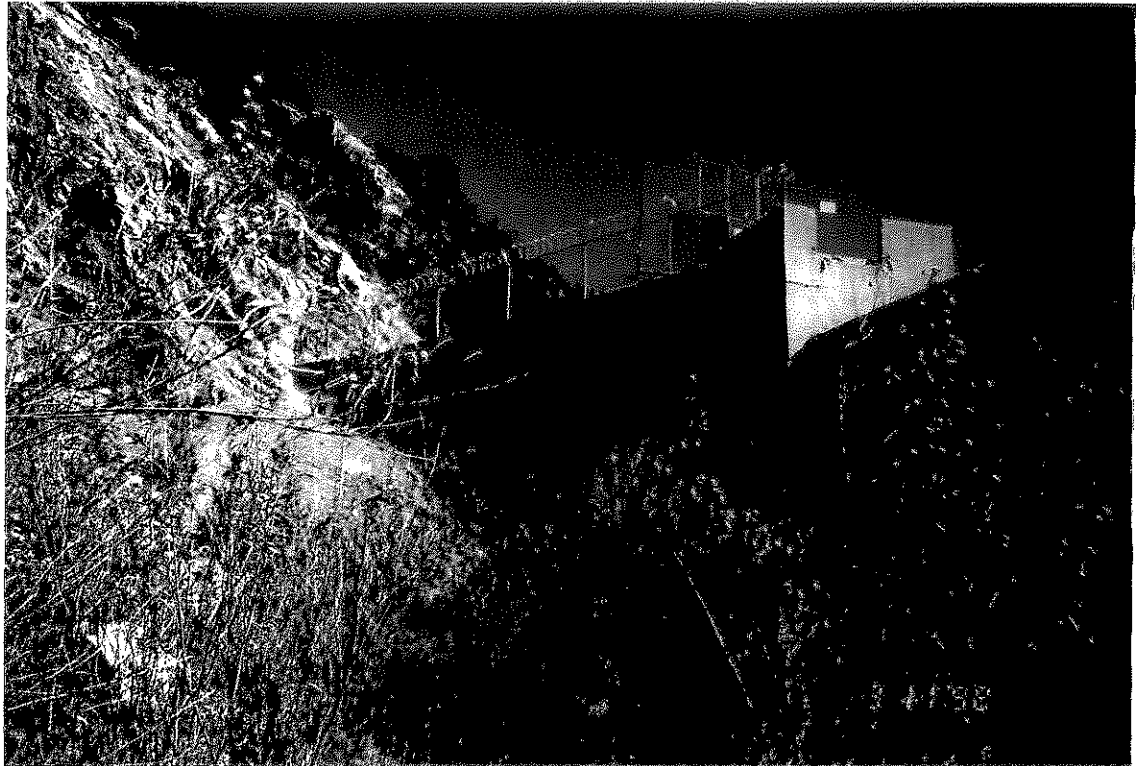
Figure III.6 Left Abutment at Matilija Dam

A final consideration regarding the design and construction of a fish ladder is that the area is prone to landslides and rockslides in the vicinity of the left abutment. The ladder may therefore require extensive, expensive engineering to withstand the potential impacts of a slide. If the slope is determined to be unstable, it may not be feasible to construct the fish ladder at all.
