Re: Bull Run Hydroelectric Project,  
Project No. 477  
Additional Information Request Materials

**Figure 3. The predicted annual change in bed elevation following the removal of Marmot Dam under Alternative B.**

*Draft Technical Memorandum*

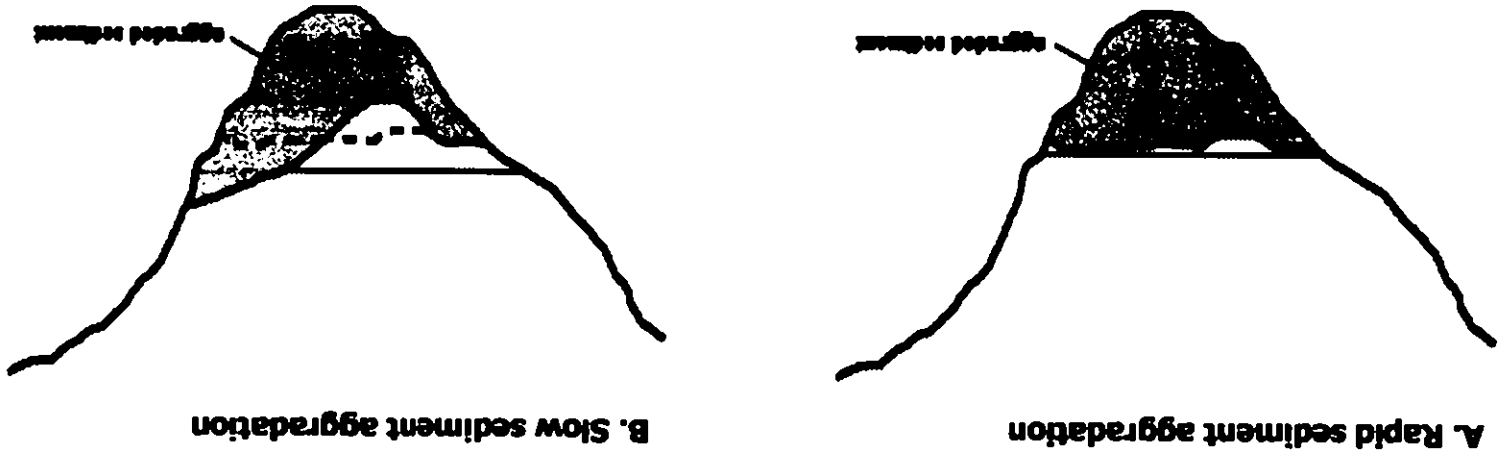
Figure 1. Schematic diagrams of sediment aggradation in the Sandy River following dam removal.

(e.g., channels with defined bars and a thalweg) are less likely to develop fish passage barriers. We further hypothesized that the rate of aggradation controls the channel complexity. For example, a rapidly aggraded surface is more likely to have a channel with a uniform bed than a slowly aggraded surface. If the aggradation occurs over a longer time period in which the river experiences a variety of hydraulic conditions, the channel will be able to recover at least part of its original complexity, and thus reduce the possibility of fish passage barriers. During the May 20 meeting, it was agreed that channel complexity rather than the amount of aggradation should be used to assess future fish passage issues.

We believe that the best metric for assessing channel complexity is the standard deviation of channel cross section elevation. For example, the standard deviation of bed elevation is much lower for a rapidly aggraded surface (shown in Figure 1A) than a slowly aggraded surface (Figure 1B). We propose to use the standard deviation of bed elevation over two pool-riffle complexes to quantify channel complexity over a reach. In areas where the channel is plane-bedded, or has very long pools, we recommend that the monitoring reach be 10 channel widths long, if possible. Because erosion and deposition will alter the channel complexity, bed elevation will be surveyed and the standard deviation of bed elevation will be calculated for at least three years prior to the removal of Marmot Dam to establish the natural range of pre-dam removal bed complexity. Following dam removal, bed elevation will be surveyed annually during the summer low-flow season and the results will be compared with previous surveys. A decrease in the standard deviation of bed elevation reflects reduced channel complexity, which corresponds to an increased likelihood of fish passage barrier formation. An increase in the standard deviation of bed elevation reflects increased channel complexity, which indicates a decreased potential for the formation of fish passage barriers. Following dam removal, if channel complexity has returned to its pre-dam removal condition, or has improved for two consecutive years, we believe that the potential for fish passage barrier development caused by dam removal is low.
