INDIGENOUS MONITOR OVERVIEW REPORT

Month: September 2022

Project Region: Lower Mainland

Indigenous Monitors on the Trans Mountain Expansion Project – Overview

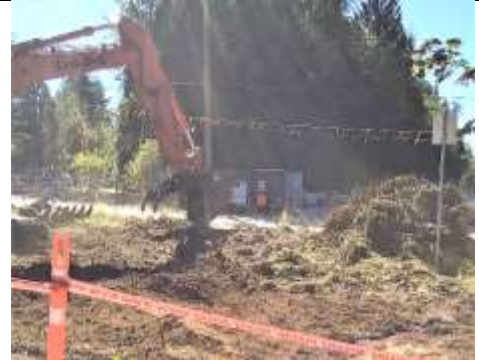
The Indigenous Monitor observed stumping and grubbing near KP 1179, alongside an Environmental Inspector and Archaeological Resource Specialist. The activity was monitored closely to identify any potential archaeological chance finds that could be unearthed. No potential archaeological materials were discovered.

Stumping and grubbing observed near KP 1179. No archaeological chance finds were discovered during inspection.

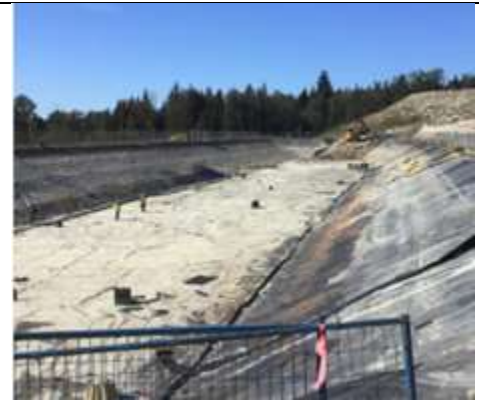
In September, the Indigenous Monitor observed the removal of sediment from the Burnaby Terminal Intermediate Storm Water Retention Area (ISWRA). then cleaning of the ISWRA and repairs to the liner. The sediment was collected and disposed of at the terminal's portal waste area. Compliance measures were in place and no concerns were noted during inspection of this activity.

Intermediate Storm Water Retention Area (ISWRA) has been drained and sediment has been removed.

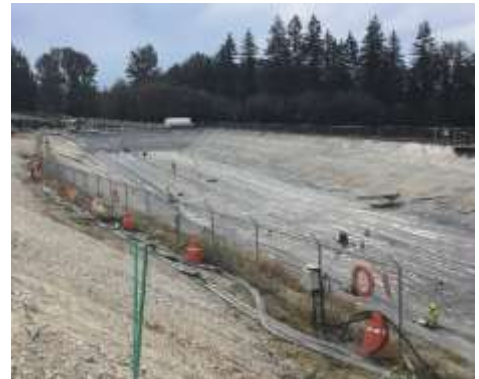
Cleaning of the ISWRA and patching of any tears in the liner occurred.

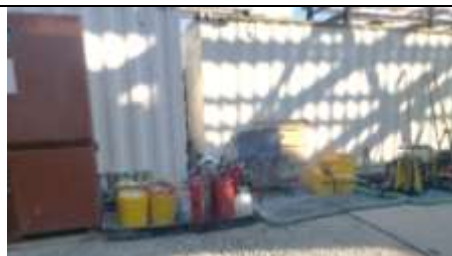
The Indigenous Monitor conducted housekeeping inspections at Burnaby Terminal and WMT. Indigenous Monitors also check that secondary containment is placed underneath machinery and stored petrochemicals such as paint and gasoline. At WMT, the Indigenous Monitor inspected the marine loading platforms for site housekeeping measures. No deficiencies or non-compliances were observed.

Secondary containment inspected at one of the WMT marine loading platforms.

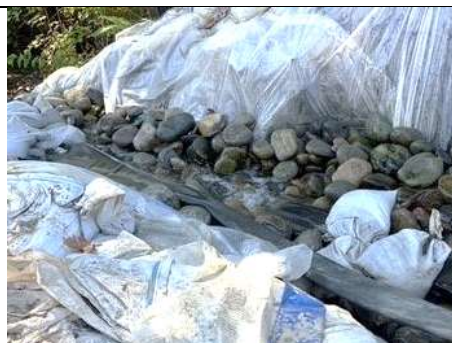
At Holmes Creek (watercourse BC-783b) near KP 1175, the Indigenous Monitor observed the watercourse restoration measures. The Indigenous Monitor observed natural bed material being replaced in the channel prior to restoring flow, and placement of vegetation and coarse woody debris along the bank of Holmes Creek to assist with erosion control and regrowth of vegetation. Environmental feature signage was also inspected in the vicinity. No concerns were reported.

Holmes Creek bed restored near KP 1175 and water running clear after release of the watercourse diversion.

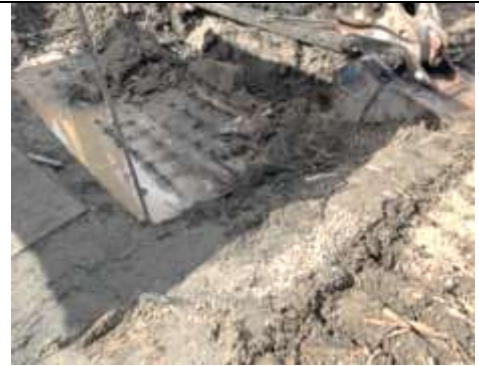
The Indigenous Monitor observed and inspected various environmental mitigations at the temporary workspace, including erosion and sediment control measures, site housekeeping, and secondary containment for equipment and machinery. During inspections the Indigenous Monitor observed additional spill containment measures installed around the HDD borehole pit area to be working effectively and mitigating potential sediment transfer into a nearby fish-bearing watercourse. They also monitored excavation at the HDD pit area and monitored alongside the Archaeological Resource Specialist for potential archaeological chance finds that might be unearthed. No archaeological material was discovered.

Excavation of the HDD borehole pit at Colony Farm.
