Building inspection report here

48 North Avon Road, Christchurch
Building Report

Client Name
Griha Limited

Date/Time
19/08/2026

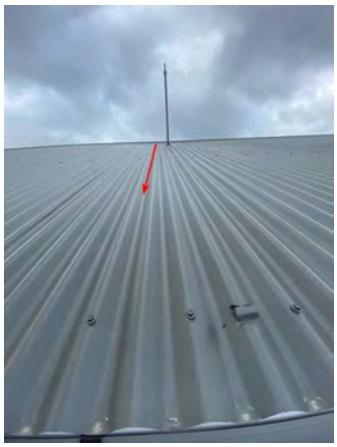
Uplift to roof cladding.

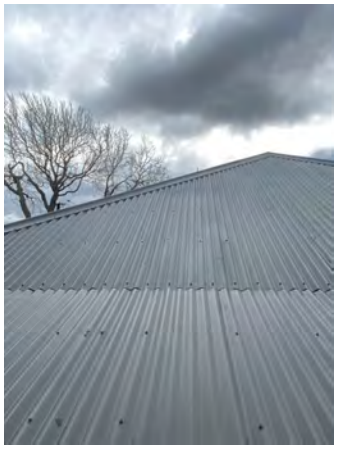
The middle area of the roof appears to be higher than either end. I've been informed that a PS4 has been provided by an engineer regarding this detail. The floor was lowered in flat one causing the height variation in the roof as seen in the photo provided.

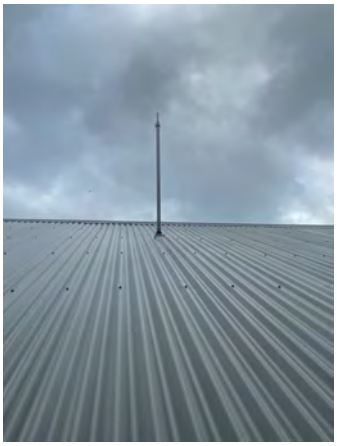
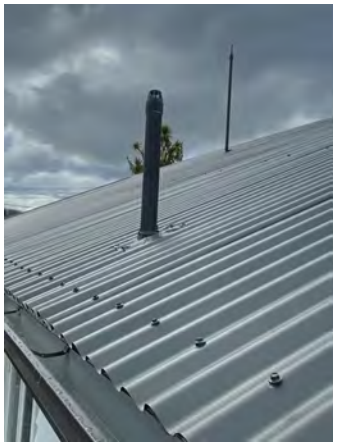
Minor denting noted.

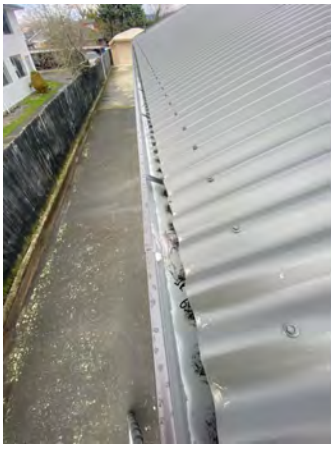
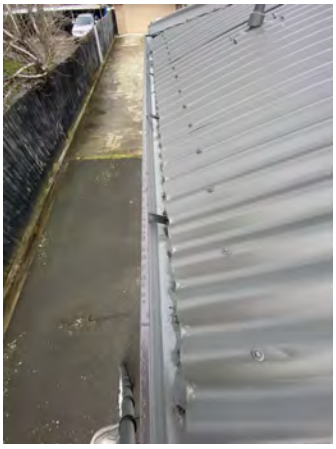
Downpipes and gutters fixed well in place and not loose. Downpipes on the main dwelling discharge into ground risers. Gutters and downpipes clear from debris build up.

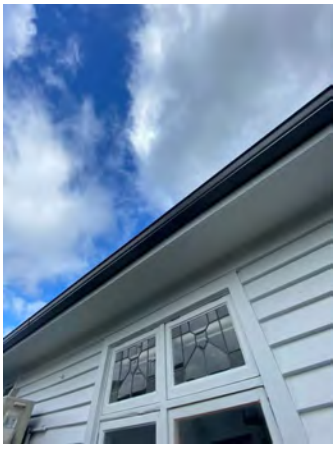
Typical borer sign.

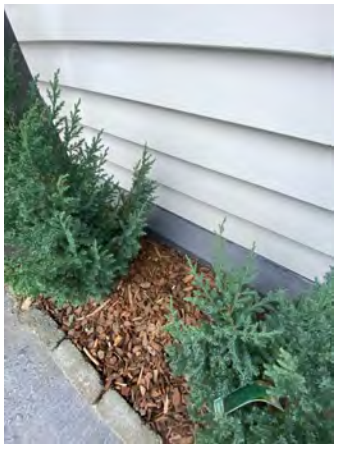
The exterior of the concrete ring foundation appears to have been recently repainted. There does not appear to be any obvious or significant cracking noted at the time of inspection. Crack repairs appear to have been previously completed to some locations. These areas have been concealed partially by paint. New subfloor vents have been installed.

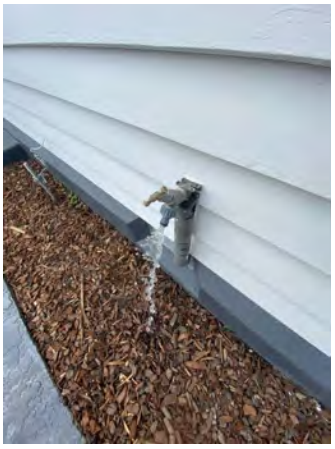
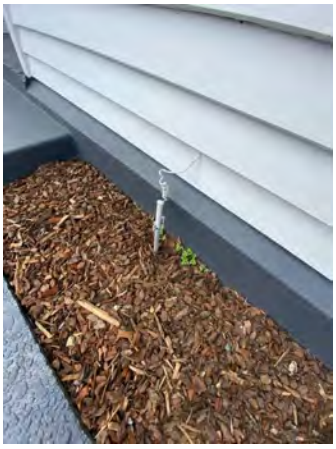
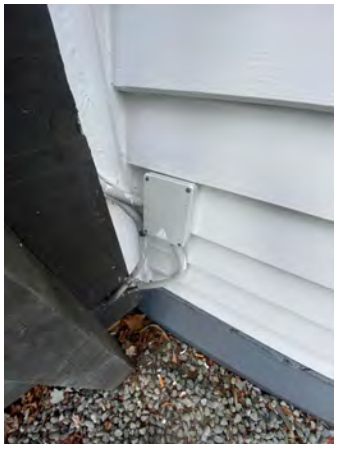
Gully traps are sufficient height off finished ground level. Traps are configured properly and do not have downpipes directing stormwater into them. A grate should be installed onto the traps to prevent debris entering the grey water system. It is noted that the gully traps visible are earthenware/clay piping; earthenware pipes are more susceptible to damage from seismic activity than PVC. Seismic activity can cause some breakages or cracks to occur in the pipes under the ground.

Earthenware. Grate missing.

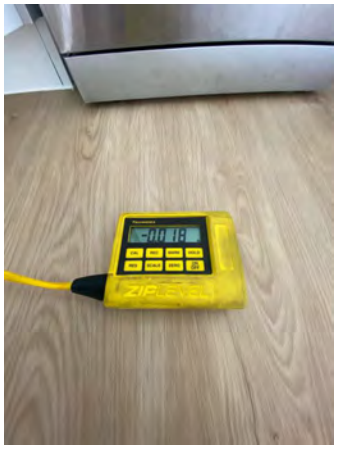
16mm step down from carpet to laminate flooring.

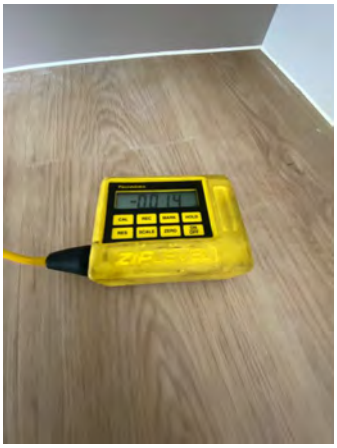
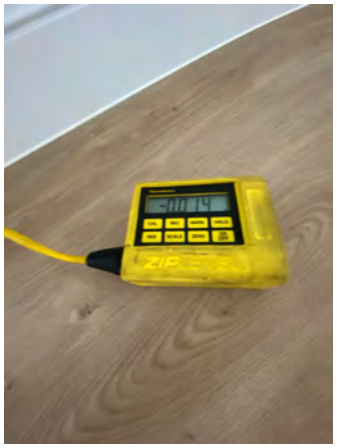
14mm step down from carpet to laminate flooring.

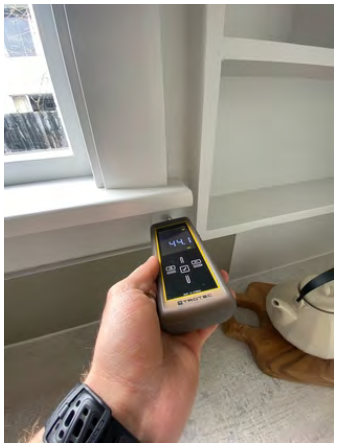
Kitchen window, slightly elevated moisture reading. This Is likely caused from driving rain when the window has been left open.

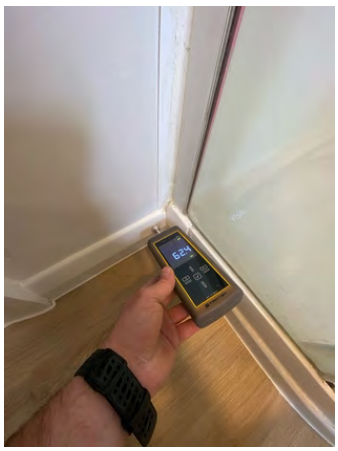
Shower, slightly elevated moisture reading.
This may be caused from failed sealant.

Shower, slightly elevated moisture reading.

Qualified Plumbing Specialist

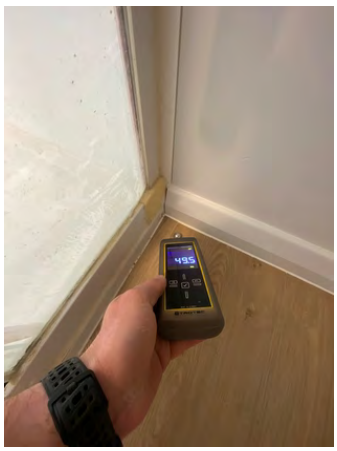
Shower, slightly elevated moisture reading. This may be caused from failed sealant.

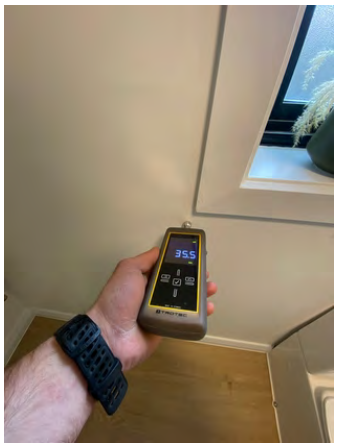
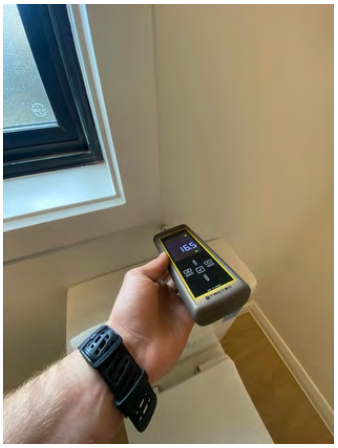
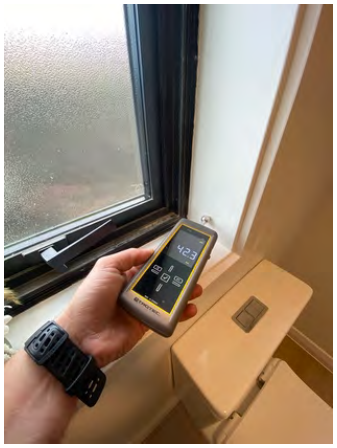
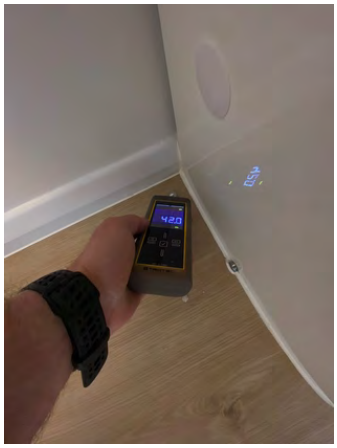
Shower.

Behind the shower, in the kitchen.

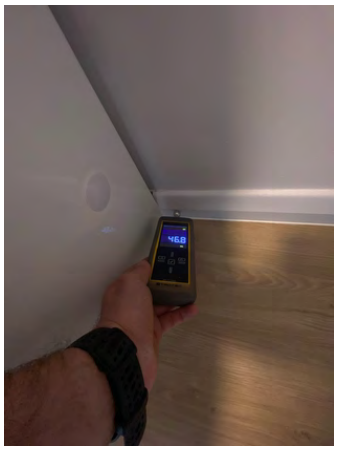
Toilet.

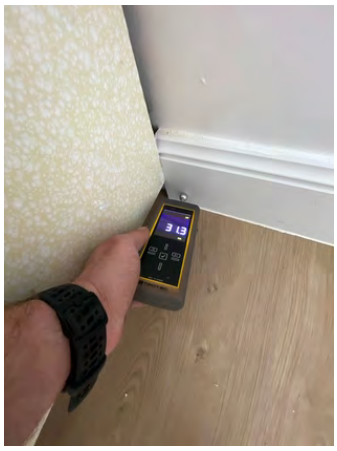
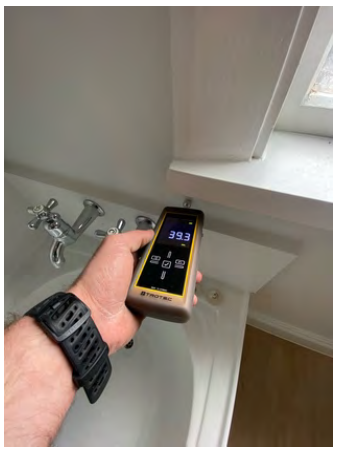
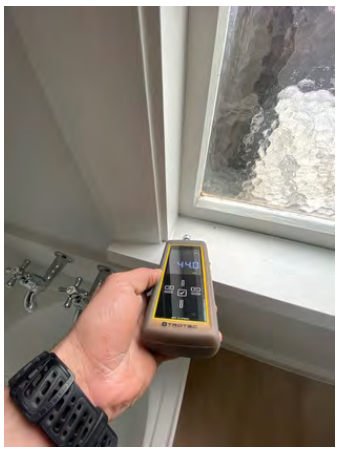
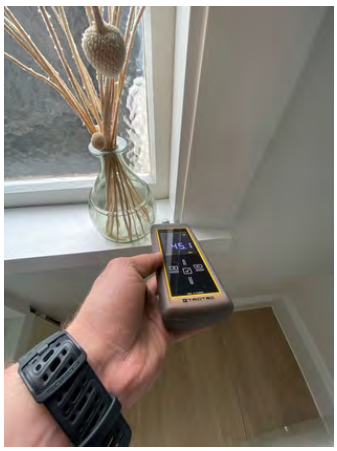
Shower.

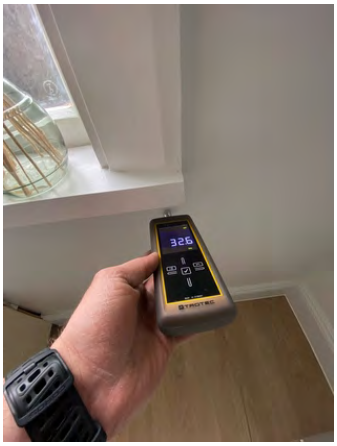
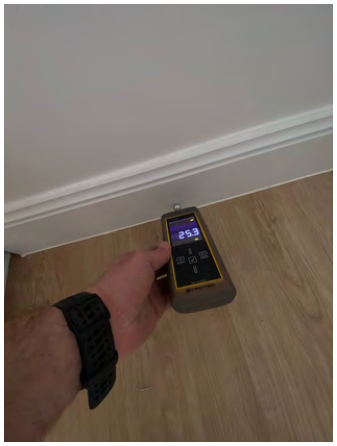
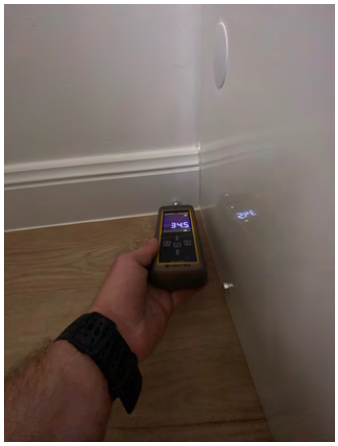
Shower.

Behind the shower, in the hallway.

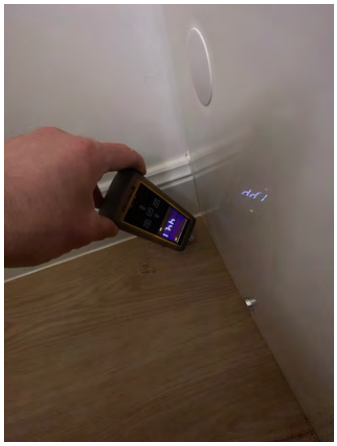
Bath.

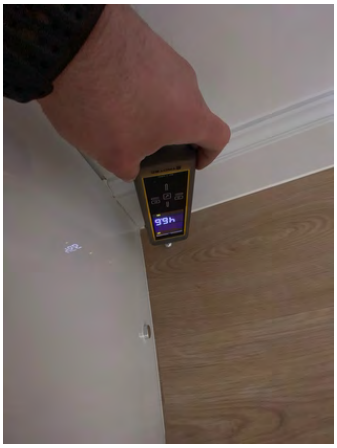
Bath.

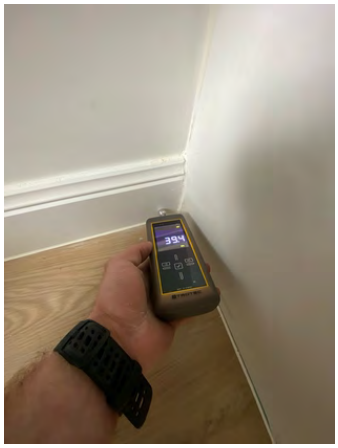
Toilet.

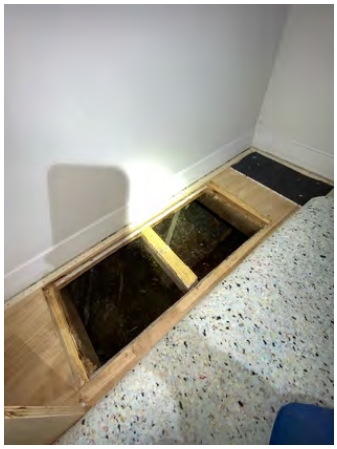
No obvious signs of rot. The piles don’t have any obvious pile to framing connections. This is typical for a property of this age.

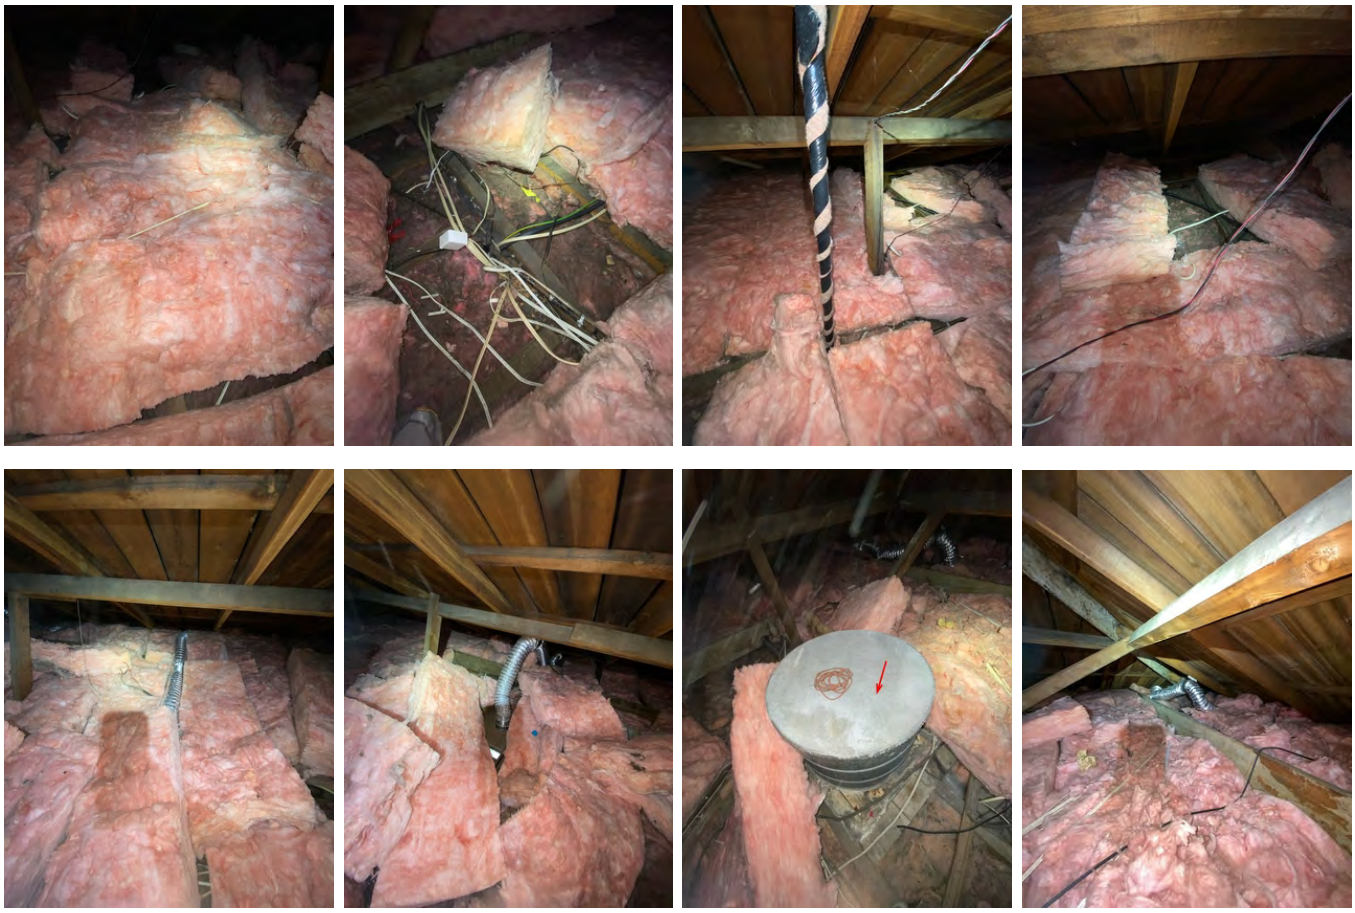
Please note that our view of the wiring is limited to what can be visually sighted, and we cannot confirm anything beyond what is visible or enclosed behind wall linings, under insulation, etc. Modern TPS noted – Please note that due to the era of the home, there is still potential for some older wiring elements to be present. Houses from approximately the 1970s and earlier were generally wired with older non-compliant wiring unless these have been fully replaced. Therefore, we are unable to confirm the extent of the modern TPS wiring. It is recommended that you check any records of wiring work that has been carried out to confirm whether the home has been fully or partially rewired, and consult a suitably qualified electrical specialist if you are concerned about this.

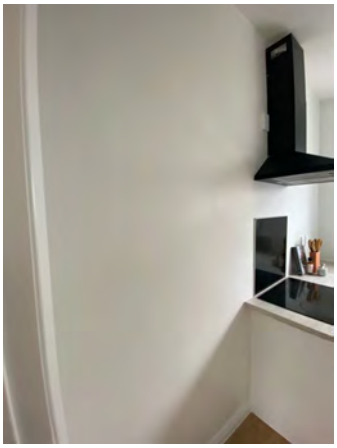
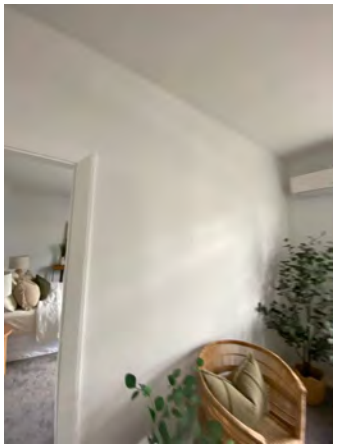
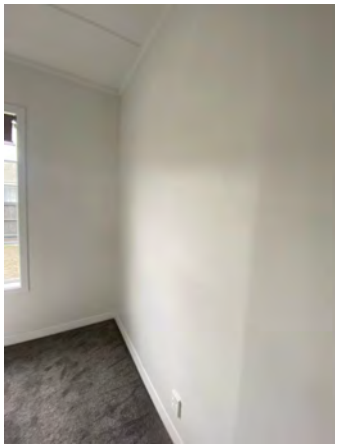
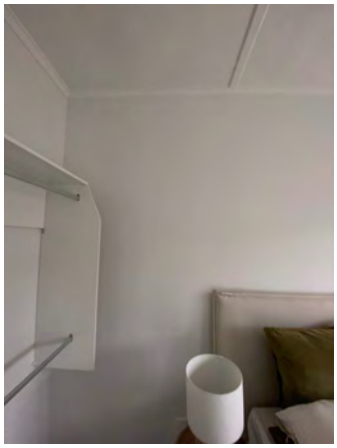
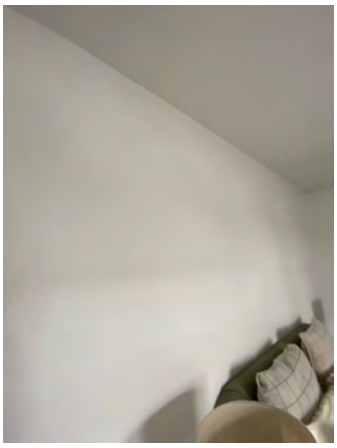
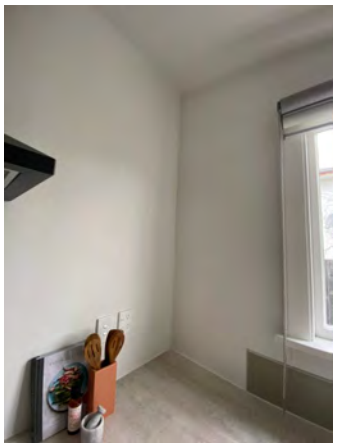
Flat 2.

Minimal marks or damage; nothing more than you would reasonably expect for its age. Looks to have been recently repainted. Some dark shadowing and marks have been noted in places; this is known as ‘ghosting’. Ghosting occurs when dirt and dust particles become attracted to cold spots on a surface, causing dark marks on the wall linings. Often, these can be cleaned off; however, sometimes, they stain the lining.

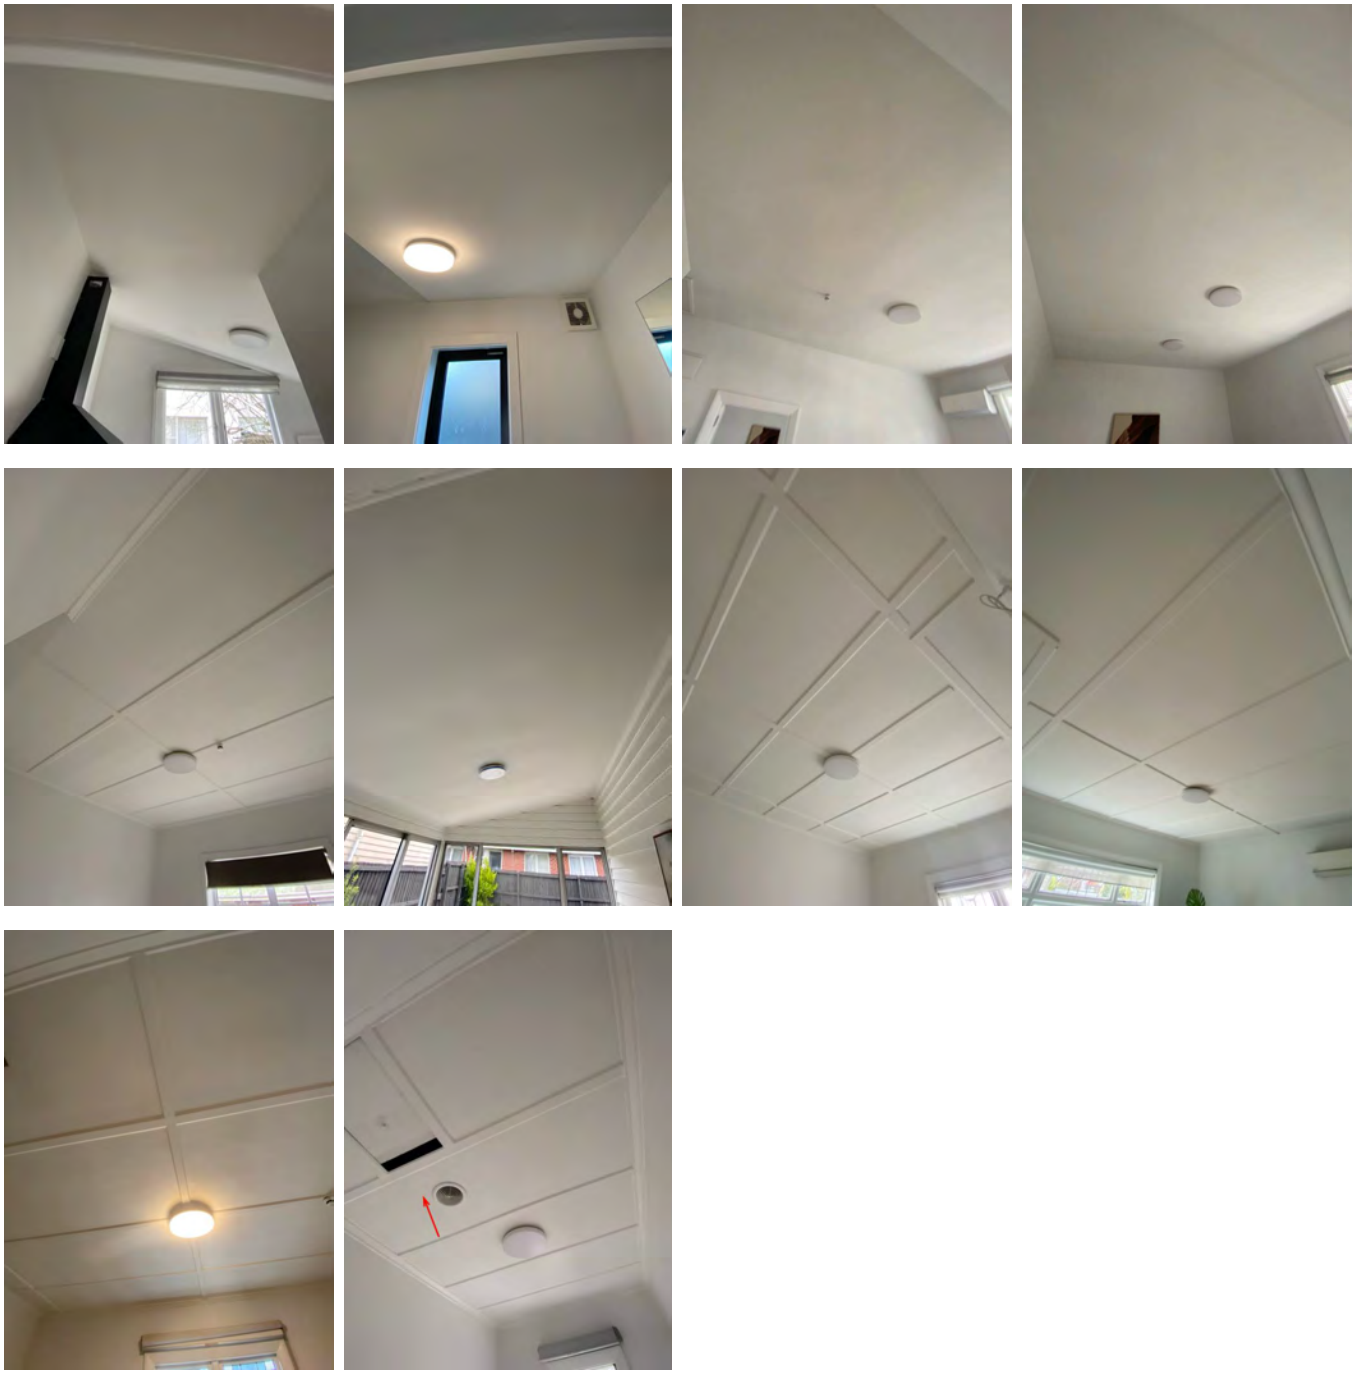
Comments
No obvious signs of water damage. Some dark shadowing and marks have been noted in places; this is known as ‘ghosting’. Ghosting occurs when dirt and dust particles become attracted to cold spots on a surface, causing dark marks on the ceiling linings. Often, these can be cleaned off; however, sometimes, they stain the lining. Minor cracking noted.

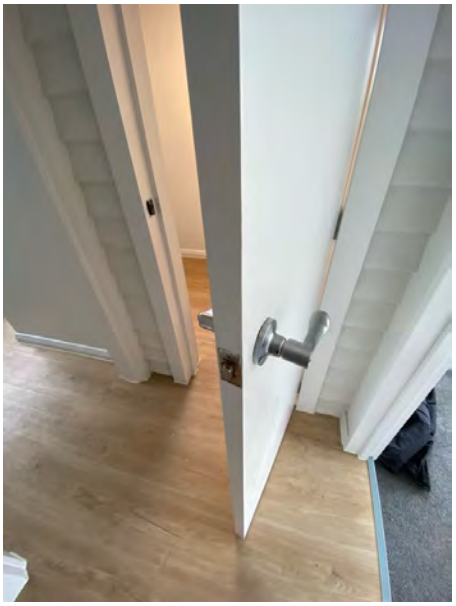
Flat 1 Door needs adjustment.

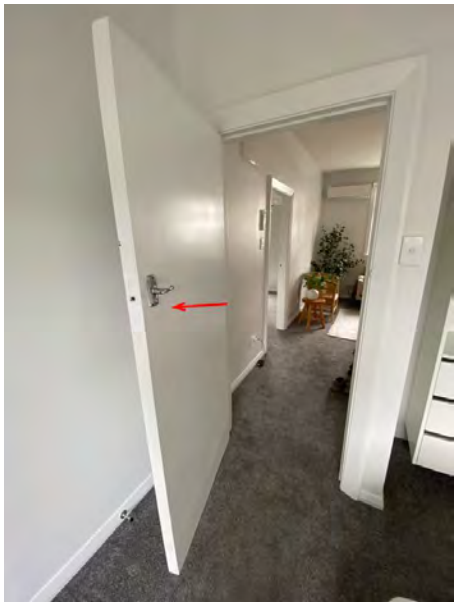
Flat 2 Door handle is loose.

Handyman

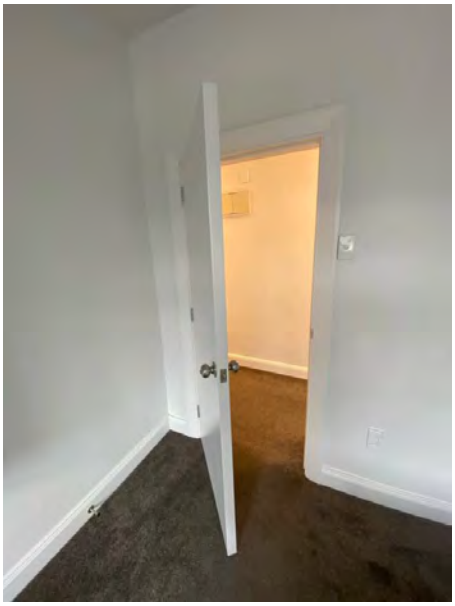
Flat 2 Door needs adjustment.

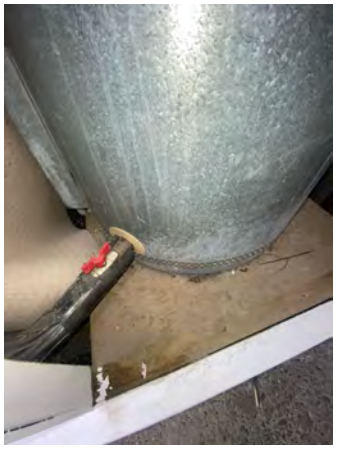
No leaks observed. Proper seismic restraints installed to hot water cylinder.

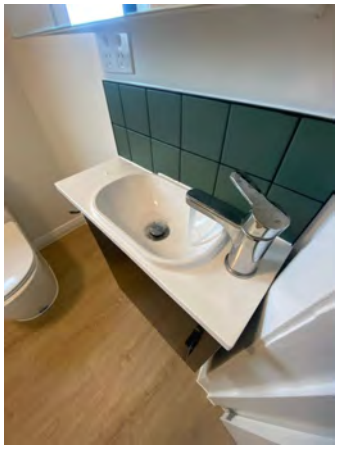
Taps were turned on, and no leaks were observed from the waste piping. No leaks observed from water supply under sinks.

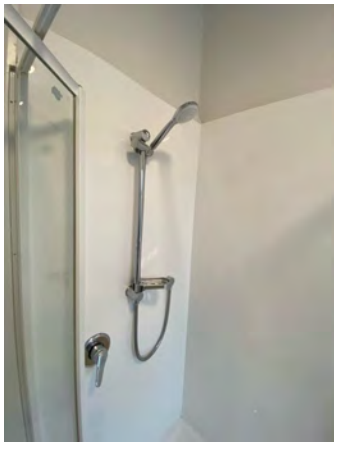
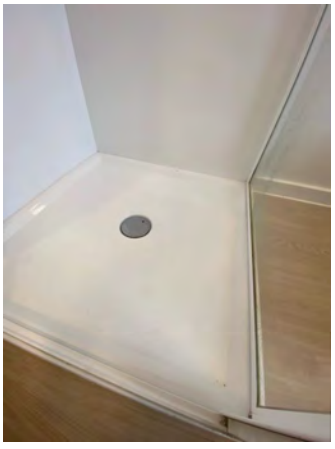
Flat 2

Leaks from shower(s)?
No leaks were detected at the time of inspection.

Leaks from shower fittings?
No

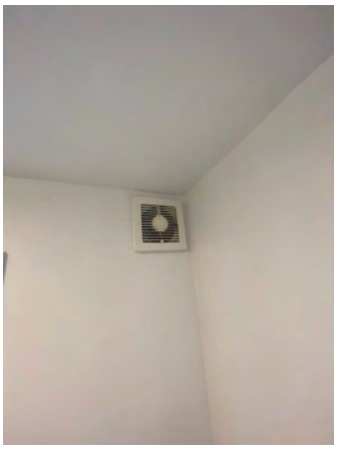
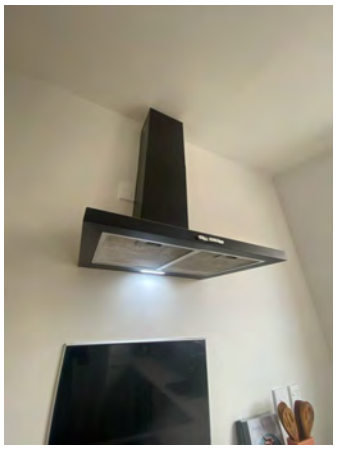
Flat 1

Powered on and appears to be operating fine. From what can be physically sighted, the extractors appear to be ducted externally.

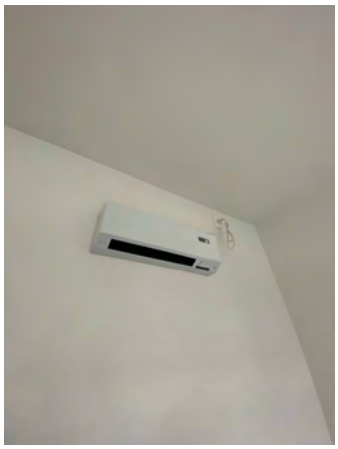
Flat 1 Functions fine.

Flat 1 Did not function at the time of inspection.
