Building inspection report

81 Blighs Rd Strowan Christchurch 8052 New Zealand

Building Report

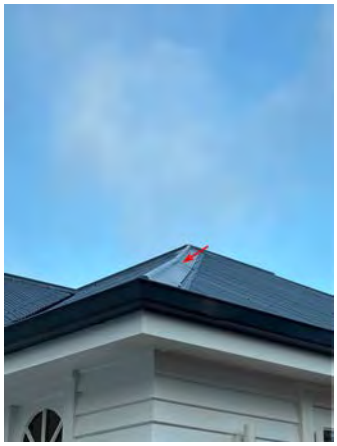
Looks to be sealing and functioning as intended. Free from debris build up.

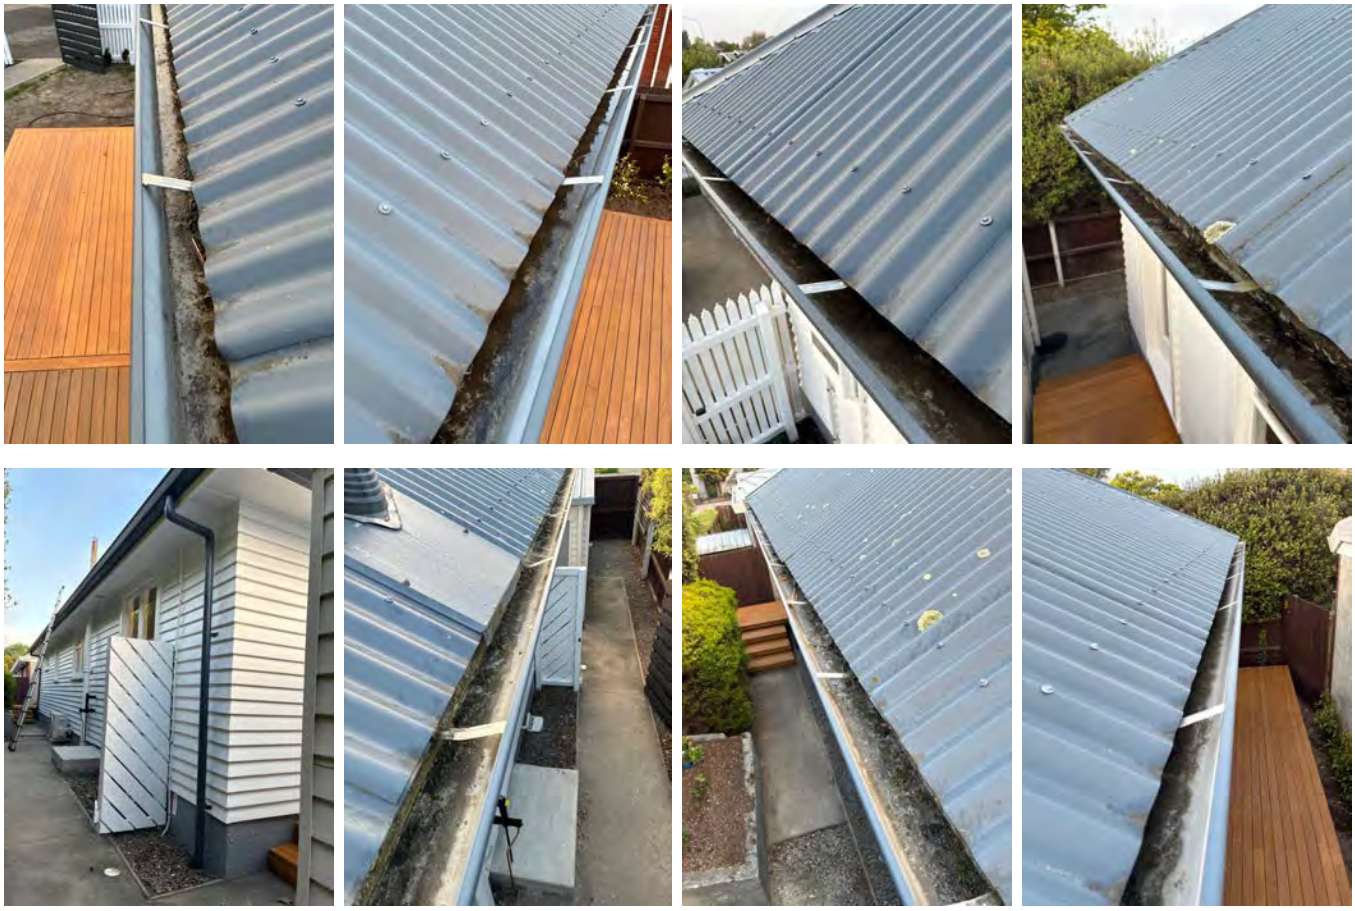
Downpipes and gutters fixed well in place and not loose. Downpipes on the main dwelling discharge into ground risers. Gutters and downpipes clear from debris build up.

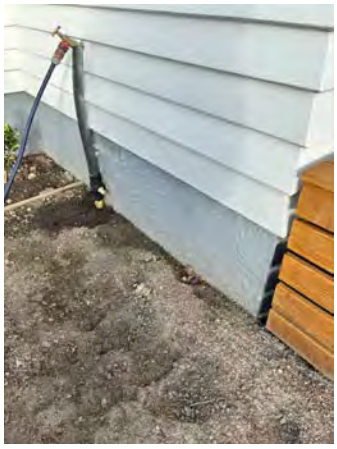
Vents installed to help airflow and keep subfloor dry. The exterior of the concrete ring foundation has typical cracking visible next to some of the vents. Epoxy crack injection can be completed for general ongoing maintenance.

Example of cracking.

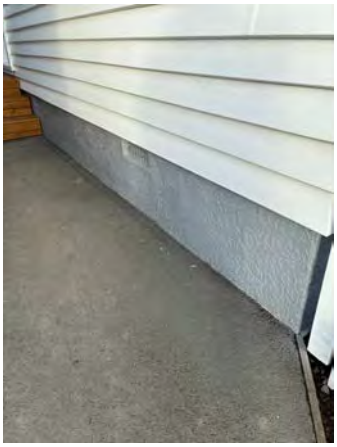
Example of cracking.

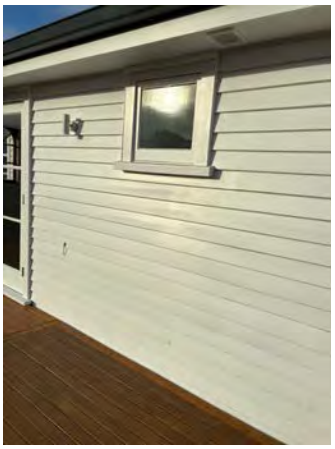
The timber weatherboard cladding system has been well maintained and appears to have been recently repainted. There is no obvious or significant timber rot noted at the time of inspection. The boards appear to be fixed back well.

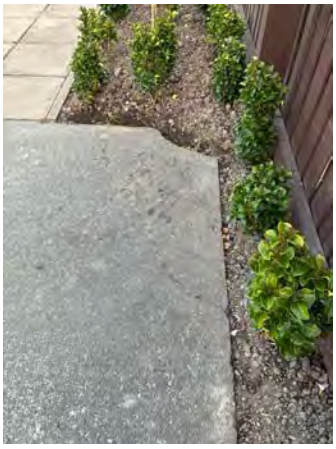
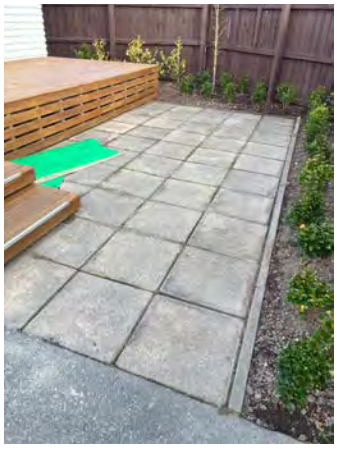
Expansion gaps cut to help prevent cracking to hardscaping. Some typical cracking and settlement was noted to the hardscaping in areas; however, nothing significant was noted. Maintained well with regular cleaning.

The timber decks don’t have any obvious concerns noted at the time of inspection. The decks appear to have been recently stained.

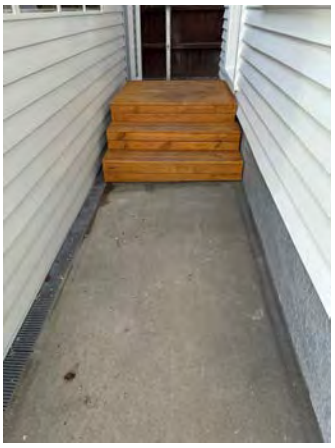
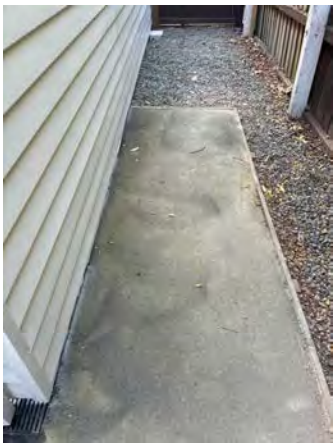
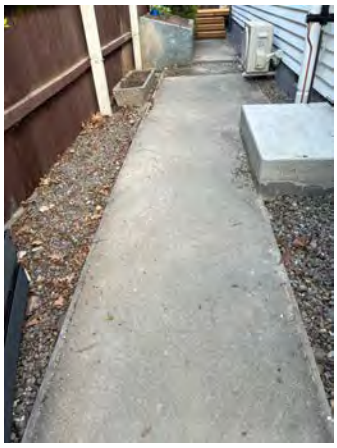
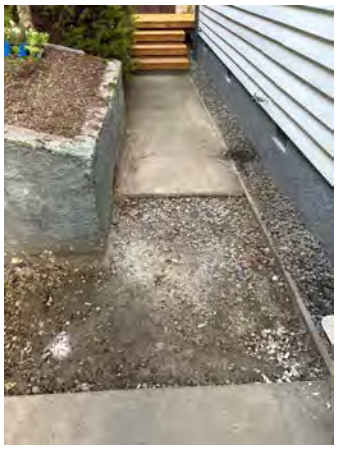
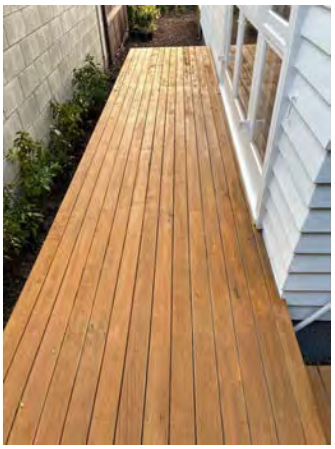
One part of the driveway appears to have been recently replaced. There are typical defects to the other areas but nothing unexpected or concerning.

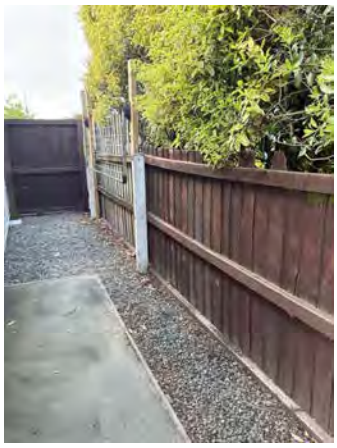
The gates are working fine. Some of the fences have been repainted while other areas require minor maintenance but nothing unexpected or concerning.

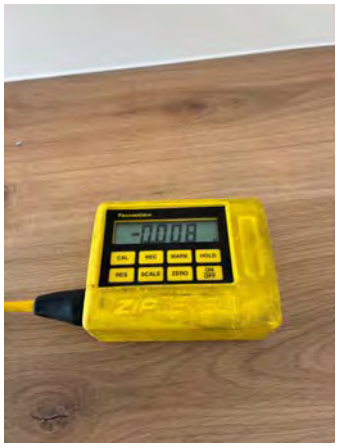
2mm step down from carpet to laminate flooring.

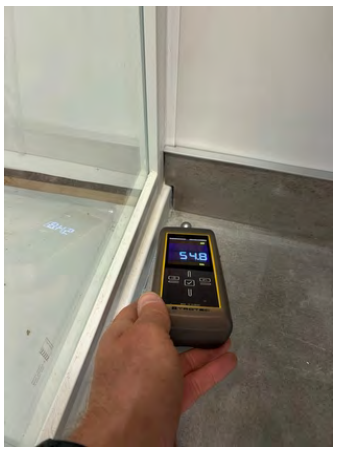
Shower.

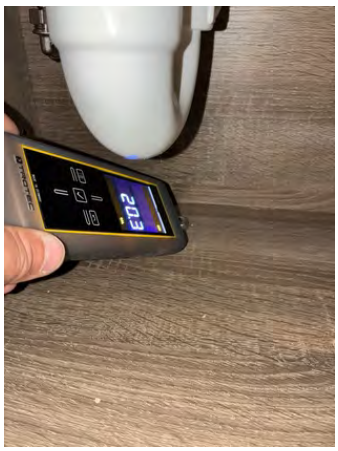
Vanity.

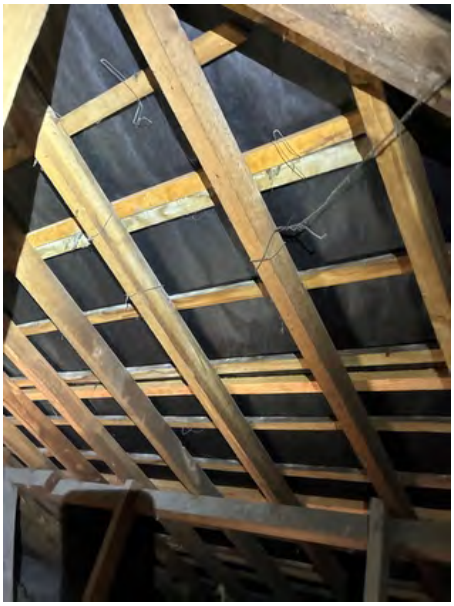
Extra timber supports have been installed to help support the roof load.

A beam has been installed.

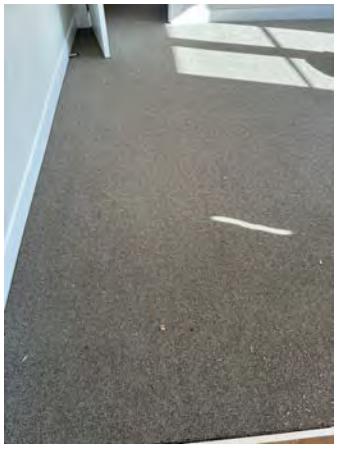
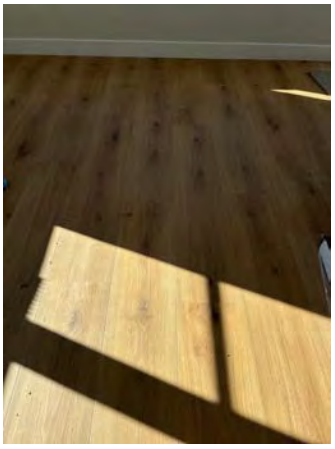
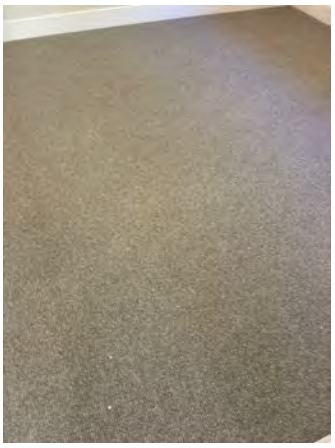
FLOORS

The floor coverings have been recently installed. There is no obvious damage visible at the time of inspection.

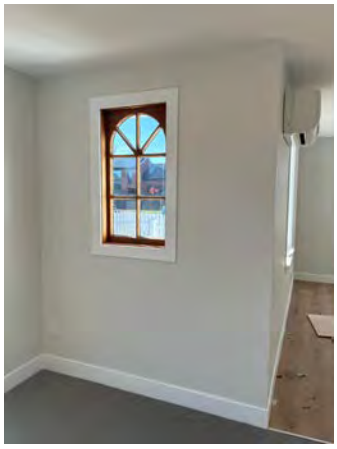
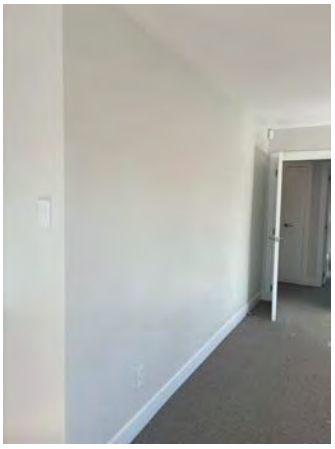
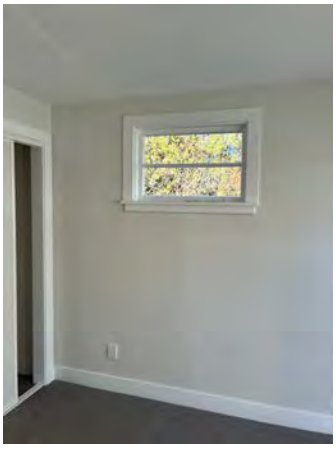
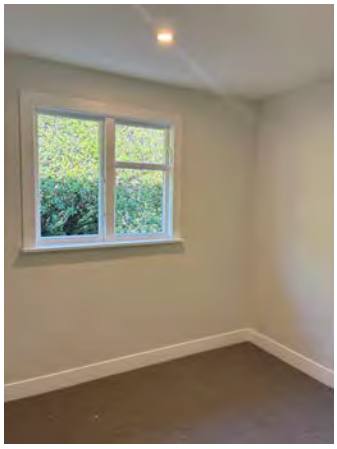
WALLS

Minimal marks or damage; nothing more than you would reasonably expect for its age. Looks to have been recently repainted. Some dark shadowing and marks have been noted in places; this is known as ‘ghosting’. Ghosting occurs when dirt and dust particles become attracted to cold spots on a surface, causing dark marks on the wall linings. Often, these can be cleaned off; however, sometimes, they stain the lining.

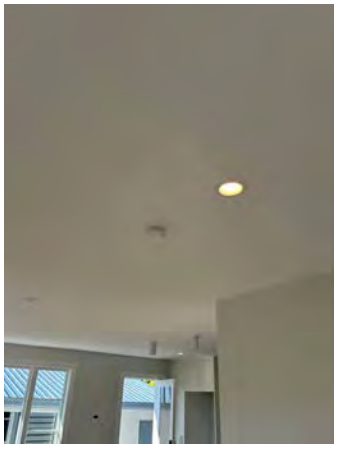
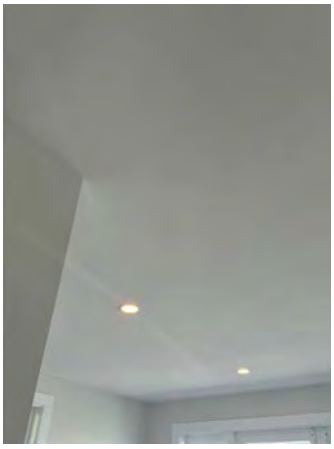
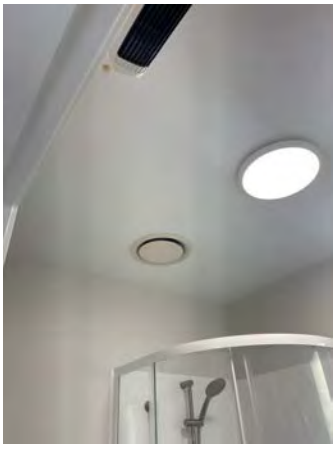
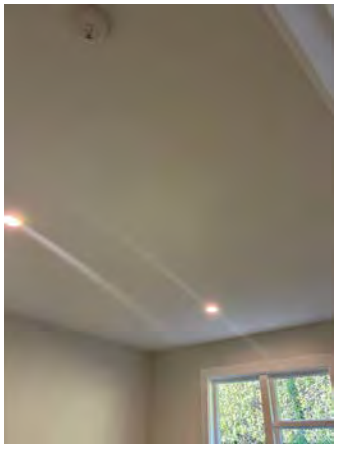
CEILINGS

No obvious cracks noted. No obvious signs of water damage. Some dark shadowing and marks have been noted in places; this is known as ‘ghosting’. Ghosting occurs when dirt and dust particles become attracted to cold spots on a surface, causing dark marks on the ceiling linings. Often, these can be cleaned off; however, sometimes, they stain the lining.

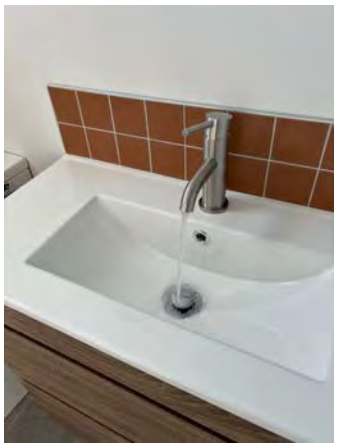
WASTE PIPING & WATER SUPPLY (UNDER SINKS)

Taps were turned on, and no leaks were observed from the waste piping. No leaks observed from water supply under sinks.
