# Property Info Pack

**226 Westminster  
Street, St Albans.**

# Pre Sale Building Report

## 226 Westminster Street, Mairehau

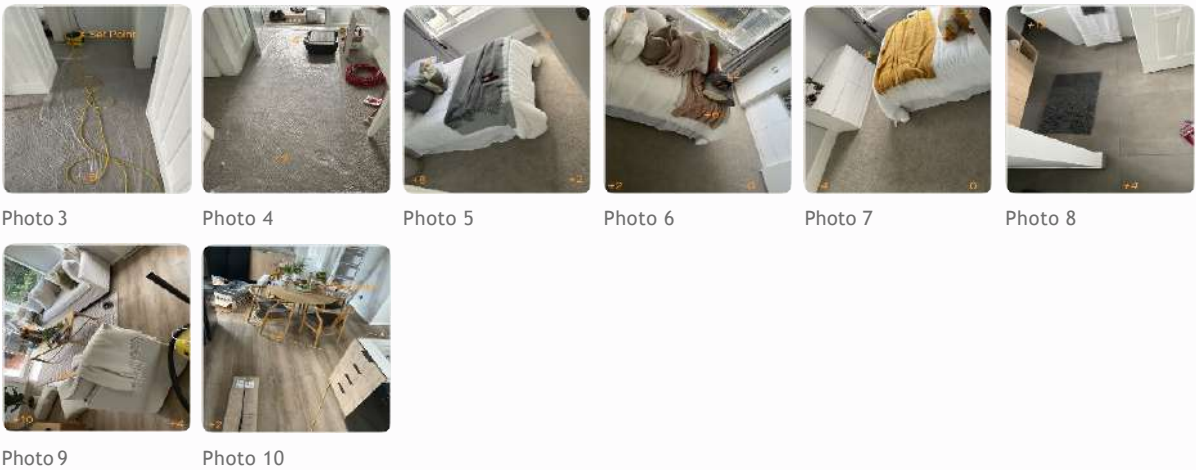
Floor level Media

| Are levels within the required MBIE guidelines over a short distance being 0.5% Or 10mm over 2meters? | Yes |

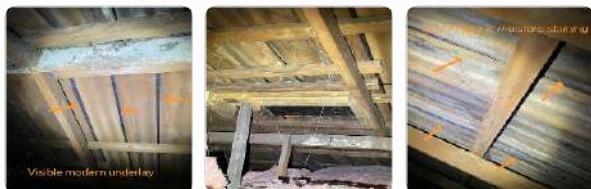
Minor historic moisture staining noted to original timber Sarking.

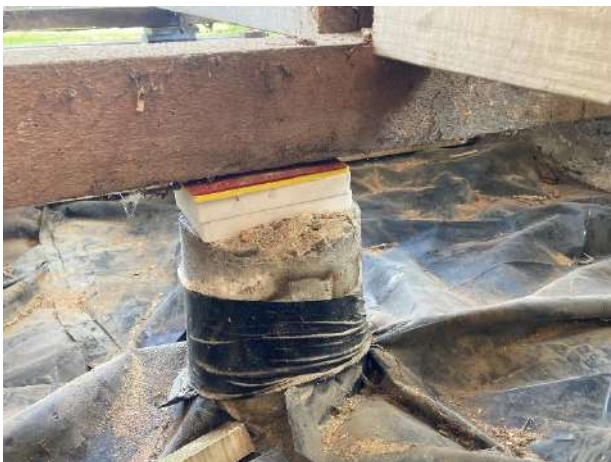
*Figure 3 – Packers must be restrained and connected to bearer/piles to prevent slipping.*

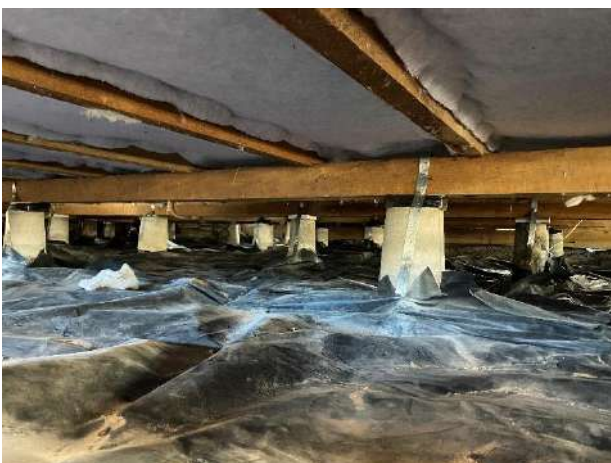
*Figure 4 – New subfloor fixings in place, Packers are restrained*

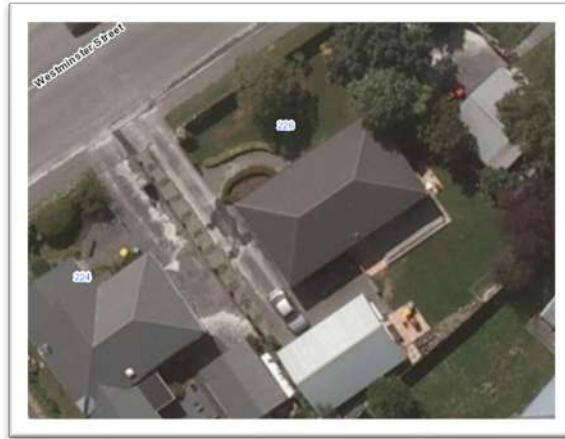
- 2.3 There was liquefaction ejecta both on the property and in the surrounding areas following the February 2011 earthquake event.

*Figure 1 - Aerial images immediately after the February 2011 earthquake event*

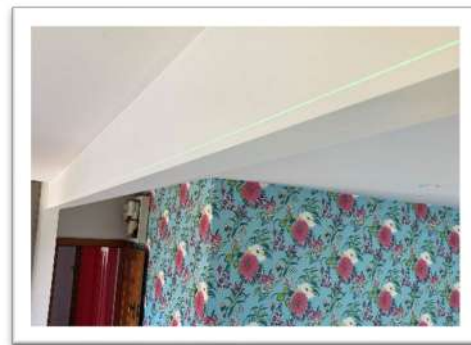
- 3.7 At some time in the past, a wall between the kitchen and dining/living rooms has been removed in order to create a more open plan living space. A beam has been installed to replace the support provided by the original wall. This beam drops approximately 24mm down towards the east, although the ceiling is relatively level along the length of the room.

*Figure 3 - Image of the beam*

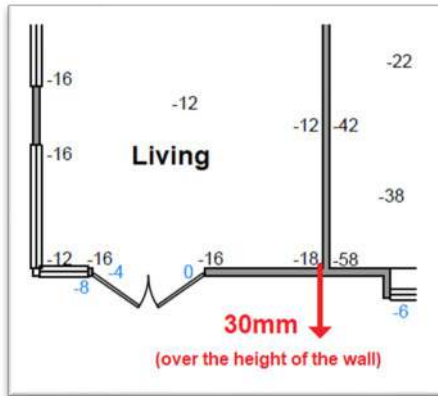
- 3.8 The walls in the east-west direction are all generally leaning towards the north. The extent of the leans vary, although the most significant lean we measured was approximately 30mm.

Figure 4 - Location of one of the more significantly leaning walls

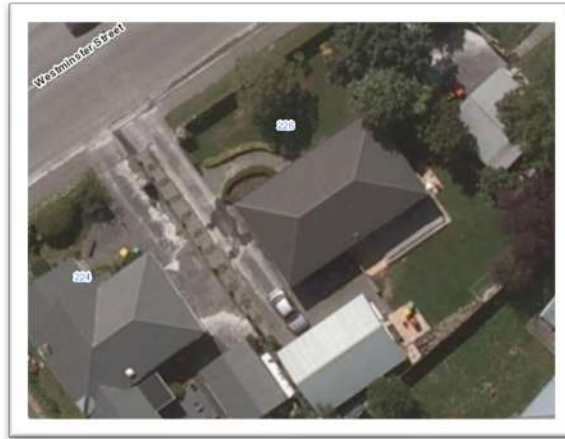
- 2.3 There was liquefaction ejecta both on the property and in the surrounding areas following the February 2011 earthquake event.

*Figure 1 - Aerial images immediately after the February 2011 earthquake event*

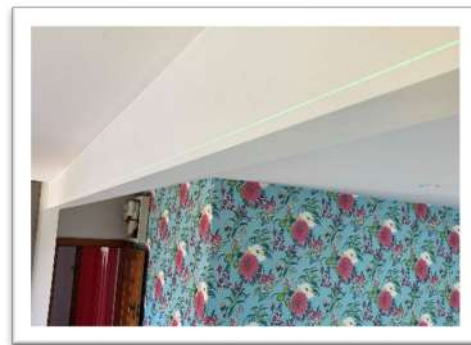
*Figure 3 - Image of the beam*
