**Information request – CLM/2011/100661 - 6 Freebairn Street, Redwood, Christchurch 8051.**

**Date Created:** 25/08/2011 16:21  
**Created :** Miller, Doug  
**Subject:** Assessment  
**Note:** 1967 one level dwelling, 3 bedrooms, brick veneer exterior cladding, decromastic tile roof, on concrete piles and ring foundation. Lounge extension and garage - concrete slab foundation. Moderate cracking to brick veneer and ring foundation, exterior chimney to be removed to ceiling and reinstated. Minor cracking in garage concrete slab. Cosmetic cracking to walls and ceilings throughout interior rooms.  
 No liquefaction. 100% free space sub floor, 600mm Habitable and weatherproof

<b>Address</b>	6 FREEBAIRN STREET, REDWOOD, CHRISTCHURCH, 8051	<b>EQC Claim Number</b>	CLM/2011/100661
<b>Hazards</b>	Nil hazards	<b>EQC Assessor (L,F)</b>	Miller, Doug
<b>Inspection Date</b>	25-Aug-2011	<b>Placard</b>	No Sticker
		<b>EQC Estimator (L,F)</b>	Blaauw, John

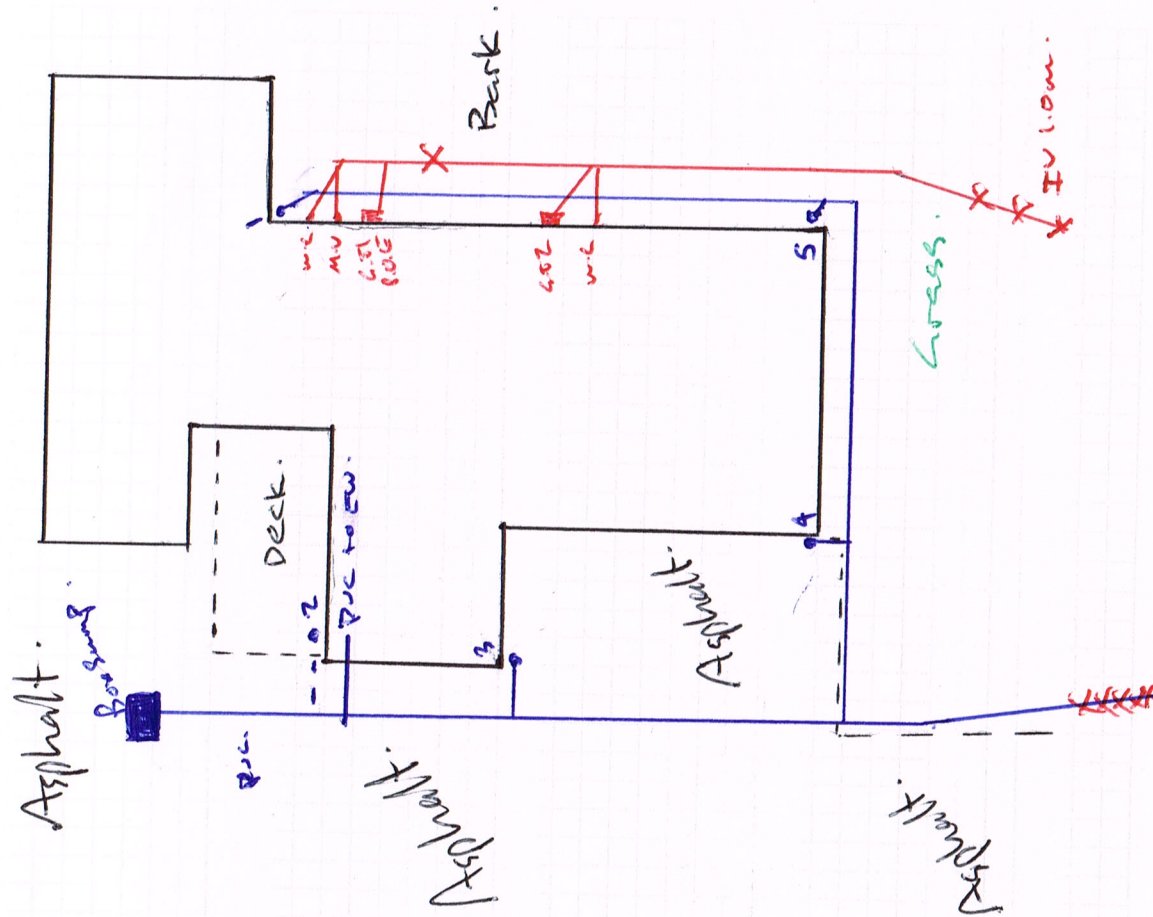
As Built (Damage) / Proposed Repair

As requested we attended the above address to survey the drainage  
 We have found earthquake damage  
 Our recommendations are  
 repair repair on sewer and the stormwater

repair 1m repair IV and 1 x 2 metre repair
