Information request - CLM/2011/105656 - 19 Philpotts Road, Mairehau, Christchurch 8052.

Dwelling Inspection Checklist: Show measurements indicate damage

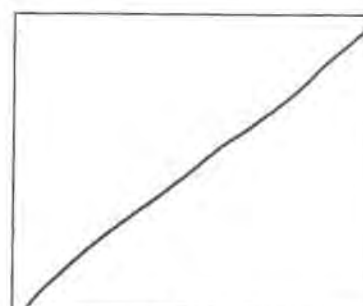
Foundation

CRACKS TO WEST & SOUTH CONCRETE RING.
3 @ 400mm x 2mm
FOUNDATION
400mm high.

| Element | Damage | Repair | |
|---|---|---|---|
| Ring foundation (Load bearing - Concrete - 47.00 l/m) | Cracks to ring foundation | Grind out and epoxy fill cracks | 6.00 l/m |
