Building and Timber Pest Inspection Report

Inspection Date: Thu, 3 Oct 2024

Property Address: 11 Patomar St, Kedron QLD 4031, Australia

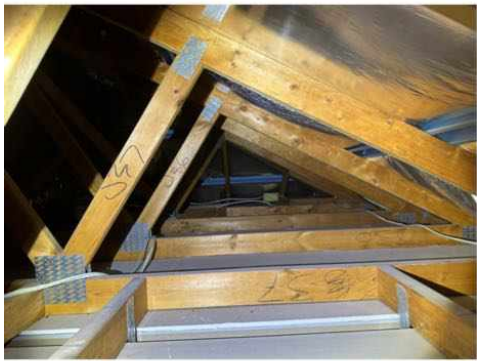
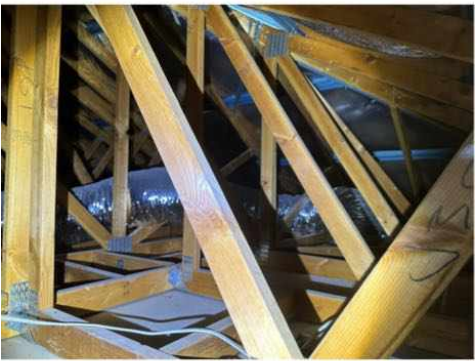
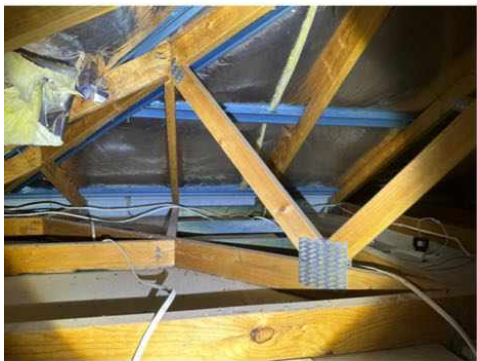
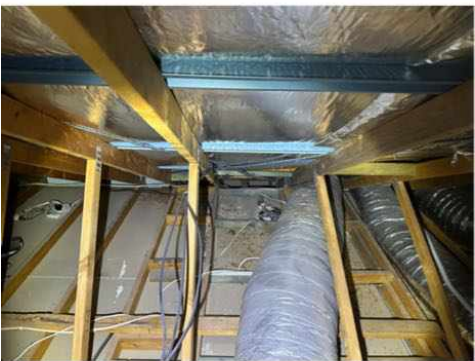
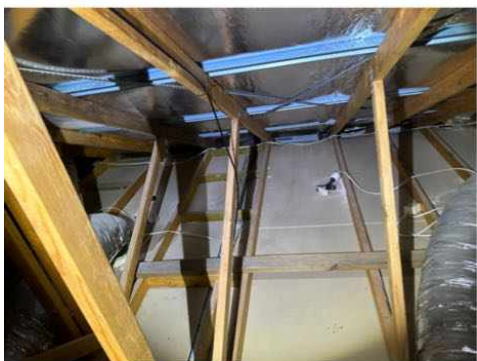
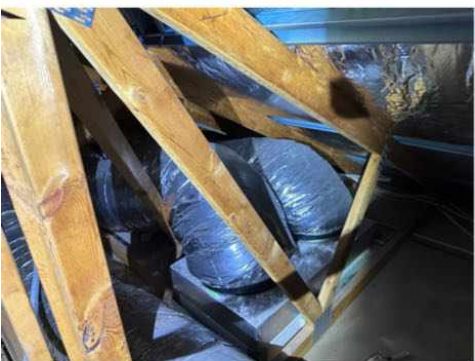
Building: Main Building
Location: Roof Void
Finding: Additional Photos
Information: Additional photos are provided for your general reference.

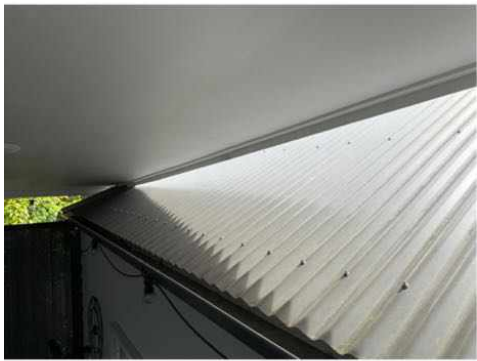
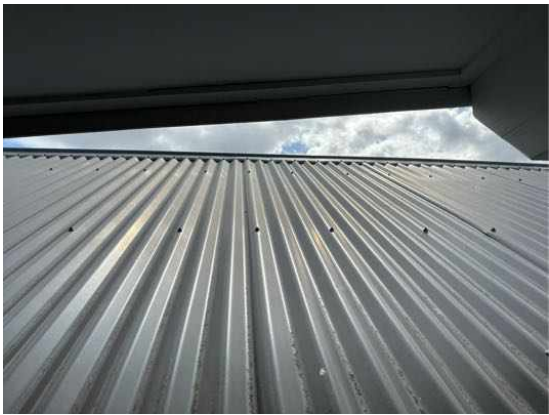
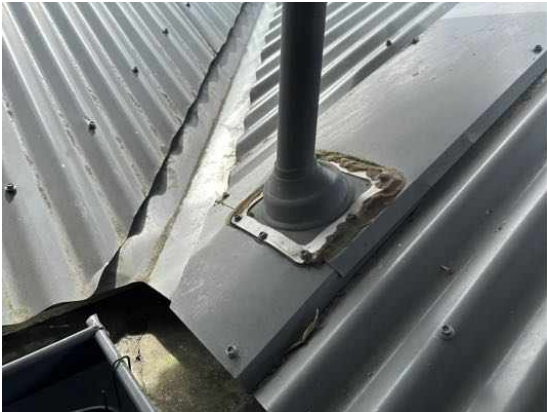
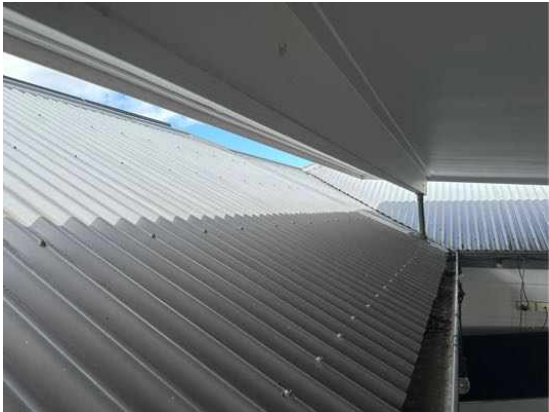
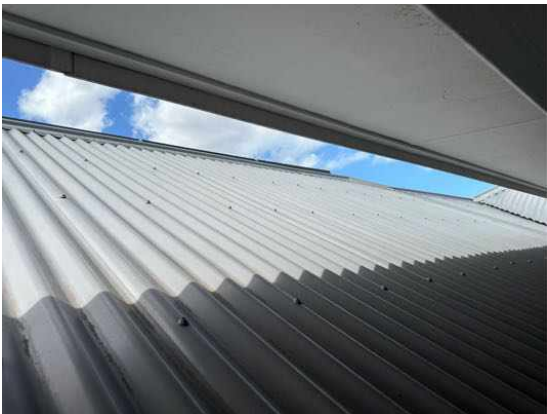
Building:	Main Building
Location:	Roof Exterior
Finding:	Additional Photos
Information:	Additional photos are provided for your general reference.

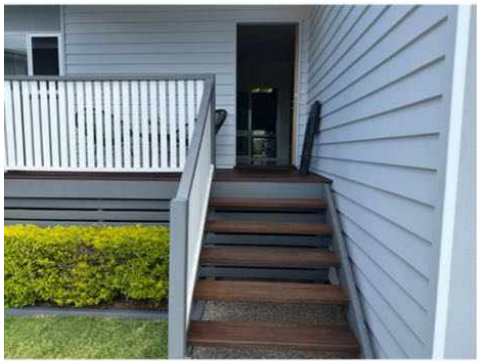
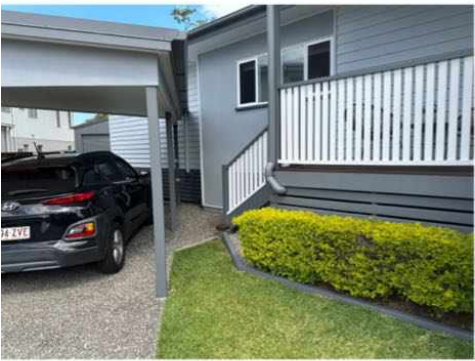
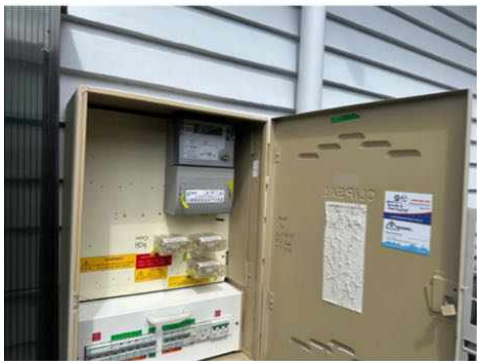
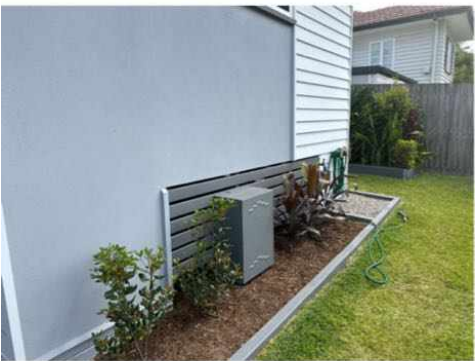
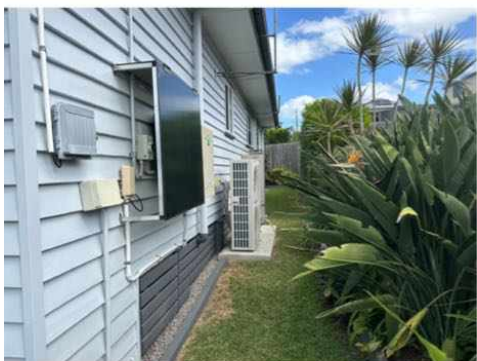
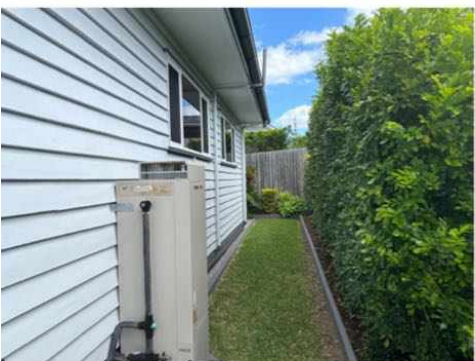
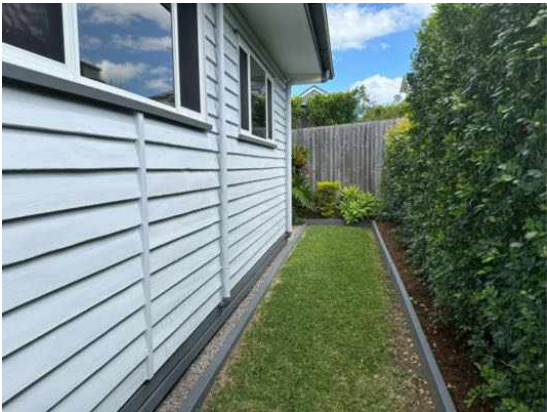
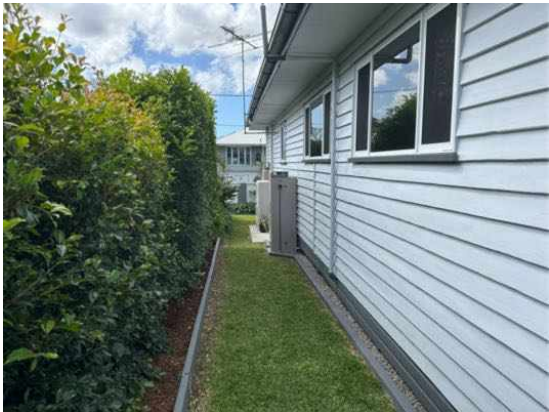
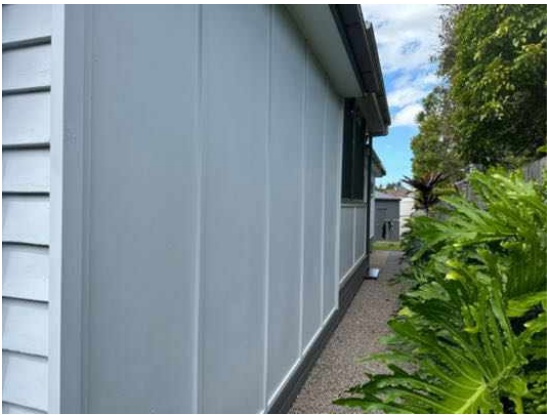
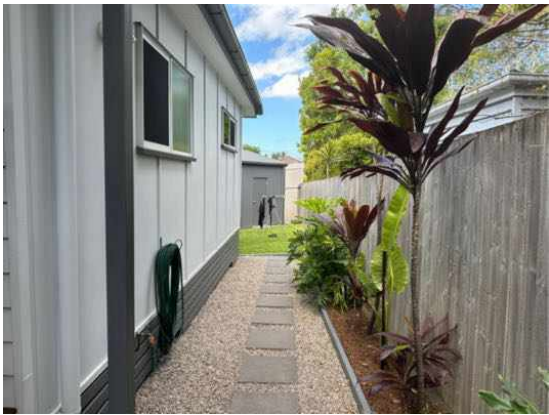
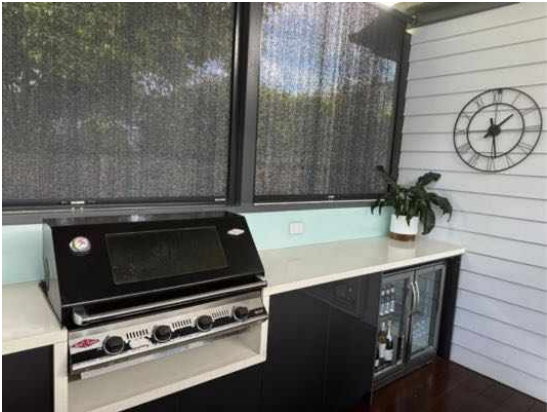
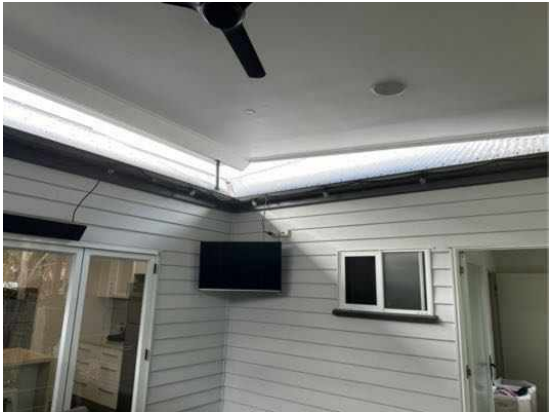
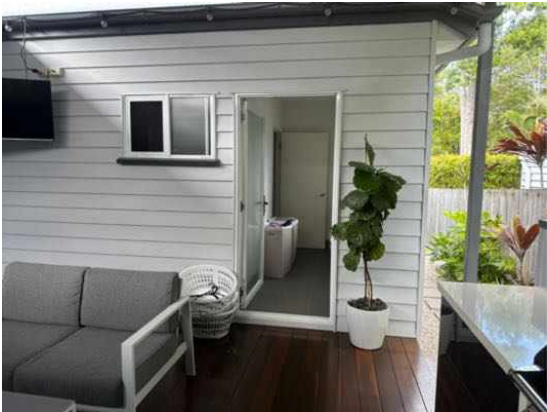
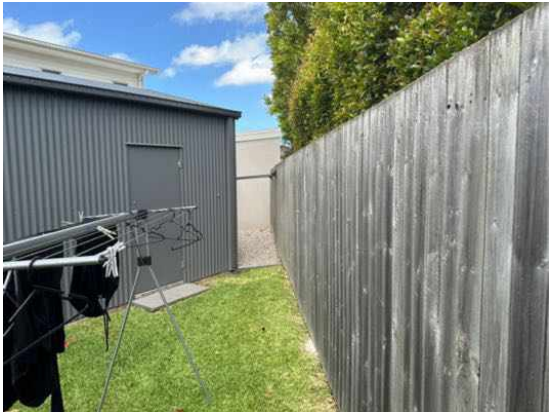
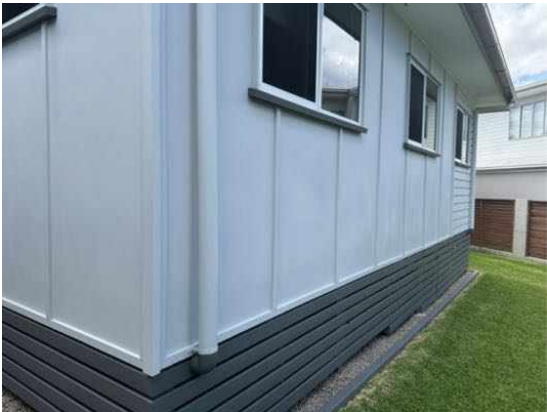
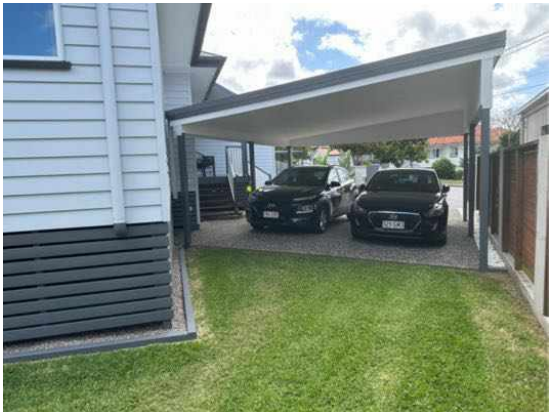
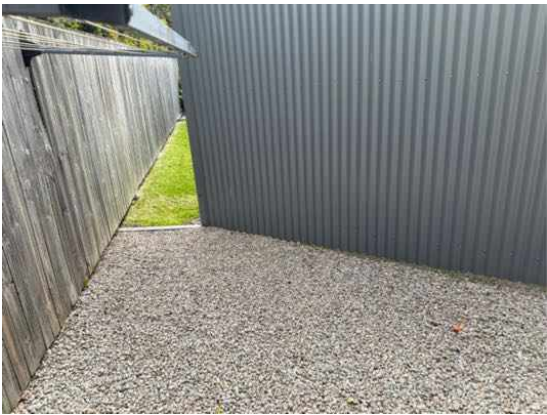
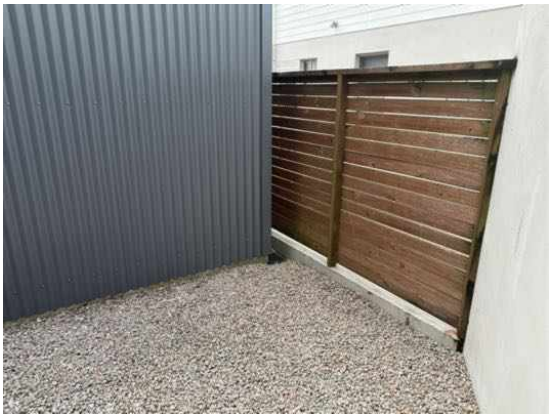
Building:	Main Building
Location:	All External Areas
Finding:	Additional Photos
Information:	Additional photos are provided for your general reference.

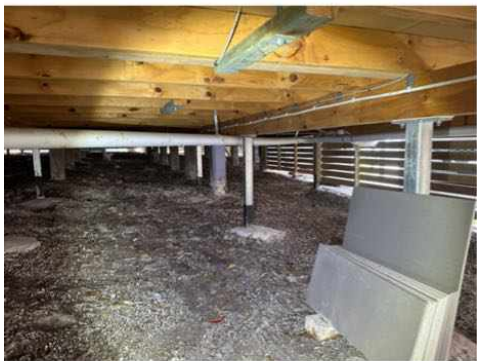
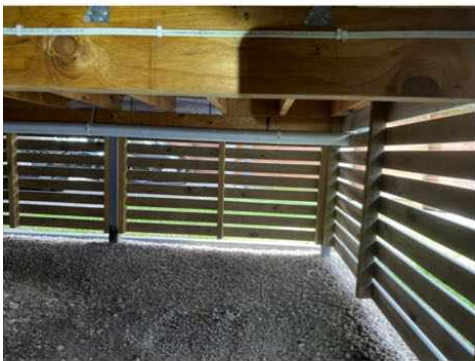
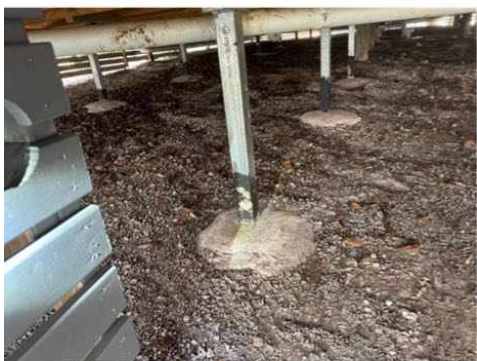
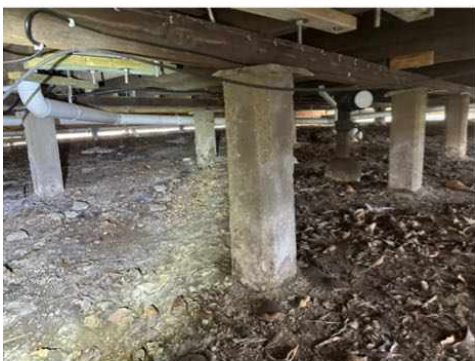
Building: Main Building
Location: Subfloor
Finding: Additional Photos
Information: Additional photos are provided for your general reference.
