Pre-Sale Property Inspection Report

**33 Monte Crescent
Lincoln**

Property report number: 3922.

Inspection date & time: 06th January-2025 at 10:00 am.

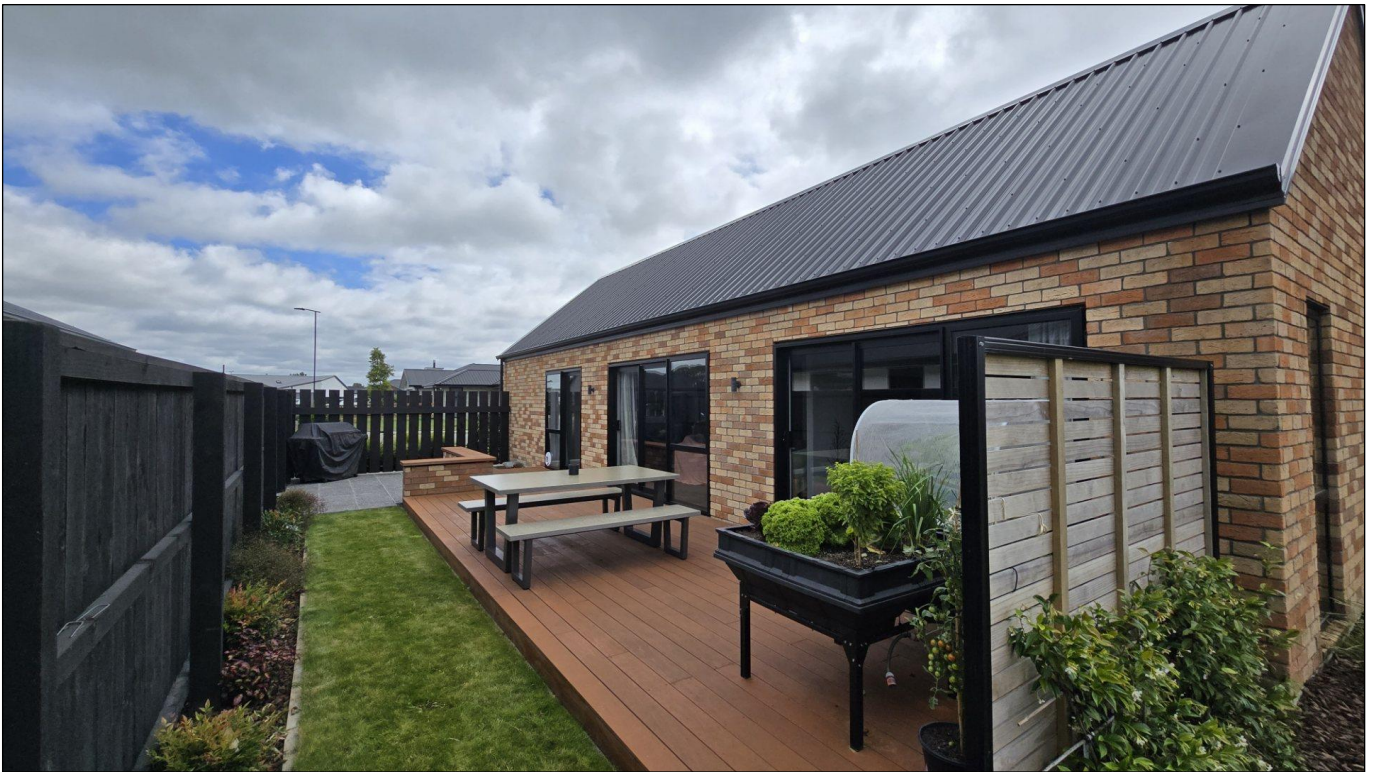
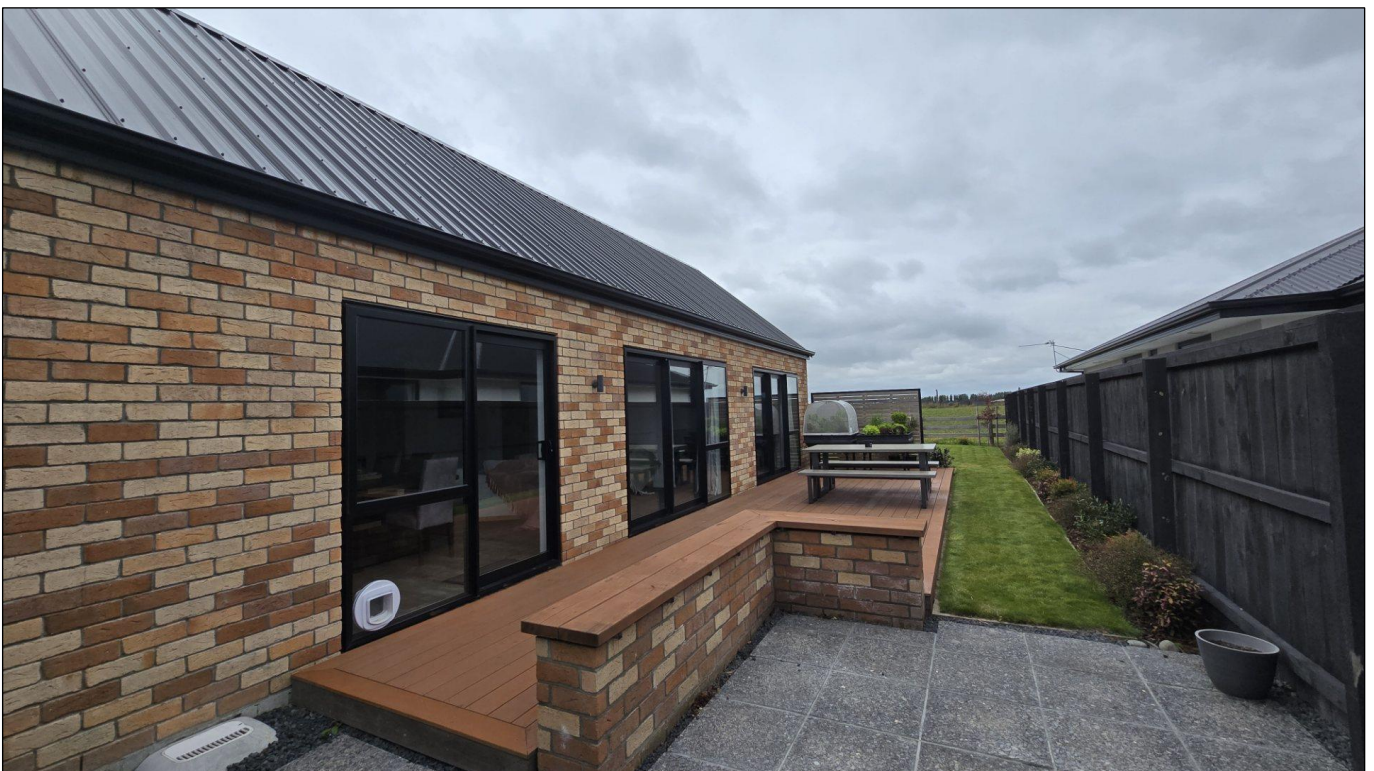
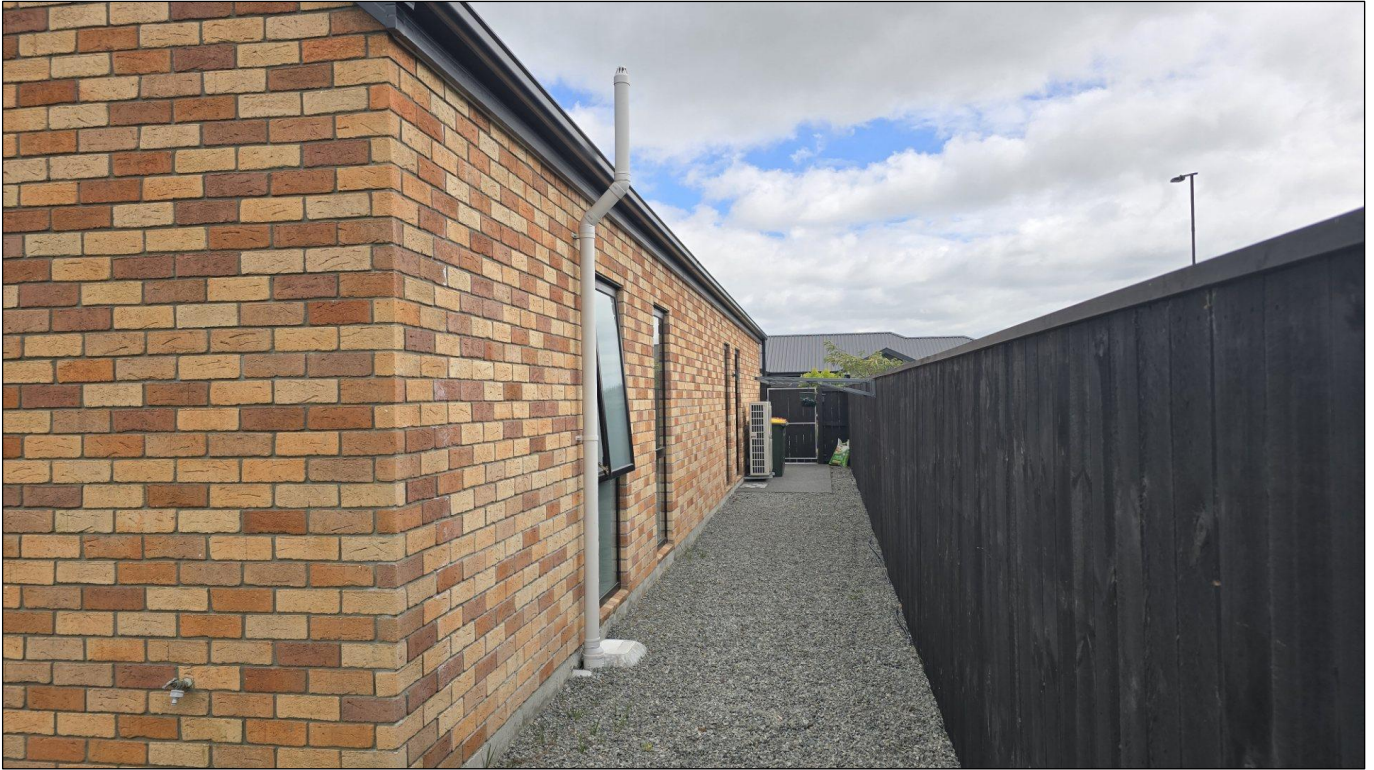
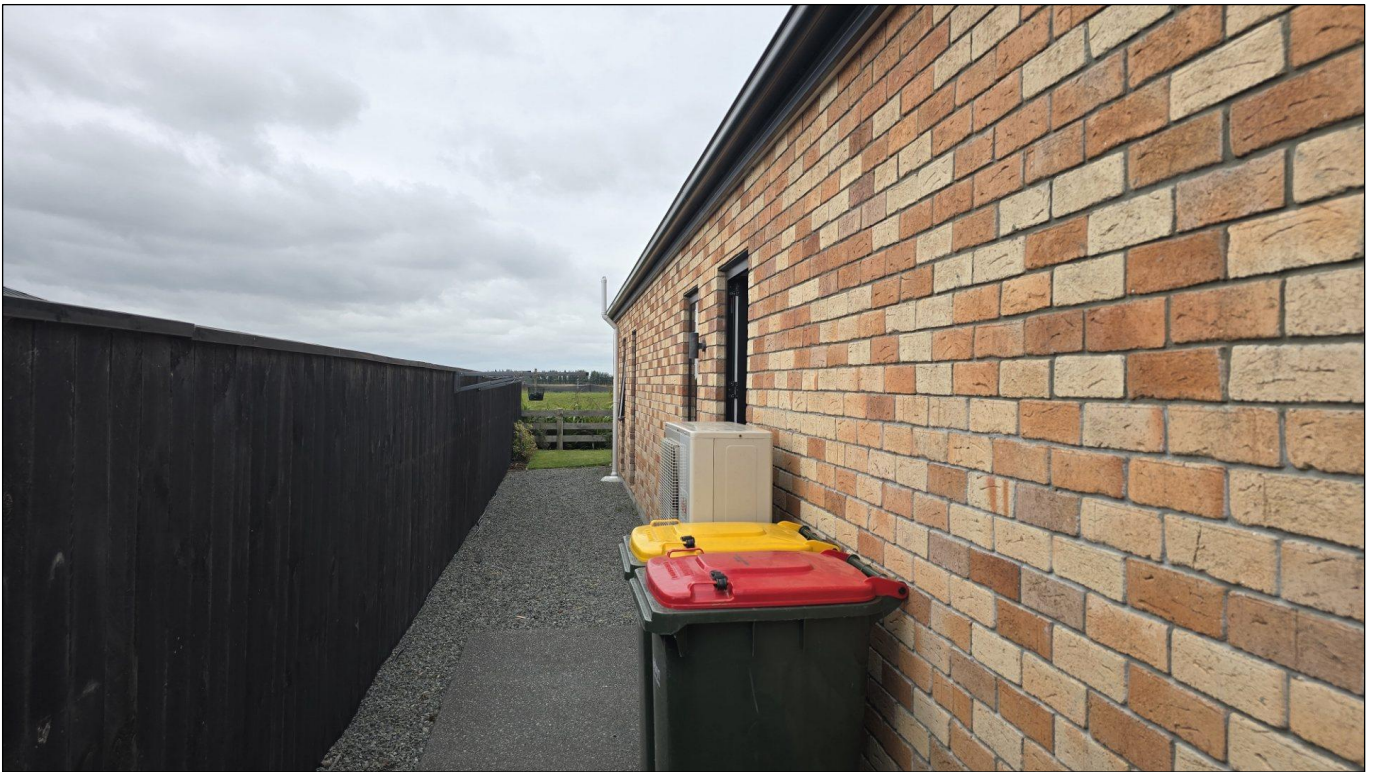
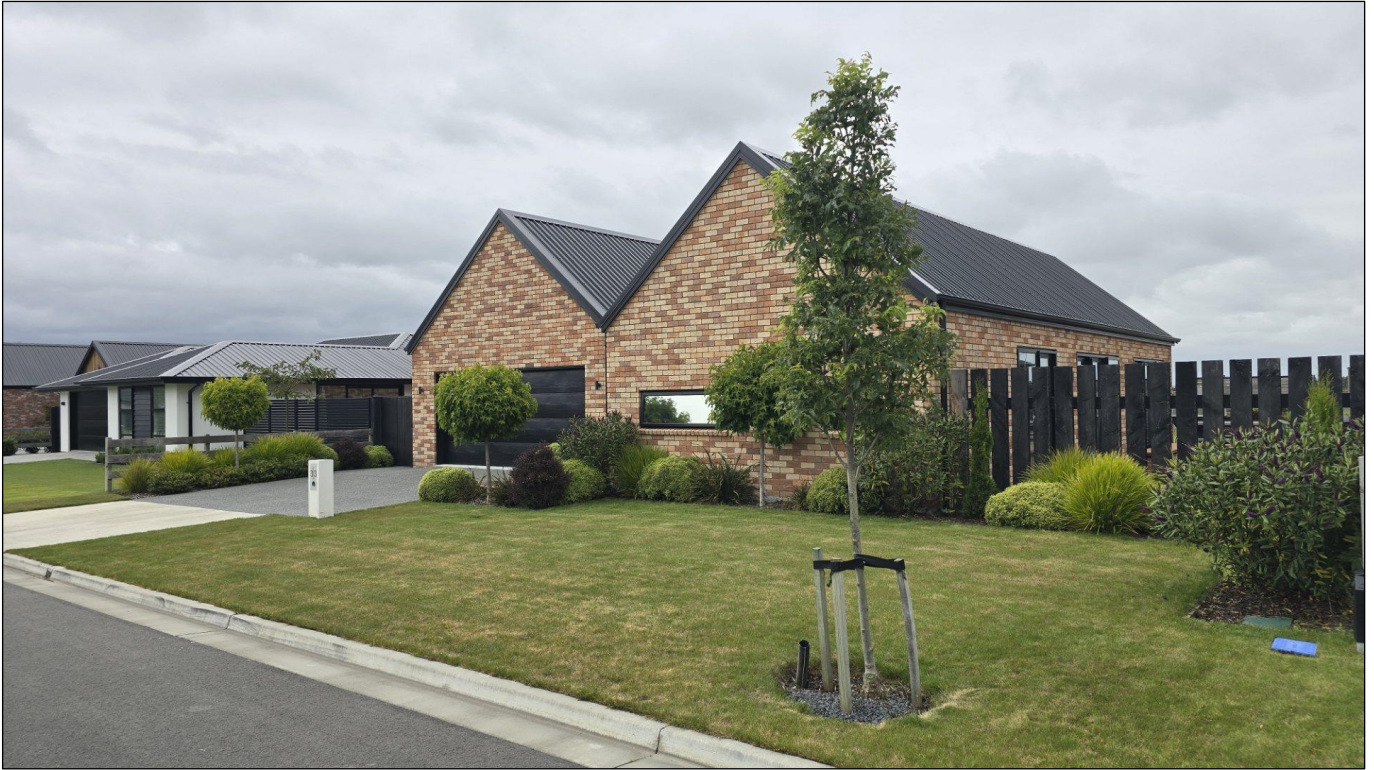
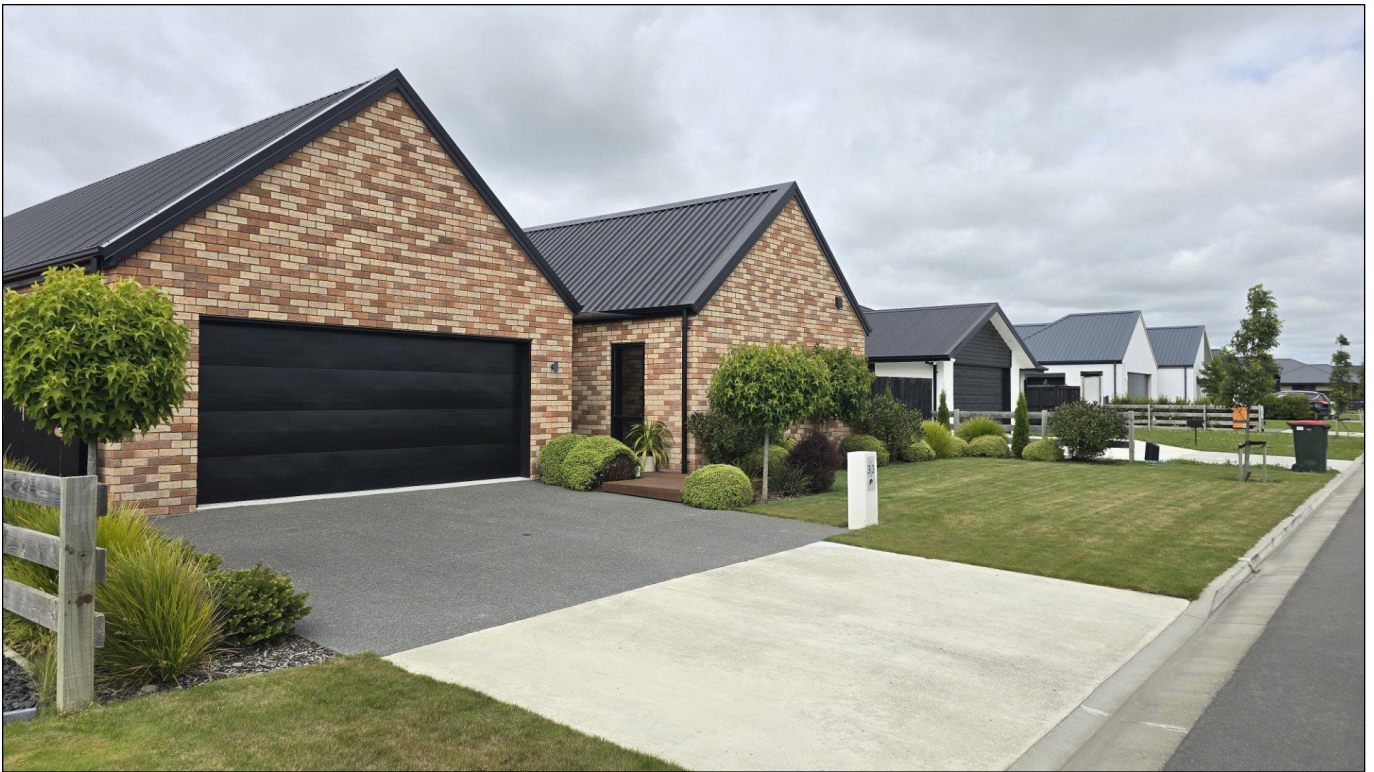
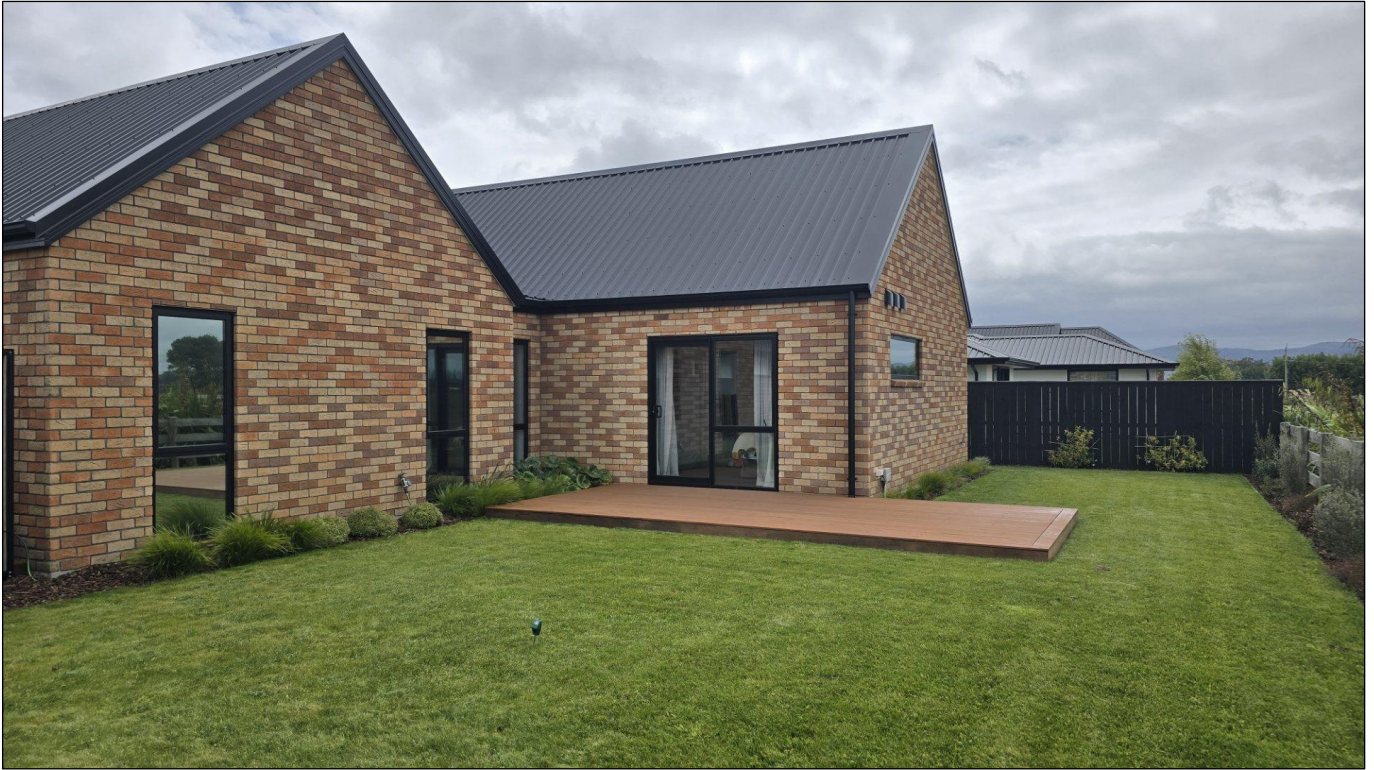
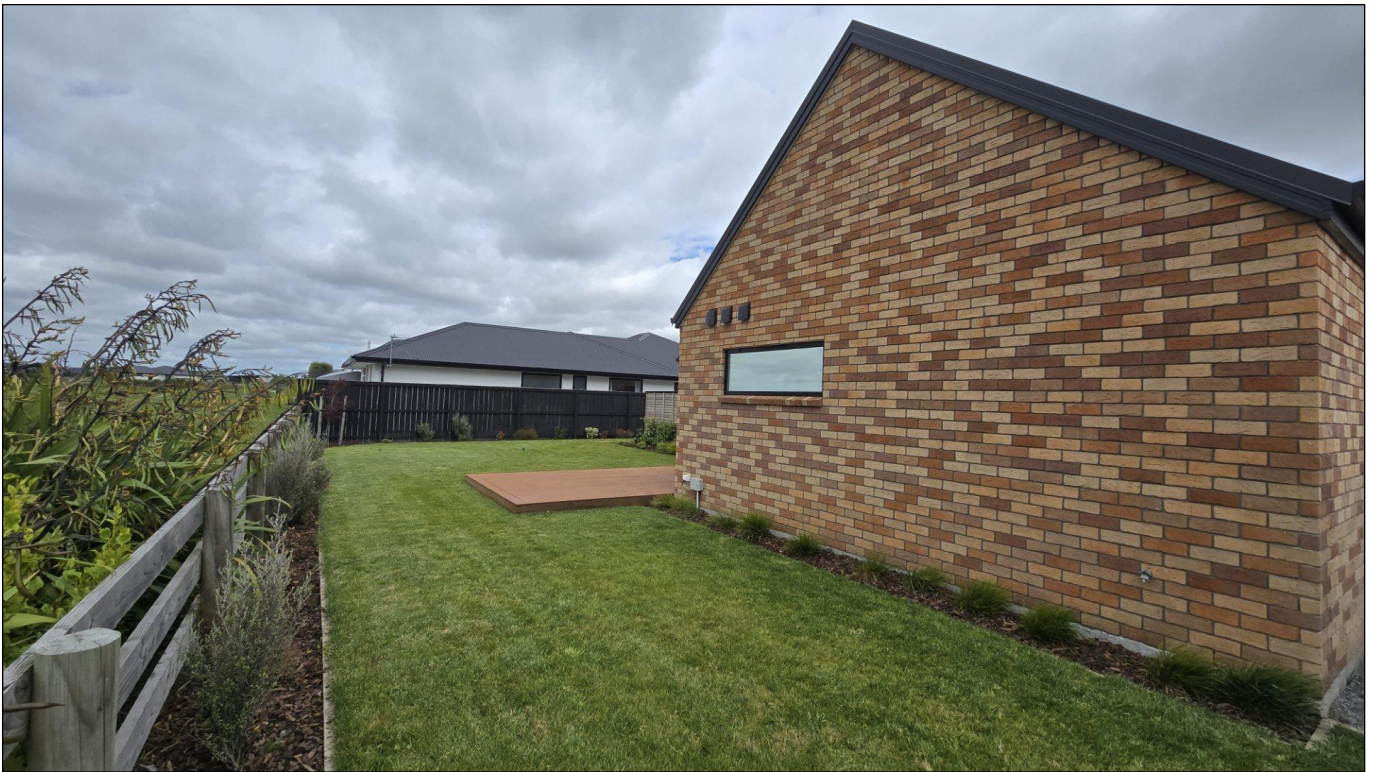
- Moss/lichen on the brick veneer in areas, moss/lichen treatment is advised to prevent deterioration to the brick mortar.
- Missing brick mortar, and minor cracking in the mortar, repairs by a brick layer are advised.

We recommend you seek the services of a home maintenance person or an LBP / Qualified contractor to repair or replace as required.

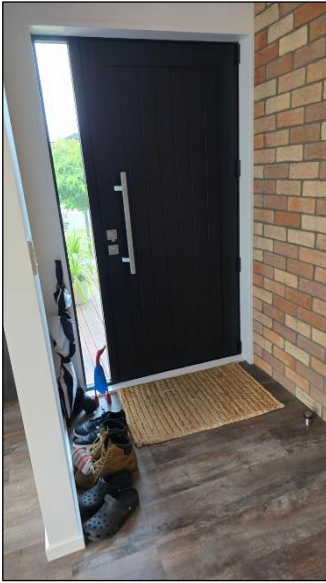
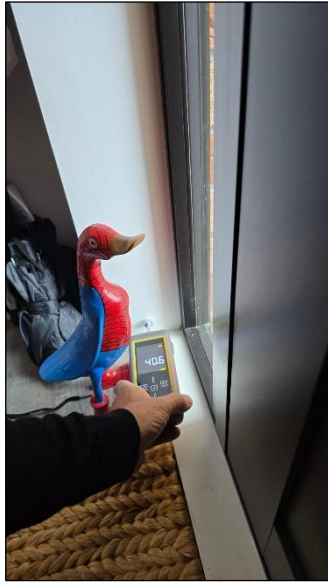
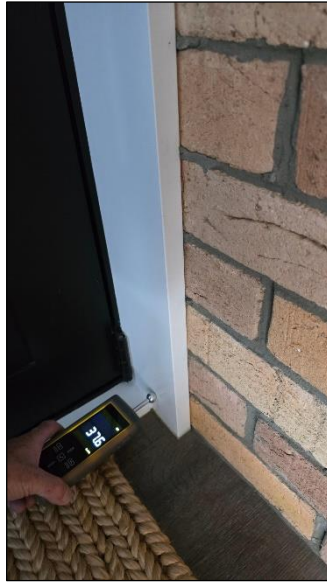
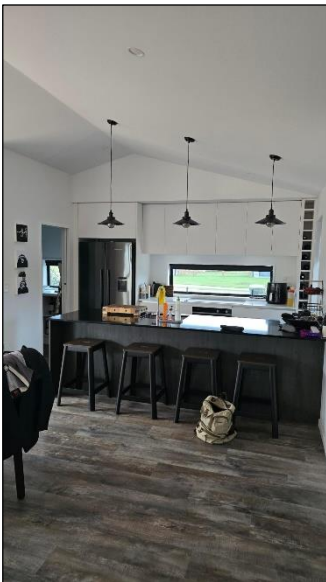
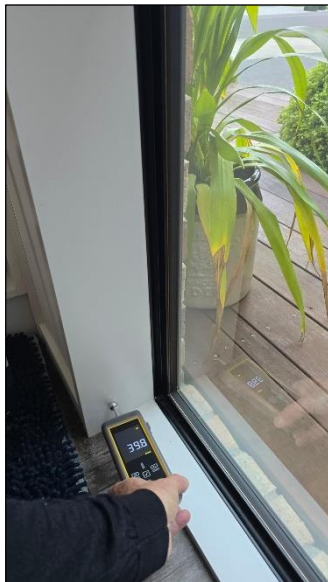
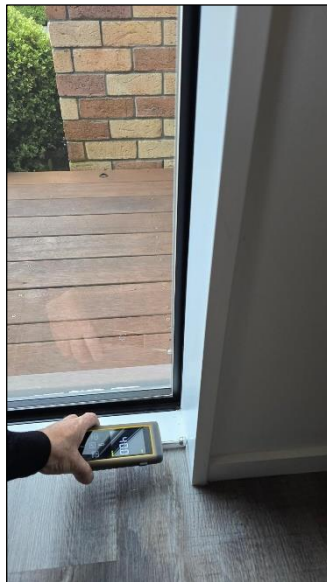
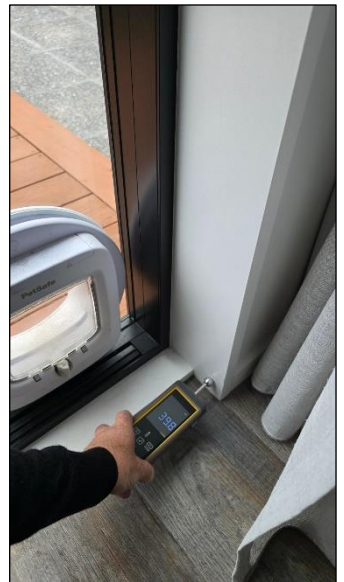
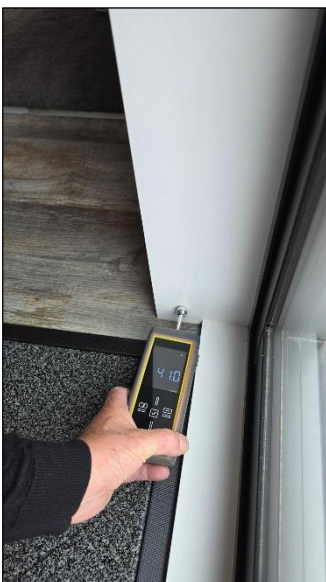
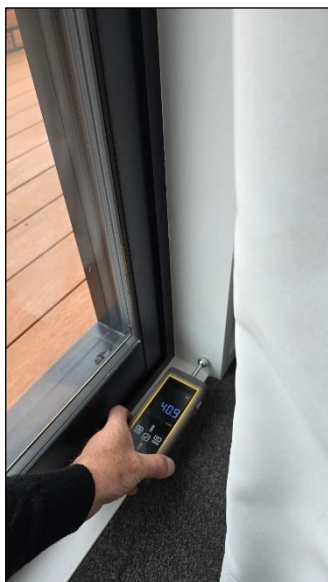
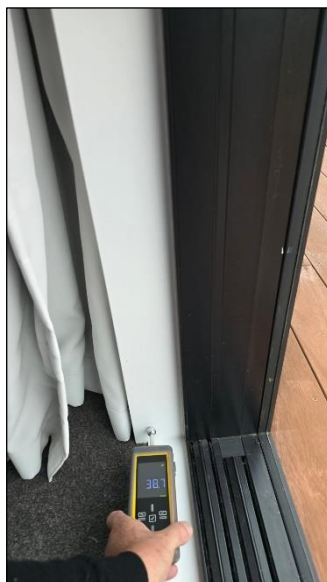
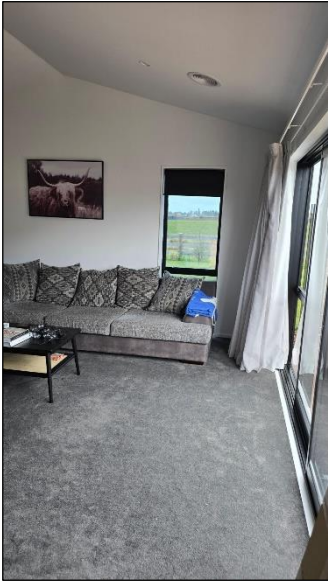
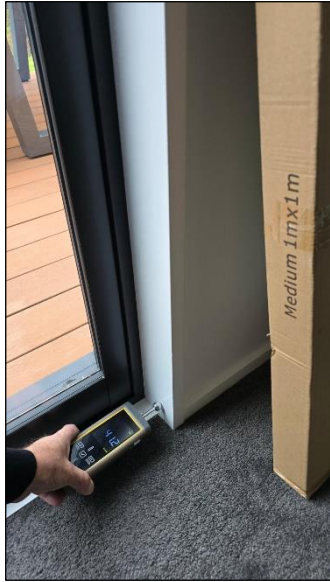
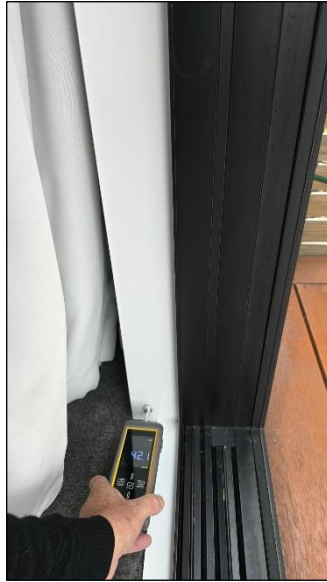
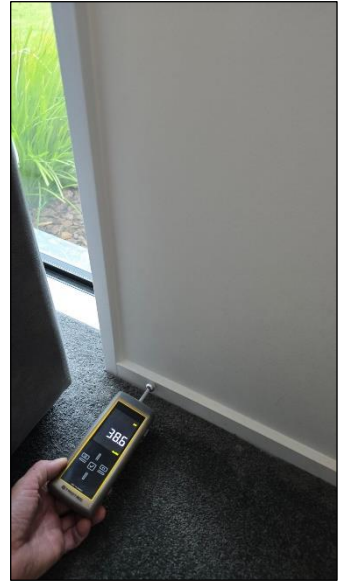
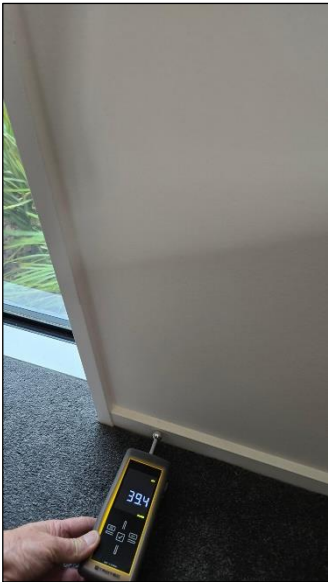
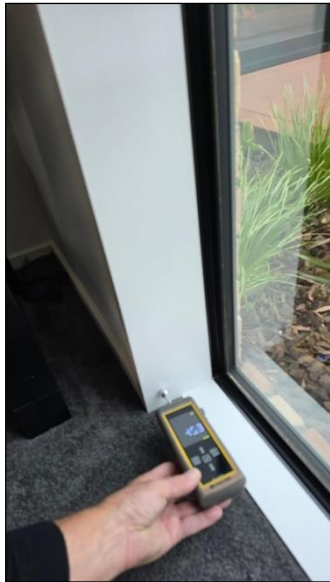
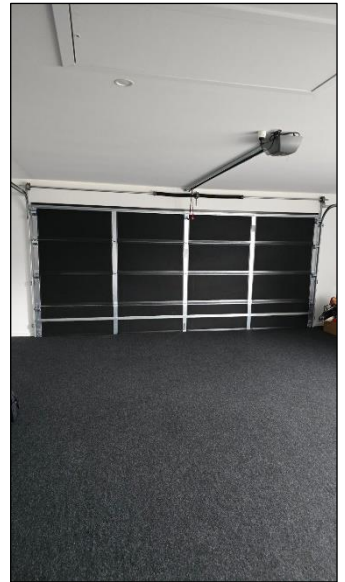
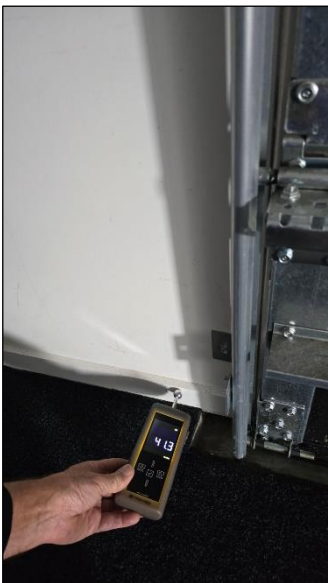
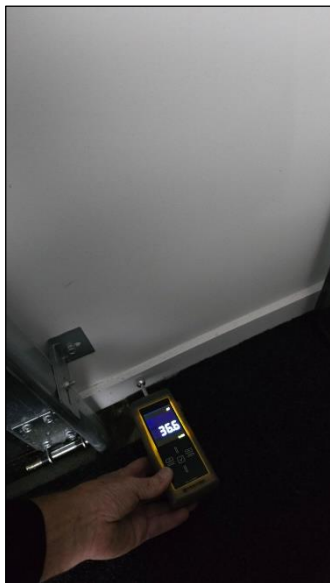
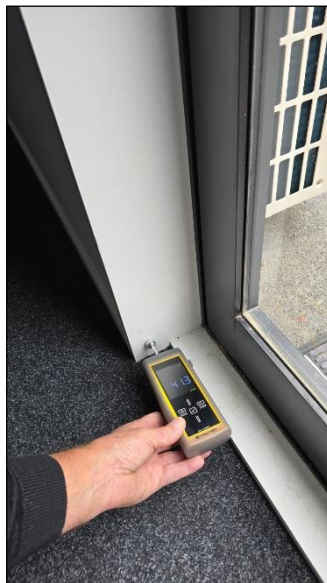
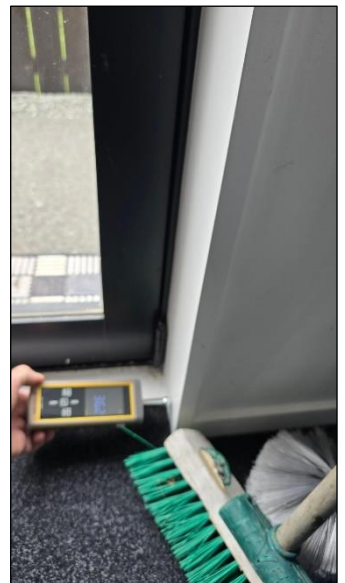
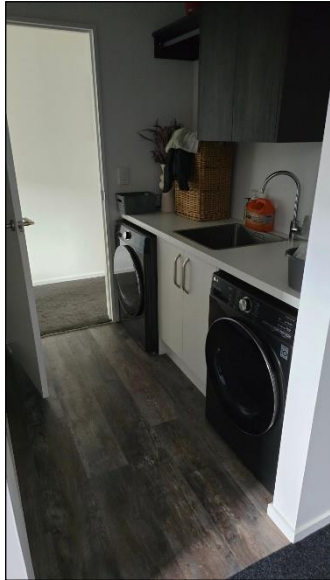
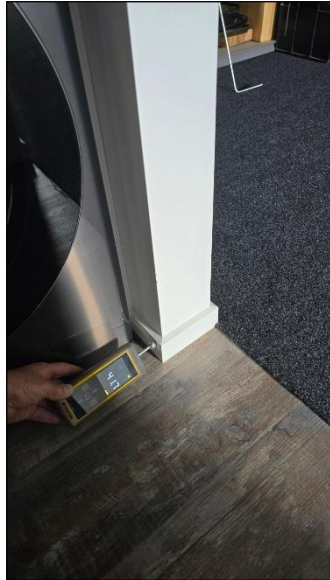
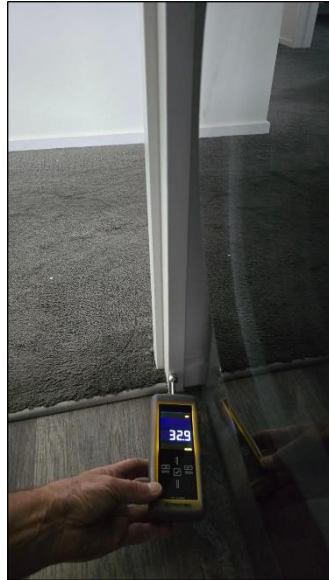
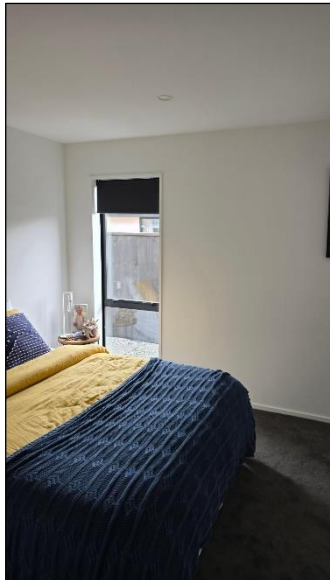
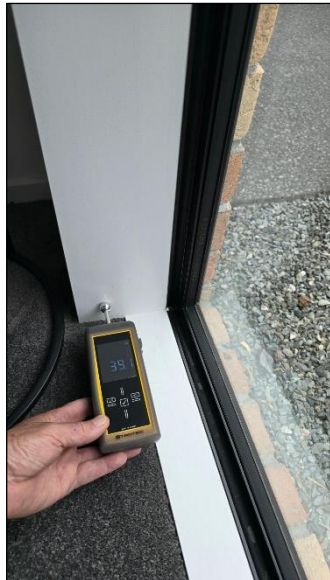
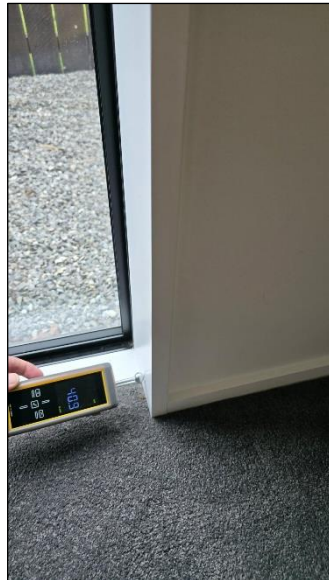
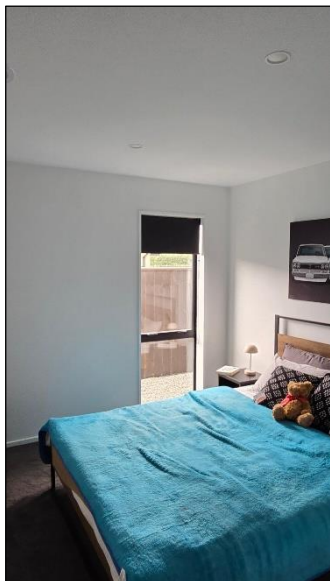
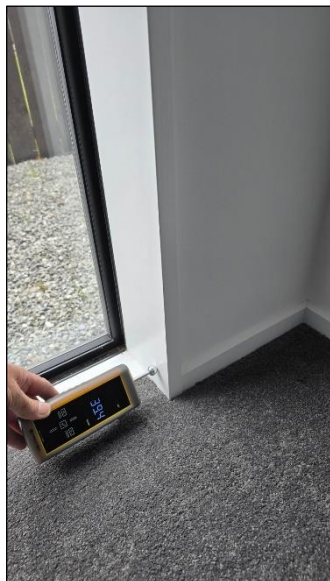
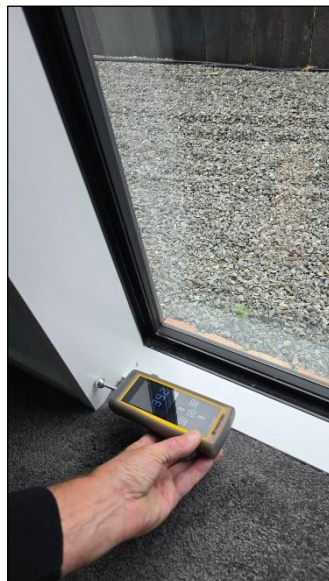
Moisture Test Photos

Non-invasive moisture readings were in the DRY range.
