EARTHQUAKE RECOVERY (EQR) DOCUMENTATION

EQR Property Overview Report

EQC Property ID	Property Address	Vulnerable?	Property F Status	Property Finalisation Indicator		
2010013897	1/126 HALSWELL JUNCTION ROAD, HALSWELL		F3 - Complete & Finalised	Some Finalisation has taken place		
Main Contractor:	CLOSED OUT-Interproducts Limited t/a Frame Contracting ***** (S049)		Property F2'd By:	Blair Jones	F2 Completed Date:	29-03-2016
Cont Managing Hub:	<MULTIPLE>	Not Vulnerable	Property F3'd By:	Blair Jones	F3 Completed Date:	29-03-2016

1/126 Halswell Junction Road

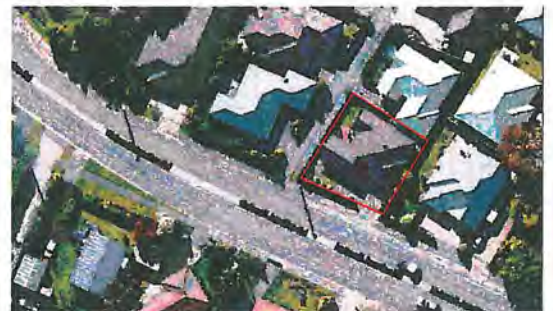
LEVEL SURVEY PLAN
SCALE 1:100 @ A4

Cracking in the floor slab along the construction joints has been observed where the joints have opened by a maximum of 20mm in some areas. Refer to sketch SK02 for locations of separation in floor slab along construction joints and widths of joint openings. The concrete slab does not appear to have settled differentially across the cracks. A 2mm crack in the concrete floor slab has also been observed and indicated on sketch SK02. There is one crack in the perimeter foundation on the North-western corner.

mm Crack in SLAB.

Crack in MASONRY.

Crack in PERIMETER
FOUNDATION.

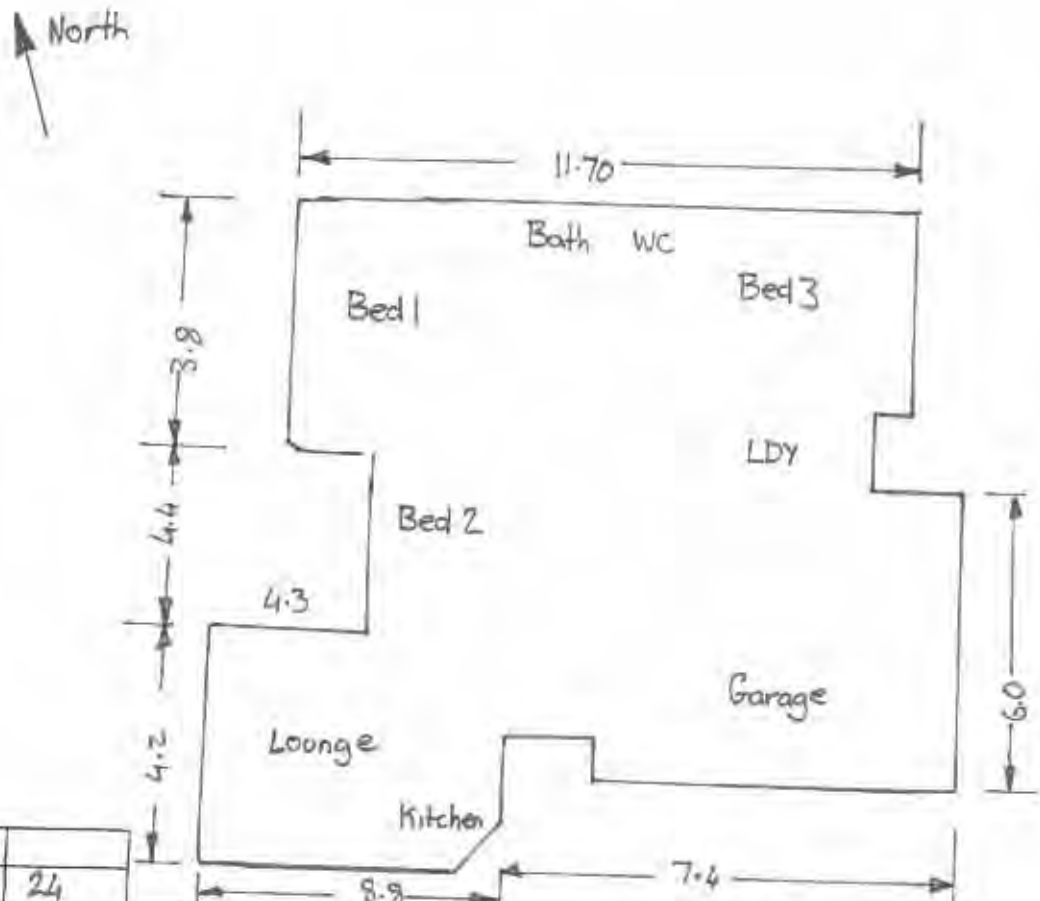
⊗	Crack to Gable End Wall
mmv	Cracking to floor Slab
~~~~~	Ceiling Cracking
DJ	Door jammed or out of Alignment

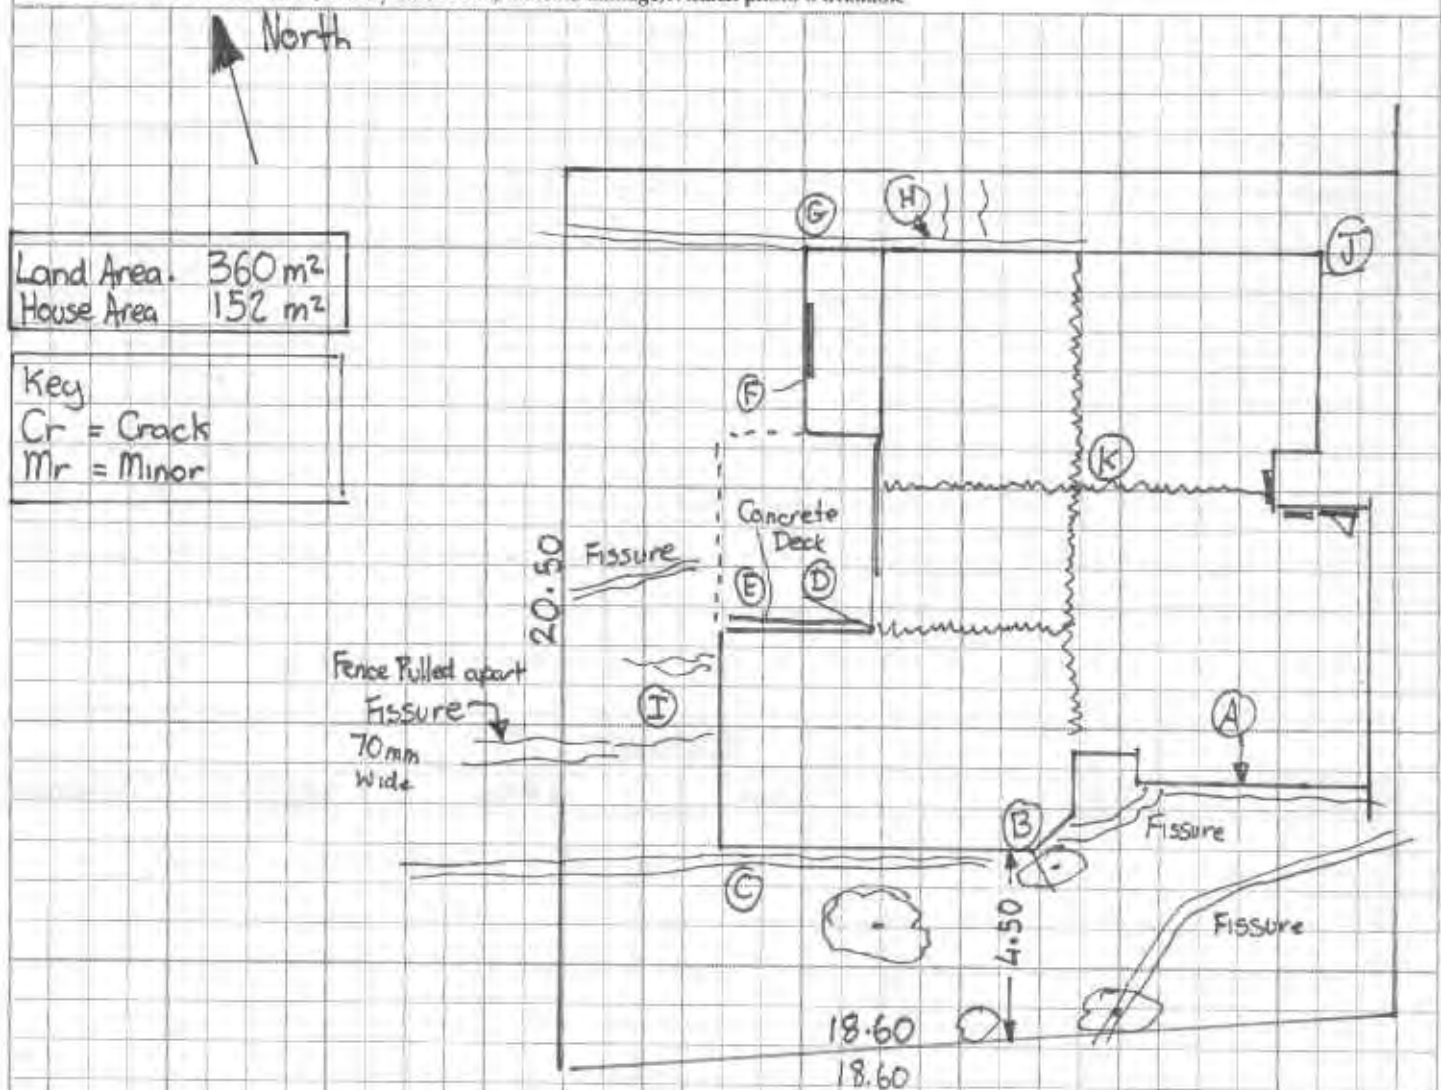
PLAN SKETCH OF PROPERTY (identify each room, indicate damage). Attach photo if available

- (A) Cracking to Garage Door head, Re Seal & Paint (B) Mortar/Cr (C) Fissure 30mm (D) Mortar, Bricks broken, lines up with Internal Slab Cracking (E) Concrete Deck pulled from house 10mm & Mr/Cr (F) Loose Brck top Corse  
 (G) Mr/Plaster Crack (H) Concrete path Pulled from house 30mm & Cracked (I) Paths Cracked (J) Cracked Mortar  
 (K) Floor Slab Cracking
