# INSIGHT BUILDING INSPECTIONS

## RESIDENTIAL INSPECTION

1/126 Halswell Jct Rd  
Christchurch, Canterbury 8025

FEBRUARY 26, 2025

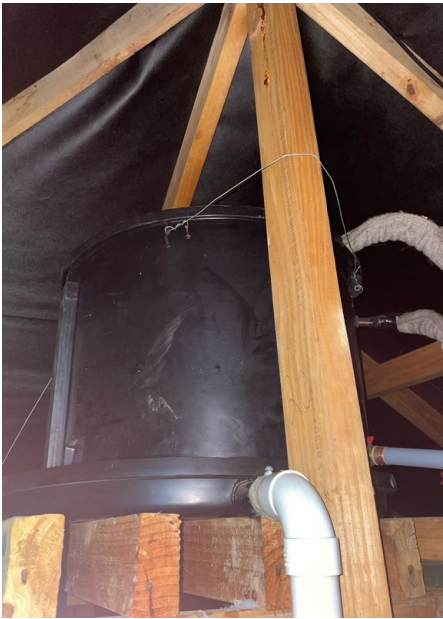
Header Tank: Material  
Plastic

### LEAKING AT HEADER TANK

**UPDATE 25/03** - Ballcock and overflow to the header tank have been professionally repaired.

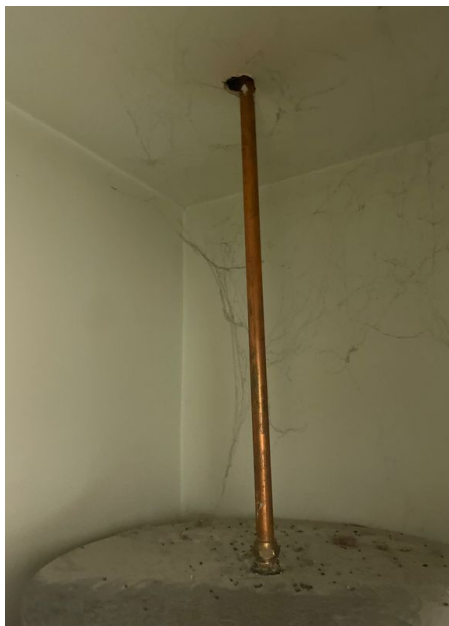
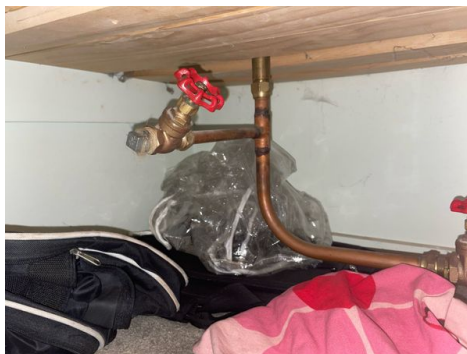
The HWC is beyond its life expectancy and should be considered for replacement

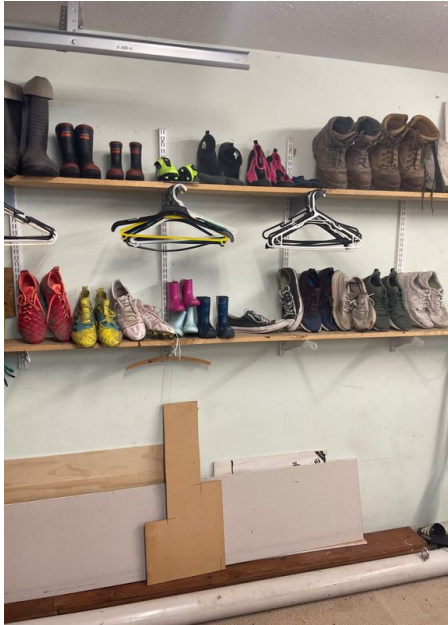
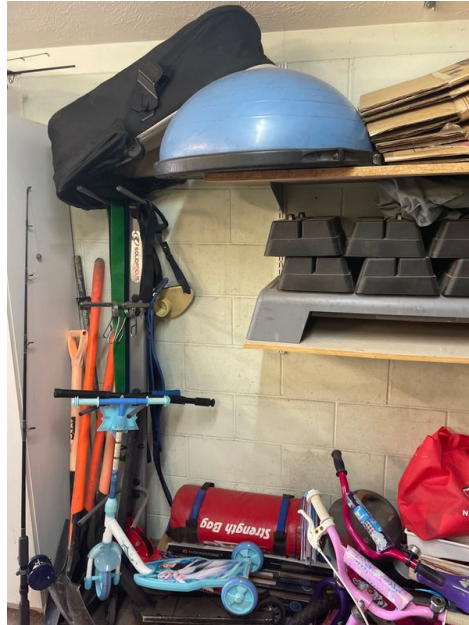
## 18.5.1 Walls

**GENERAL WEAR TO WALL LININGS**

The wall linings to the garage have general wear observed

Unfinished areas of lining are present to the garage. This can be repaired if desired

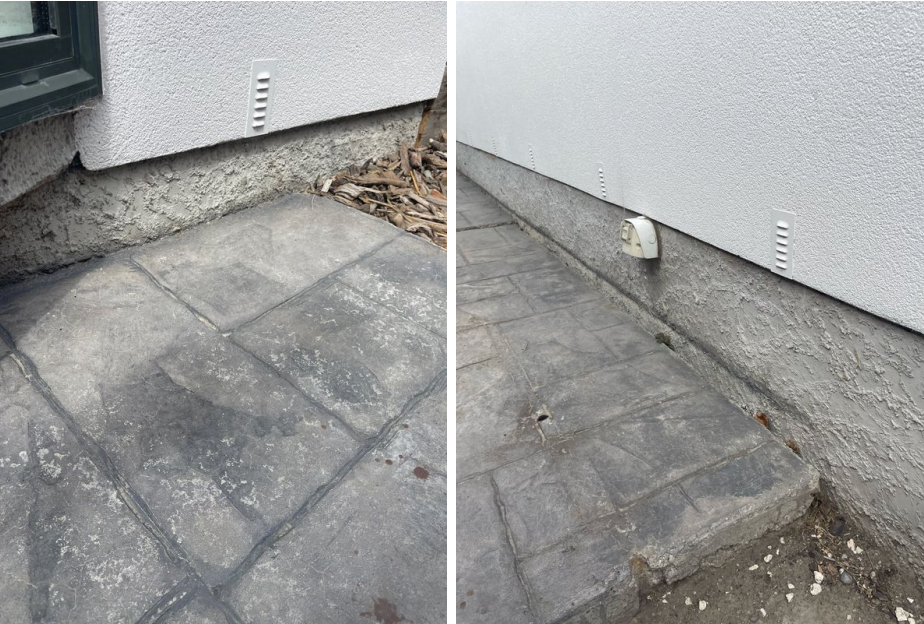
Spot floor levels

Spot floor levels were taken. An approximate variation of 26mm was recorded. This measurement is within MBIE guidelines which state a maximum allowable variation of 50mm across the floor plate.

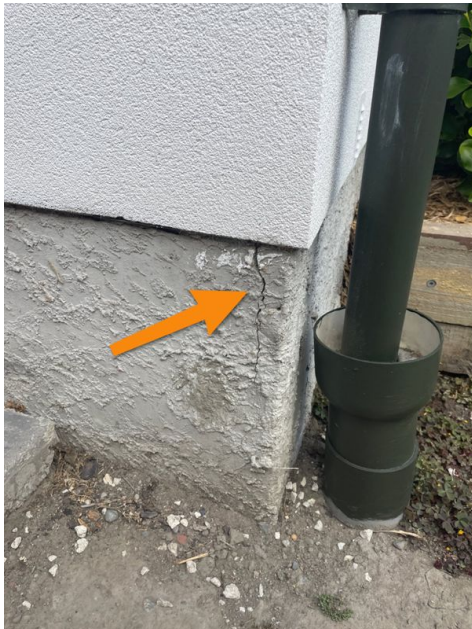
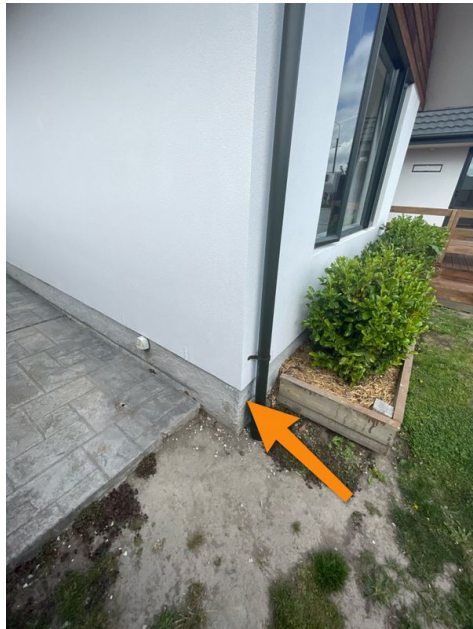
19.2.1 Foundation Type

CRACK TO CONCRETE FLOOR SLAB

There is cracking in the floor slab in the NW corner, likely caused by the Canterbury EQ sequence. Epoxy injection repair by a concrete repair specialist is recommended.

Update 04/03 - the crack has been repaired by the vendor
