Building and Timber Pest Inspection Report

Inspection Date: Wed, 19 Mar 2025

Property Address: 11 Somers St, Nudgee QLD 4014, Australia

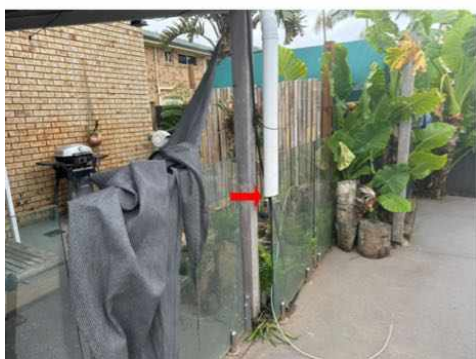
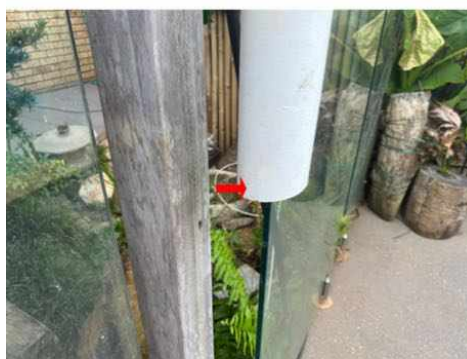
Finding 3.04

Building: Main Building
Location: All External Areas
Finding: External painting deteriorated
Information: Areas of external paintwork have been neglected and require attention to prepare and re-paint.

Whilst incomplete or missing paint finish is generally an appearance defect, it can also lead to the development of secondary building defects over time. Incomplete areas of paint finish expose the area to moisture, potentially accelerating the deterioration of underlying building materials.

Degraded paint finishes should be sanded back, filled, leveled and painted, as applicable. Where inadequate or missing paint protection has led to the deterioration of the associated building element, repair and/or replacement of this building element may be required.

A painting contractor should be appointed as soon as possible to perform necessary works to aid the appearance of the affected area and to ensure the area is protected against further deterioration. Alternatively, the homeowner following manufacturer instructions may perform these works.

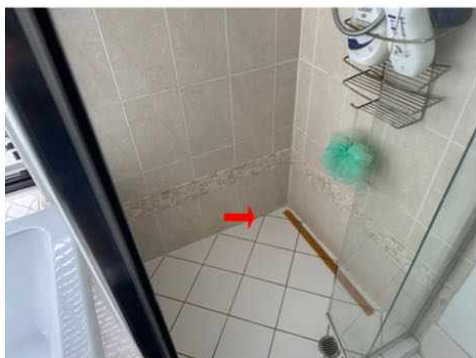
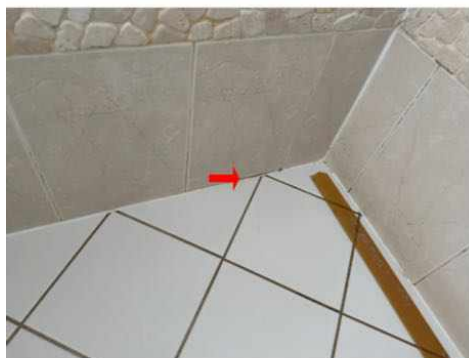
Finding 3.12

Finding: Floor tiles - Cracked

Information: Cracking in the floor tiles was evident in this area at the time of inspection. It is suspected that this cracking has occurred as a result of the floor being uneven and lacking a solid or suitable foundation for the tiles to be laid on. Settlement in the floor foundations may also have caused movement and resulted in the cracking of tiles in this area.

Cracked tiles throughout the household detract from the overall appearance of the affected areas, as well as creating potential for water penetration to adjoining building elements. If left unmanaged, water damage may occur as a result of constant water penetration over a prolonged period of time.

While not considered a matter of urgency, replacement of cracked floor tiles is advised as a solution. A tiling contractor or general handyperson may be appointed to perform these works at client discretion. Where cracks become more numerous, consultation with a registered builder specialising in re-stumping may be required.

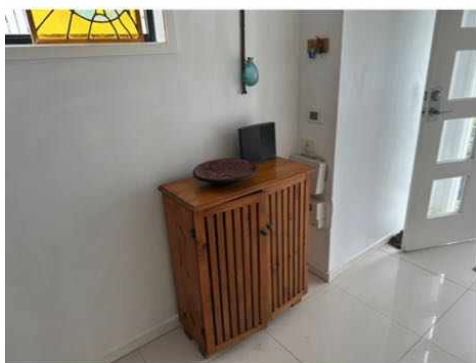
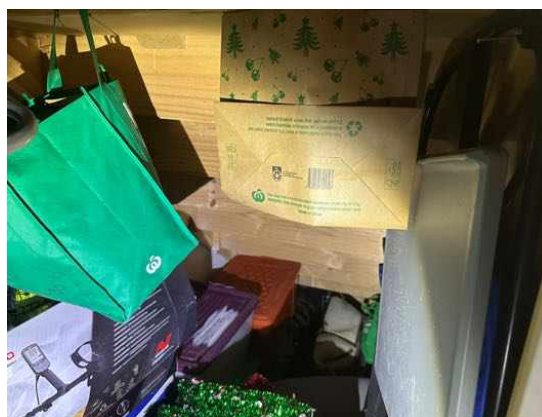
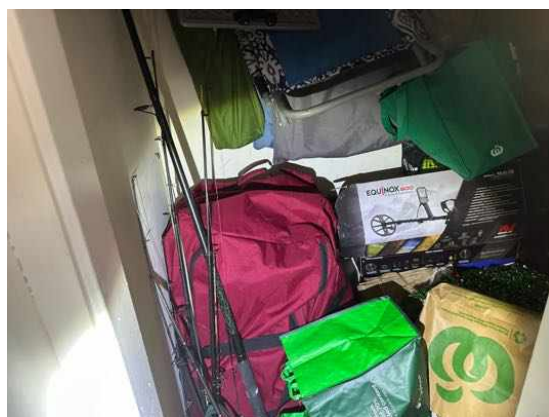
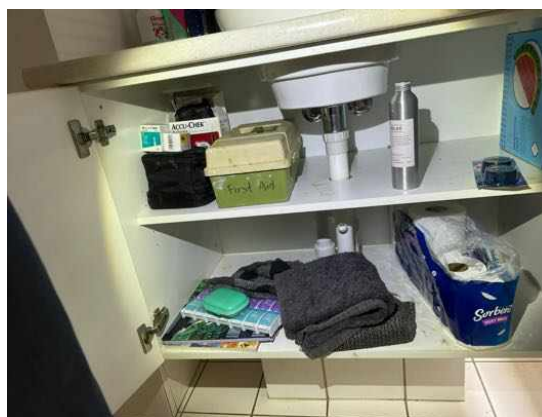
Noted Item

Building: Main Building
 Location: All Internal Areas
 Finding: Additional Photos - Obstructions and Limitations
 Information: These photographs are an indication of the obstructions and limitations which impeded full inspection of the property at the time of inspection. These obstructions can hide an array of defects and should be removed to allow full inspection to be carried out. A re-inspection is recommended once the areas are made accessible.

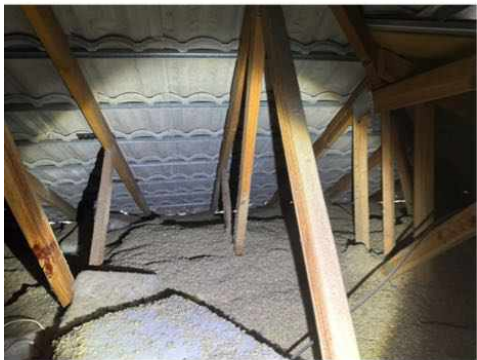
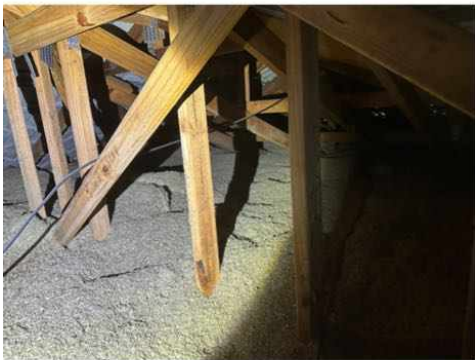
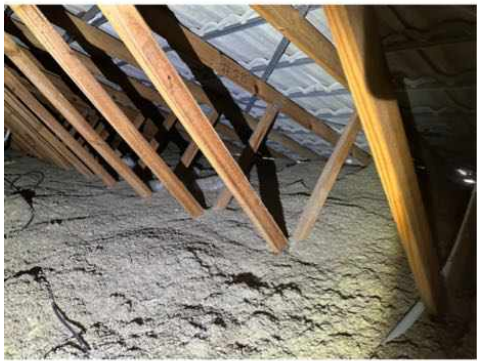
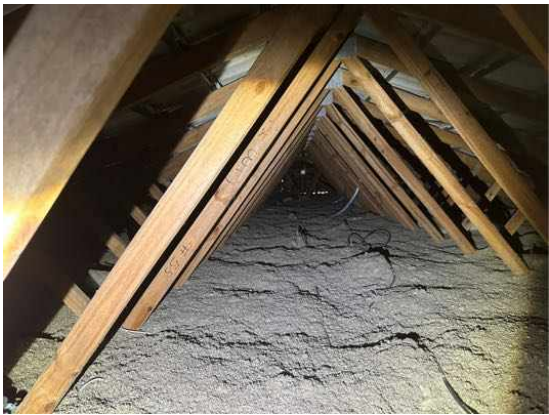
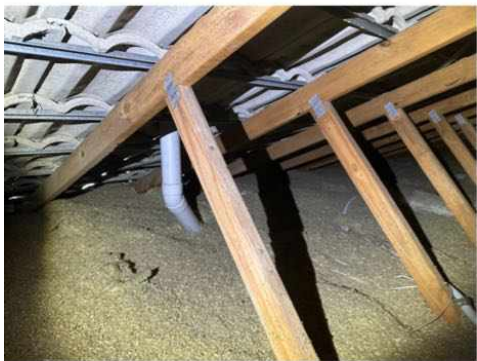
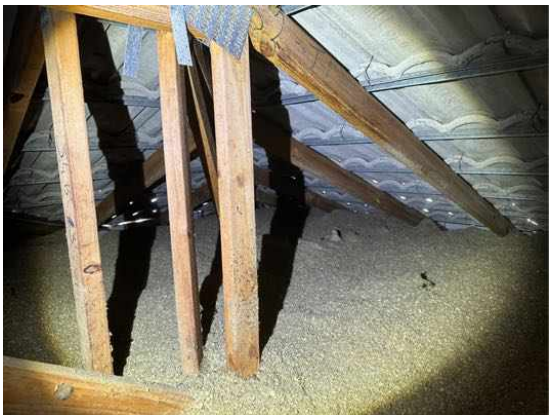
Building: Main Building
Location: Roof Void
Finding: Additional Photos
Information: Additional photos are provided for your general reference.

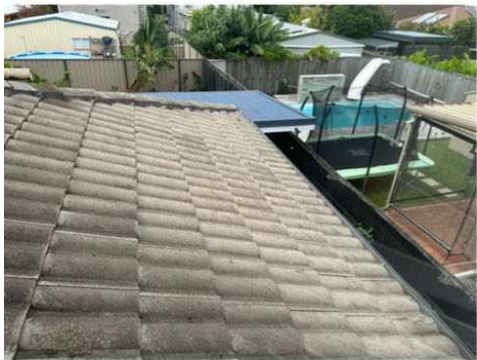
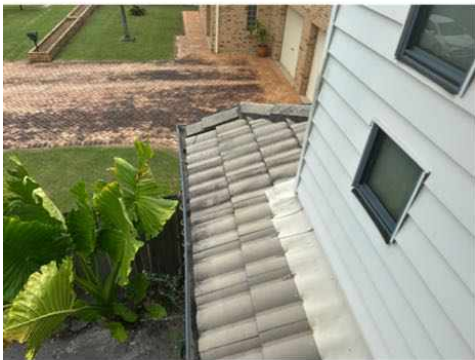
Building: Main Building
Location: Lower Roof Exterior
Finding: Additional Photos
Information: Additional photos are provided for your general reference

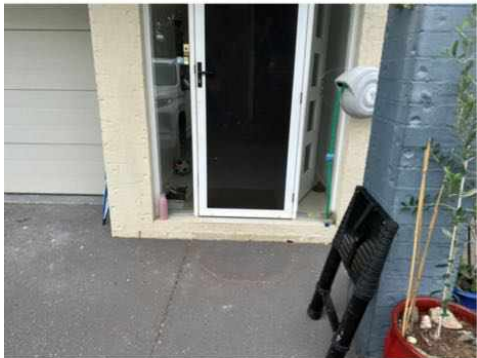
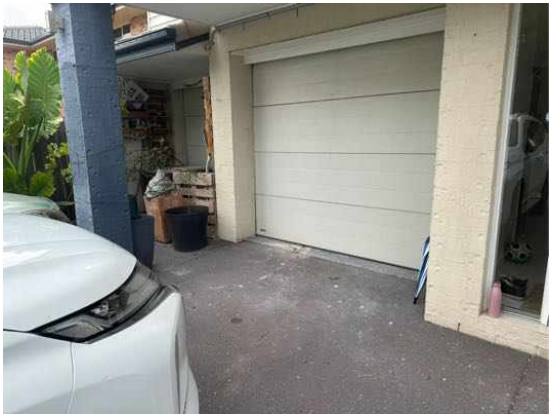
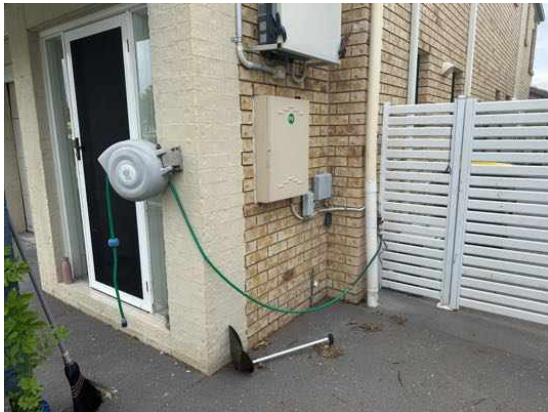
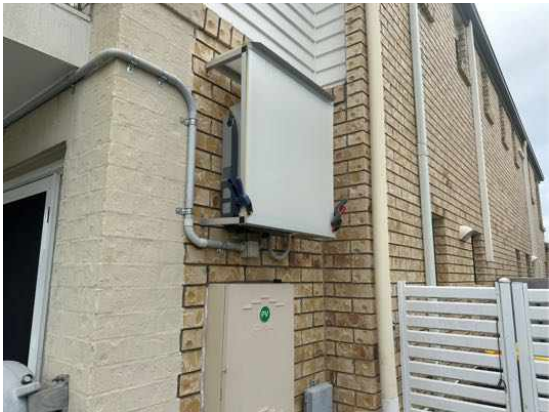
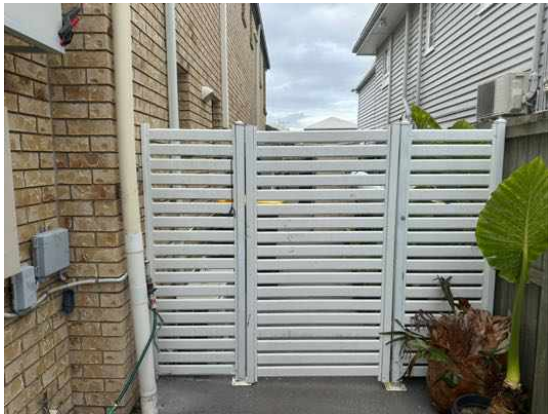
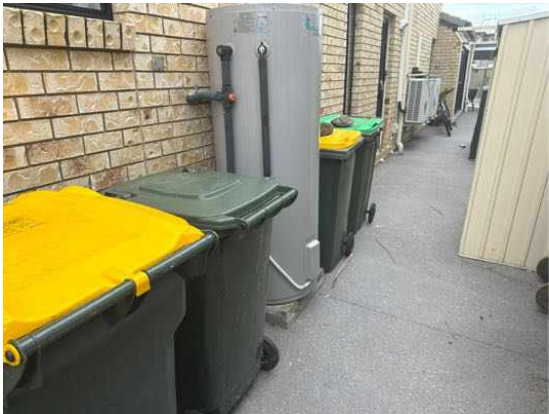
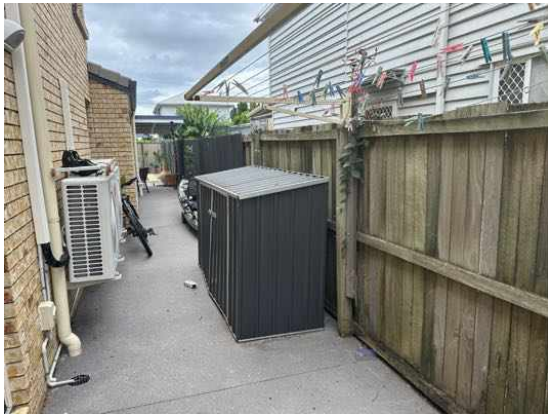
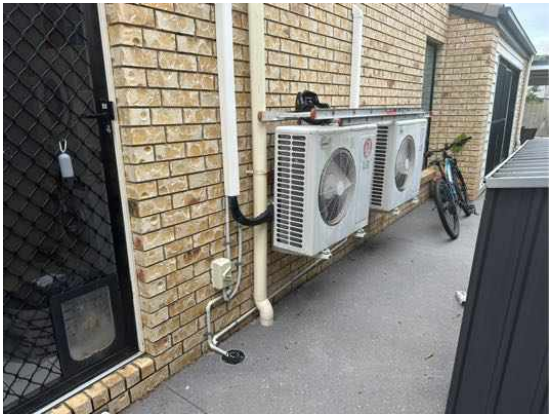
Building: Main Building
Location: All External Areas
Finding: Additional Photos

Information: Additional photos are provided for your general reference

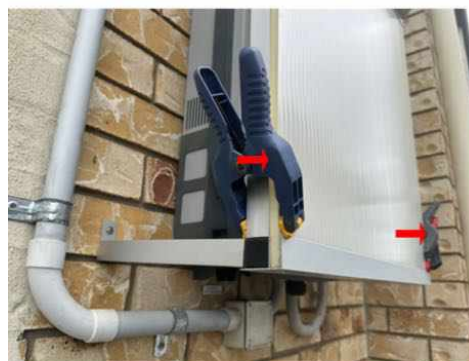
Building: Main Building
 Location: Exterior walls - right side
 Finding: Inverter cover
 Information: The inverter cover is temporarily secured by hand clamps.

It is recommended that a general handyman is engaged to secure the cover to the frame.

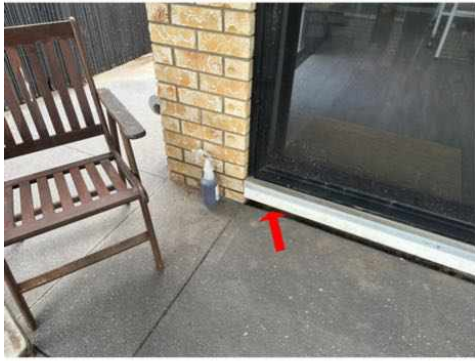
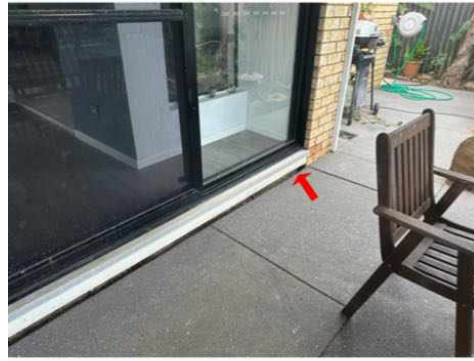
Building: Main Building
 Location: Deck
 Finding: Additional Photos - Obstructions and Limitations
 Information: These photographs are an indication of the obstructions and limitations which impeded full inspection of under the deck at the time of inspection. These obstructions can hide an array of defects and should be removed to allow full inspection to be carried out. A re-inspection is recommended once the areas are made accessible.

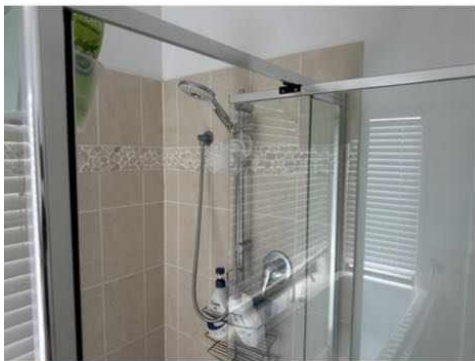
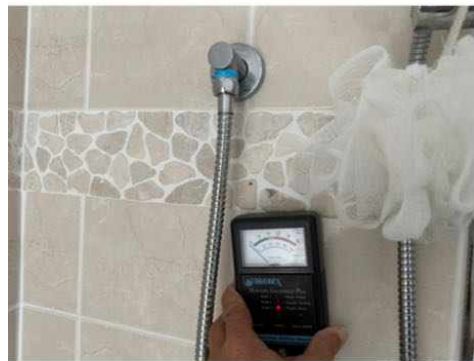
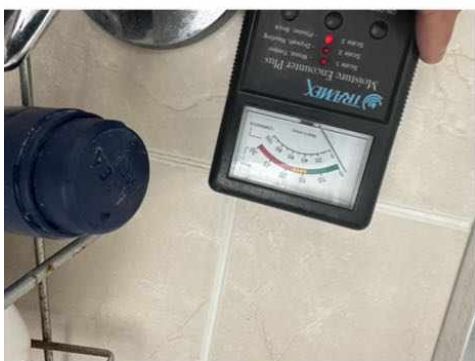
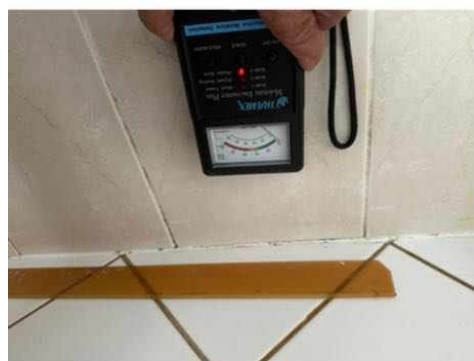
Building: Main Building
 Location: Bathroom
 Finding: Additional Photos
 Information: Additional photos are provided for your general reference. No moisture detected.

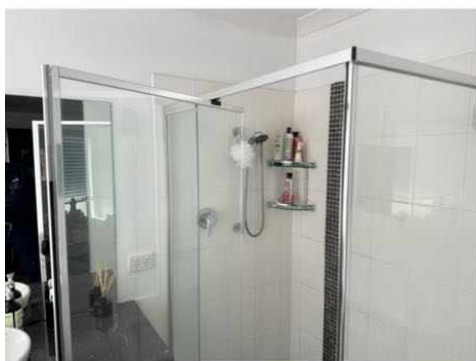
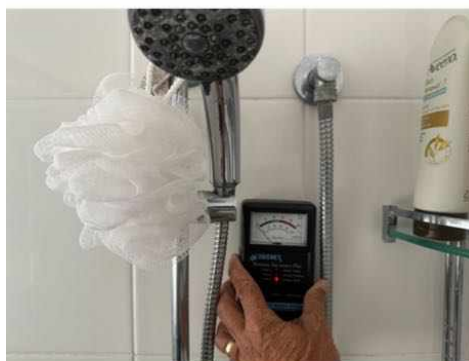
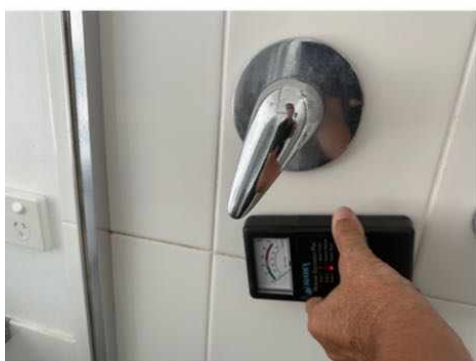
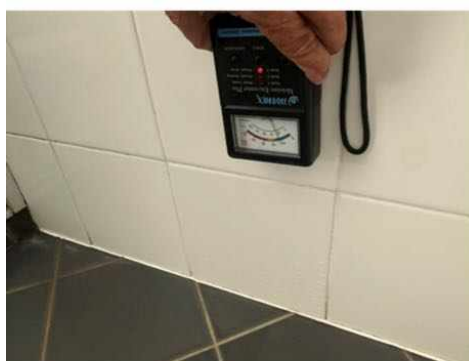
Building: Main Building
 Location: Ensuite
 Finding: Additional Photos

Information: Additional photos are provided for your general reference. No moisture detected.

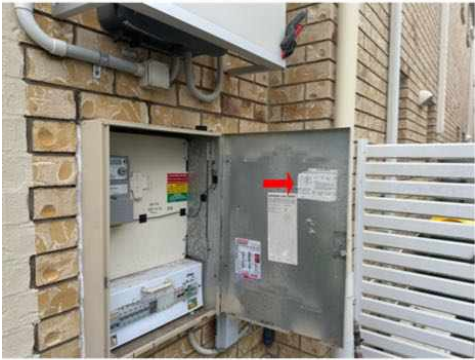
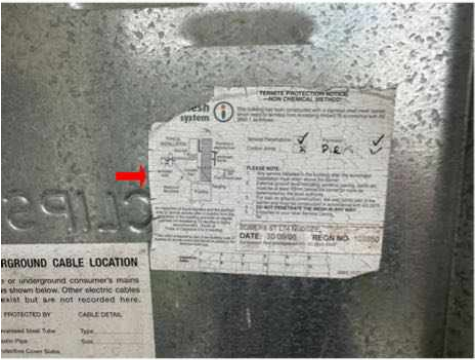
Where a Termite Management System has been identified you should refer to the type of barrier date of installation warranty conditions and any documentation provided by a builder or past owner. Consult the company who installed the barrier to confirm whether the system is still under warranty.

Most chemical termite management systems expire and require replenishment and all physical systems are primarily designed to prevent concealed entry.
