Building and Timber Pest Inspection Report

Inspection Date: Mon, 30 Jun 2025

Property Address: 125 Kirby Rd, Aspley QLD 4034, Australia

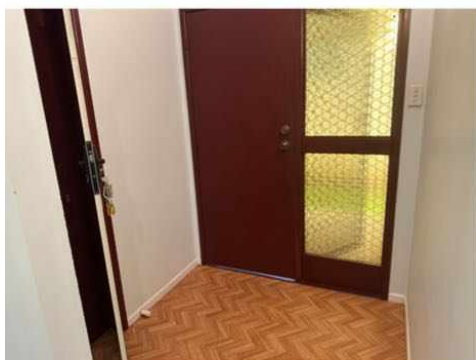
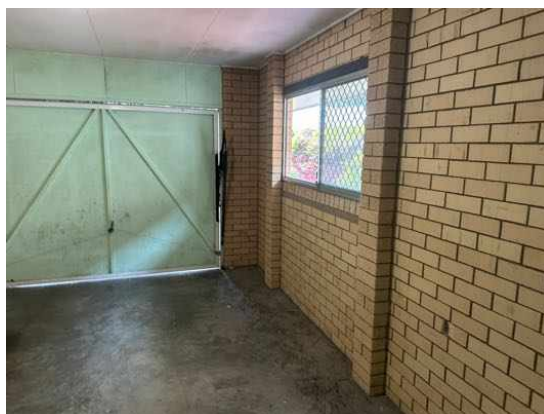
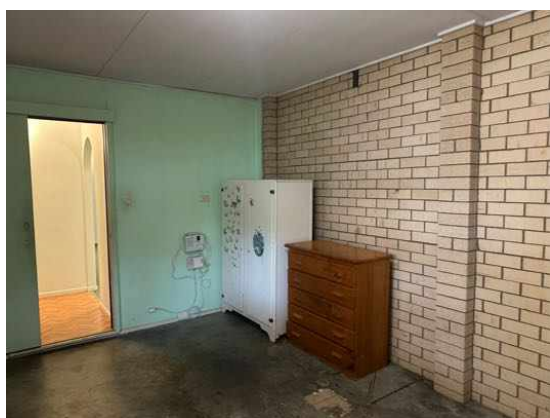
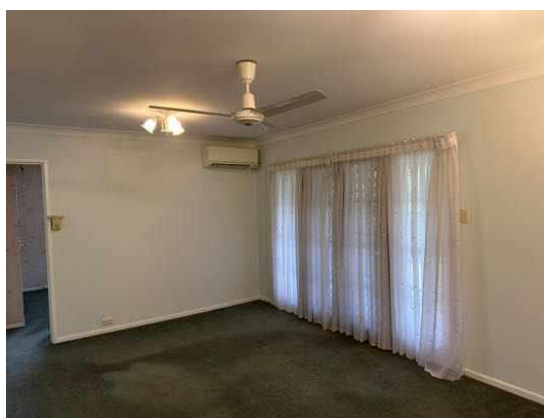
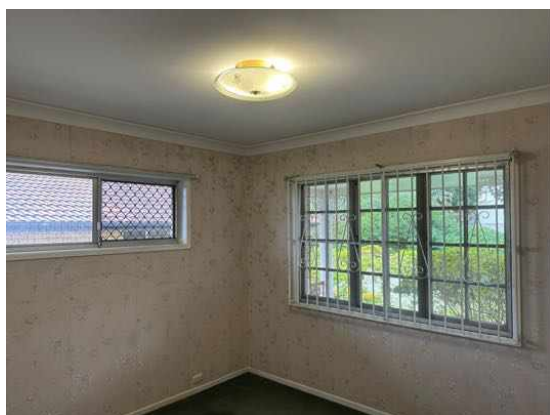
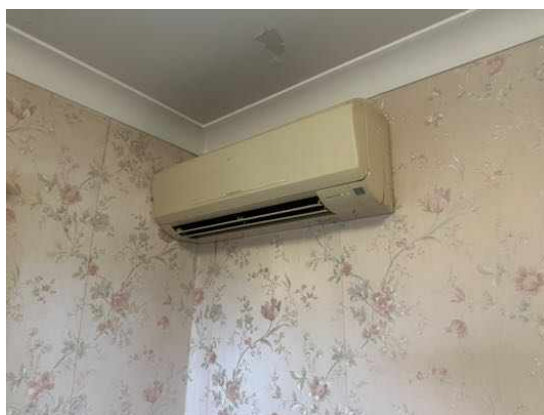
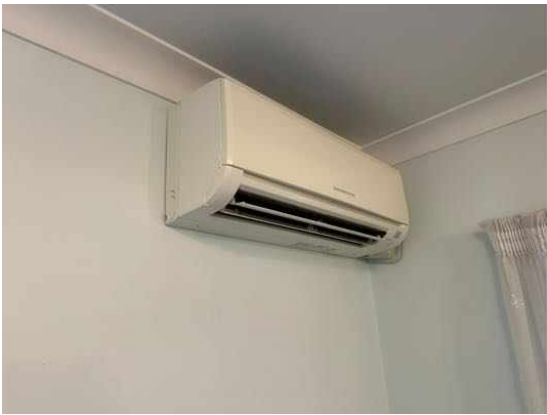
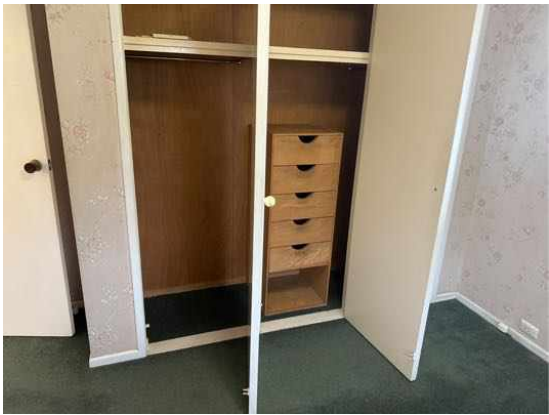
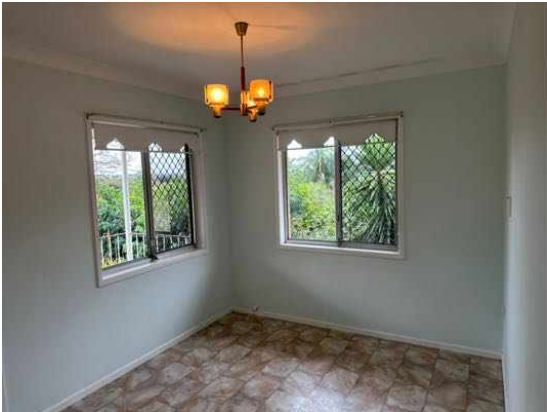
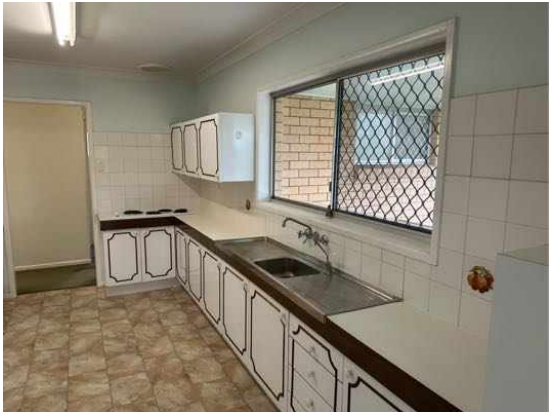
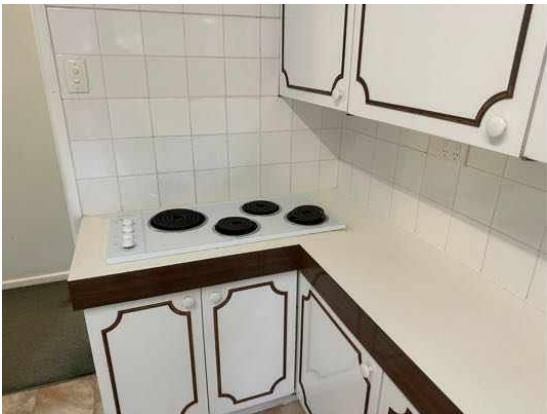
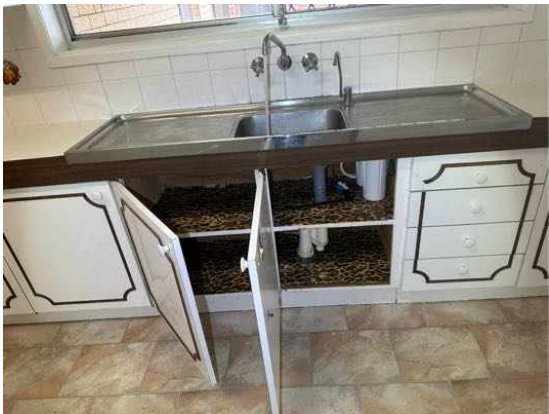
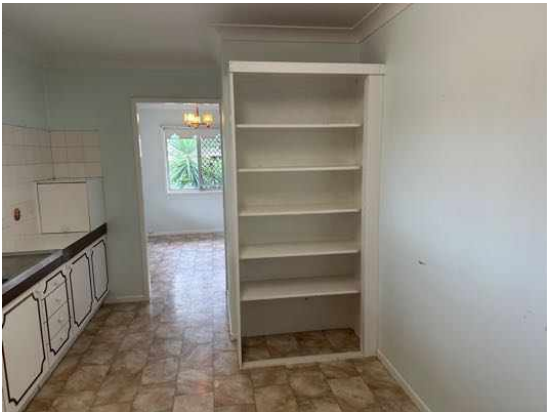
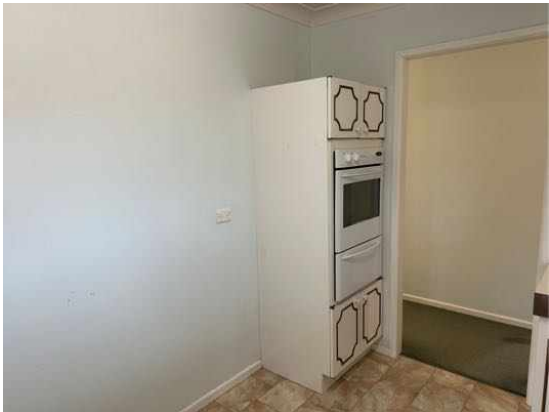
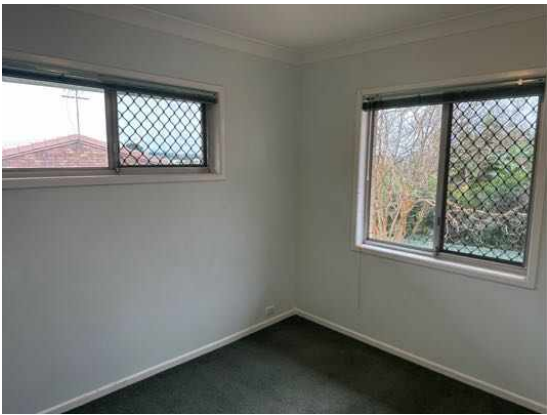
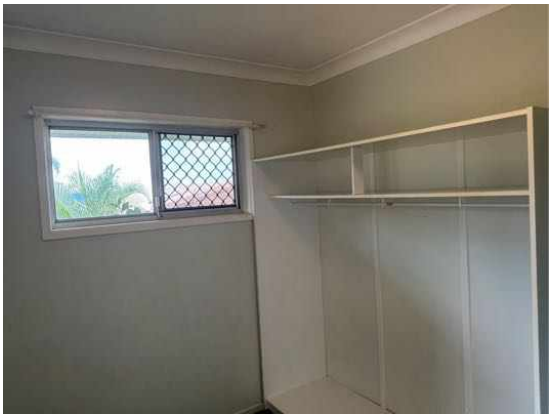
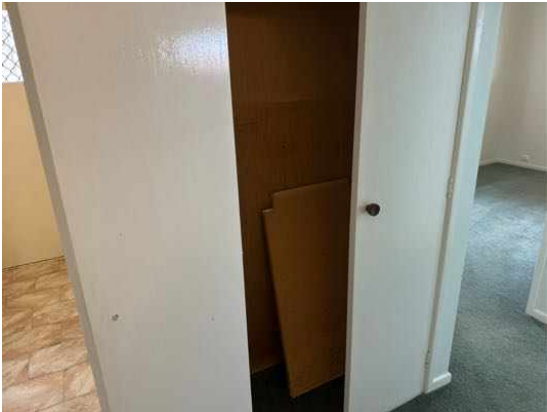
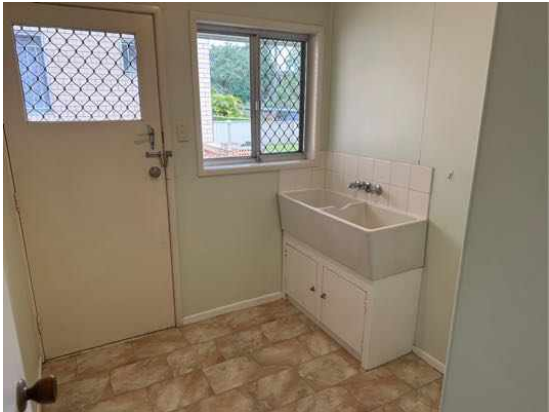
Noted Item

Building: Main Building
Location: All Internal Areas
Finding: Additional Photos
Information: Additional photos are provided for your general reference.

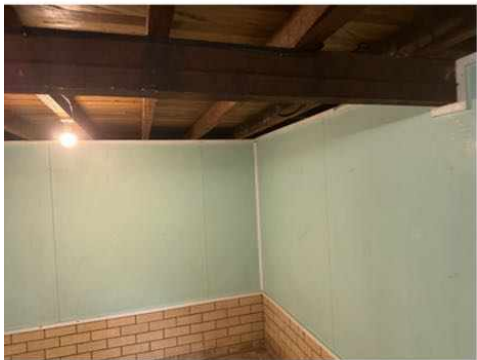
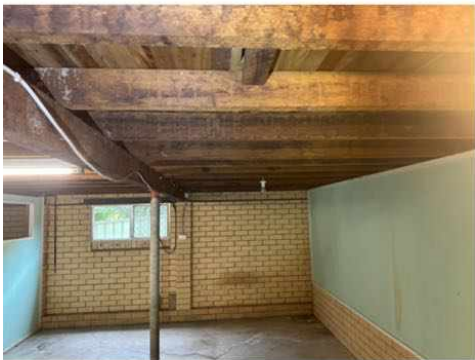
Noted Item

Building: Main Building
Location: Subfloor
Finding: Additional Photos
Information: Additional photos are provided for your general reference.

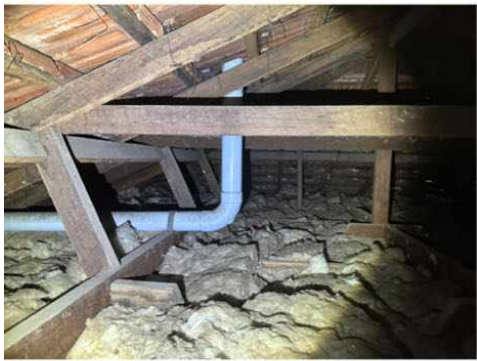
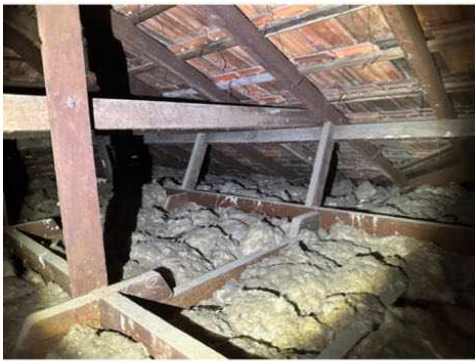
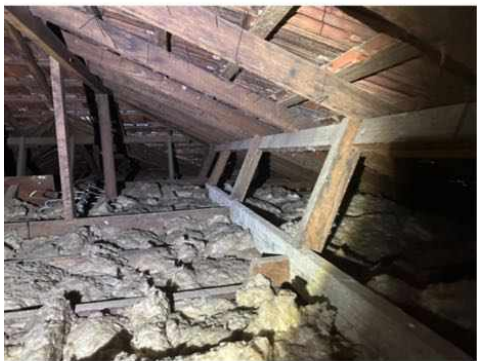
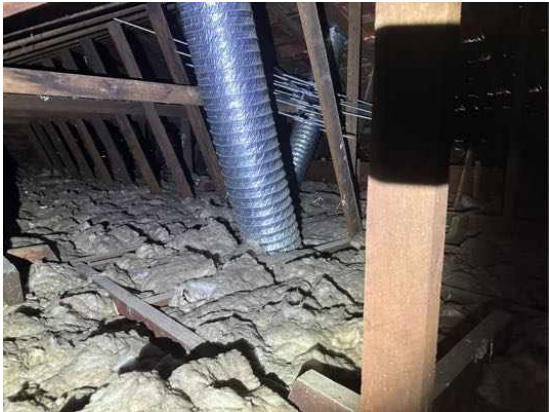
Building:	Main Building
Location:	Roof Void
Finding:	Additional Photos
Information:	Additional photos are provided for your general reference.

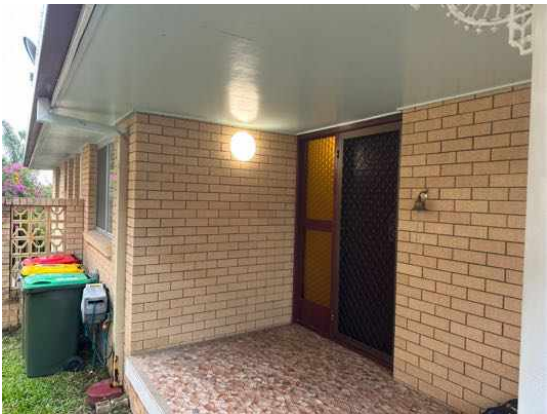
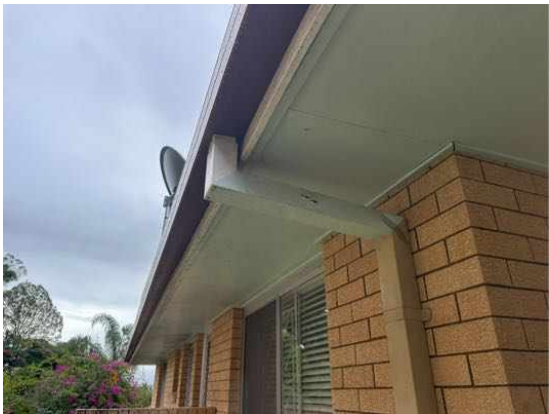
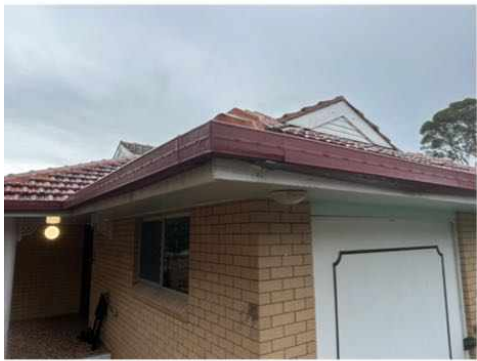
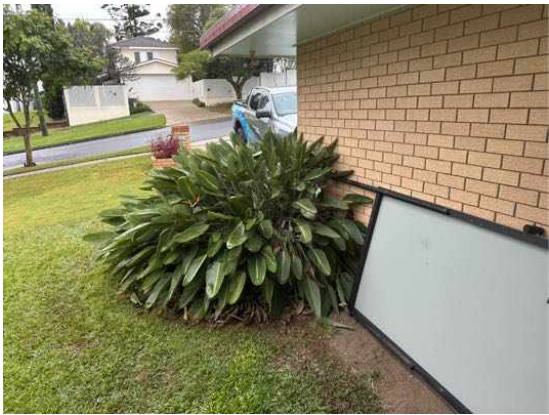
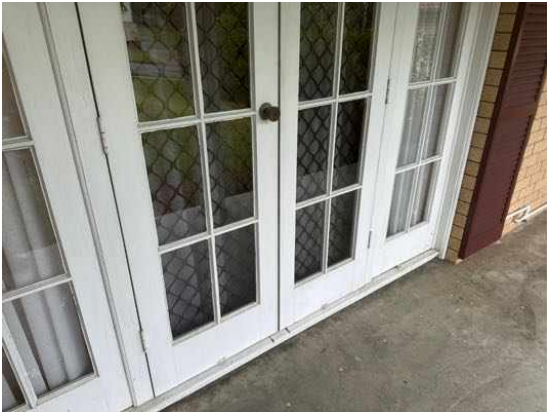
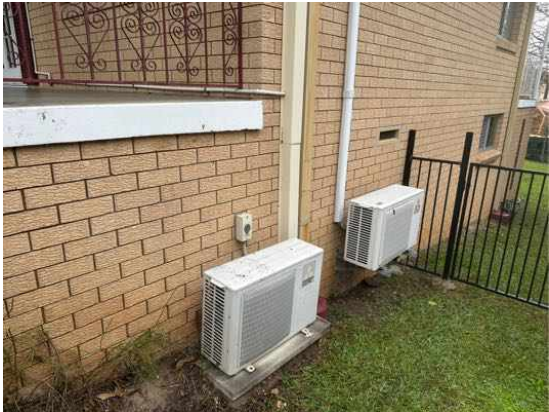
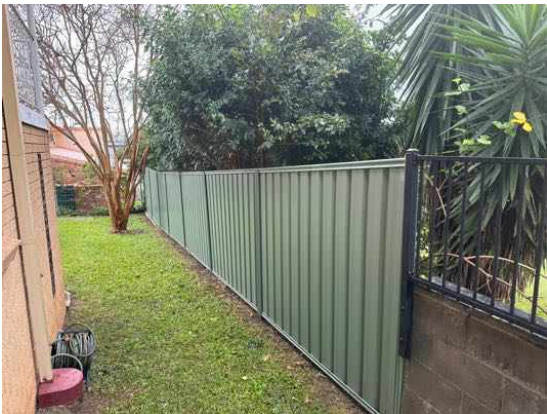
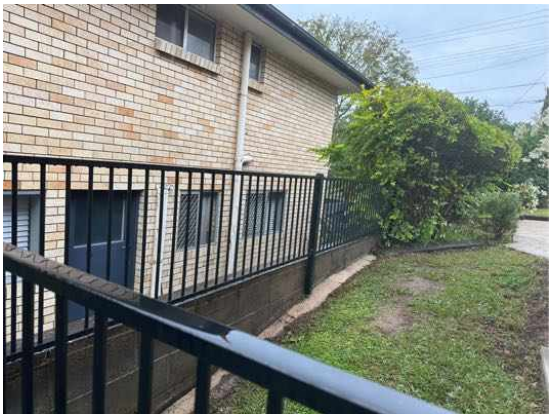
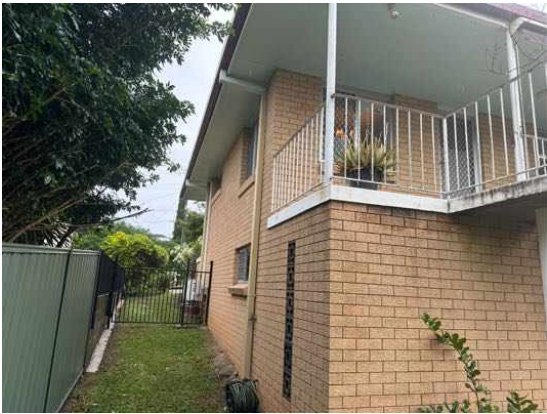
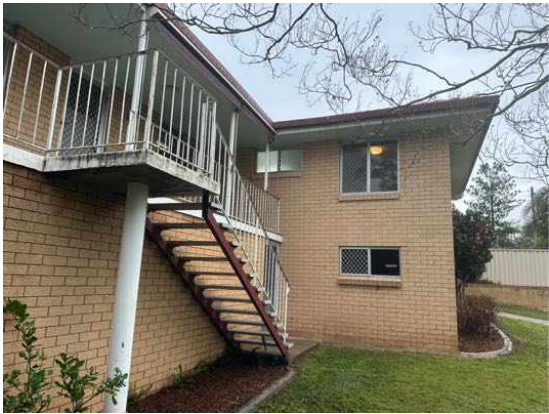
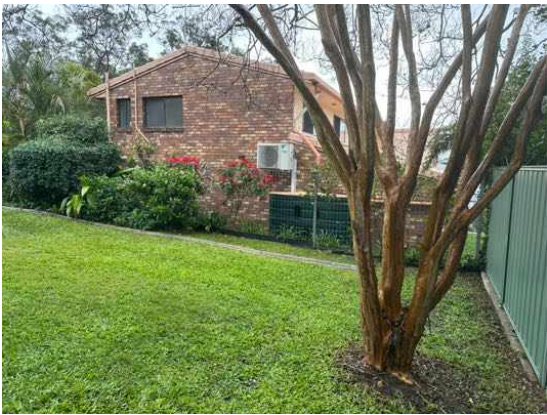
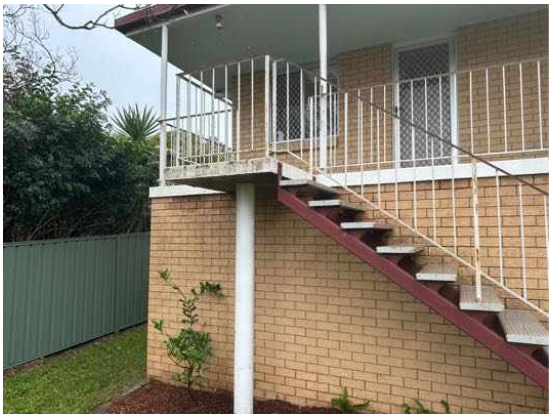
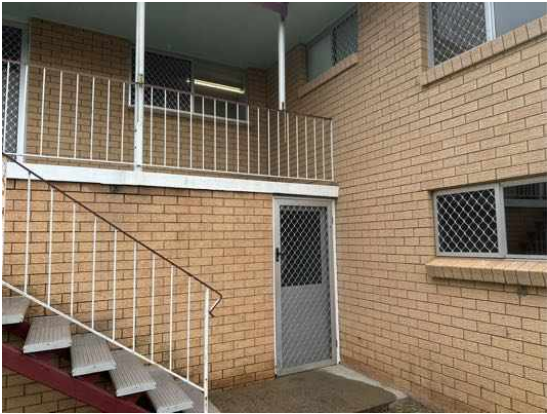
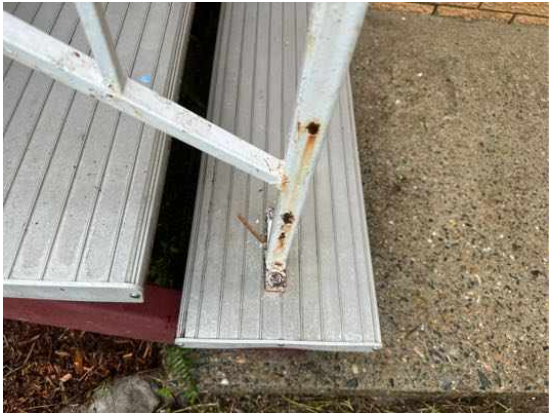
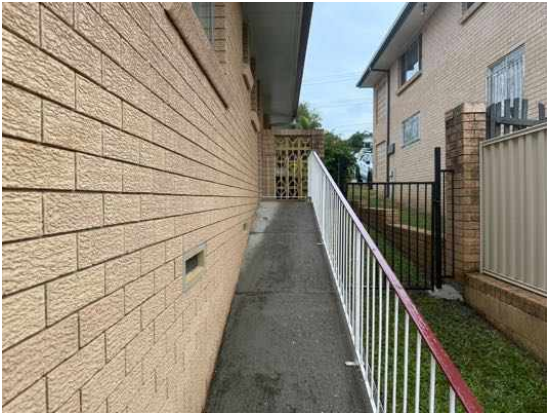
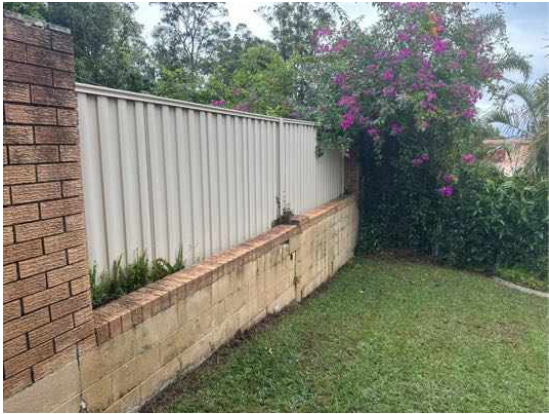
Building: Main Building
Location: Roof Exterior
Finding: Additional Photos
Information: Additional photos are provided for your general reference.

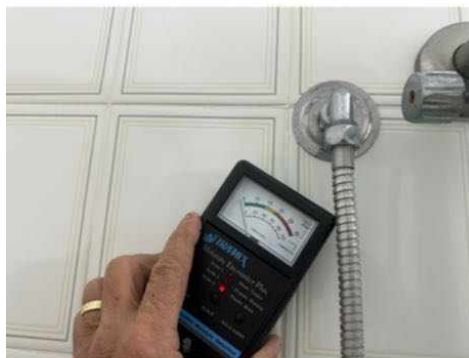
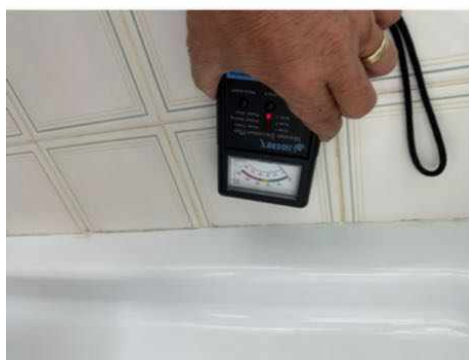
Building: Main Building
Location: Bathroom
Finding: Additional Photos
Information: Additional photos are provided for your general reference. No moisture detected.
